CONSERVATION TALK

Are “Simple Epoxy Repairs” Really That Simple?

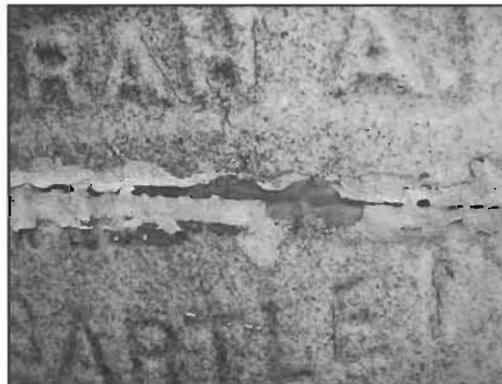
Here the handyman attempted to hide the epoxy repair by using paint to cover the excess epoxy. Of course the effort failed and the stone is even more significantly disfigured.

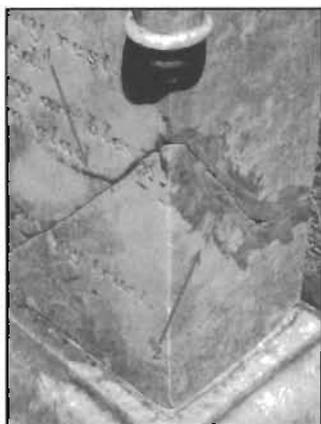
This photo shows a broken obelisk with a “simple,” but very sloppy and unprofessional epoxy repair.

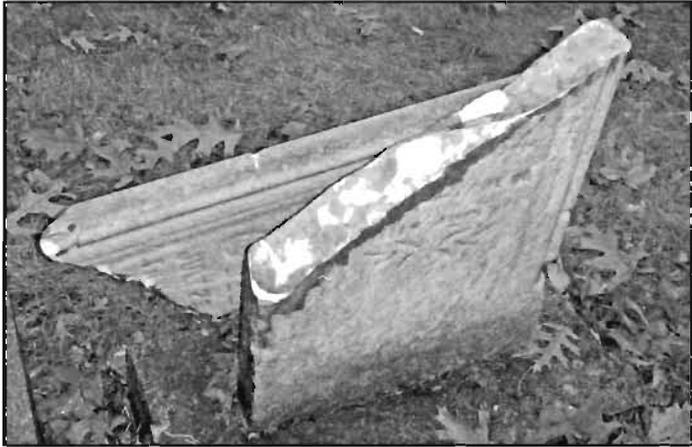
This is a type failed “simple epoxy repair.” Notice that the break follows the original repair, except for about 2-inches of new break. Notice also the epoxy smeared on the face of the stone.

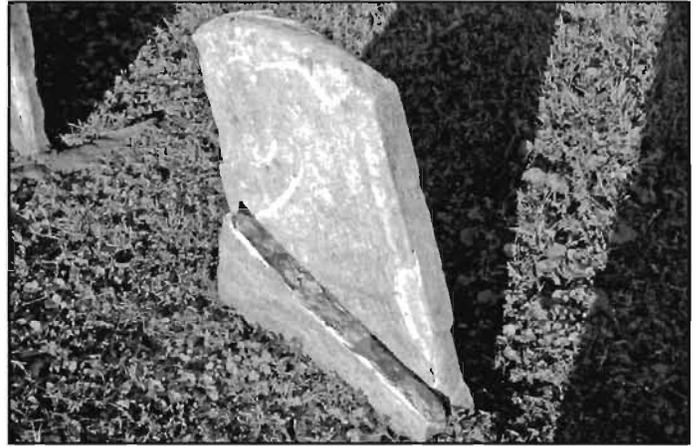
This stone with a simple epoxy repair failed within months of the repair.

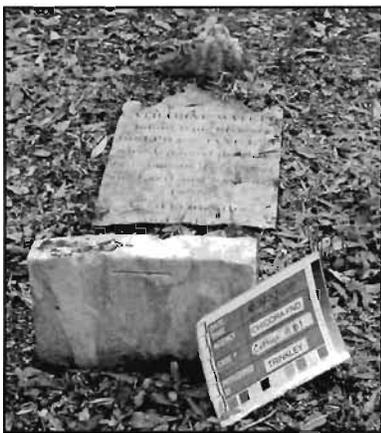
Another failed “simple epoxy repair.”

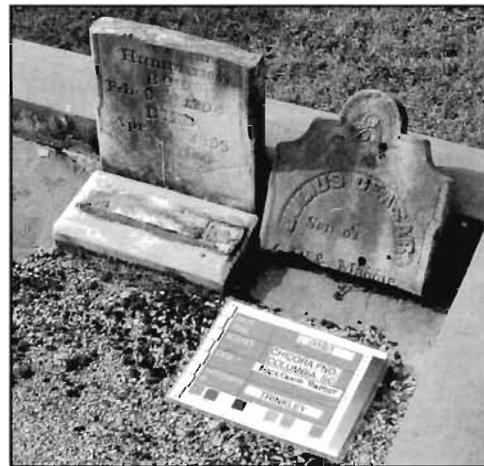
No matter how much epoxy is used, repairs like this are doomed to failure—and can often result in additional damage to the stone as the epoxy joint fails.
