**MONITORING CONSTRUCTION ACTIVITIES AT THE  
MIDDLETON PLACE MILL, 38DR16: PHASE TWO**

Michael Trinkley

Chicora Research Series 128

December 20, 1993

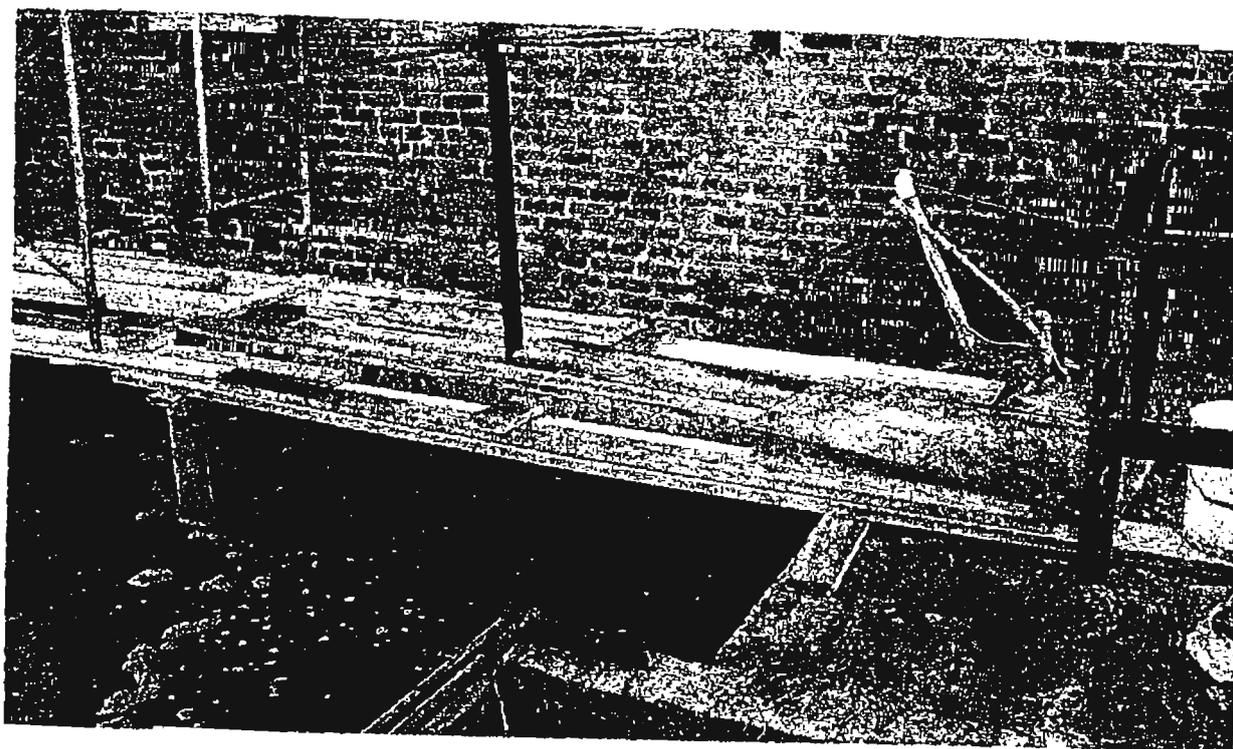
During our subsequent monitoring visit on December 17, we discovered that the contractor had disregarded this change notice -- not only placing scaffolding over and around the previously identified features, but had also mucked adjacent to the building and placed the originally proposed stucco coat (Figures 7 and 8). This work almost certainly resulted in the loss of significant archaeological information, through the construction of the scaffolding, the mucking of soil adjacent to the building foundation, the application of the stucco coat, and the possible exposure of the wood remains to damaging environmental fluctuations. At the time of our second phase of monitoring the tide was again high, so we can not determine the amount of this damage. Nor could we determine if the area was stabilized to prevent additional damage through erosion, periodic wetting and drying, and growth of vegetation.

Figure 7. Scaffolding placed over and around area removed from the scope of work.

At this point it seems likely that the most serious damage has been done. We do, however, recommend that the mill be examined at the lowest possible tide to determine if any measures can be taken to minimize the damage and secure the archaeological features.
