# PENETROMETER STUDY OF THE MACEDONIA BAPTIST CHURCH, CHEROKEE COUNTY, SOUTH CAROLINA

Prepared By:  
Michael Trinkley, Ph.D., RPA

Prepared For:  
Macedonia Baptist Church  
c/o Mr. James Goforth  
849 S. Green River Rd.  
Gaffney, SC 29341

February 5, 2007

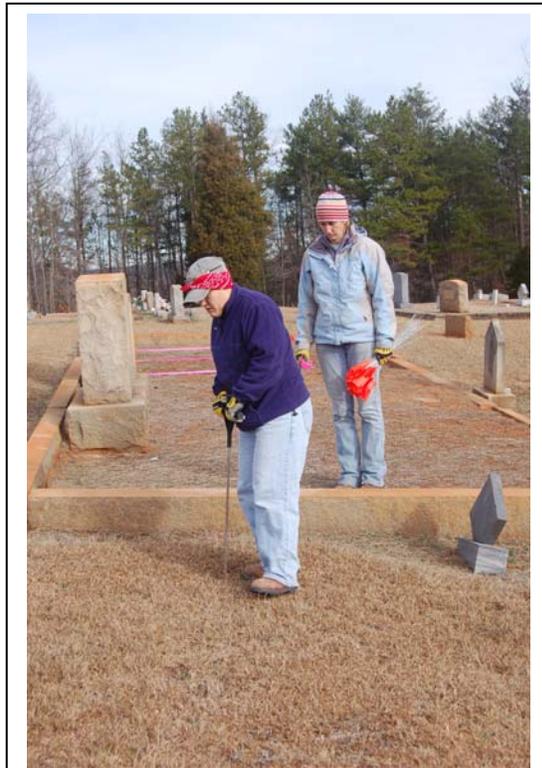
Figure 4. Conducting the penetrometer survey. In the background are three unmarked graves identified by the study that have been flagged.

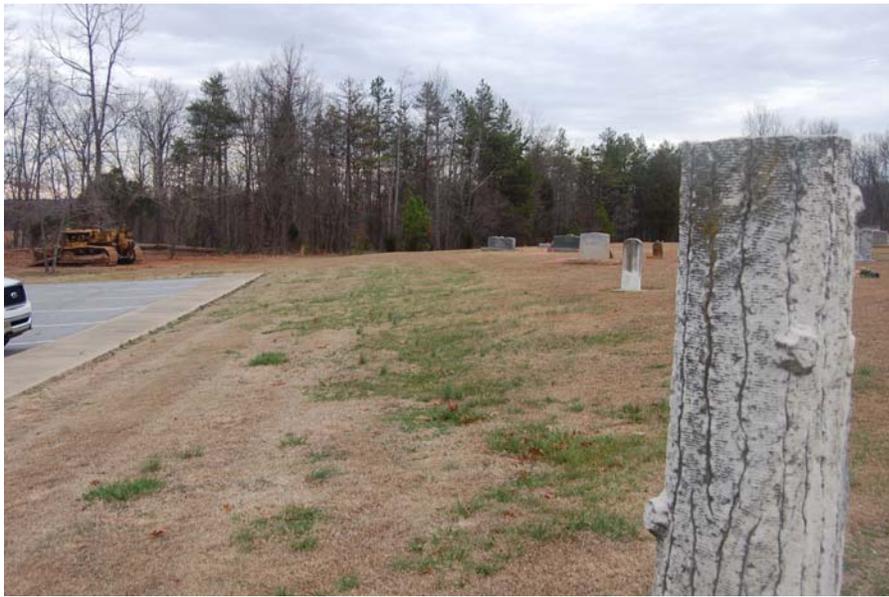
Figure 5. Area on the northwest edge of the cemetery showing grading and an absence of graves.

levels (200 psi and higher) in this area are consistent with clay subsoils, perhaps with additional compaction through the use of heavy equipment. Not only were we not able to identify any areas of lower compaction that might represent graves, but the removal of 1-2 feet of soil would almost certainly have revealed coffin outlines. Thus it is highly unlikely that graves are found in these areas.

We found that no graves were identified along the outer northwest or southeast edges of the cemetery. To the northwest, along the edge of the parking lot, the topography has a swale and slope that is characteristic of grading. The compaction

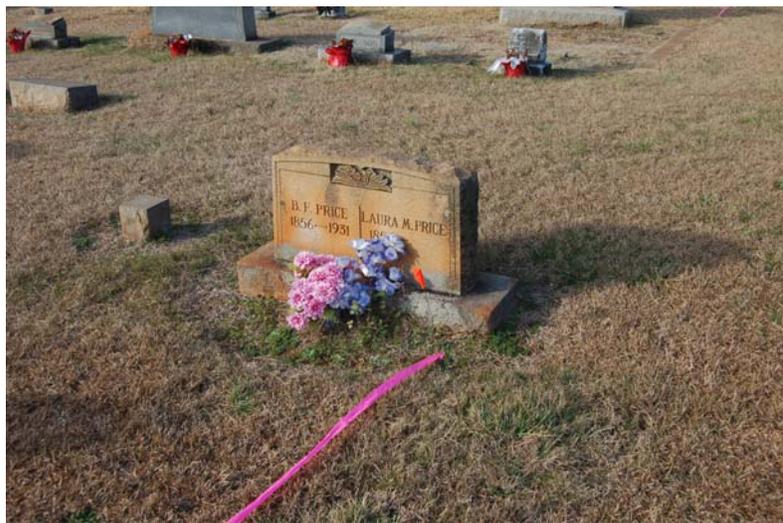
Figure 6. Although the stone has no death date engraved, the penetrometer study confirmed a burial.

We observed stones without death dates, but where the plot was shown to be occupied by the penetrometer. While relatives no doubt are aware that the plot has been filled, there is no obvious, public record without the stone being updated.

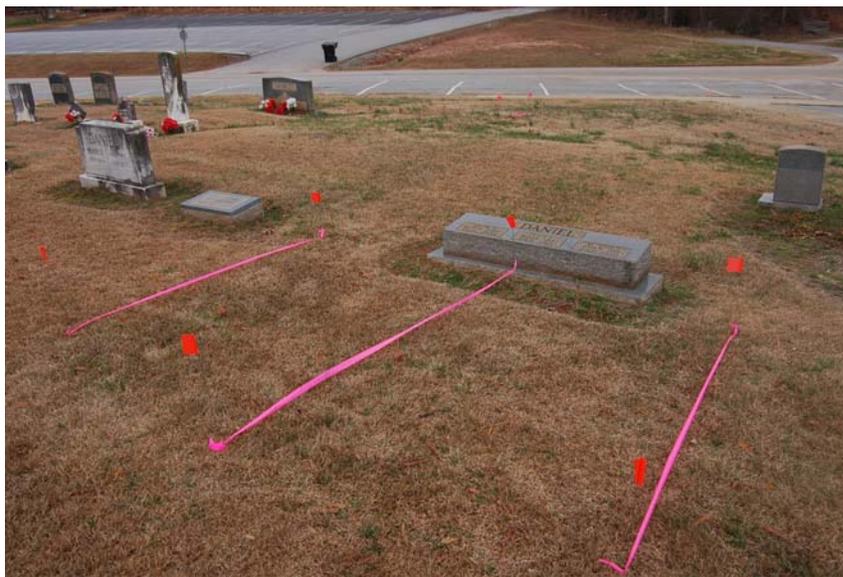
Figure 7. View of cemetery showing graves (marked with flags and flagging tape) identified by the penetrometer study.

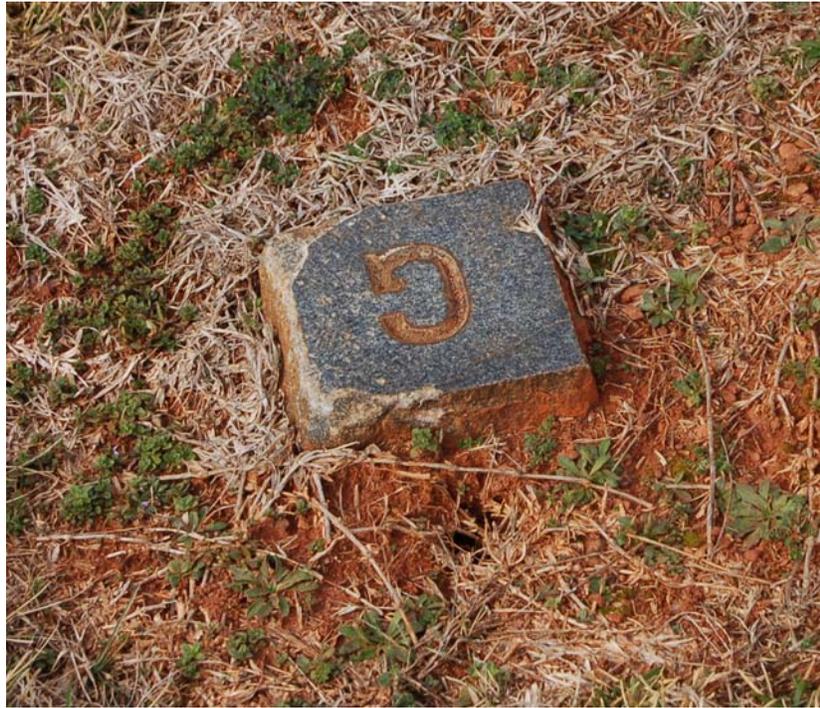
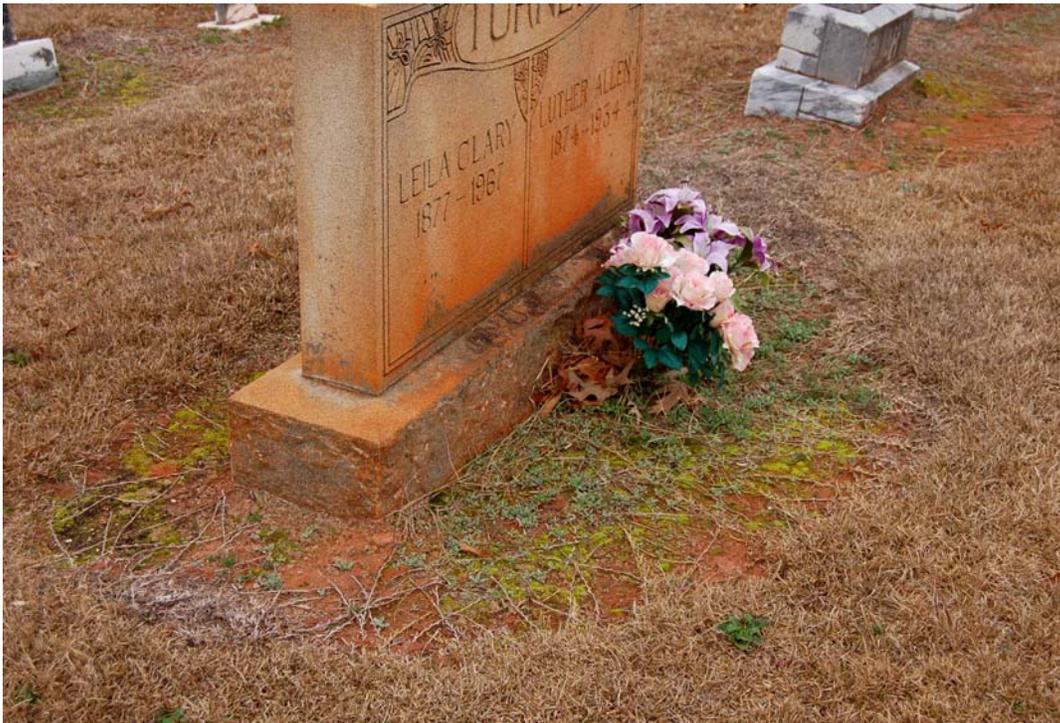
There is also abundant evidence that the lawn service has used a broad spectrum herbicide to kill the grass around stones and plots. This is a very bad practice and should cease immediately. It is disfiguring to the landscape, causing erosion around the stone, with much splash-back and staining of the stones. With the grass killed, it promotes a heavy weed infestation that will spread into the turfgrass. In addition herbicides contain salts that will, over time, cause serious damage to the stones. In the place of this poor management practice the lawn service should use

We observed a number of stones that evidenced damage as a result of mowing. The Church should ensure that a more sensitive and careful approach is taken.

Figure 8. Lawn maintenance problems. The top photo shows mower damage to a flush monument. The lower photo shows the results of herbicide use: increased weeds, disfigured landscape, and much splash back of clay from erosion.

There is extensive damage to markers from scalping during mowing, as well as impact by mowers. All mowers in the cemetery should have closed cell foam bumpers installed. Workers should be cautioned to slow down and take greater care. And the Church should have a representative approve all actions in the cemetery.

2. The use of herbicide to create “kill zones” around monuments must cease immediately. This is professionally unacceptable and is causing extensive damage to the landscape and the cemetery.

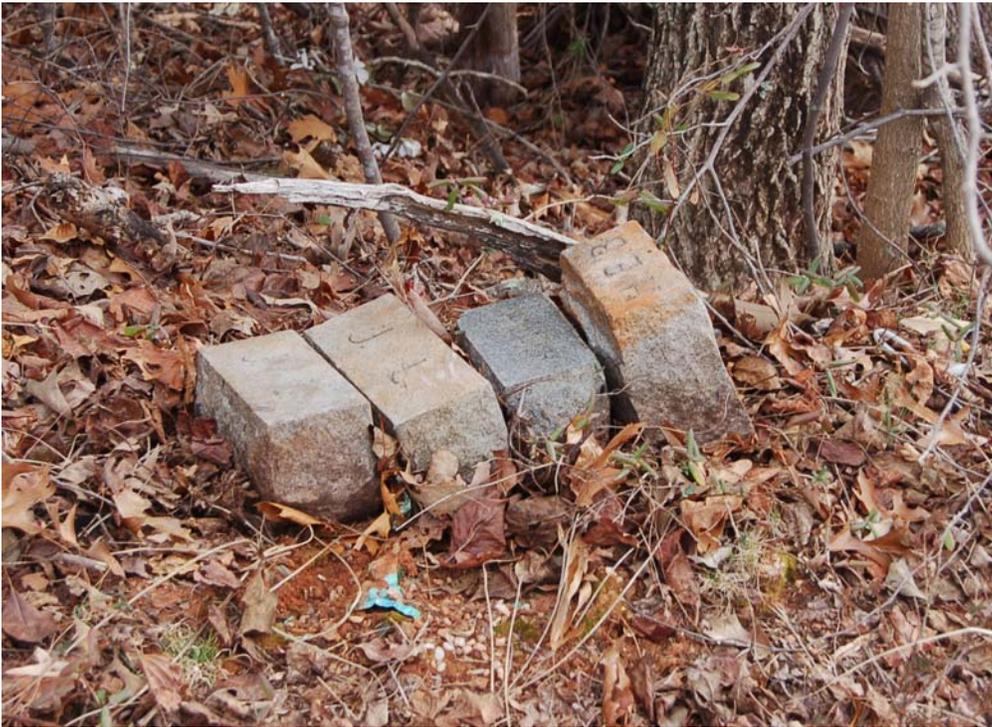
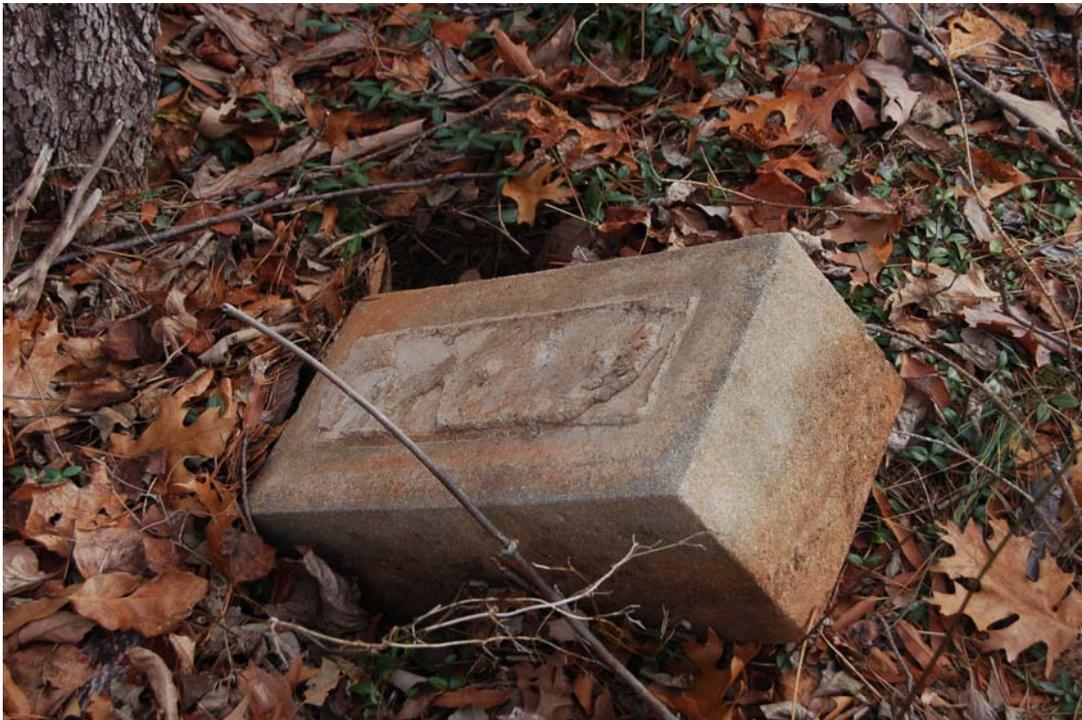
We observed numerous footstones, curbing, stone bases, and statuary discarded in the woods around the edge of the cemetery. This suggests that items were moved to allow backhoe access for the excavation of graves and then were discarded by the grave excavation service, rather than being replaced.

Figure 9. Markers discarded in the woods around the edge of the cemetery. This practice must cease immediately and these stones replaced in the cemetery.

An effort should be made to replace those elements that have been discarded.

4. There is evidence that the firms retained to excavate burial pits have been discarding markers that have been in their way. This is an unacceptable practice that must cease immediately. We recommend that the Church oversee all future excavations and require immediate repair of any damage. If backhoes are unable to operate in a safe and respectful manner in the cemetery, then the Church should require hand excavation of all graves – a practice that is actually quite common in historic cemeteries.

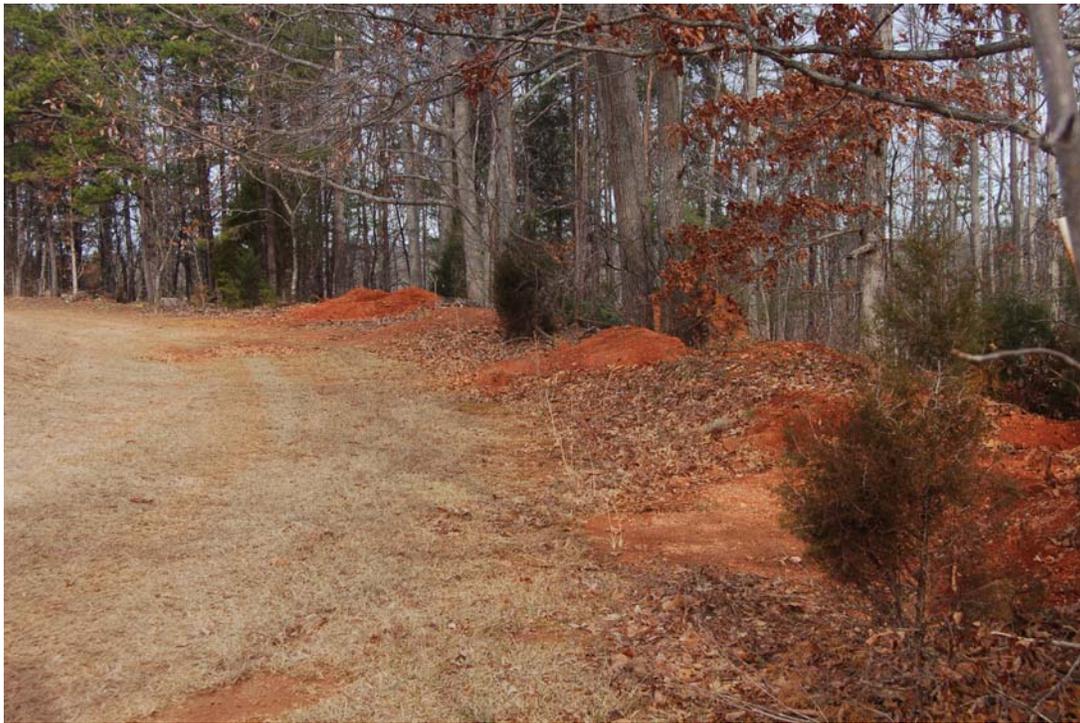
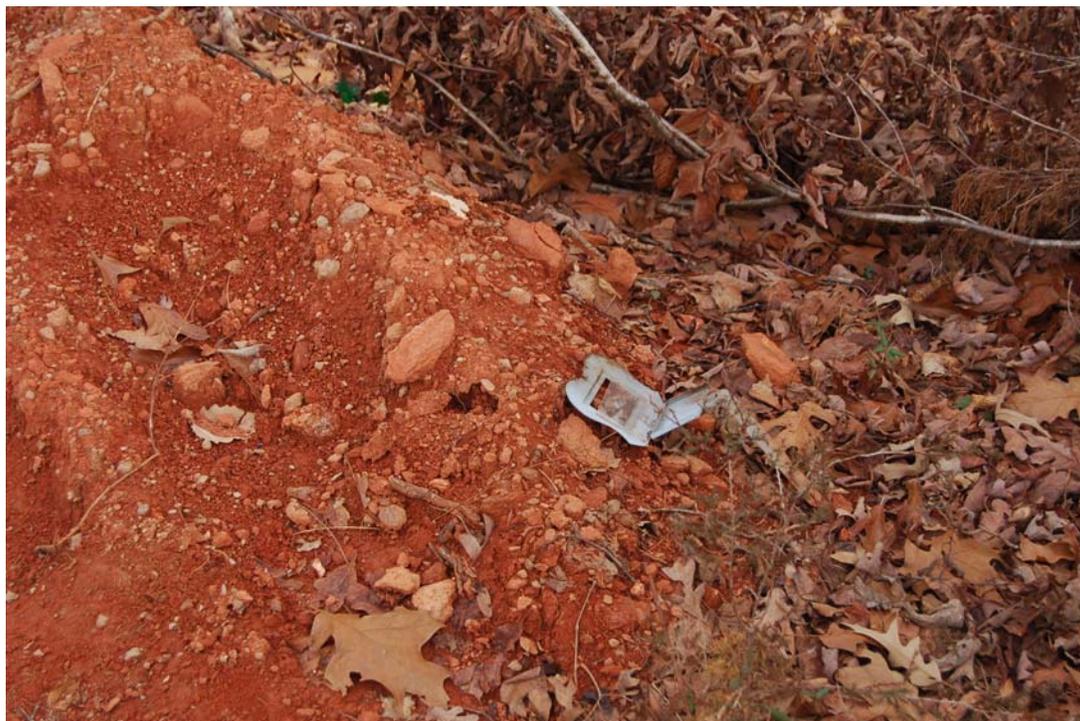
Figure 10. Spoil piles at the edge of the cemetery. In one we identified the remains of a funeral home plate that had been removed with the spoil - effectively losing this burial information.

We also observed large mounds of spoil, resulting from the use of vaults. This spoil should not be placed at the edge of the cemetery. It disfigures the landscape and detracts from the beauty of the cemetery. Burial firms should be directed to remove all spoil (or the church may direct its disposal in other areas). Again, any firm violating this requirement should be prohibited from doing future work or a bond should be required.

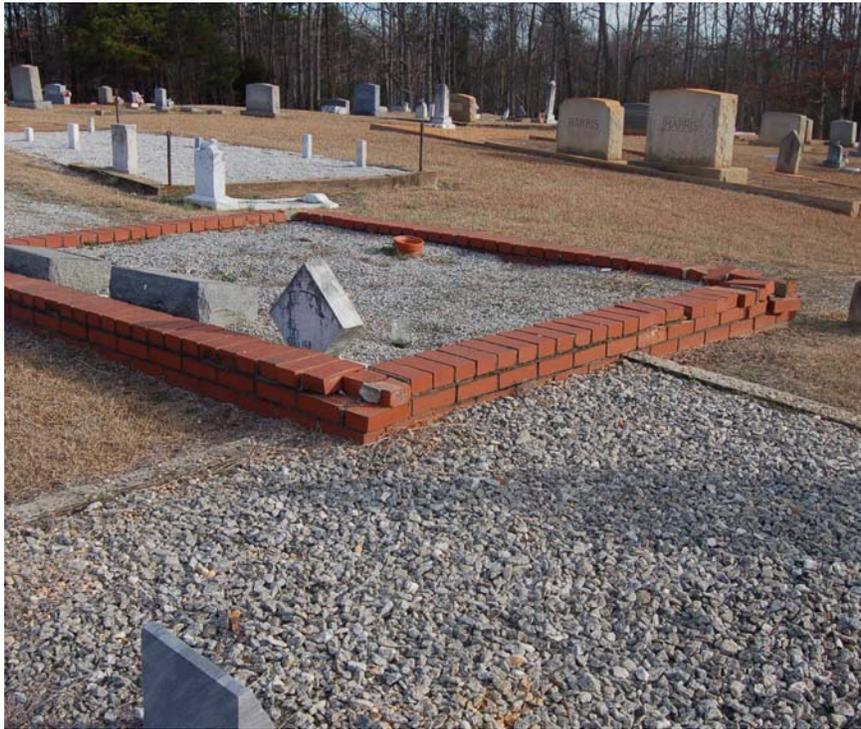
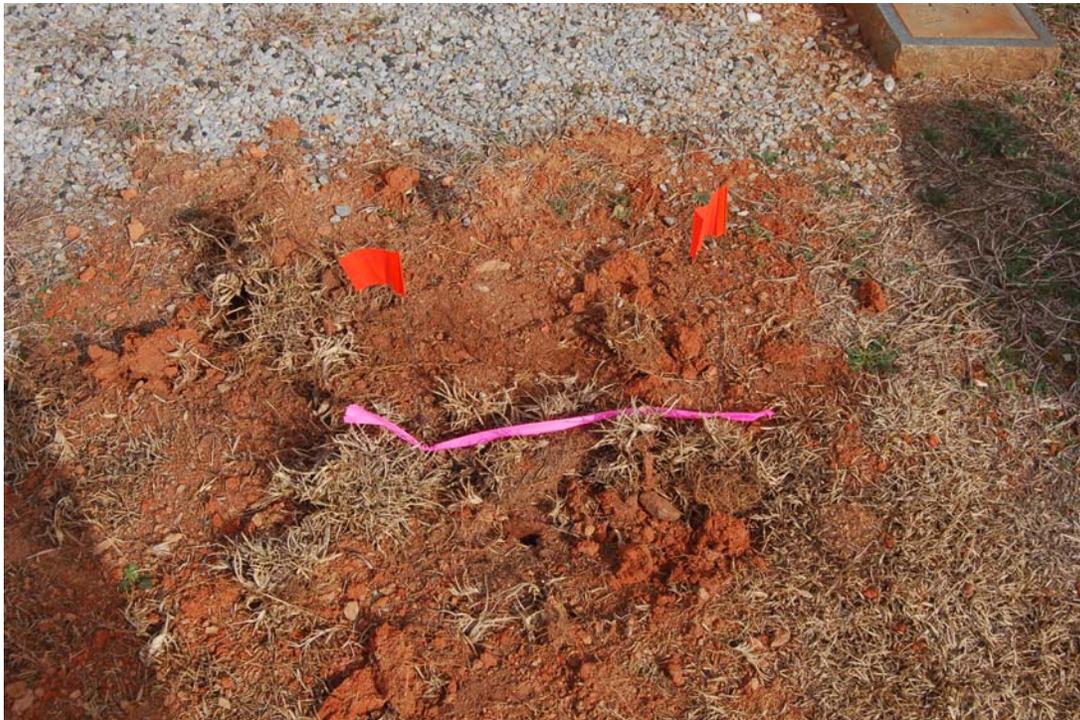
Figure 11. The top photo shows one plot built over another. The lower shows remains placed in the cemetery without the knowledge of the church.

made without any prior arrangement with the church. This is not only obvious by the poor workmanship of the burial excavation firms, but also by the discovery of a stone with no associated grave and an excavation for cremains about which the church was unaware.

3. All burials and burial locations in the cemetery must be authorized in advance by the church. The laissez faire approach exercised thus far has caused plots to overlap and for plots to be placed between pre-existing rows.

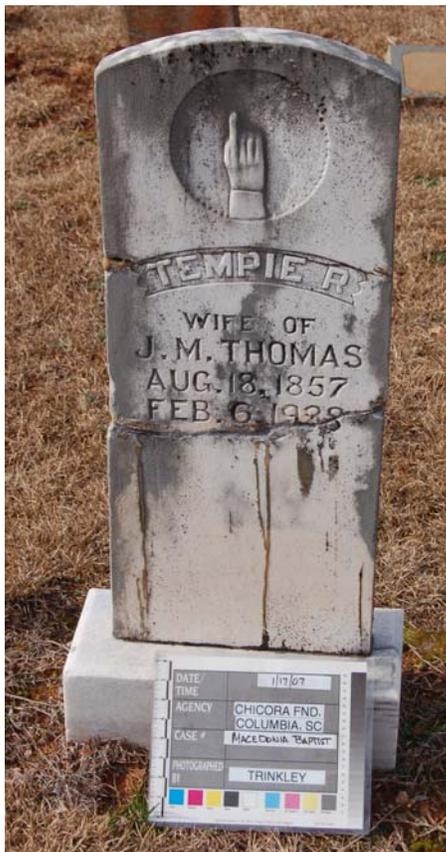
Figure 12. Example of unacceptably repaired stone. The stone is poorly matched on the sides and there is much epoxy left dribbling down the face of the marker.

We observed several stones that had been repaired in the past. In general these repairs are poorly executed, resulting in additional damage to the stone. The church should assist families in locating appropriate repair assistance. In general, monument companies, while familiar with modern stone are neither trained in, nor do they have the expertise, to repair historic stone.

Repairs should be conducted by trained stone conservations who subscribe to the code of ethics and standards of practice of the American Institute for Conservation (AIC).

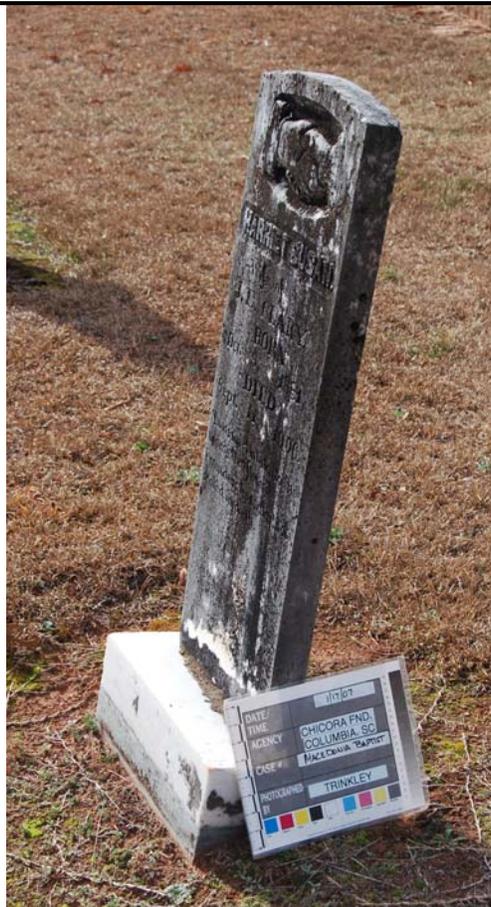
Marble tab in socket. Stone is well set in socket, but die is poorly set, resulting in the stone being out of plumb by about 15°. This puts additional stress on the stone and contributes to the stone breaking. The monument also exhibits heavy atmospheric staining, likely gypsum crust. Moderate biologicals.

Stone will be reset in a pea gravel footing. This will promote drainage away from the stone and will also allow some movement should the stone be impacted by lawn maintenance or other activities. Once reset the stone will be cleaned with D/2 Architectural Antimicrobial and flushed with potable water.

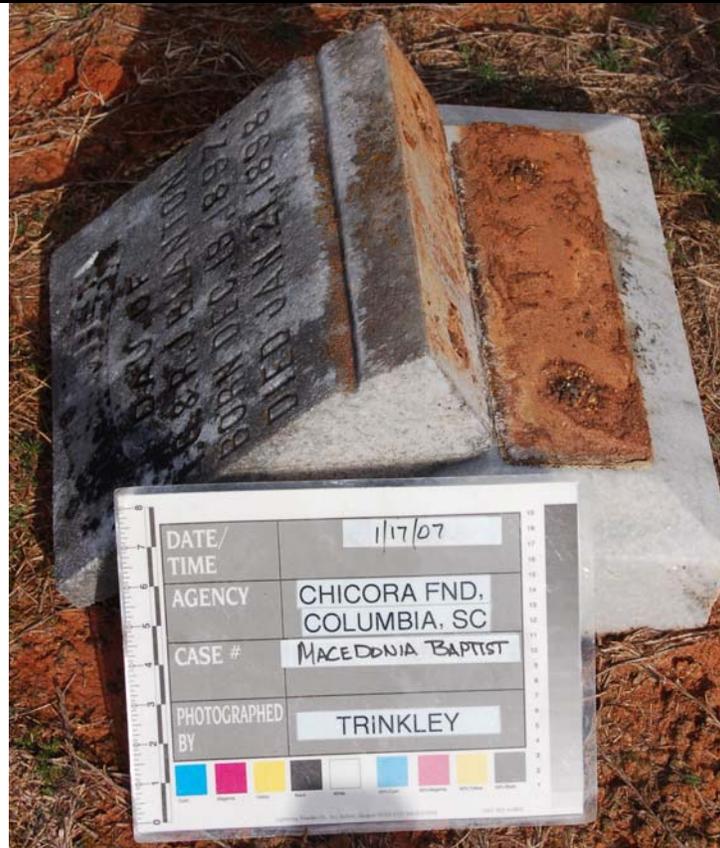
Marble die on base with two ferrous pins, both broken and exhibiting extensive iron jacking. The die is no longer stable on the base. The base is no longer set level. Moderate atmospheric staining and moderate biologicals. Some iron staining from the ferrous pins and the clay. These iron pins must be removed or they will continue to corrode and will eventually spall the stone.

A diamond core drill will be used to remove the four ferrous pin stubs. The base will be leveled in pea gravel to promote drainage and to allow some movement should the stone be impacted by lawn maintenance or other activities. The ferrous pins will be replaced with threaded 316 stainless steel pins. These pins will be adhered in the lower holes only using a hi-mod, moisture insensitive structural epoxy. A 1:3 mix of NHL 3.5 and sand will be used to reset the stone. After curing the stone will be washed using D/2 Architectural Antimicrobial and flushed with potable water.

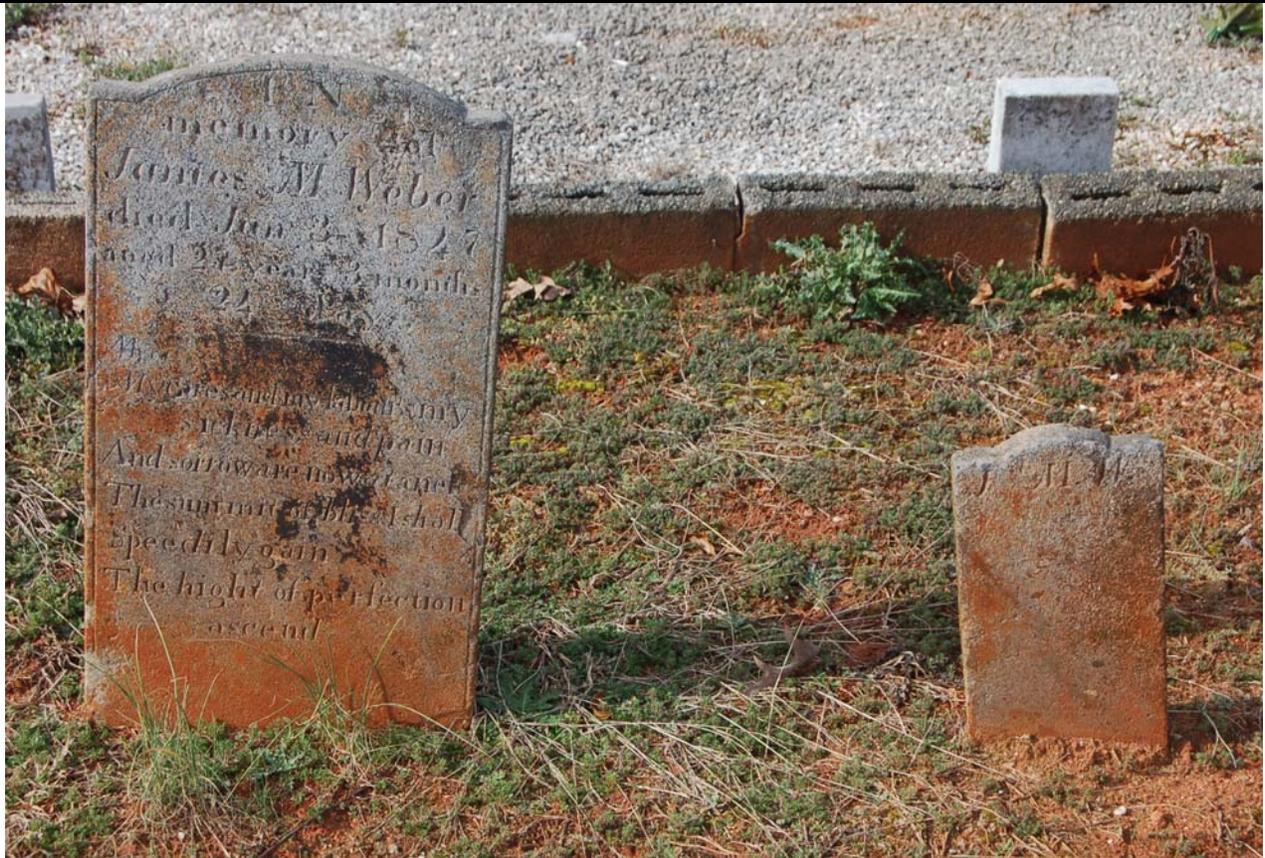
Steatite headstone and footstone. The footstone has been improperly set (likely to allow easier mowing) and requires appropriate placement. Both are heavily stained by clay. The headstone exhibits black staining of unknown origin which requires testing for removal. This represents one of the earlier stones (1847) and is particularly valuable.

The footstone will be excavated and replaced ca. 5-feet from the headstone, set in a pea gravel footing. This will promote drainage away from the stone and will also allow some movement should the stone be impacted by lawn maintenance or other activities. Several cleaners will be tested on the black material found on the headstone to determine the best cleaning approach. The selected product will be used to remove the stains.

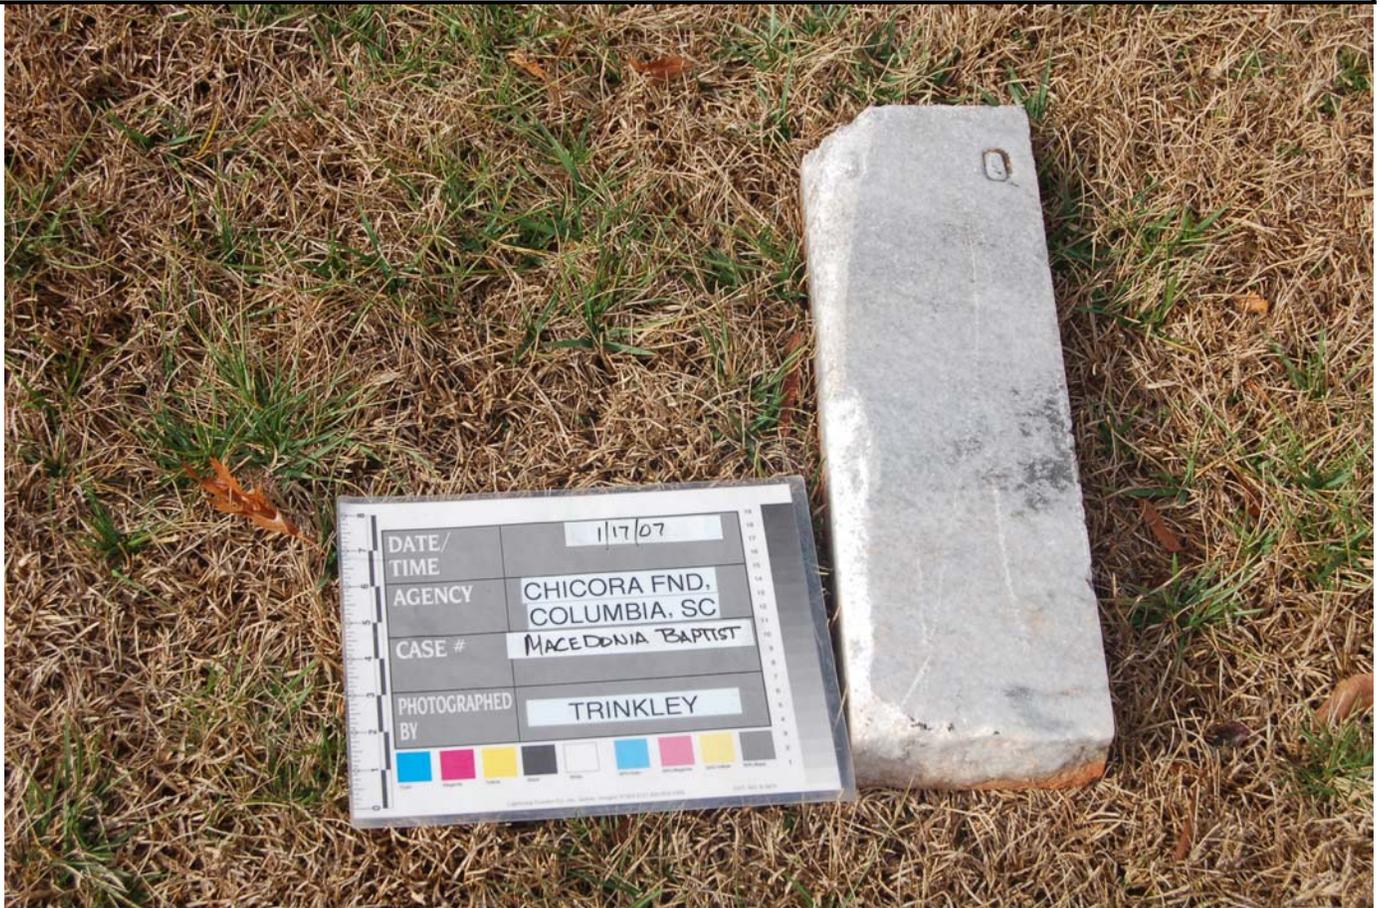
Marble footstone out of the ground and lying on the surface, subject to damage or theft. Stone requires resetting. Afterwards the stone will be cleaned using D/2 Architectural Antimicrobial and flushed with potable water.

The footstone will be paired with its headstone and reset ca. 5 feet below the headstone in a pea gravel footing. This will promote drainage away from the stone and will provide some movement should the stone be impacted by lawn maintenance or other activities. Afterwards the stone will be cleaned with D/2 Architectural Antimicrobial and flushed with potable water.

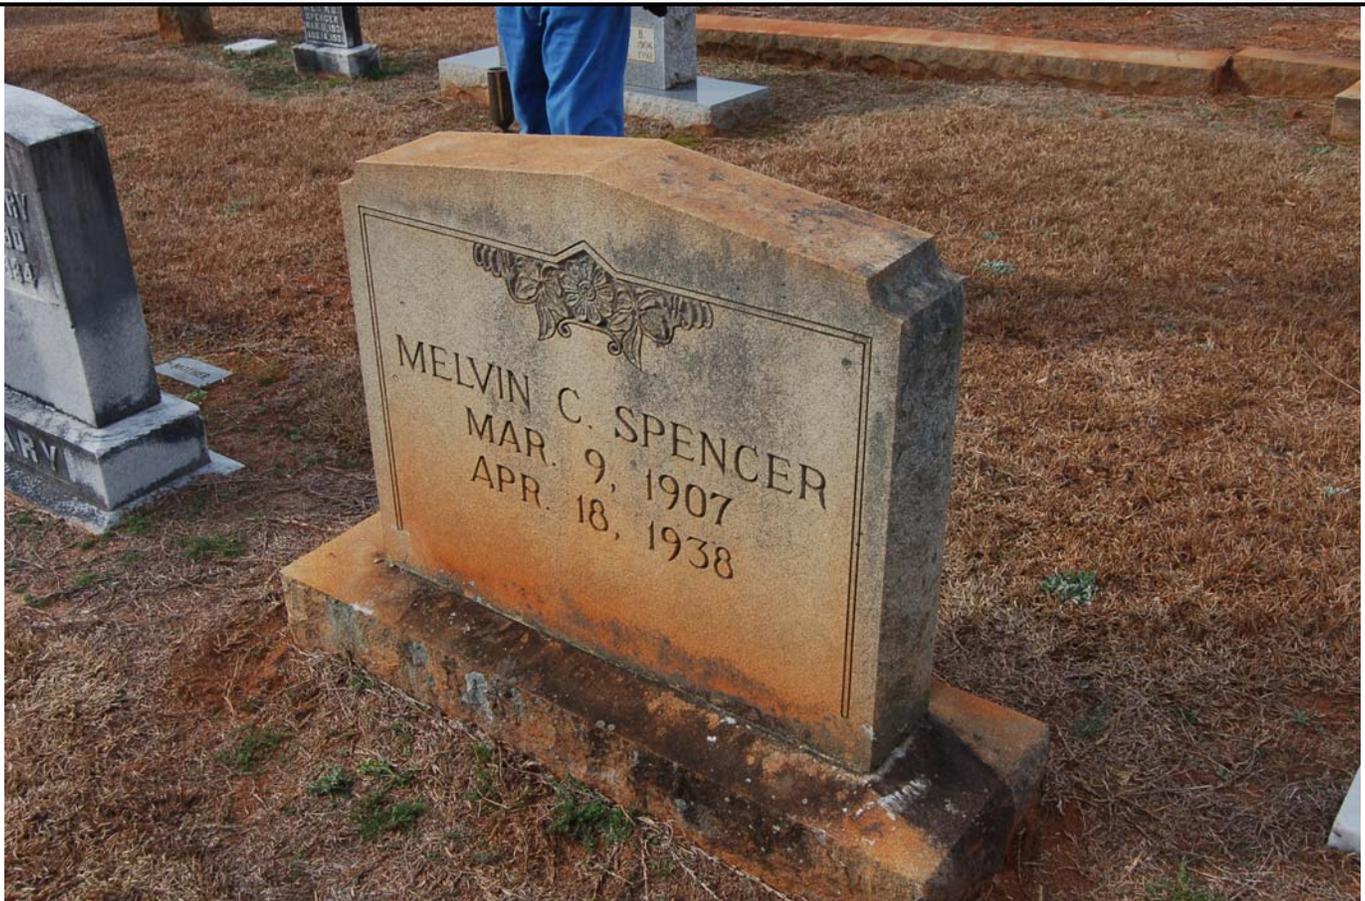
Granite die on base. The die is no longer attached to the base and is unstable. Much old setting compound on the die and base. Moderate biologicals overall.

Granite die will be removed, allowing the base of the die and the top of the base to be cleaned of adhering setting compound. The die will be reset using proprietary setting compound designed for granite markers. The stone will be cleaned using D/2 Architectural Antimicrobial and flushed with potable water.

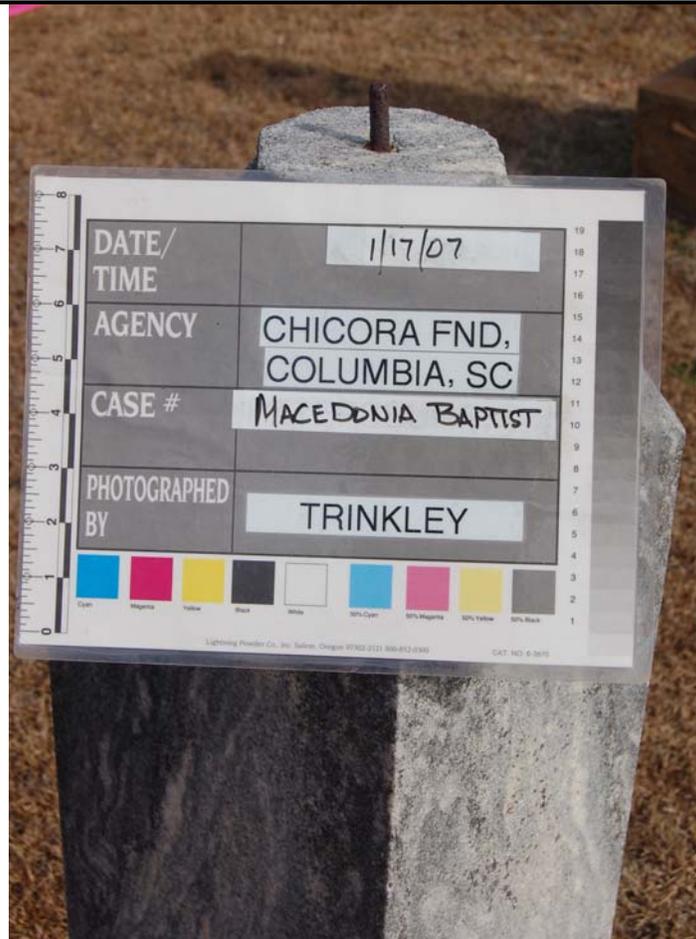
Marble pedestal tomb with missing finial. There is a ferrous pin still in place which require removal. Otherwise biologicals and atmospheric staining are light. Monument appears stable.

The ferrous pin will be core drilled out and the hole will be infilled with Jahn M120 Marble Mortar. After setting the stone will be cleaned using D/2 Architectural Antimicrobial and flushed with potable water.

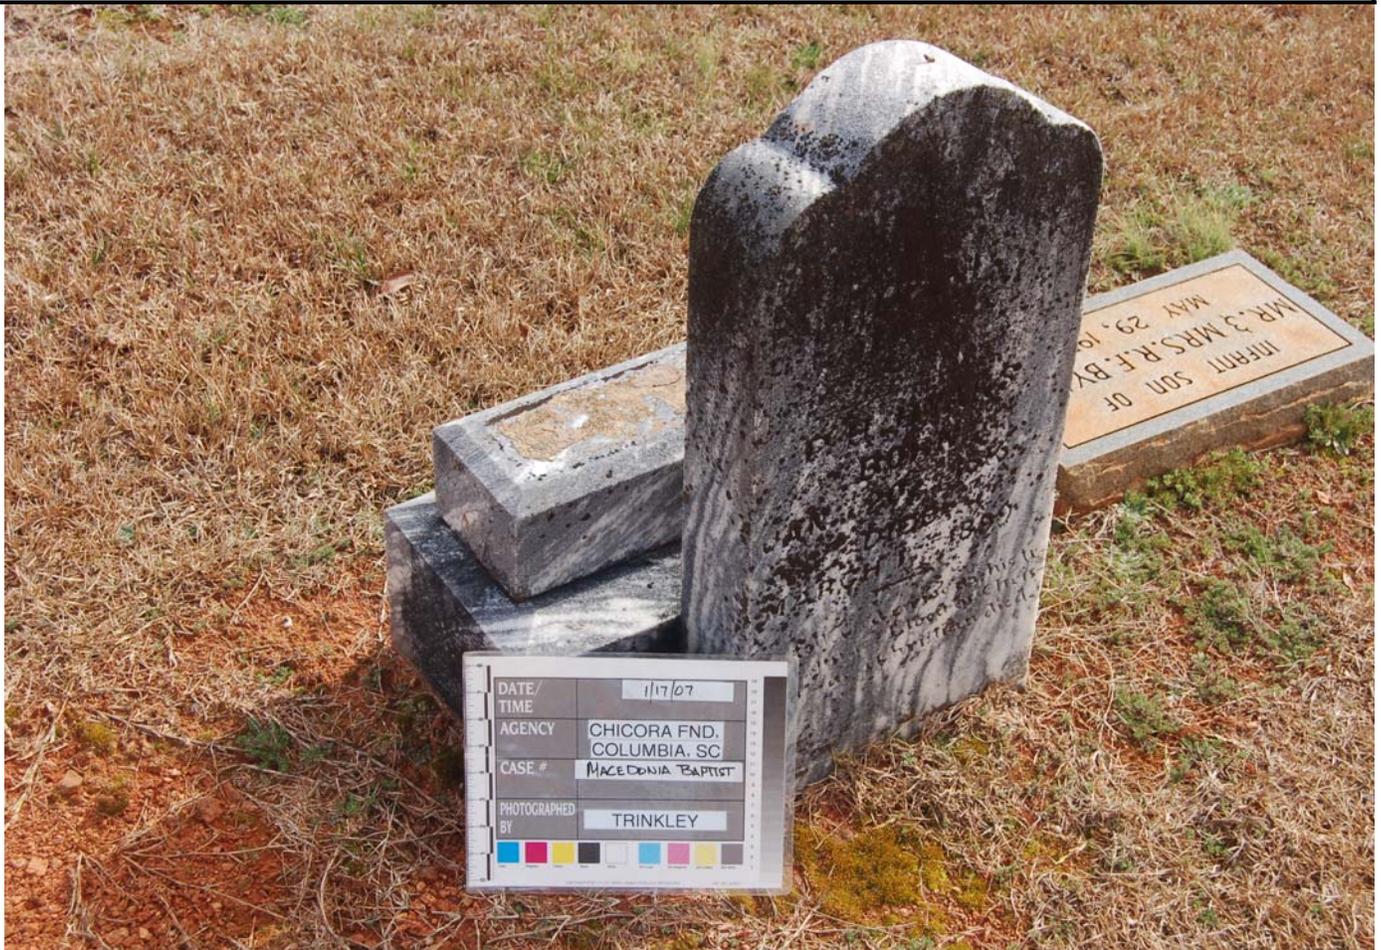
Marble die on base. Die has fallen, middle base is loose. There are no pins. Base requires leveling. Heavy biologicals overall.

Base will be reset in pea gravel to promote drainage away from the stone and to allow some movement should the stone be impacted by lawn maintenance or other activities. The base, middle base, and die will be drilled for insertion of two 5/8-inch threaded 316 stainless steel pins to connect them. These pins will be set using a hi-mod, moisture insensitive, structural epoxy. Each base will be set using a 1:3 mix of NHL 3.5 and sand. Once set the stone will be cleaned using D/2 Architectural Antimicrobial and flushed with potable water.

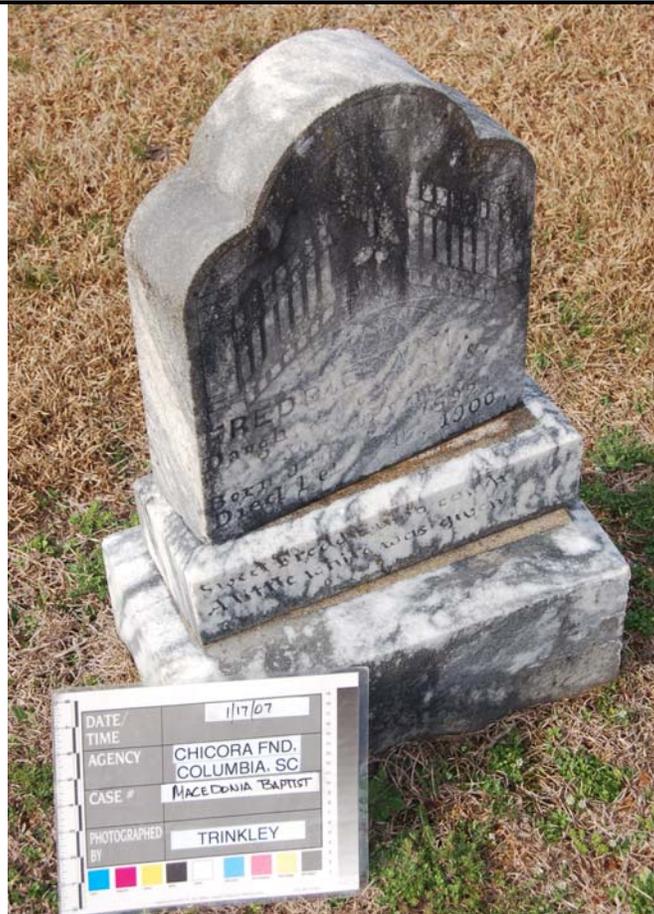
Marble die on base. Die and middle base are loose. There are no pins. Base requires leveling. Moderate biologicals overall.

Base will be reset in pea gravel to promote drainage away from the stone and to allow some movement should the stone be impacted by lawn maintenance or other activities. The base, middle base, and die will be drilled for insertion of two 5/8-inch threaded 316 stainless steel pins to connect them. These pins will be set using a hi-mod, moisture insensitive, structural epoxy. Each base will be set using a 1:3 mix of NHL 3.5 and sand. Once set the stone will be cleaned using D/2 Architectural Antimicrobial and flushed with potable water.

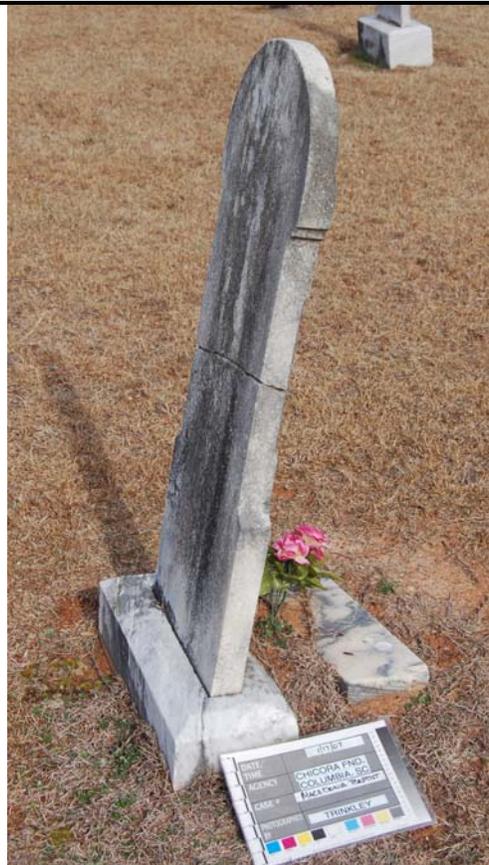
Marble tab in socket. There is an old break mid-way up the die; this appears to have received a simple epoxy repair which, at present, is stable. The die, however, is loose in the socket, allowing the stone to lean and this is putting additional stress on the old repair. Treatment has a high priority to prevent additional damage to this stone. The footstone has also been removed and is lying at the base of the headstone. Moderate biologicals and atmospheric staining overall.

The die will be removed from the base, allowing the base to be reset if necessary. Both the footstone and base of the headstone, if necessary, will be reset in pea gravel to promote drainage away from the stone and allow some movement should the stone be impacted by lawn maintenance or other activities.

Should the old repair fail during resetting additional treatment, consisting of mechanical removal of the old epoxy, and drilling the stone for the insertion of two threaded 316 stainless steel pins ½-inch in diameter and about 18 inches in length. These will be set using a hi-mod, moisture insensitive structural epoxy. Registration will be checked and the two fragments will be clamped to allow the epoxy to cure for 24-48 hours. The cost of this work is not included in the estimate below, but will add approximately \$375 to the total cost.

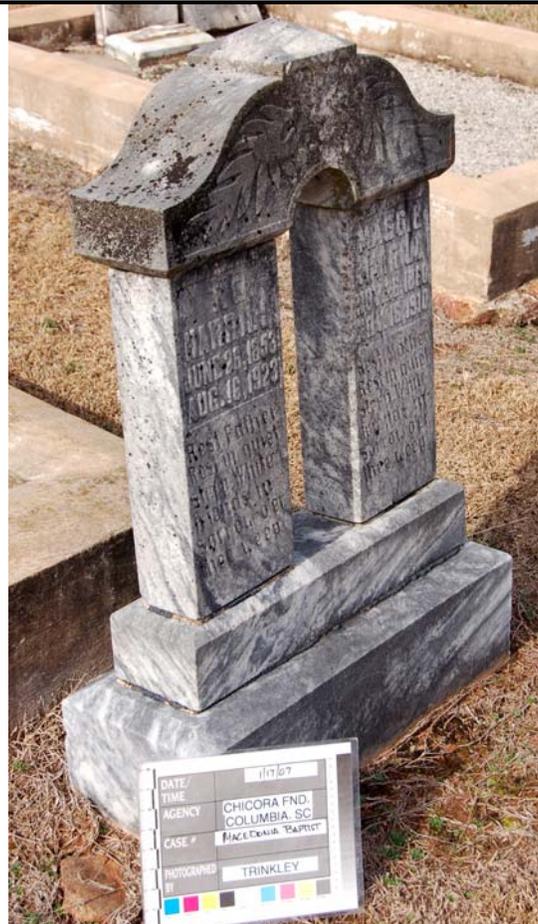
Marble arched pedestal tomb. All components are loose. Ferrous pins are present in at least the columns. Monument is severely leaning. Moderate atmospheric staining and biologicals, notably at the top.

Monument will need to be disassembled to the base, which requires resetting in pea gravel to level. This will promote drainage away from the stone and will allow some movement should the base be impacted by lawn maintenance or other activities.

Ferrous pins will be core drilled out and will be replaced with 316 stainless steel threaded pins of a suitable diameter. The base and sub-base will also be drilled for the insertion of two threaded 316 stainless steel pins. All pins will be set in a hi-mod, moisture insensitive structural epoxy. Stone will also be set using a 1:3 mix of NHL 3.5 and stone dust during reassembly.

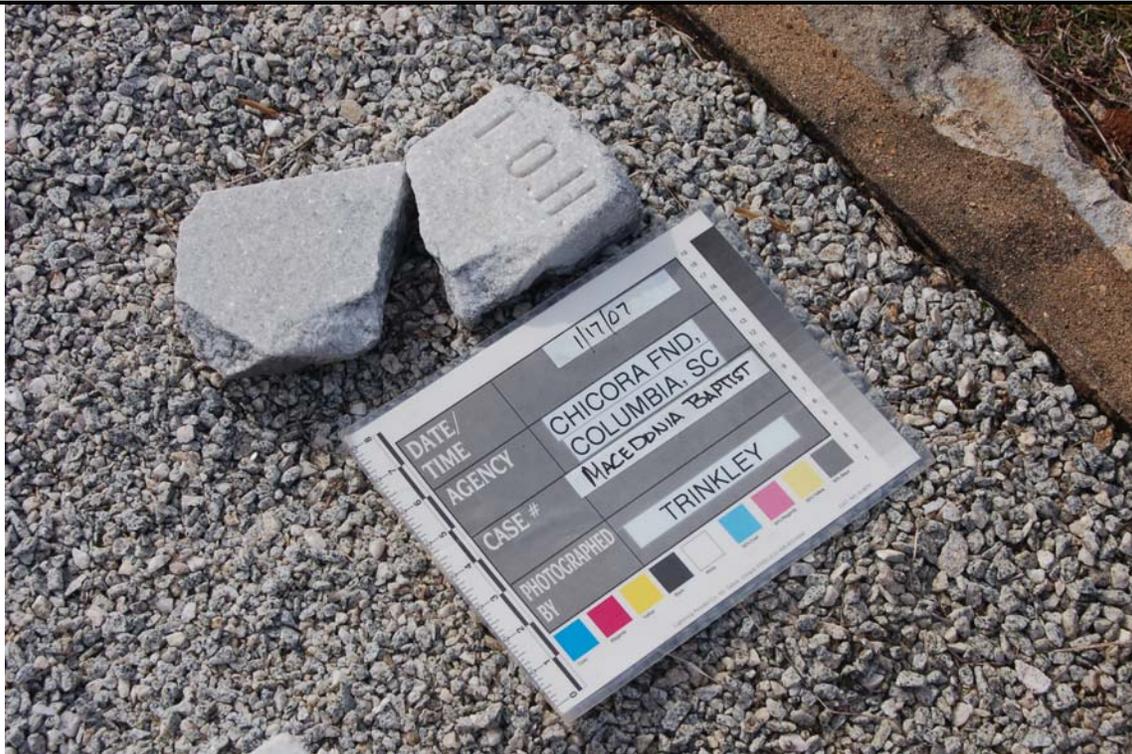
Marble footstone broken into three fragments (one is likely still below grade). No biologicals.

The lower portion of the footstone will be identified through probing and removed for repair.

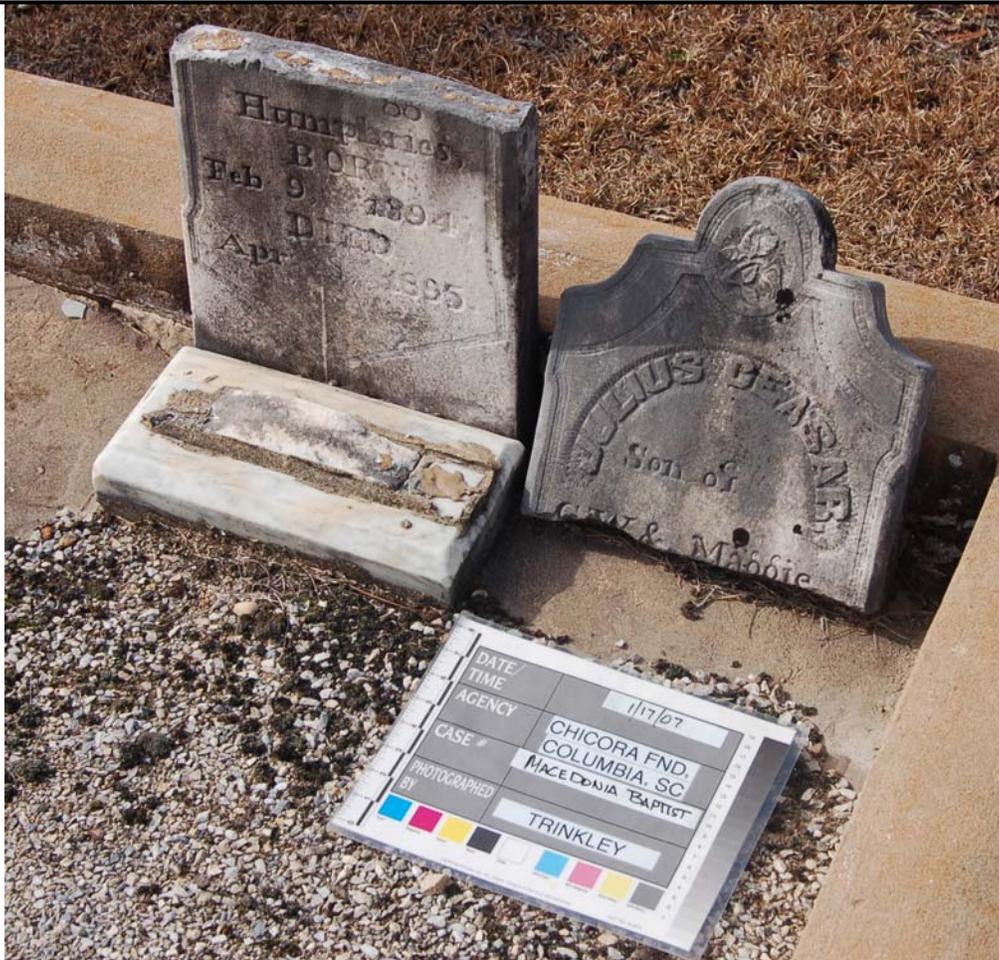
Marble tab in socket with two breaks – one at socket and another mid-way up the stone. Both evidence old, failed repairs and the parts are currently set in the plot. Moderate biologicals, heavy atmospheric staining.

All old repair material will require mechanical removal.
