INITIAL ASSESSMENT, LANDRY TOMB, DONALDSONVILLE, LA

Chicora Research Contribution 516

Prepared By:
Michael Trinkley, Ph.D.

May 2009

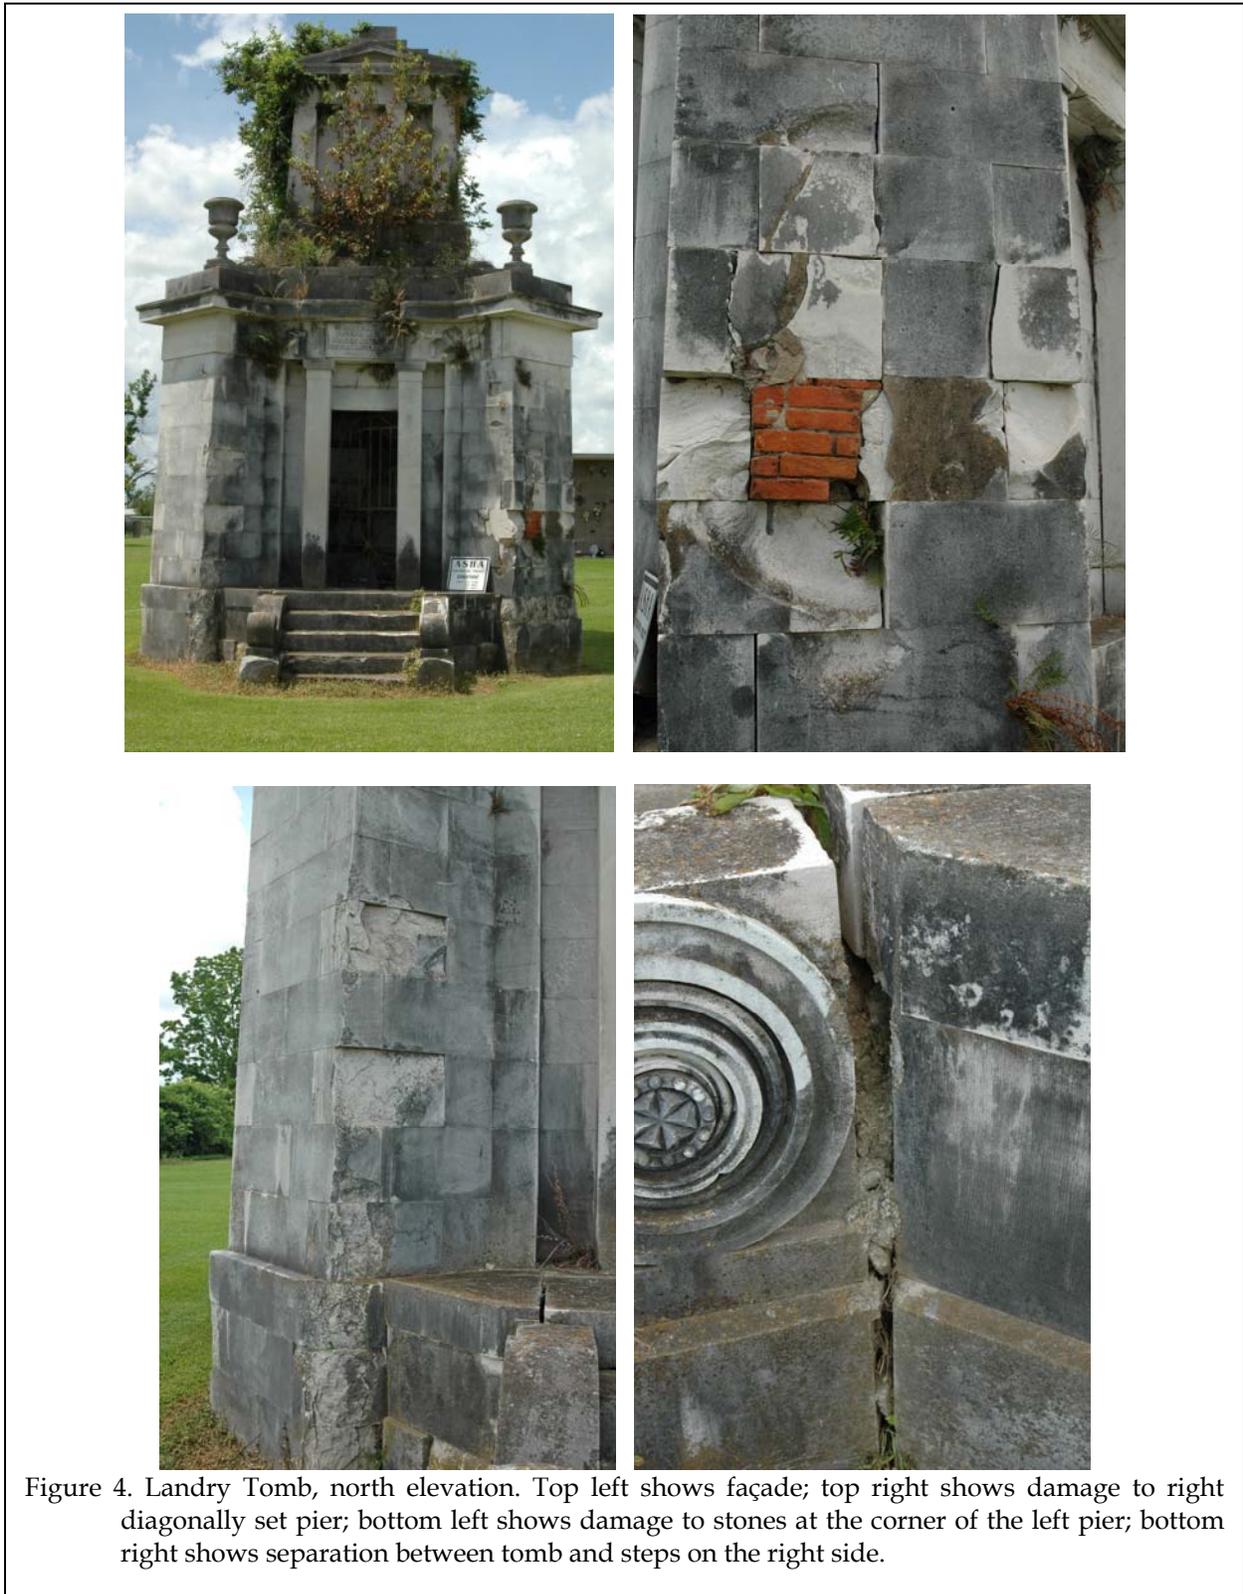
Figure 4 shows the north face of the Landry Tomb. This north elevation is the front of the tomb and centered are steps leading to the entrance. Vegetation is found growing from joints in the walls, but is primarily confined to the pavilion top. Condition of the pavilion was not ascertained because of the vegetation and the absence of a lift to allow close examination.

The cornice immediately above the entrance is damaged, with about 2' missing at the right and additional damage to the left. The ashlar stone is generally in good condition, except at the two corners from about midway down to the ground level. In these areas the stone is spalling. The diagonal pier to the right of the entrance exhibits three split stones. Two have been repaired (or partially repaired) using ordinary Portland cement (OPC). A portion of a third stone is missing, having been replaced with brickwork.

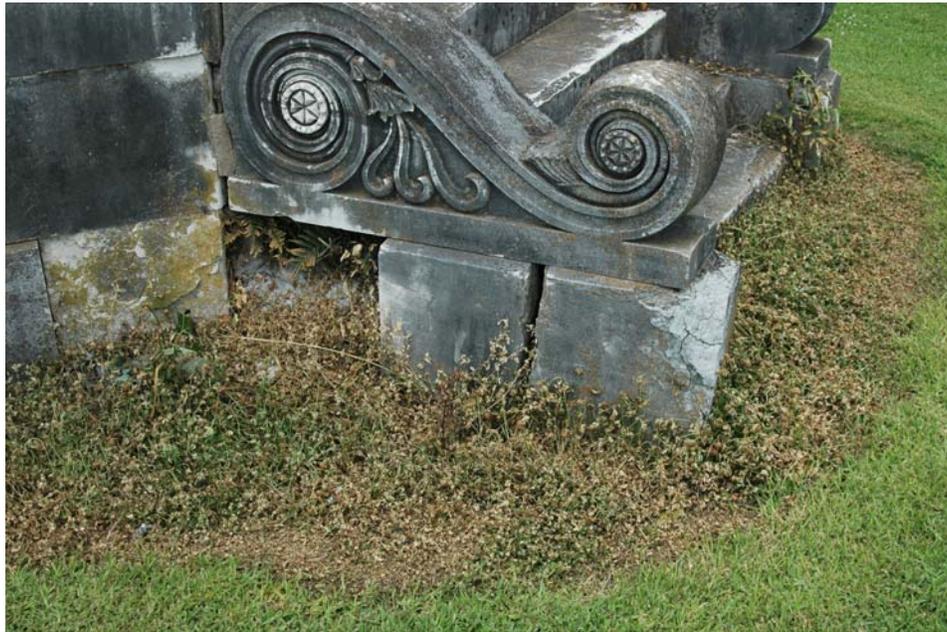
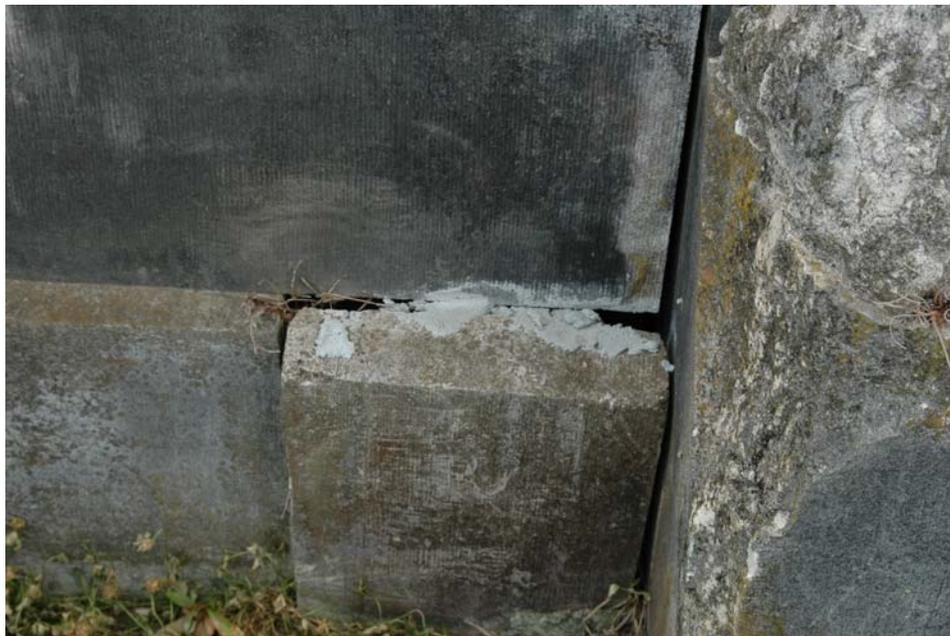
The steps themselves appear to have shifted away from the tomb and reveal an old repair effort using OPC on both the right and left sides in an effort to point the resulting gap. The left side has lost a portion of one stone, while on the right side a similarly displaced stone has been inappropriately and only partially replaced using white Portland cement (Figure 5).

Figure 5. Landry Tomb, north elevation. Top photo left side of steps showing spalled stone and separation from the tomb. Bottom photo right side of steps showing effort to replace fallen ashlar block.

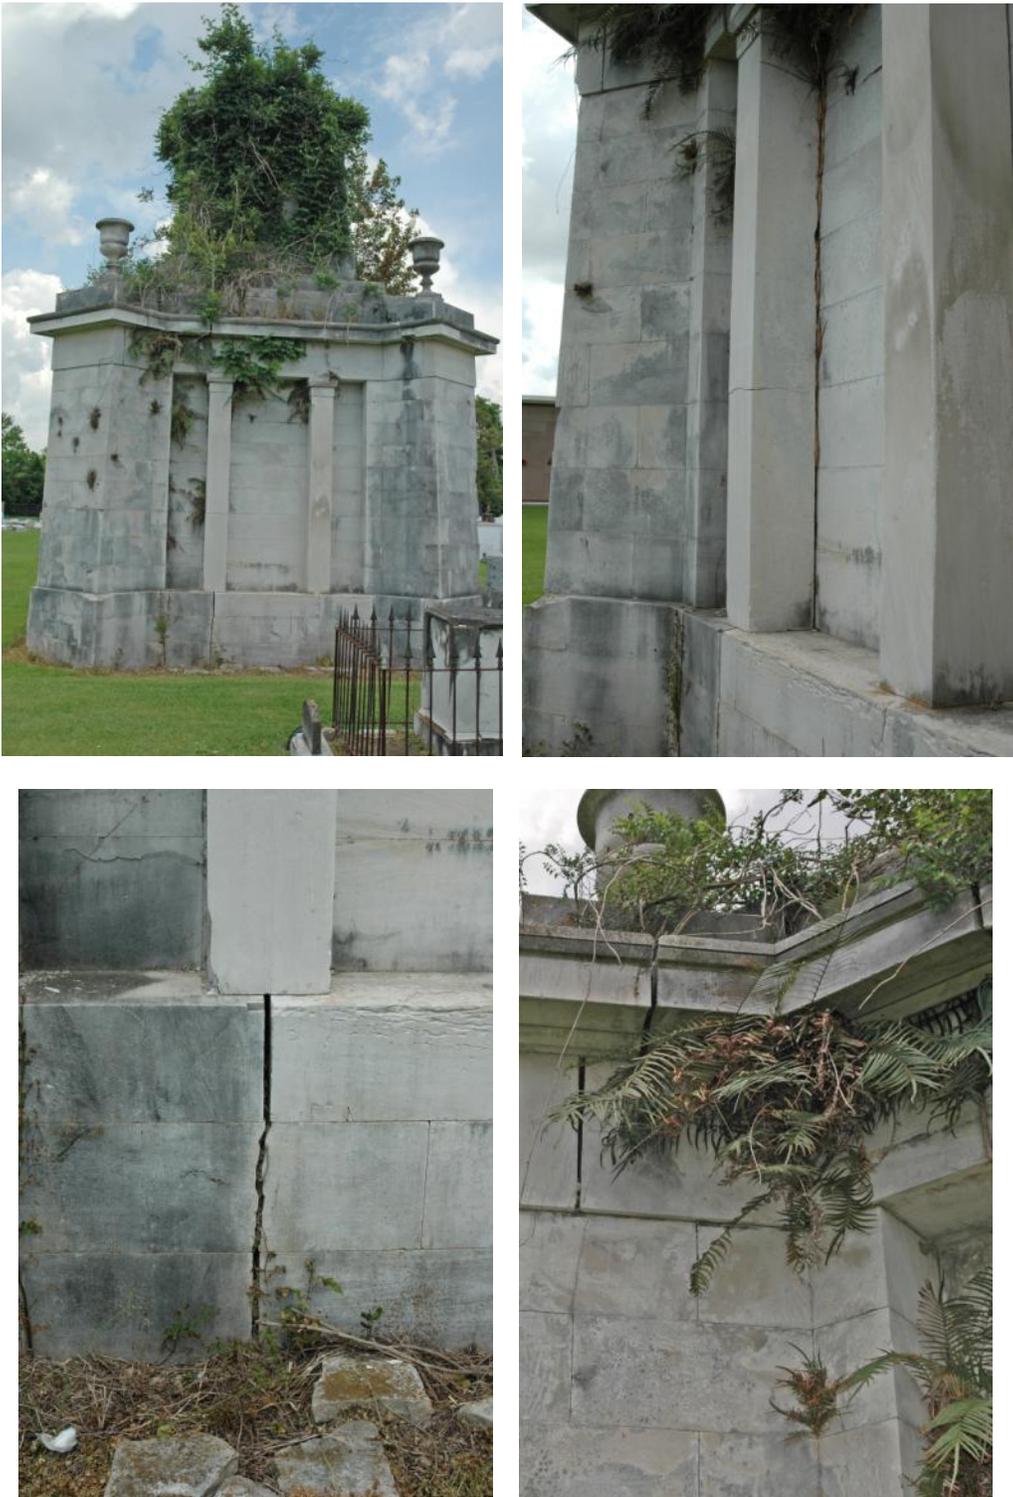
Figure 6 shows the east elevation. Vines are very heavy on this side, almost completely obscuring the pavilion top.

The cornice, while intact, shows shifting outward, away from the tomb core, in two locations. In one area the shift is approximately $\frac{3}{4}$ ".

The left pilaster appears bowed and cracked about 3' up. It has also separated from the wall by about $\frac{3}{4}$ ". The foundation at the base of this left pilaster exhibits a diagonal crack about $\frac{1}{2}$ to $\frac{3}{4}$ " in thickness, representing both shifting and splitting of one block.

Figure 6. Landry Tomb, east elevation. Top left shows façade; top right shows shifted and cracked pilaster; bottom left shows foundation crack; bottom right shows shifted cornice.

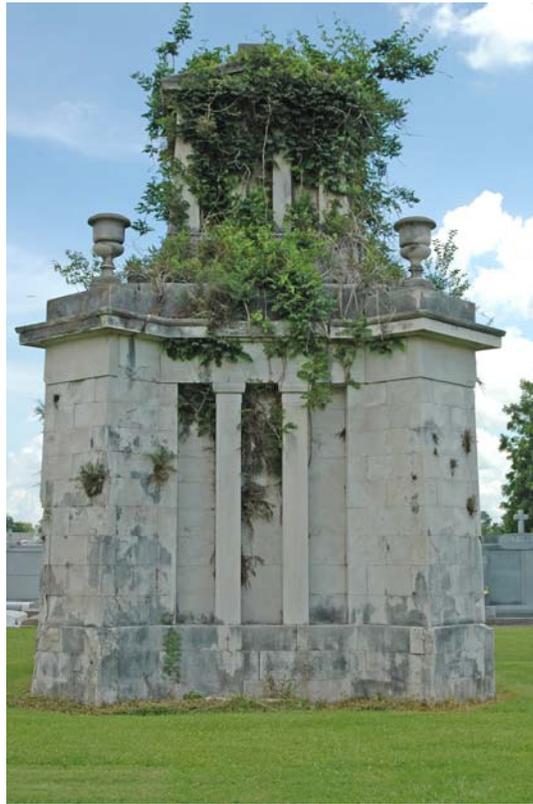
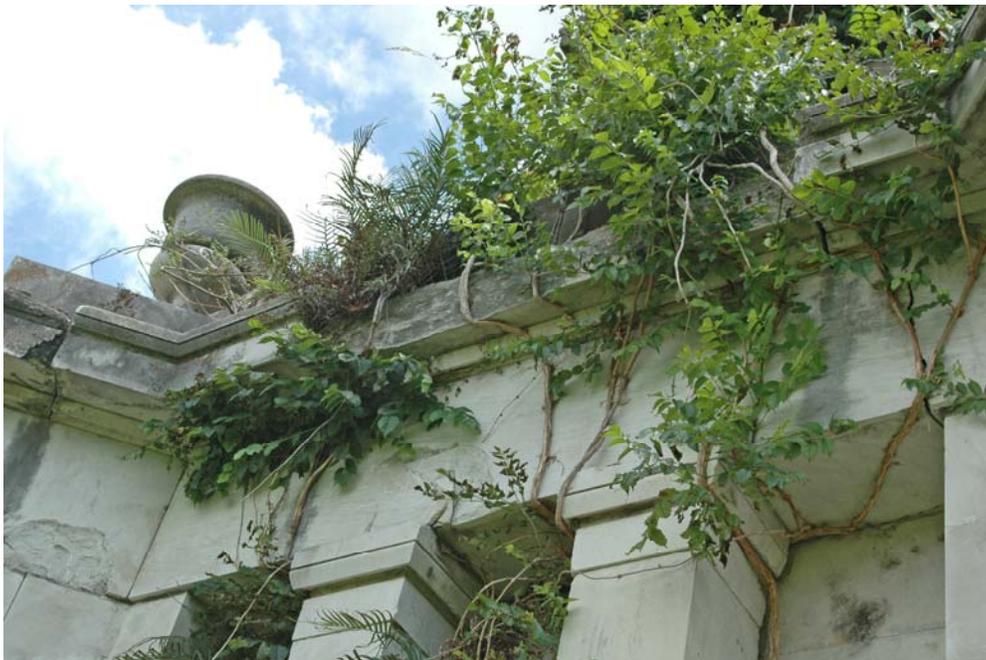
The south elevation at first glance appears unremarkable. It exhibits the same degree of vegetation found on the north and east facades, as well as a similar soiling pattern. Stone damage seems most severe at the corners.

The right pilaster, however, has shifted out at the base about $1\frac{1}{4}$ ". This may be the one shift previously noted by Chaux Vive.

There is also extensive damage to the cornice, with the loss of about a 6' foot section. Additional damage is seen to the left of this central area of loss.

Figure 7. South elevation of the Landry Tomb. Top photo is the façade. Bottom photo shows loss of the cornice and extensive growth.

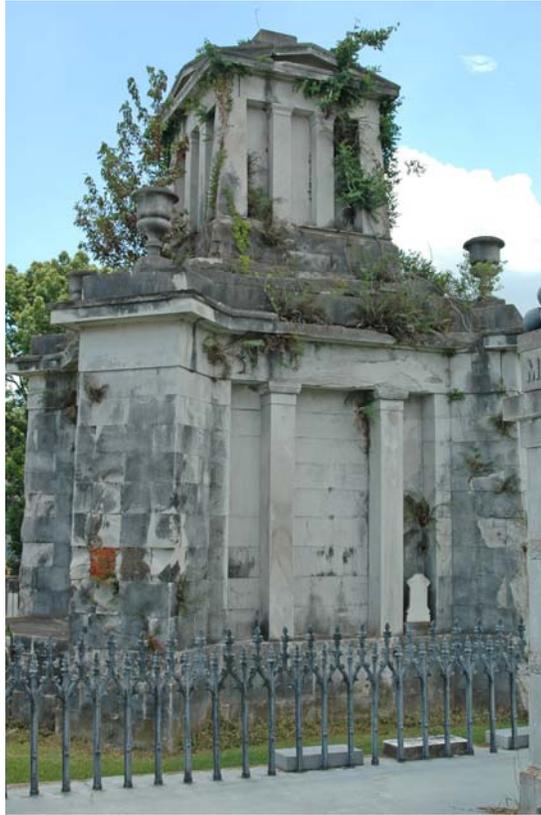
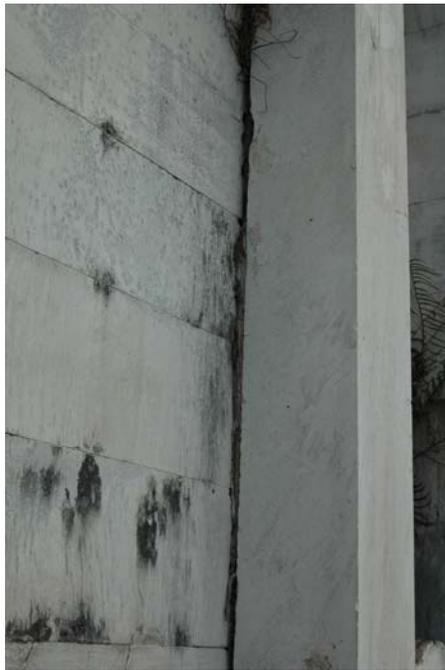
The west elevation (Figure 8) reveals damage to the upper pavilion, including stone loss. Immediately below this a 7 to 8' section of the cornice has been lost and there is extensive stone spalling below.

Figure 8. Landry Tomb, west elevation. Top shows façade. Bottom shows pilaster shift in the middle.

The right pilaster is displaced about ¾" at the bottom and about 1" at the top. It, like the others, appears to be shifted by the extensive vine growth originating below.

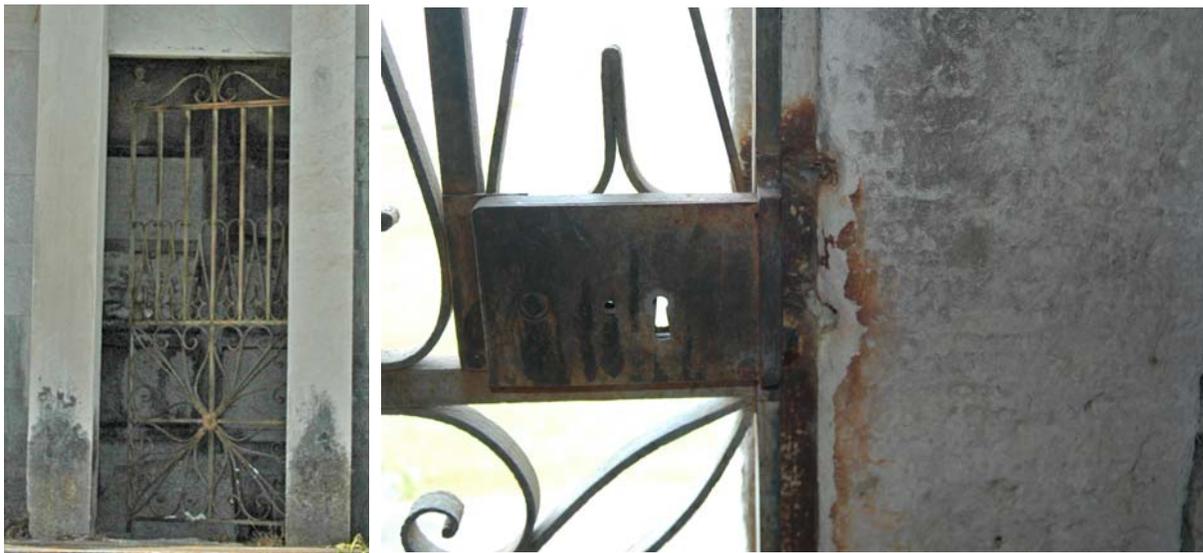
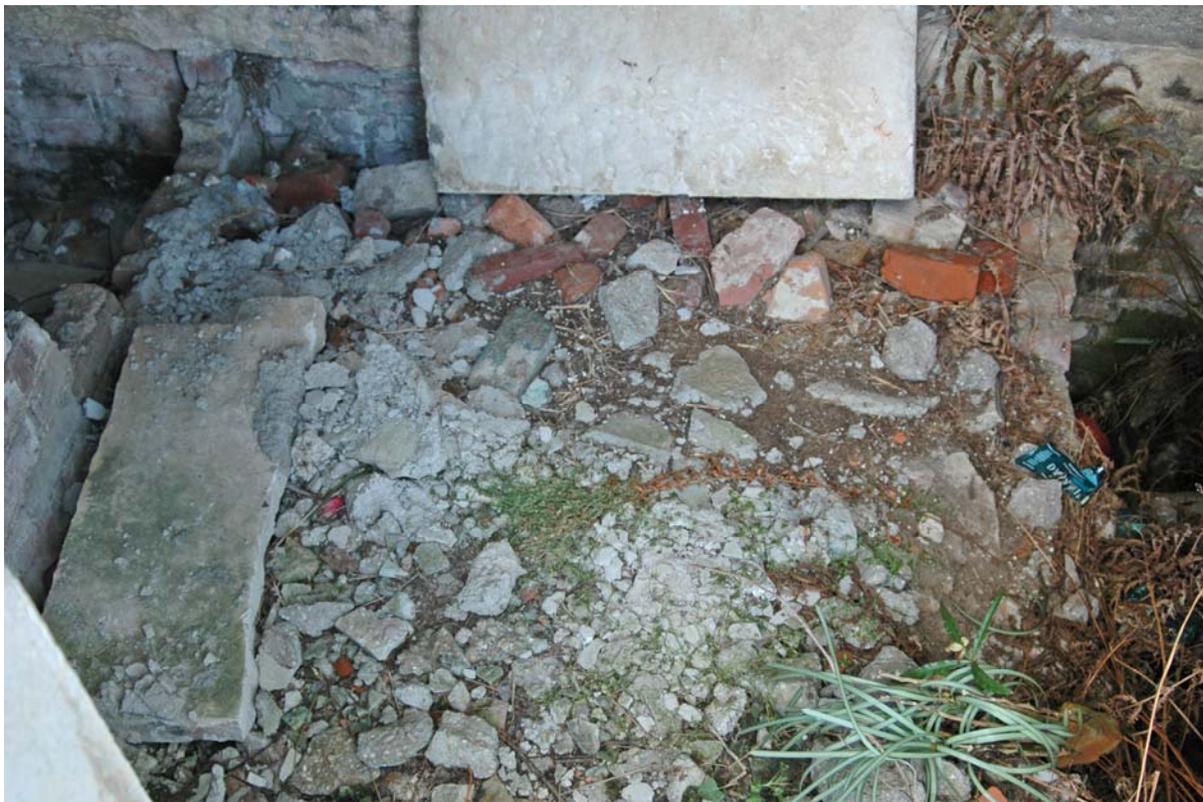
Figure 9. Door and tomb interior. Upper left, filigree door from exterior. Upper right, interior view of the rim lock and missing lock keeper. Lower photo showing the interior floor with trash, vegetation, and architectural debris.

The tomb is guarded by an inward opening iron filigree door that is intact. It exhibits relatively little corrosion and it has been previously painted white. Its closure consists of a rim lock with an exterior knob. The lock keep on the interior of the stone jamb is missing.

The interior floor appears to have contained 4 vaults, with an additional 20 more built into the south wall. While the center two vaults appear intact, the eastern and western vaults appear damaged and partially excavated. The interior floor is scattered with architectural rubble and there is no hint of the original floor. Many, although not all, of the marble tomb plaques are still in place.

A temporary eye bolt can be set in the interior wall and a chain and padlock used. The eye bolt, once removed can be patched over. A more sensitive approach, however, would be to replace the missing lock keeper. Cast iron examples are widely available from antique lock dealers (see, for example, <http://houseofantiquehardware.com/s.nl/sc.10/category.163/.f>) or one can be readily fabricated to fit existing holes. The existing lock can be removed and repaired by an antique locksmith, although ideally a locksmith may be able to do the necessary repairs on-site. For example, H. Rault Locksmith in New Orleans has some experience with antique materials.

Assuming that there are no structural contradictions, the interior floor can be readily stabilized by cleaning out the vestibule, removing vegetation and trash, and infilling the open holes with clean sand. This will not disturb any of the existing remains (human or archaeological) and will allow the interior to be put into some more reasonable appearance at a relatively low cost. Although it should be considered temporary, this is readily reversible.

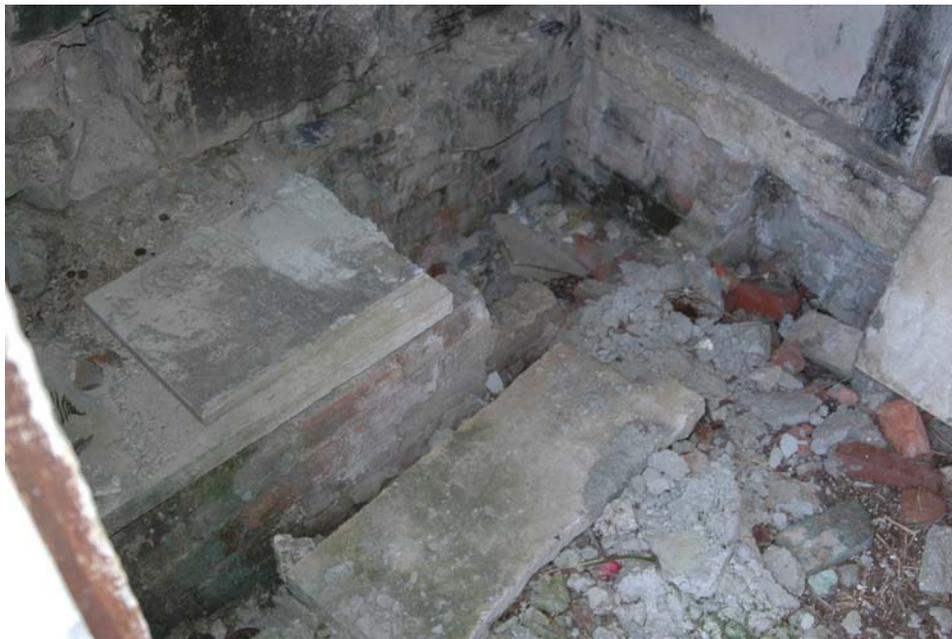
Figure 10. Interior left of the Landry tomb showing one of the four floor vaults partially open.
