# **PRESERVATION ASSESSMENT OF TOLSON'S CHAPEL CEMETERY, SHARPSBURG, MARYLAND**

**Chicora Research Contribution 552**

Prepared By:  
Michael Trinkley, Ph.D.  
and  
Debi Hacker

May 1, 2013

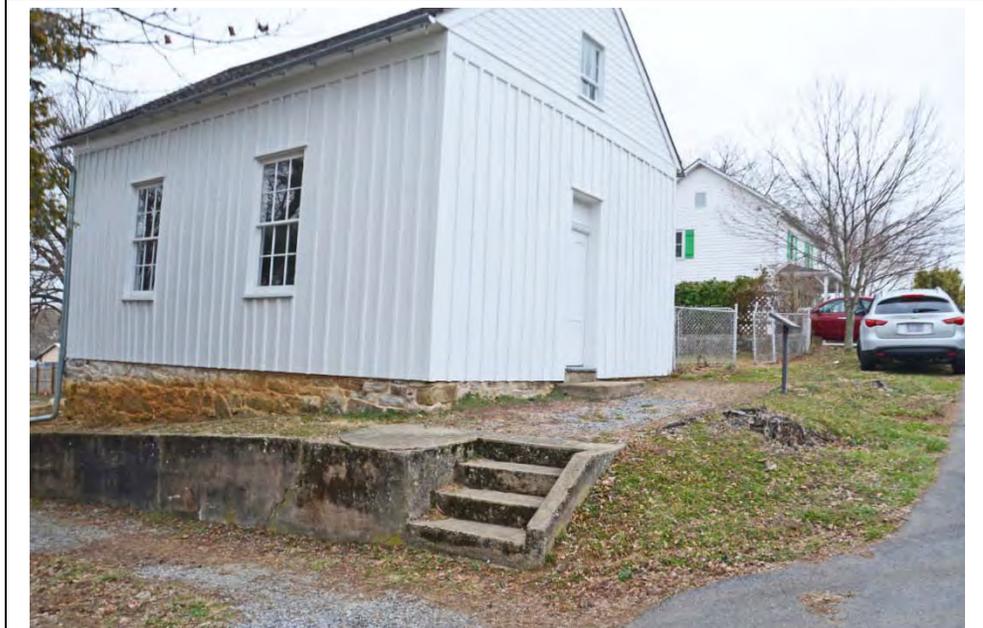
Figure 18. Steps and graveled walkway in front of Tolson's Chapel. Note also the limited parking area. The entrance gates are to the left of the parked automobile. View is to the northeast.

area in front of the double gates to the cemetery. The steps lack a handrail and the path is in poor condition. There is a small concrete step that provides access to the chapel's single width door projecting into the edge of the pathway.

**The cemetery and associated chapel have limitations on accessibility. FOTC should explore whether they are responsible for the stairs at the front left of the chapel. We also recommend signage warning visitors of the steep slope and potentially slippery terrain.**

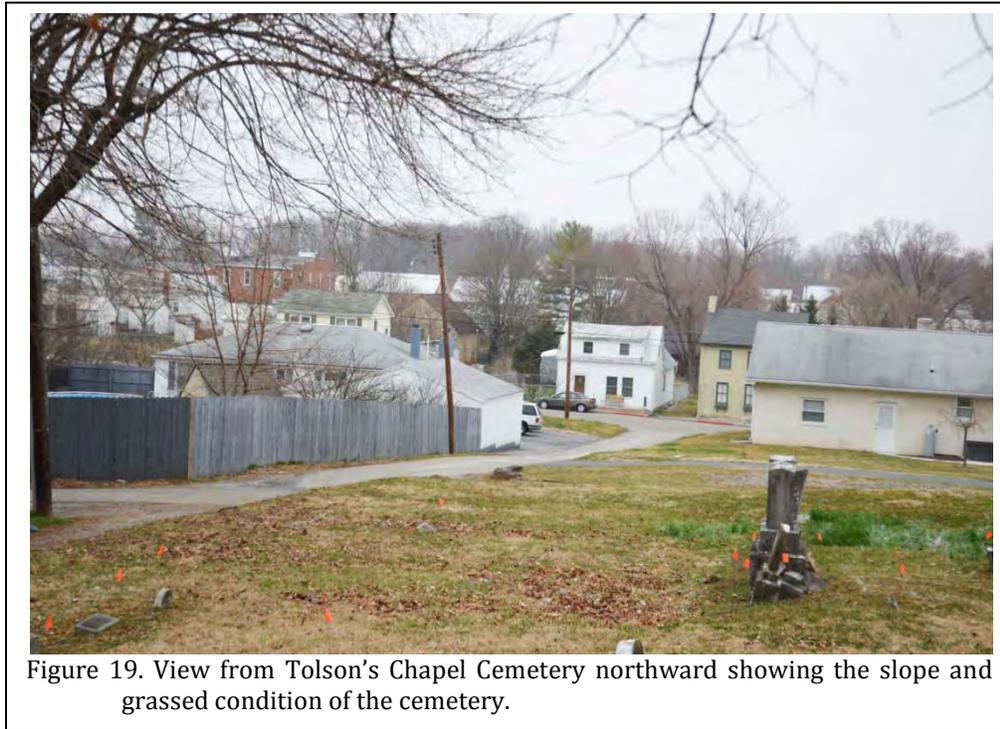
Figure 19. View from Tolson's Chapel Cemetery northward showing the slope and grassed condition of the cemetery.

The steps to the left (west) of the chapel are not accessible and lack a handrail. Whether this is an issue depends on whether these steps are owned by Sharpsburg or by FOTC.

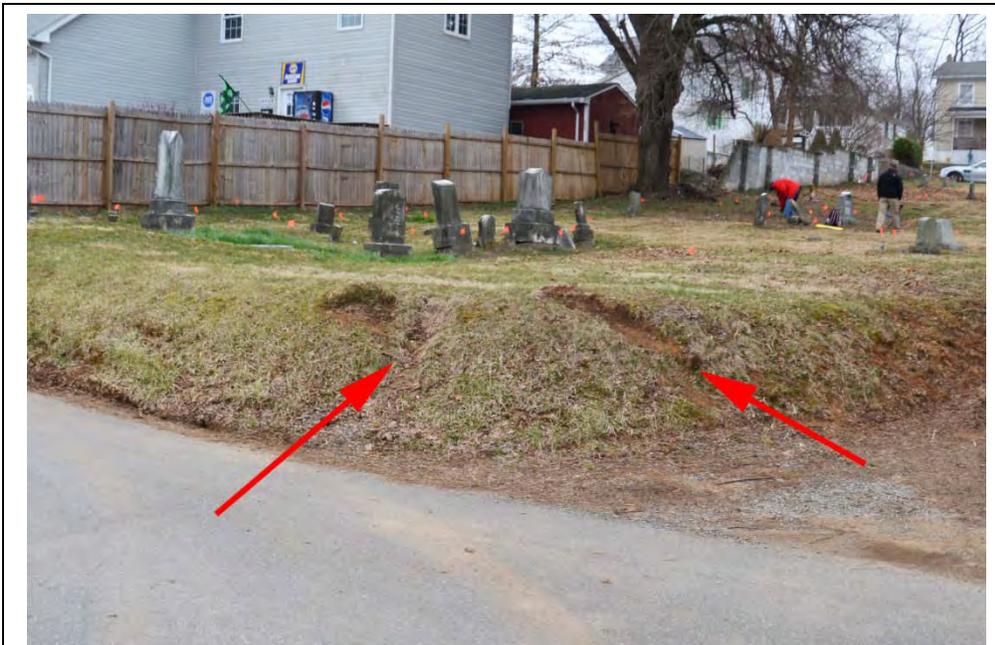
Figure 21. Rear of cemetery showing erosional areas caused by using the slope as a bike ramp. View is looking to the southeast.

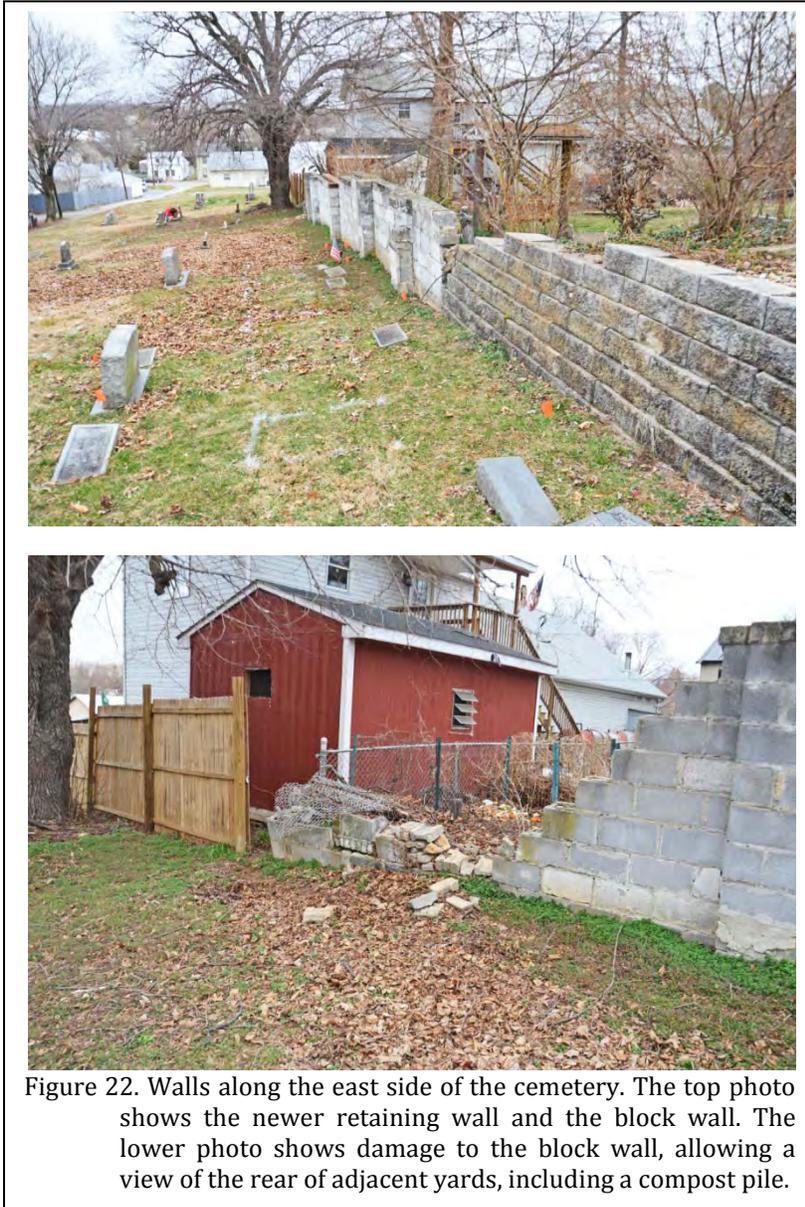
Figure 22. Walls along the east side of the cemetery. The top photo shows the newer retaining wall and the block wall. The lower photo shows damage to the block wall, allowing a view of the rear of adjacent yards, including a compost pile.

appropriate and do little to screen the cemetery from adjacent structures and activities. Structures to the north and west are not screened at all. This certainly affects the landscape character and visitor experience.

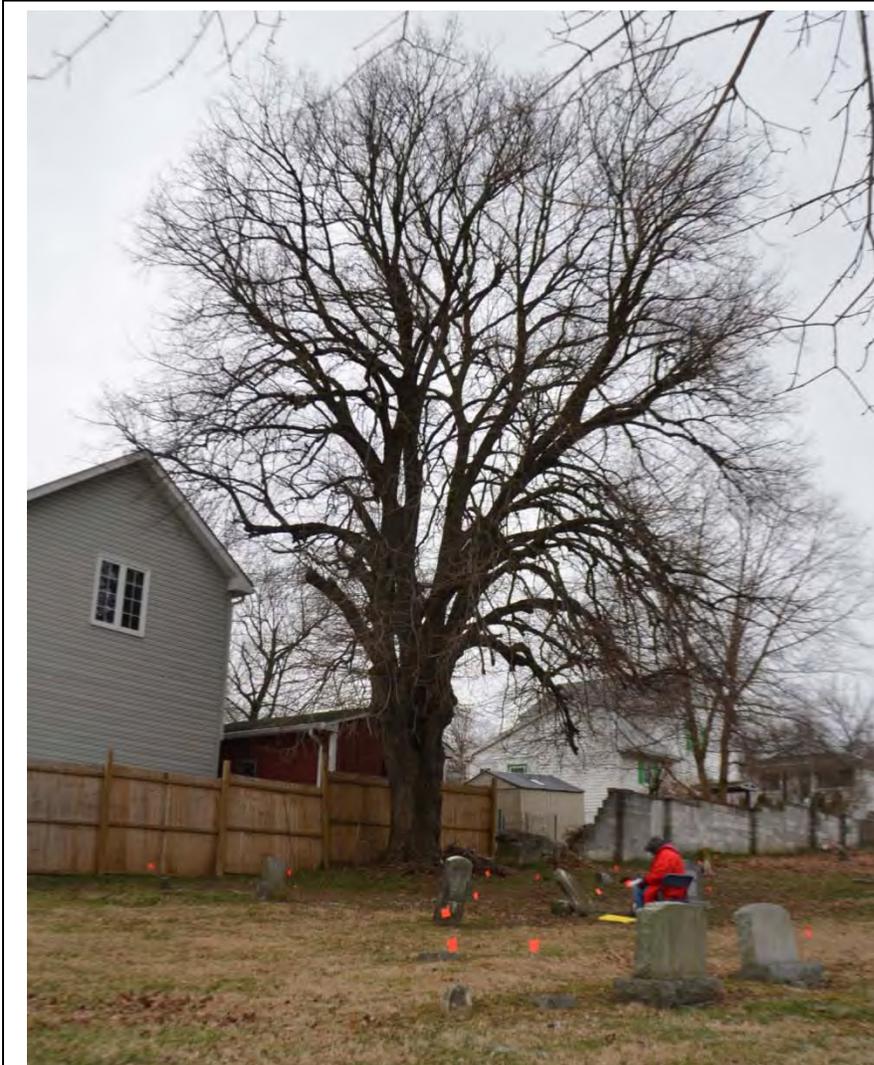
Figure 24. Maple along the east edge of the cemetery. Note damaged branches, crossed branches, and the need for pruning by a certified arborist.

for either thinning or cleaning. Thinning is a technique of pruning that removes selected branches to increase light and air movement through the crown. This also decreases weight on heavy branches. The natural shape of the tree is retained and its overall health is improved. In cleaning, the pruning removes branches that are dead, dying, diseased, crowded, broken, or otherwise defective.

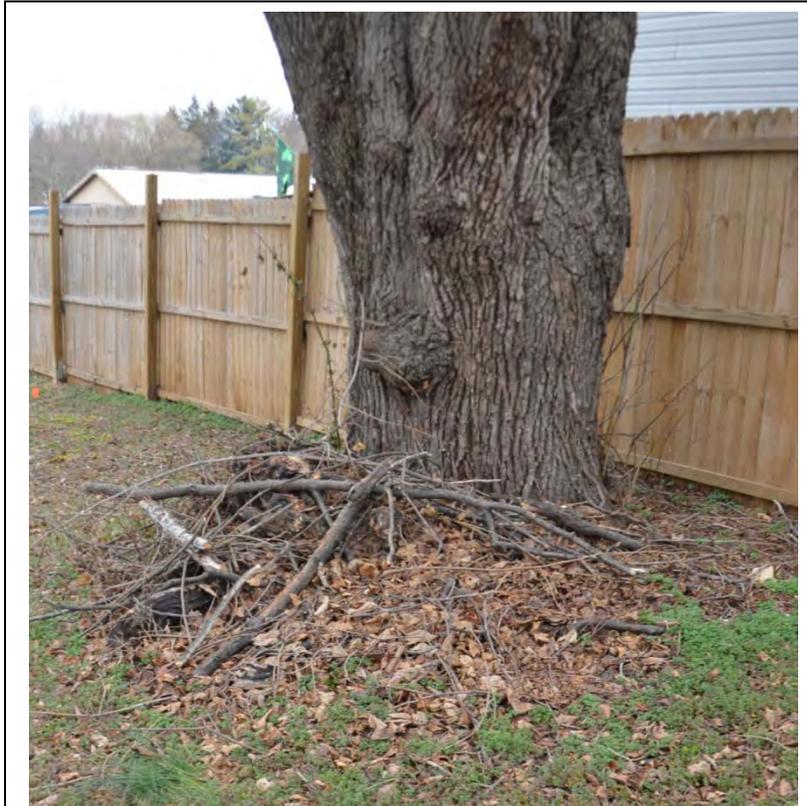
Figure 25. Branches and limbs stacked at the base of the maple should be immediately removed. Picking up and disposing of downed branches should be part of every mowing.

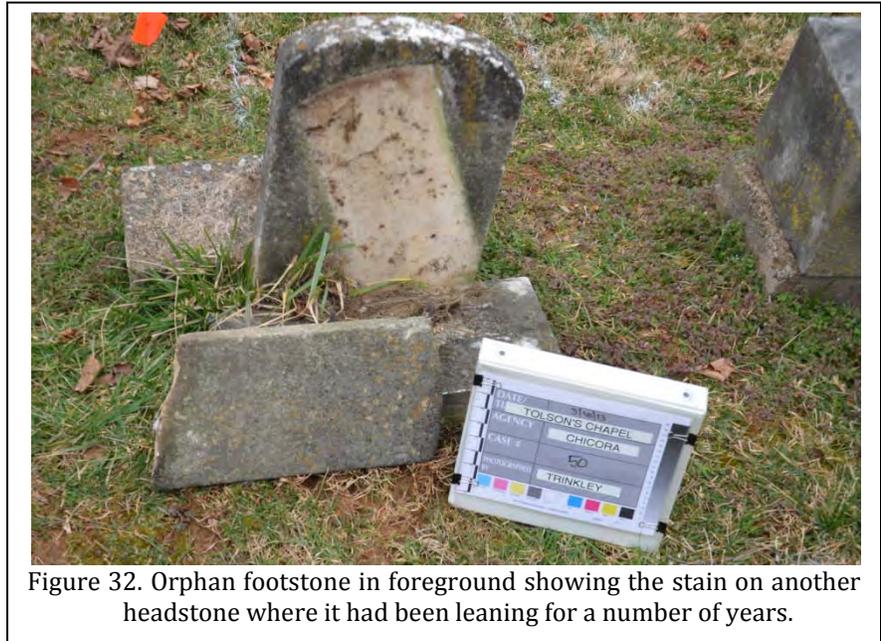
Figure 32. Orphan footstone in foreground showing the stain on another headstone where it had been leaning for a number of years.

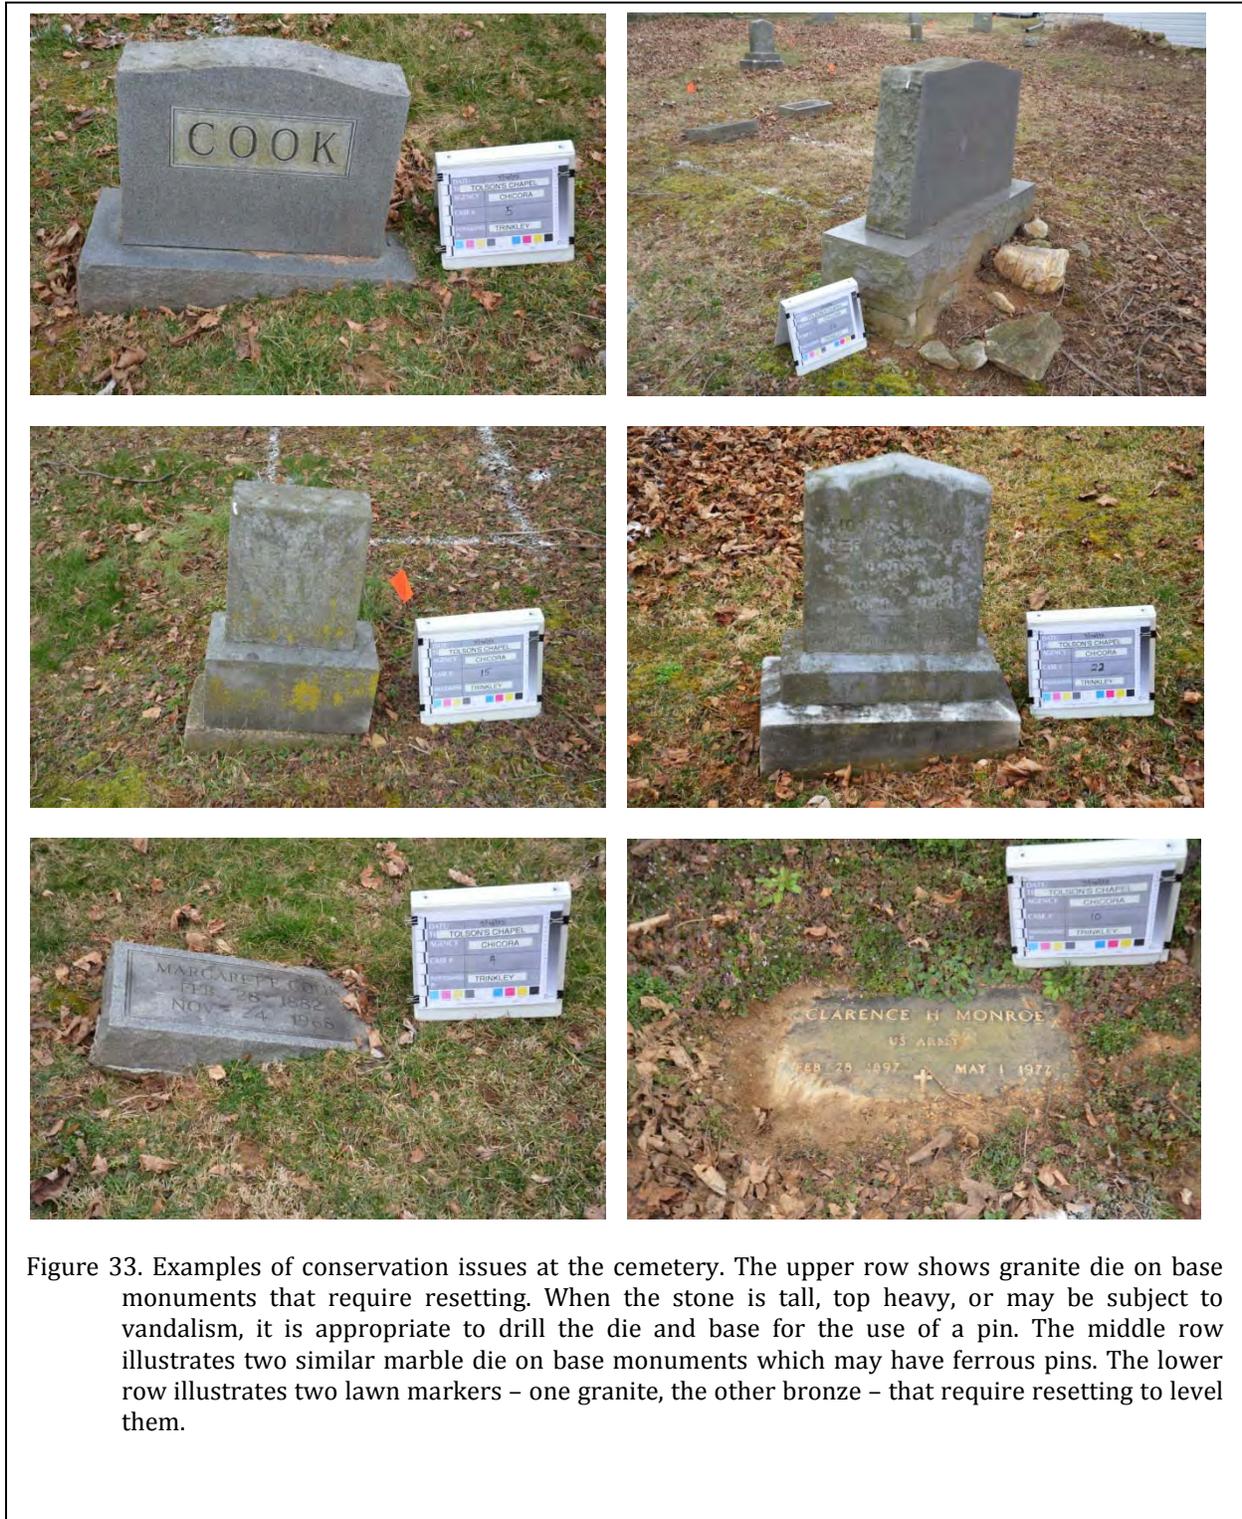
Figure 33. Examples of conservation issues at the cemetery. The upper row shows granite die on base monuments that require resetting. When the stone is tall, top heavy, or may be subject to vandalism, it is appropriate to drill the die and base for the use of a pin. The middle row illustrates two similar marble die on base monuments which may have ferrous pins. The lower row illustrates two lawn markers – one granite, the other bronze – that require resetting to level them.

The stone should be excavated, being careful to avoid shovel damage. There are some lawn markers that have been set in concrete and the removal of this material may require a conservator to ensure that the stone itself isn’t damaged. Otherwise, the hole can be deepened

and filled with pea gravel or decomposed granite as bedding. The lawn marker should be reset about 1 inch above the ground level – tall enough to prevent being covered by soil and grass, but not so tall that it will be damaged by mowing. Additional pea gravel should be packed in around the stone as it is being leveled. The upper inch of backfill should be soil to allow for revegetation.

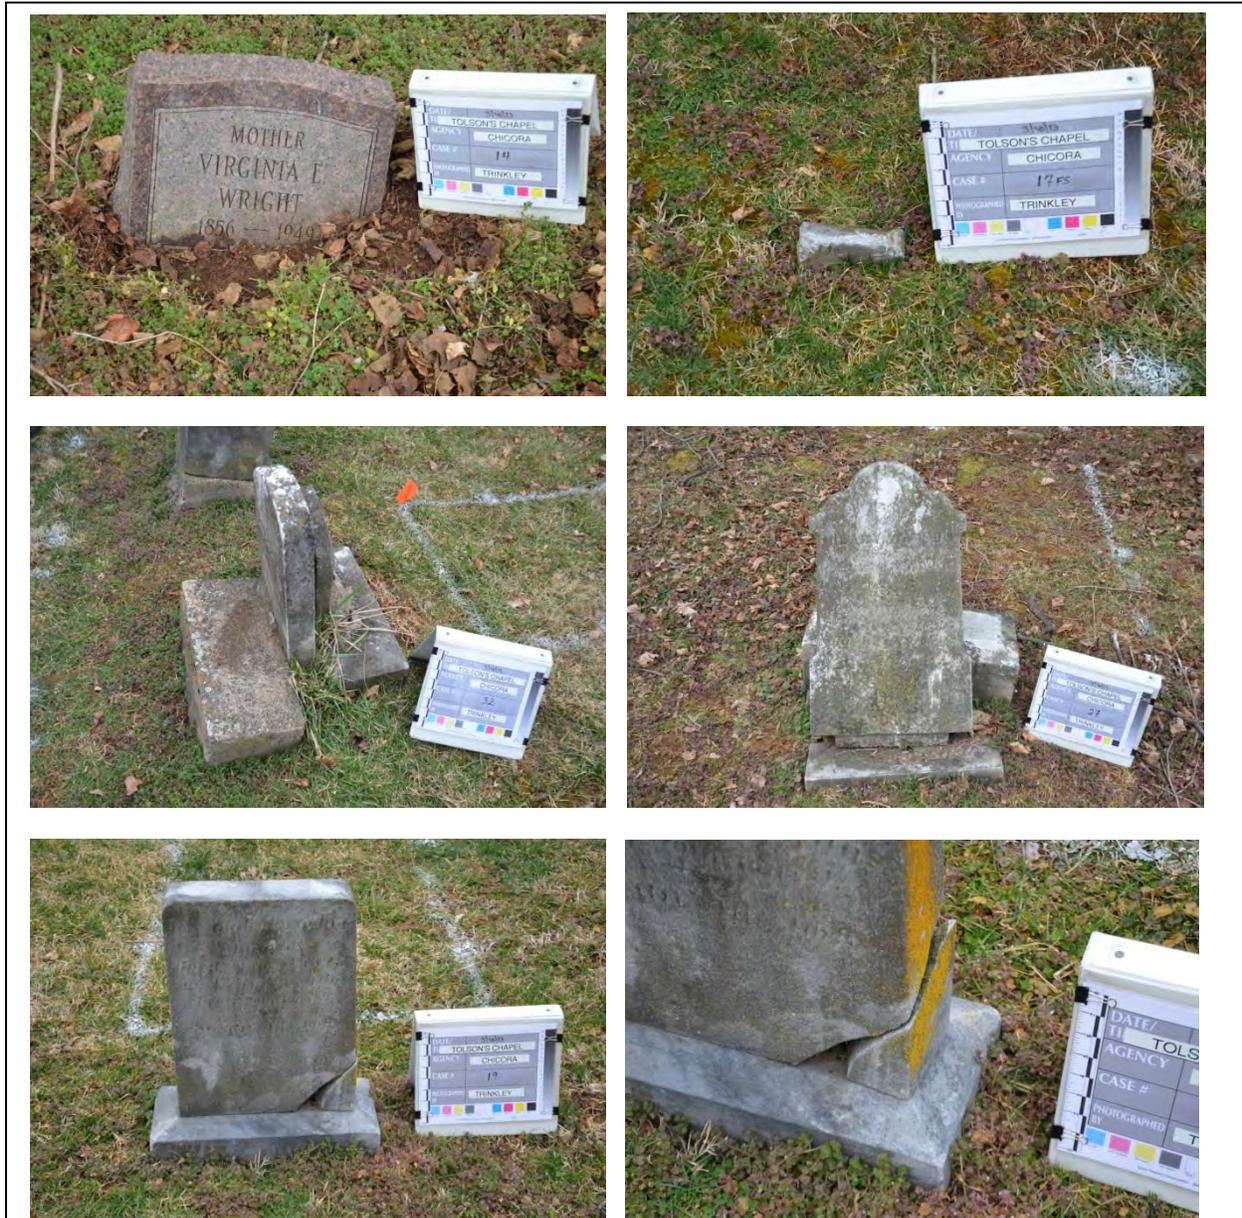
Some die on base stones were observed that had been set using ferrous pins to join the die and base. These stones should be given a high treatment priority since, left untreated, the corrosion of the ferrous pin will cause significant spalling, cracking, and breakage of the stones – a process known as “iron jacking.” The corrosion products of these ferrous pins have a greater volume than the original pin and as the corrosion products expand, they crack the stone.

Figure 34. Examples of conservation issues at the cemetery. The upper row shows a granite plaque stone on the left and a marble footstone on the right that require resetting to level and ensure they are at the correct height. The middle row left stone is broken and requires drilling and pinning. The middle row right stone is a marble tab in socket that simply requires resetting using a lime-based mortar. The bottom row shows a stone where the ferrous pin has caused iron jacking, spalling off the marble corner. Such stones require that the ferrous pin(s) be drilled out and replaced with a fiberglass or 316 stainless steel pin.

It is necessary to use diamond core drills to remove the corroded ferrous pins and replace them with either fiberglass or, rarely, stainless steel. Afterwards it is necessary to fill the voids with a natural cementitious composite stone material such as that previously described for infill repairs.

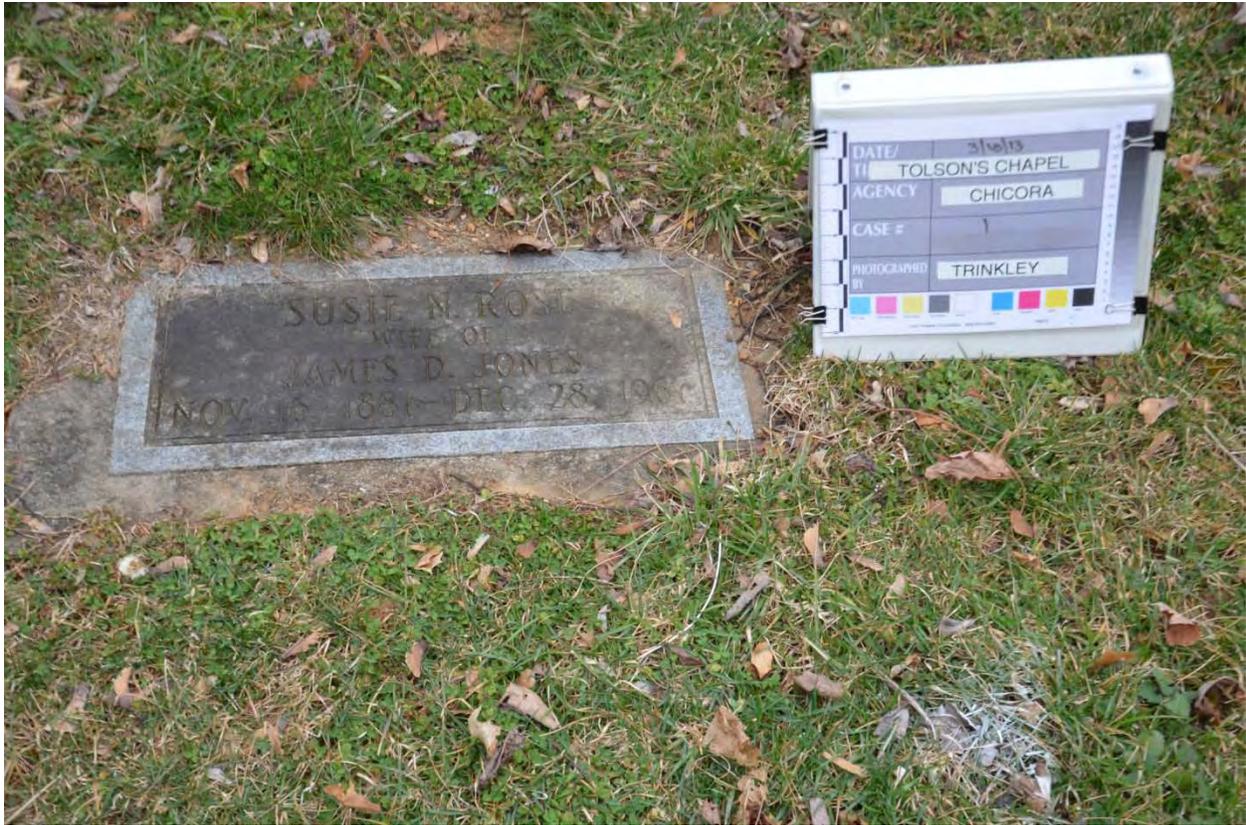
DATE/TIME	
TOLSON'S CHAPEL	
AGENCY	
CHICORA	
CASE #	
1	
PHOTOGRAPHER BY	
TRINKLEY

**Priority:** 3      1) hazardous, immediate action; 2) unstable, requires treatment ASAP; 3) ongoing deterioration, treatment required 2-3 years; 4) re-inspect in 5-10 years; 5) irreparable      **Cost:** \$75

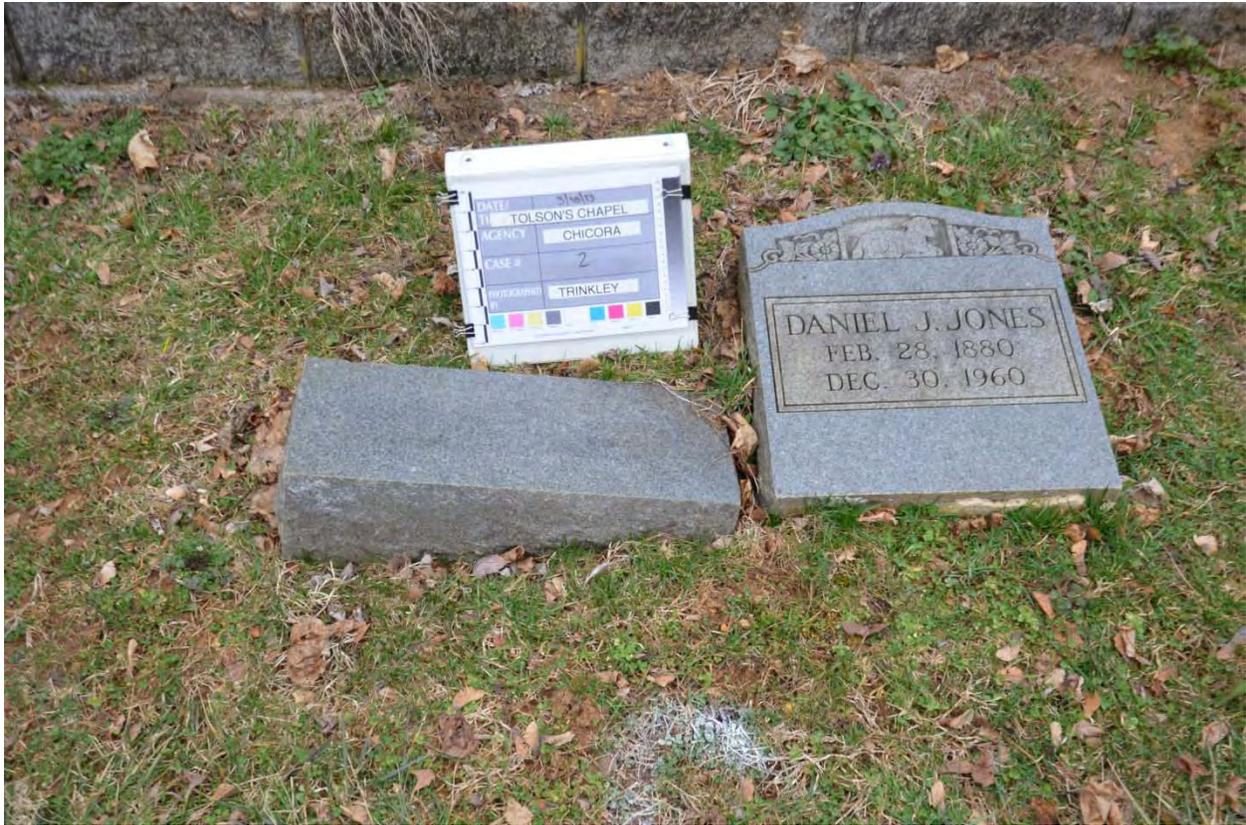
DATE:	9/16/10
CHURCH:	TOLSON'S CHAPEL
AGENCY:	CHICORA
CASE #:	2
PHOTOGRAPHER:	TRINKLEY

**Priority:** 3      1) hazardous, immediate action; 2) unstable, requires treatment ASAP; 3) ongoing deterioration, treatment required 2-3 years; 4) re-inspect in 5-10 years; 5) irreparable      **Cost: \$218**

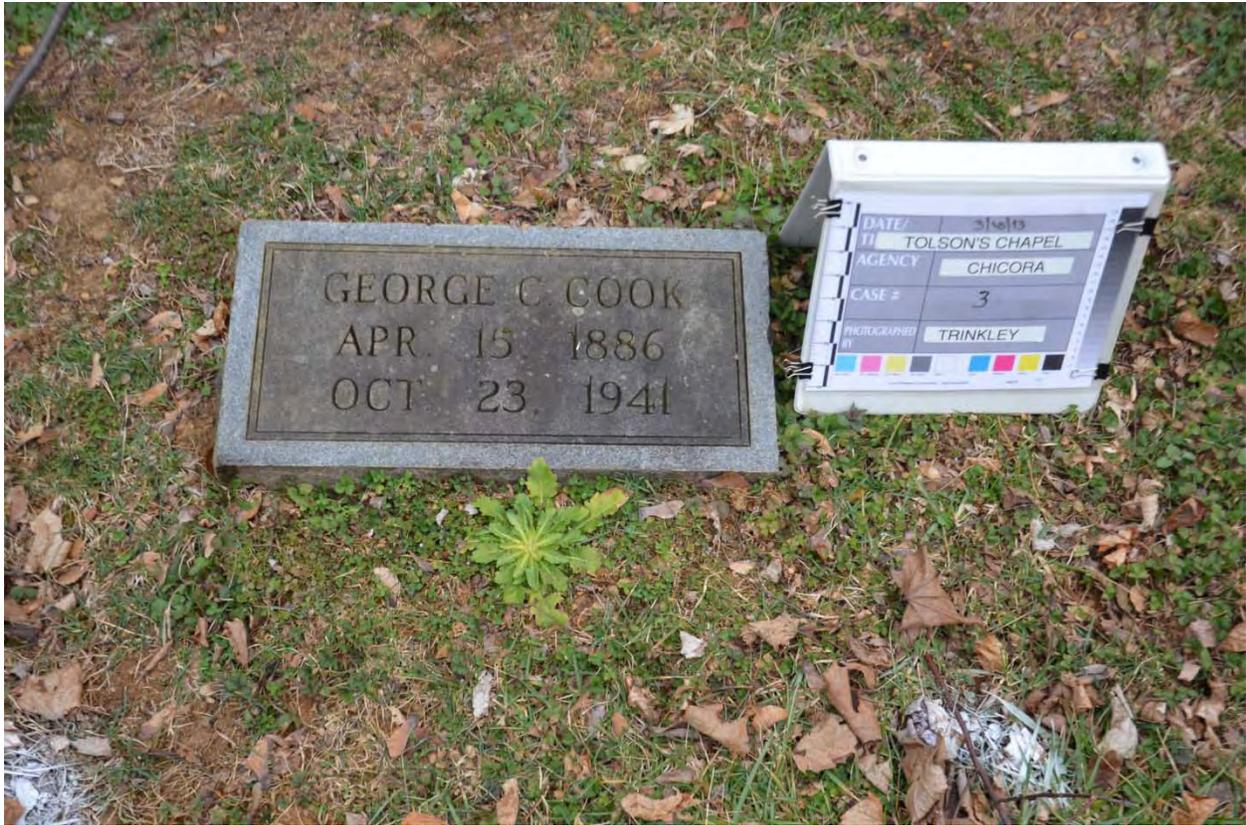
DATE/TI	3/6/18
AGENCY	TOLSON'S CHAPEL
CASE #	CHICORA
PHOTOGRAPHER BY	3
	TRINKLEY

**Priority:** 3      1) hazardous, immediate action; 2) unstable, requires treatment ASAP; 3) ongoing deterioration, treatment required 2-3 years; 4) re-inspect in 5-10 years; 5) irreparable      **Cost:** \$75

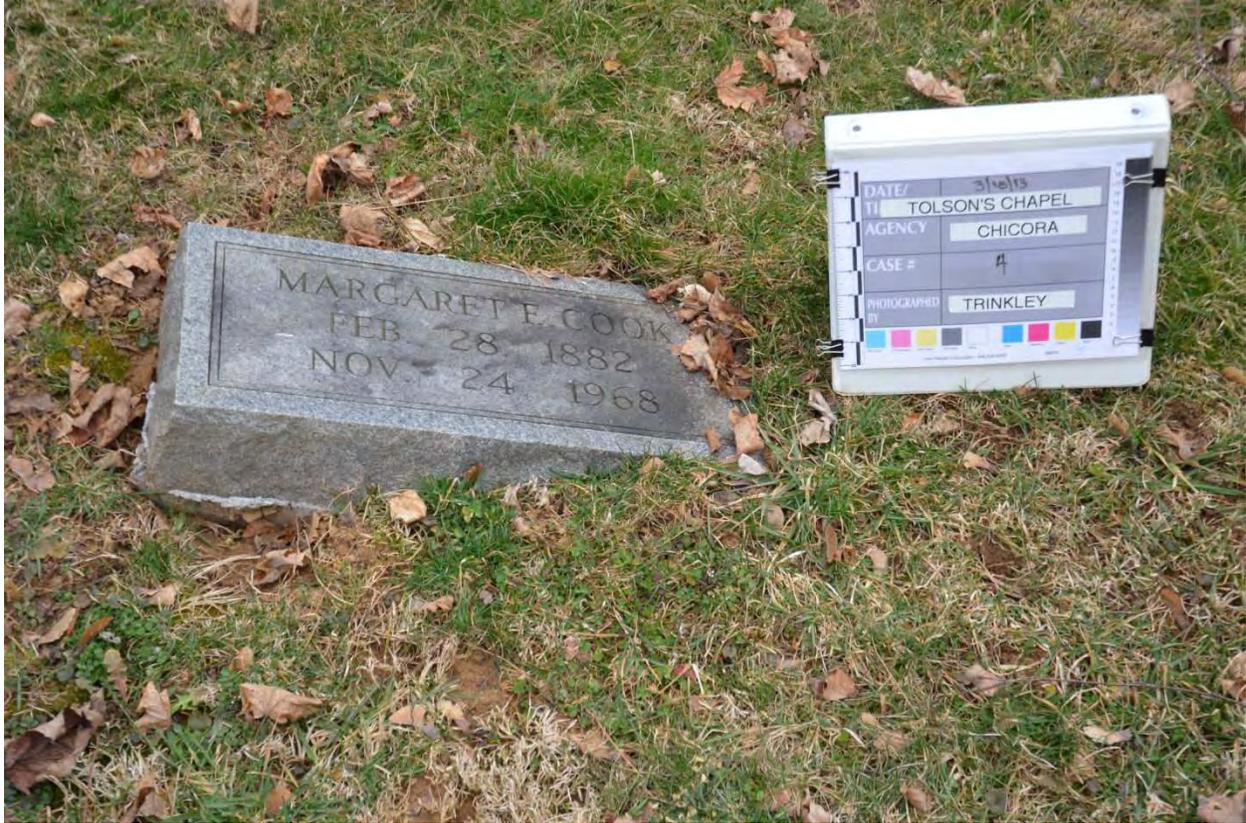
DATE/	3/10/13
TT	TOLSON'S CHAPEL
AGENCY	CHICORA
CASE #	4
PHOTOGRAPHER BY	TRINKLEY

**Priority:** 3      1) hazardous, immediate action; 2) unstable, requires treatment ASAP; 3) ongoing deterioration, treatment required 2-3 years; 4) re-inspect in 5-10 years; 5) irreparable      **Cost:** \$275

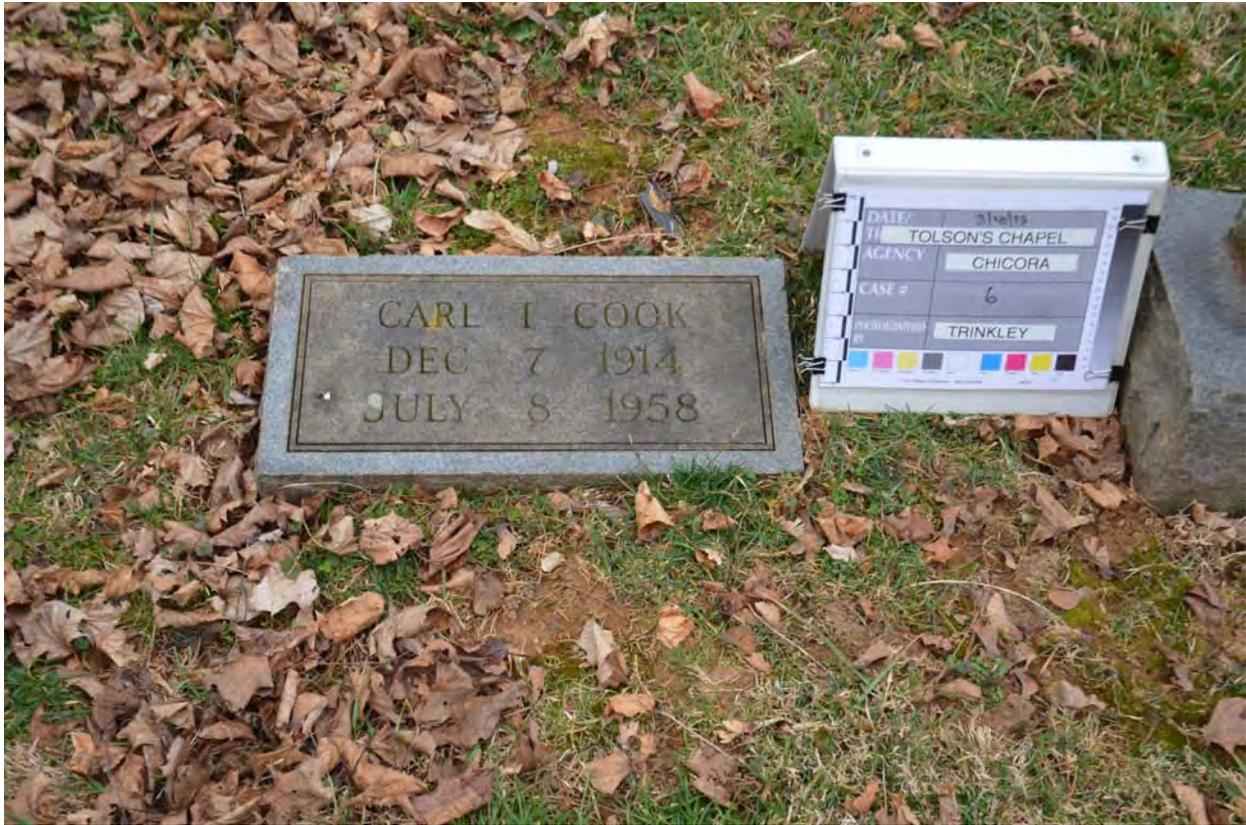
DATE:	5/16/13
TOLSON'S CHAPEL	
AGENCY:	CHICORA
CASE #:	6
TRINKLEY

**Priority:** 4      1) hazardous, immediate action; 2) unstable, requires treatment ASAP; 3) ongoing deterioration, treatment required 2-3 years; 4) re-inspect in 5-10 years; 5) irreparable      **Cost:** n/c

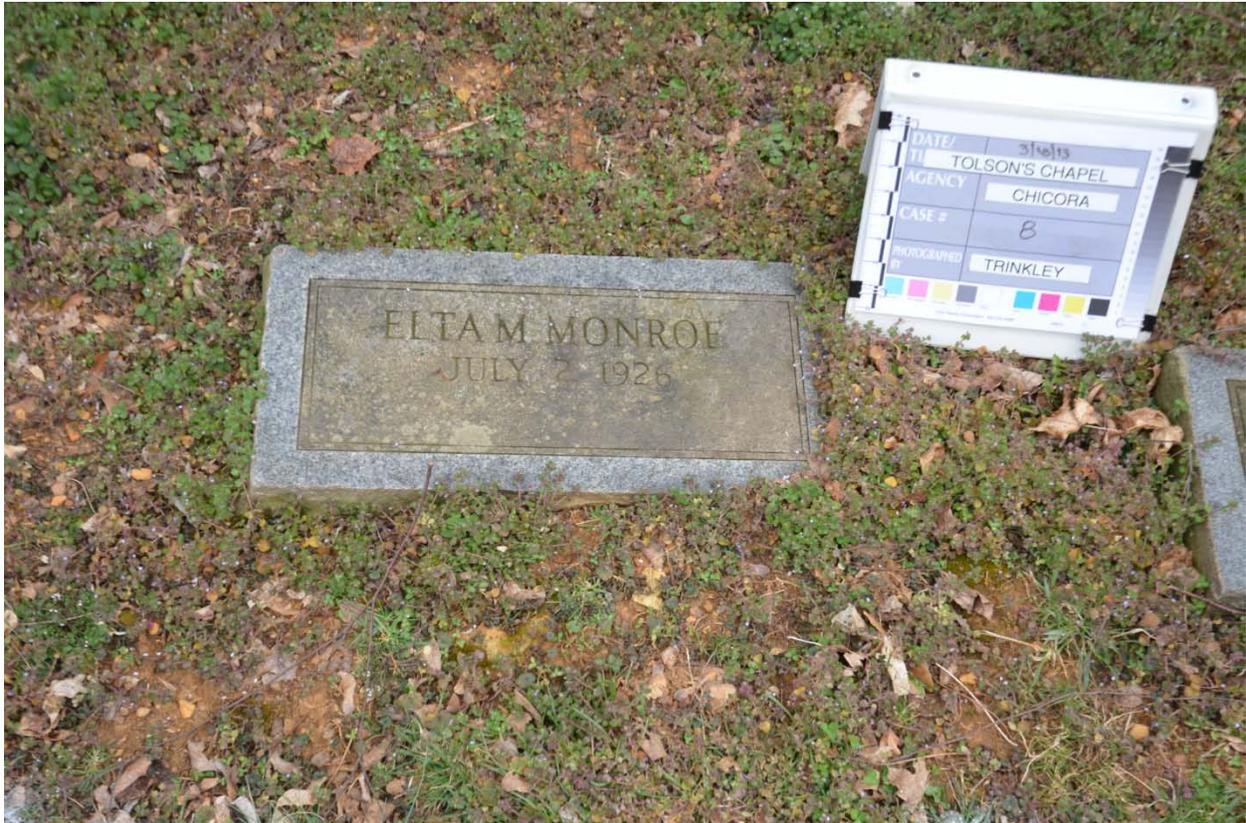
DATE/TIME	3/4/19
AGENCY	TOLSON'S CHAPEL
CASE #	CHICORA
PHOTOGRAPHER	B TRINKLEY

**Priority:** 3      1) hazardous, immediate action; 2) unstable, requires treatment ASAP; 3) ongoing deterioration, treatment required 2-3 years; 4) re-inspect in 5-10 years; 5) irreparable      **Cost:** \$75
