PRESERVATION ASSESSMENT OF THE LYNNHAVEN HOUSE CEMETERY, VIRGINIA BEACH, VIRGINIA

Preservation Assessment of the Lynnhaven House Cemetery, Virginia Beach, Virginia

Prepared By:
Michael Trinkley, Ph.D.
and
Debi Hacker

August 2013

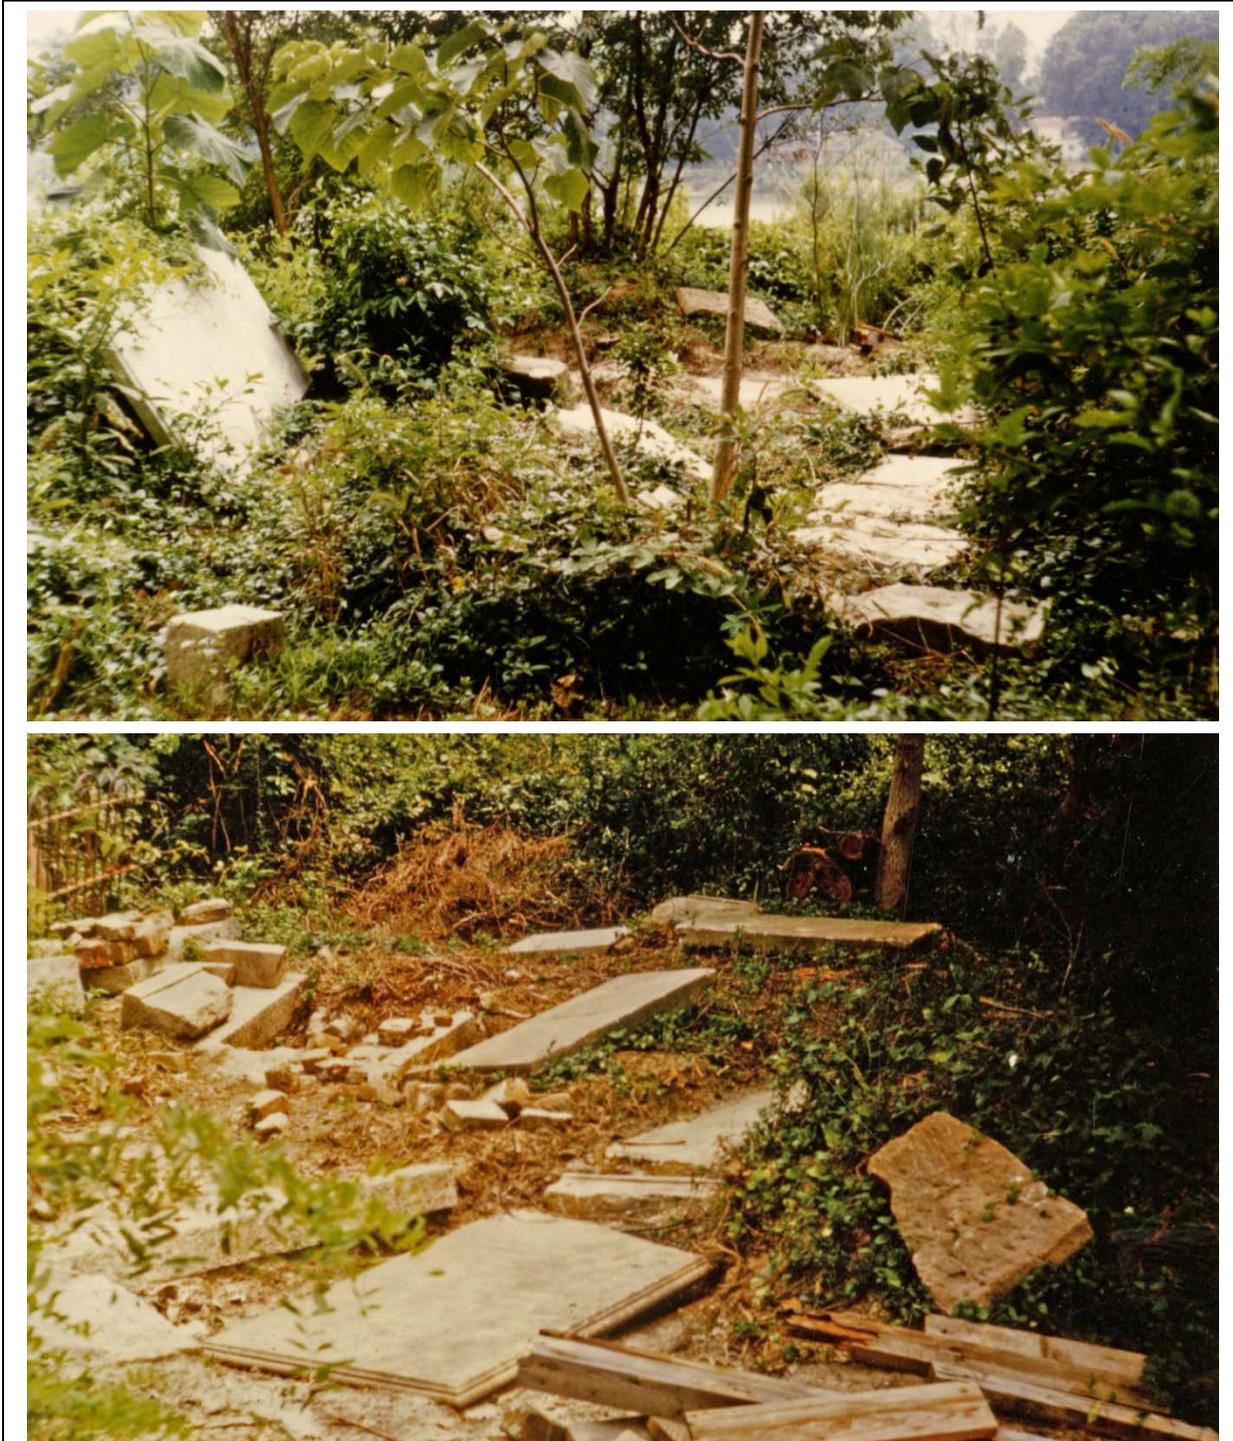
Figure 9. Condition of the Lynnhaven House Cemetery in July 1975. The upper photograph shows the cemetery, probably after clearing, looking south toward the man-made Lake Wishart. The lower photograph shows the cemetery looking east (City of Virginia Beach Department of Museums).

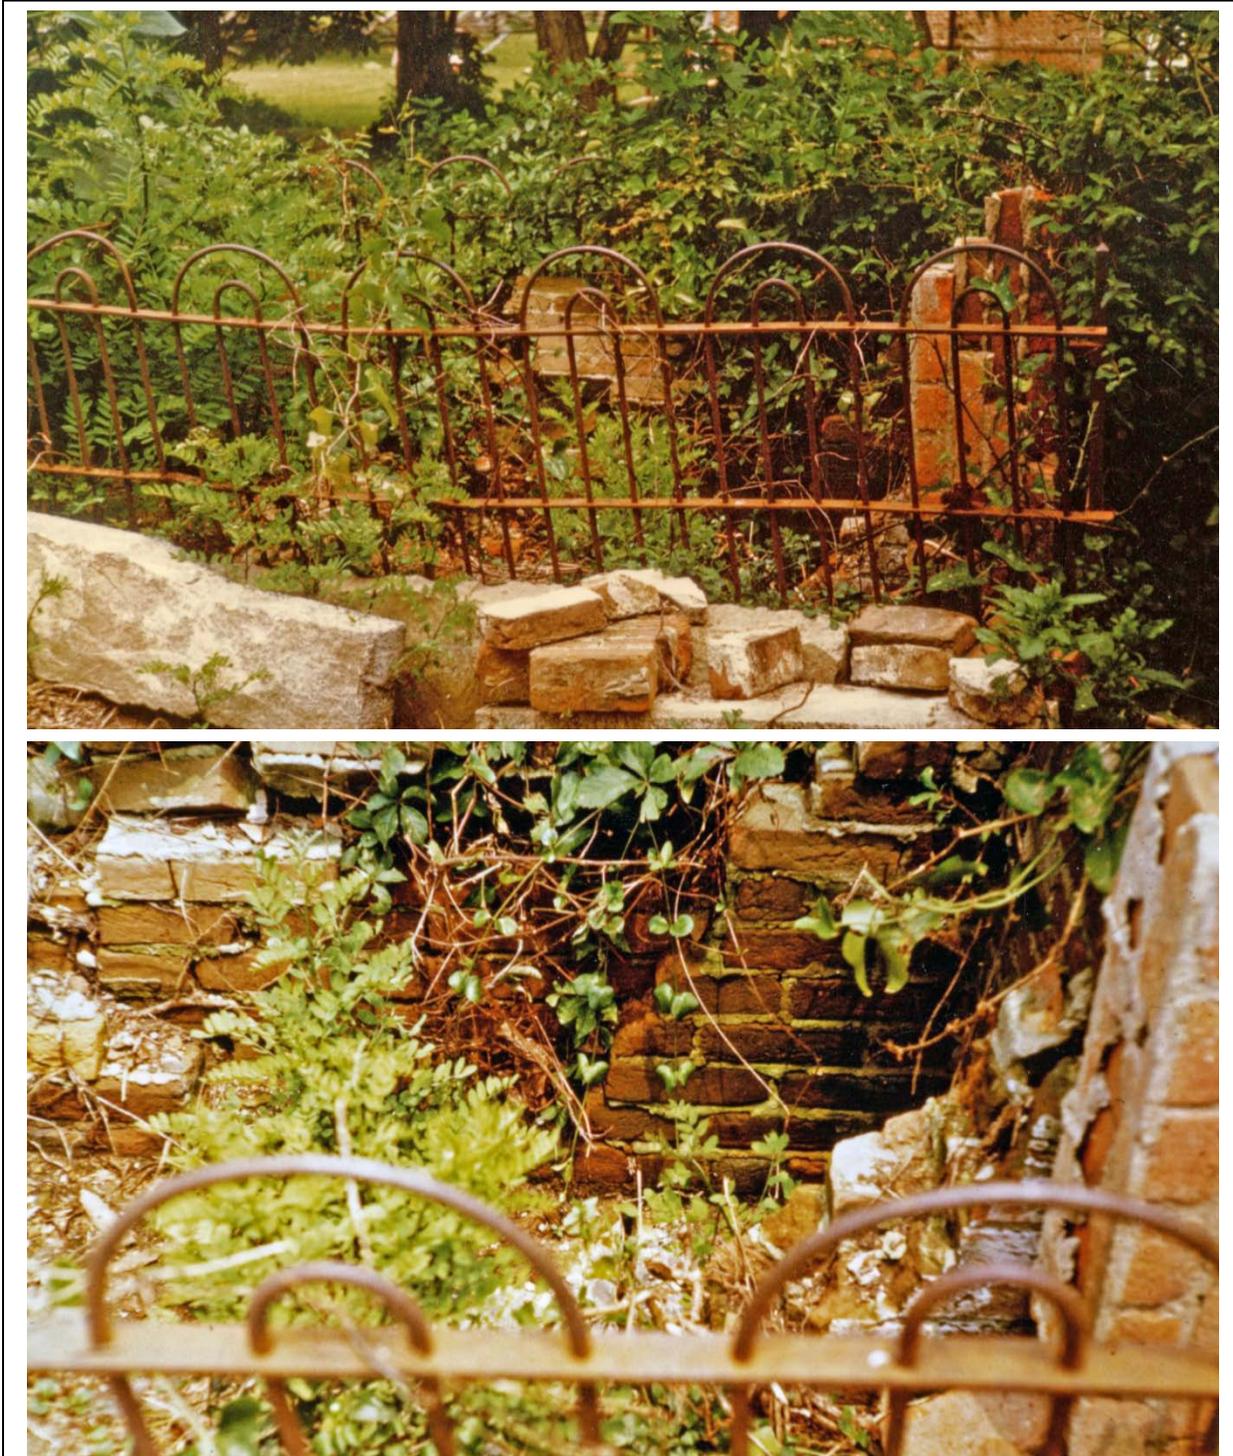
Figure 10. Condition of the brick box tomb and fence in July 1975. The upper photograph is looking north toward the house (in the background). The lower photograph is a close-up of damage (City of Virginia Beach Department of Museums).

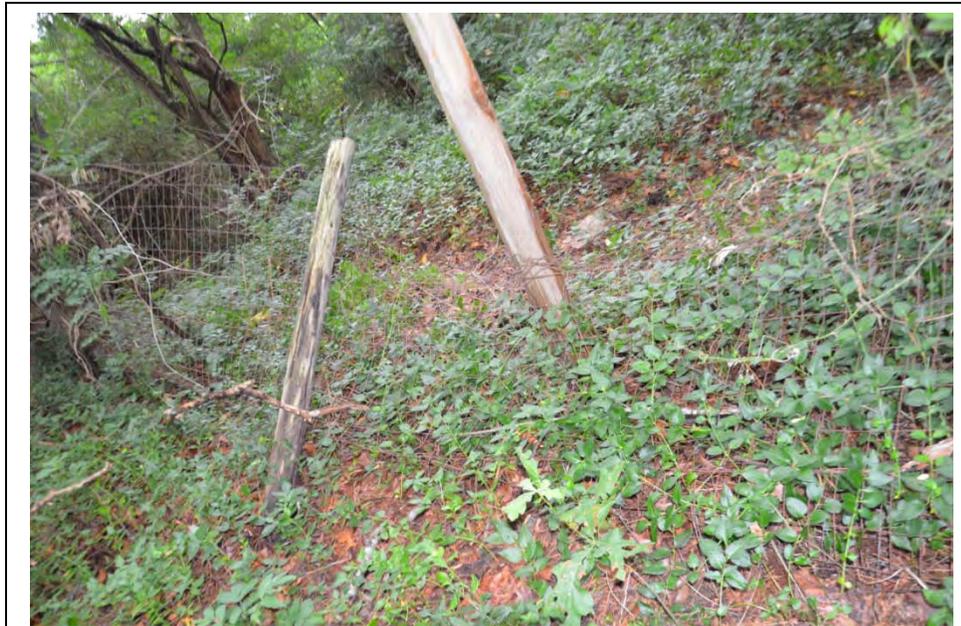
Figure 20. Dilapidated fence at the boundary between the cemetery and Wishart Lake. This fence should be replaced.

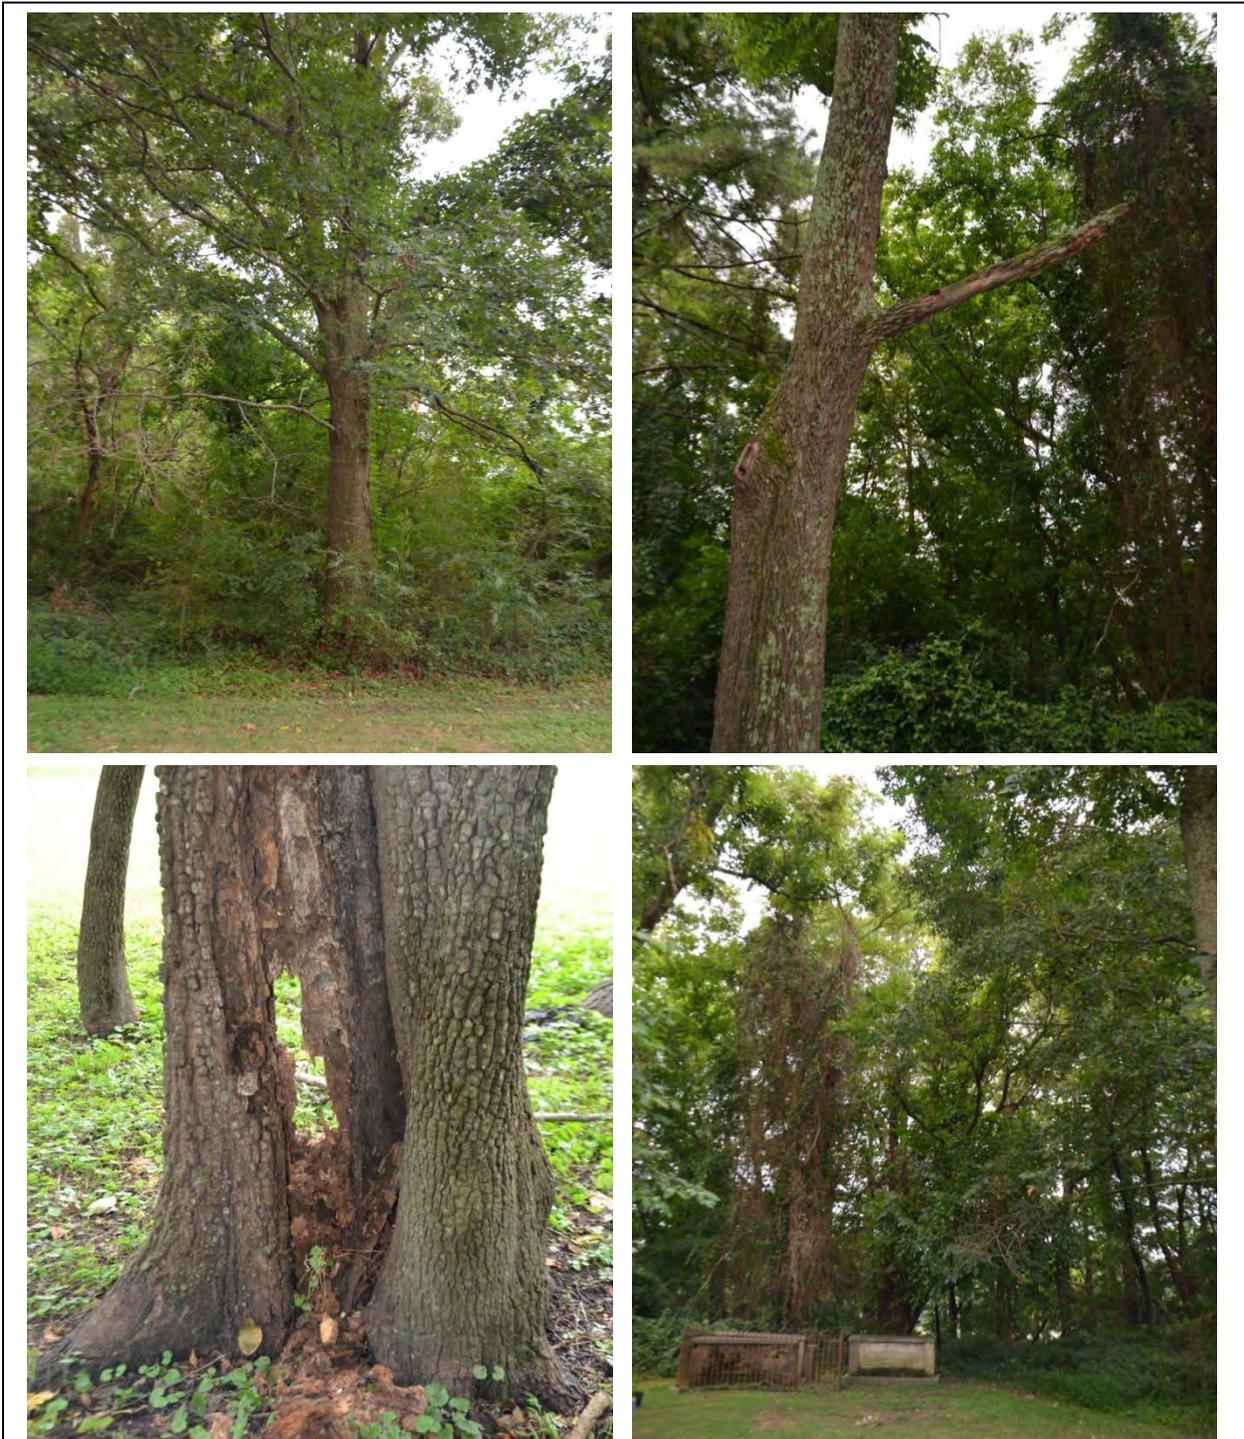
Figure 22. Tree problems. The upper photographs show deadwood and the need for pruning. Lower left photo shows a hickory that requires removal. Lower right photograph shows trees south of the cemetery overtaken with vines. These trees, predominately cherry laurels, should be removed.

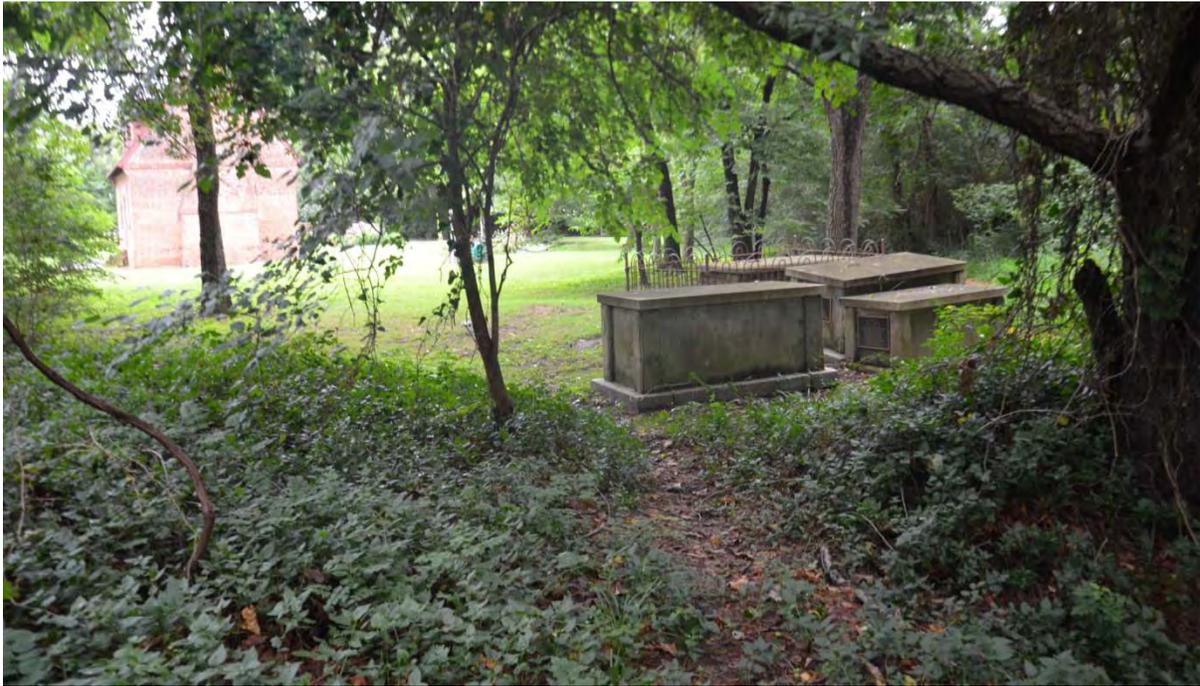
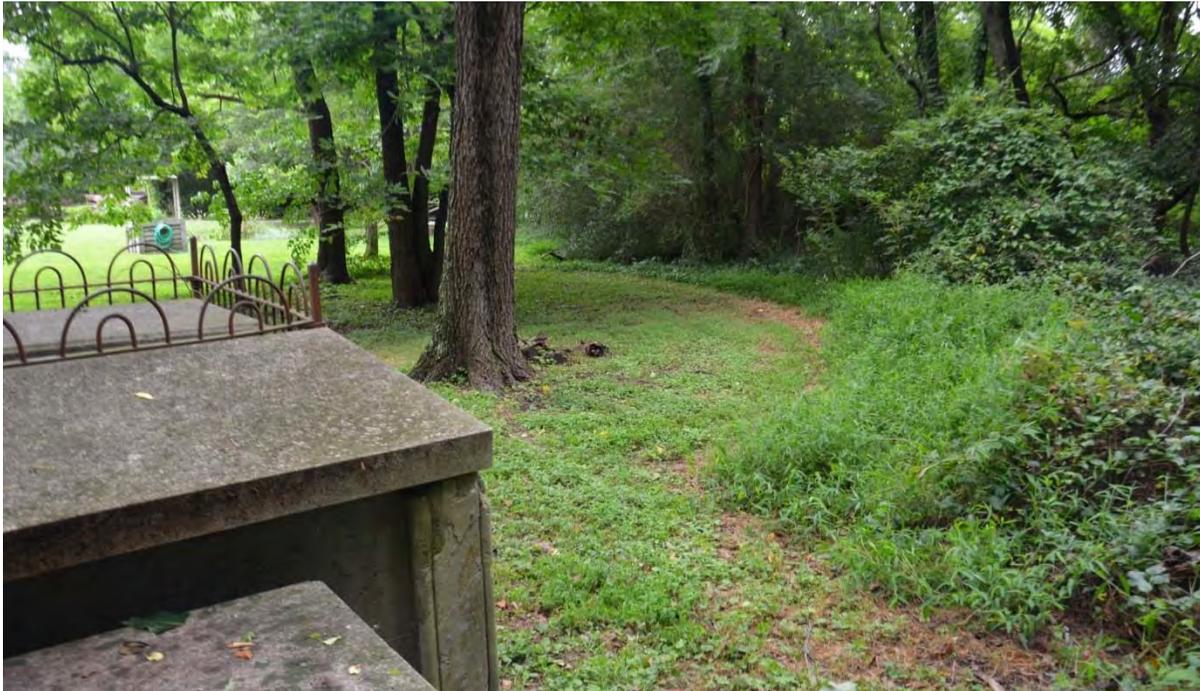
Figure 23. Vegetation requiring removal from around the cemetery. These photographs show the vegetation on the south, east, and west sides that should be pushed back to open the cemetery, giving it a more pleasing and attractive appearance to visitors.

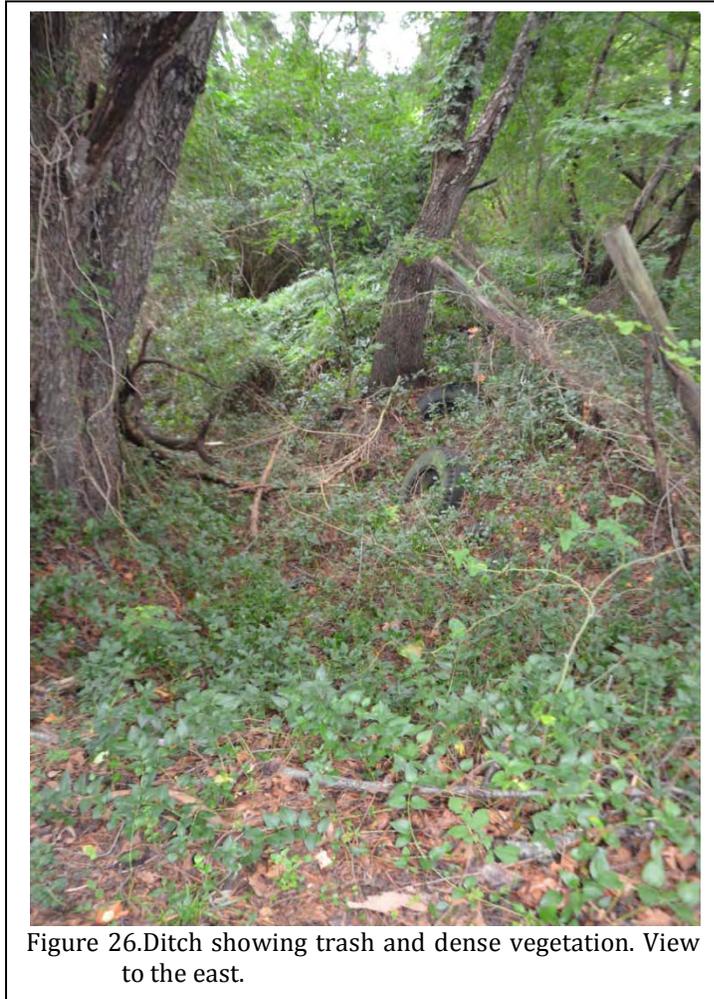
We did observe trash in the ditch south of the cemetery, including tires and bottles (Figure 26).

Figure 26. Ditch showing trash and dense vegetation. View to the east.

As part of the efforts to reduce vegetation, we recommend that the ditch be cleaned. Trash should be removed and vegetation should be brought under control. Making this area look better and increasing visibility will also help reduce the potential for vandalism.

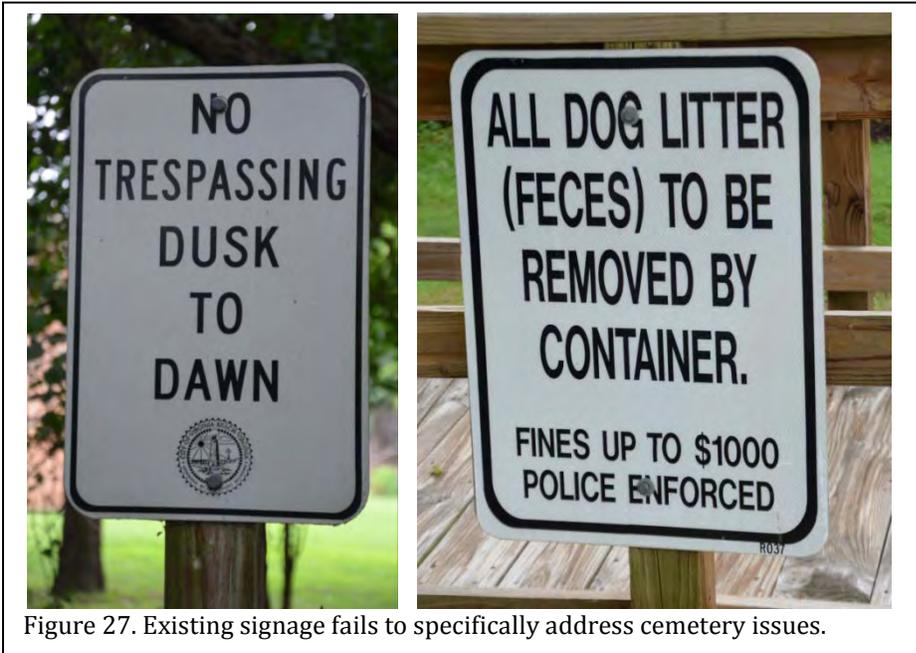
Figure 27. Existing signage fails to specifically address cemetery issues.

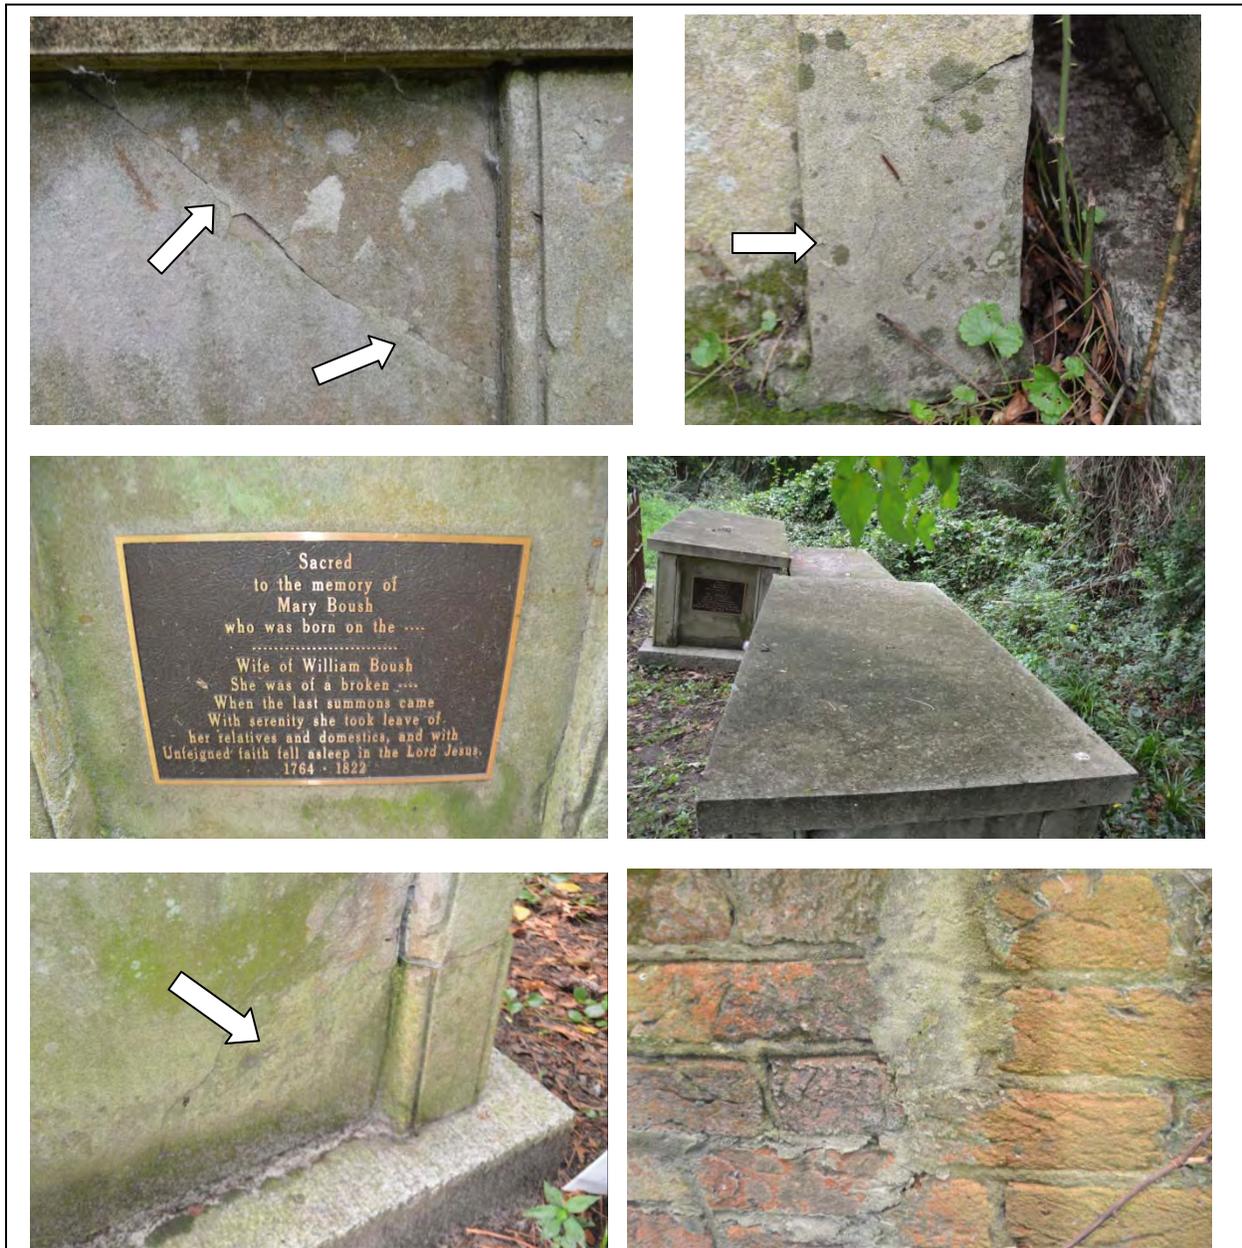
Figure 29. Conservation issues. Upper left photo shows a crack or break repaired with hard OPC mortar. Upper right photo shows OPC used as a patch. Middle left photo shows inappropriate mounting of plaques to the original sandstone box tomb. Middle right photo shows replacement cast stone ledger devoid of carving or artistry. Lower left photo shows spalling at the base of an end panel. Also visible is a repair using OPC of the support leg. Lower right photo shows poor brickwork.

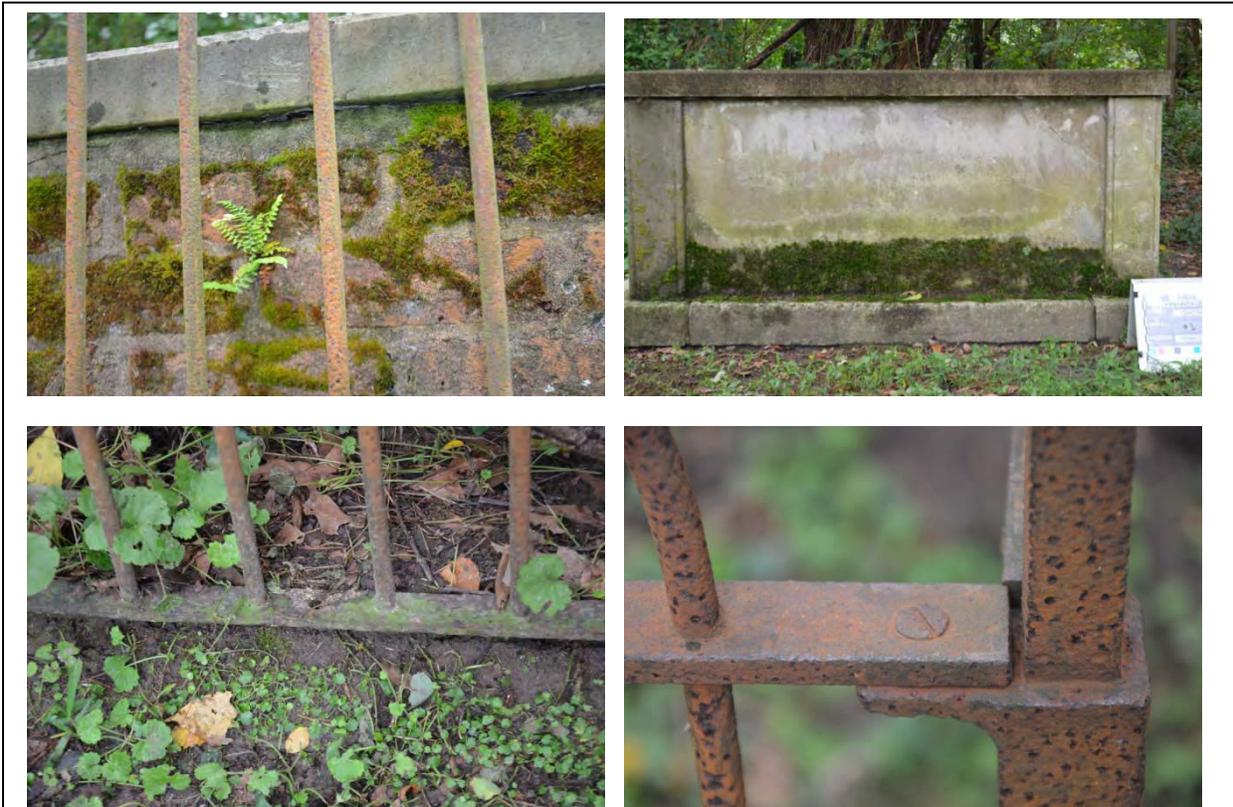
Figure 30. Conservation issues. The top row photos show extensive biologicals on both brickwork and the sandstone box tombs. These require cleaning with a biocide such as D/2. The bottom left photo shows the bottom rail of the Walke fence in the soil. This requires resculpting of the soil to provide additional clearance. The bottom right photo shows an absence of paint and pitting of the ironwork. This fence should be immediately painted to provide protection against additional corrosion.

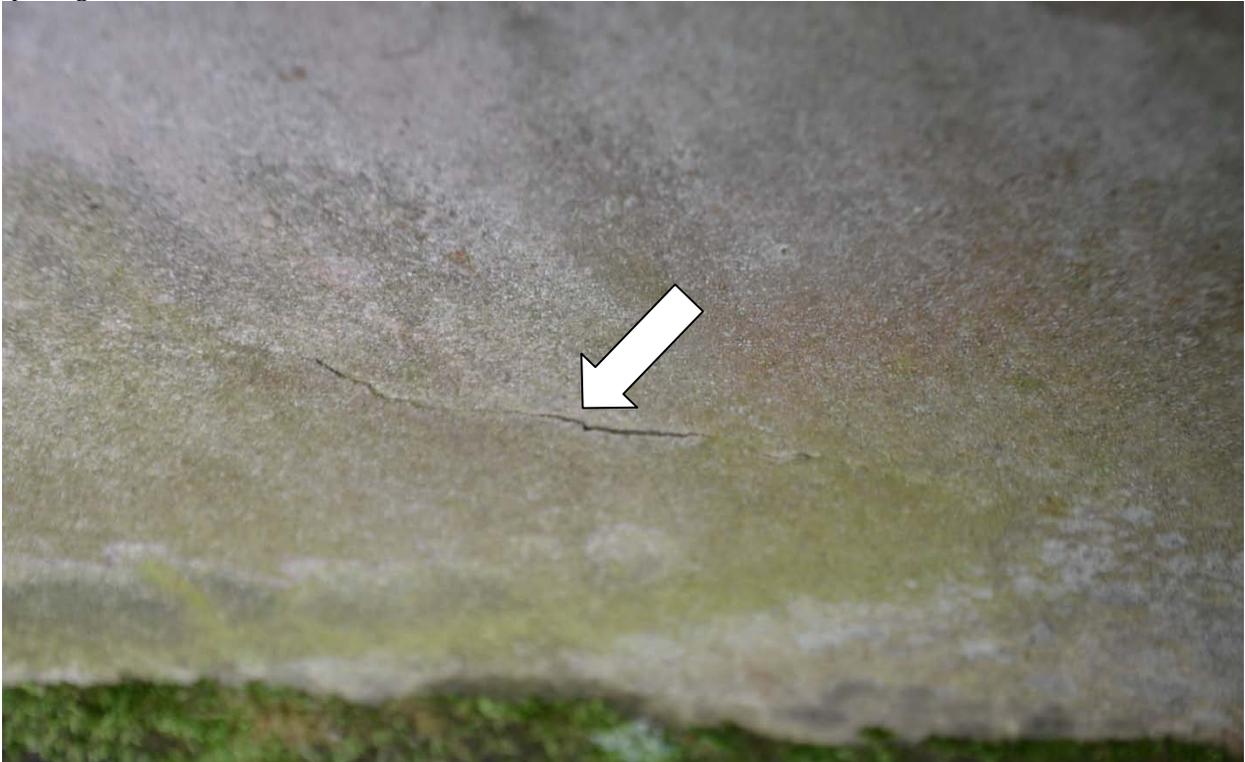
Spalling on north face:

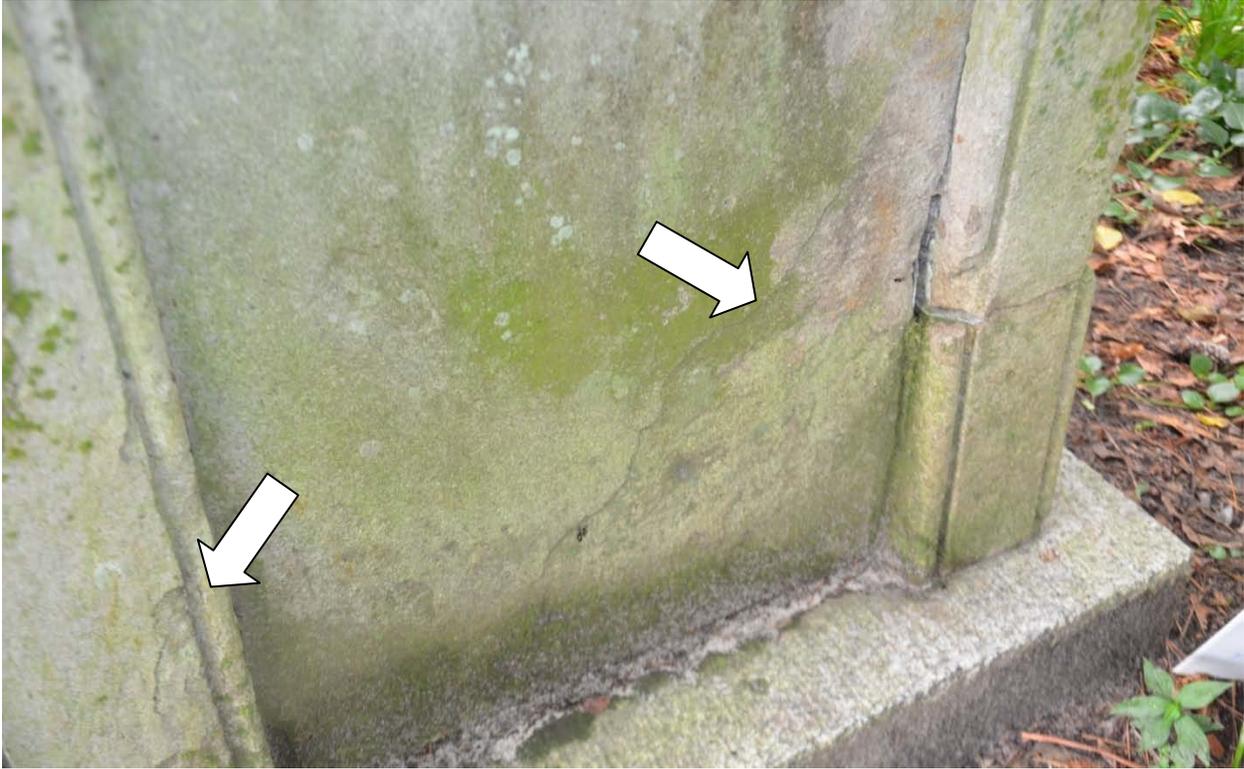
Spalling on west face:

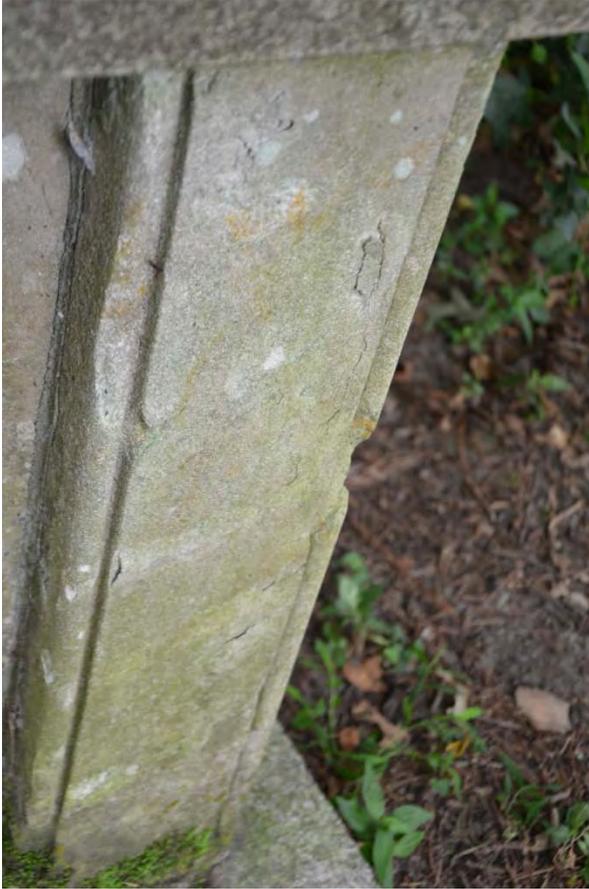
Spalling on northwest leg:

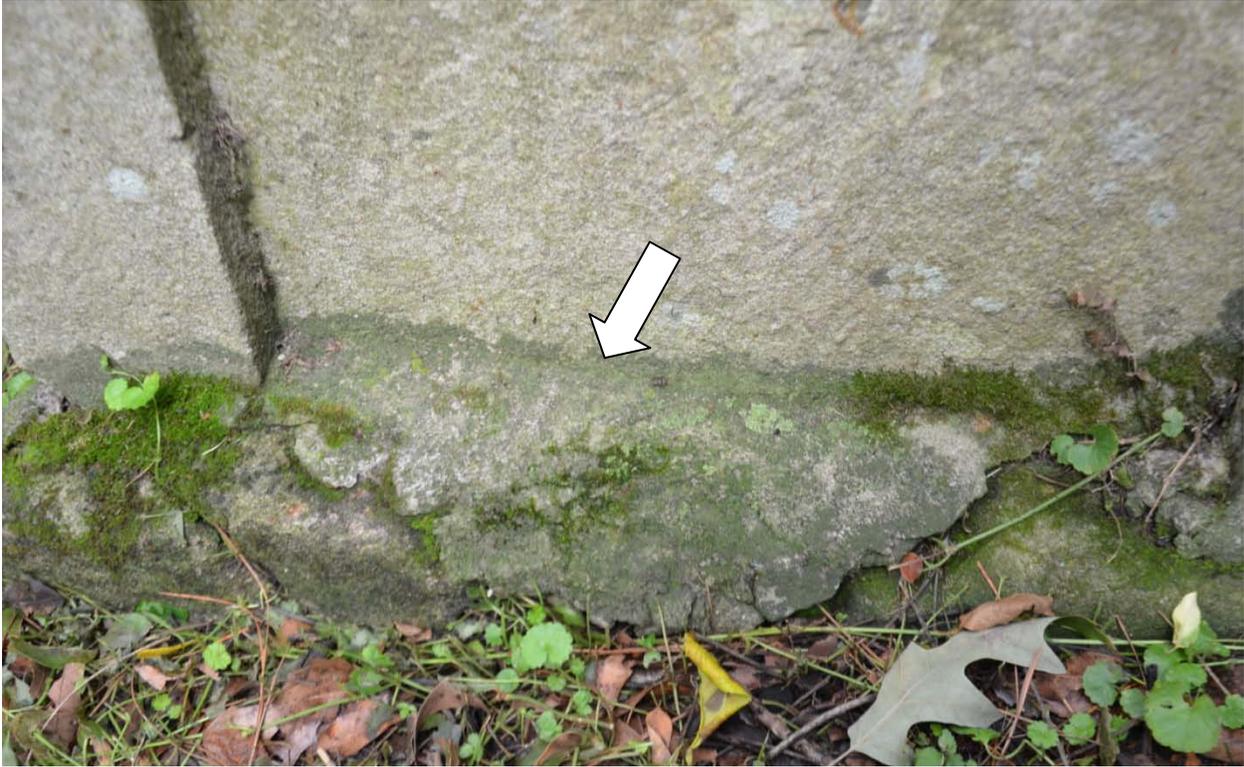
East side, southeast corner showing OPC repair:

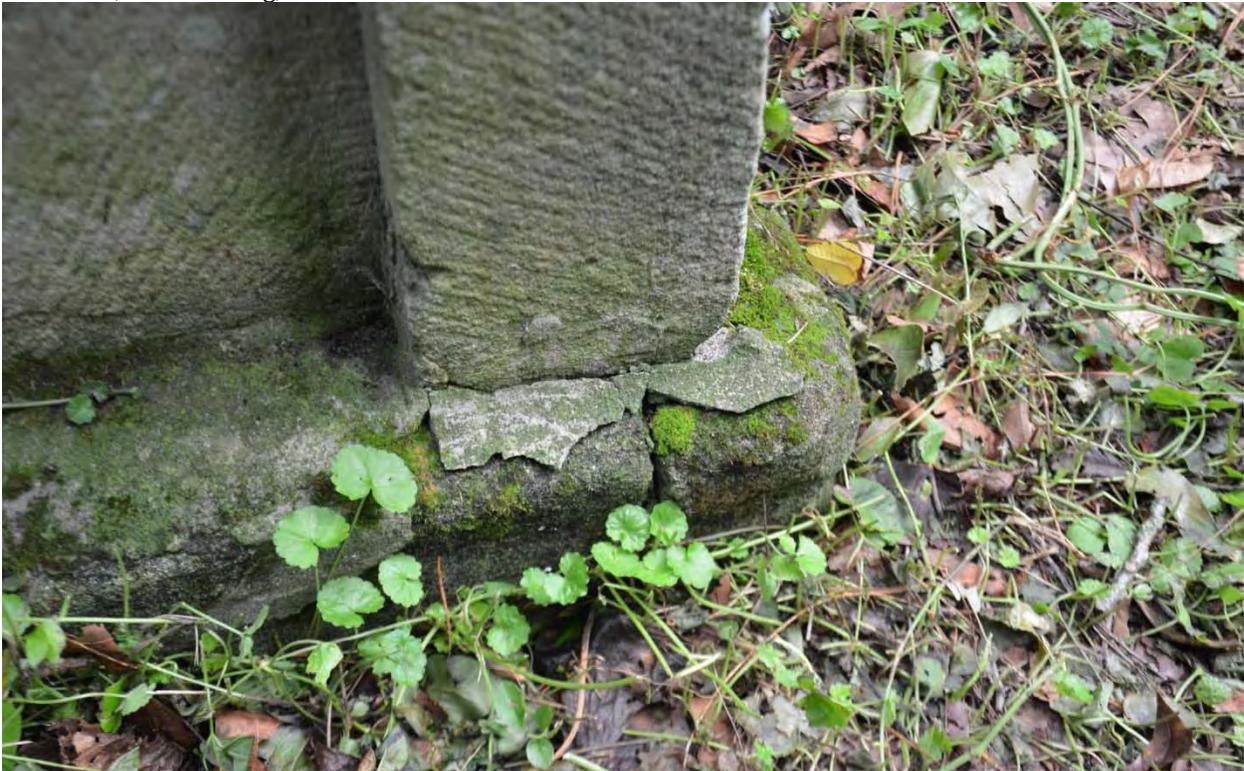
South side, southeast leg, set in OPC:

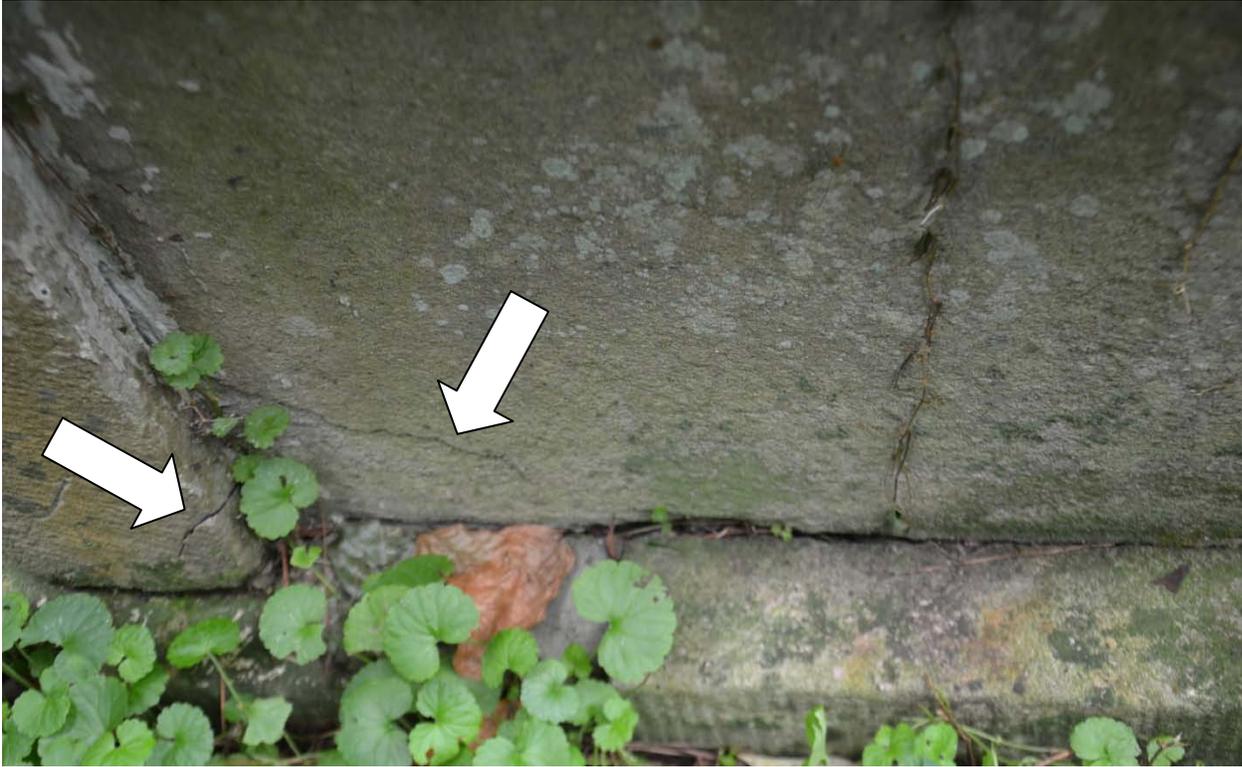
South side, southwest corner showing crack in corner support and spalling (note also vegetation):

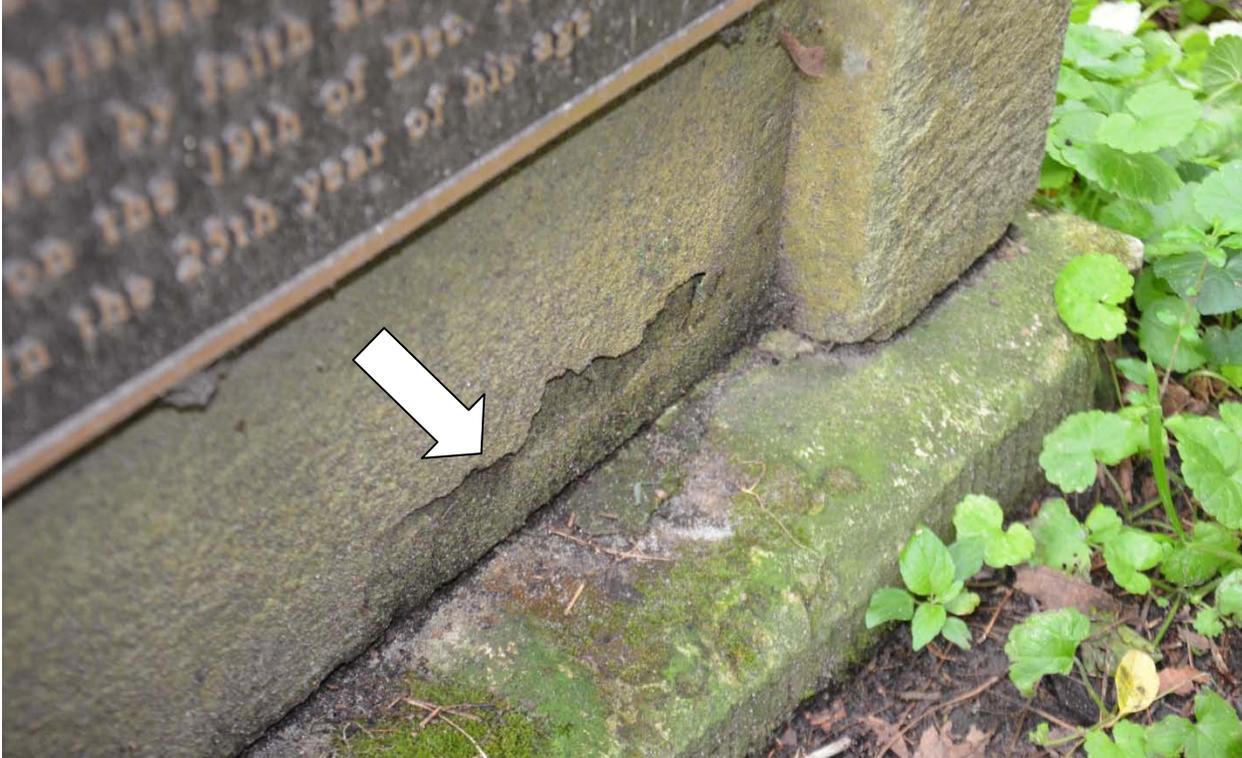
Spalling west side base:

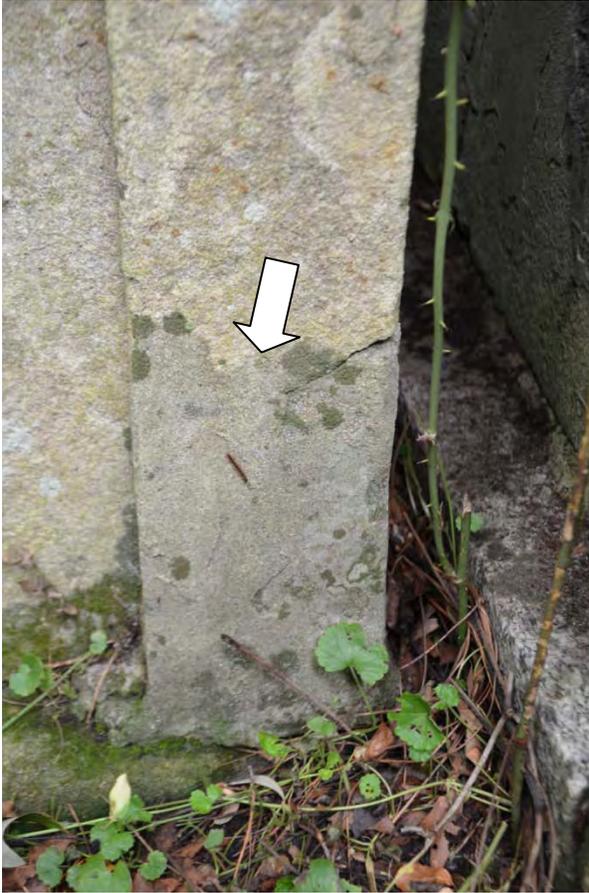
East side, northeast leg, OPC repair:

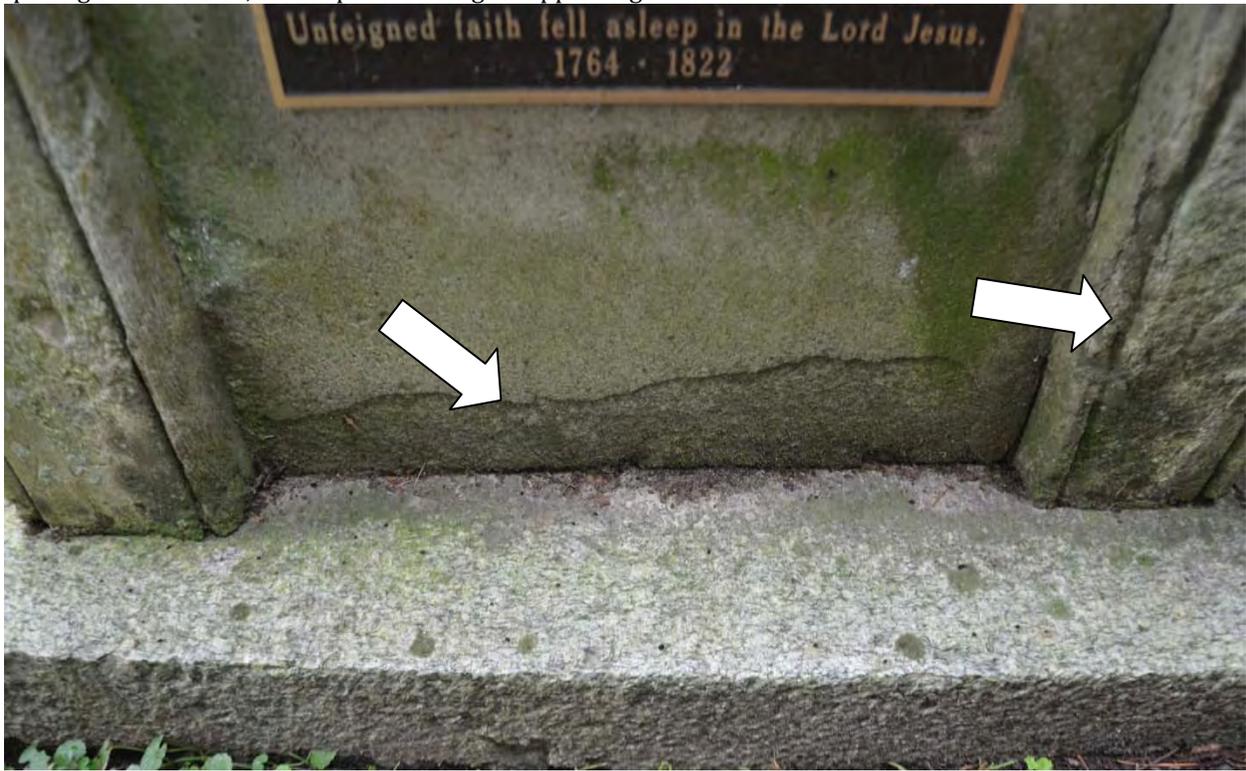
Spalling on north side, center panel and right support leg:

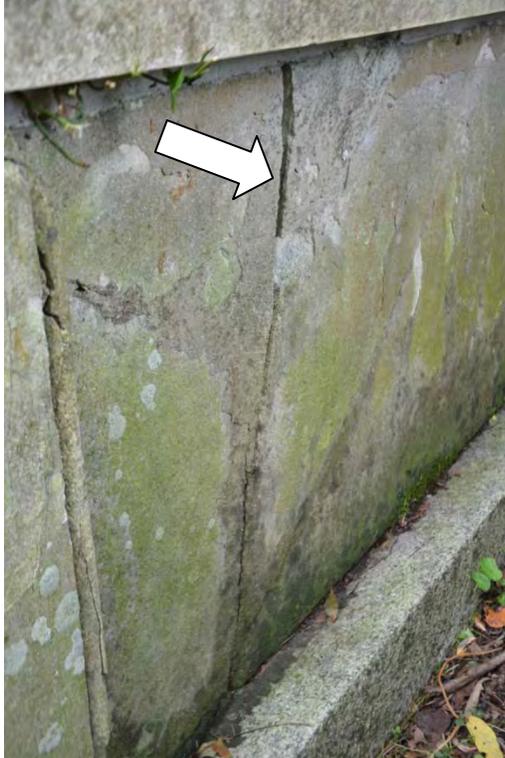
Repair of broken north side panel:

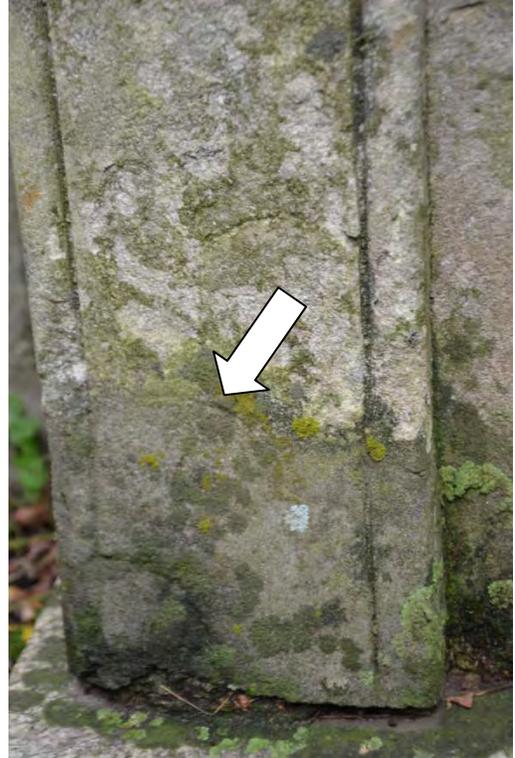
East side, SE leg repair using OPC:

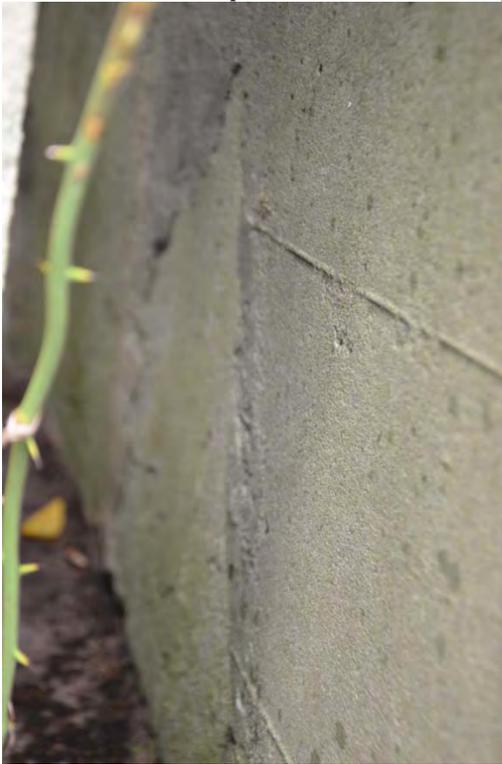
South side, board impressions in cast OPC repair:

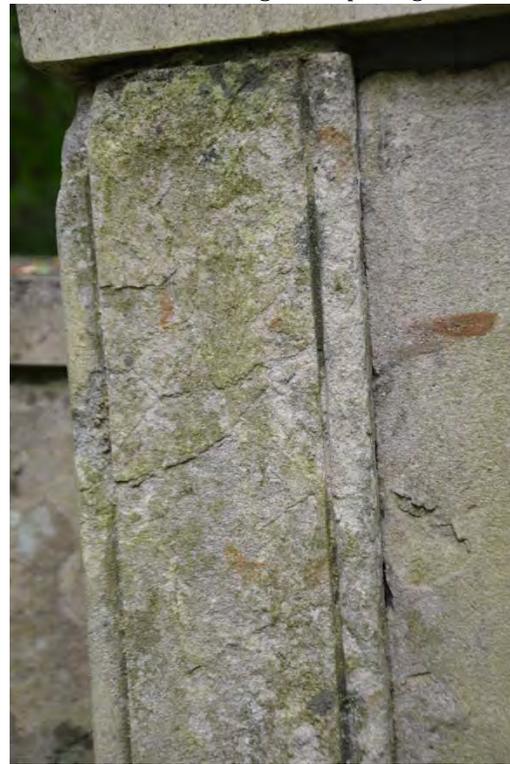
East side, southeast leg with spalling:

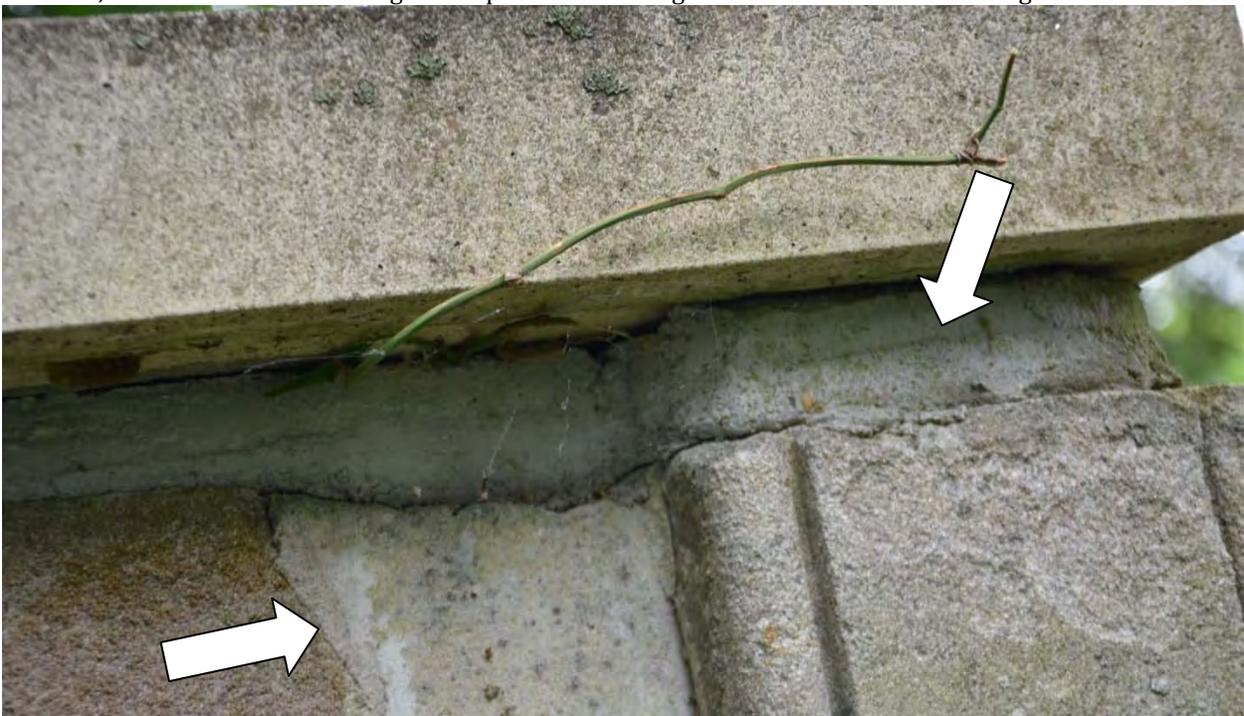
East side, northeast corner showing OPC repair and cast ledger set on thick OPC for leveling:
