PRESERVATION ASSESSMENT OF THE LYNNHAVEN HOUSE CEMETERY, VIRGINIA BEACH, VIRGINIA

Preservation Assessment of the Lynnhaven House Cemetery, Virginia Beach, Virginia

Prepared By:
Michael Trinkley, Ph.D.
and
Debi Hacker

August 2013

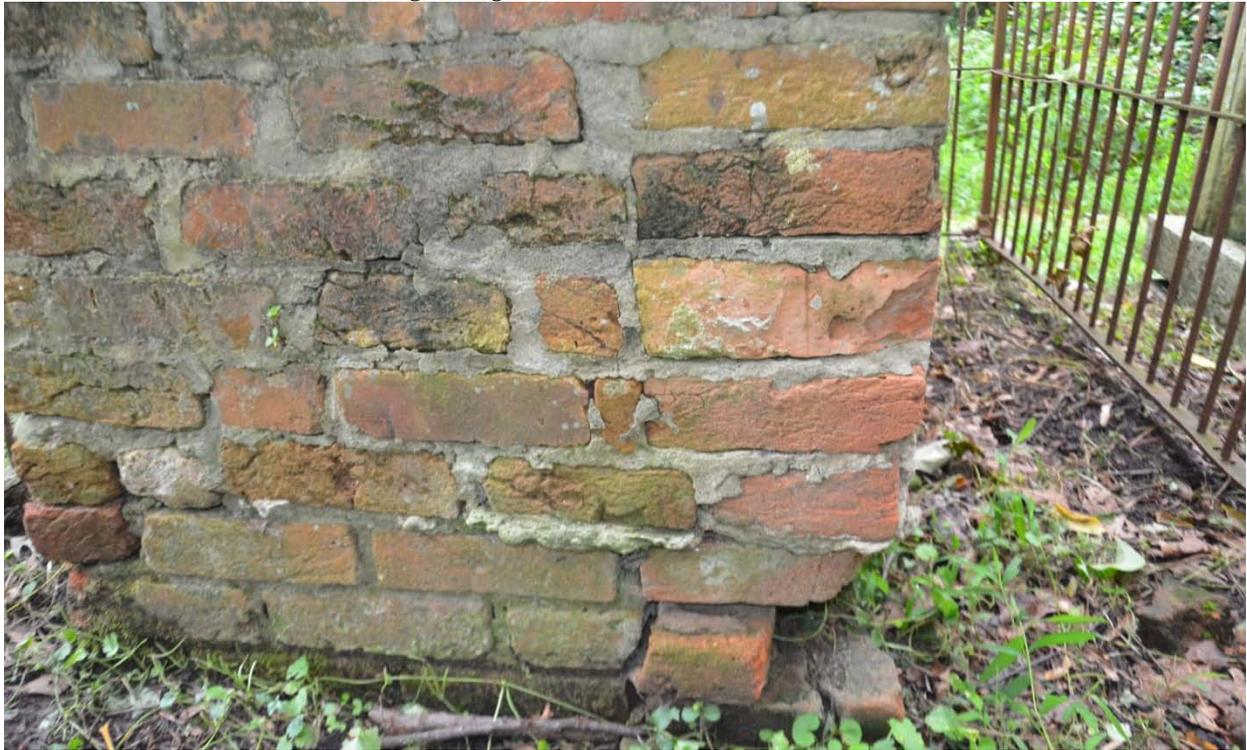
West side, southwest corner showing damage:

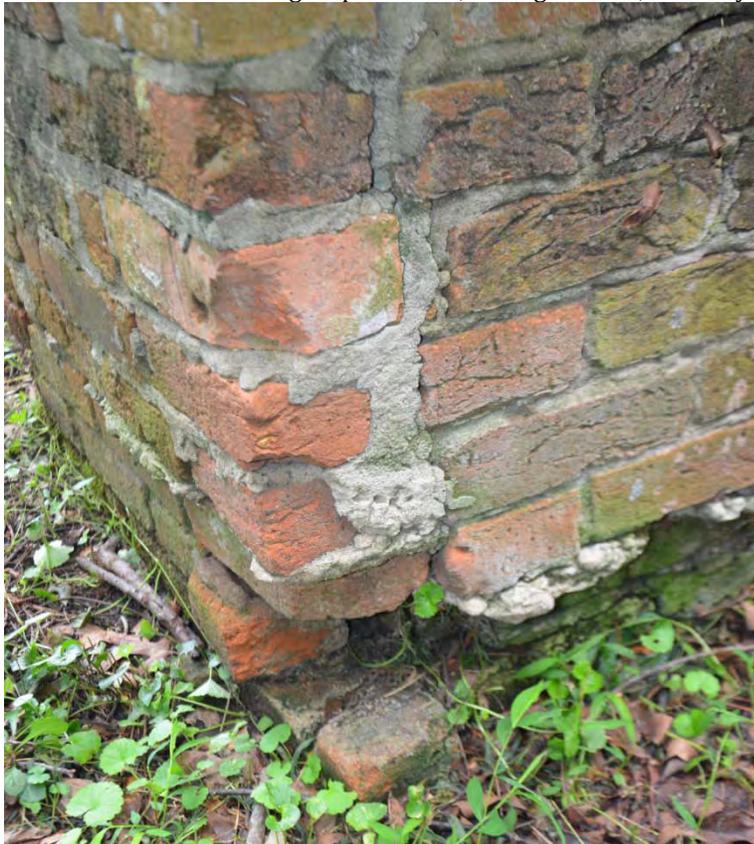
Southwest corner showing displacement, damaged brick, and very poor workmanship:

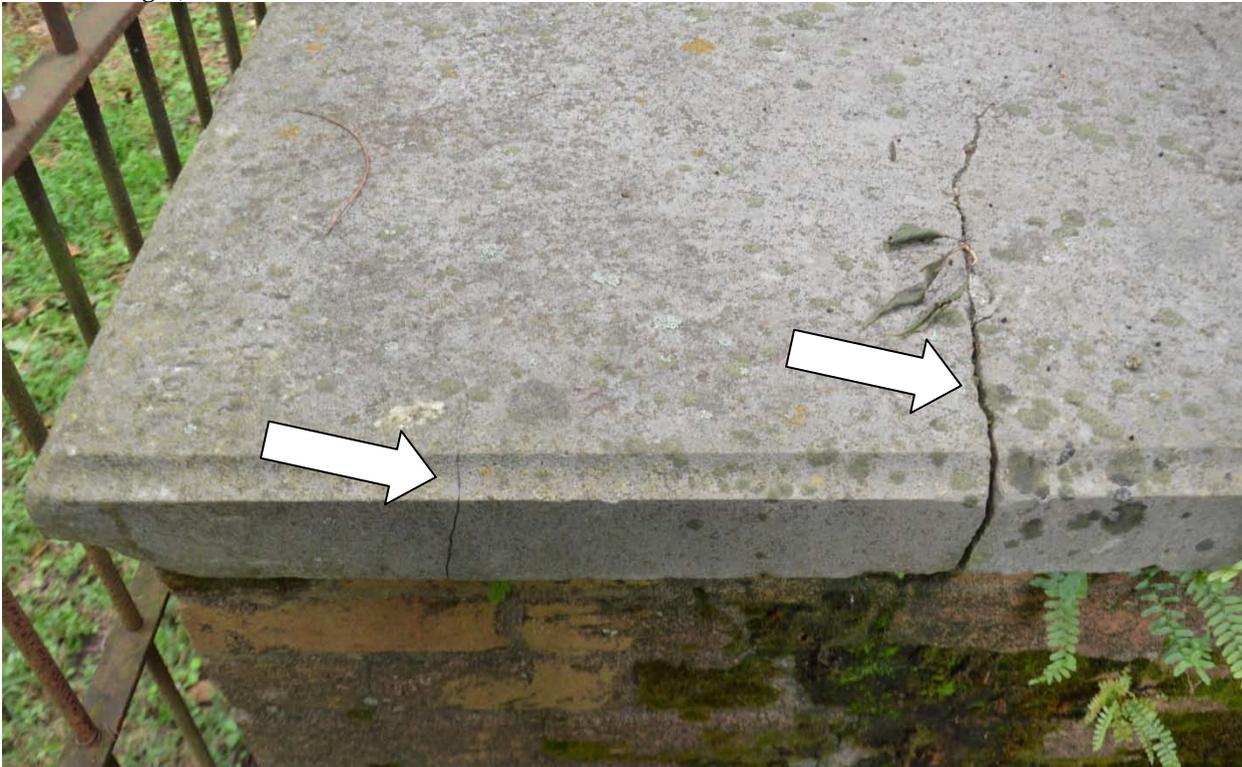
Cracks in ledger, north side:

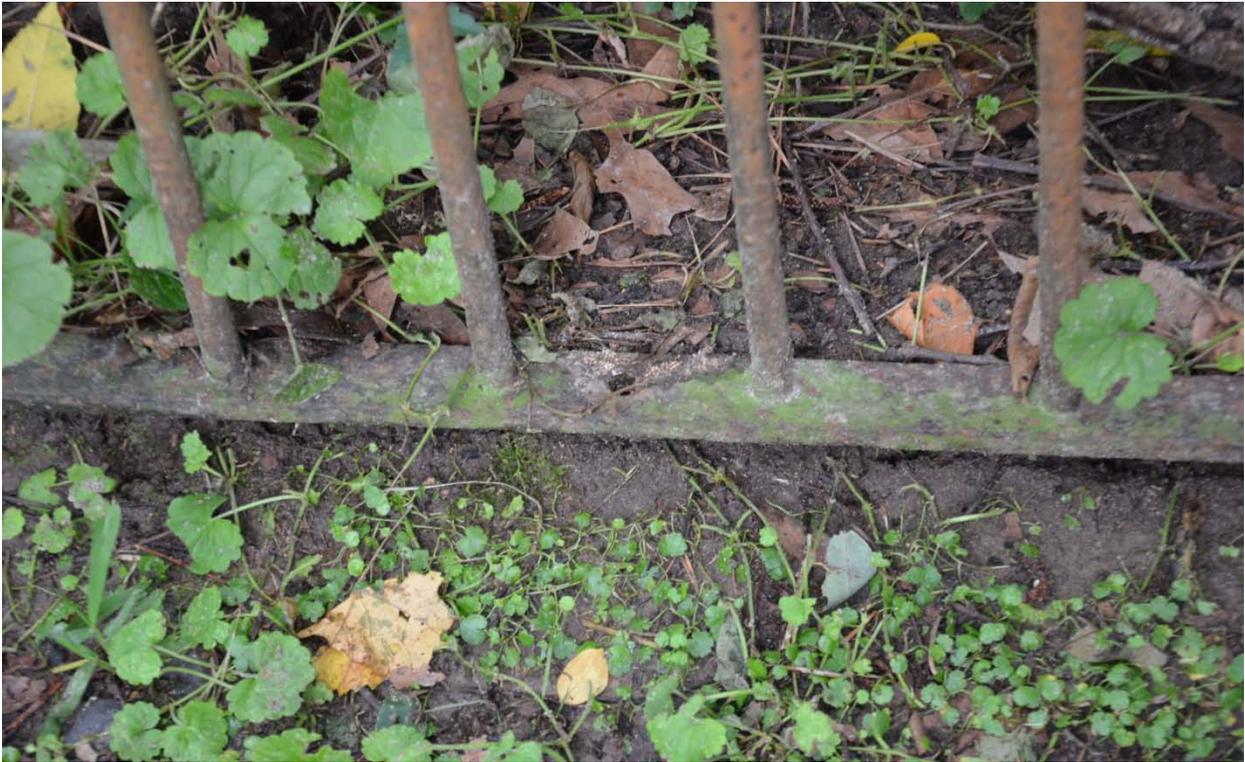
North side, fence bottom rail buried in soil:

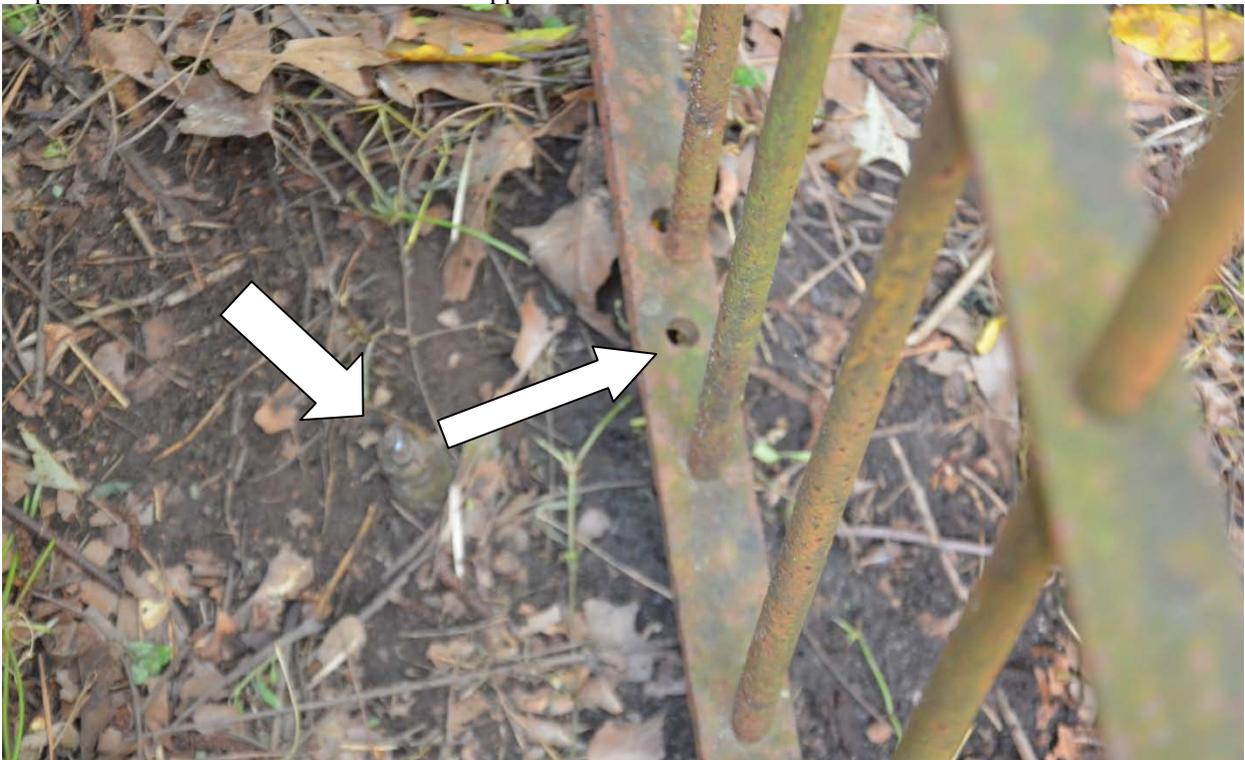
Displaced and disconnected center fence support:

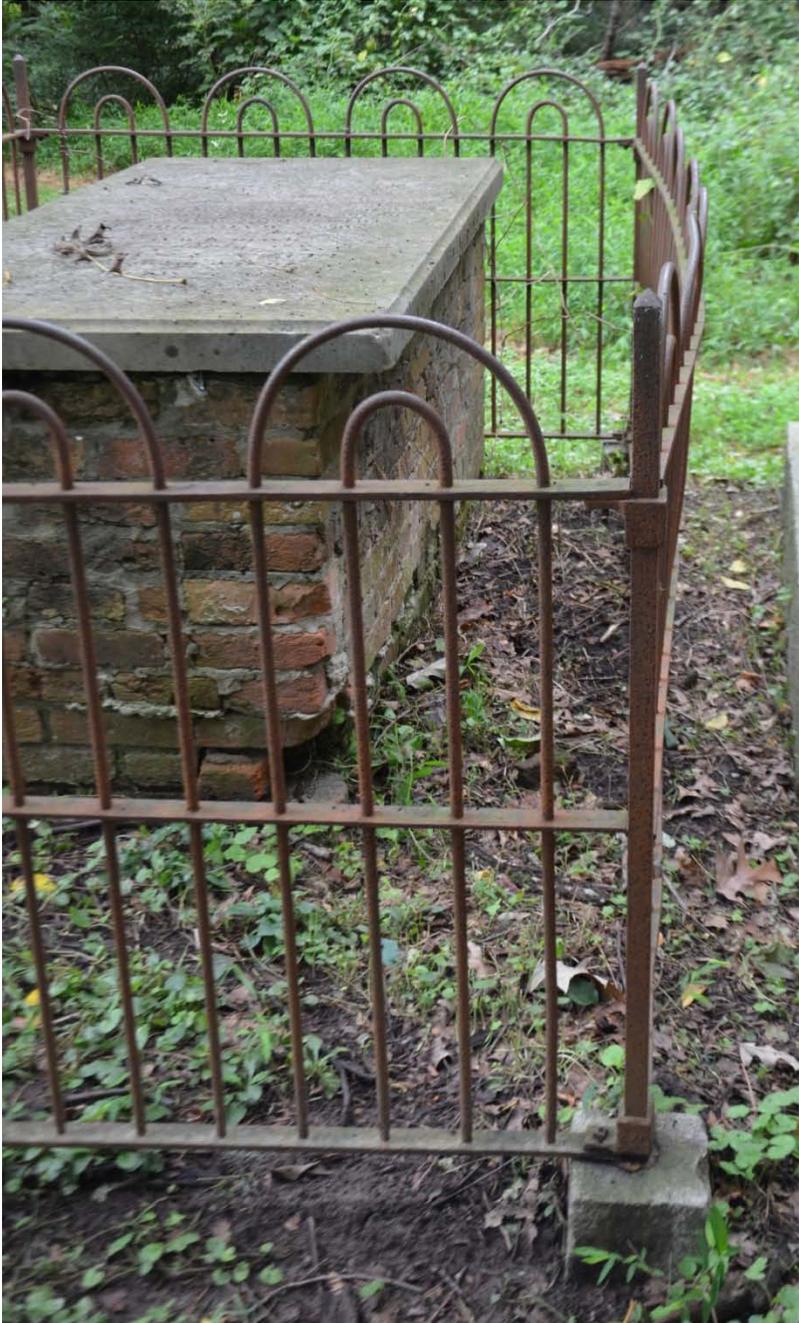
Bend in south side of fence:
