# **ASSESSMENT OF THE CHURCH STREET GRAVEYARD, MOBILE, ALABAMA**

**Chicora Research Contribution 566**

Michael Trinkley  
And  
Debi Hacker

September 2015

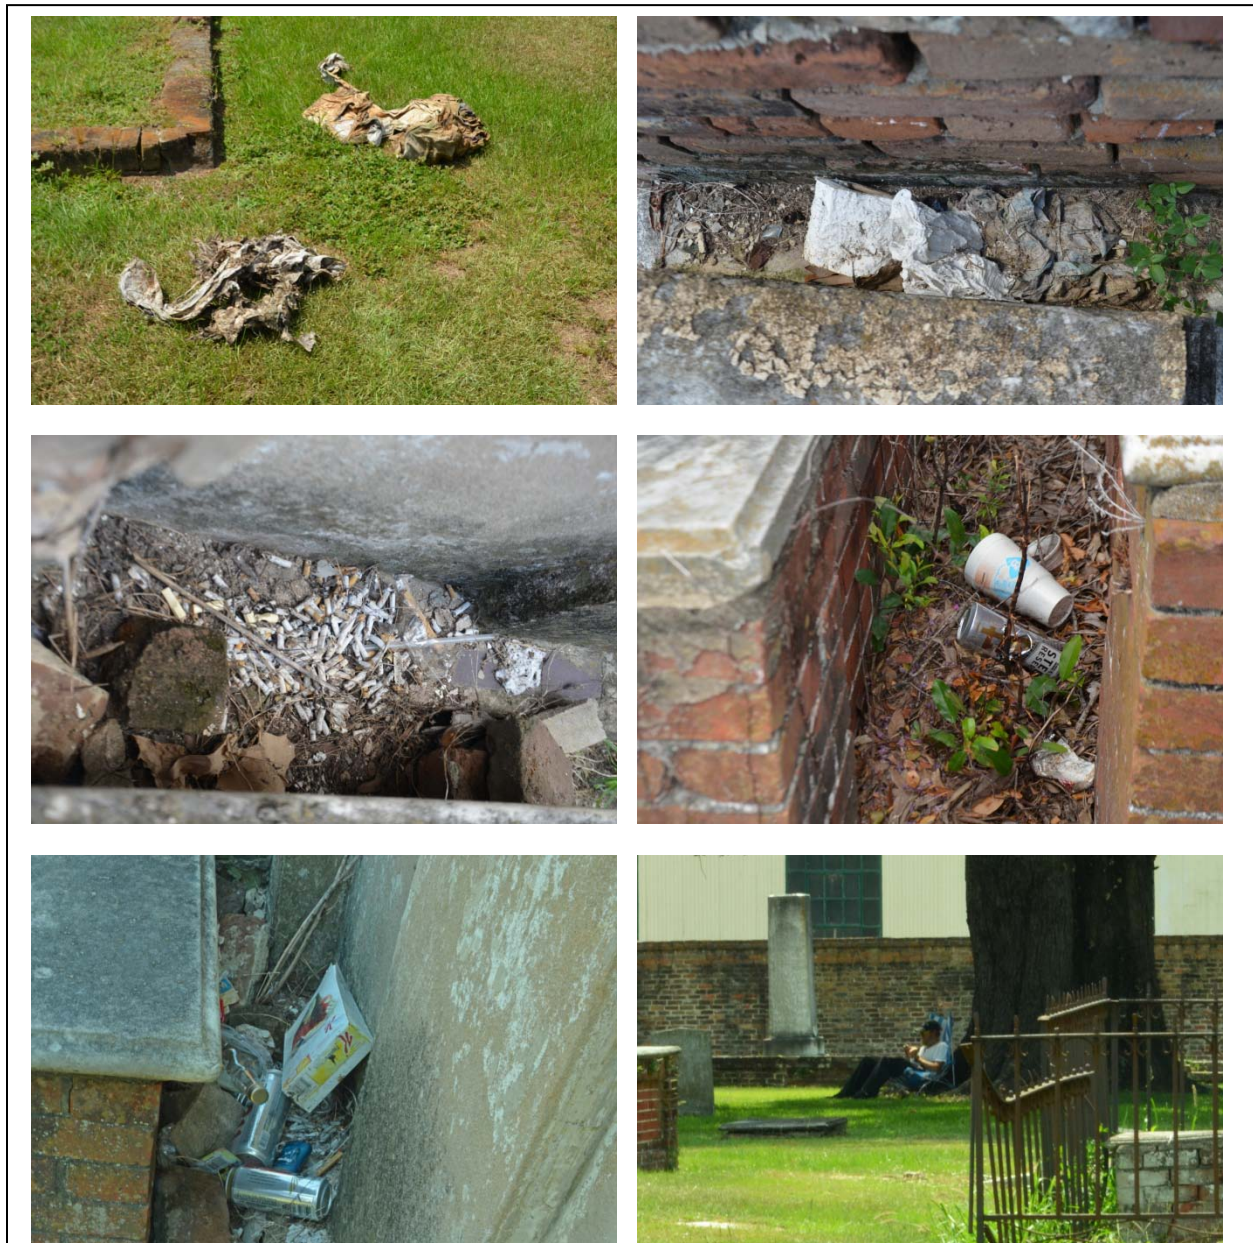
Figure 22. Example of problems created by the homeless in the Church Street Graveyard. Upper left photo shows pants and a shirt found on top of a vault. Elsewhere underwear and socks were found. Upper right photo shows used toilet paper and a toilet paper roll between two box tombs. Middle left shows hundreds of cigarette butts between two box tombs. Middle right shows a drink cup, alcohol container, and food trash between two box tombs. Lower left photo shows a large stash of supplies and trash, including cereal box, alcohol cans, liquor bottle, deodorant stick, and other trash between two tombs. Lower right shows one homeless individual who lives in the cemetery at night, leaving his chair “hidden” behind the tree during the day. He was present on all three days of our work.

Prior to locking the gates the cemetery must be cleared – either by City staff or by a police patrol. This will serve to put everyone on notice that the closing hours will be enforced and provide the opportunity to inform individuals that should they come back into the cemetery they will be subject to arrest.

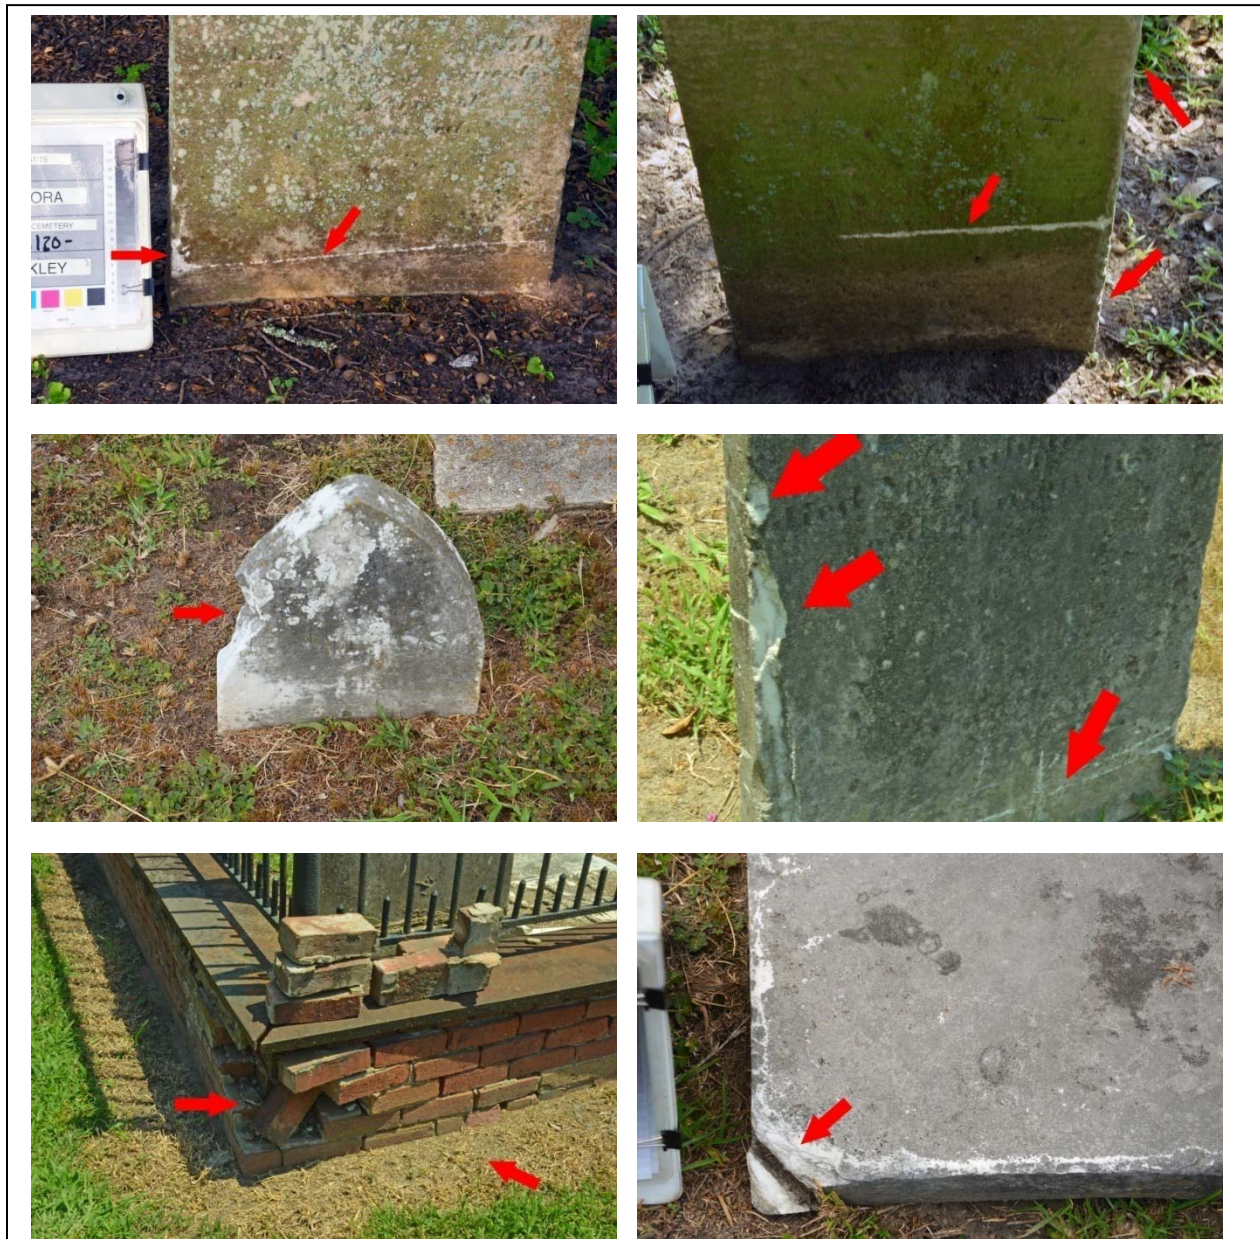
Figure 30. Mower damage at the Church Street Graveyard. Upper left photo shows a mower impact (on the left) and scrape across the reverse of a stone in R11 L120. Upper right photo shows damage to one of the stones in the Jewish section in R12, L119. In addition to the scrape, there is edge damage on the right from the upper to the lower arrow, indicating repeated strikes. Middle left photo shows a stone in R17 L84 hit so hard that a large fragment has been removed. Middle right photo shows a stone in R14 L37 with multiple impacts and multiple scrapes at the bottom. Lower left photo shows a brick wall, R4 L37, which has been so severely impacted by a mower that bricks have been not only dislodged, but also shifted to the right. Lower right photo shows a ledger in R19 L102 with the corner broken and additional mower damage along every edge.

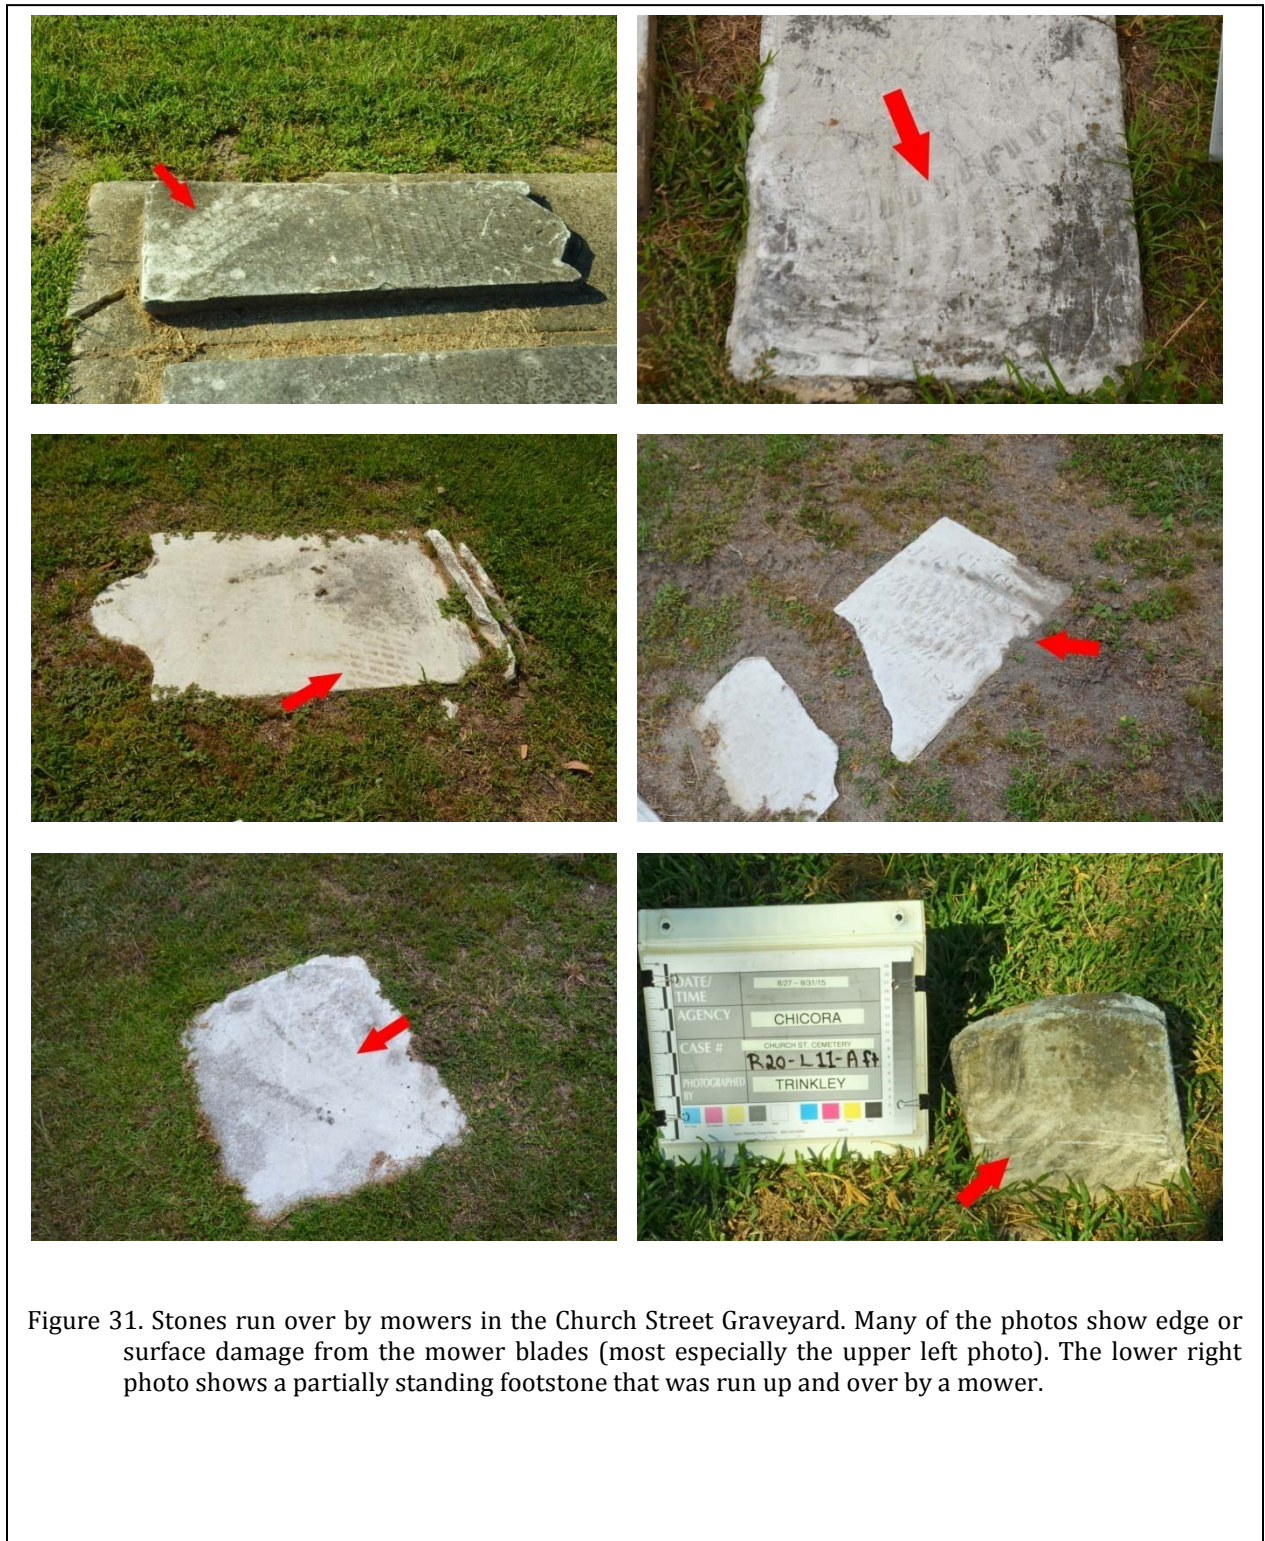
Figure 31. Stones run over by mowers in the Church Street Graveyard. Many of the photos show edge or surface damage from the mower blades (most especially the upper left photo). The lower right photo shows a partially standing footstone that was run up and over by a mower.

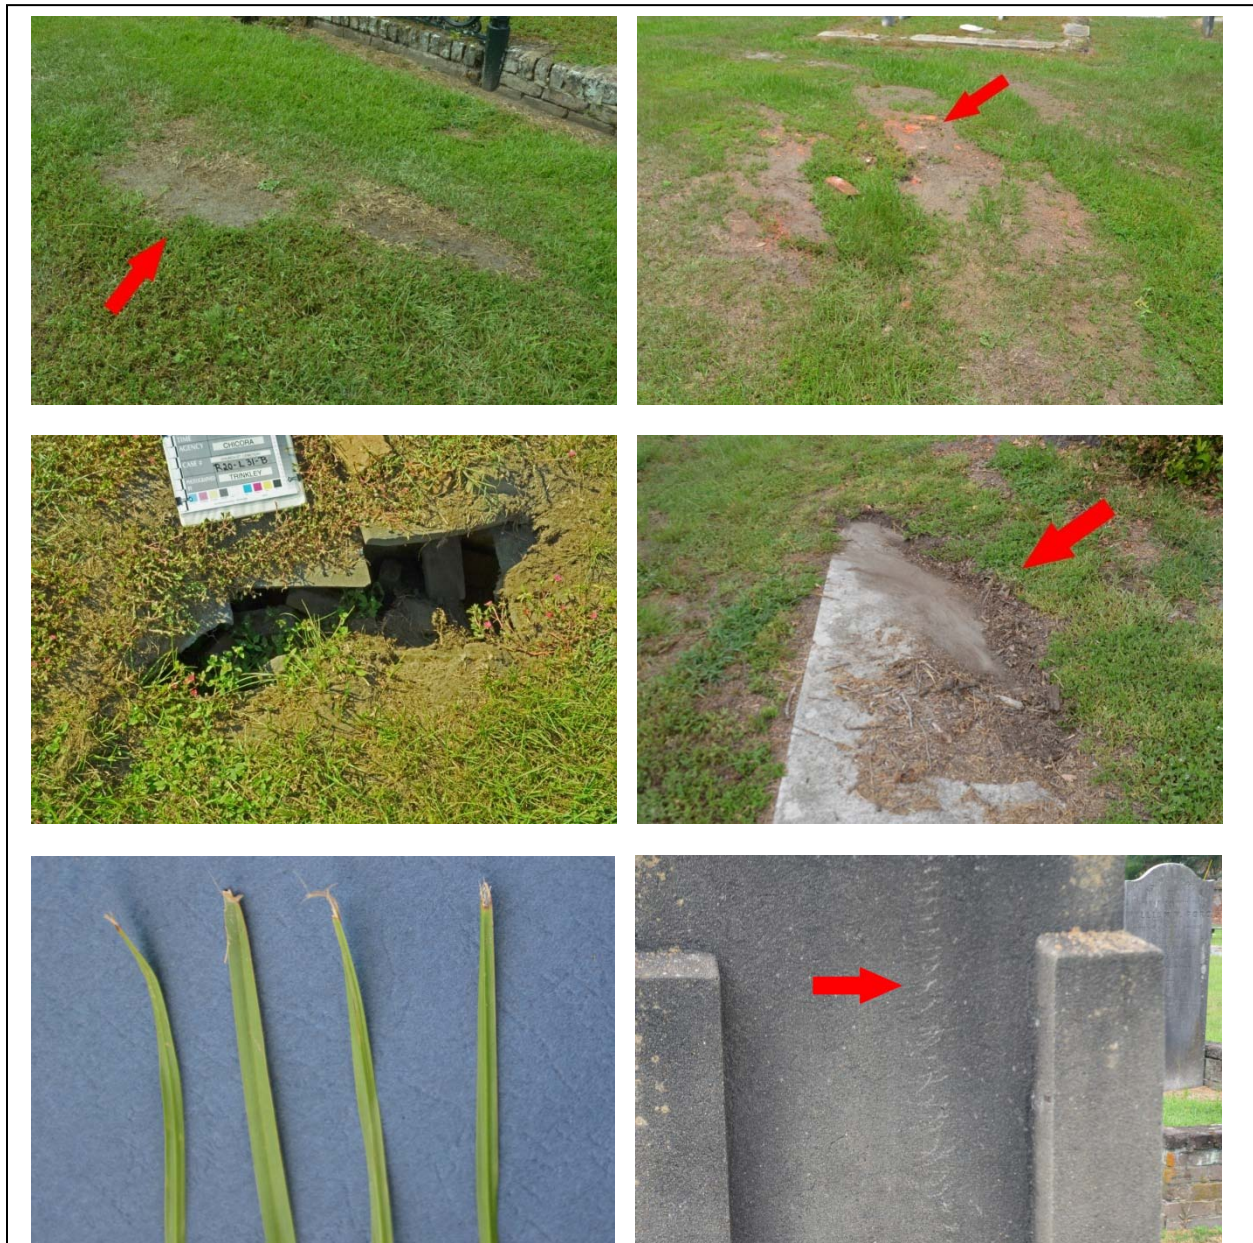
Figure 32. Other mowing problems. Upper left photo shows scalped grass in the cemetery, resulting from use of mowers that are too large. Upper right photo shows where scalping has exposed brick remains on a seemingly vacant plot. Middle left shows damage to the below ground vault resulting from a heavy mower breaking open the vault cover. Middle right shows a ledger that, while sinking, is also being covered with mowing debris never blown off. These debris are “mulching” on the marble, leading to the loss of the monument. Lower left photo shows grass tips that have been torn – not cut – by dull mowers at the Church Street Graveyard. Lower right photo shows trimmer damage up the face of a monument, probably the result of an effort to remove vines using incorrect equipment.

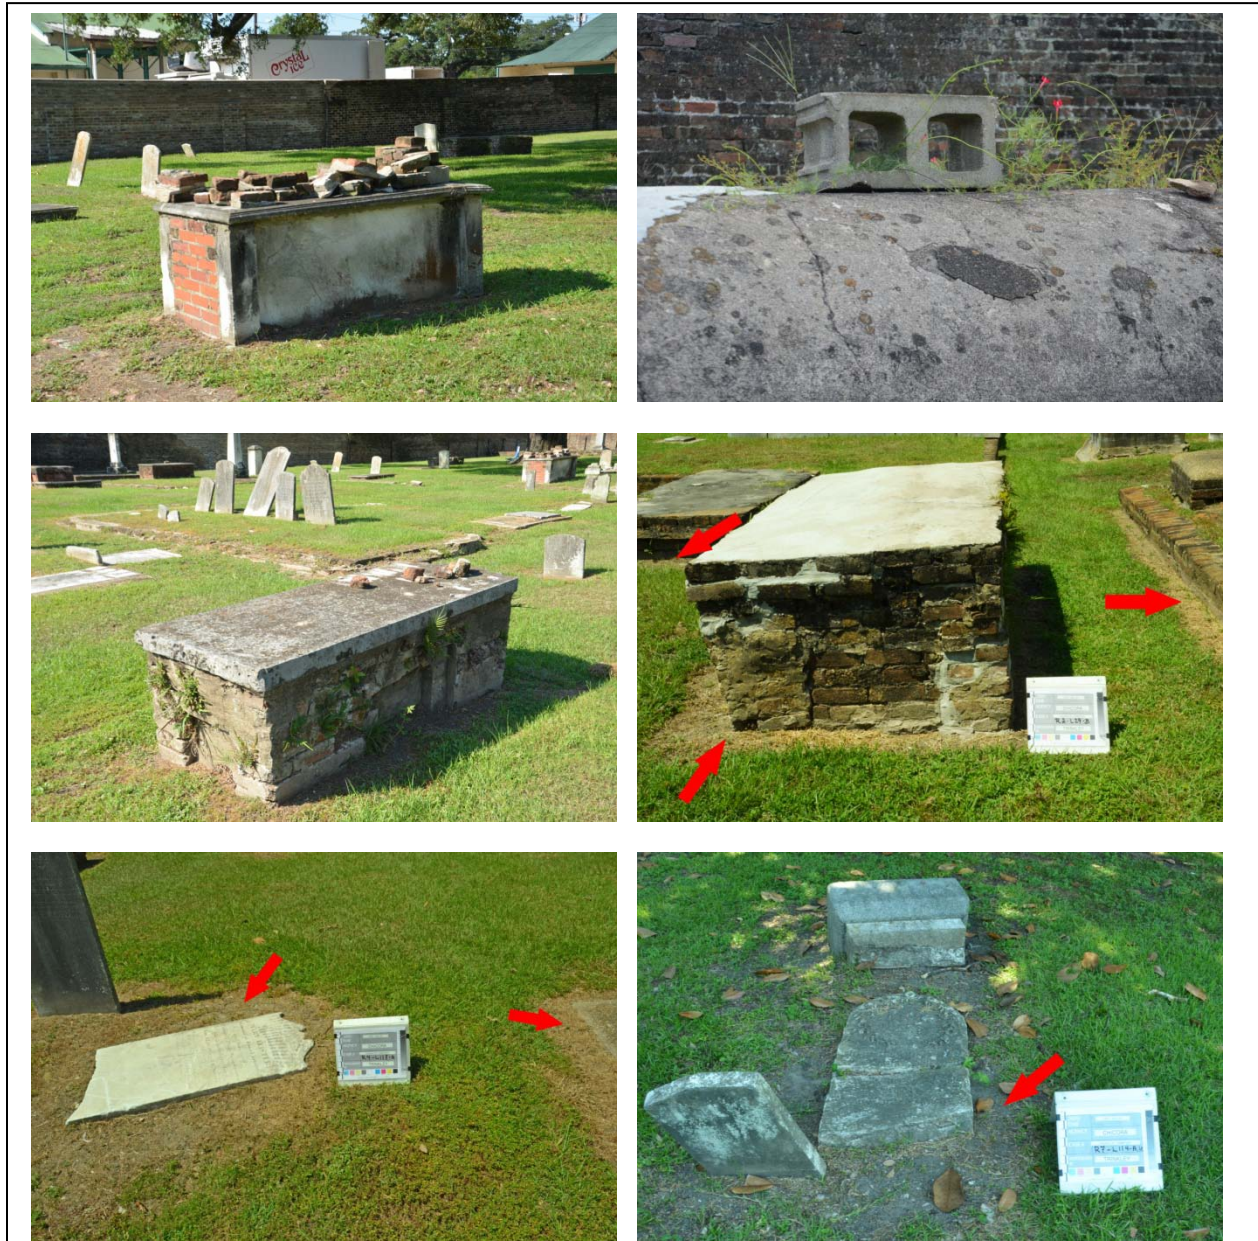
Figure 35. Items stacked on tombs and herbicide use in the cemetery. Upper row and middle left show examples of bricks and other materials stacked on tombs. The middle right and lower left photos show recent use of an herbicide to prevent the need for string trimming. The lower right photo shows previous use of herbicide, with grass and weeds just trying to recolonize the area around the stones.

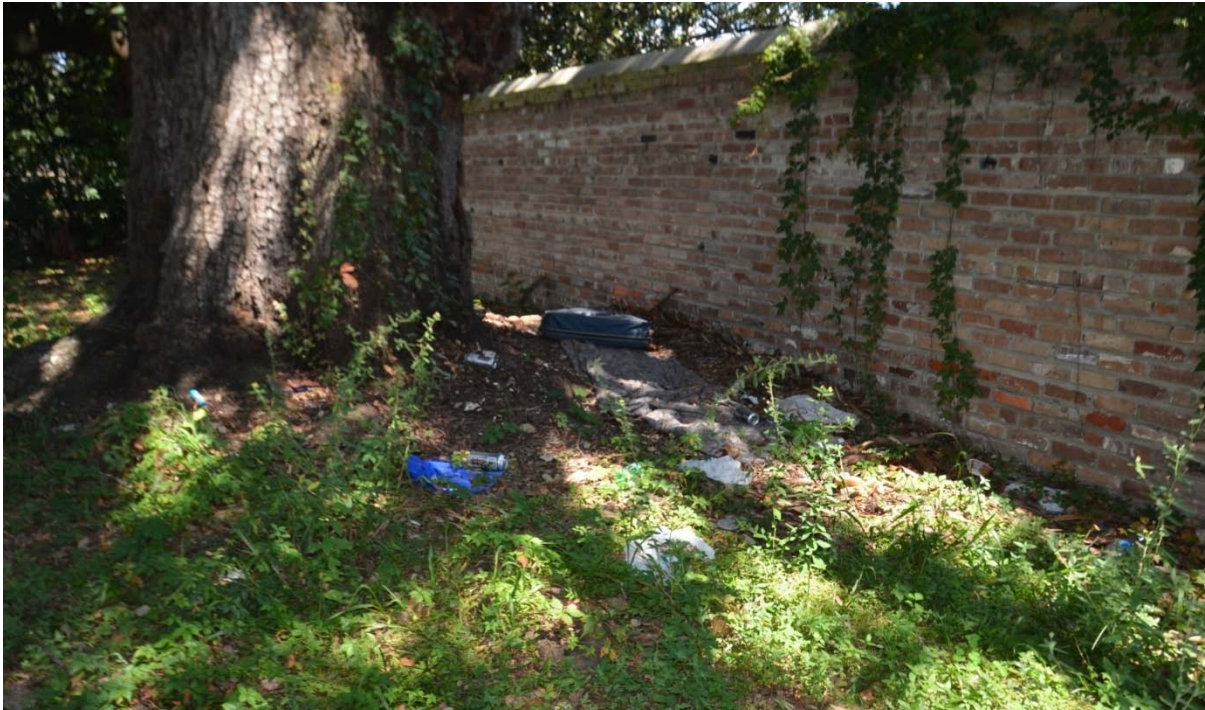
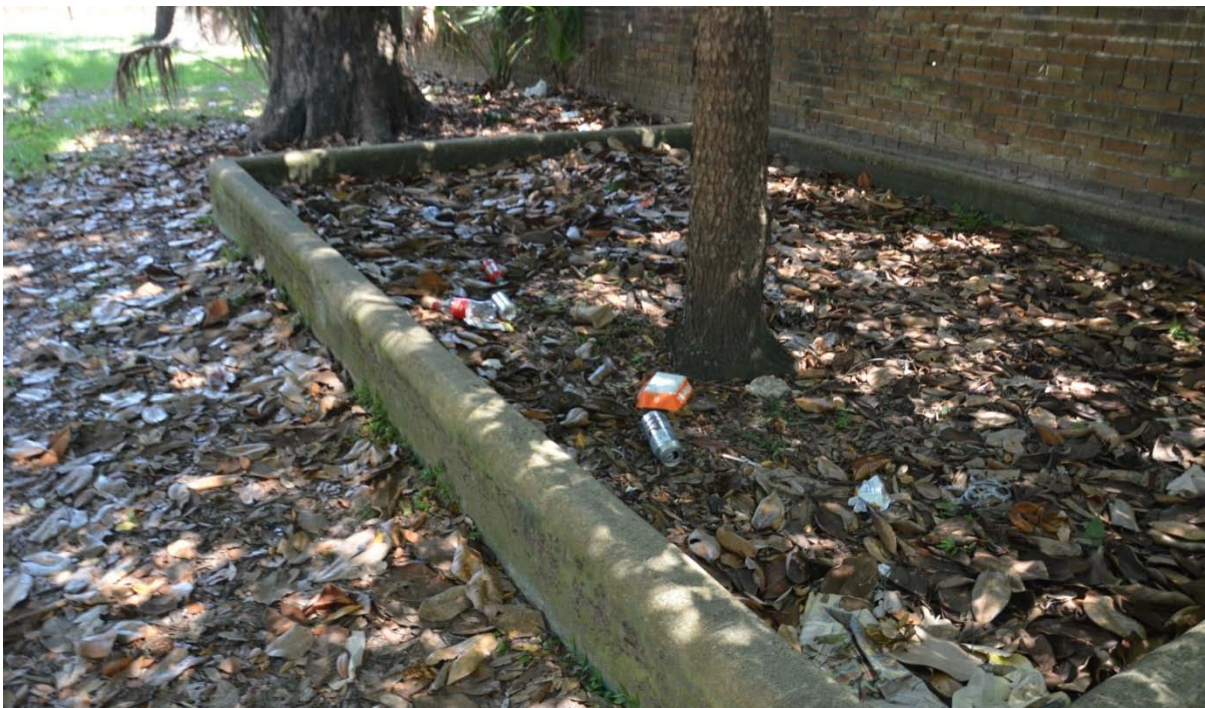
Figure 41. Trash ridden “parking” area outside the cemetery walls that was once part of the graveyard.

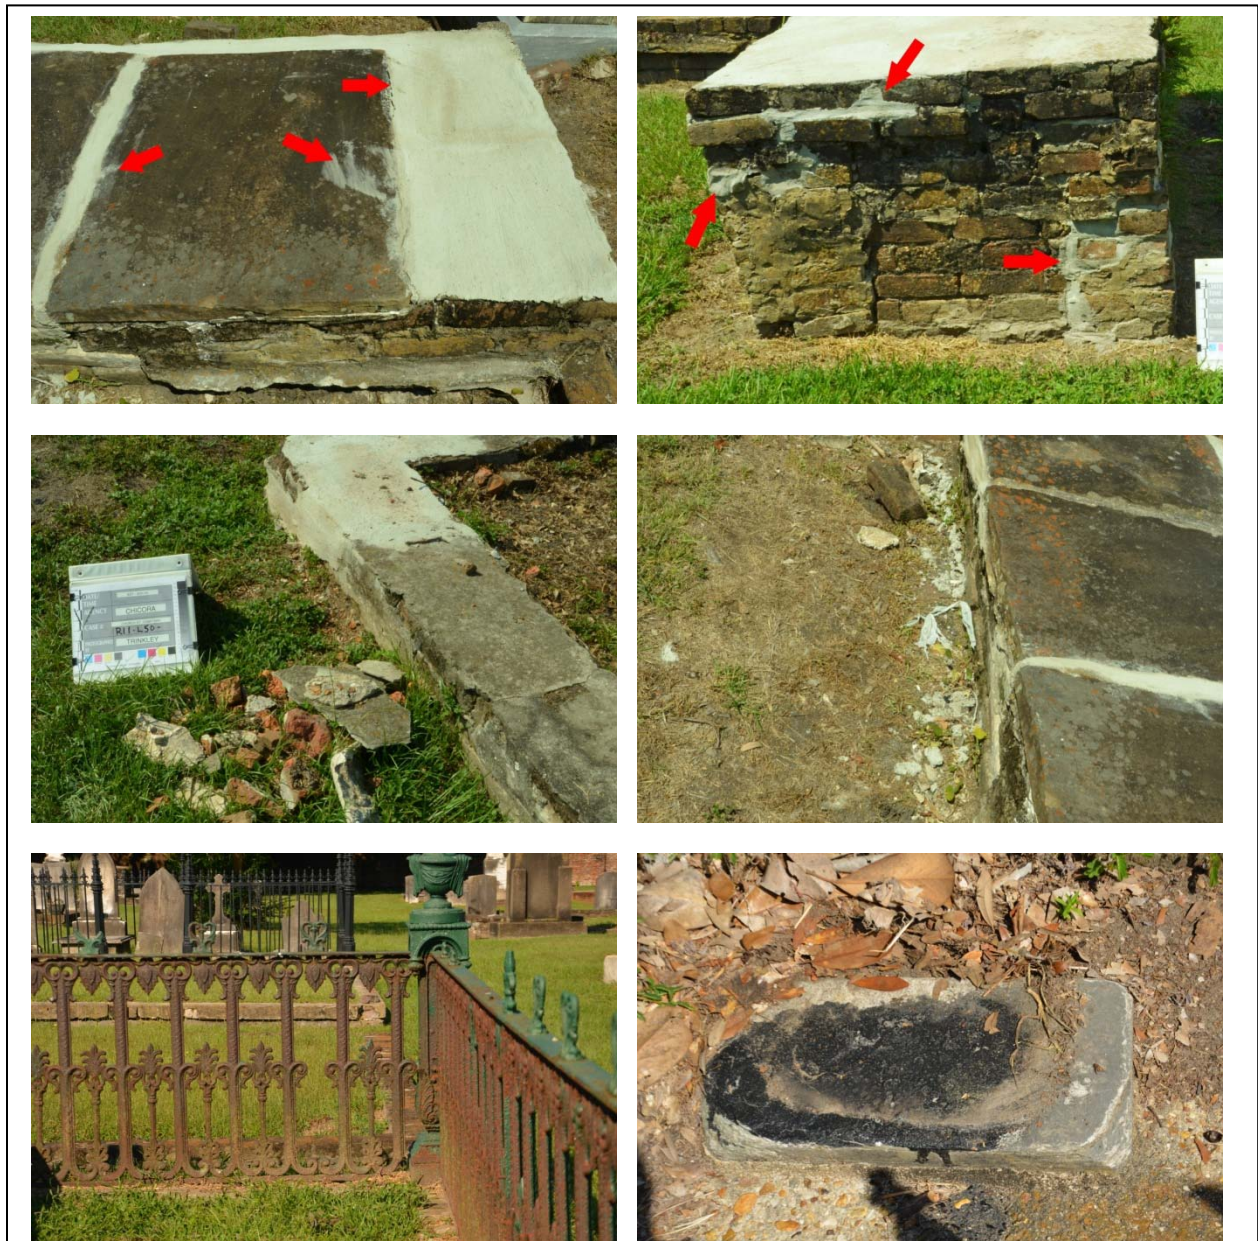
Figure 46. Past repair efforts and work in the Church Street Graveyard. Upper left photo shows mortar smears and a recent shrinkage crack forming (since mortar is not intended to be used as stucco). Upper right photo shows very poor pointing with mortar smeared over the brick, very wide joints, and unfinished joints. Middle left photo shows brick rubble not picked up after repair of corner. Middle right photo shows rubble not collected after repairs. Lower left photo shows one of several fences painted only on the outside. Lower right photo shows where paint was spilled on a footstone with no effort to clean up the spill.

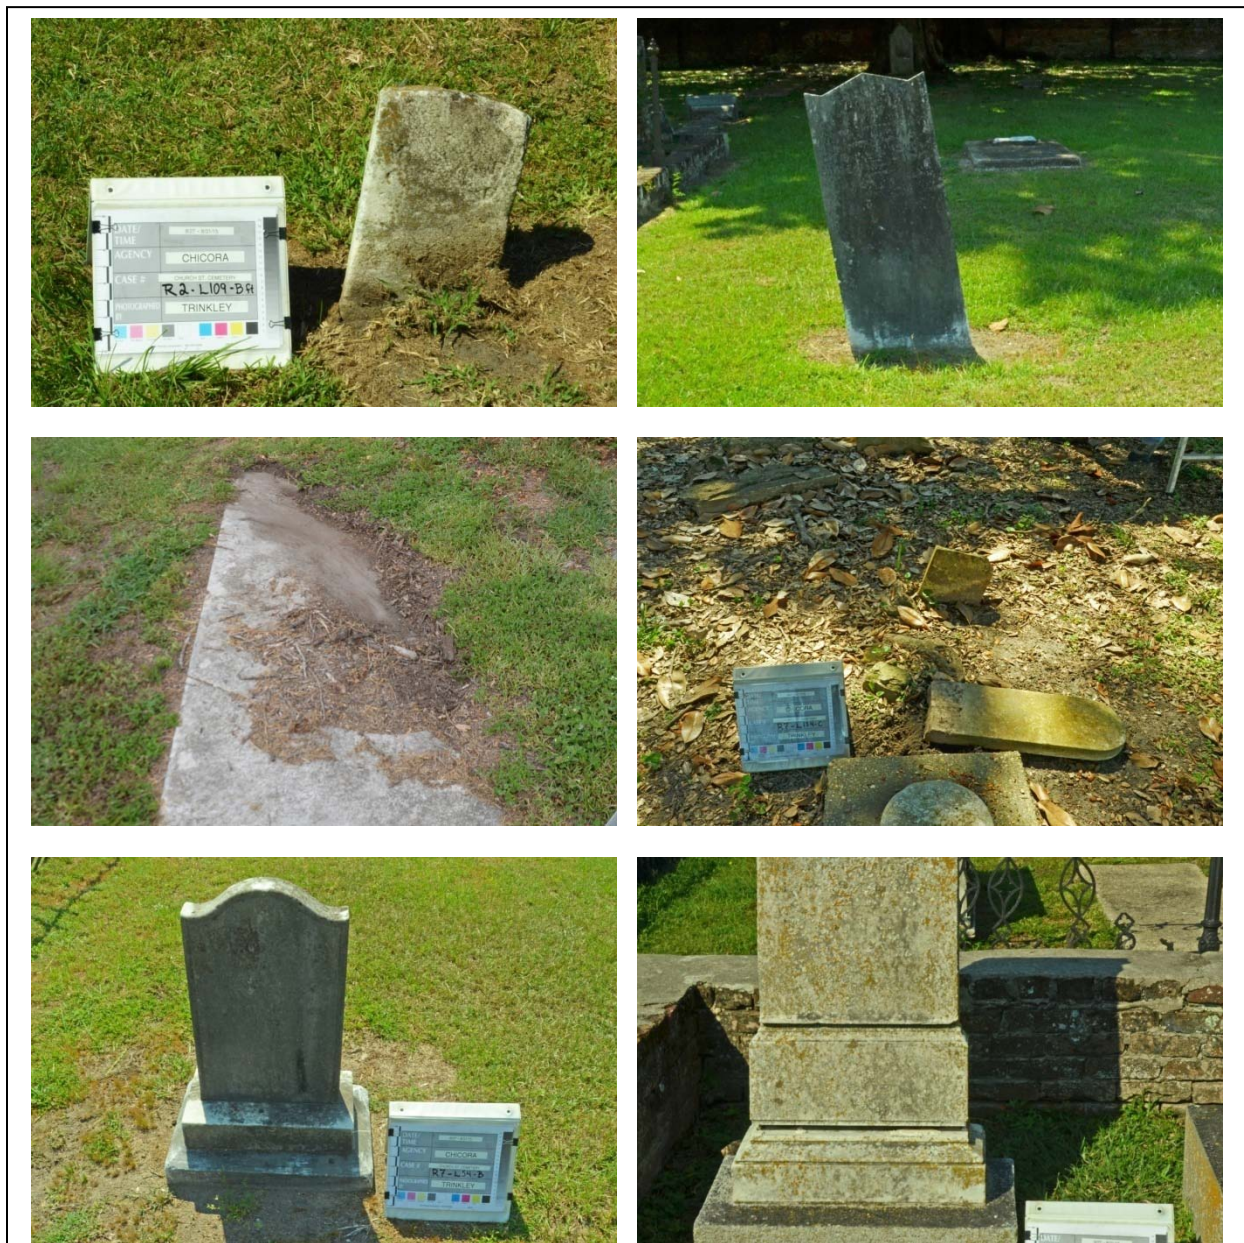
Figure 48. Types of stone damage at Church Street Graveyard. Upper left and right photos are of a footstone and tablet that require simple resetting. Middle left photo shows a ledger that requires excavation and resetting on a solid foundation. Middle right photo shows a tilted footstone in the background and, in the foreground, a footstone that is entirely out of the ground and requires resetting. Lower left photo shows a die on base monument that is both tilted and unattached, so it is unstable. Lower right photo shows a die on base monument with pins that has been shifted backward placing pressure on the pins and risking serious damage.

In order to reset a die on base that is loose or shifted, it is first necessary to remove the die and set it aside. The base then must be checked to determine if it is both stable and level. In many cases it will be necessary to remove the base, establish a new foundation with pea gravel or decomposed granite, being sure that the base is both level and plumb.

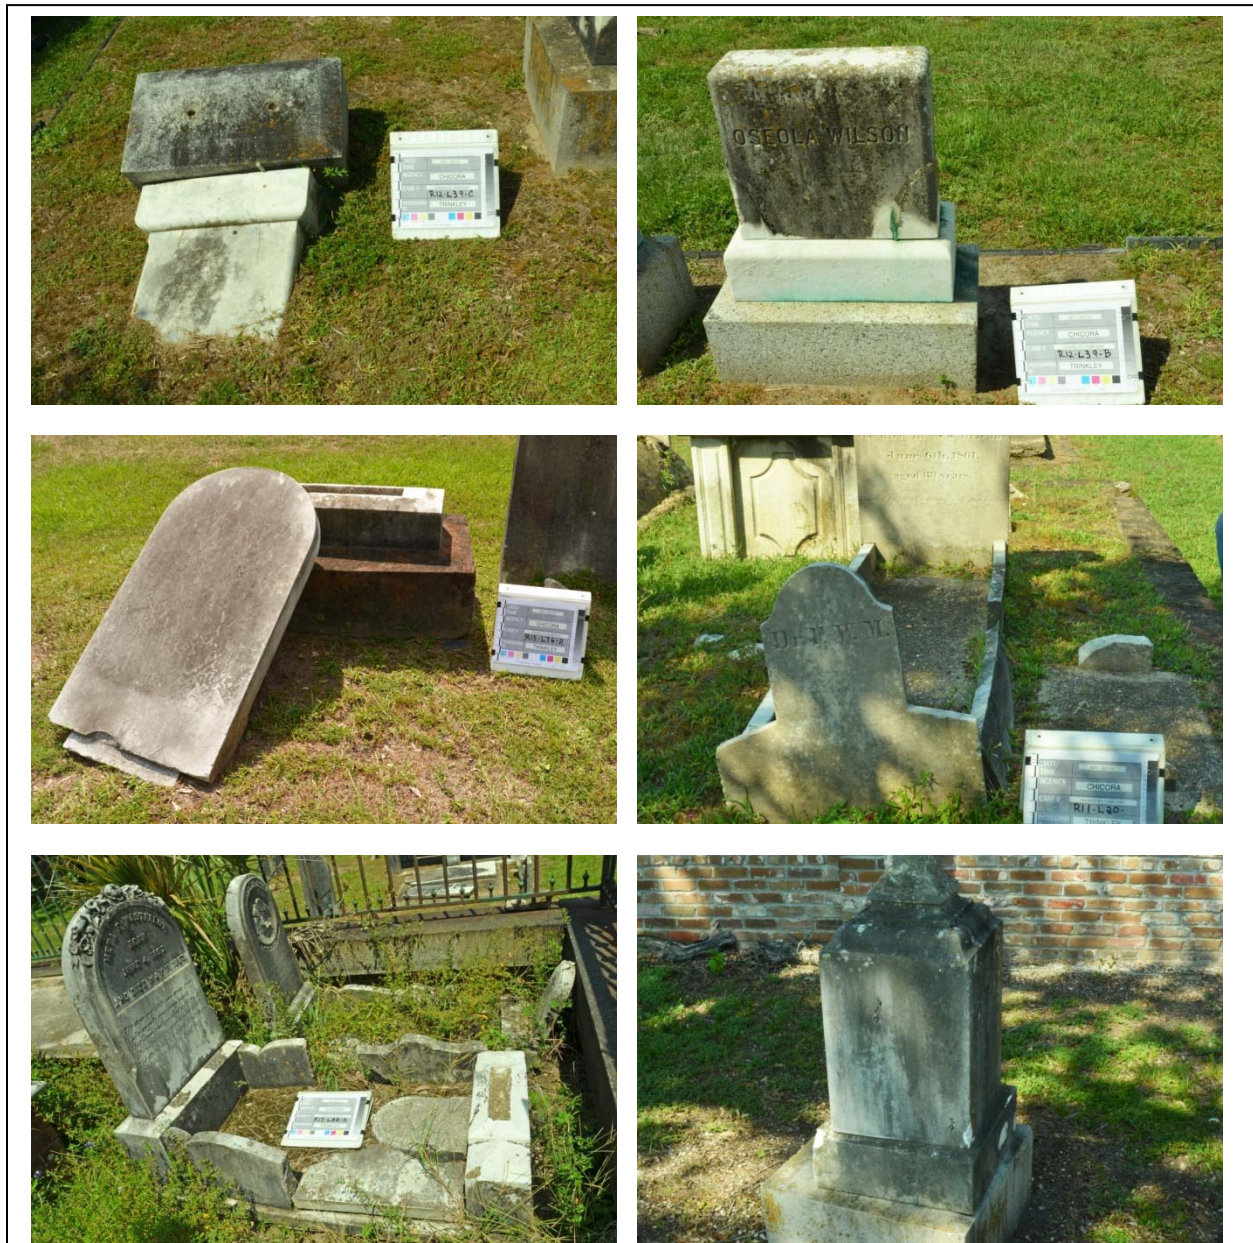
Figure 49. Types of stone damage at Church Street Graveyard. Upper left photo shows a die on base that has toppled. The original pin holes are visible in the base and one pin is shown caught between the granite sub-base and the marble base. Upper right shows a die on base that had ferrous pins. Iron jacking broke both corners. The ferrous pins were replaced by brass pins (note the staining) and OPC was used as a repair. Middle left photo shows a fallen tab in socket stone that needs only to be reset using a high lime mortar. Middle right photo shows a partially collapsed cradle grave with broken side rails. Lower left photo shows two damaged cradle graves with fallen and broken side rails and tilted or displaced dies at the head and foot. Lower right photo shows a die on base that has nearly shifted off its base because it lacks pins.

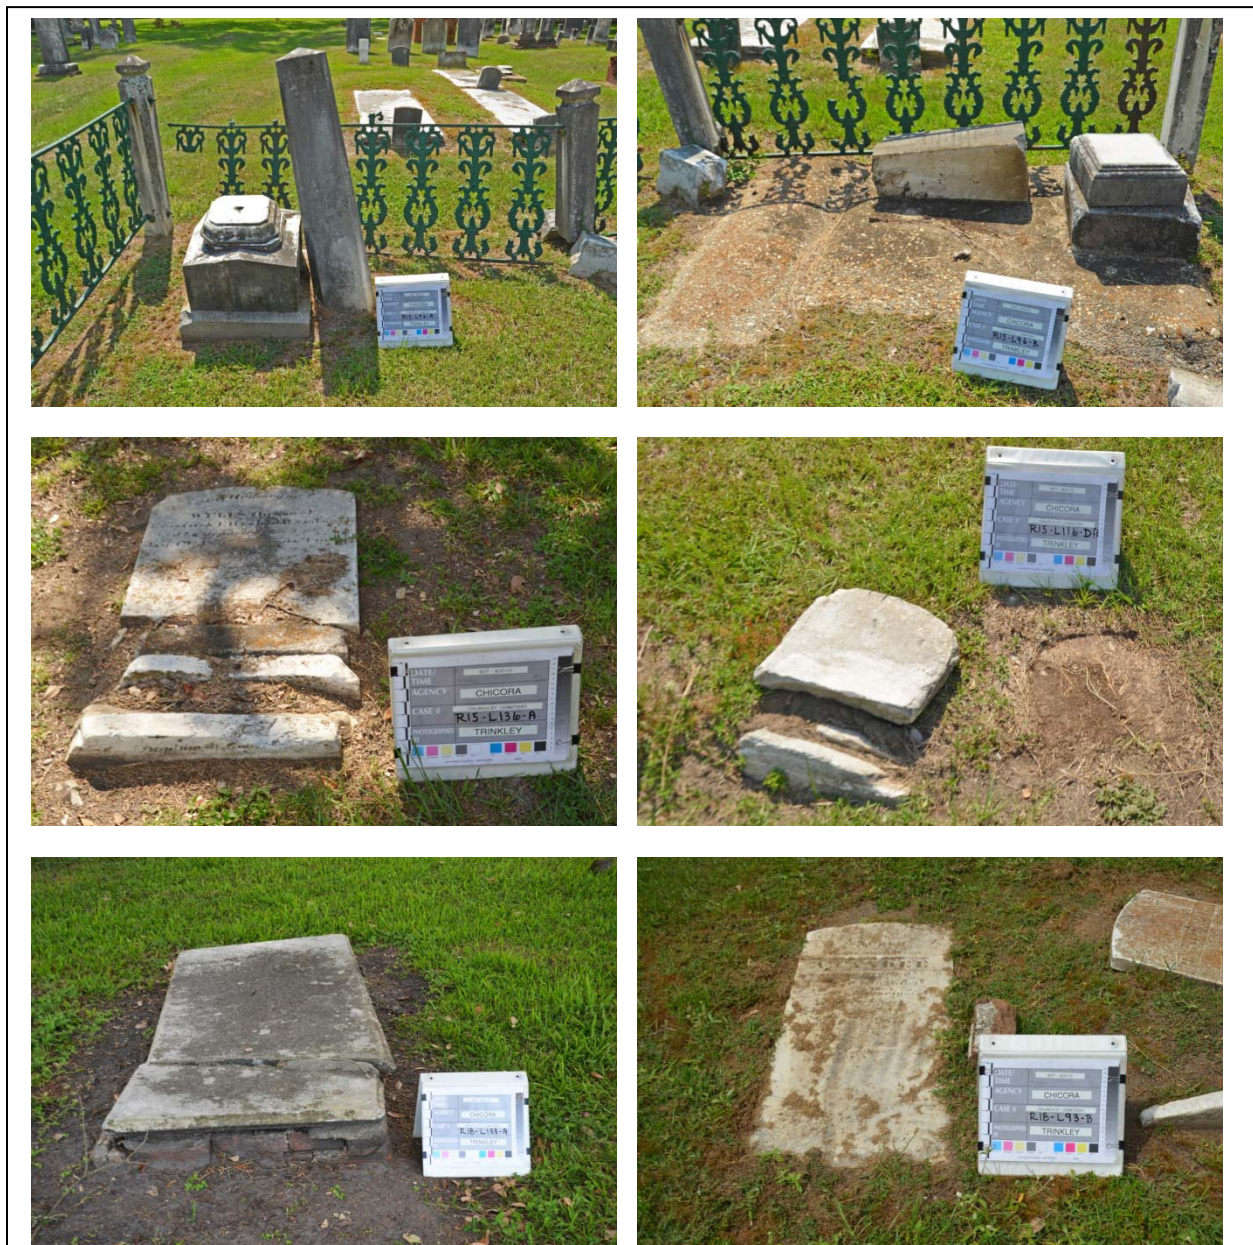
Figure 50. Types of stone damage at Church Street Graveyard. Upper left shows a fallen obelisk and tilted base that will require a tripod to reset. Upper right shows a similar obelisk that also broke when it fell and requires more extensive repairs. Middle left photo shows a tabletstone with multiple breaks. Middle right photo shows a footstone with a simple break that has been further damaged by aggressive mowing. Lower left photo shows a broken ledger that also requires repair to its brick support. Lower right photo shows a stone that may not have a base. It may be possible to provide a new slotted base for resetting the stone.
