**THE DESECRATION OF GOD'S ACRE:
ASSESSMENT OF DAMAGE TO THE MEEKINS FAMILY CEMETERY,
MARLBORO COUNTY, SOUTH CAROLINA**

**Natalie Adams
Michael Trinkley**

Chicora Research Contribution 92

September 11, 1992

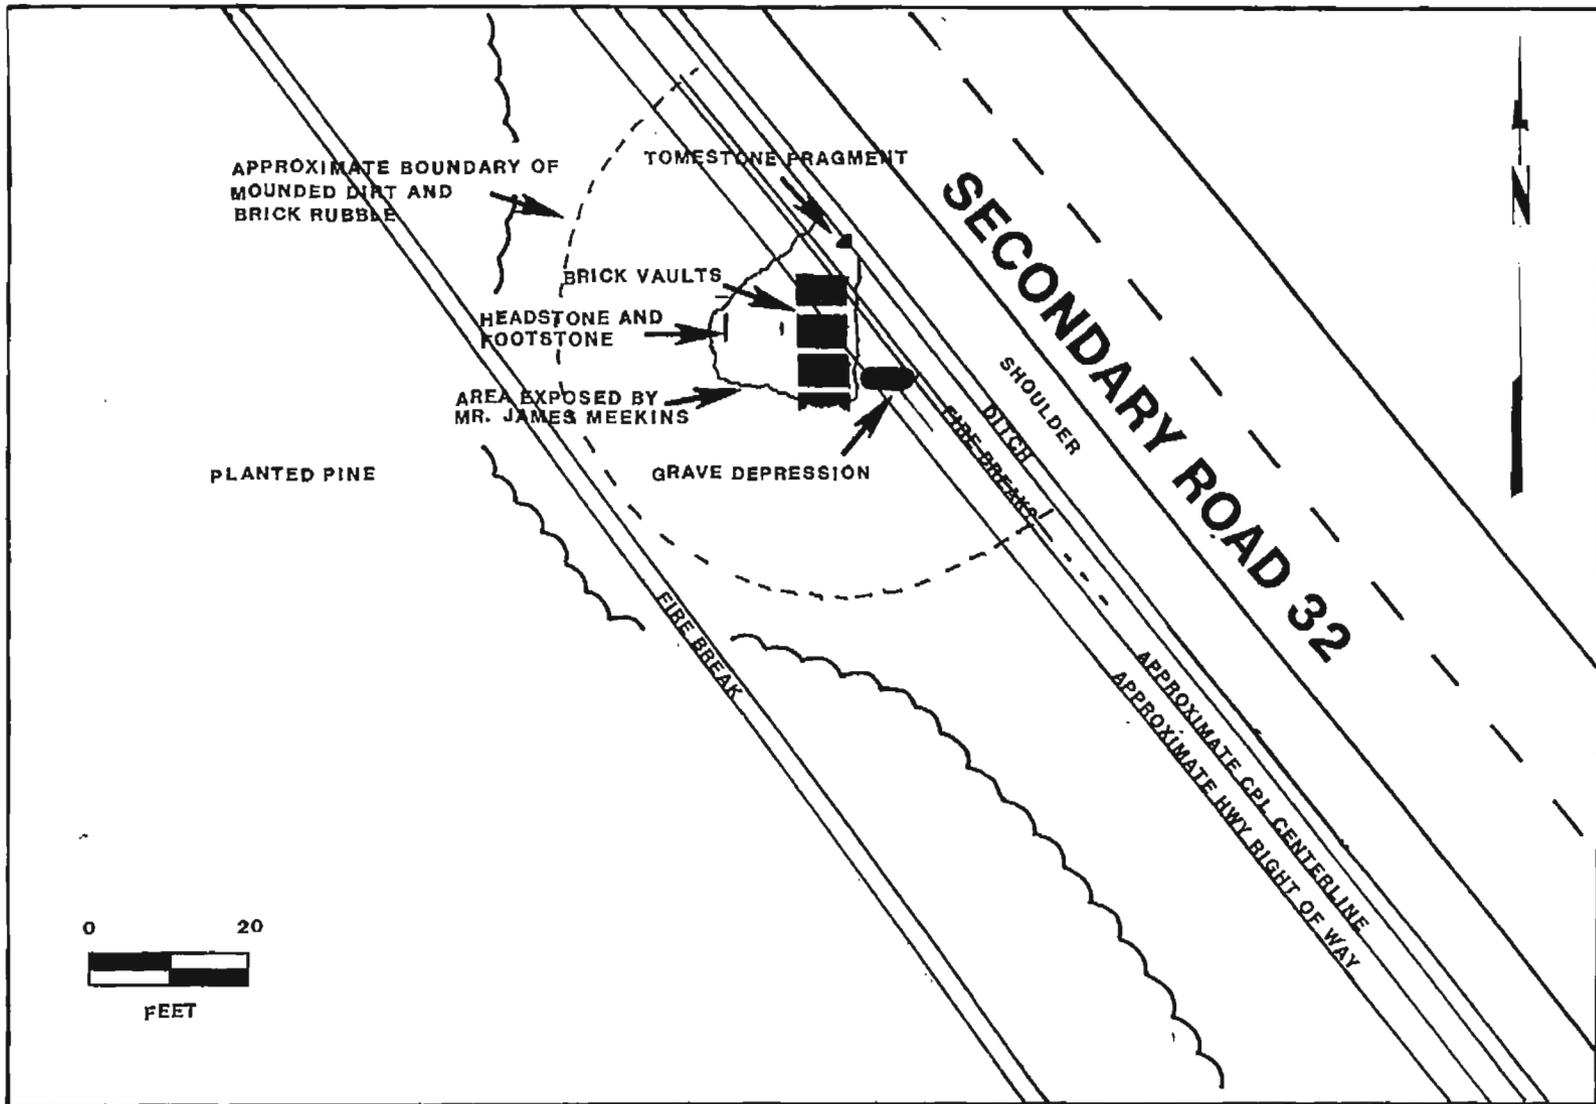
Figure 2. Approximate location of features associated with the Meekins cemetery.

Initial walk over of the area indicated that the overburden covers an area from the ditch to an area of planted pines approximately 75 feet to the west. To the north and south, planted pines extend closer to the road area, and it is possible that they mark the boundaries of the cemetery. From the planted pines looking toward Secondary Road 23, the overburden can be easily seen. It appears that this fill only covers the cemetery area, since further south near Five Forks Road overburden is not obvious. Our best estimate is that at least 2 feet of fill is present over much of the cemetery, although we have not undertaken any excavations, and this is based only on a visual examination and the work that has been conducted by Mr. Meekins. Some evidence of ditching can also be seen along the edge of the planted pines, and another probable ditch can be seen along the road edge (Figure 2).

This investigation revealed that Mr. Meekins had found three side by side brick vaults and it appears that more are present, based on dense concentrations of brick rubble in other areas of the cemetery. One un-vaulted grave associated with Christian Meekins was found just west of the vaults. The markers consist of a broken headstone and a slightly displaced footstone. To the south and east of the vaults is a depression, oriented east-west as the other graves are. All or part of the cemetery had been surrounded by a wrought iron fence, and small sections of the fence were found during Mr. Meekins initial clean up efforts. There is also evidence that at least one or two graves (and possibly more) have been heavily impacted by the cutting of the road ditch adjacent to Secondary Road 23

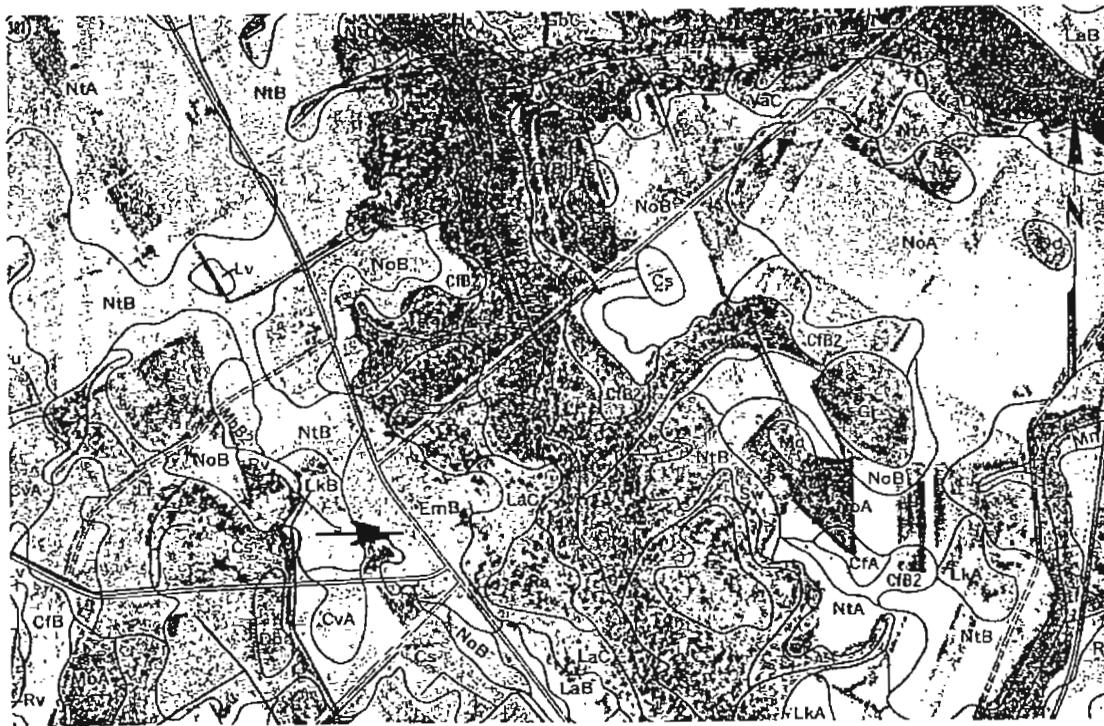
Figure 4. 1964 aerial photograph of the cemetery area.

A 1917 soil survey map does not show the cemetery, nor does the 1972 USGS topographic map. However, a series of aerial photographs give indication of the cemetery's location and changing land use patterns. A 1949 aerial photograph shows the area in fields. The cemetery appears as a small clump of trees at the edge of Secondary Road 23 (Figure 3). The 1964 soil survey aerial photograph shows virtually no change in land use. Again, a small clump of vegetation can be seen in the area of the cemetery (Figure 4). Approximately ten years later, the area of the cemetery is shown as wooded (Figure 5), and today the area behind the cemetery is planted pine.

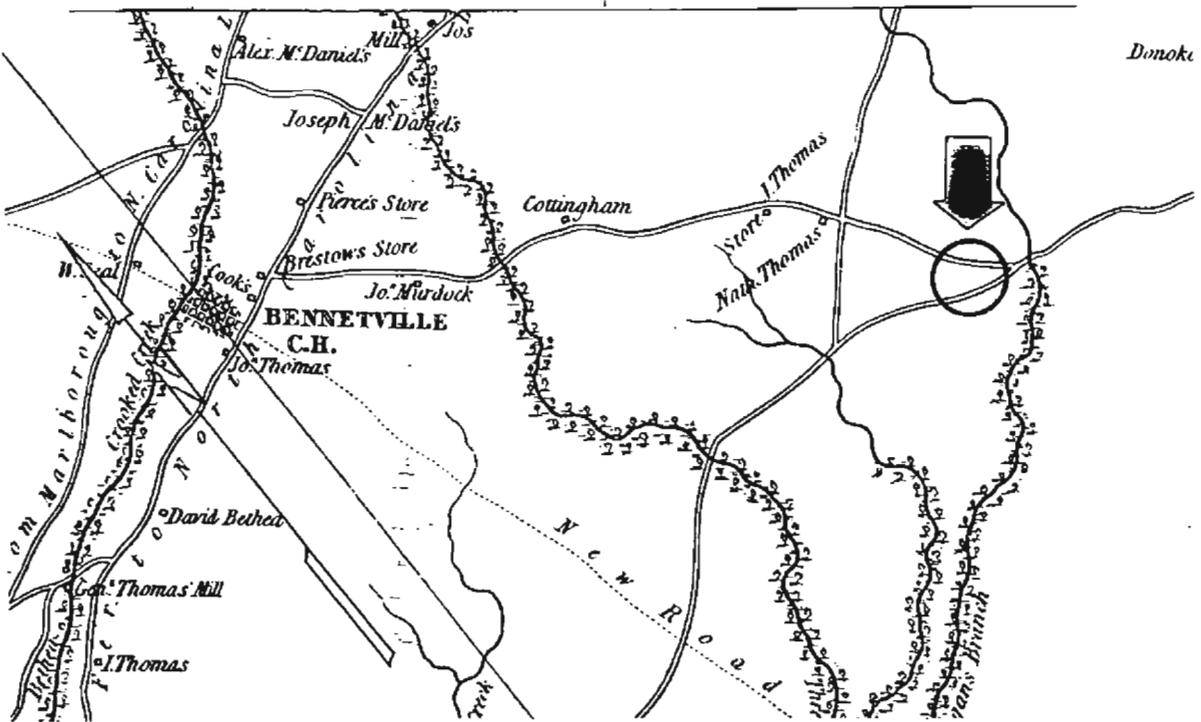
Figure 6. Mills Atlas showing the area in the 1820s.

Secondary Road 23 has a long history. While the initial date of construction is unknown, the present road closely follows the alignment of a road shown on Mills' Atlas from the 1820s (Figure 6). Some disturbance to the cemetery could have occurred during the 1958 improvements. The 33 foot right-of-way on either side of the center line puts the S.C. Department of Highways and Public Transportation boundary through the cemetery. It is likely that ditch construction for road drainage damaged several graves. Future cleaning and maintenance of these ditches will continue this destructive process.
