Conservation Talk

The Role of Lichen in Stone Deterioration

Michael Trinkley, Ph.D.
Chicora Foundation

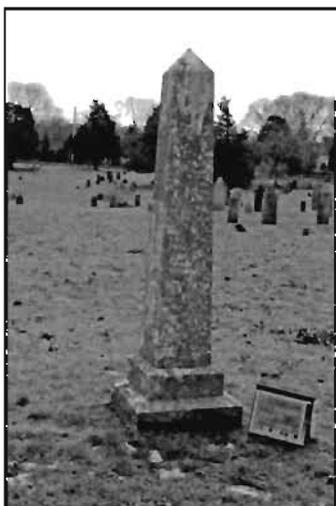
Marble obelisk showing moderately severe growth of crustose lichens.

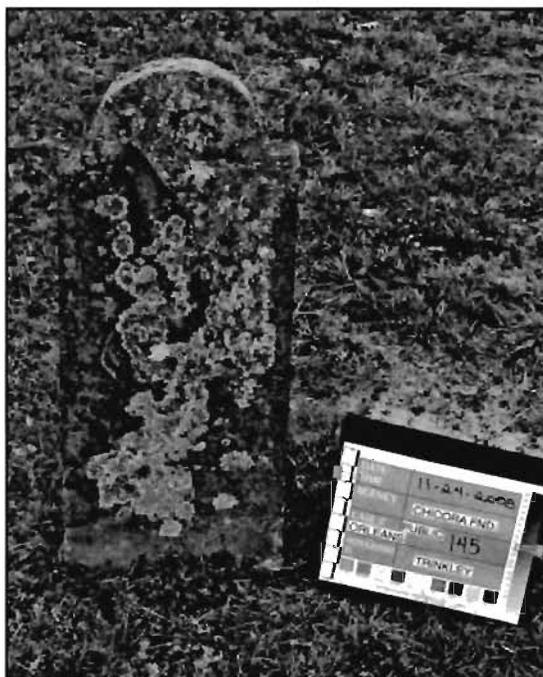
Sandstone headstone showing both crustose and foliose lichen. Although much of the face has spalled off, the small amount left is unreadable because of the lichen deposits.

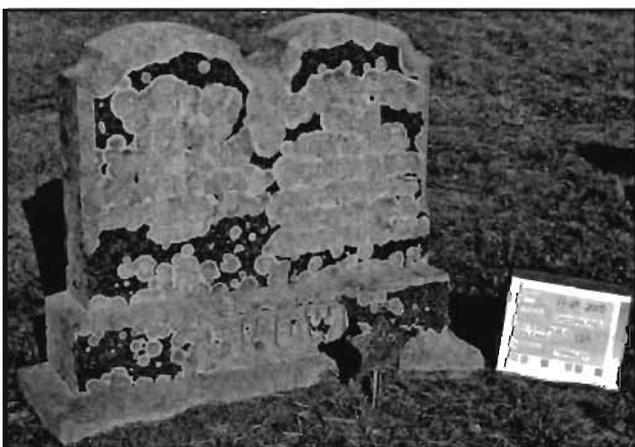
Granite die on base showing severe growth of crustose lichens over both unpolished and polished surfaces.

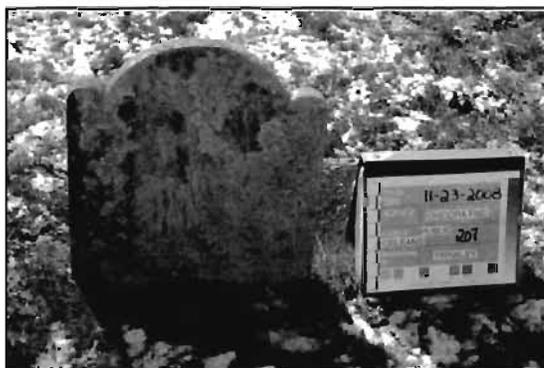
Slate headstone with grayish-green foliose lichen and a broader covering of crustose lichen. Together they make the stone illegible.
