Chicora Foundation, Inc.
 PO Box 8664, Columbia, SC 29202

June 2010

Monumental Issues

Chicora Treats Biloxi National Cemetery Monument

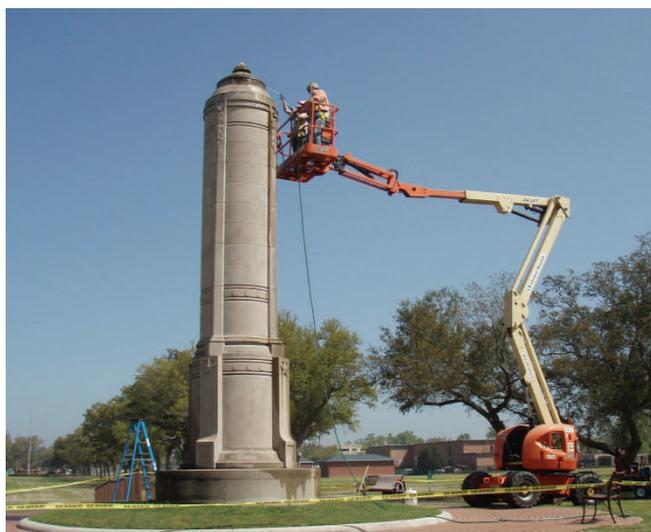
Beginning at the bottom and working up, the Chicora team completely cleaned the monument using D/2.

cleaning, as well as repointing of some mortar joints and the repair of several damaged areas.

The work was undertaken by Chicora conservators in April. Because of the height of the monument an aerial lift was required. The monument was thoroughly cleaned using D/2 Biological Solution from Cathedral Stone and potable water. Afterwards, mortar joints were cleaned and repointed using NHL mortar from Virginia Lime Works. In several areas the limestone monument was patched using Jahn M-70 Mortar.

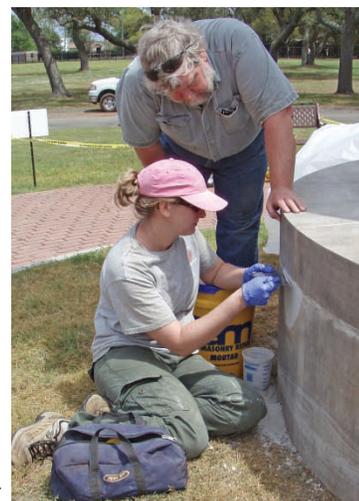
Shaping the Jahn patch.

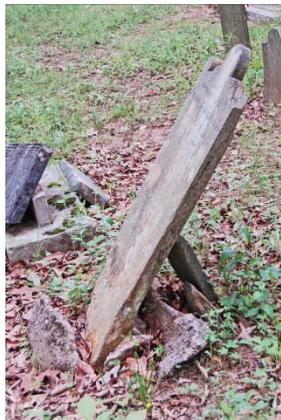
The cemetery’s stones are beautiful, but many are broken and some – like this example – are certain to suffer additional damage if not properly repaired.

We found significant damage to a broad range of the stones in the cemetery. Many of these stones also exhibited inappropriate

repairs that had been made over the past 30 years in an effort to maintain the burial grounds. A number of stones were found out of the ground – these “orphan stones” should be reset to prevent their loss or damage by mowing.

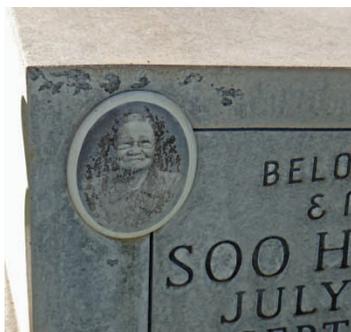
Dissolved minerals are coating this stone, obscuring the porcelain photograph.

This is a particularly serious issue in the southwest where often water is pulled from relatively shallow wells where the water is loaded with dissolved minerals.

The minerals are deposited on

– and in – stones as a result of irrigation. The results range from disfiguring monuments to the actual spalling of stone – even granite.

Solutions include curtailing irrigation, using flood irrigation, seeking new sources, or eliminating irrigation entirely.

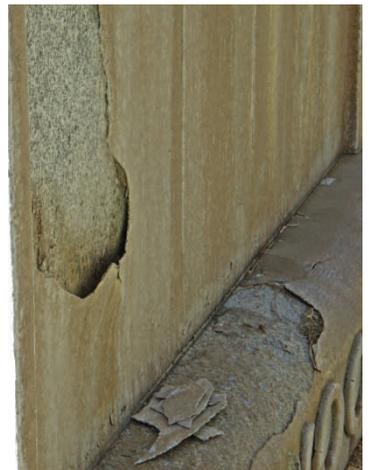
Here the deposits are causing spalling of a granite monument.
