# Monumental Issues

## Treatments Continue in Mobile's Magnolia Cemetery

Chicora conservators are continuing with the treatment of high priority monuments in Mobile's beautiful Magnolia Cemetery.

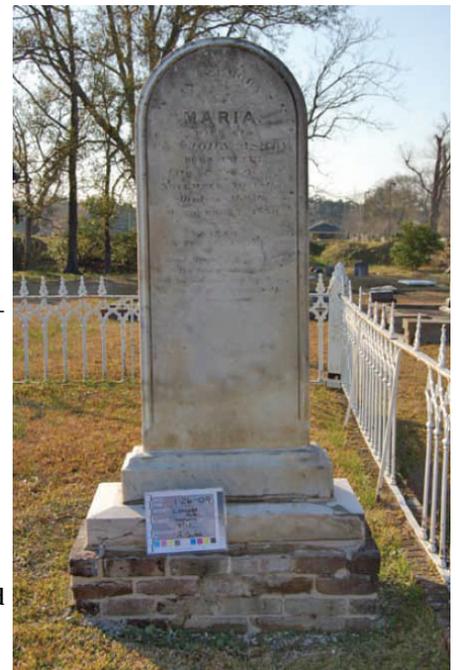
### After Treatment

The result was not simply a repaired stone, but also one that looks dramatically different. The elevation of the monument today reflects the original three-dimensional intentions of the original craftsmen.

Using a tripod rated at 1-ton, the die was lifted and reset on the base. The stainless steel pins were attached using what conservators call a hi-mod (i.e., high strength) moisture insensitive structural epoxy.

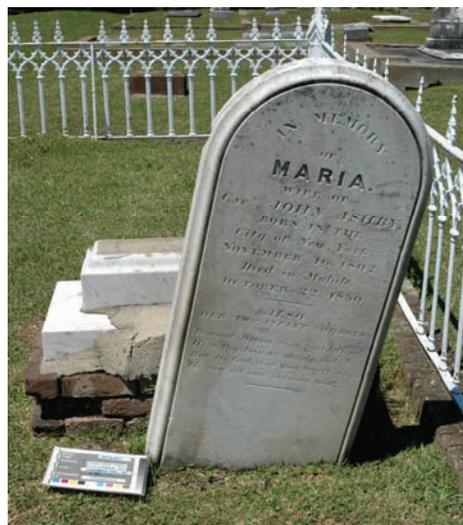
Before Treatment

One interesting monument, of Maria Ashby, was a very large and heavy tab in socket stone. The tab and socket were both damaged and the socket had been filled with Portland cement. The die had fallen and

was sunk into the soft Mobile soil nearly a foot. To complicate matters, the stone had been placed on a brick foundation that raised the stone an additional foot and half. Much of this pier was deteriorating with mortar eroded from joints and bricks either loose or entirely missing.

Treatment required that the Portland cement be partially removed, so that it would not be visible after the repair. It also required

support the massive stone.

that the brick support be extensively repaired. It was re-pointed using a 1:2 mix of NHL 3.5 and sand.

The die was removed from the soil and drilled for the insertion of two 5/8-inch 316 stainless steel rods to connect the die to the socket and its base. The rods needed to go through both in order to adequately

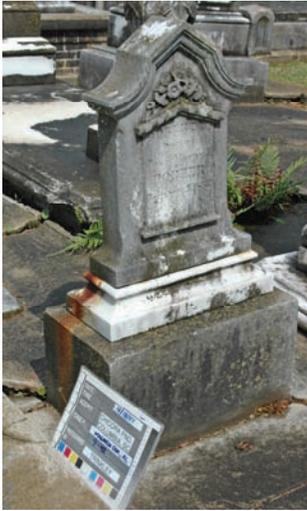
**Before Treatment—**note the corrosion staining on the left side.

The original stone mason had set the marble die on base using two ferrous pins to connect the die with base. Over time these pins had begun to corrode. This process is known as iron jacking and the iron begins to expand with the corrosion products taking up more and more room. Eventually the corroding pins will crack and split the stone. The before treatment photo clearly shows

the corrosion staining down the left side of the monument.

Treatment involved taking this monument apart, using a diamond core drill to remove the old, corroded pins, and replacing them with 316 stainless steel pins.

The monument could then be reset, using a 1:3 mix of NHL 3.5 and stone dust. The stone was cleaned using D/2 and the corrosion stains were removed using a poultice to draw the discoloration out of the marble.
