May 2008

Monumental Issues

Chicora Conducts Assessment of South View Cemetery in Atlanta

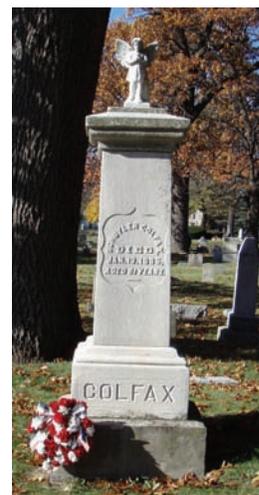
When part of a monument is damaged or lost, sometimes there is an urge to make a replacement — and too often we get results like shown here. The replacement angel is entirely too small, making the monument appear off balance.

In such cases it is better not to make replacements. Remember that the Secretary of the Inte-

rior's Standards for Preservation (http://www.nps.gov/history/hps/tps/standguide/preserve/preserve_standards.htm) specify that original fabric is to be respected and the character of the monument will be preserved. It's better to have a damaged marker than one that is no longer historic.

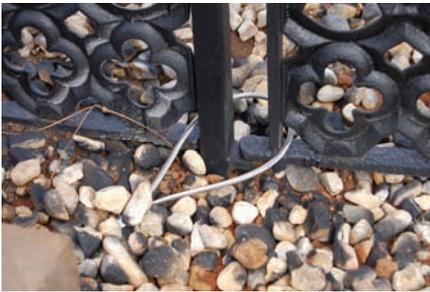
A properly secured gate will make theft more difficult, perhaps protecting your ironwork from becoming a statistic. It is also almost invisible — and it requires only \$20 per gate.

We've advocated using woven stainless steel cable to attach gates to their hinge posts. The woven wire is tough and hard to cut. It'll prevent thieves from just picking up the gate — they'll have to spend 4-5 min-

utes cutting through the wire — assuming they have the correct tools. Chances are, they'll leave and go where the picking is easier.

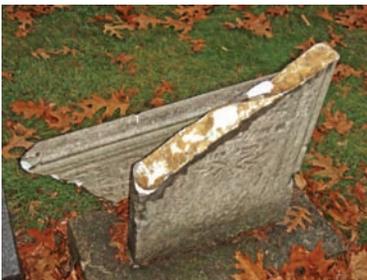
A typical “simple” epoxy repair that was doomed to failure. This inappropriate repair will make a correct repair more time consuming — and costly.

But attempting to re-attach a typical marble ground break with only epoxy isn't going to be a long-term solution. While the epoxy is very “strong,” the stone isn't, and the repair fails just above or below the original break. The monument falls, often breaking into more frag-

Another problem is that continuous epoxy joints are impermeable. This creates an area where moisture contributes to failure.

The only effective solution in most cases in a more complex blind pin repair, which requires the training of a professional stone conservator.
