Monumental Issues

Trinity Box Tomb Transformed

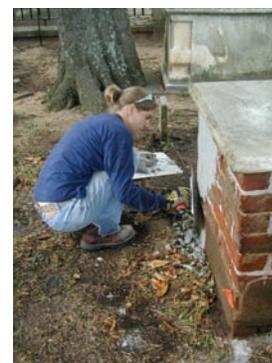
Nicole Southerland applying Jahn stucco to the Mary Hampton box tomb.

The first step was to gently remove all of the loose and failing stucco. We found most of this to be composed of an inappropriate hard Portland cement. Areas where the original stucco could be found suggested that it was much softer.

Afterwards it was necessary to repoint the brick using a lime putty mortar. Some brick that was badly spalling had to be

removed and replaced with matching brick in better condition. This work had to cure for a month before new stucco could be applied.

The stucco chosen for this project was Jahn M60. Available from Cathedral Stone, this is a single component, cementitious mortar that is compatible with the substrate and allows ready movement of water vapor.

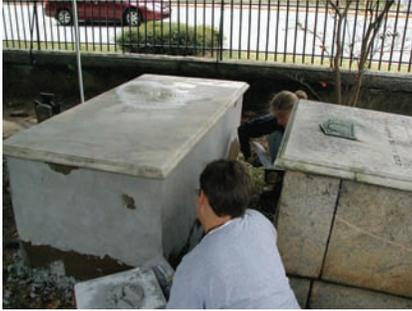
Julie Poppell and Nicole Southerland with the Mary Hampton almost completed.

No color matching was chosen since the stucco was going to be colored with Silin® Lasur mineral stain to replicate white-wash, but provide greater dura-

bility and less maintenance (this final application has yet to be applied since we are waiting for warmer weather).

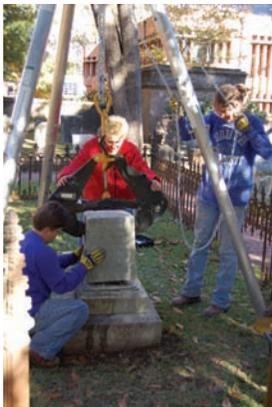
Although an aluminum tripod such as this can make moving heavy monuments easier, it also requires additional safety practices.

A case in point is the use of aluminum tripods and gantries for the movement of heavy

stones. Both are used at Chicora, depending on the space involved and the weight (our aluminum tripod is used for stones up to 1 ton, while our gantry is rated up to 2 tons).

Steel toed boots are a must. But so, too, is an understanding of how to inspect the rigging and

hoist for damage; understanding load limits, and being able to prepare the load for lifting.
