CHICORA RESEARCH CONTRIBUTION 319

**RECONNAISSANCE PRESERVATION ASSESSMENT  
OF ST. PAUL'S CHURCH CEMETERY,  
AUGUSTA, GEORGIA**

Prepared By:  
Michael Trinkley, Ph.D.

March 19, 2001

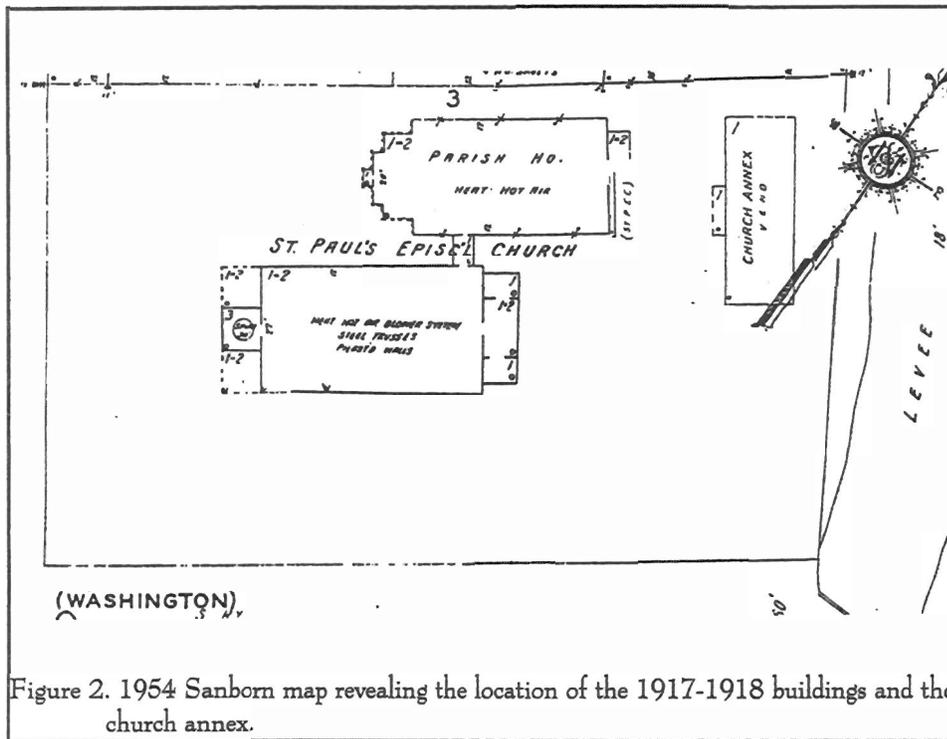
Figure 2. 1954 Sanborn map revealing the location of the 1917-1918 buildings and the church annex.

shown on a 1954 Sanborn map, along with a church annex placed in the rear northern corner of the church lot (Figure 2).

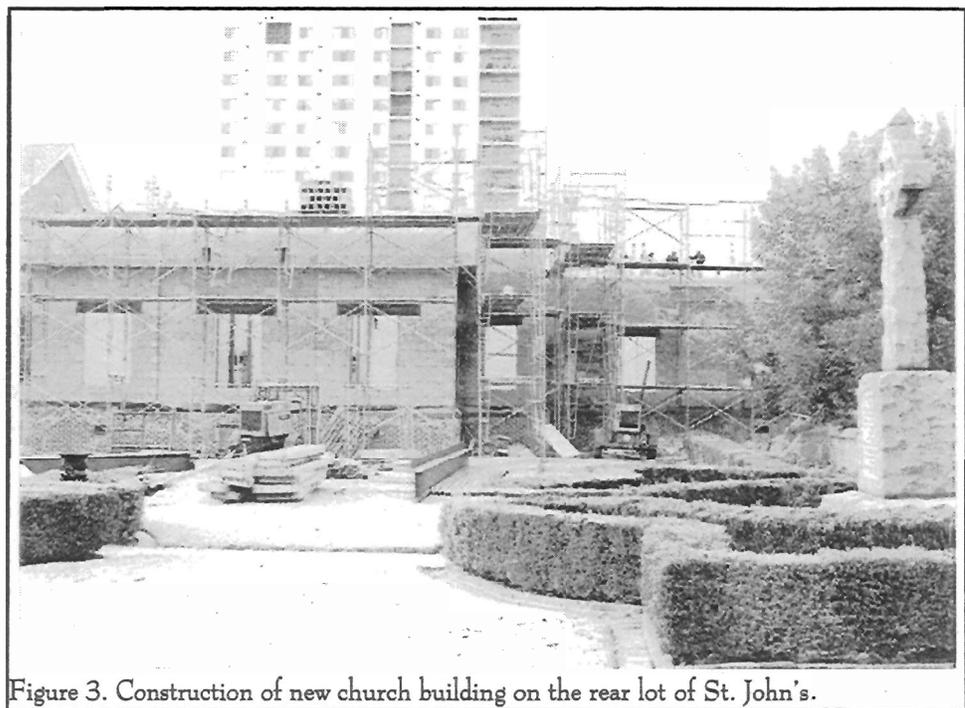
Figure 3. Construction of new church building on the rear lot of St. John's.

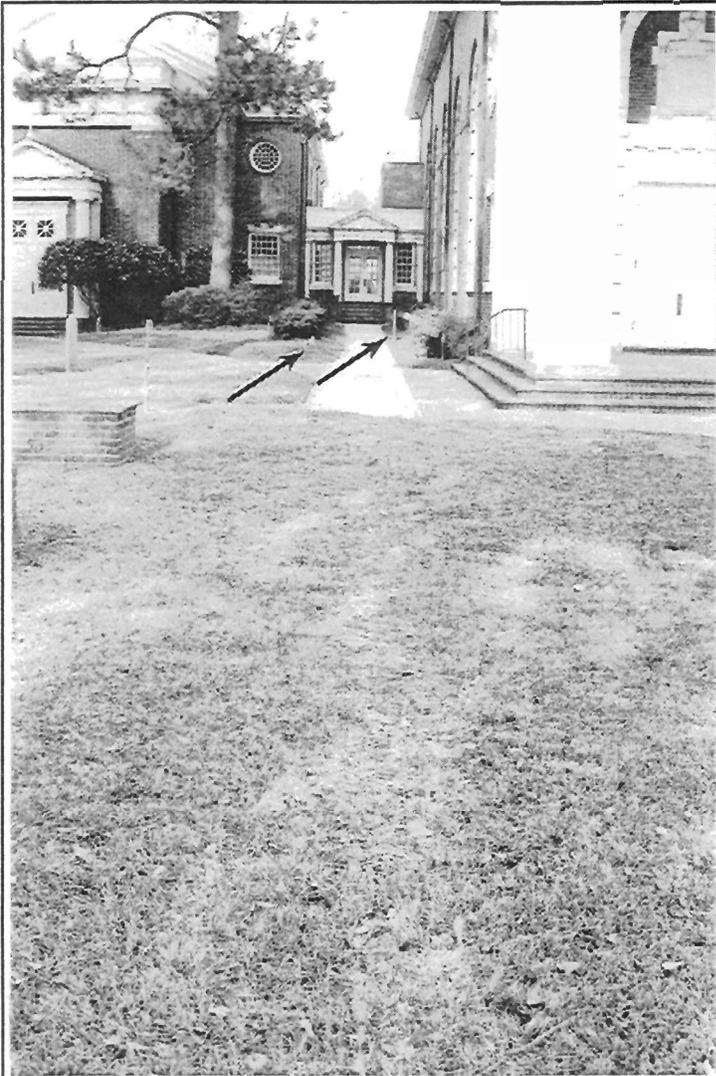
Figure 4. Area of new walkways and underground drain running through the cemetery. Arrows point to graves now covered or disturbed.

I caution the Church and Oglethorpe Foundation that **any future ground disturbing activities — regardless of how innocuous they may seem at first — should be investigated by an archaeologist with experience in cemetery preservation.**

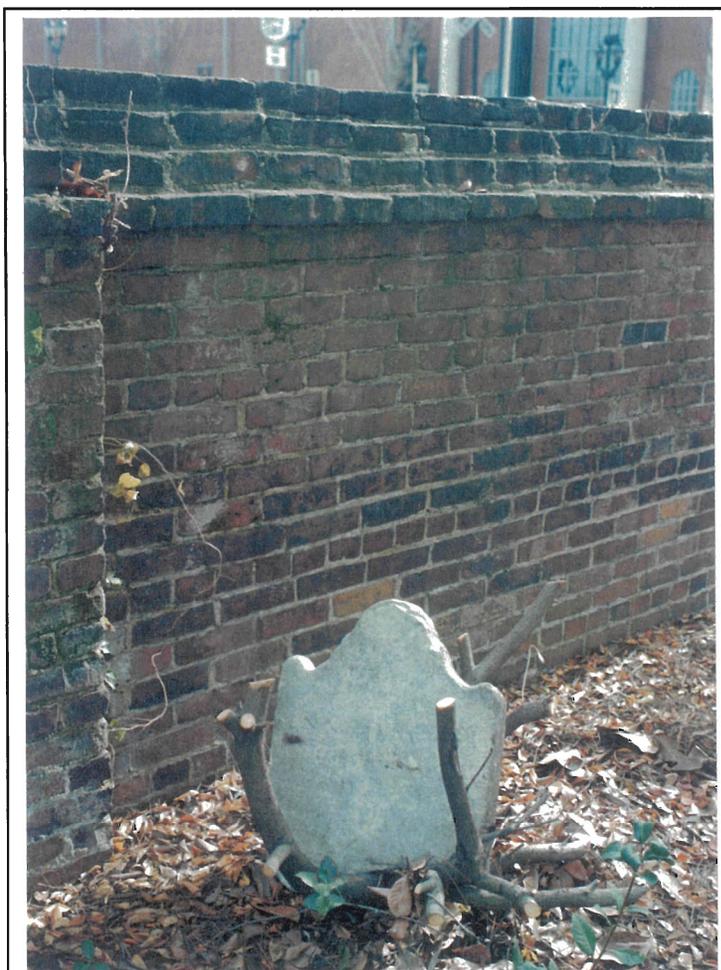
Figure 5. Loose stone found cradled in pruned bush, suggesting it may have been dropped there by an individual scaling the wall.

As I toured the cemetery I noticed a number of places where displaced stones had simply been placed to one side or stacked against the church walls. Figure 5 shows a stone discarded in the branches of shrubbery next to the Sixth Street wall. Figure 18 not only shows this same stone in the background, but several others stacked against the wall. Figure 19 shows a broken tabletstone leaning against another stone's support. Figure 20 shows several stone fragments leaning against

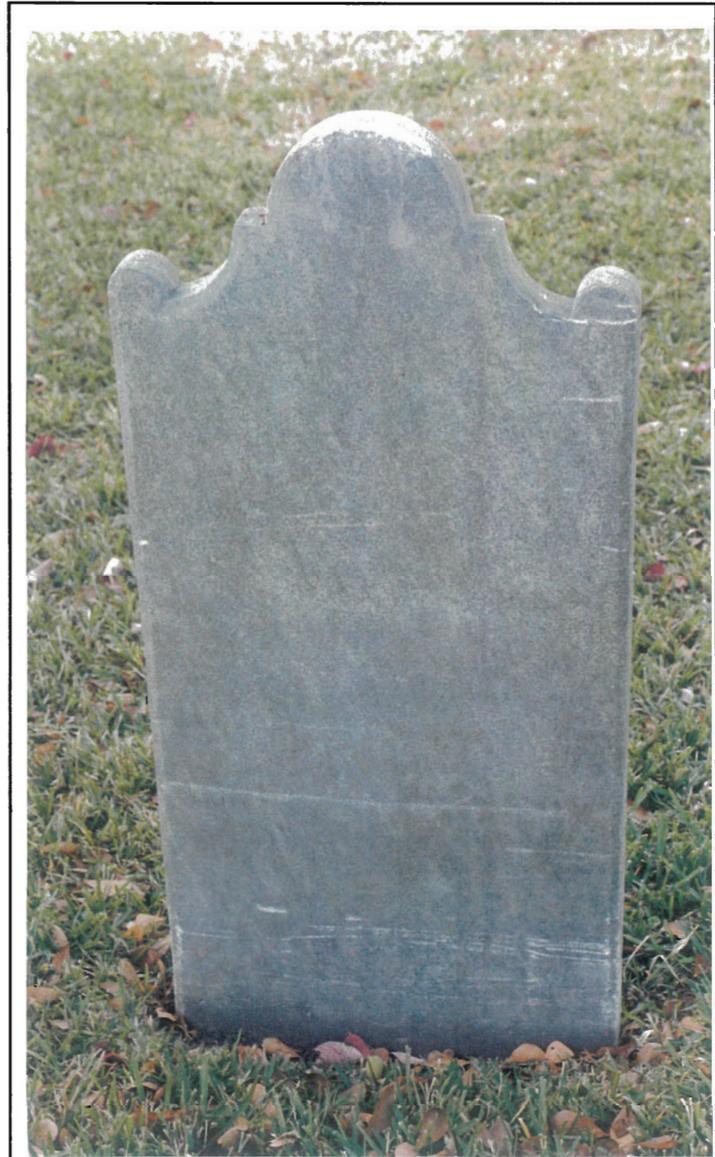
Figure 6. Reverse of a marble tabletstone showing mower and nylon trimmer damage. The striations on the upper two-thirds are likely from riding mower damage. The numerous parallel striations at the base are from nylon string trimmers.

with clear evidence of recent mower damage (Figures 6 and 7). This suggests that mowing is aggressive.

Strangstad has suggested that a safe groundcover be used around stones to eliminate the need for mowing. This remains an option. Under this scenario, an area about 12-18 inches around a fragile or friable stone has the grass

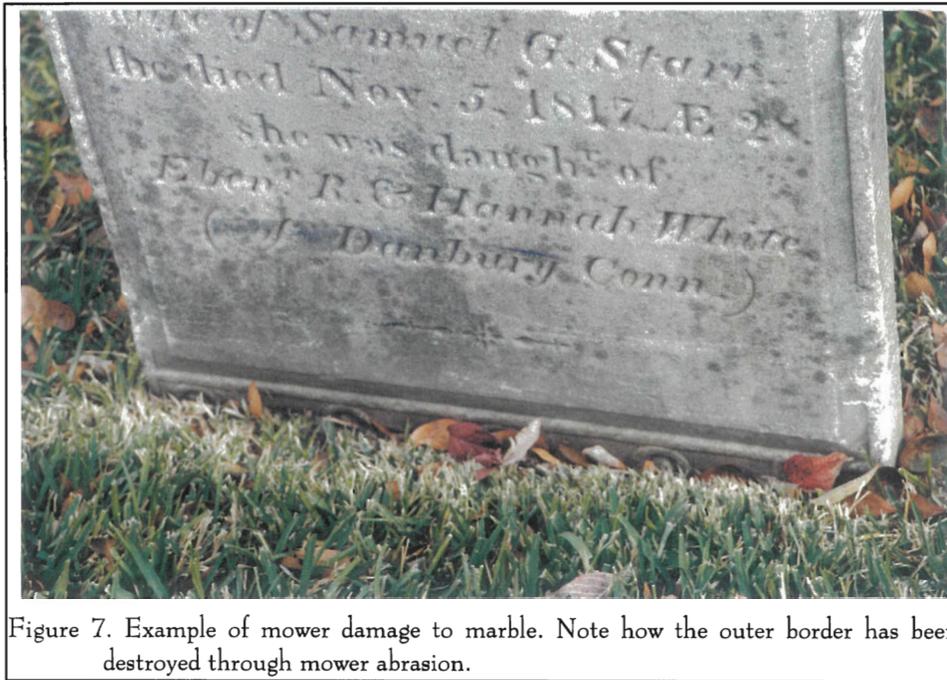
Figure 7. Example of mower damage to marble. Note how the outer border has been destroyed through mower abrasion.

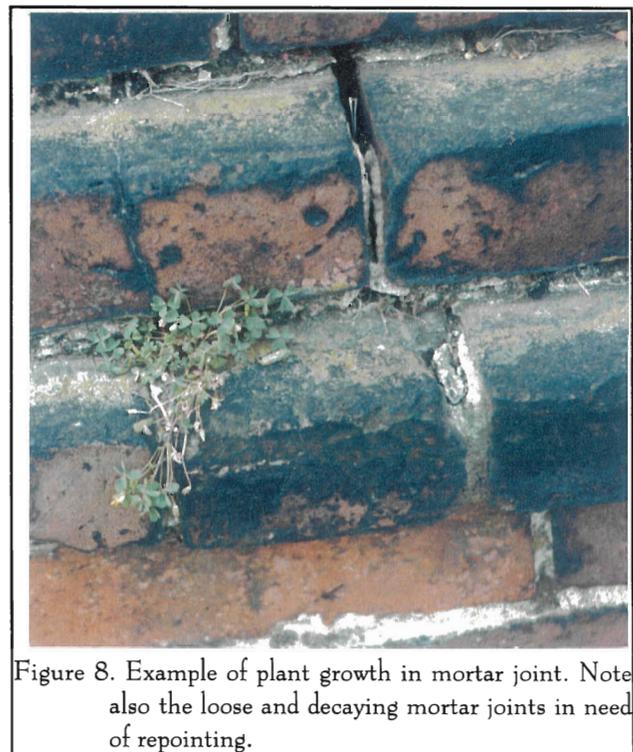
Figure 8. Example of plant growth in mortar joint. Note also the loose and decaying mortar joints in need of repointing.

cause a wide variety of problems. Their root systems focus on mortar joints (Figure 8) although soft brick

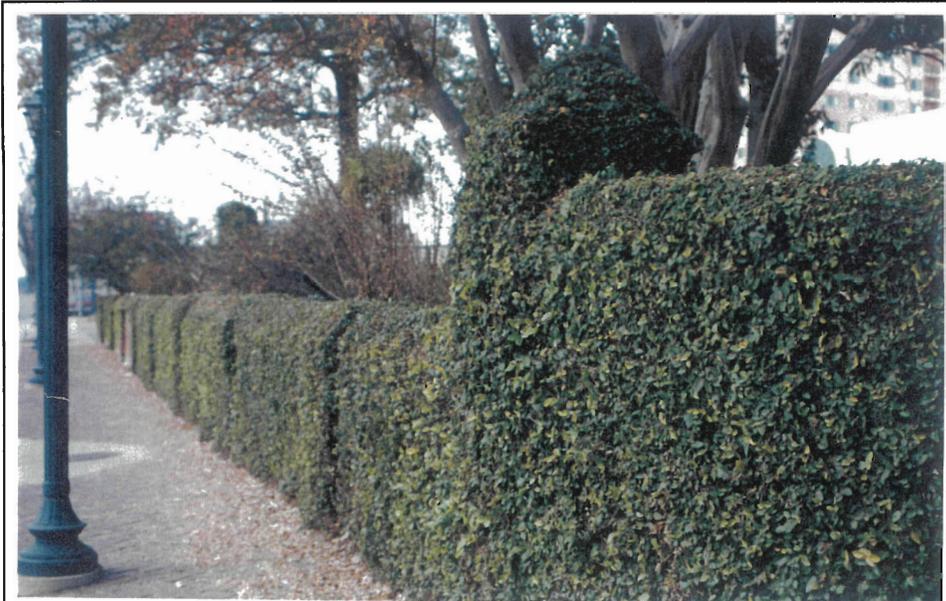
Figure 9. Vines attached to the brick wall along Reynolds Street should be removed to protect the stability of the brickwork.

itself can be penetrated. The dense growth holds moisture, further promoting the deterioration of the joints. Through time the joints are eroded out and the stability the brickwork suffers. In the case of the Ashton monument this process has proceeded so far that the Church is facing a clear crisis.

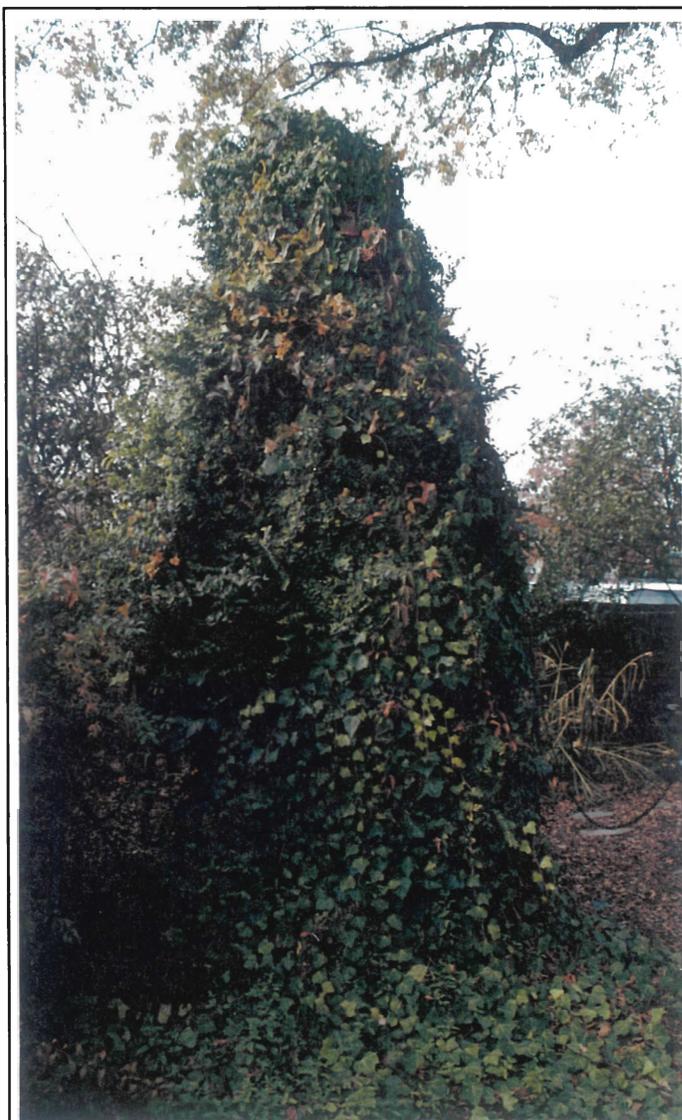
Figure 10. View of the vine covered Ashton brick monument. The deterioration of this monument is severe and requires immediate attention.

- A scaffold needs to be erected around the monument to assist in the evaluation process. This process should be lead by a conservator.
- All ivy needs to be painstakingly removed by clipping individual, small sections. No ivy should be “pulled” off

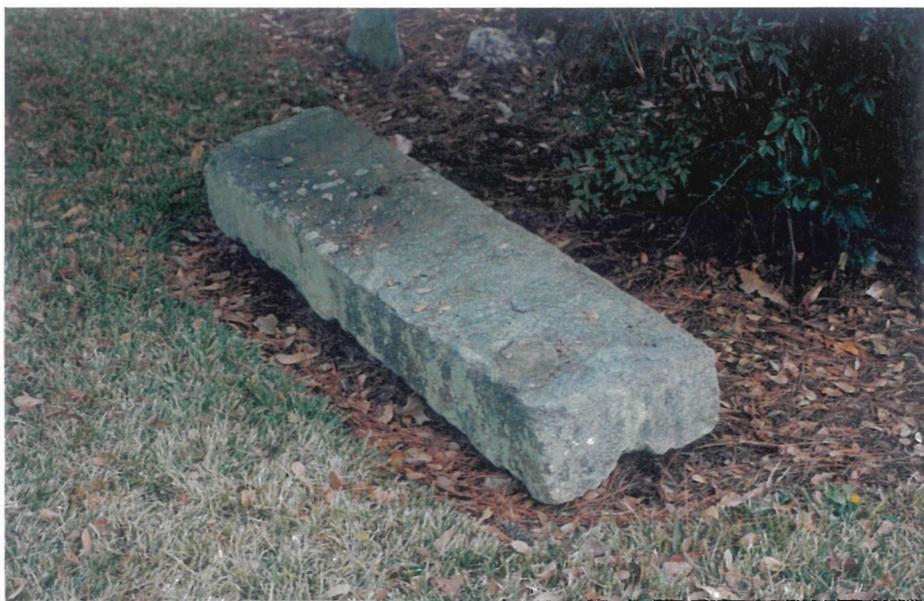
Figure 11. Stone "bench" that is poorly arranged and essentially non-functional. With a little additional effort these can be made into useful additions to the cemetery landscape.

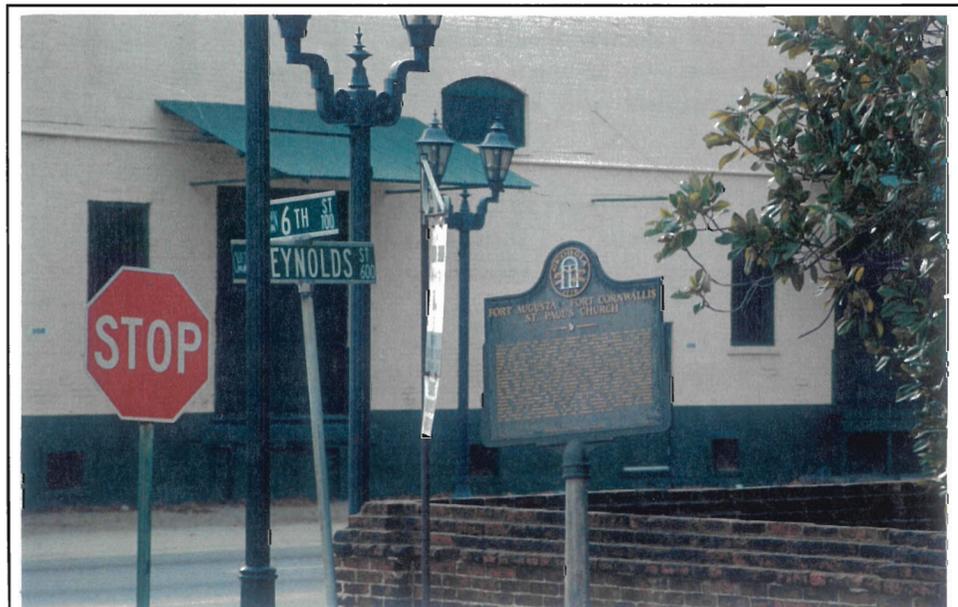
Figure 12. Cluster of signs at the corner of Reynolds and Sixth streets. The historic sign is verbose and difficult to read.

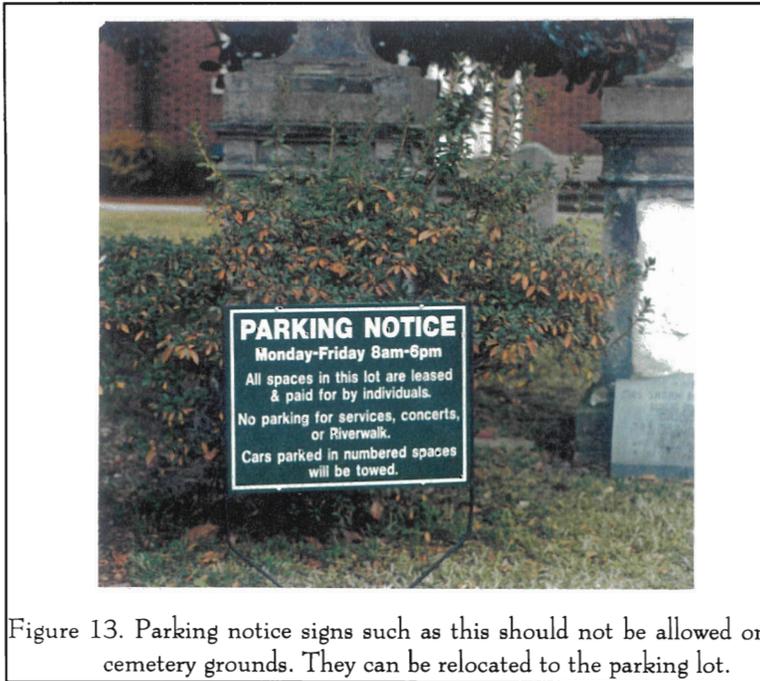
Figure 13. Parking notice signs such as this should not be allowed on cemetery grounds. They can be relocated to the parking lot.

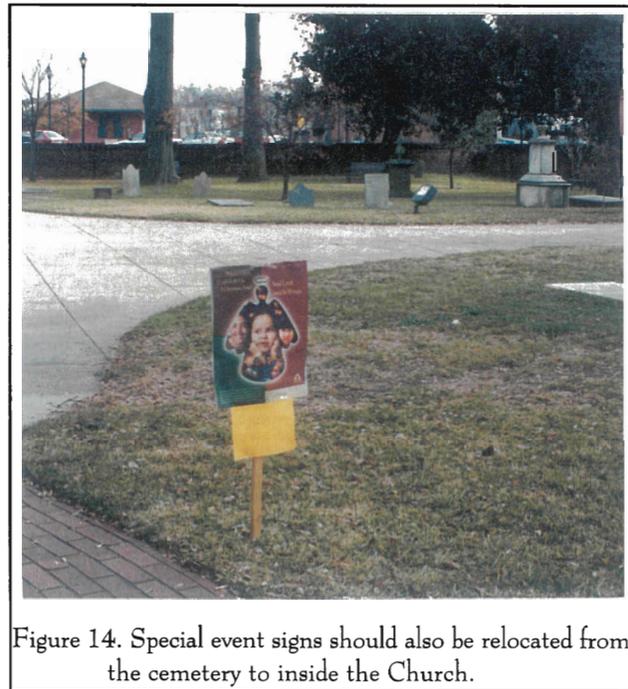
Figure 14. Special event signs should also be relocated from the cemetery to inside the Church.

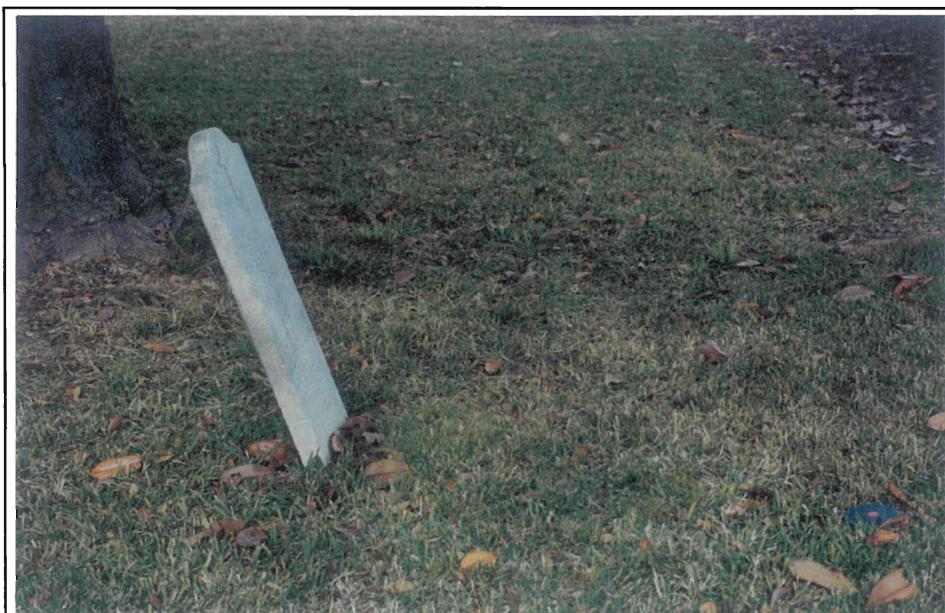
Figure 15. This stone is not only leaning dangerously, but is also located too close to the impulse sprinkler head (see Figure 16).

Sprinkler systems pose a variety of concerns in cemeteries. First and most fundamentally, they have to be placed through graves and I do not believe that this demonstrates the level of care and dignity appropriate for these sacred spaces. In addition, sprinklers require constant maintenance and, if allowed to leak, can cause serious waterlogging problems. Sprinklers also encourage the use of grass — which is unable to withstand even mild droughts. This increases water use, as well as mowing maintenance. In addition, industrial landscape sprinklers often use far too much water pressure and direct the water onto stones that are not able to withstand this routine damage. Figures 15 and 16 illustrate this problem well.

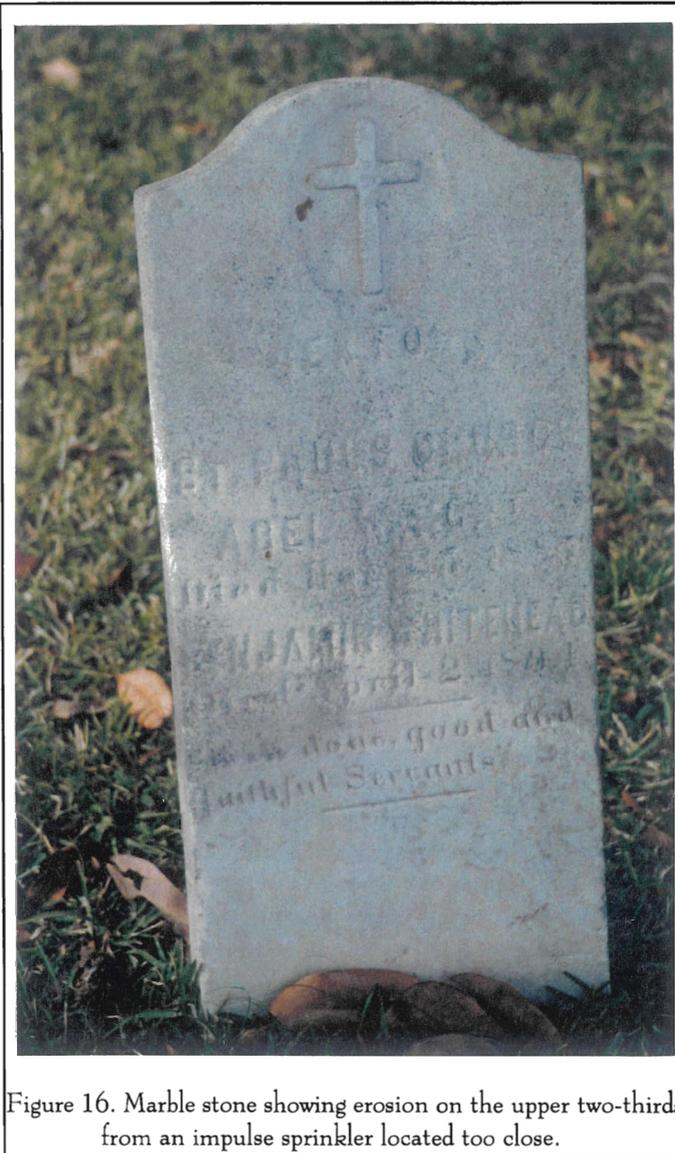
Figure 16. Marble stone showing erosion on the upper two-thirds from an impulse sprinkler located too close.

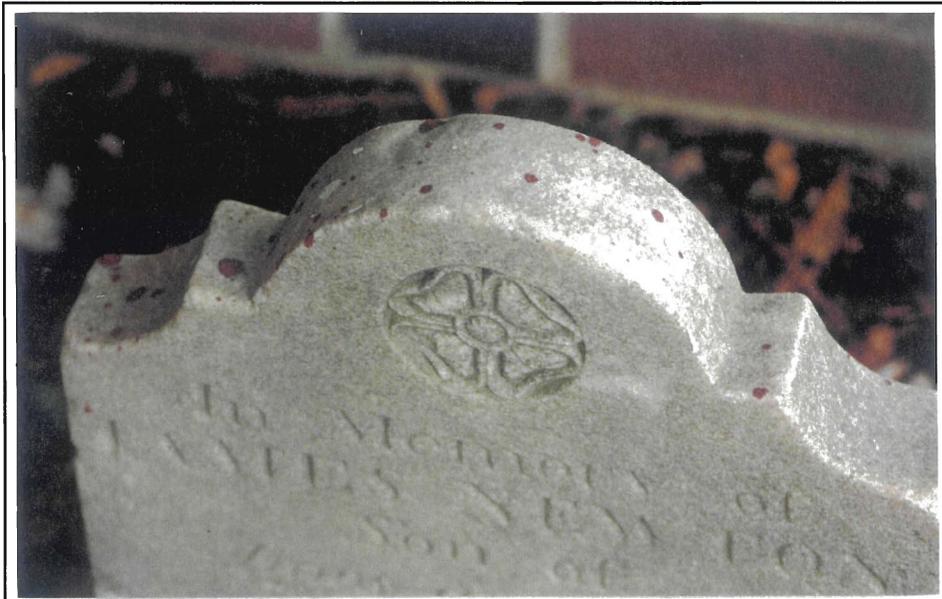
Figure 17. Splatters from overhead painting on a marble stone near the Church building.

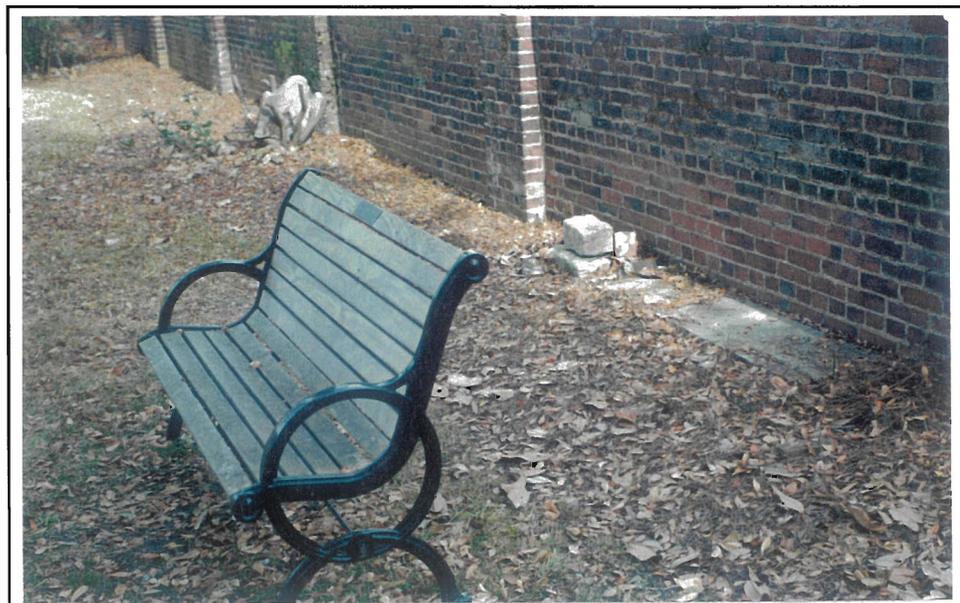
Figure 18. Broken markers stacked up against brick wall.

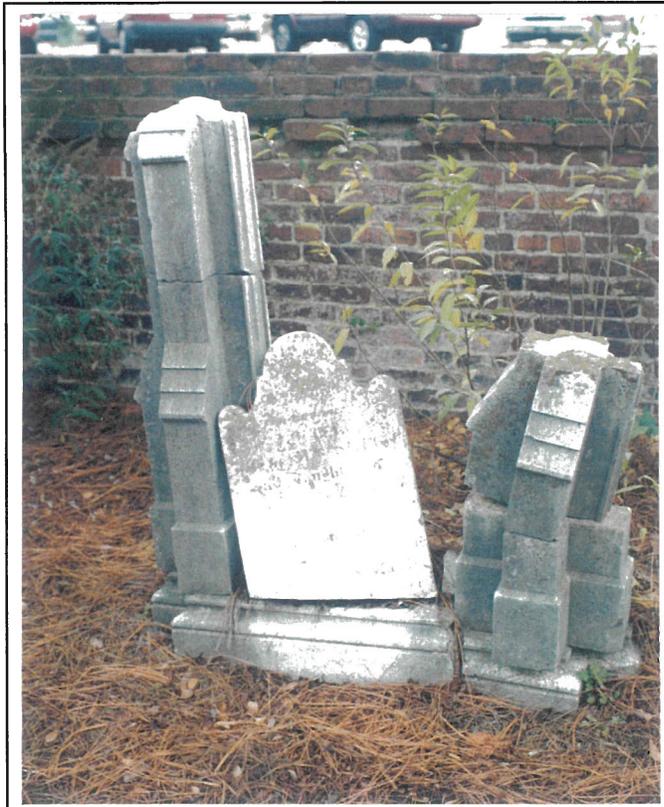
Figure 19. Tabletstone leaning up against support for a different marker.

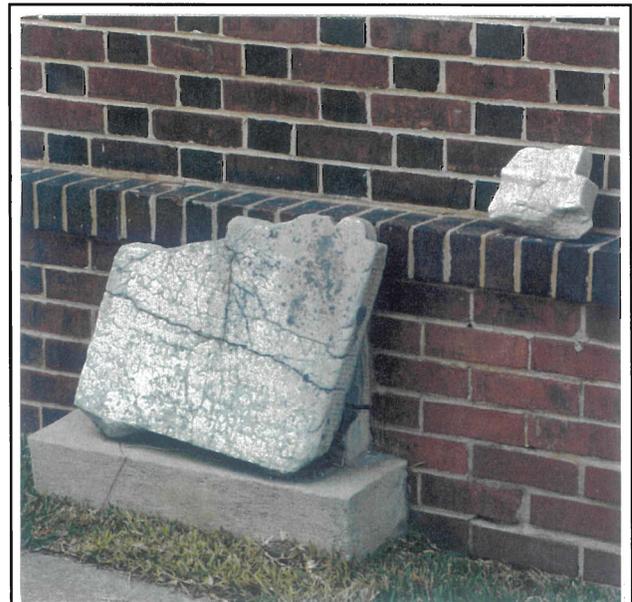
Figure 20. Broken markers leaning up against Church wall.

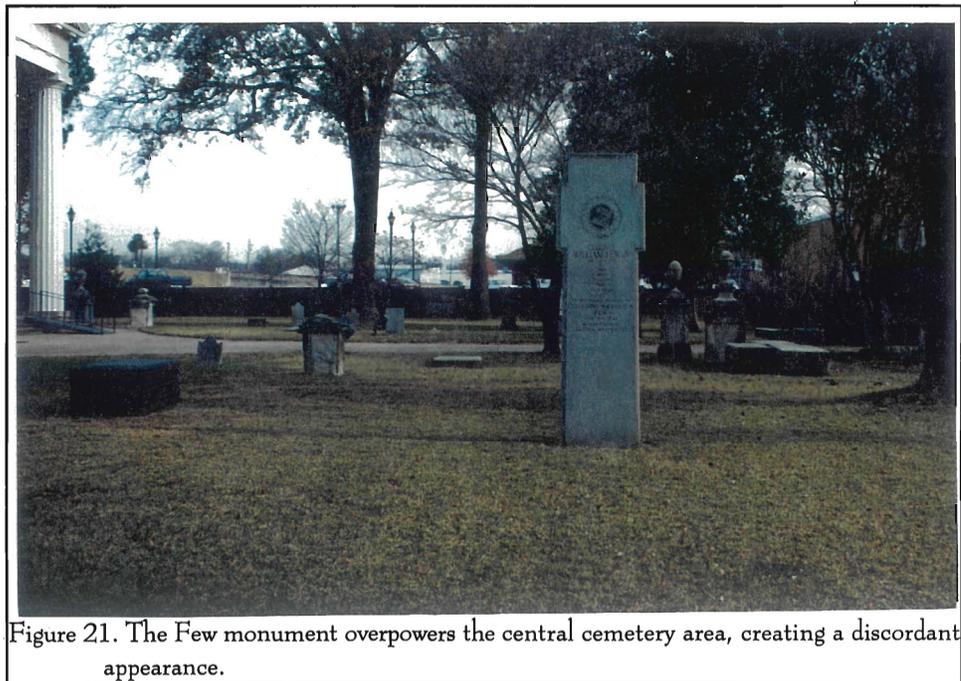
Figure 21. The Few monument overpowers the central cemetery area, creating a discordant appearance.

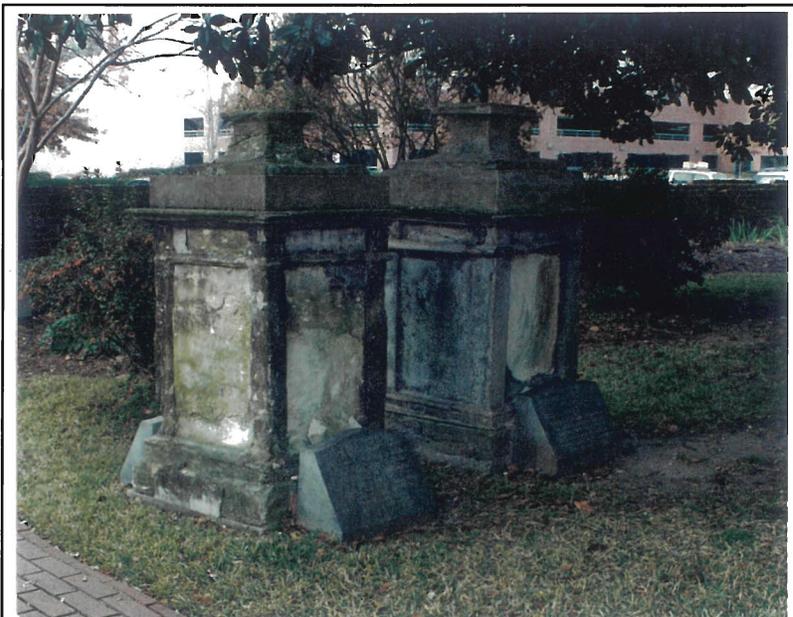
A somewhat similar situation is found at the two Phinizy monuments. Because of loss at those monuments, the inscriptions were replicated and placed at the base of the original monuments. Again, the use of granite is inappropriate. This material has no place in a cemetery the age of St. John’s. In addition, the plaque marker style overwhelms the grace and art of the original monuments. As a result, it appears that the monuments have had “bumpers” installed on them. Far more appropriate would have been deeply cut marble installed as small ledgers, flush on the ground. This would have allowed the original wording to again be read, but would not have distracted the viewer from the beauty of the original monument. What were once stunning pieces that caught your attention as you entered the cemetery from the parking area have been

Figure 22. The installation of granite plaque markers on both sides of the Phinizy monuments makes it appear that they have "bumpers." Flush markers would have been far more appropriate and in keeping with the cemetery.

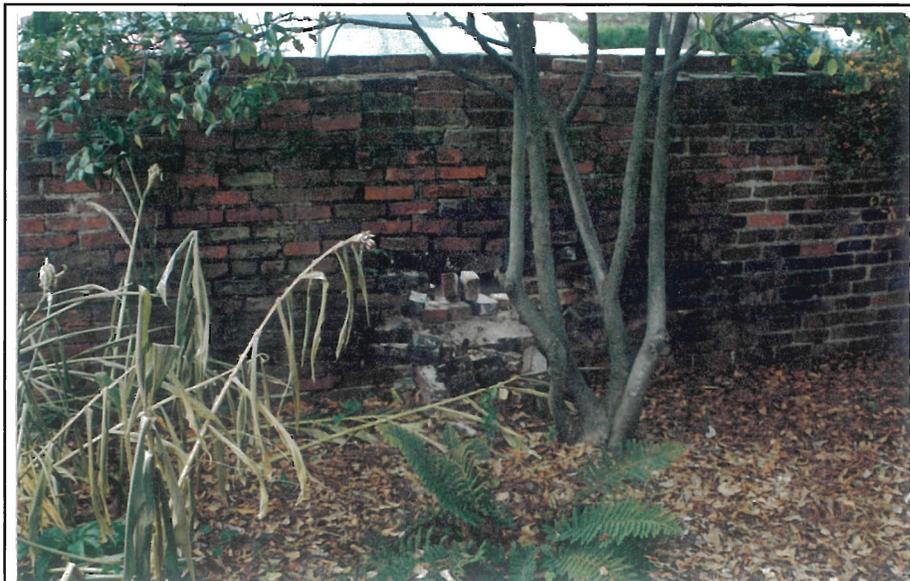
Figure 23. Interior damage to wall bordering the parking lot.

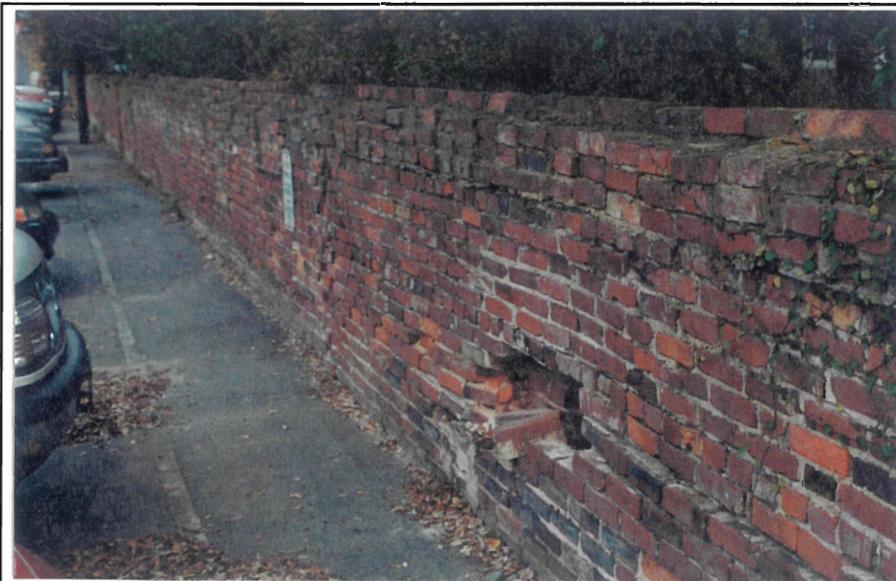
There is also a badly damaged section of this wall. While from the interior of the churchyard it appears that the wall has simply collapsed, if the damage is examined from the parking lot it becomes

Figure 24. Damage on the parking lot side of the brick wall section shown in Figure 23. Note that the wall is bowed inward for a distance about 20 feet. All of this will need to be taken down and reset. There is no "simple fix" for this impact damage.

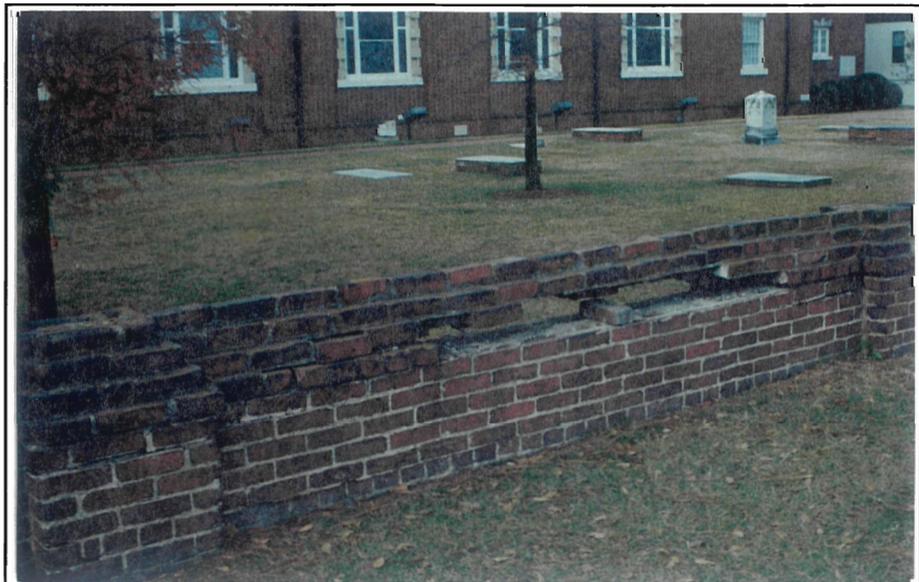
Figure 25. Damaged wall section along Sixth Street. About 25 feet of the top four to five courses will need to be disassembled and reset.

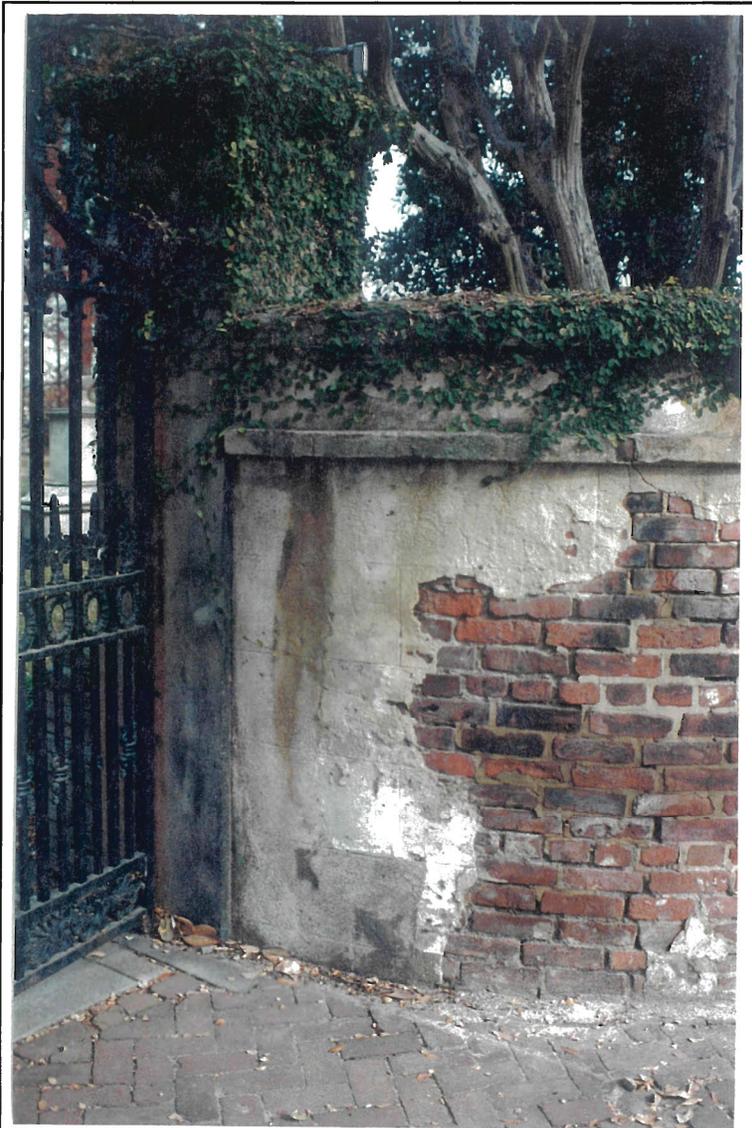
Figure 26. Example of deteriorated stucco at entrance. Here the vines need to be removed, the stucco documented, and then replaced with a product such as Jahn M60.

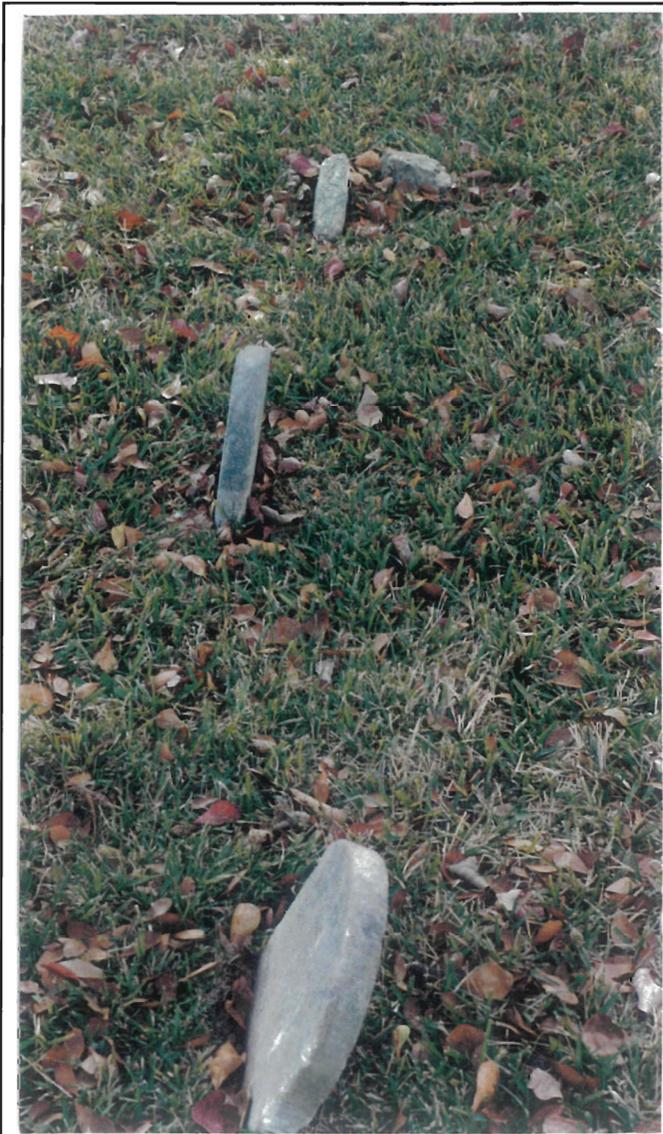
Figure 27. Leaning and sunken stones which should be reset.

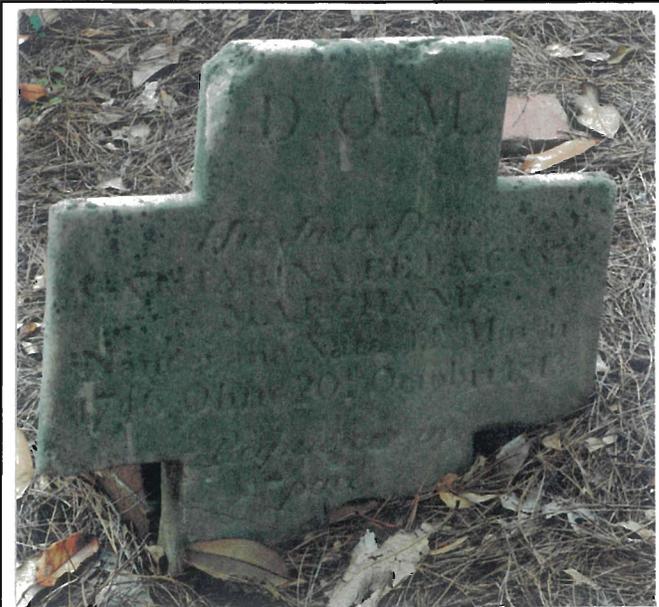
Figure 28 reveals a different type of resetting. This stone is currently leaning against a brick pillar. Unattached, this unusual stone is in danger of theft. In this case, resetting the stone may require some physical attachment to the brick column, or there may be a below grade base from which it has been broken. Regardless, this stone require immediate attention before it is lost. It is not possible to estimate a cost since its original attachment, hidden by landscaping, was not examined.

Figure 28. Unusual marker which needs to be reset to prevent theft.

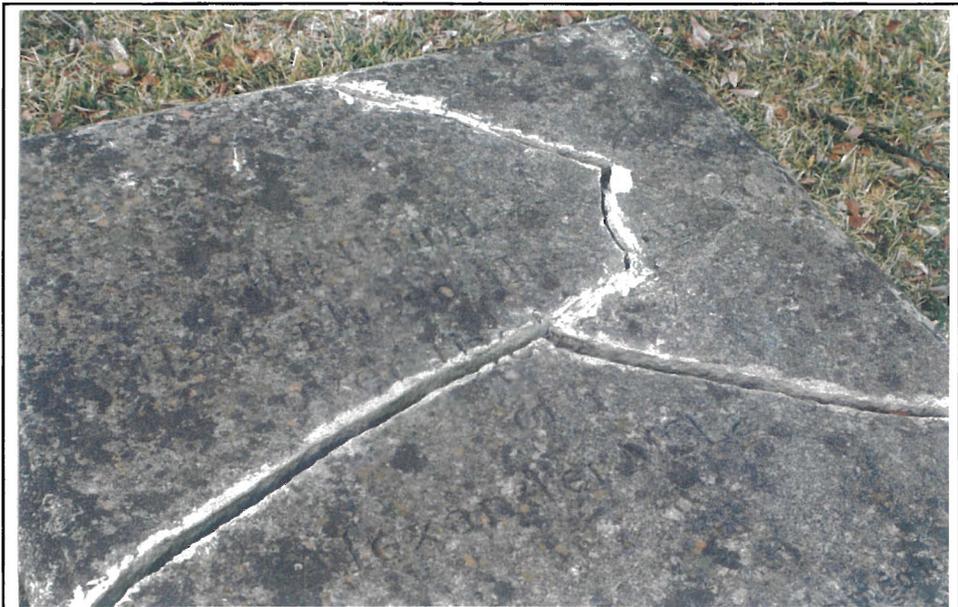
Figure 29. Example of broken ledger (Alexander McLaws) with failed previous repair. This stone requires mechanical repair before it suffers additional damage.

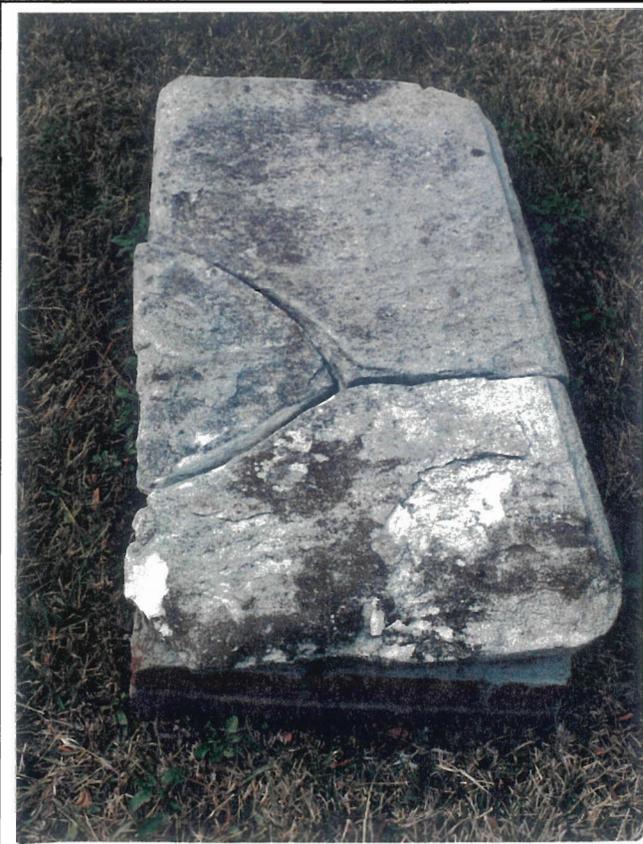
Figure 30 is an example of a very low box tomb with a badly broken ledger. This stone also requires mechanical repair. It will also likely require leveling on its brick base. In addition, the stone is very weathered and it is likely that additional infill will be

Figure 30. Broken ledger set on a low box tomb. This stone also requires extensive mechanical repair before fragments are lost or suffer additional damage.

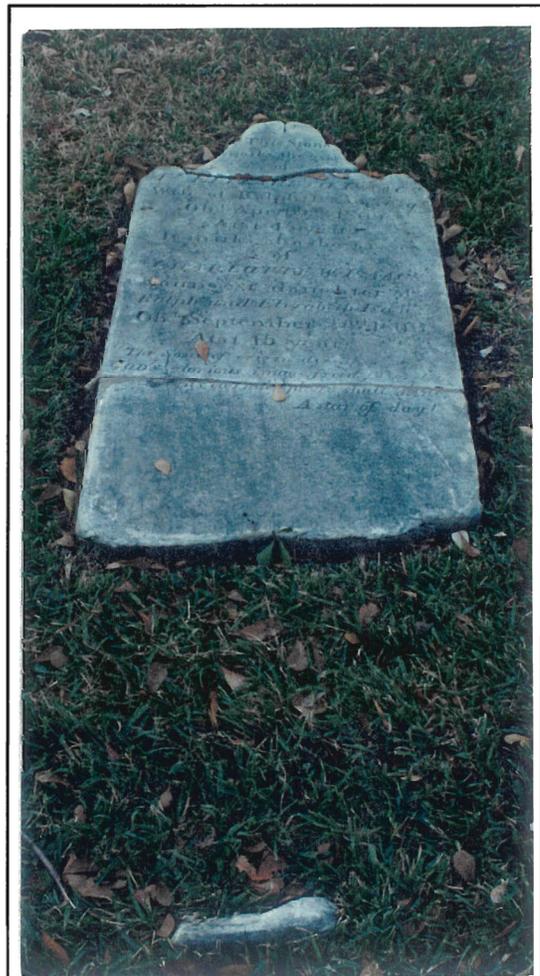
In the case of this stone there may also be a footstone (seen in the foreground of the photo). It appears that the footstone has sunk and has been badly damaged by lawn mowing activities. While repair may also be needed, at the very least this footstone should be reset, bringing it up, out of the

Figure 31. Broken tabletstone (Elizabeth & Charlotte Issacs) which needs to be repaired and reset with additional support. The footstone also needs to be reset.

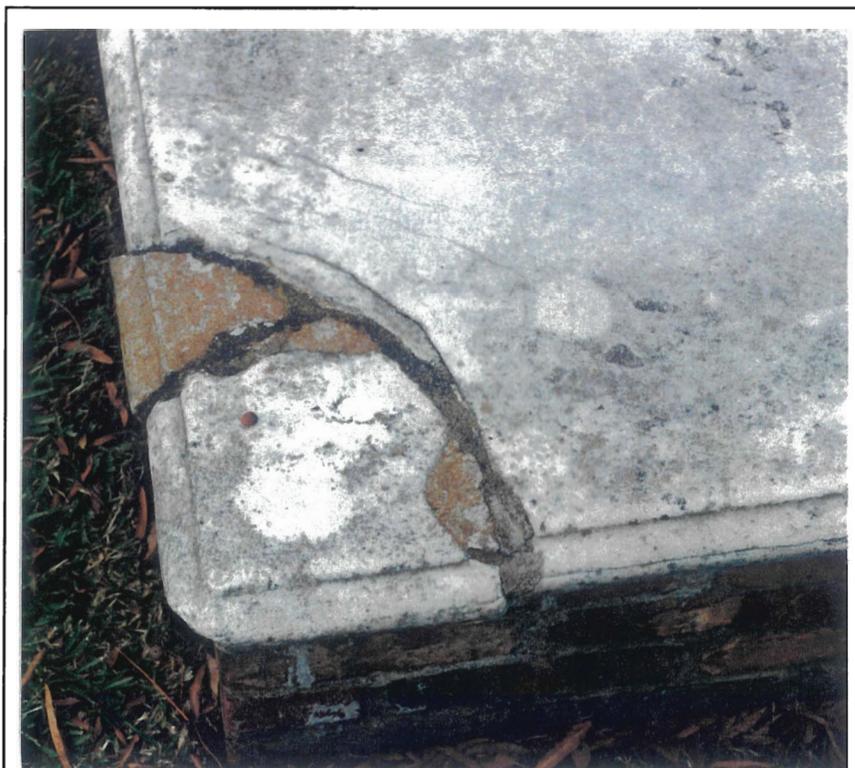
Figure 32. Example of an inappropriate, poorly executed repair. It is, however, stable and should be left alone until such time as it fails.

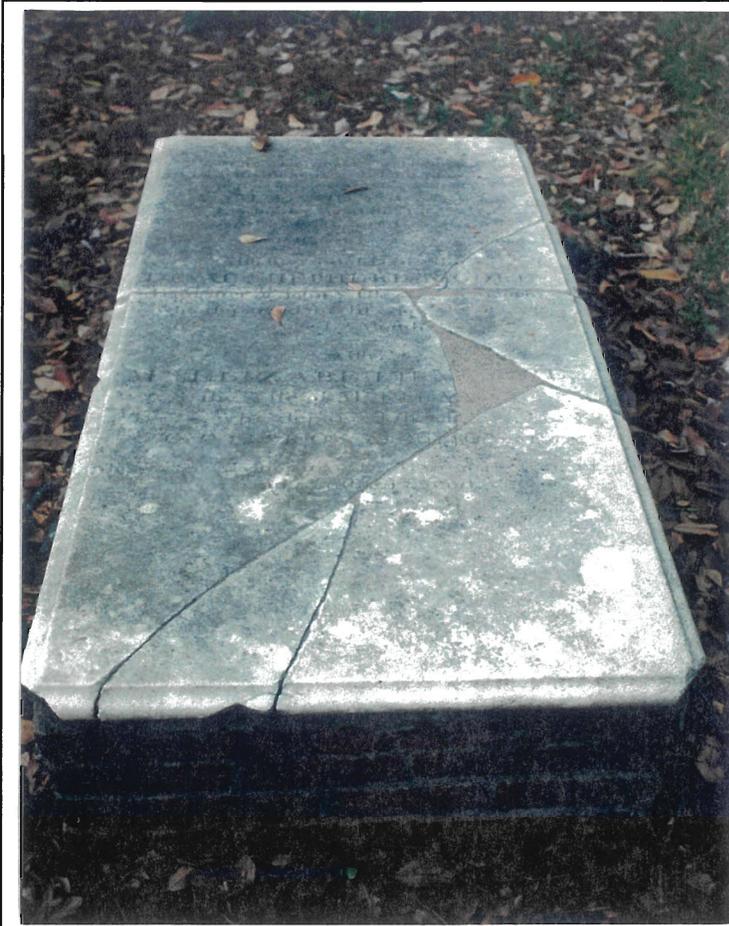
Figure 33. Although concrete was also used in this repair, the workmanship is far superior to the repair shown in Figure 32. The repair is stable and should be left alone until such time as it fails.

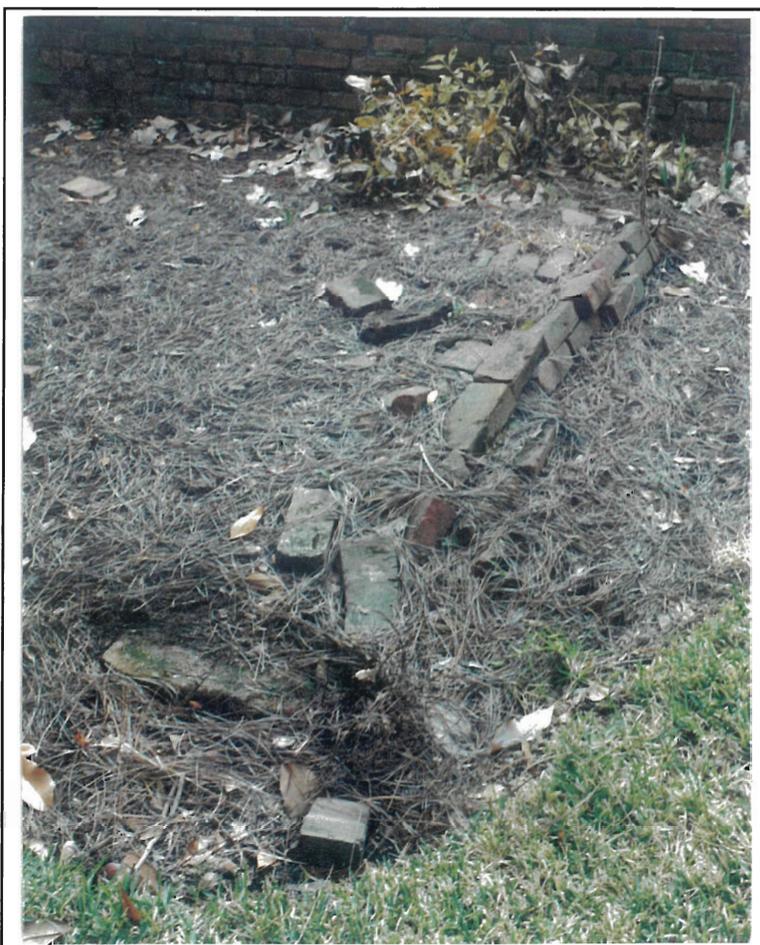
Figure 34. Probable hogback brick vault at St. John's. Additional investigation is necessary to determine whether enough of this vault has survived to allow reconstruction.
