CHICORA RESEARCH CONTRIBUTION 319

**RECONNAISSANCE PRESERVATION ASSESSMENT  
OF ST. PAUL'S CHURCH CEMETERY,  
AUGUSTA, GEORGIA**

Prepared By:  
Michael Trinkley, Ph.D.

March 19, 2001

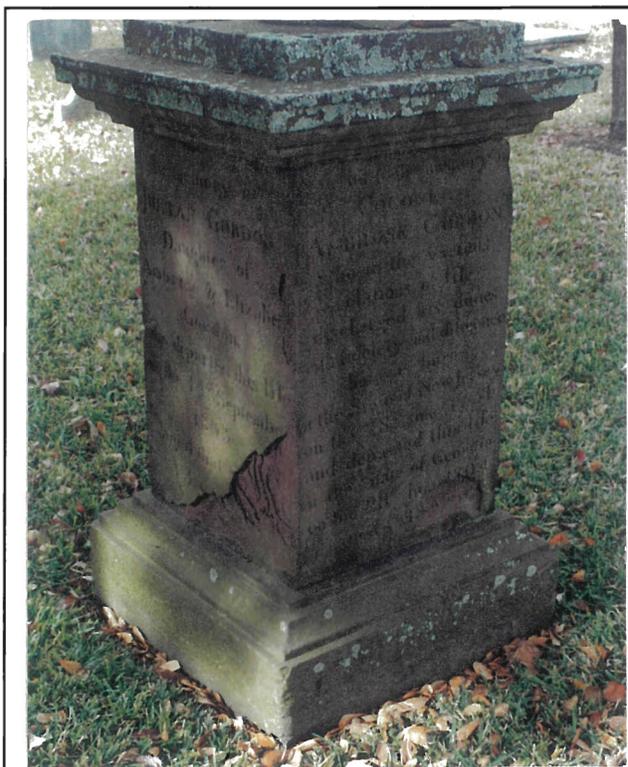
Thus far the best explanation is based on observations that the detached surface of the sandstone has become completely blocked with gypsum, with the separation occurring as a result of fatigue failure of the stone just behind the choked layer. The best research suggests that this phenomenon is related to air pollution. The working hypothesis is that rainwater may contain dilute solutions of calcium sulphate. This soaks

Figure 35. Sandstone monument showing evidence of contour scaling. The probable cause is air pollution.

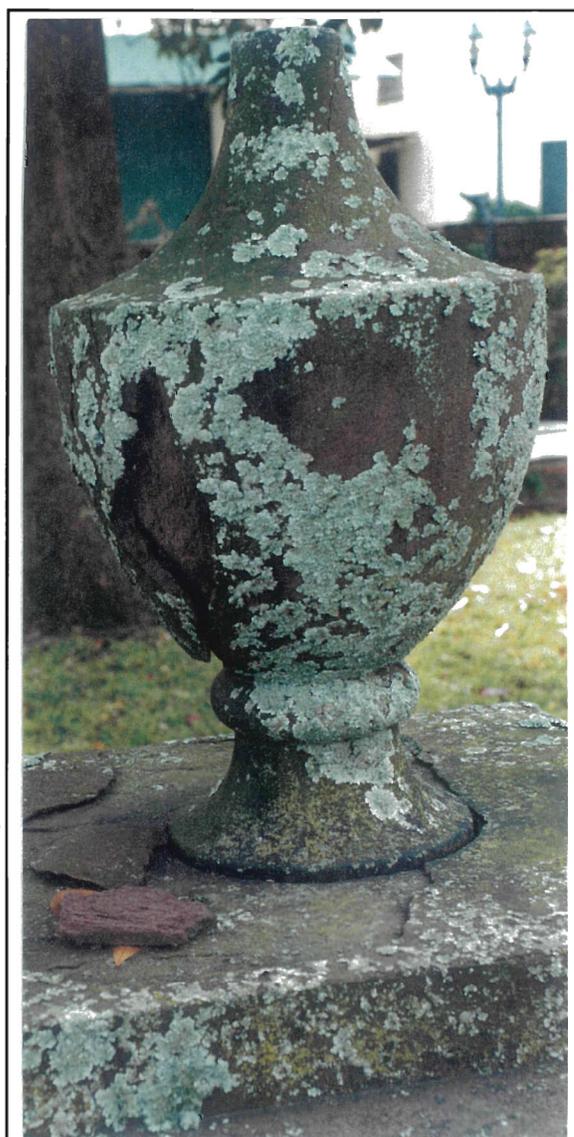
Figure 36. Contour scaling on carved urn topping the monument shown in Figure 35.

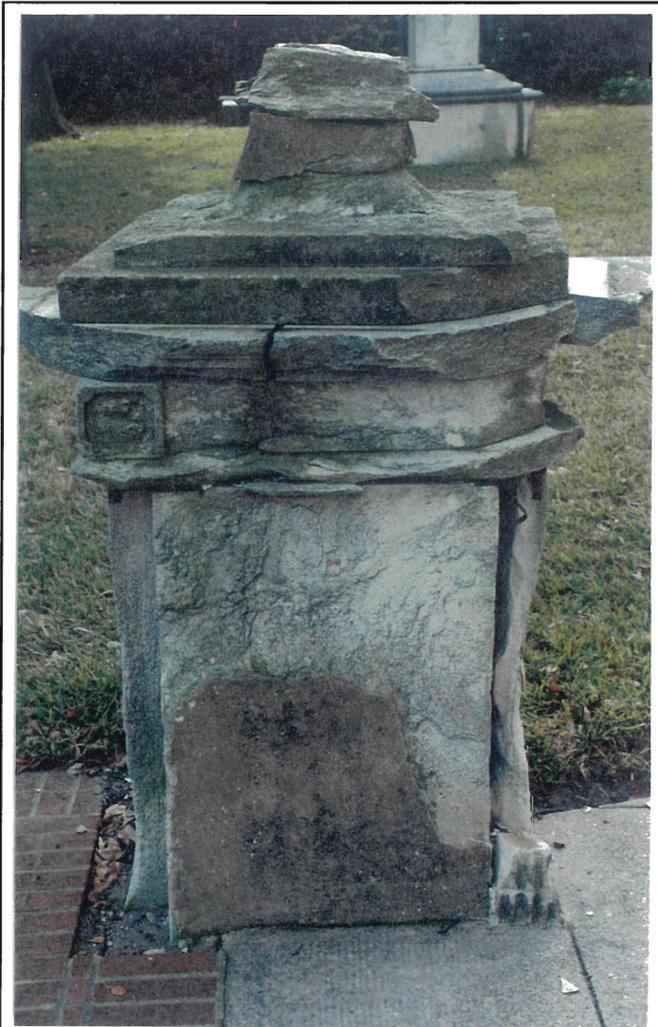
Regardless, the stones exhibit extraordinary delamination and even powdering, with the result that the monuments appear to almost be “melting.” Some at St. John’s have had a concrete coating applied to

Figure 37. Example of severely delaminating schist monument at the entrance to St. John's. A previous effort to retard erosion is evidenced by the concrete patch on the lower half of the base. Most has already spalled off.
