**ARCHAEOLOGICAL EXAMINATION OF
NINETEENTH CENTURY ROSE HILL PLANTATION,
PRINCE WILLIAM'S PARISH
BEAUFORT COUNTY, SOUTH CAROLINA**

CHICORA FOUNDATION RESEARCH CONTRIBUTION 174

October 1995

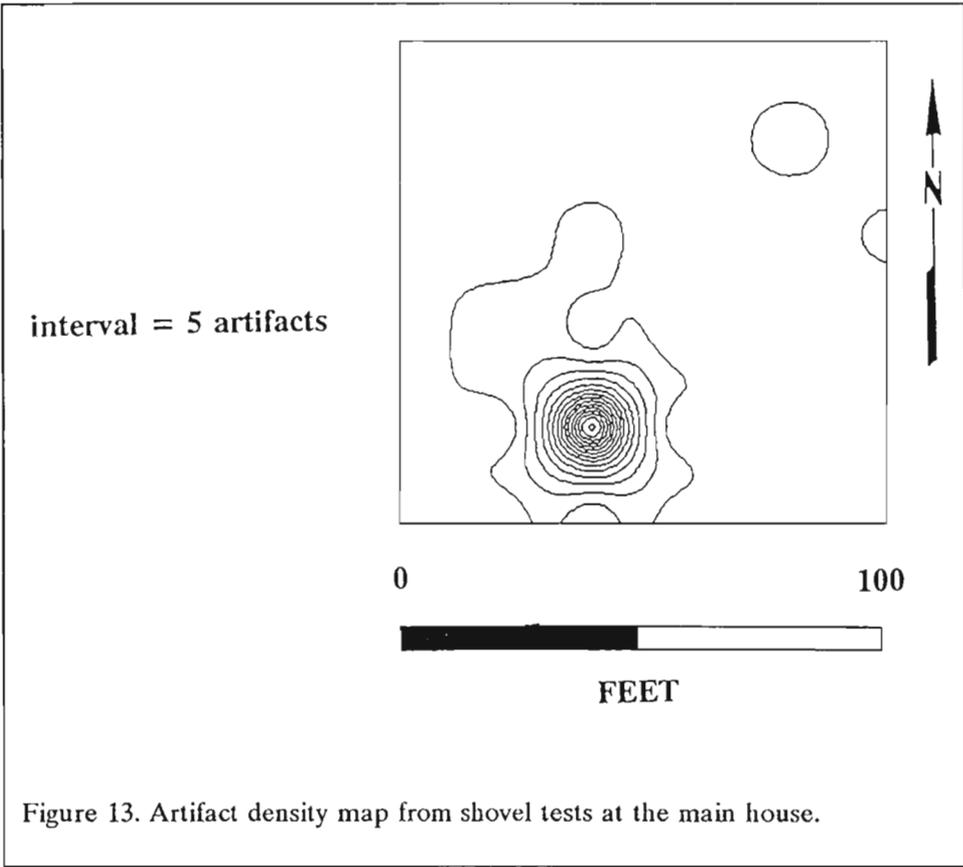
Figure 13. Artifact density map from shovel tests at the main house.

Field density maps were then created for artifacts and brick rubble (Figures 13 and 14). These maps illustrated a dense concentration of artifacts in the south central portion of the grid. It should be noted, however, most of the artifacts in this vicinity came from a single shovel test. Brick densities showed two concentrations: one in the area of the dense artifact concentration (220R240) and one further to the north and east (260R300).

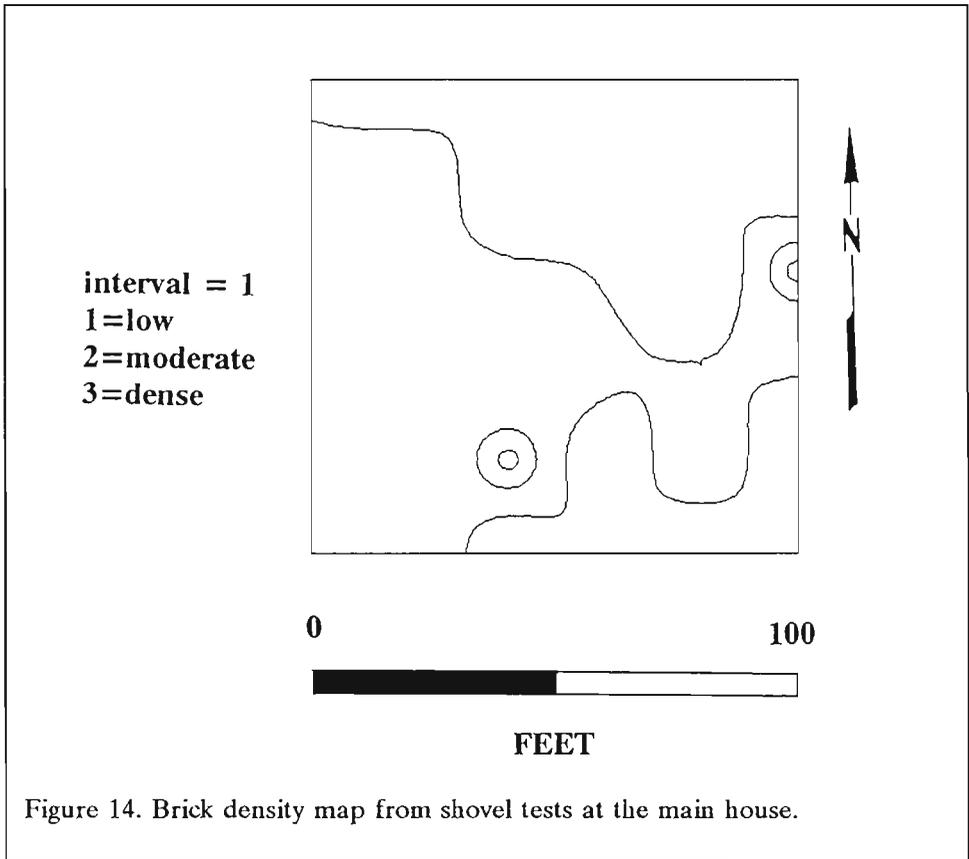
Figure 14. Brick density map from shovel tests at the main house.

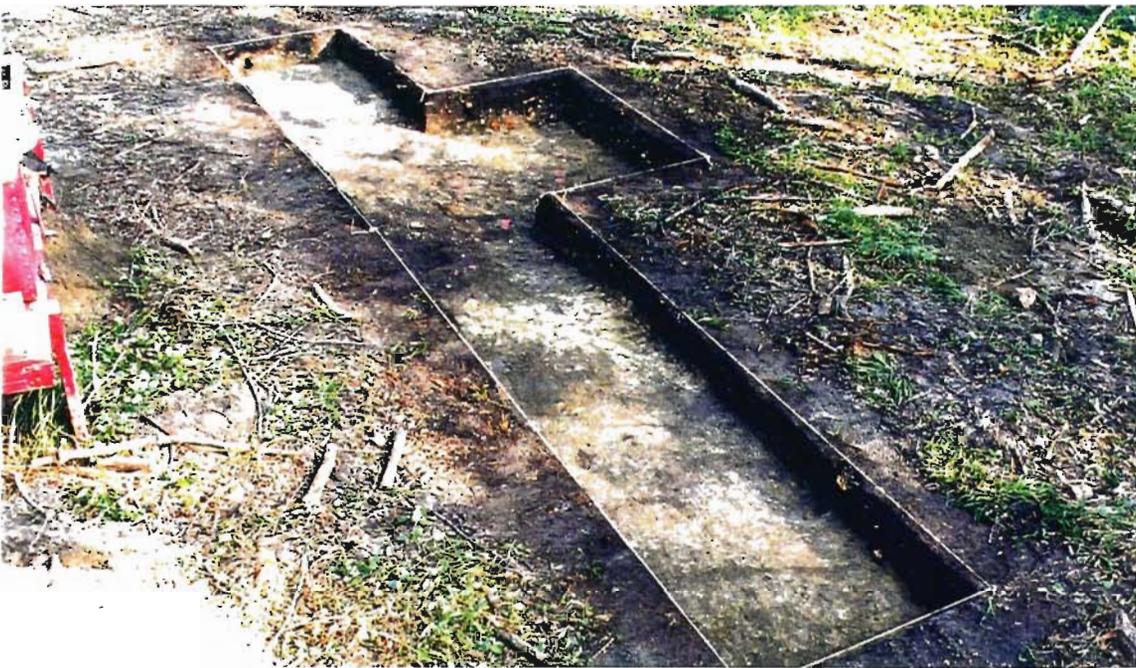
Figure 15. Excavation units in the vicinity of 220R240 showing dense brick rubble smear.

These smears consisted of a large area of rubble initially located during the excavation of TU1. After opening additional units, this area was believed to have contained the chimney, given the size of the smear and quantity of rubble. Additional smaller stains were found which are believed to represent the remnants of brick piers, like the partially intact one found in TU5. These

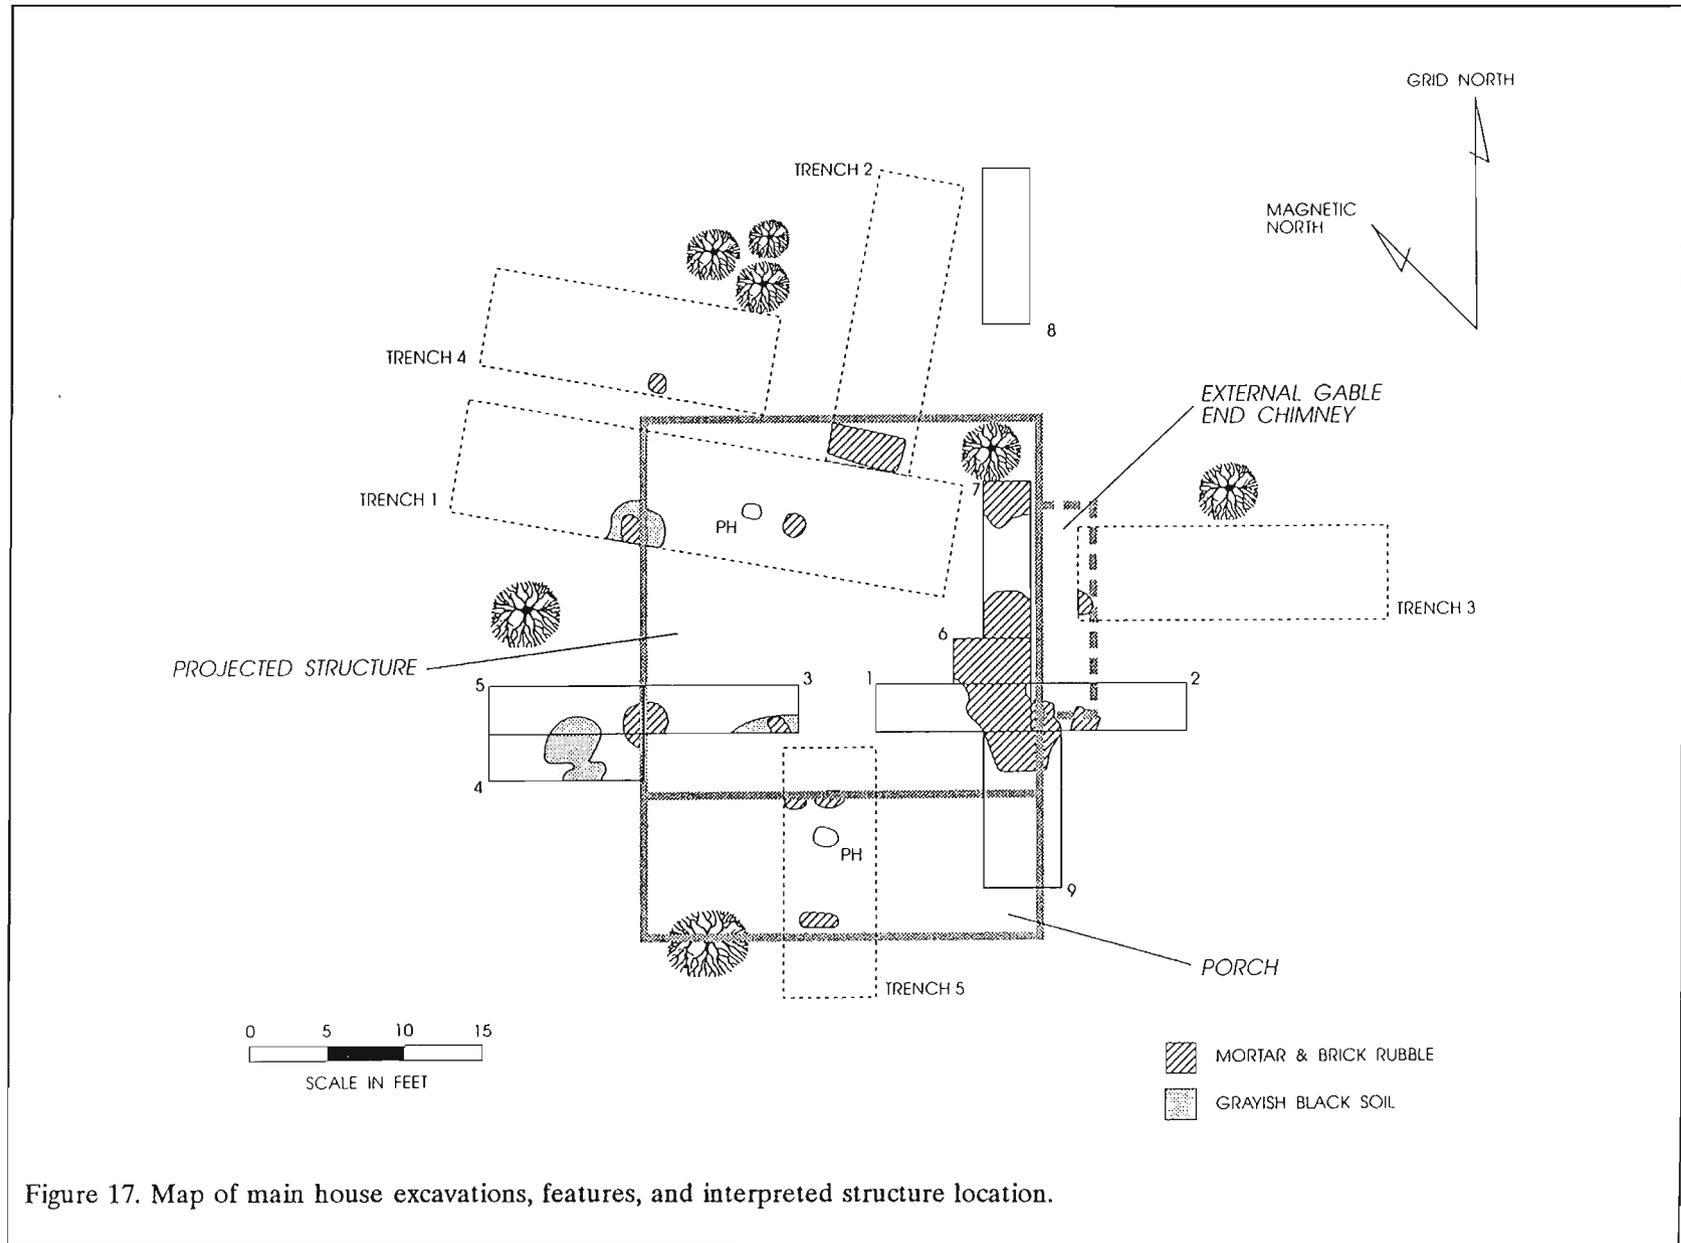
Figure 17. Map of main house excavations, features, and interpreted structure location.

rubble concentration and exposed brick rubble smears and a displaced brick pier with a clearly defined construction pit adjacent to it. Hand excavations were then placed to the north and south of the brick concentration to identify either additional architectural features or locate the extent of the brick rubble. After this was accomplished, five bulldozer trenches were excavated to expose other portions of the structure (Figure 16 and 17). Since the only clear architectural feature was the displaced pier and associated construction pit (Figure 18), house configuration and dimensions were determined based on the locations of brick rubble smears in the subsoil (see Figure 17).

pier remains are believed to represent the boundaries of the outer wall, and perhaps two of them were used to support a dividing wall. The brick rubble stains in Backhoe Trench 5 are believed to have supported the threshold, and the stain further south is probably associated with a porch.

Based on the location of these smears, the house is believed to have measured approximately 24 feet by 28 feet. A gabled end chimney was probably located on the east end and there was probably a door centered on the south wall, opening up to the oak alleé. There is also some evidence for a porch on the south end, perhaps measuring about seven feet deep (see Figure 17). The structure consisted of a brick pier foundation with a wooden superstructure. Internal layout of the house was probably a simple two room plan with the larger east room measuring 24 by 18 feet and the smaller room measuring 24 by 10 feet. It is also possible that the smaller room was divided into two 10 by 12 foot rooms. It is also possible that the house contained a loft.

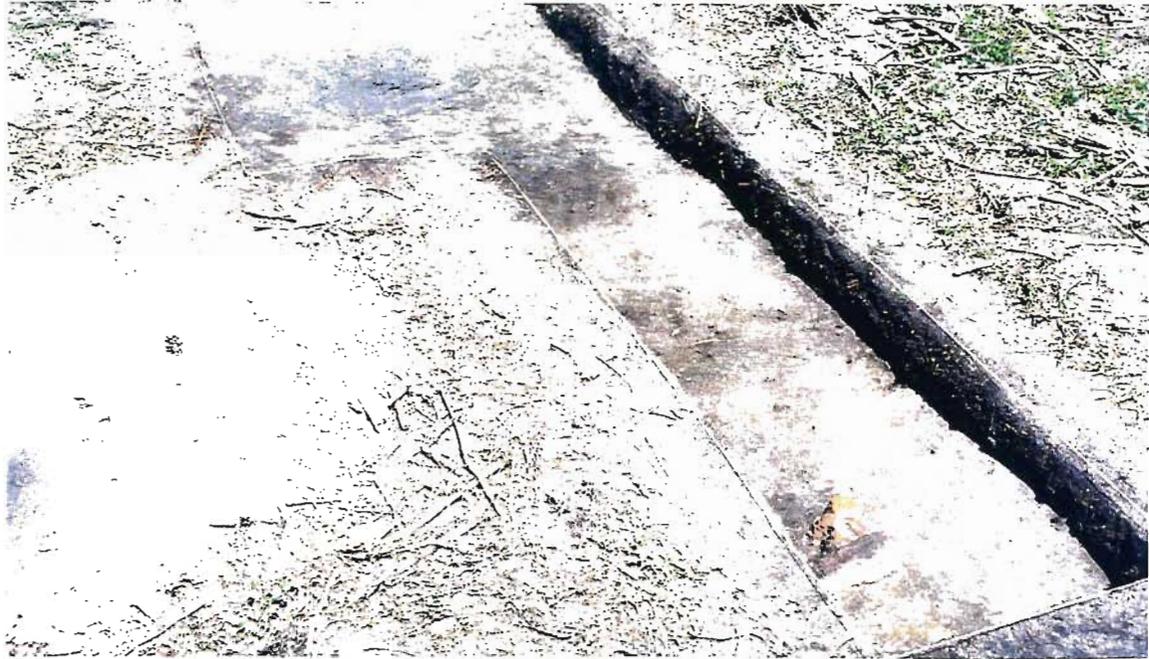
Figure 18. Displaced pier in TU3.

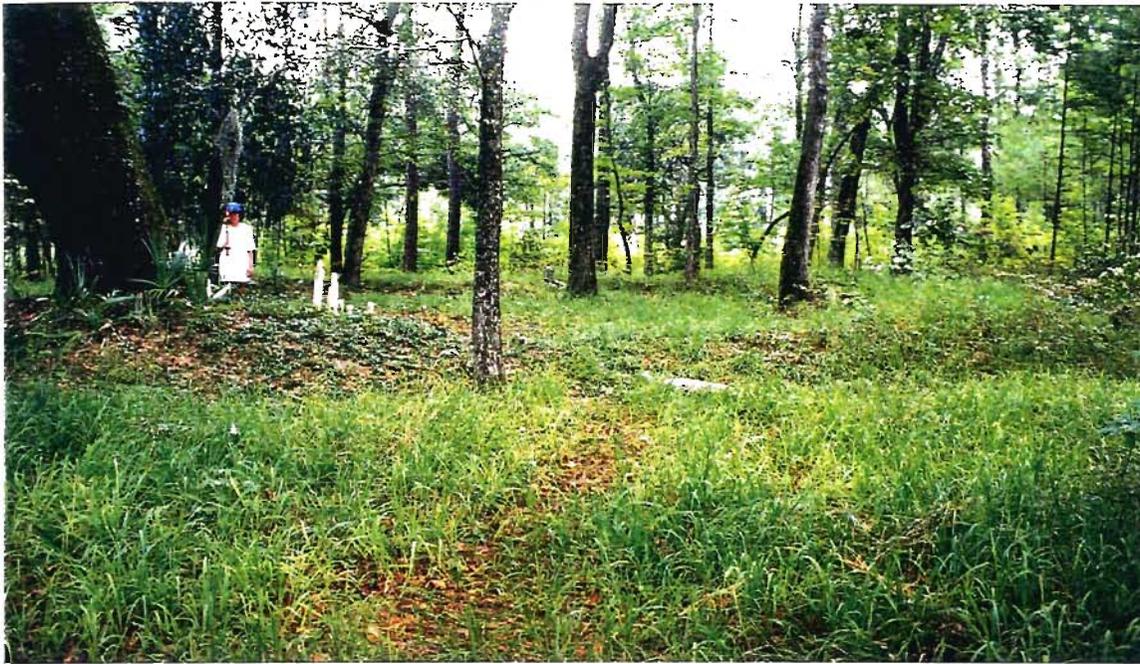
Figure 22. View of embankment at the graveyard.

We at first thought the feature may have been added to keep out flooding, which must certainly have occasionally occurred in this area. However, the open entrance would largely defeat any such function. Likewise, the relatively low walls would be unlikely to exclude any significant storm surge. Stuck (1980:176) observes that the Wahee soils, on which the graveyard is situated, are rarely flooded. We also considered the possibility that the earthen wall was the foundation for a wooden or metal fence. It has been our experience that even when metal fences were totally removed (usually for scrap or by vandals) there are always fragments. Consequently, we examined the entire cemetery using a metal detector. No readings were encountered on the dike or in the associated exterior ditch. The absence of even nails would also preclude a wooden fence.

It seems more likely that the earthwork was added because of problems associated with the very poorly drained Wahee soils. Stuck (1980:176) does note that the soils have a seasonal high water table within a foot of the ground surface. The ditch, excavated to about 1.5 below the ground surface (and originally, before gradual filling, deeper), would have served to reduce the groundwater level in the graveyard. The associated dike may simply have been a convenient place in which to dispose of the soil. Lowering the ground water was probably related to a cultural concern

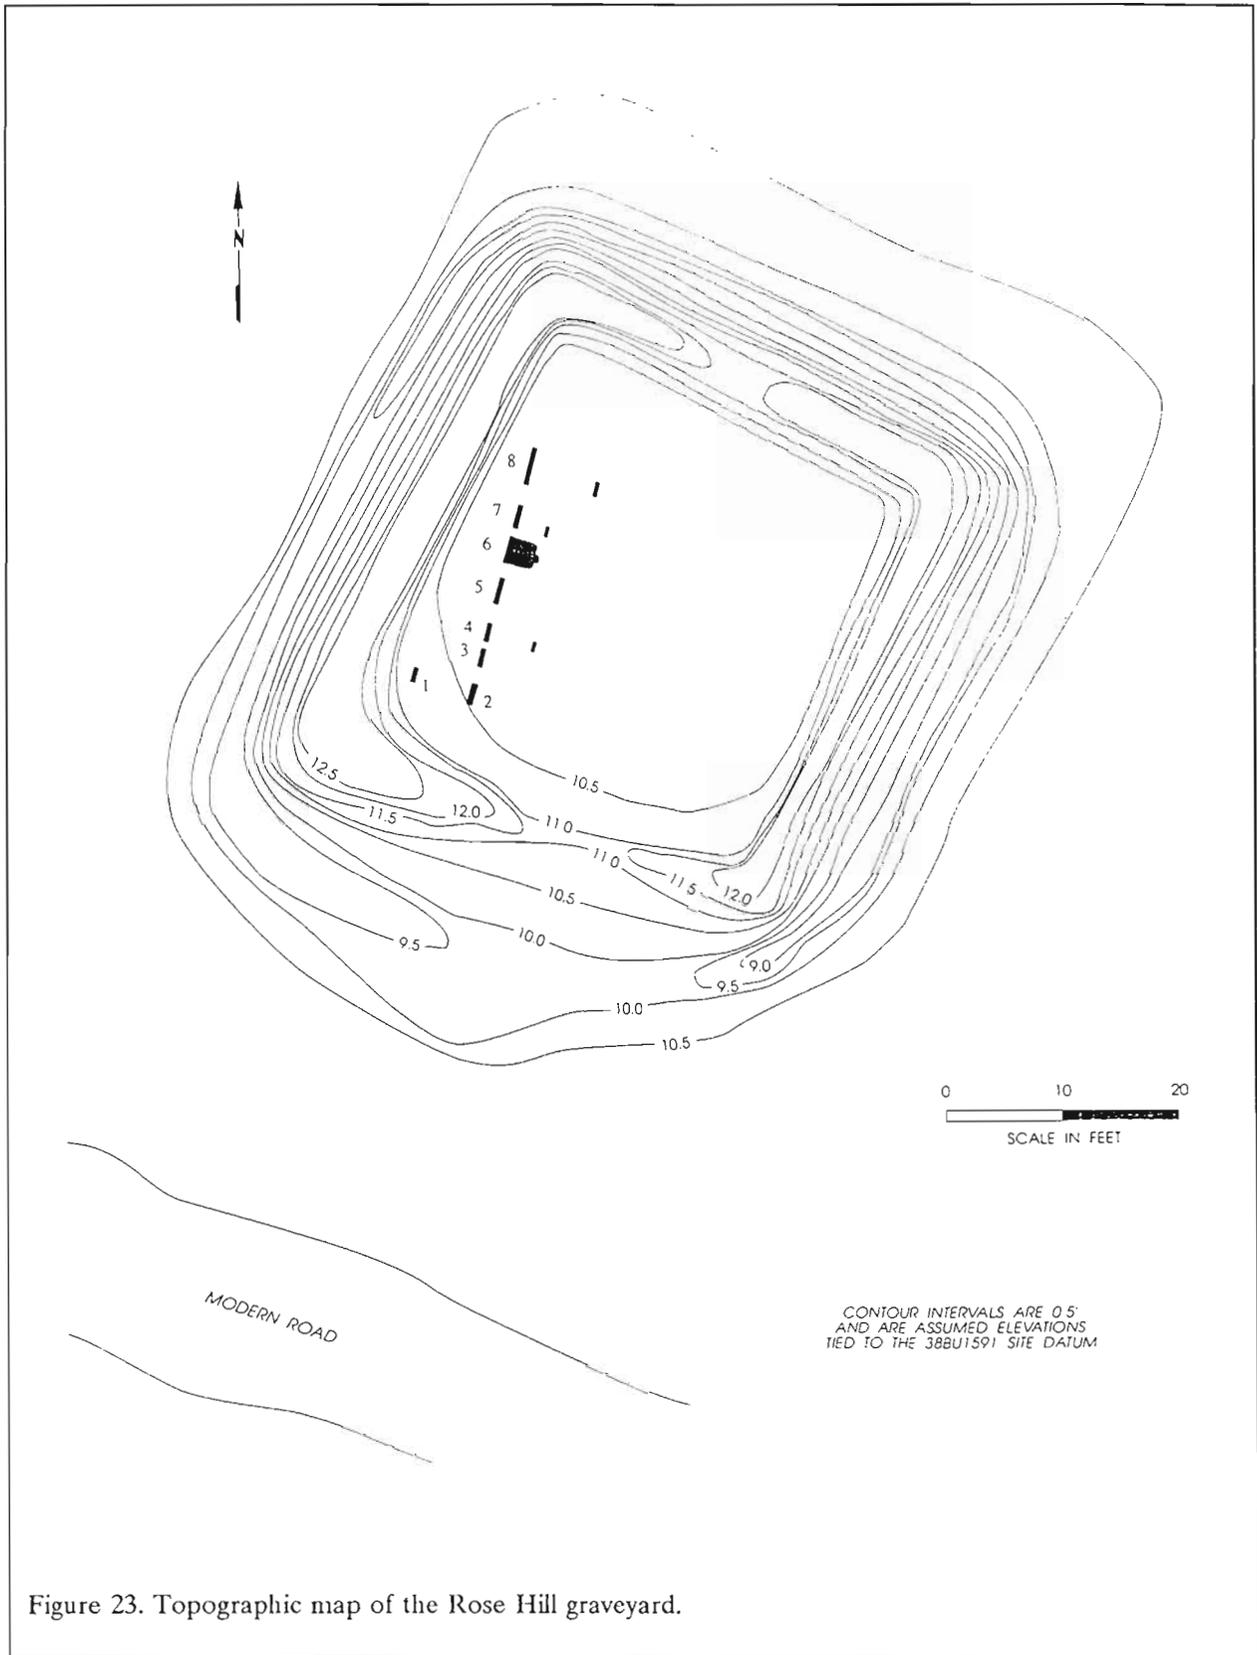
Figure 23. Topographic map of the Rose Hill graveyard.

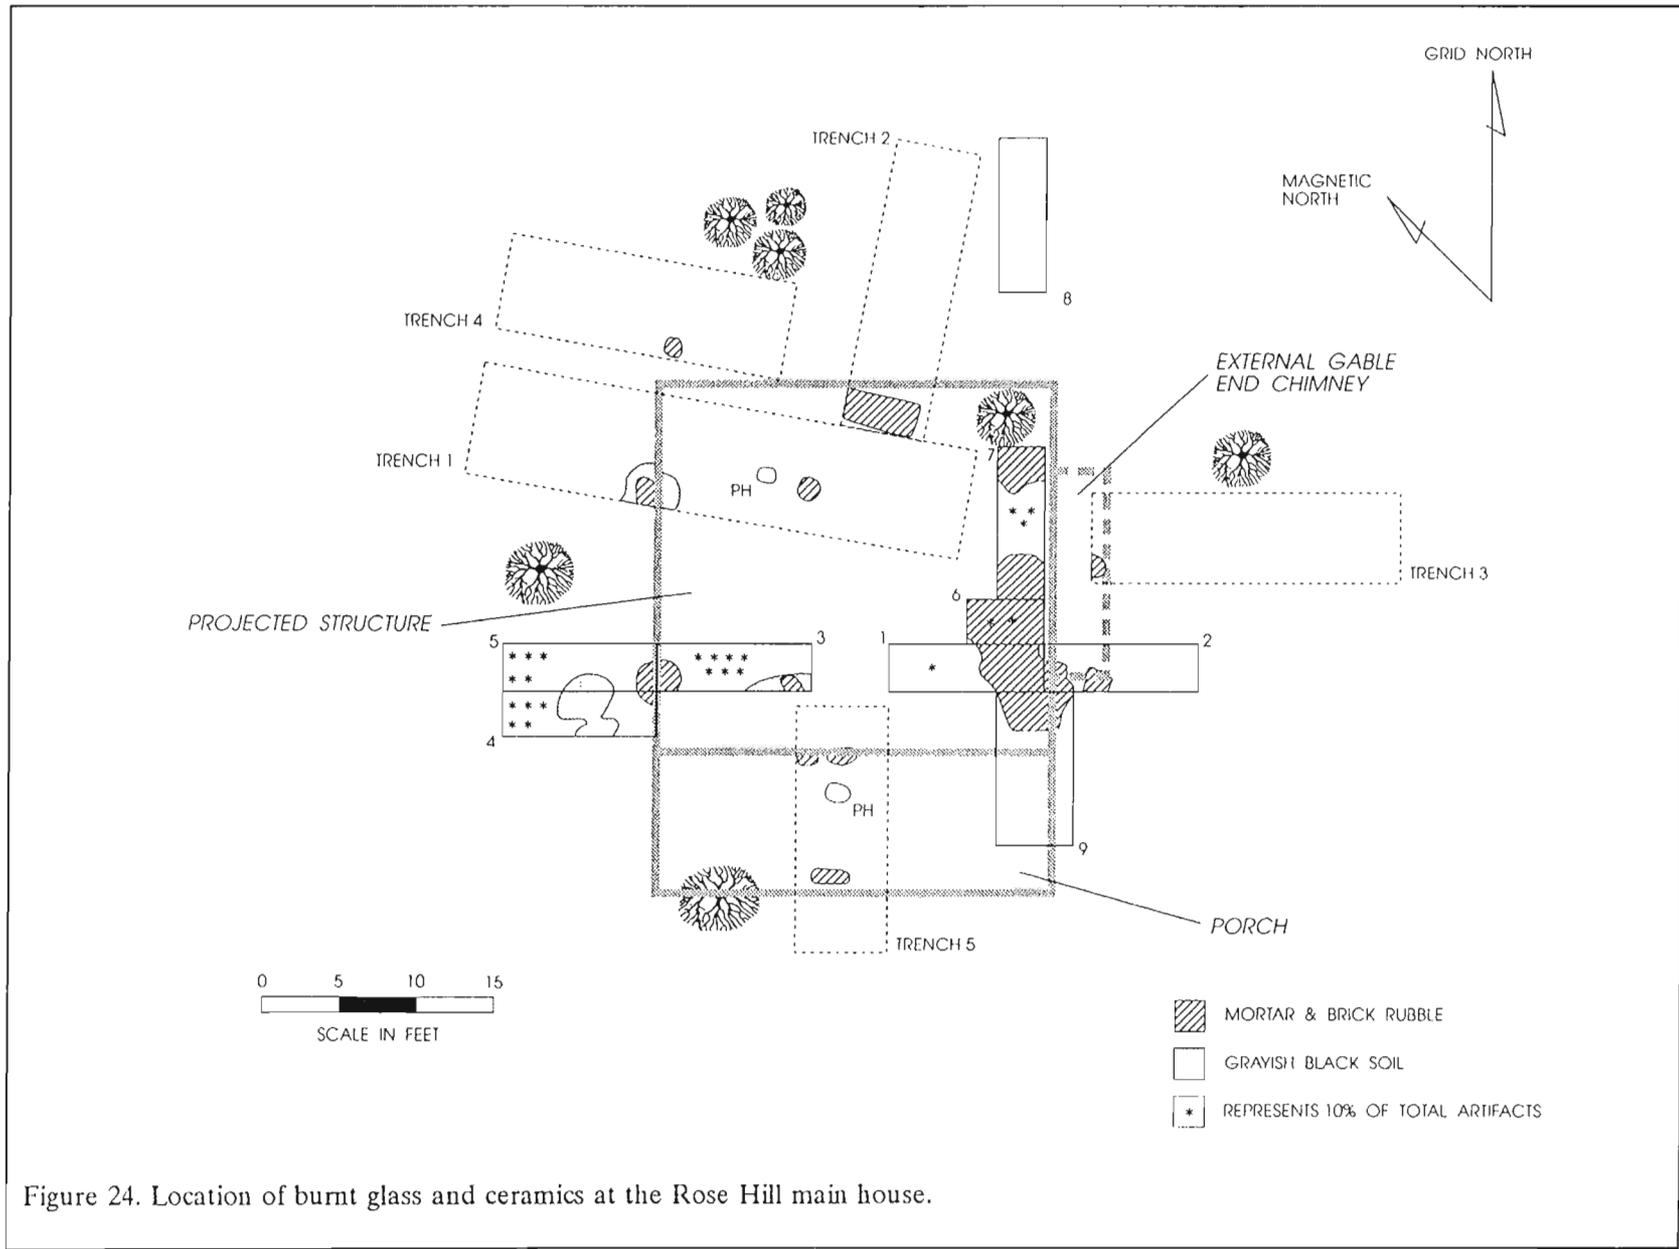
Figure 24. Location of burnt glass and ceramics at the Rose Hill main house.

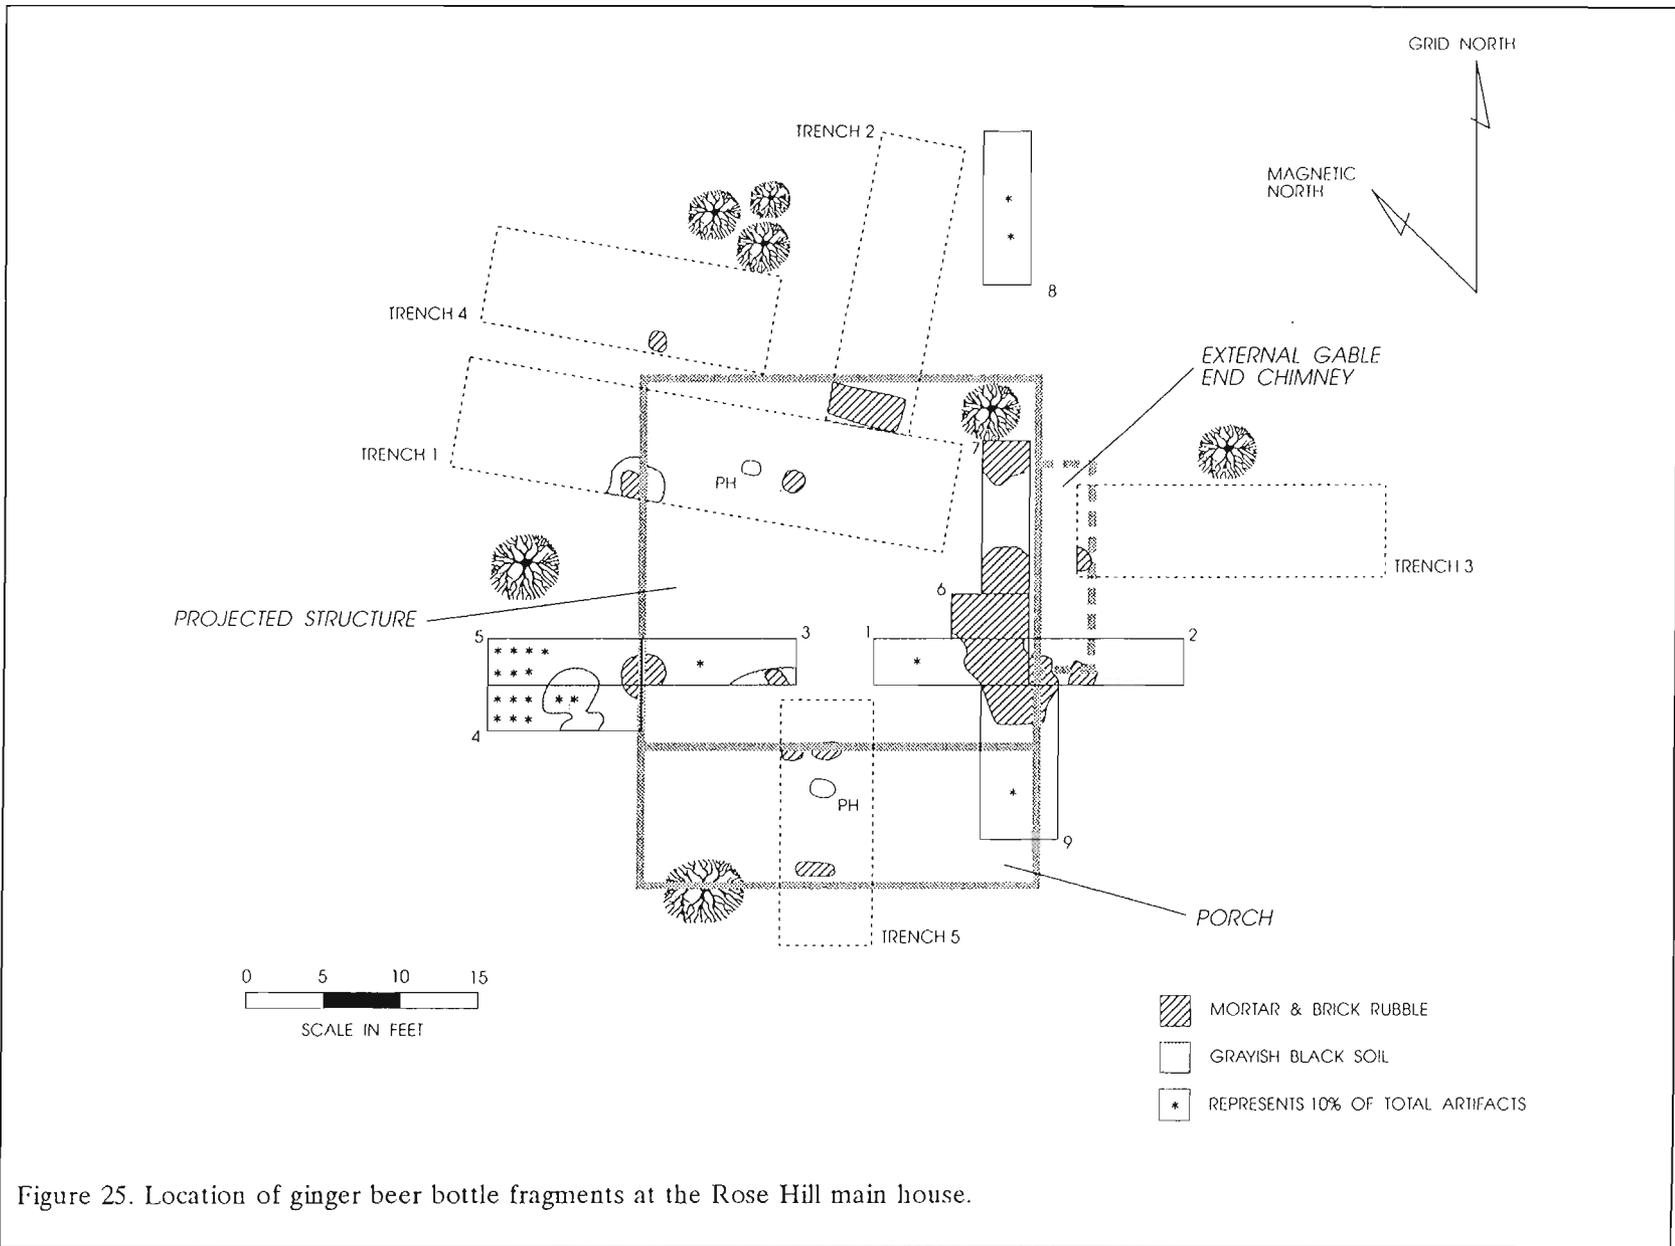
Figure 25. Location of ginger beer bottle fragments at the Rose Hill main house.

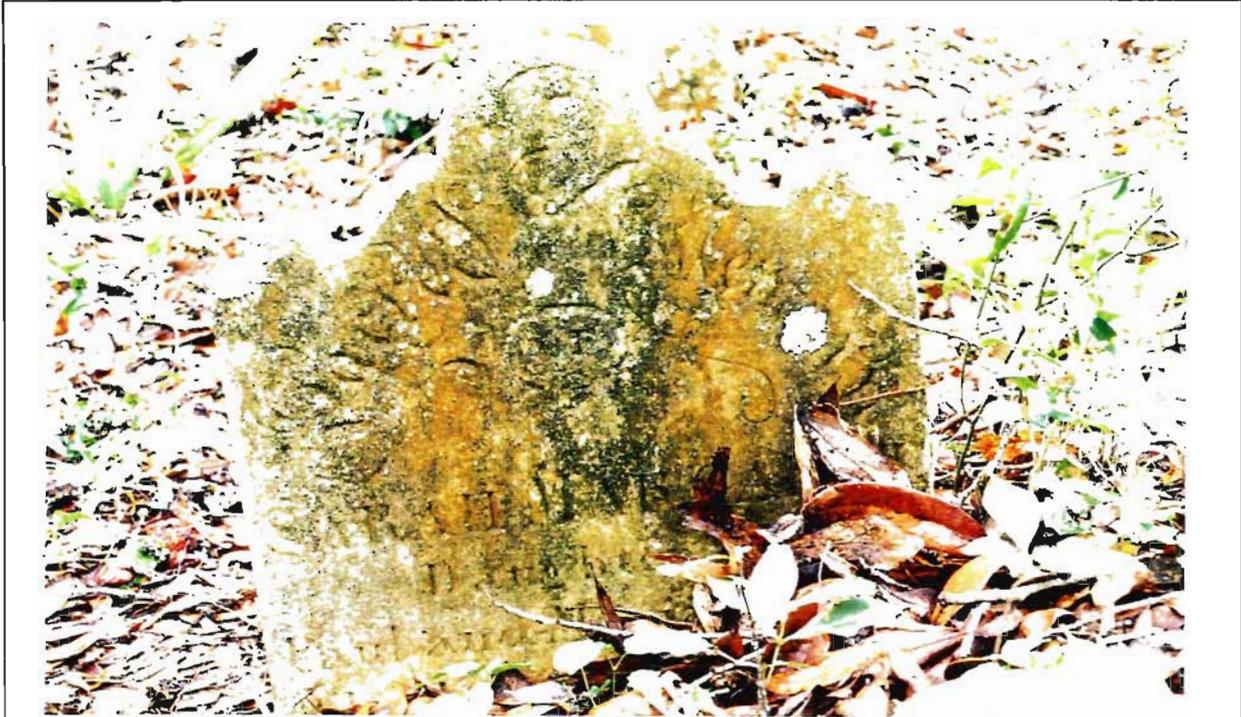
- moss and lichen appear to have caused orange/brown and gray/black staining, respectively.
- growth of old oak tree on boundary of cemetery is causing marker to sink.

Figure 26. Stone 1, before treatment, view to the east.

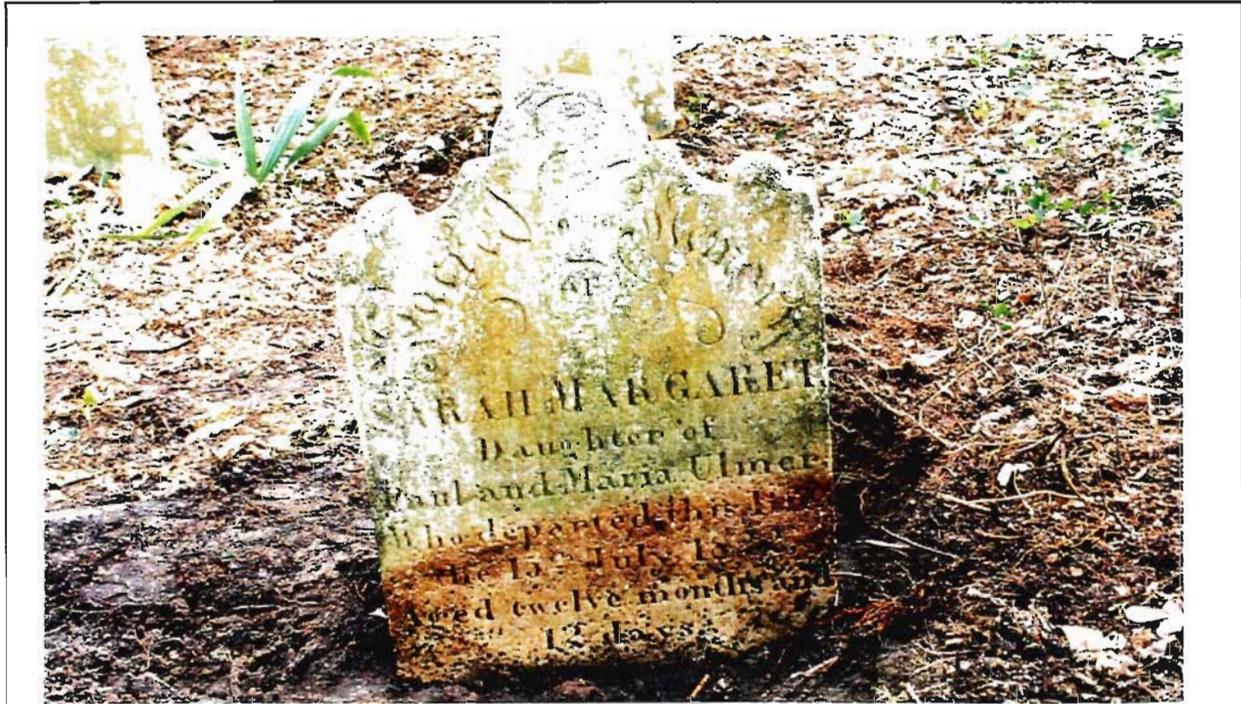
Figure 27. Stone 1, after treatment, view to the east.

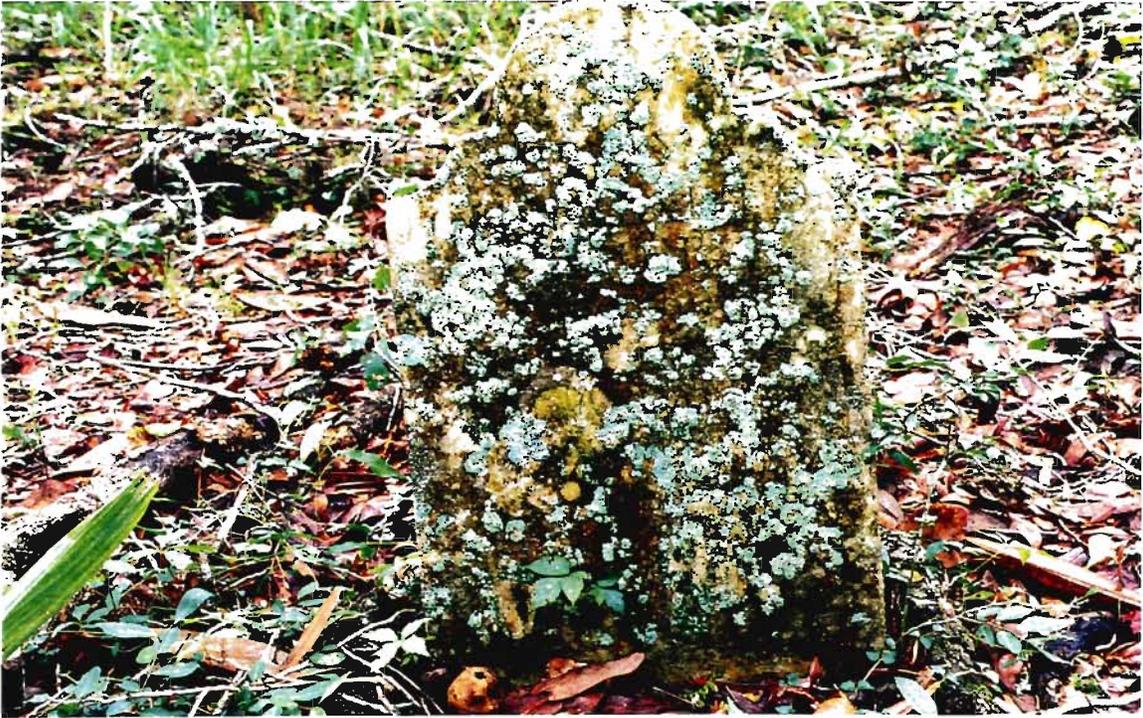
- moss and lichen appear to have caused orange/brown and gray/black staining, respectively.

Figure 28. Stone 2, before treatment, view to the east.

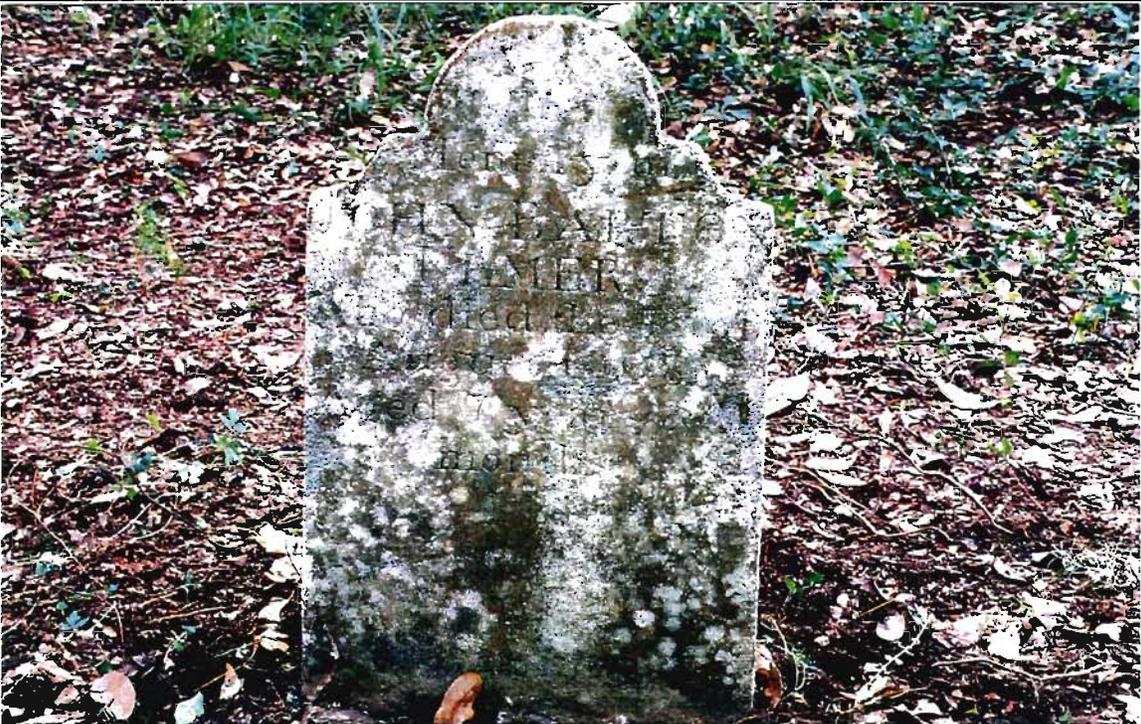
Figure 29. Stone 2, after treatment, view to the east.

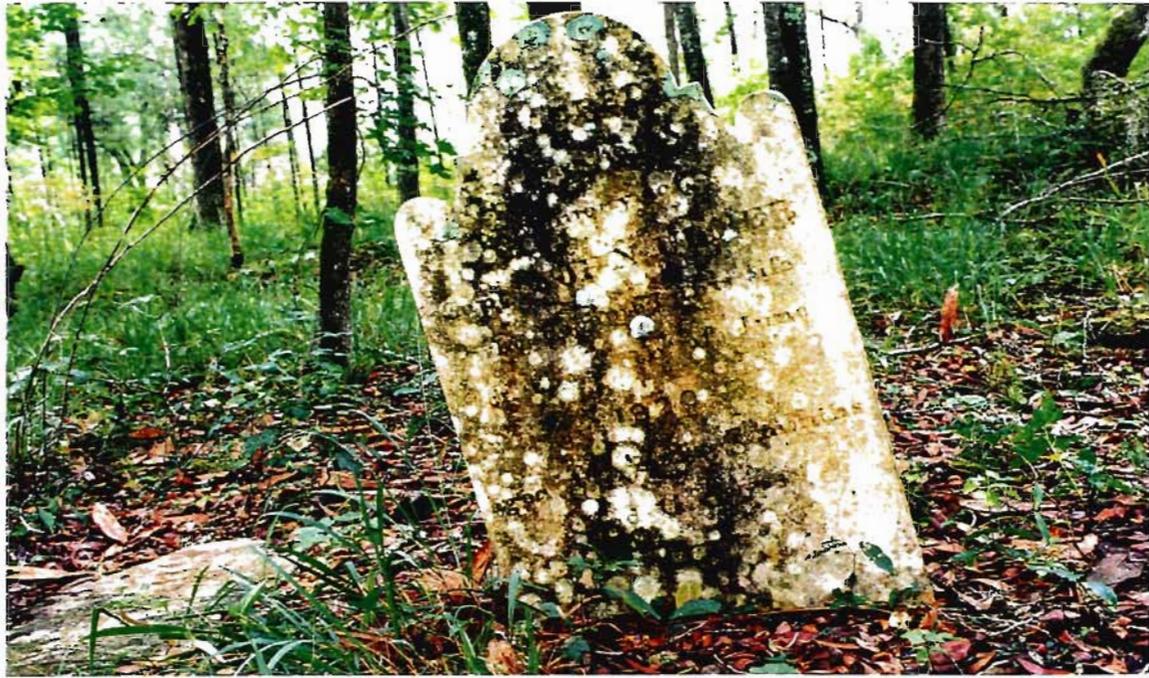
- moss and lichen appear to have caused orange/brown and gray/black staining, respectively.

Figure 30. Stone 5, before treatment, view to the east.

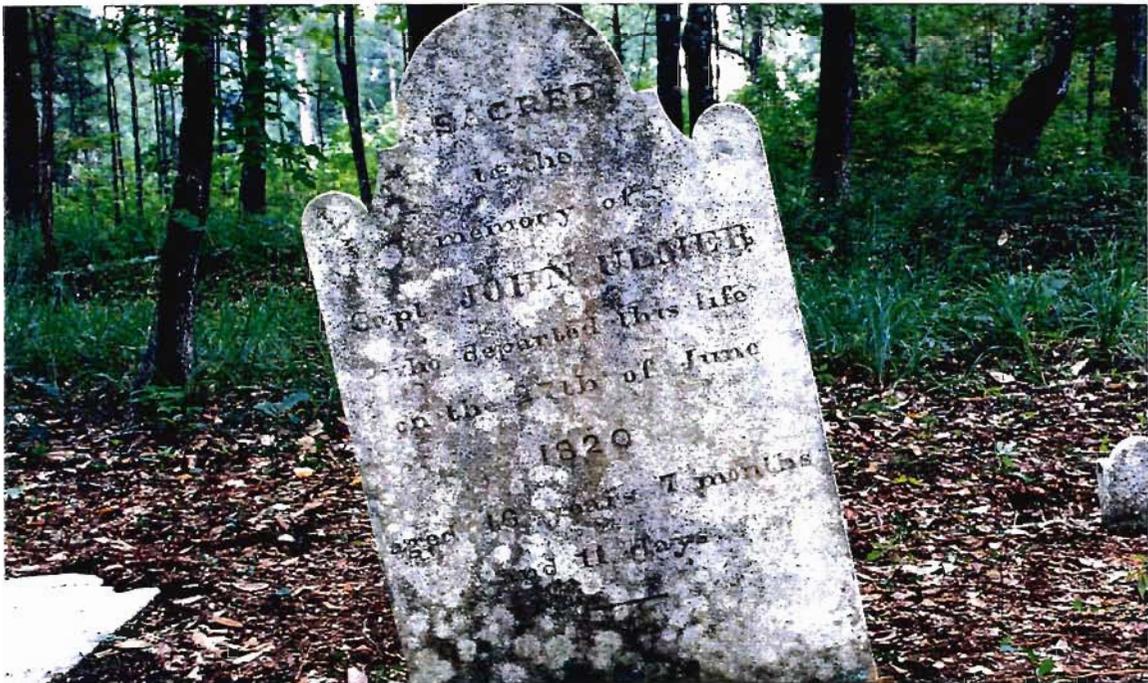
Figure 31. Stone 5, after treatment, view to the east.

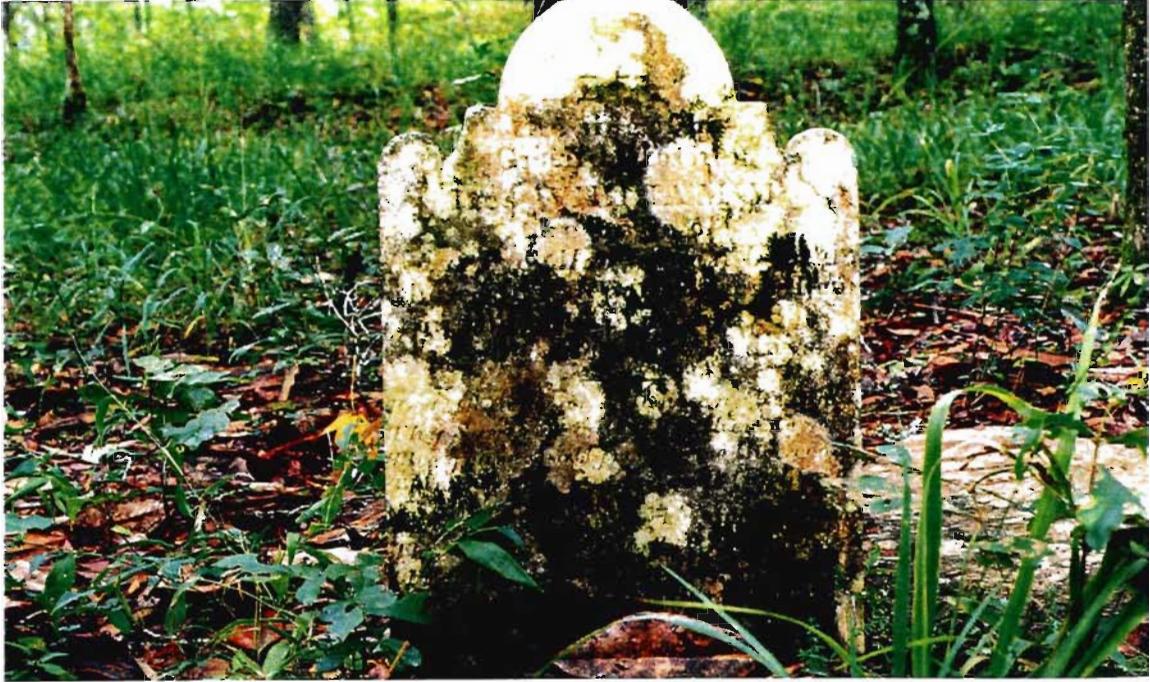
- moss and lichen appear to have caused orange/brown and gray/black staining, respectively.

Figure 32. Stone 7a, before treatment, view to the east.

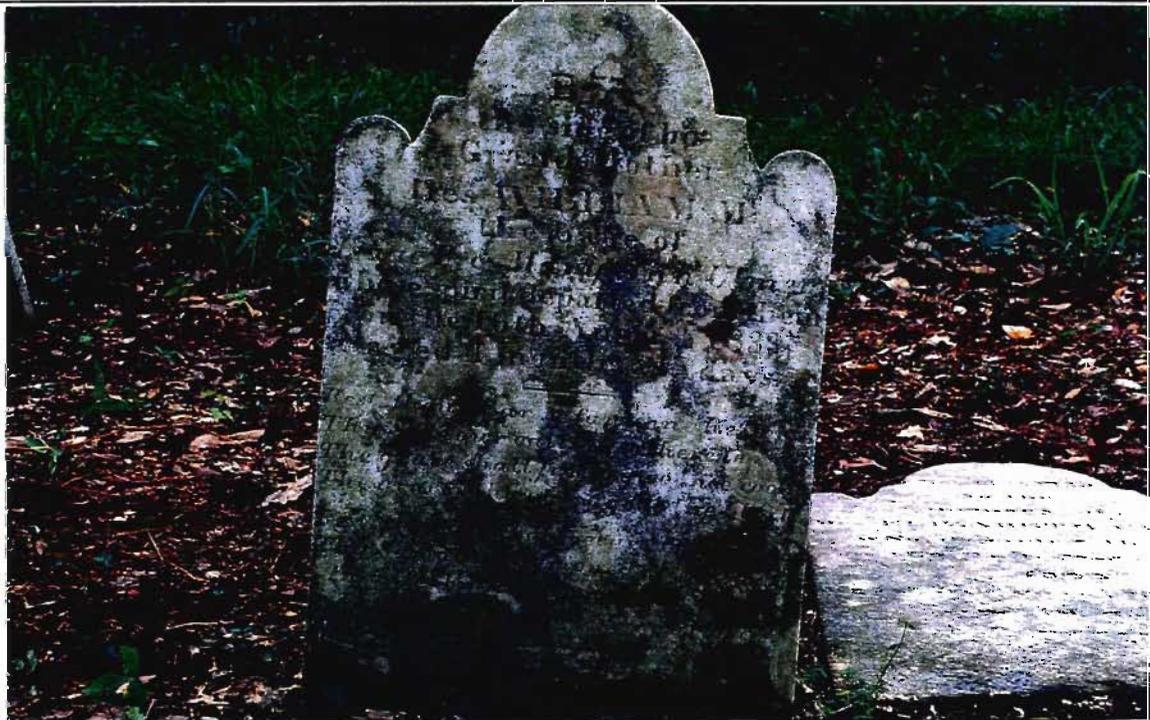
Figure 33. Stone 7a, after treatment, view to the east.
