**ASSESSMENT AND MANAGEMENT PLAN FOR THE
BANNACK STATE PARK CEMETERIES,
BANNACK, MONTANA**

Prepared By:
Michael Trinkley, Ph.D.
Debi Hacker

Prepared For:
Angie Hurley, Park Manager
Bannack State Park
Bannack, Montana

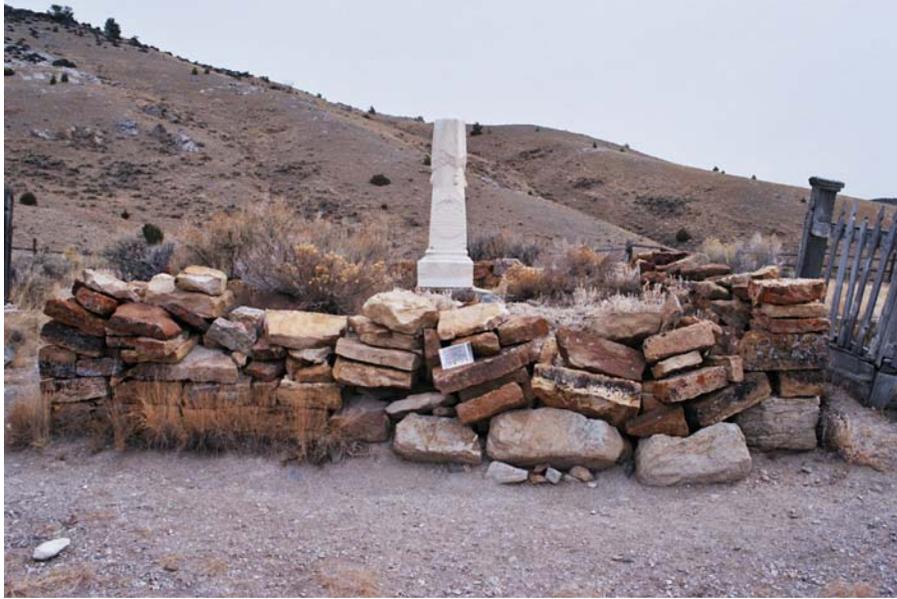
Figure 4. The Trask monument and associated dry-laid cut sandstone wall. View is to the southeast.

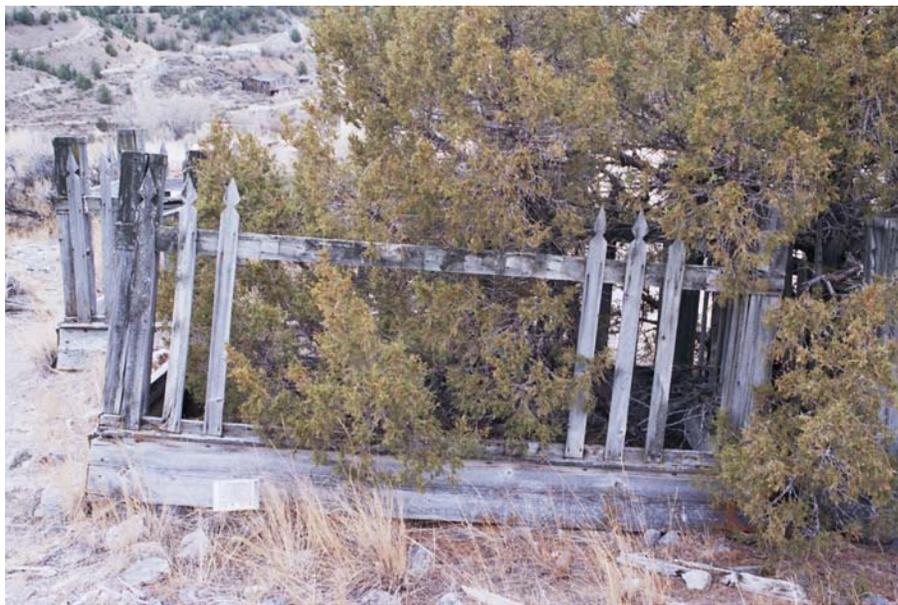
Figure 7. Example of a grave fence (Grave 21) in better condition showing the loss of fabric. The juniper tree, a recent volunteer, should be removed.

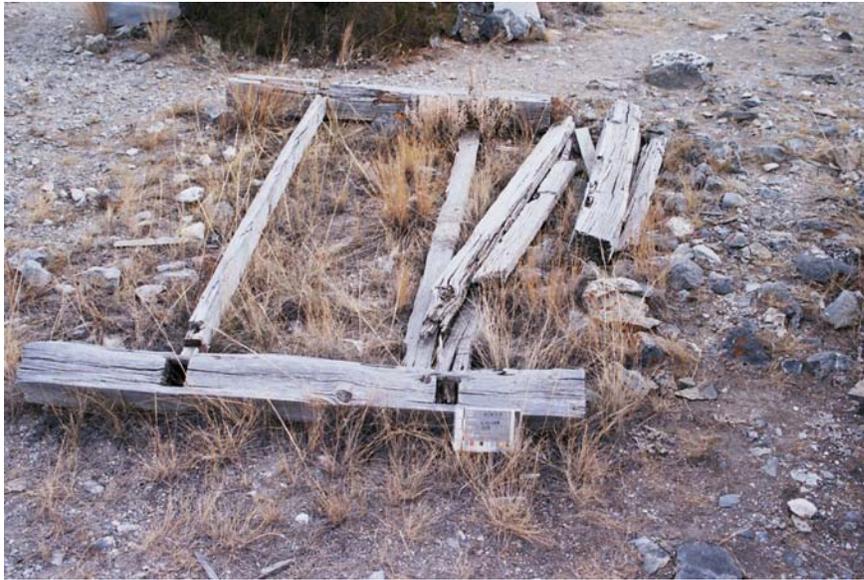
Figure 8. Example of a collapsed grave fence (Grave 22). Such spots should be marked by a replacement skeleton fence.

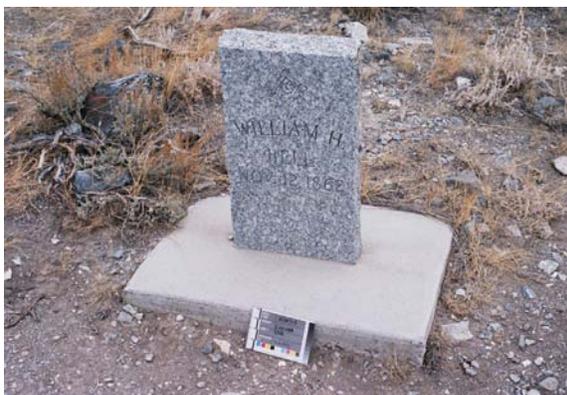
Figure 9. Example of modern monument (Grave 8) that should be replaced with a more historically sensitive memorial.

There are eight commercial monuments at the New Cemetery. At least one of these is a modern granite marker that has been set in concrete. This stone, in particular, creates discordance in the cemetery. We understand that the Park has already gotten a commitment that the stone will be replaced with a marker

more fitting for the cemetery. Something in a marble, for example, would be less intrusive and blend in better.

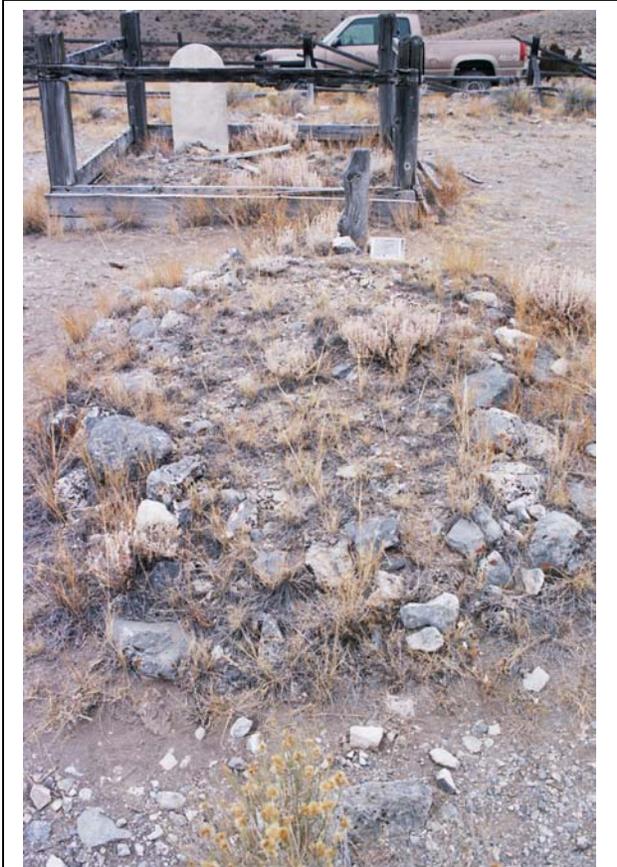
Figure 10. Grave mound showing concentration of gravel and cobbles, as well as a wood marker at the head.

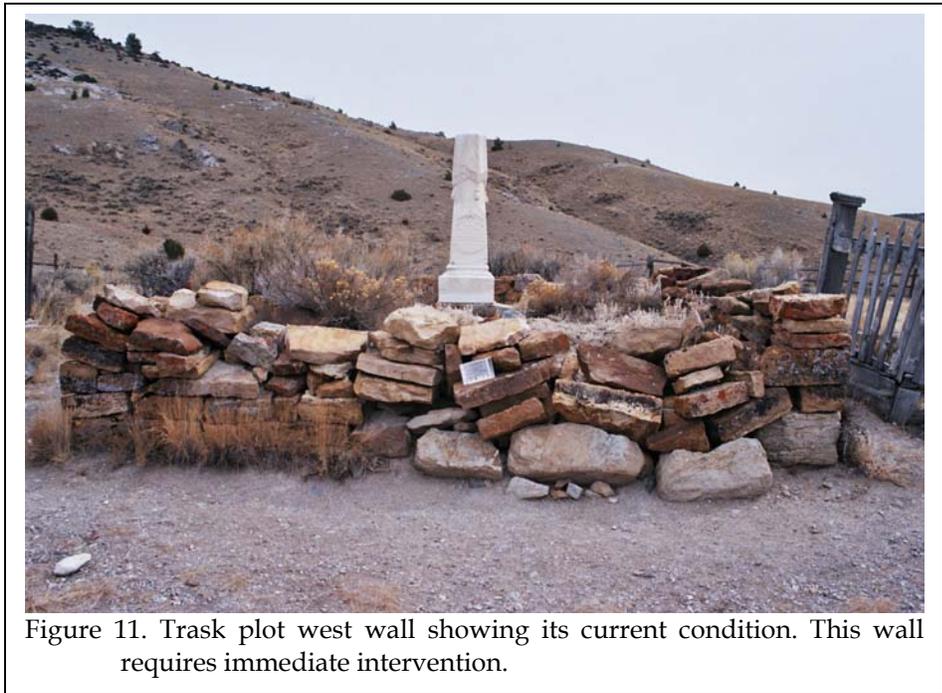
The west wall has collapsed and much

Figure 11. Trask plot west wall showing its current condition. This wall requires immediate intervention.

of the retained soil has eroded out. The rocks were piled back in the lot, although no effort was made to reconstruct the wall. This feature requires immediate intervention since it is such a prominent aspect of the cemetery. The lot is also filled with sagebrush and the monument requires resetting.

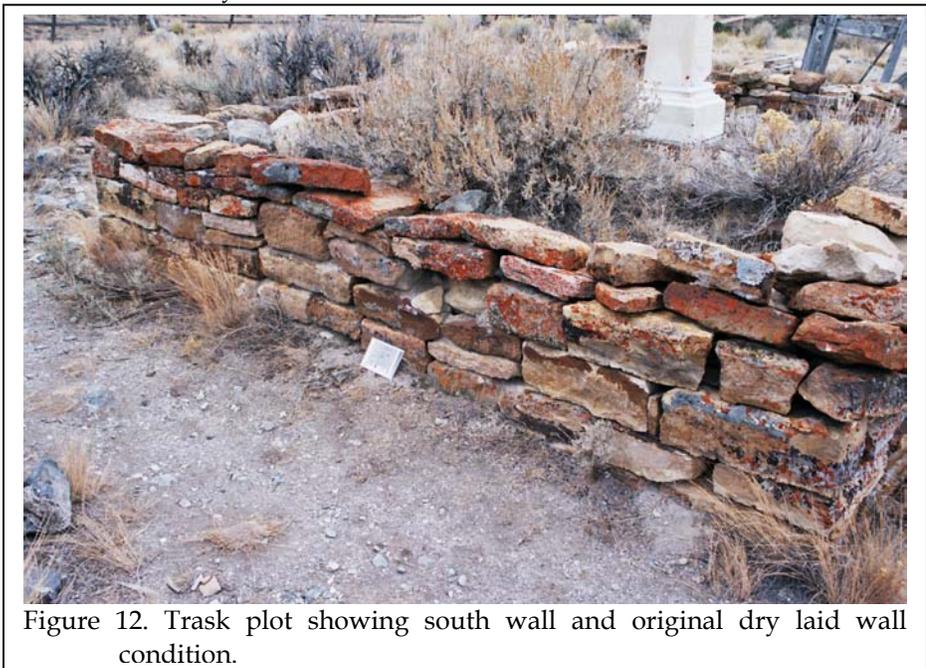
There is one lot that is surrounded by a 3-foot wall of dry laid coursed rubble consisting of roughly squared sandstone. The interior of the wall has been filled with soil and a marble pedestal tomb is placed in the lot (Trask lot; Grave 5). This lot - both today and historically - dominates the cemetery and is one of the defining elements. The memorial is clearly seen in the 1882 photograph as a small, dark squared feature blocking several of the whitewashed wood grave fences (see Figure 5).

Figure 12. Trask plot showing south wall and original dry laid wall condition.

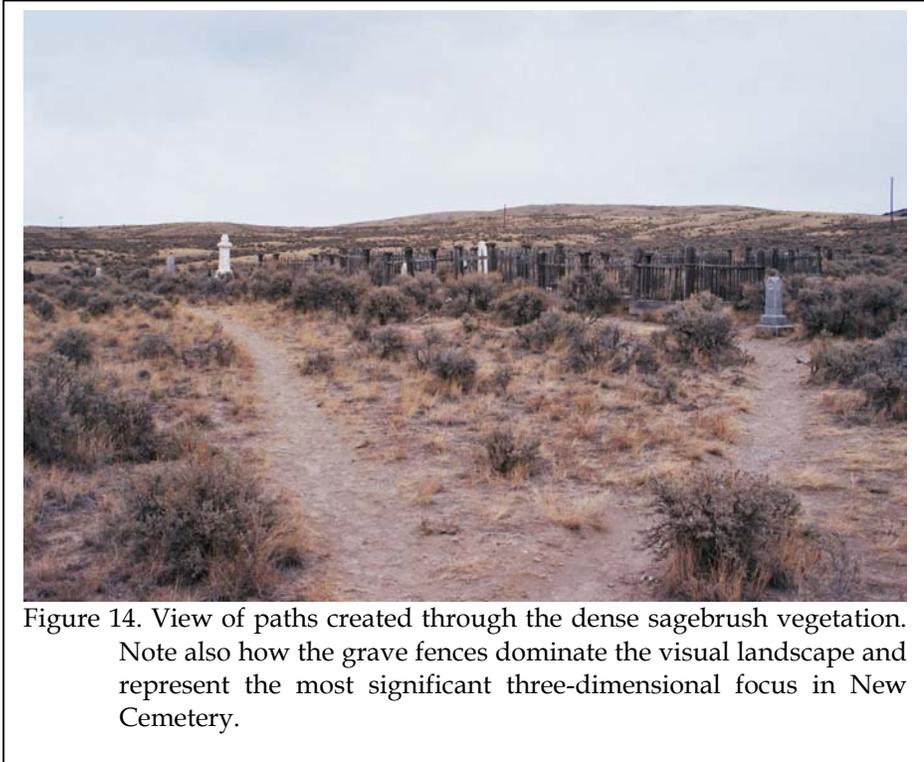
In addition, the sagebrush is causing pedestrians to create deeply worn and eroded paths through the cemetery (Figure 14) and these are damaging the visual integrity, feeling, and sense of place.

Figure 14. View of paths created through the dense sagebrush vegetation. Note also how the grave fences dominate the visual landscape and represent the most significant three-dimensional focus in New Cemetery.

As previously discussed, the sagebrush can be removed using 2-cycle gas trimmers fitted with circular saw blades. These will allow

easy cutting of the sagebrush, that can then be hand collected and removed from the cemetery for disposal.

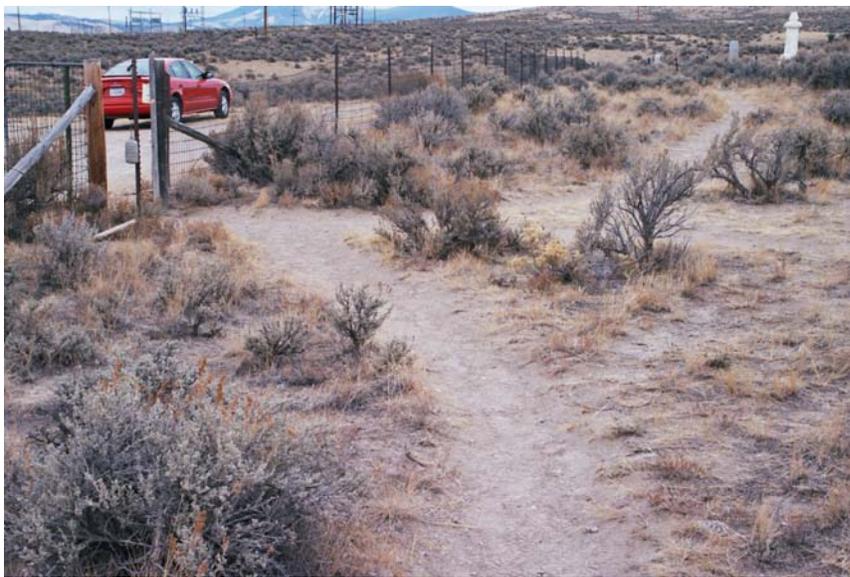
Figure 15. View of erosion being caused by sagebrush directing pedestrian traffic. Notice also the substation in the background and the open, bare gravel parking lot directly out of the gate.

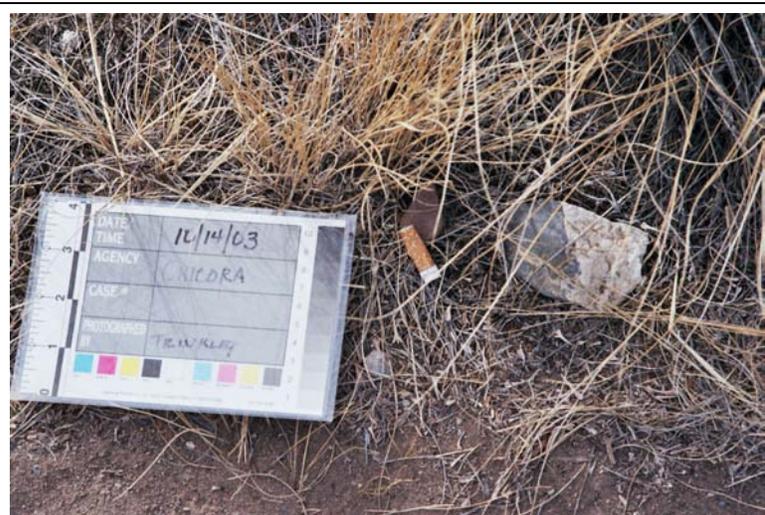
Figure 16. Example of a cigarette butt in the cemetery.

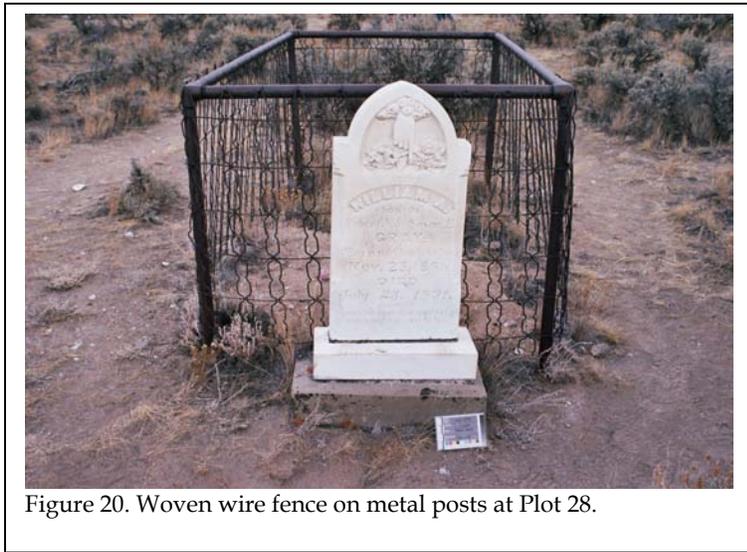
Figure 20. Woven wire fence on metal posts at Plot 28.

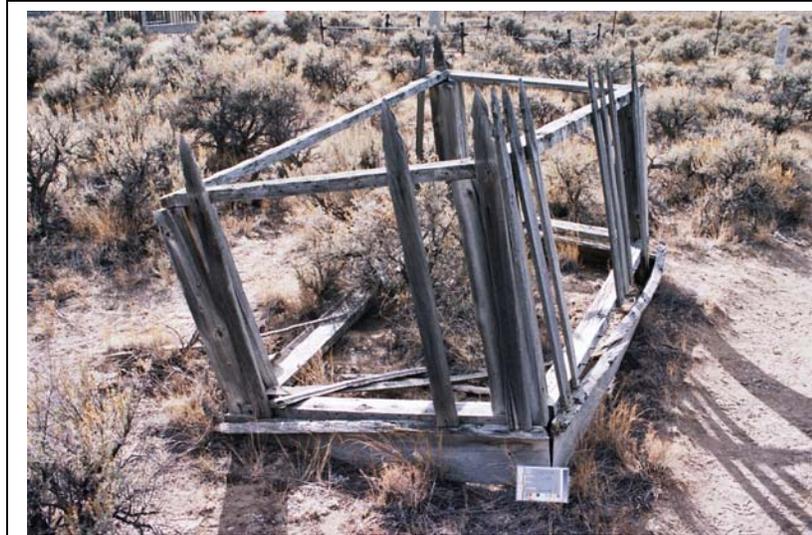
Figure 25. Example of a wood grave fence that is approaching failure. Replace a corner post, several side rails, and the bottom boards however, can help ensure its preservation. Other than reattaching loose elements, no further “restoration” should be attempted.

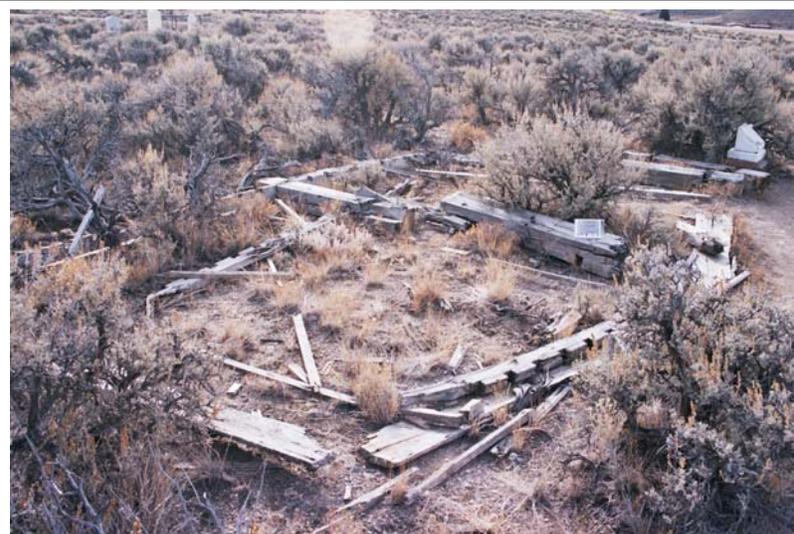
Figure 26. Fence at Plot 97 showing collapsed fence. In such a case a new skeleton fence should be erected and whitewashed, while the original fence is documented and allowed to remain in place.

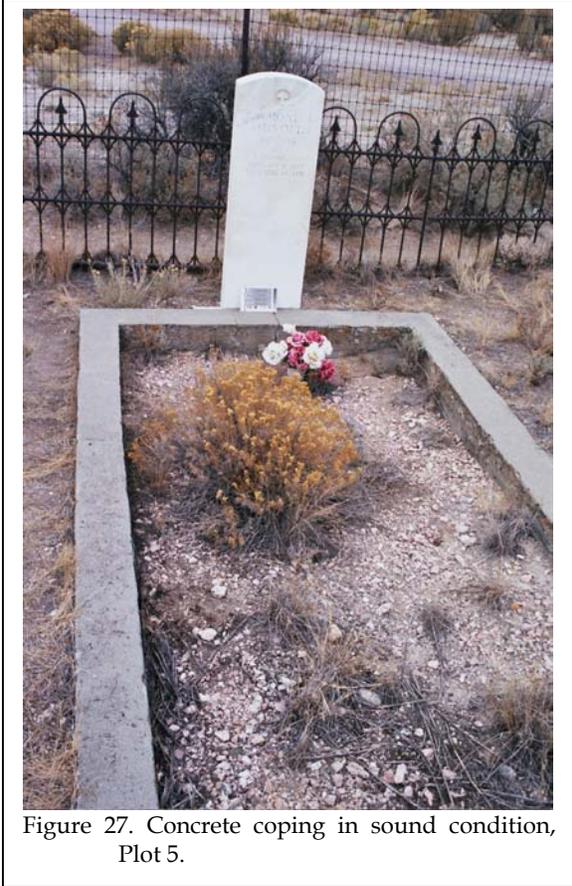
Figure 27. Concrete coping in sound condition, Plot 5.

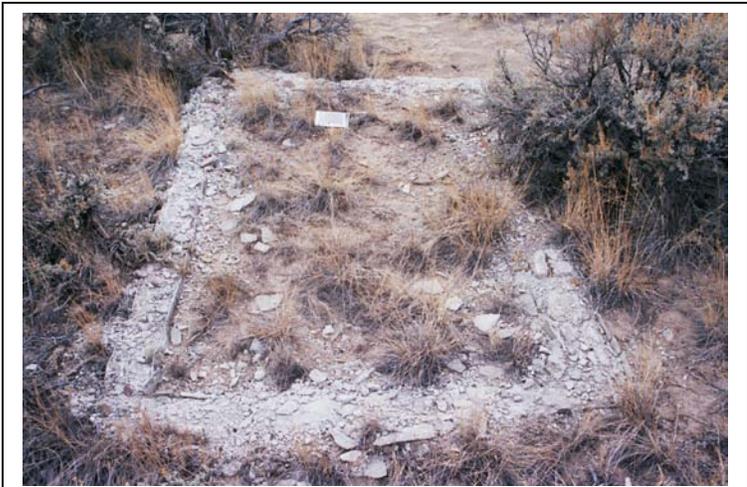
Figure 28. Grave coping at Plot 112 that has failed. Note the large cobbles used for aggregate.

Where the coping has failed it will probably be ineffectual to attempt repair.

Instead, it is more appropriate to document the size and placement of the original coping,

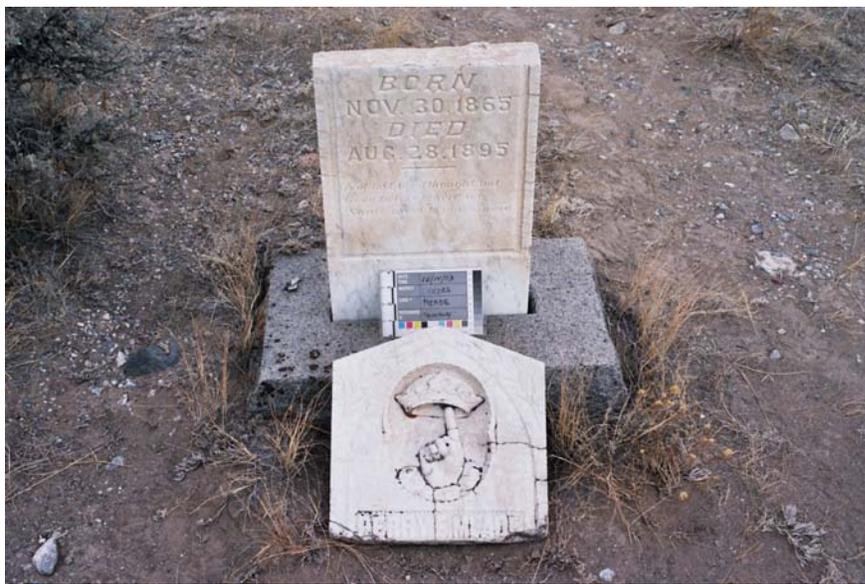
Figure 30. Marble stone (Plot 39) with a clean, simple break. The stone is also loose in the granite base and requires resetting.

In cases where stones are loose in a supporting base, resetting involves the use of a wet, high lime mortar mix. Appropriate is a 1:4:8 mix (1 part of white Portland cement, 4 parts hydrated lime, and 8 parts clean graded sand or marble dust). **Cement, mortar mixes, epoxy, or other adhesives should never be used for this purpose.**

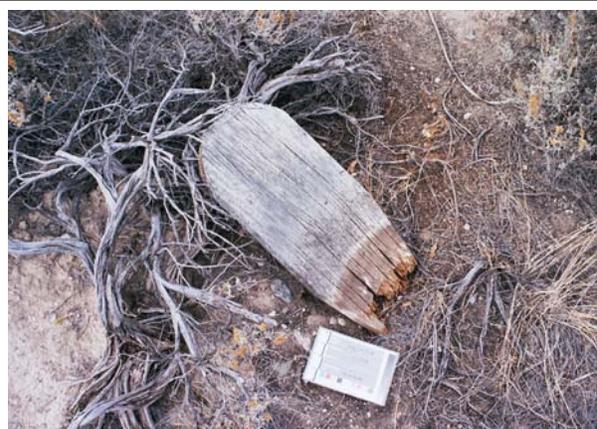
Figure 31. Example of wooden marker vandalized and broken off at ground level. This should be repaired using epoxy and stainless steel straps.

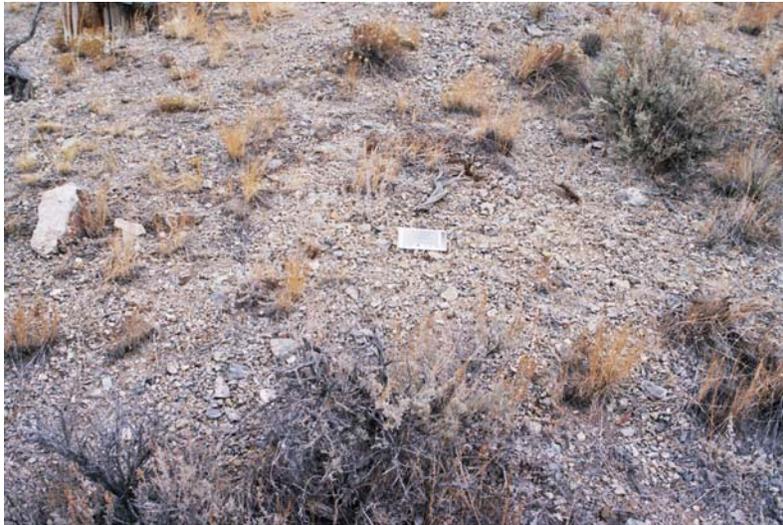
Figure 34. Grave mound with a field stone marker at the head. View is to the north.

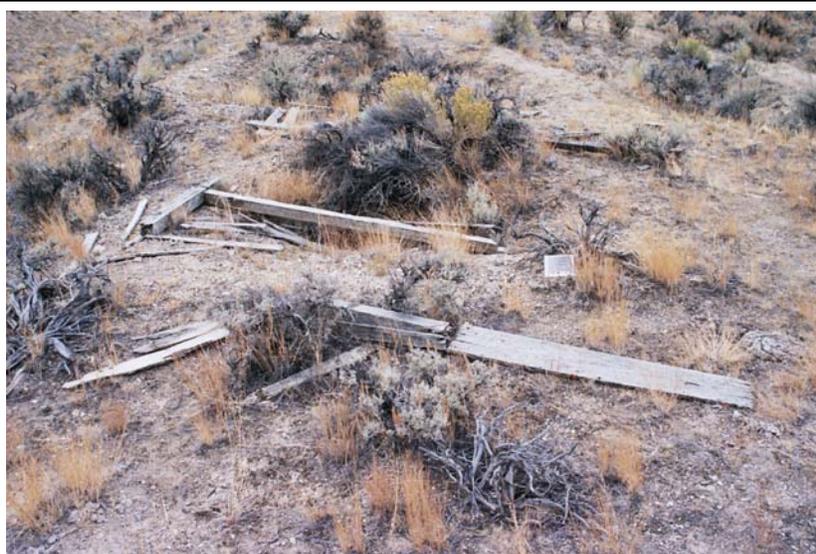
Figure 37. Area of collapsed wood grave fence. Notice how the fence is spread over a relatively large area, possibly by the excavation of the exploratory pits.

While we have elsewhere recommended that the lost wood grave enclosures be replaced by skeleton fences to help restore (or maintain) the landscape character, this practice is not appropriate at Maryville since it is impossible to determine where the fence was originally constructed.

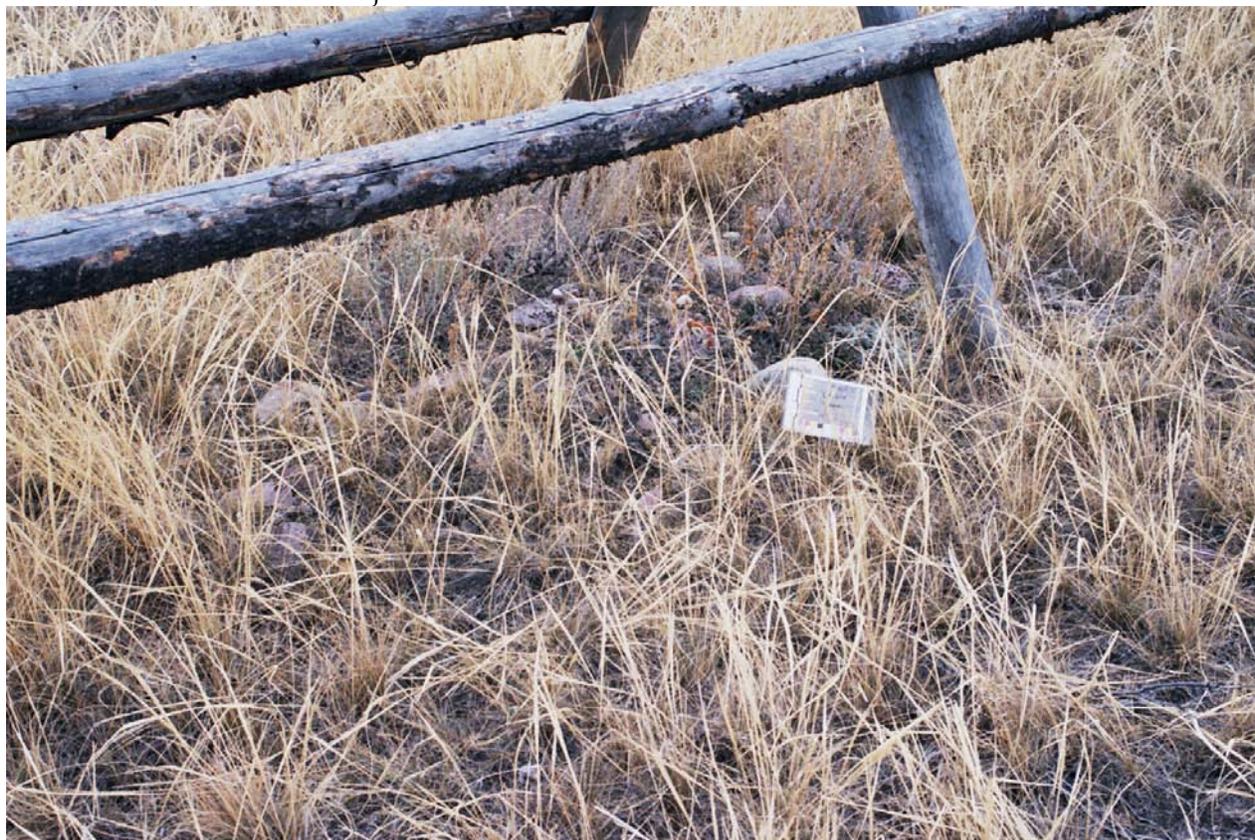
Grave Mound F situated under the jack fence

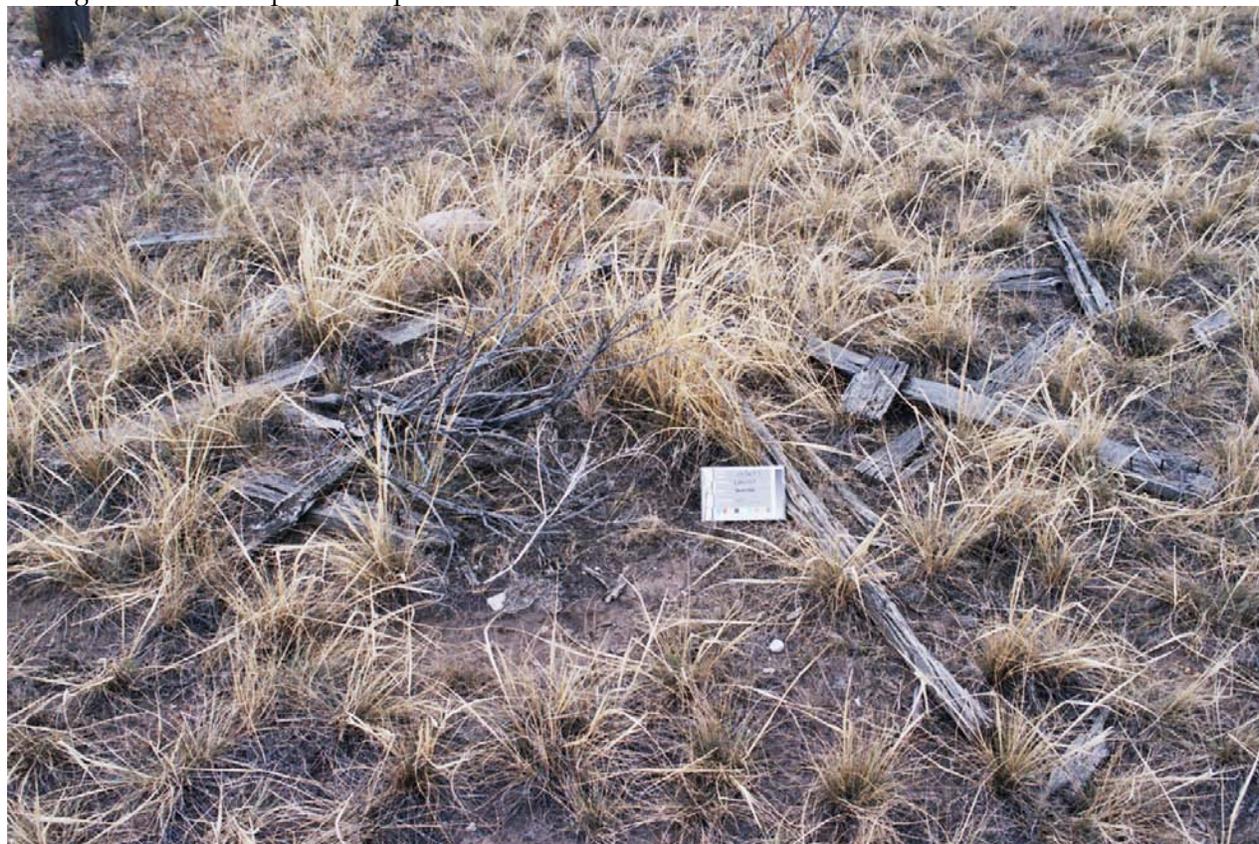
Remnant grave fence collapsed on top of Grave Mound D
