**PRESERVATION ASSESSMENT AND  
TREATMENT PROPOSALS FOR  
THE CAPTAIN TED CONAWAY  
MEMORIAL NAVAL CEMETERY,  
NAVAL MEDICAL CENTER  
PORTSMOUTH,  
PORTSMOUTH, VIRGINIA**

**October 23, 2006 Final**

**Chicora Research Contribution 450**

**Prepared for Naval Facilities Engineering Command**

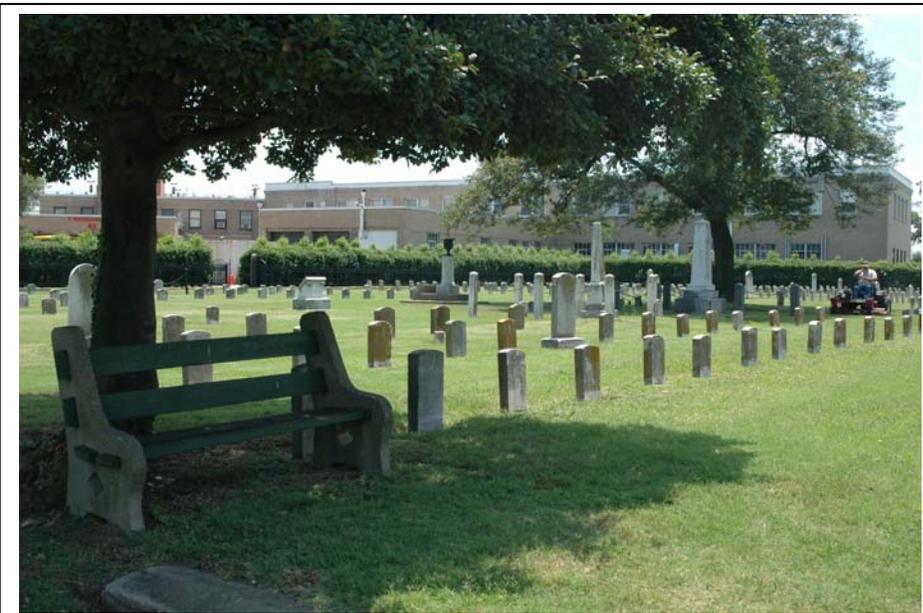
Figure 1. View of entrance to the cemetery, looking south.

The cemetery has three entrances - a double wide entrance off Gendreau Road, a pedestrian entrance off the parking lot to the north, and a double width entrance into the eastern facilities yard. It appears that the Gendreau Road entrance is rarely used (I found it difficult to operate the gate). The facility yard gate use appears to be limited to maintenance activities. Thus, it appears that most visitors enter the enter from the Facilities Management Department parking lot off Gendreau Road to the west or Sterling Cook Street to the north. This entrance is notable only in that there is a tree and bench at this entrance (see Figure 1).

This north gate is the focal point of the cemetery (in the sense that it provides the first impression to visitors), yet it is rather nondescript and offers no particularly dramatic entrance (Figure 1) or signage. In fact, one must progress to the center of the cemetery to find the only signage present.

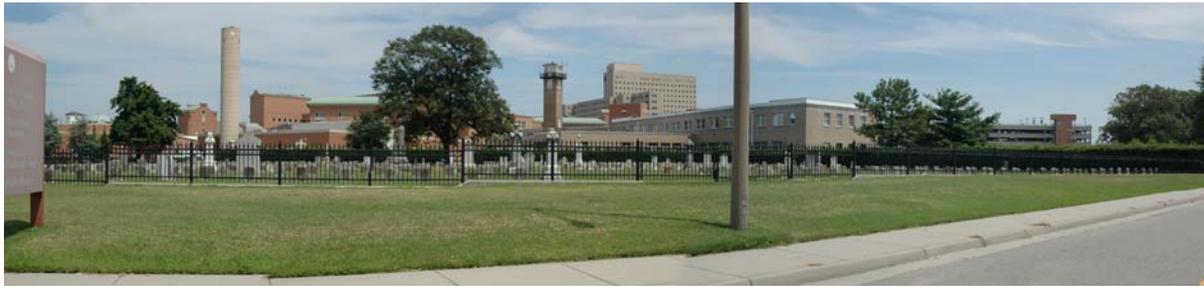
Figure 6. Panoramic view of the cemetery along Gendreau Road showing a variety of the intrusive elements.

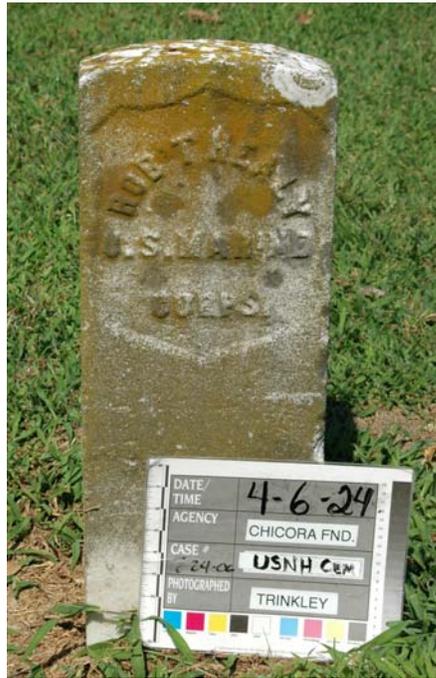
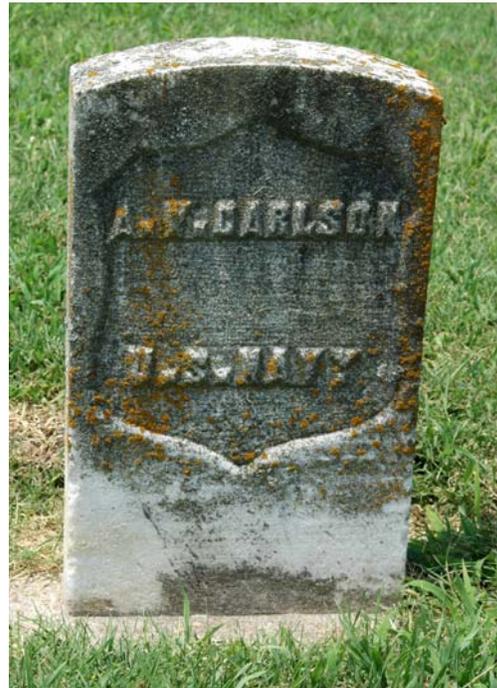
Figure 7. Examples of extant government stones. A, original 1873-1902 10-inch wide “Civil War” stone; B, 1903-ca. 1920 12-inch wide “Civil War” stone; C, modern replacement of “Civil War” stone showing deviation from the historic fabric and character; D, “General Issue” stone that is set too low, detracting from its design and historic character.

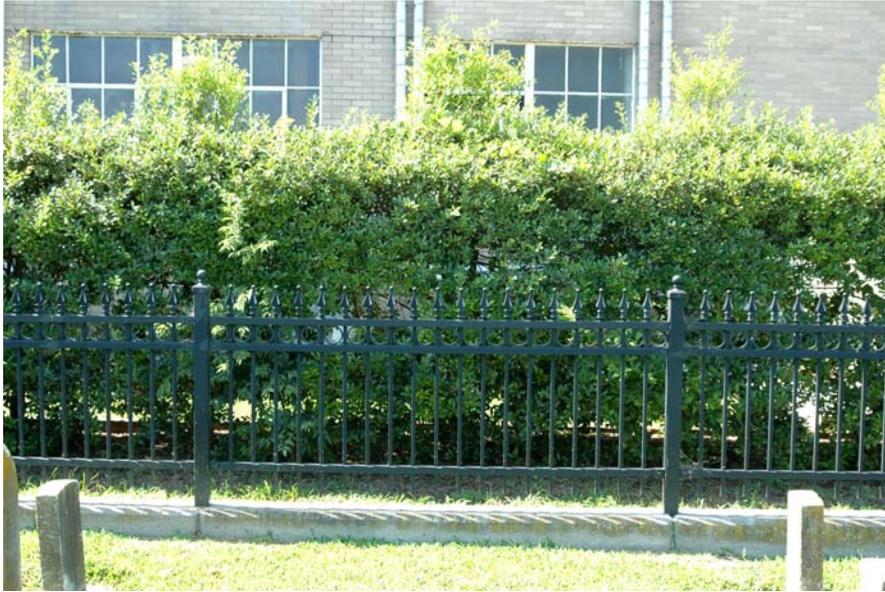
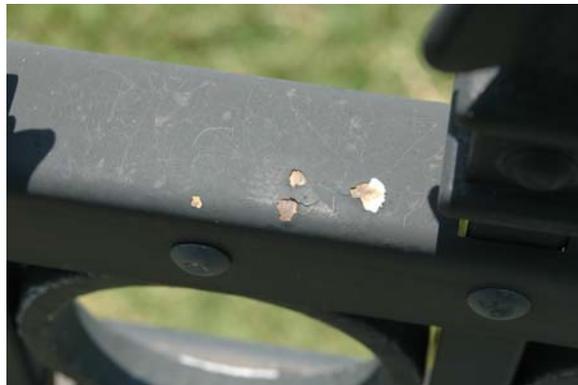
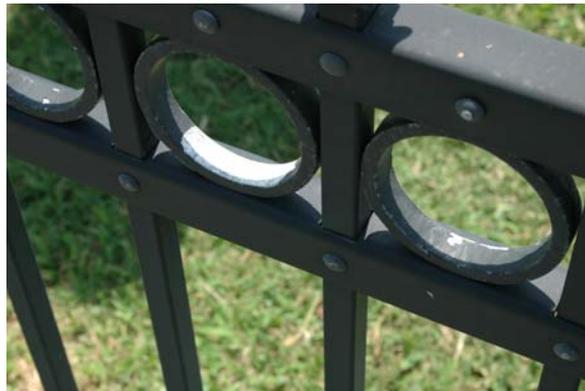
There is also evidence of missing elements (such as chain and chain weights), as well as damaged or missing retaining rings originally set in the granite posts with lead. Most troubling, however, is the evidence of very poorly performed repairs using inappropriate materials and techniques. It is critical that only trained conservators perform repairs and treatments of the historic fabric.

Figure 11. Modern boundary fence. The top photograph shows the heavy, out of scale appearance of the fence. The lower photographs illustrate paint dulling, chips with underlying corrosion, and flaking from galvanized trim. Note also the abundant use of rivets that detracts from the overall appearance.

This maintenance program will significantly improve the appearance of the ironwork in the cemetery and will help prevent additional corrosion and deterioration of the various fence components.

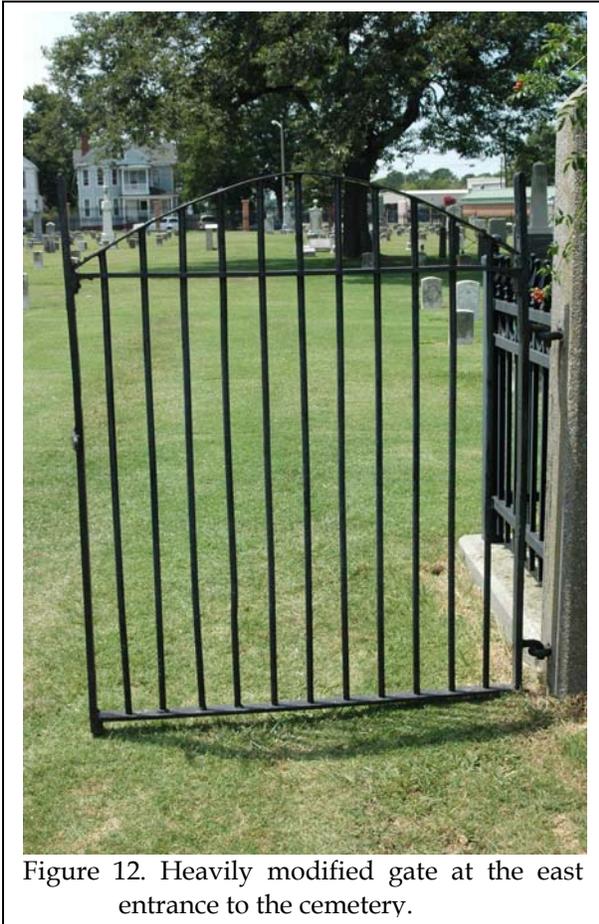
Figure 12. Heavily modified gate at the east entrance to the cemetery.

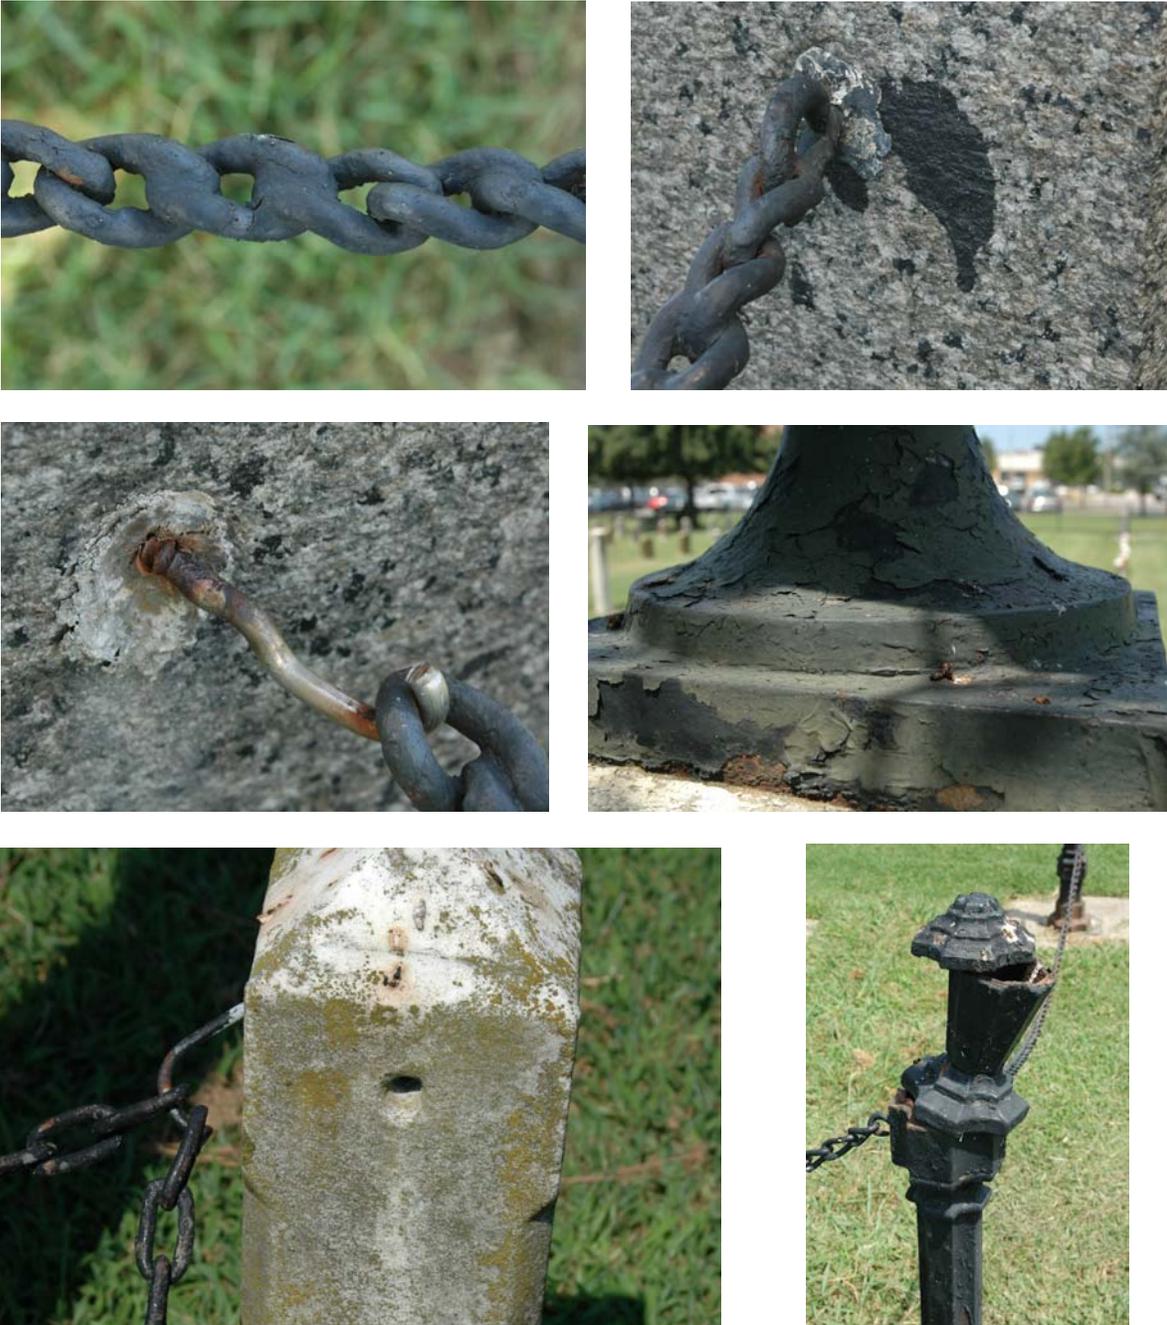
Figure 13. Extensive problems with historic fencing and monuments in the cemetery. Upper left, paint so heavily applied that details are obscured and the chain links are bonded; upper right, paint applied to the stone; middle left, inappropriate repair; middle right, heavy paint flaking and corrosion on the urn; lower left, missing and damaged connectors; lower right, heavily damaged fence post showing corrosion resulting from water penetration.

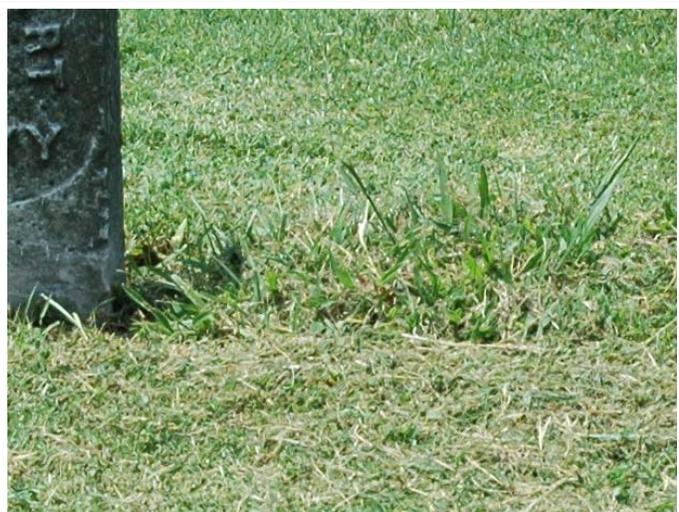
Figure 15. Excessive growing height, with removal of nearly two-thirds of the tissue.

was being delayed until the grass was over 2-inches in height and was being cut back to ¾-inch (Figure 15). Allowing the grass to grow this high produces a shaggy, unkempt appearance, while reducing its height by nearly two-thirds dramatically stresses the grass.

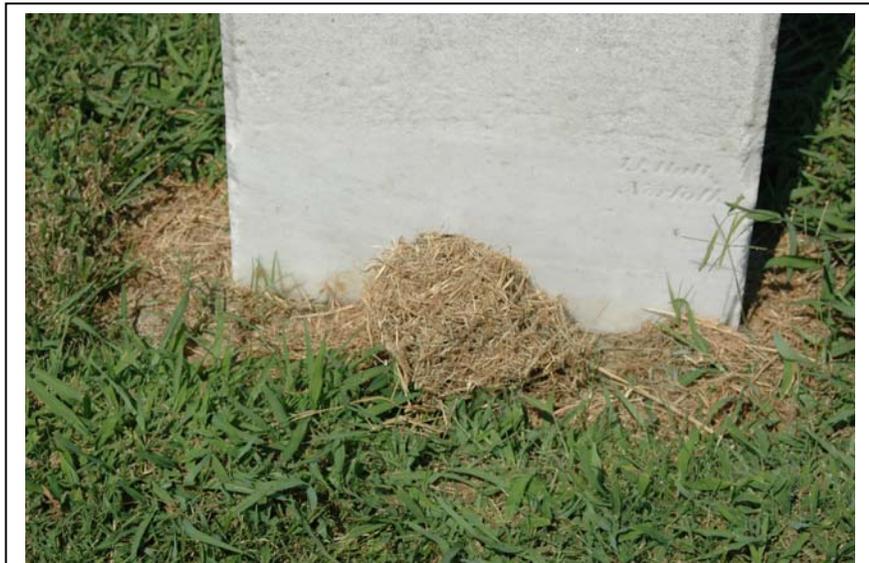
Figure 16. Grass clippings built up on stones in the cemetery.

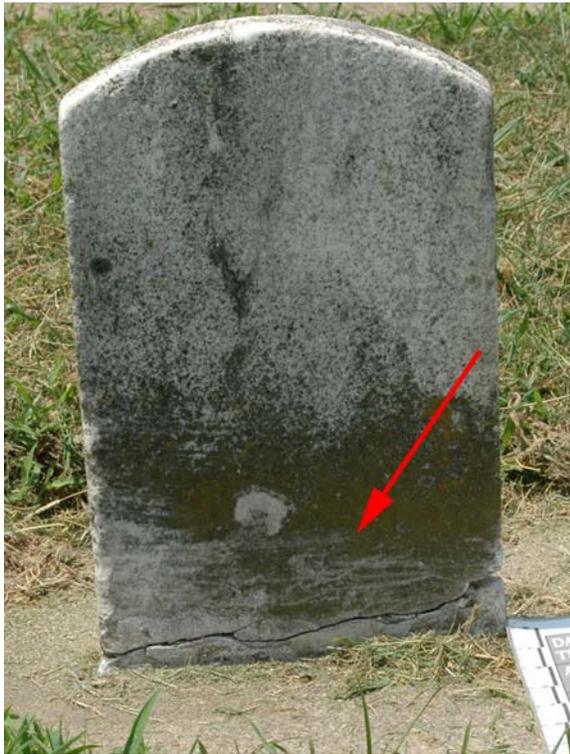
Figure 18. Nylon trimmer damage.

staff since technicians will want to use a heavier line to reduce their work and speed the process. Figure 18 illustrates one stone with abundant striations typical of aggressive nylon trimmer damage.

present as discards in the cemetery. We recommend that no line heavier than .065, or at most .095-inch, be allowed in the cemetery. This will require careful attention of the supervisory

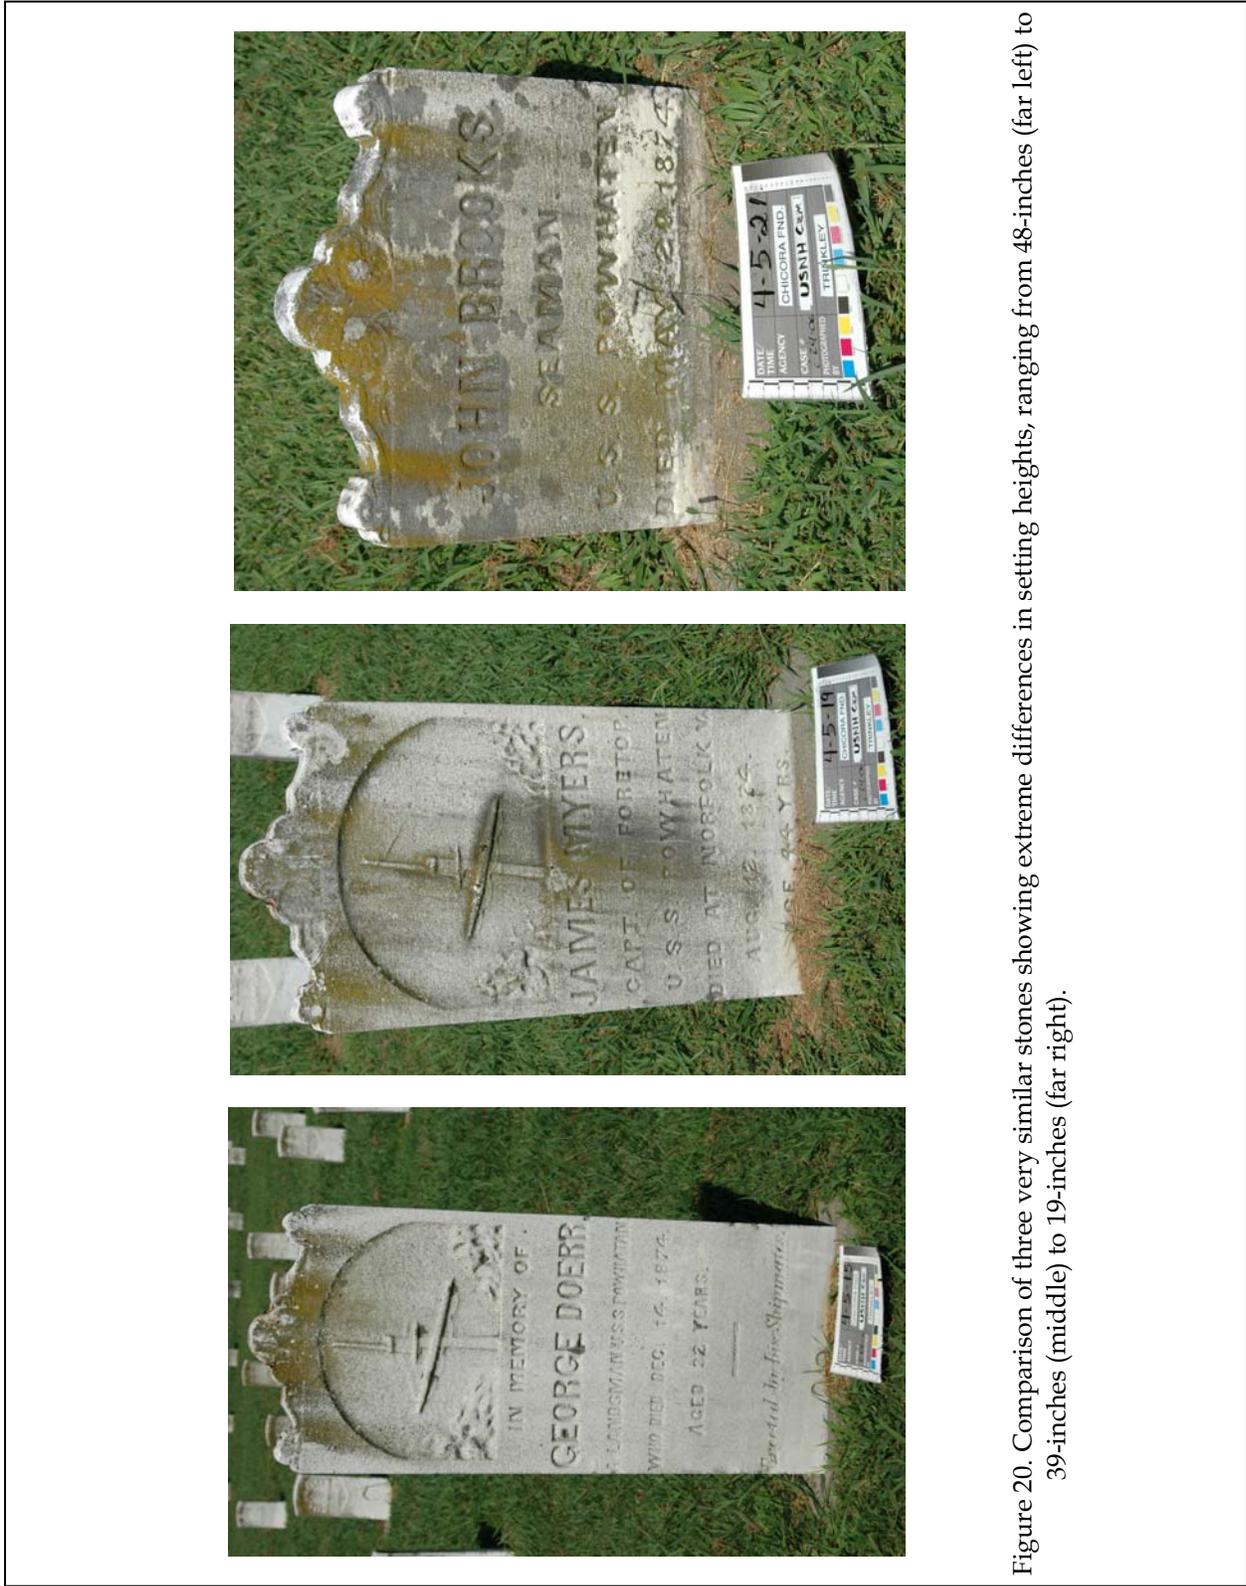
Figure 20. Comparison of three very similar stones showing extreme differences in setting heights, ranging from 48-inches (far left) to 39-inches (middle) to 19-inches (far right).

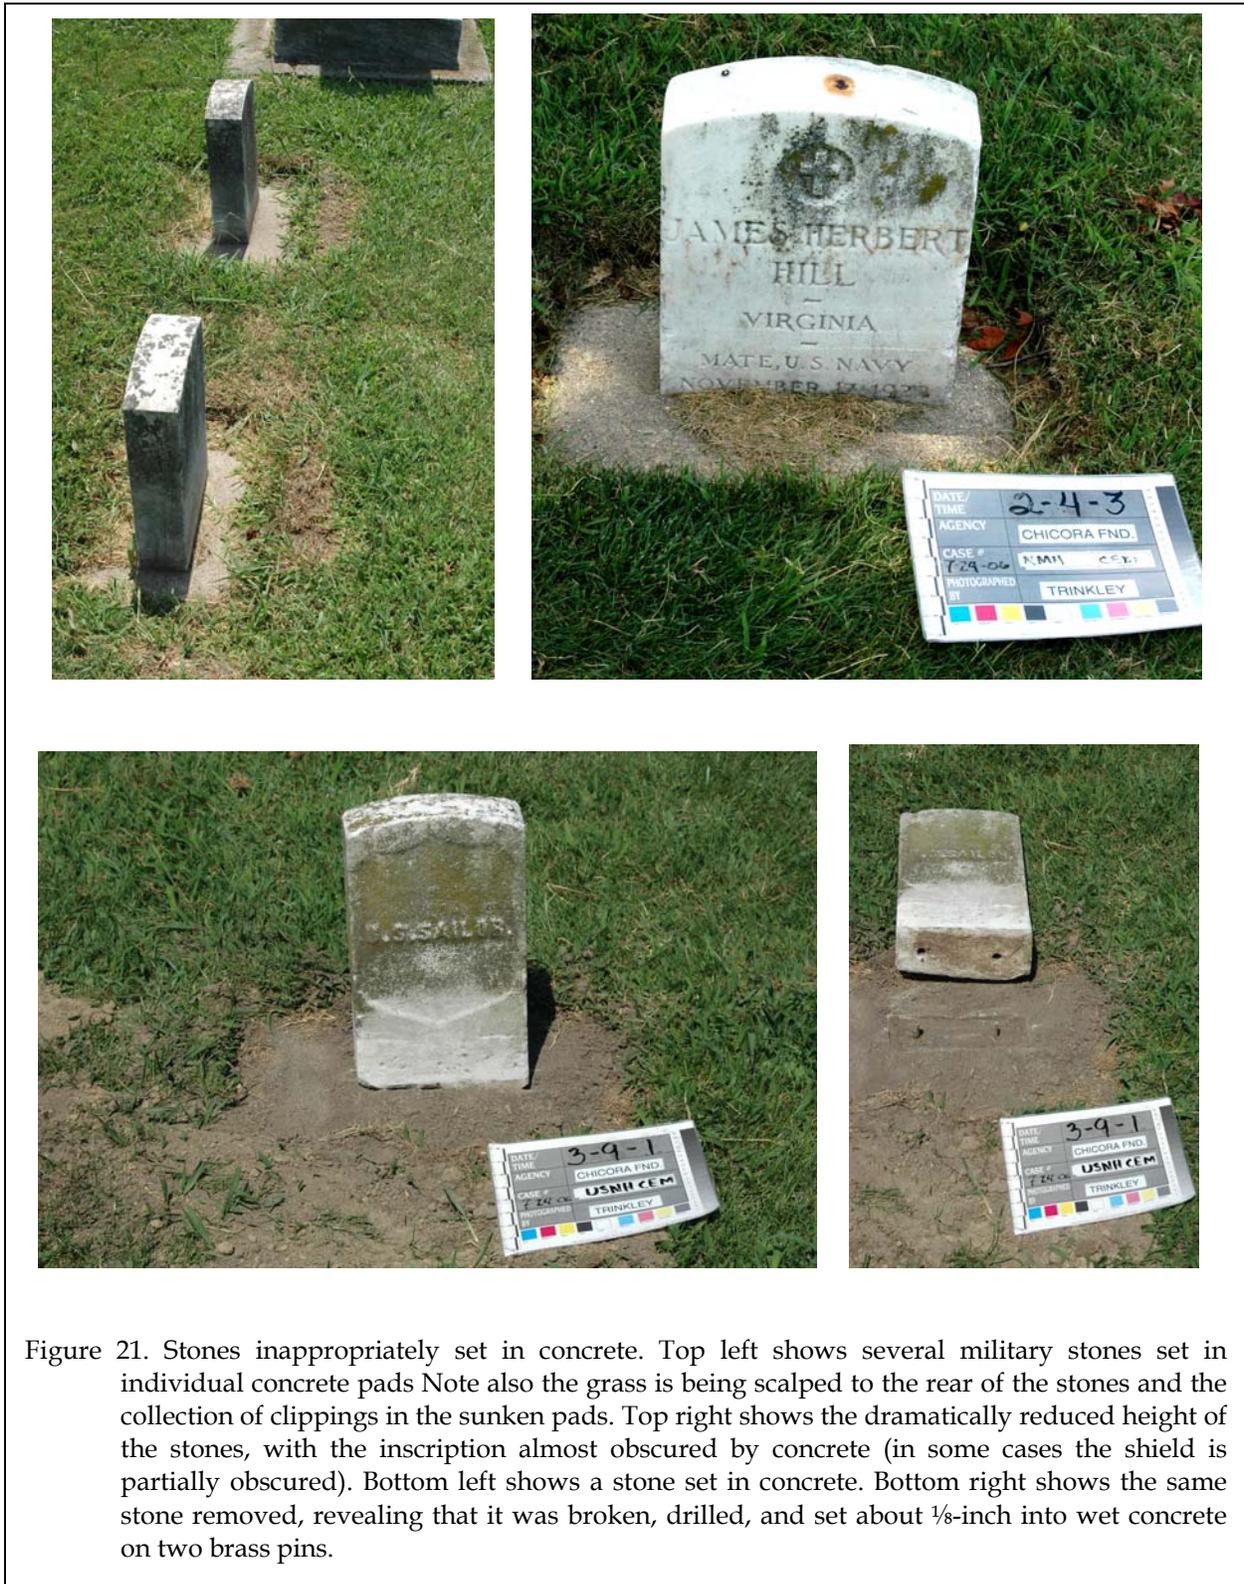
Figure 21. Stones inappropriately set in concrete. Top left shows several military stones set in individual concrete pads. Note also the grass is being scalped to the rear of the stones and the collection of clippings in the sunken pads. Top right shows the dramatically reduced height of the stones, with the inscription almost obscured by concrete (in some cases the shield is partially obscured). Bottom left shows a stone set in concrete. Bottom right shows the same stone removed, revealing that it was broken, drilled, and set about 1/8-inch into wet concrete on two brass pins.

been drilled and set into the concrete on brass pins. It is uncertain if stones were intentionally reduced in height or if these may represent broken stones that were reset.

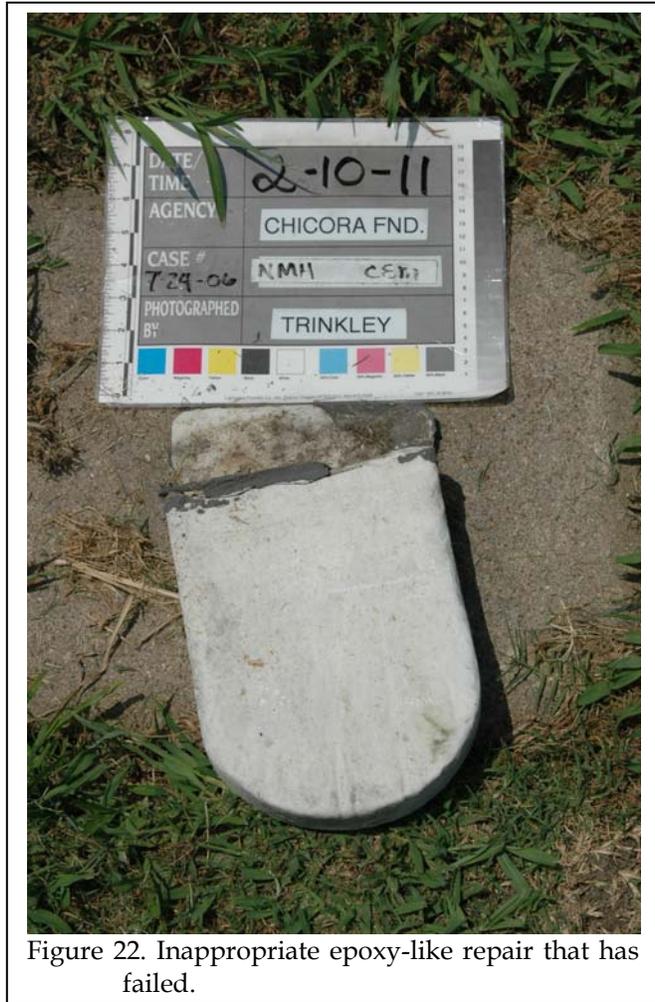
Figure 22. Inappropriate epoxy-like repair that has failed.

There is no single specification for the repair of marble or sandstone, but in general we can caution the Navy that modern monument dealers (and the general public) are unfamiliar with historic stone and have little or no appropriate experience in its care and repair. When repairs of old stones are needed, only a stone conservator who subscribes to the

Standards of Practice and Code of Ethics of the American Institute for Conservation of Historic and Artistic Works (AIC) should be retained.

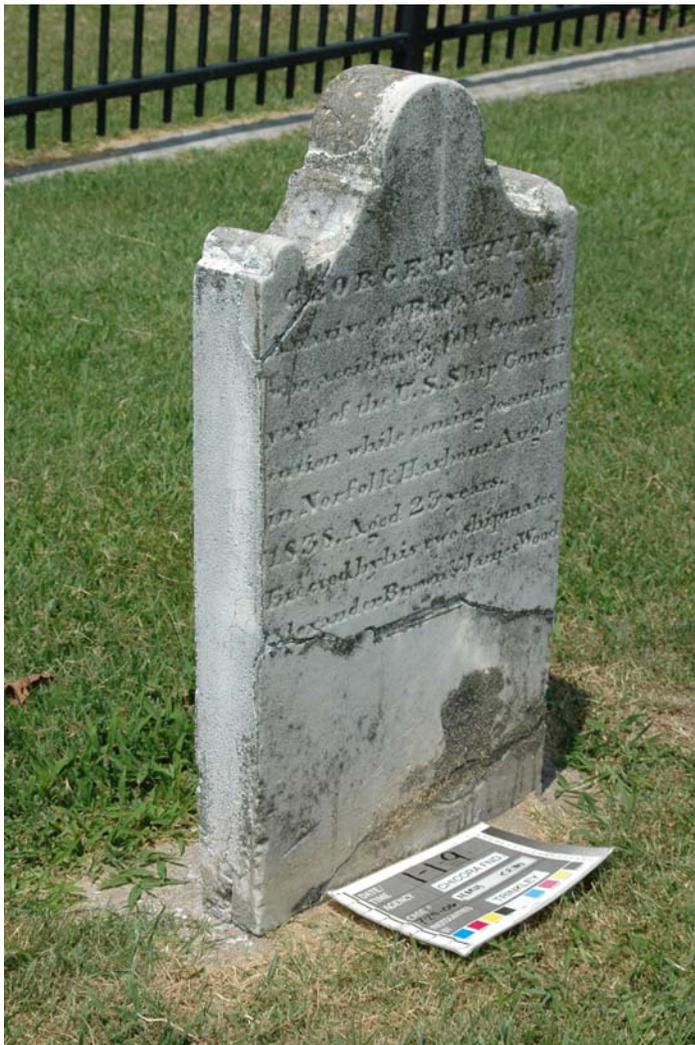
In several other cases we observed stones where repairs had been made using a white Portland cement. Unfortunately this material is entirely too hard for marble. In addition, the repair material has been applied so thickly and poorly that it has defaced the marker, making future repair far more difficult and costly.

Figure 23. Use of white Portland cement to reinforce a monument, dramatically increasing its thickness and changing its overall character.
