**ASSESSMENT OF TORNADO DAMAGE AT
THE OAK GROVE CEMETERY,
AMERICUS, GEORGIA**

ASSESSMENT OF TORNADO DAMAGE AT THE OAK GROVE CEMETERY, AMERICUS, GEORGIA

Prepared By:
Michael Trinkley, Ph.D.

March 26, 2007

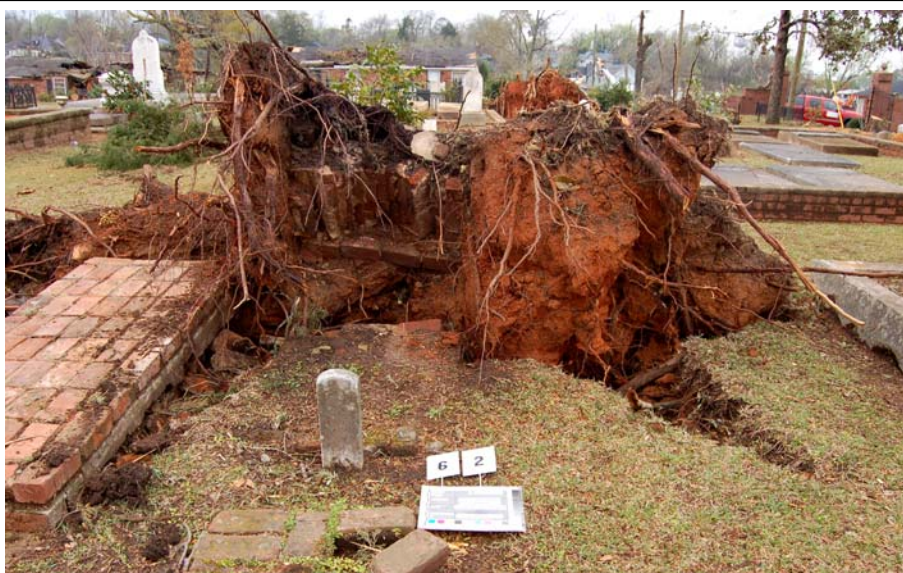
Figure 5. Example of vault damage requiring archaeological investigation. The open vault should also be secured prior to conservation treatment to prevent looting, desecration, or vandalism.

All recovered items should be photographically documented in the field. Human remains should be measured and recorded as necessary by a forensic anthropologist.

The recovered remains should be placed into an appropriate container (temporary containers such as plastic bags are typically replaced by small plywood boxes once sizes are known) for reburial in the exposed grave site (or as close to it as possible). Each of the boxes should have a small stainless steel marker with the date of the tornado and of the reburial, with a brief explanation of the disturbance and restoration.

During storage prior to reburial these remains should be kept secured, following normal “chain of custody” procedures. This will ensure that all items recovered are eventually reburied.

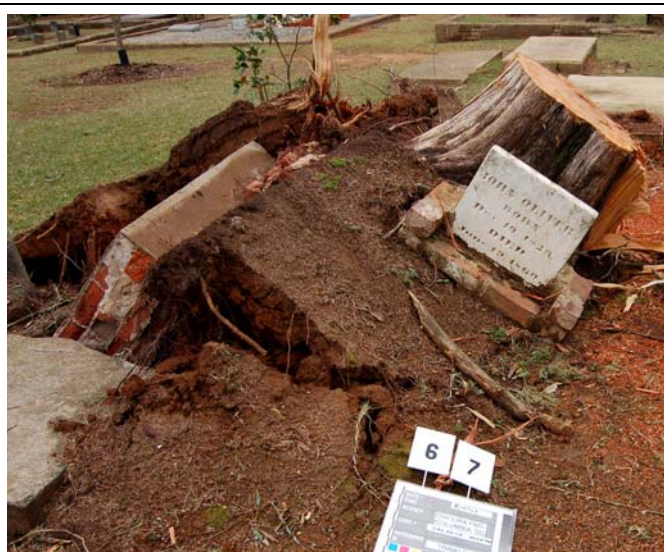
Figure 6. Tree root uplift that has potentially disturbed the grave and requires archaeological investigation prior to removal.

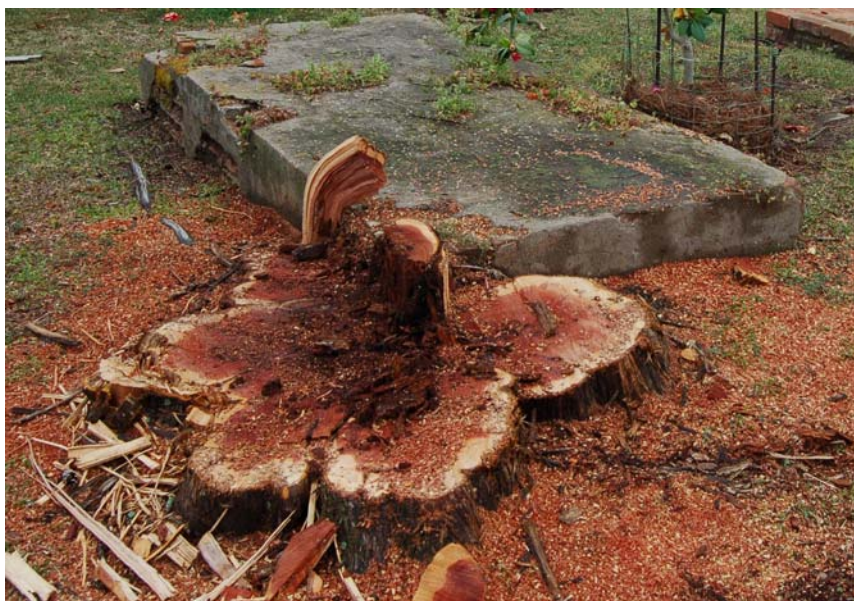
Figure 7. This is an example of a stump that should not be removed or ground, but left in place to allow natural decay. The protruding tree sections should be carefully removed.

For those stumps which are not partially or wholly removed from the soil, stump grinders may be used *only if the equipment can be placed without endangering monuments and all surrounding monuments may be protected by plywood from flying chips*. Grinding should extend no more than 2-3 inches below grade. It is also acceptable to flush-cut stumps to grade and allow them to naturally decompose.

Once all stumps have been removed, the remaining depressions should be filled with

clean white sand (or some soil that is distinguishable from the cemetery soil) and compacted.

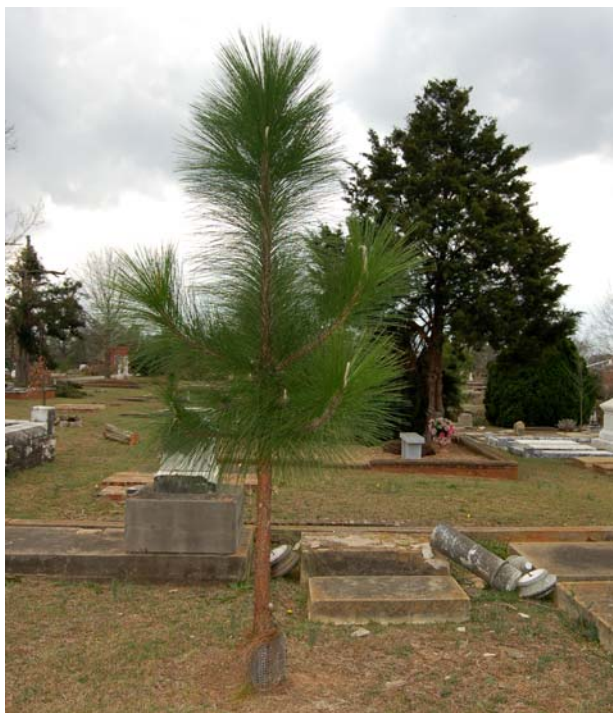
Pines are not an especially appropriate tree for cemetery use. They drop sap on monuments; produce much litter; are inherently

Figure 8. Pines such as this are not a good choice for cemetery planting. We recommend that they be removed and that lost pines not be replanted.

weak and prone to wind and ice damage; and require large amounts of water, limiting the growth of understory vegetation or turfgrass.

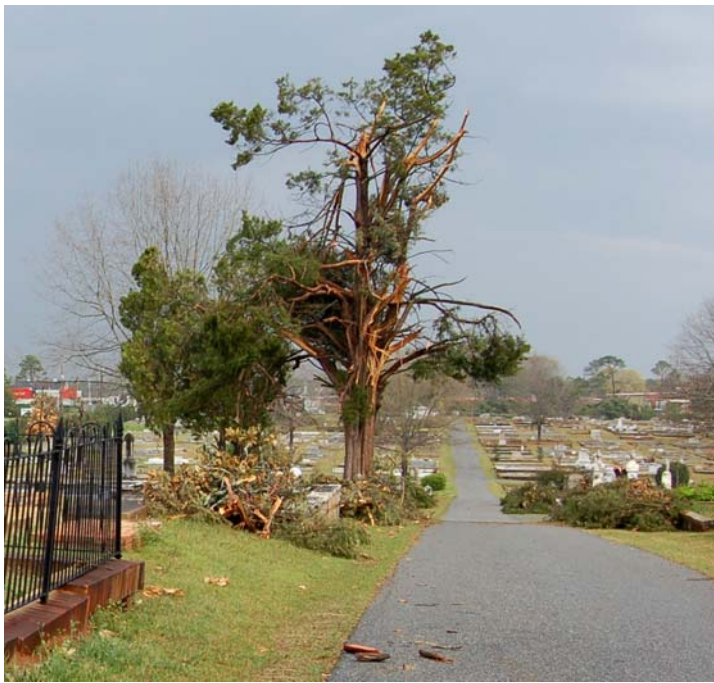
Figure 9. Example of a tree that requires an assessment by a certified arborist to determine if restoration pruning is possible.

typically handle the removal of trees in open areas or the removal of dead or hazardous limbs, a certified arborist is needed for much of the work encountered in a cemetery. In particular, a certified arborist should remove leaning trees, removing any limbs that require climbing, restoring trees, and pruning to

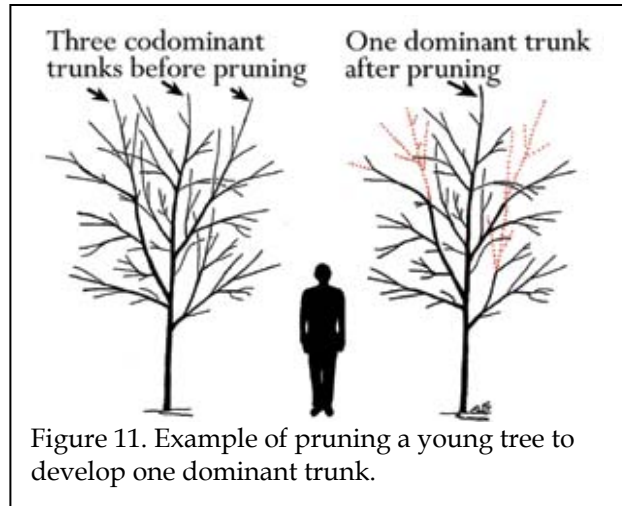
Figure 11. Example of pruning a young tree to develop one dominant trunk.

Pruning trees is a very complex issue and we can't begin to do it justice here. For example, one critical issue in pruning young trees is ensuring that they develop one dominant trunk – achieved by shortening competing branches with reduction cuts. When performed regularly, this makes trees stronger by allowing the main trunk to grow larger than the branches.
