**PRESERVATION PLANNING FOR ST.
ELIZABETHS WEST CAMPUS CEMETERY,
ST. ELIZABETHS HOSPITAL,
WASHINGTON, DC**

Research Contribution 472

Michael Trinkley
Debi Hacker

June 2007

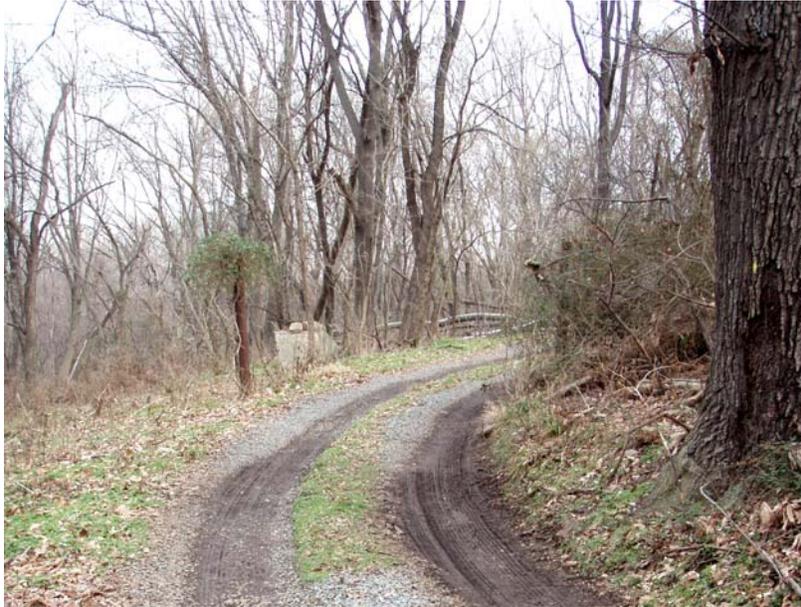
Figure 3. Access road to the West Campus Cemetery.

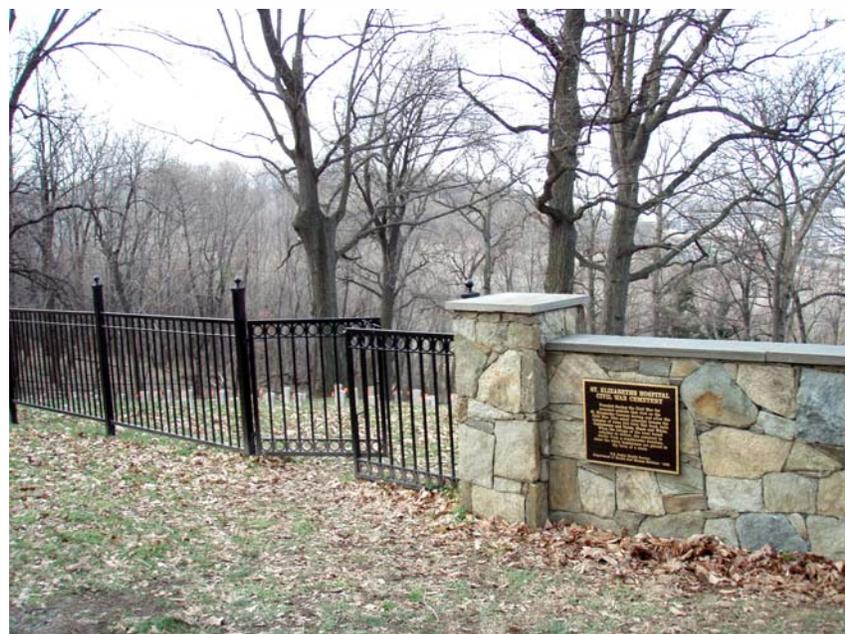
Figure 4. Entrance to the cemetery. The stone wall, iron gates, and iron fence create a sense or impression of the cemetery's importance and formality that is historically incorrect.

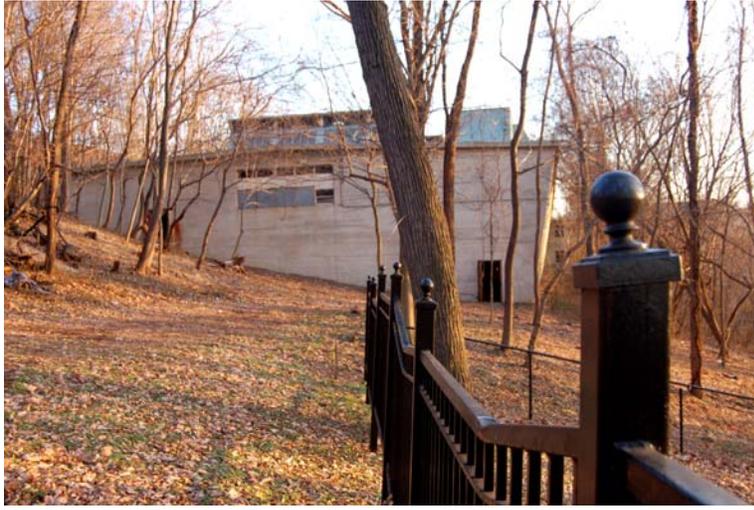
Figure 5. The abandoned hospital warehouse is situated immediately adjacent to the cemetery, creating a significant visual intrusion.

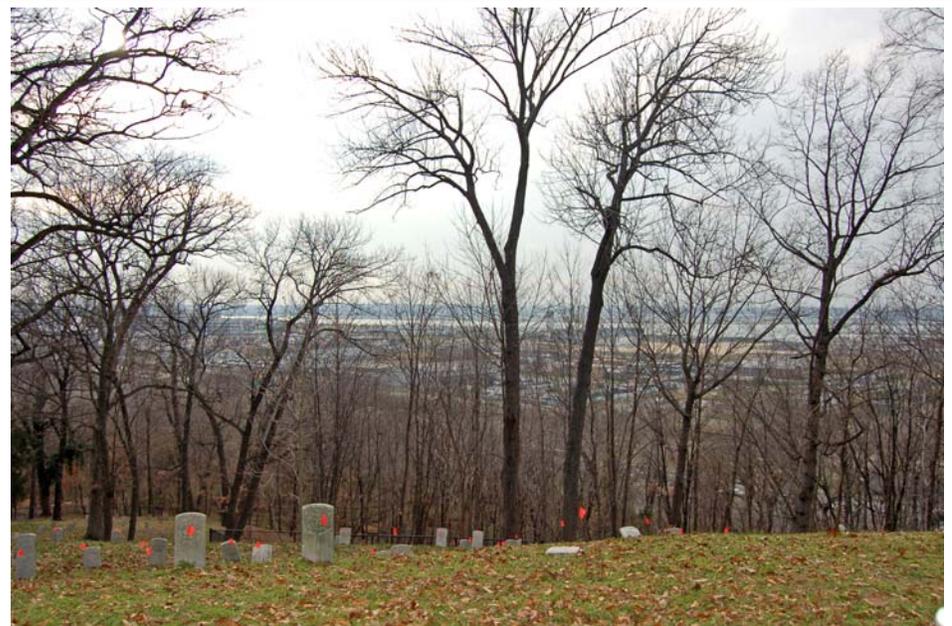
Figure 6. Winter view from the entrance of the cemetery toward the Anacostia River in the background.

Although the view in the cemetery during the winter is spectacular (Figure 6) – allowing a nearly clear vista towards the Anacostia River – the overall setting has been allowed to deteriorate

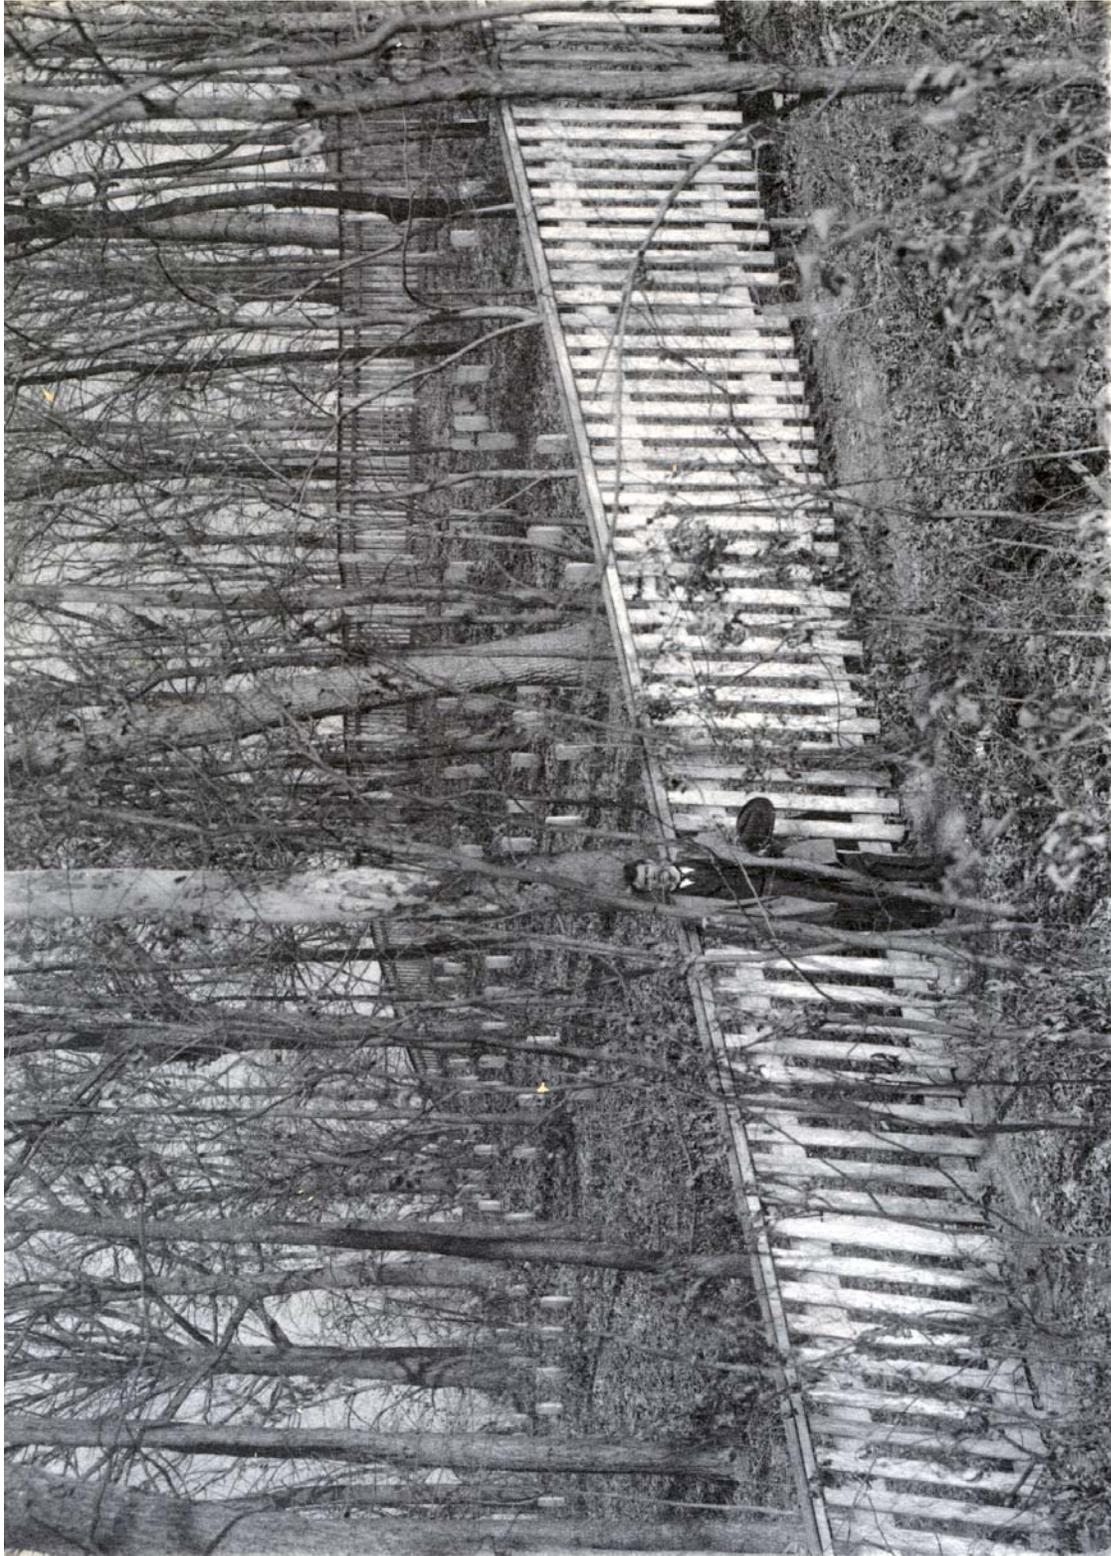
Most of the photographs of the west campus cemetery are rather recent. The one surviving photograph from an early period is shown in Figure 20. This is variously identified as a ca. 1870, 1897, or ca. 1900 photograph. Given the other photographs present in the collection it seems likely to date from the late 1880s through late 1890s and it was taken from the southeast side of the cemetery, looking north.

Figure 20. Late nineteenth century photograph of the cemetery (Maggioncalda 2004: Image 53) looking north from the southeast edge, showing the picket fence perhaps shown in the 1873 plan of the cemetery, as well as abundant scrub vegetation on the interior of the fence.

The cemetery was historically surrounded by a wood picket fence, shown in one photograph (Figure 20) and identified on the 1873 map of the cemetery (Figure 16). At some point that fence was replaced by two generations of chain link (the earliest version still evidenced by corroded post stubs in the ground and a mass of wire along the northwest edge of the modern fence). In 1992 the front (northeast) fence was replaced with a black iron fence and stone wall. Entrance is by way of a double gate which is not locked.

replacement is necessary, we recommend that this historic fabric be re-introduced to the property. The design of one such fence that surrounded the cemetery is clearly shown in a historic photograph (Figure 20), providing good design specifications. Maintenance costs can be minimized by using pressure treated wood and stainless steel attachments.

The only historic photograph of the cemetery (Figure 20) reveals considerably thicker woods than are present today. Much of this vegetation, however, appears to be second growth – young trees that self-seeded and, with minimal maintenance, were allowed to grow. Even the more mature trees appear to be natural species, suggesting little or no modification of the original vegetation by caregivers.

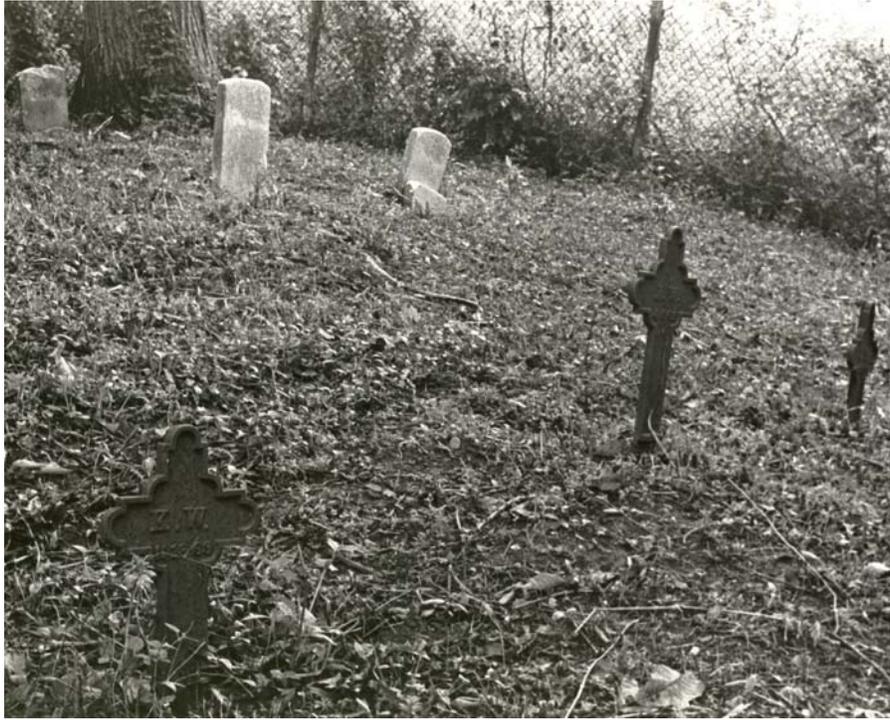
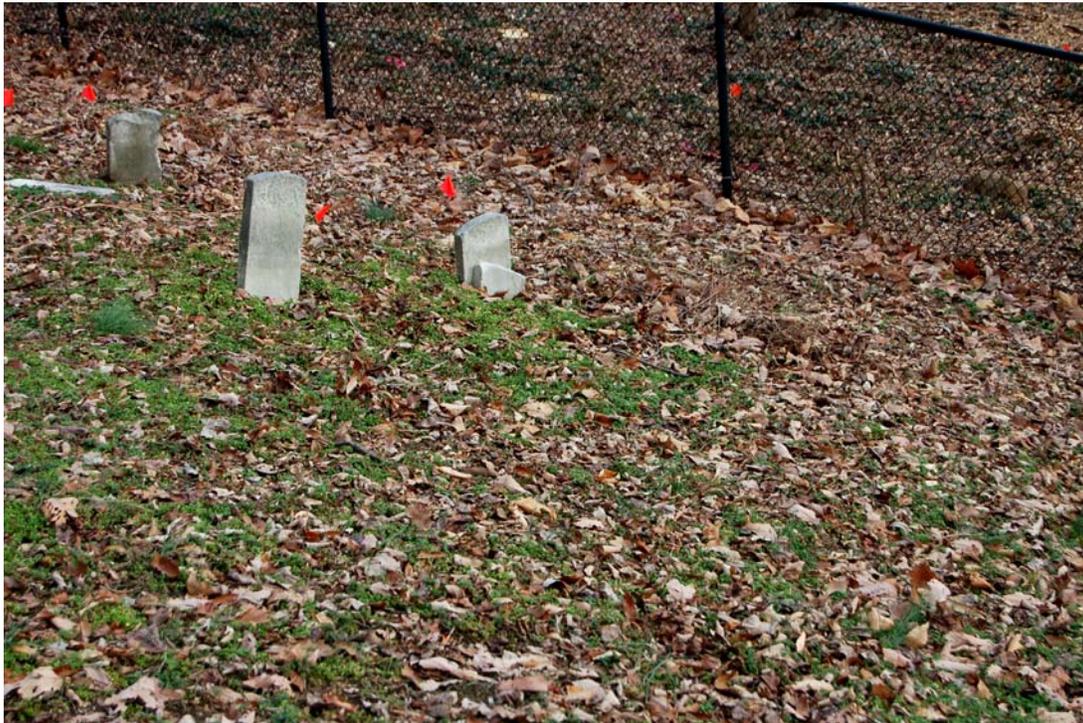
Figure 21. At the top is a 1981 photograph (Maggioncalda 2004: Image 158) of the eastern edge of the cemetery where three cast iron crosses are thought to have marked Confederate graves. Below is the same area today.

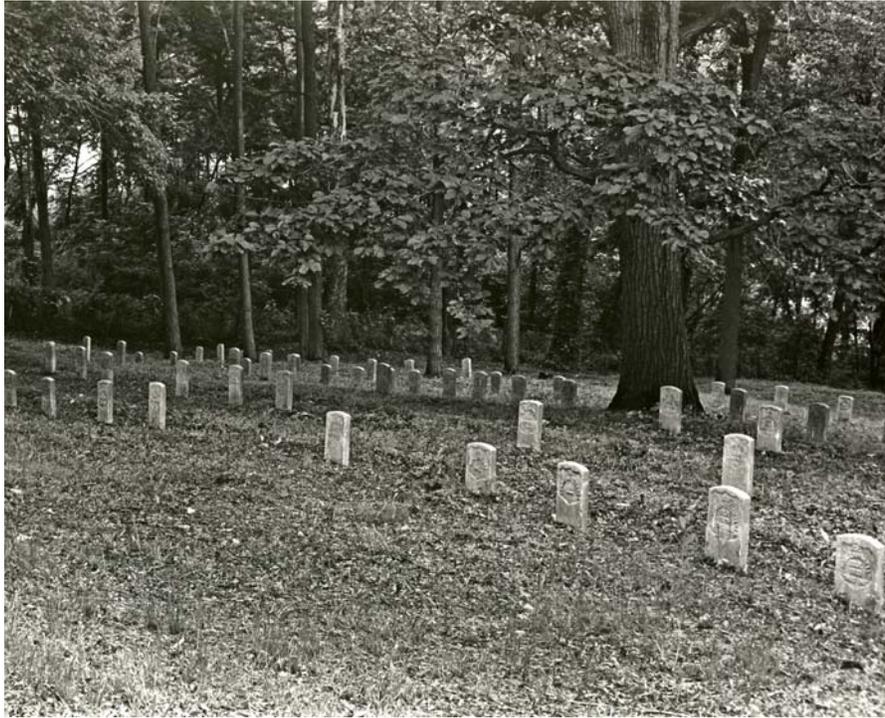
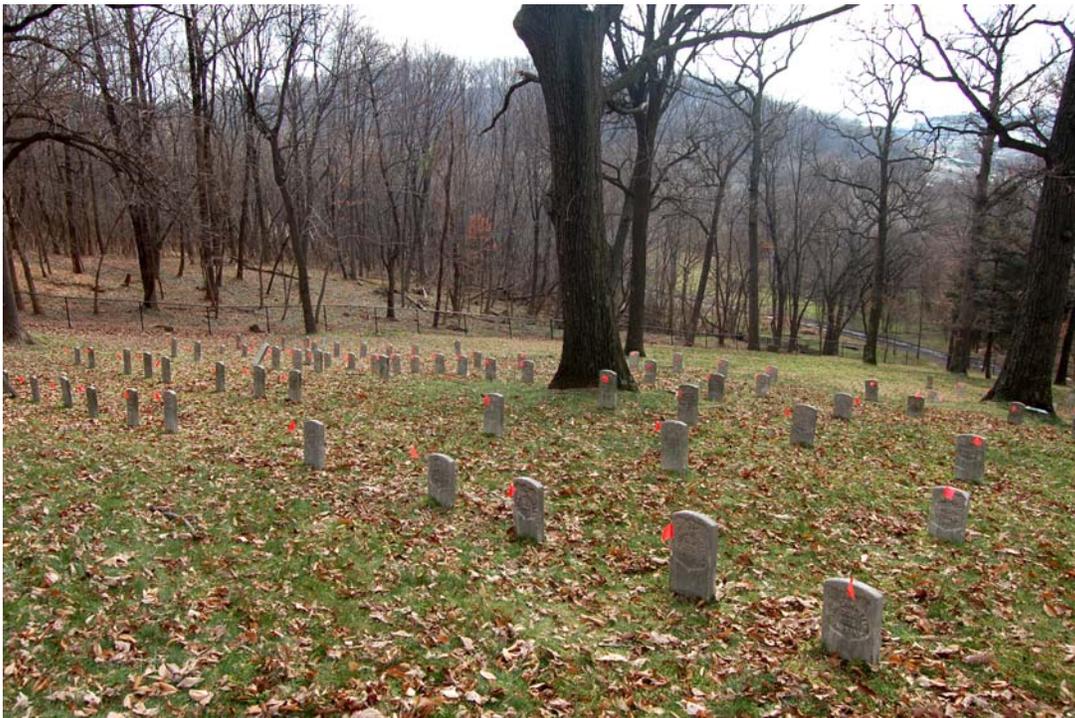
Figure 22. At the top is a 1981 photograph (Maggioncalda 2004: Image 159) of the northeastern section of the cemetery looking south. Below is the same area today.

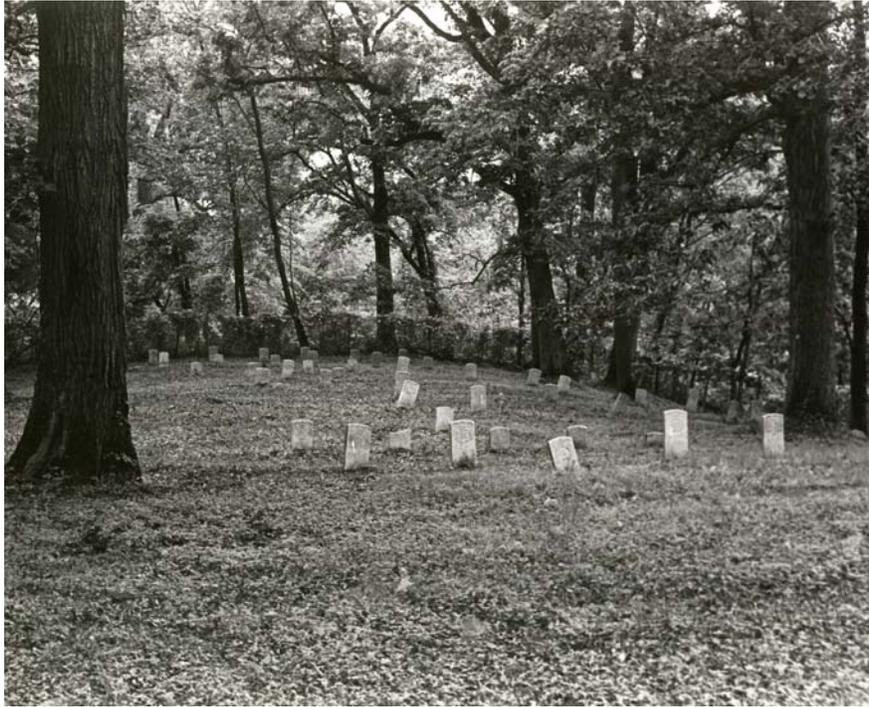
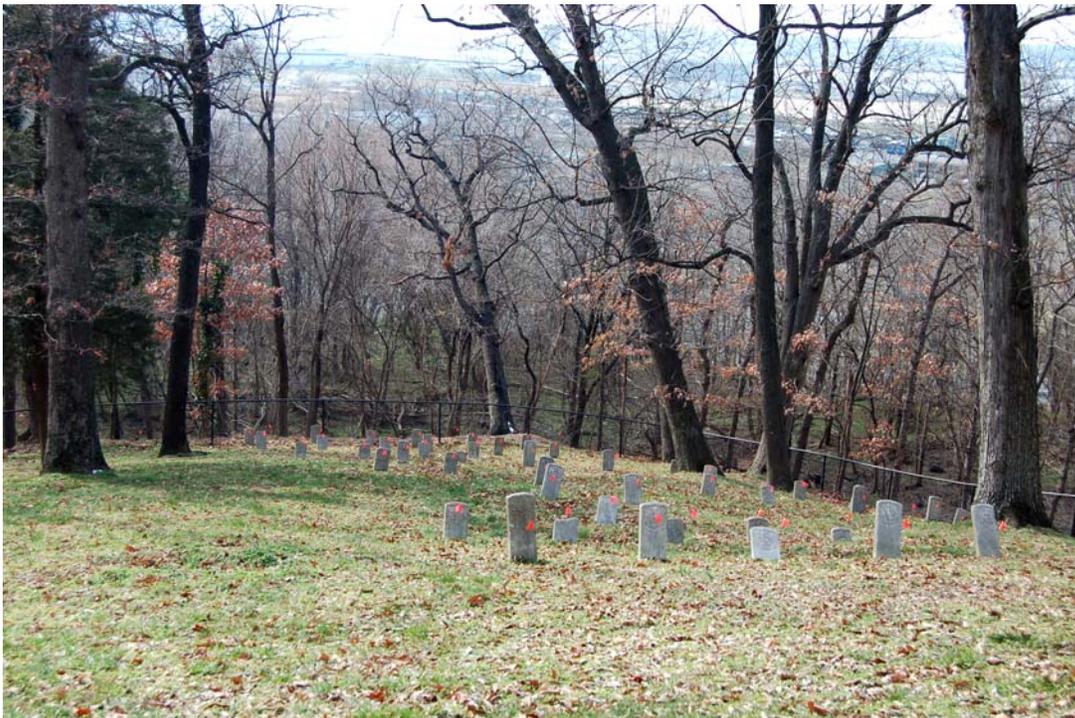
Figure 23. At the top is a 1981 photograph (Maggioncalda 2004: Image 161) of the southwestern corner of the cemetery looking southwest. Below is the same area today.

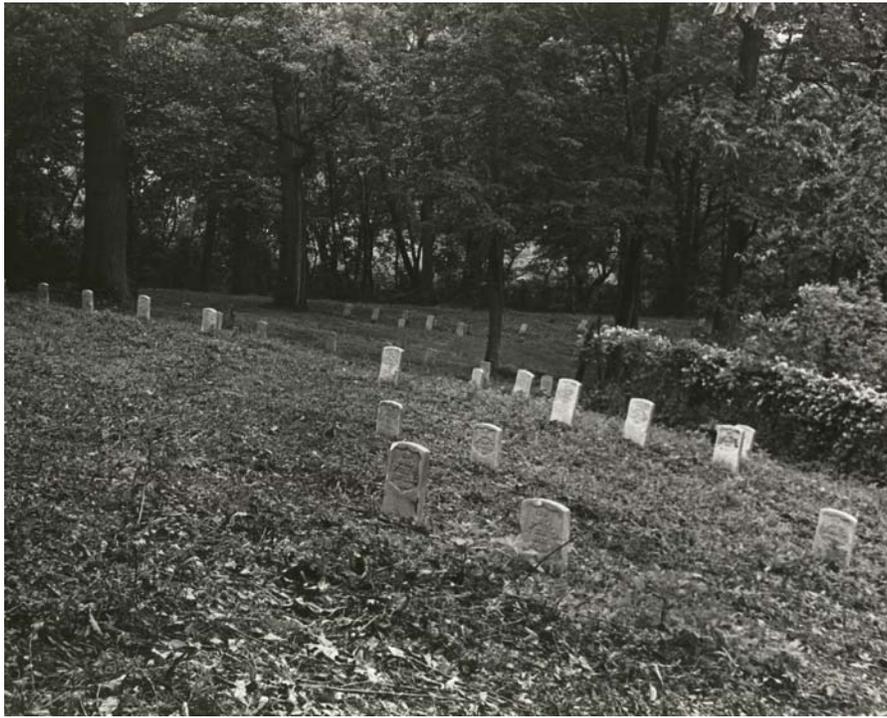
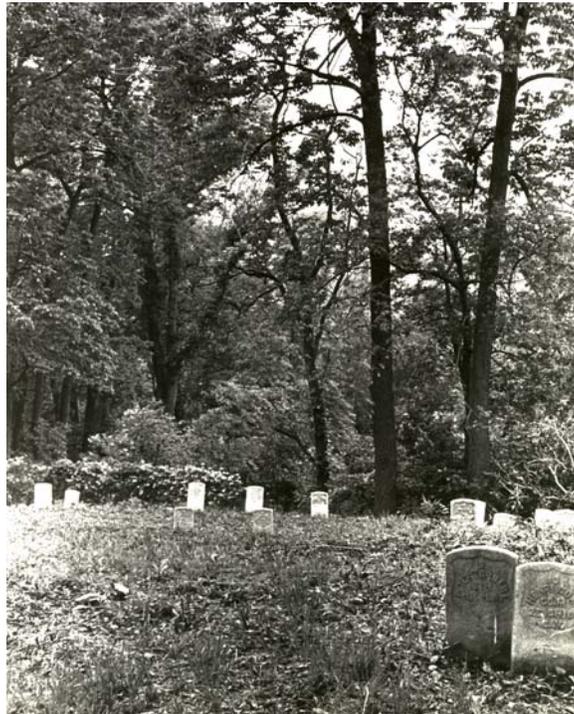
Figure 24. At the top is a 1981 photograph (Maggioncalda 2004: Images 163 and 160) of the western edge of the cemetery. The old chain link fence is entirely covered with a flowering plant, perhaps a climbing rose.

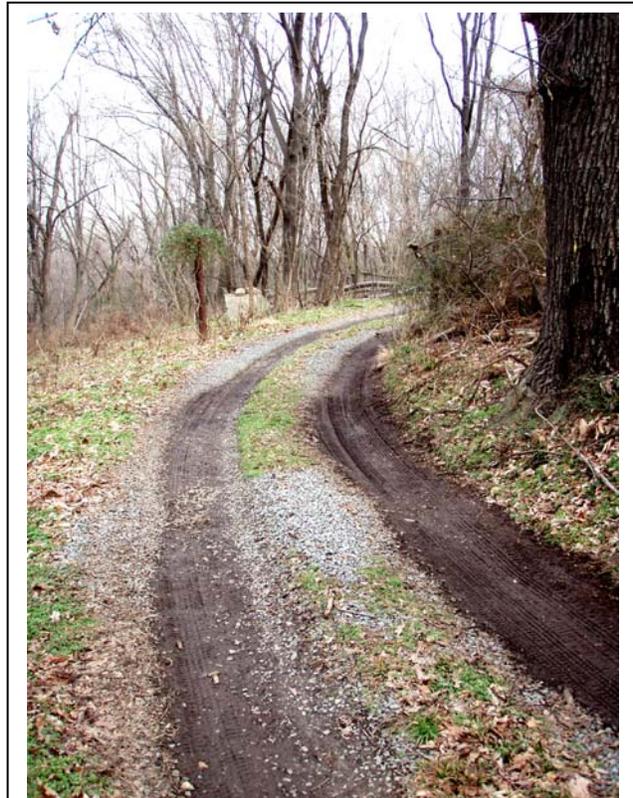
lack of an adequate crown, inadequate grading, a lack of ditches, and inadequate gravel. With just limited travel over the course of a few days under light moisture conditions, this road was

Figure 25. Cemetery access road after just a few days of winter driving. The absence of ditches, lack of a crown, and inadequate gravel all contribute to its poor condition.

Given the low volume of traffic, we see no need to pave this road. It does, however, require redesign and renewal. An excellent source of information for this is the FHWA *Gravel Roads Maintenance and Design Manual* available on-line at <http://www.epa.gov/owow/nps/gravelroads/gravelroads.pdf>.

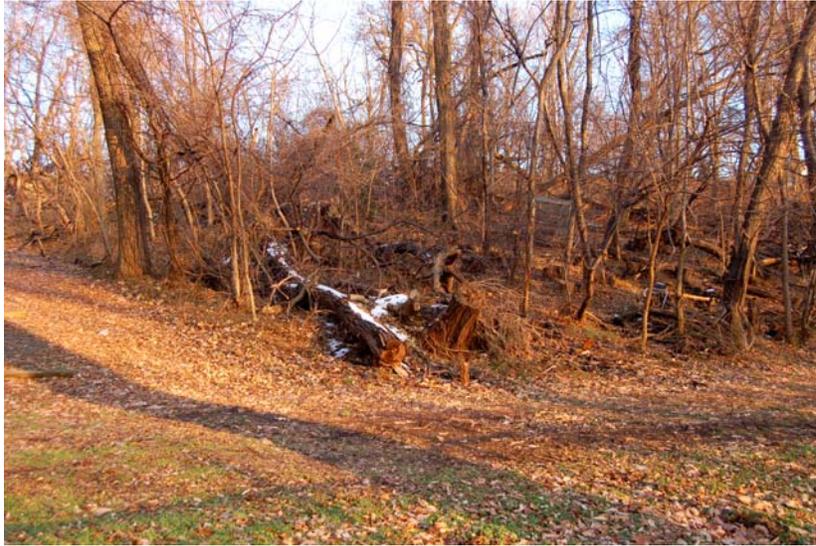
Figure 26. Trash along the slope above the cemetery.

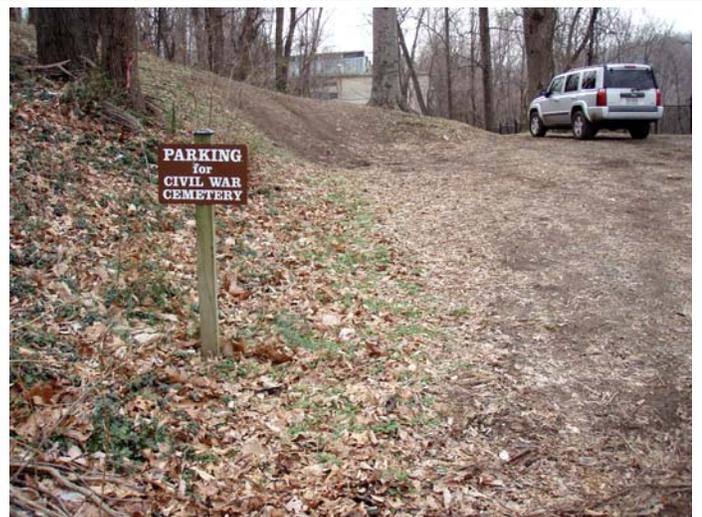
Figure 27. Parking at the cemetery is limited and poorly defined.

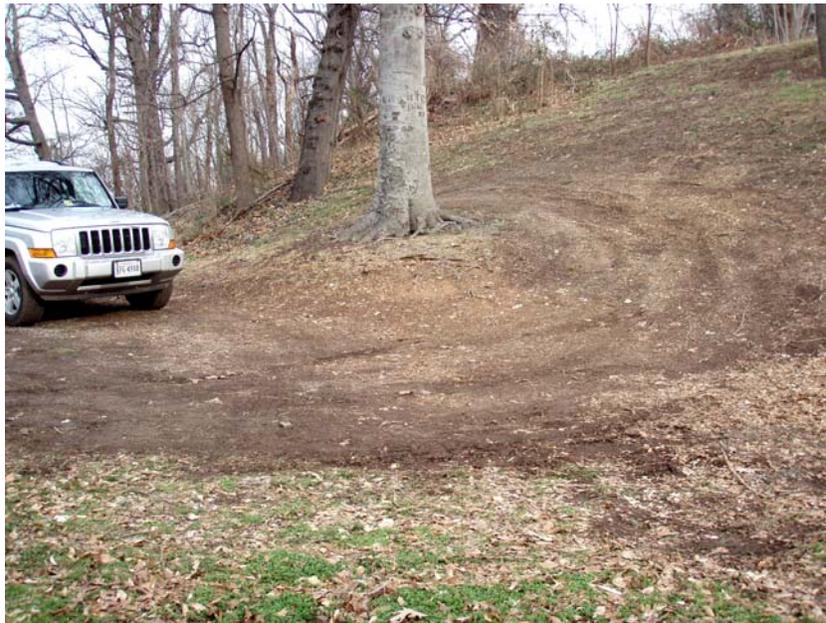
Figure 28. Erosion and compaction around the beech tree is being caused by inappropriate driving – circling around the tree on the slope to exit the cemetery.

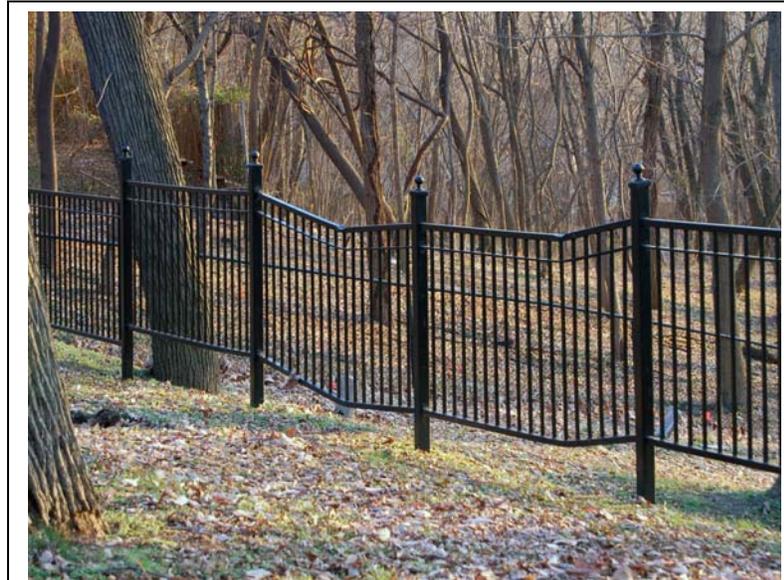
Figure 29. Damage to the modern iron fence along the front cemetery boundary.

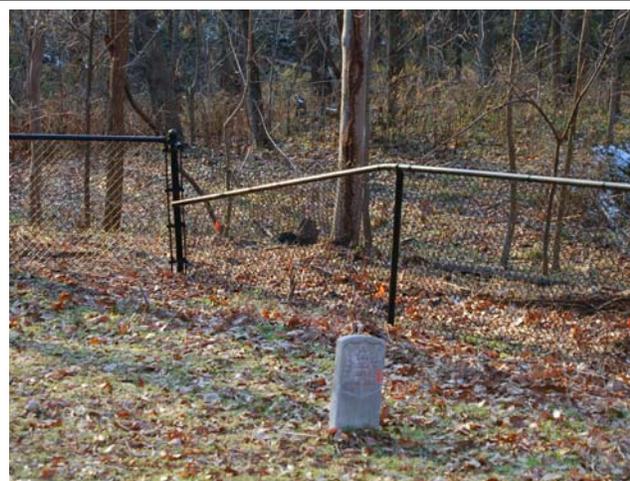
Figure 30. Damage to the chain link fence at the cemetery.

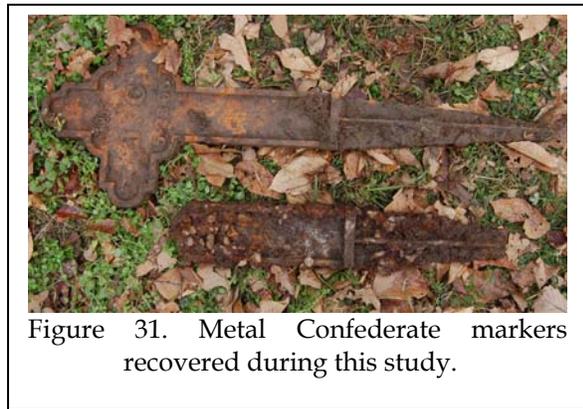
The only historic ironwork present at the cemetery were the metal crosses used to mark the Confederate graves. These likely pre-dated 1906 (at which time Congress authorized stones for Confederate dead). All have been lost from the cemetery, although one nearly intact cross (and another small fragment) was identified outside the boundaries of the

Figure 31. Metal Confederate markers recovered during this study.

- ❖ Finally, we recommend that the iron Confederate crosses, apparently placed on graves prior to the federal government allowing use of military stones at public expense, should be recast, using the one recovered as a model. These should be reinstalled in the cemetery, while the original is conserved and stored in a suitable repository, such as the Smithsonian Institution. A sum of \$5,000 is allotted to this task.

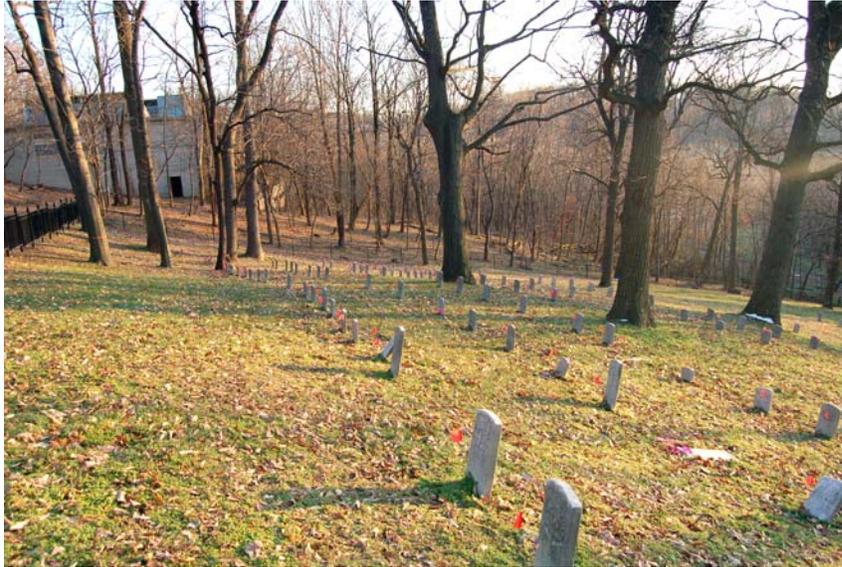
Figure 32. Overview of the cemetery showing trees in need of pruning .

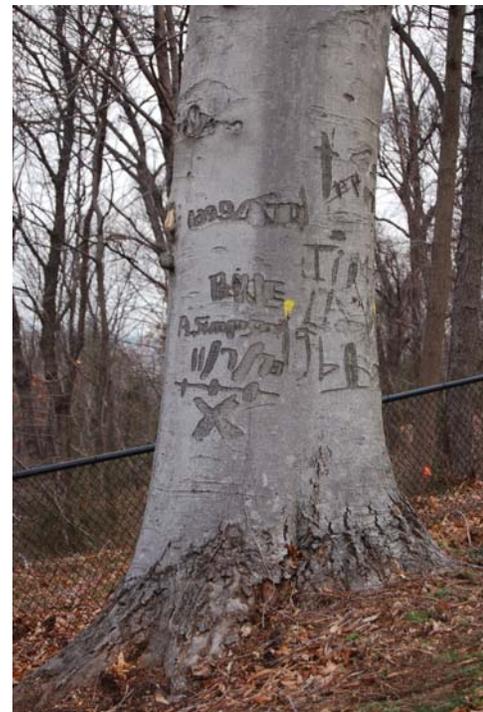
Figure 33. American beech with graffiti carved into bark showing a date of 1899.

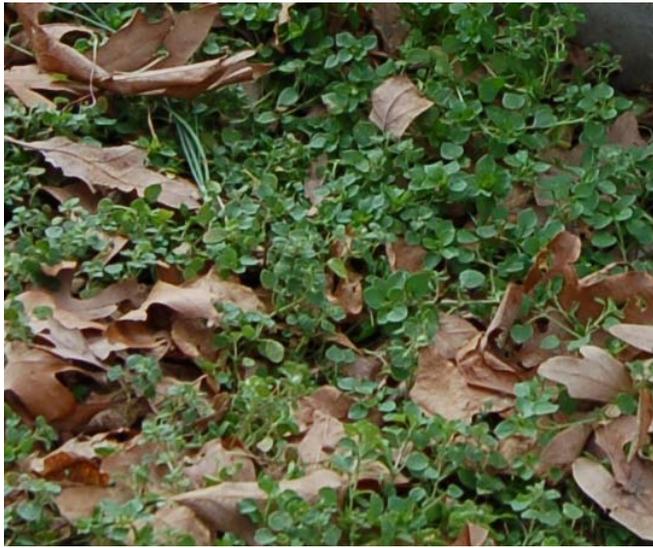
Figure 34. Example of dense weed mat and absence of turf grass in the cemetery.

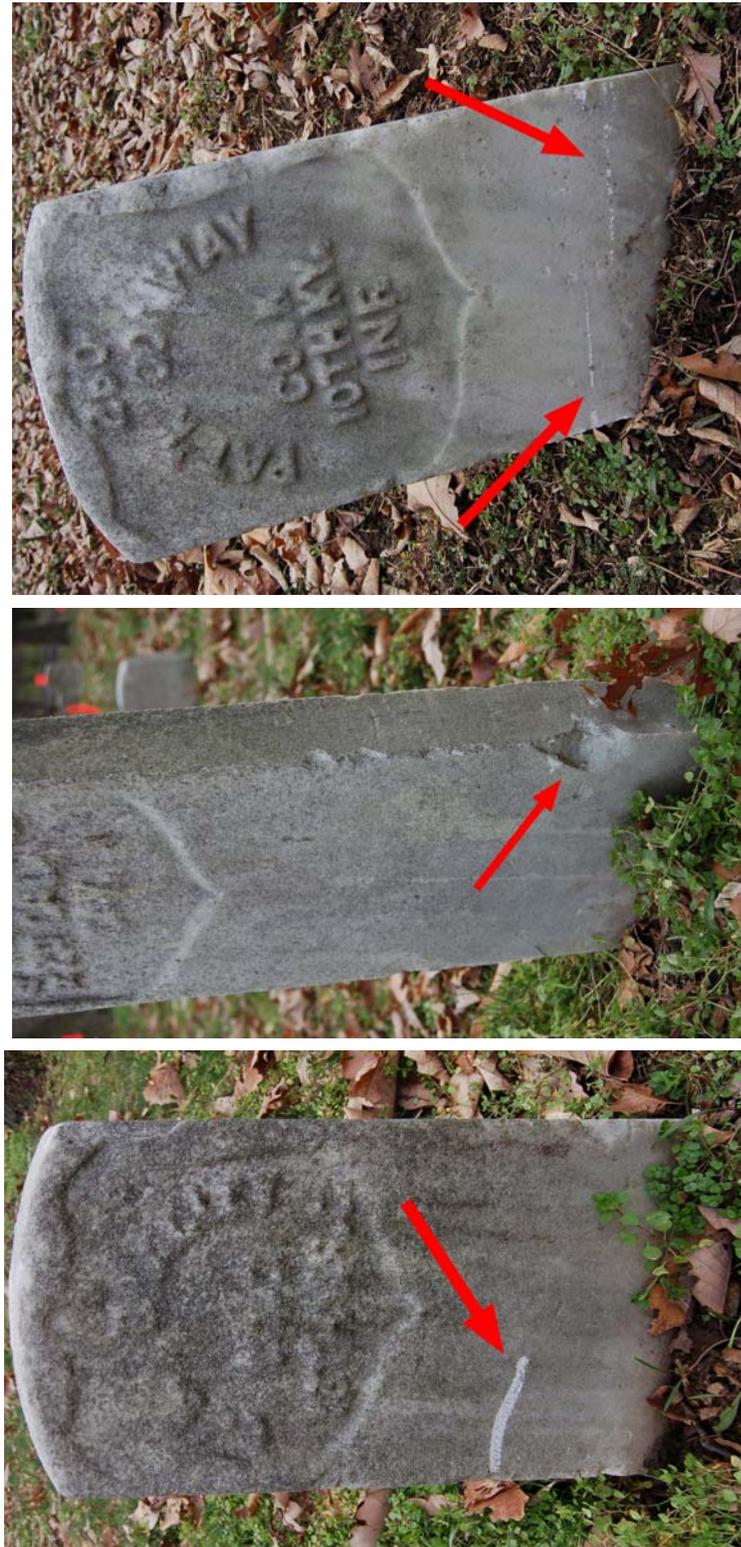
Figure 35. Examples of damage caused by mowers in the cemetery.

In general, large riding mowers are not recommended for cemetery settings - they are more difficult to control and tend to cause considerable damage in tight quarters. With the arrangement of the West Campus cemetery, however, their use may be acceptable, but only with very careful attention and only between the rows. All such equipment must remain 12-18

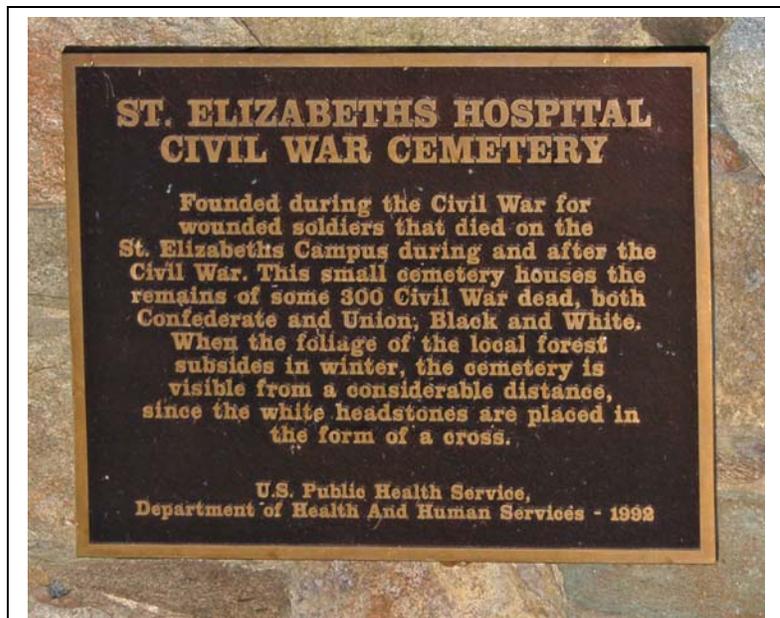
Figure 37. This is the only informational signage at the West Campus Cemetery. It fails to make any mention of the grave yard’s original function or of the civilian patients buried there. It also perpetuates the myth of the “white cross.” It should be immediately replaced.

- ❖ We also recommend the removal of the existing cemetery sign on the stone wall. The name “Civil War Cemetery” is inappropriate since the cemetery was initially intended for the use of patients – and by all accounts continued serving that function throughout its history. The existing sign as perpetuates the myth of the white cross – created late in the cemetery’s history and having no basis in reality. The cost of removal is estimated to be \$200.

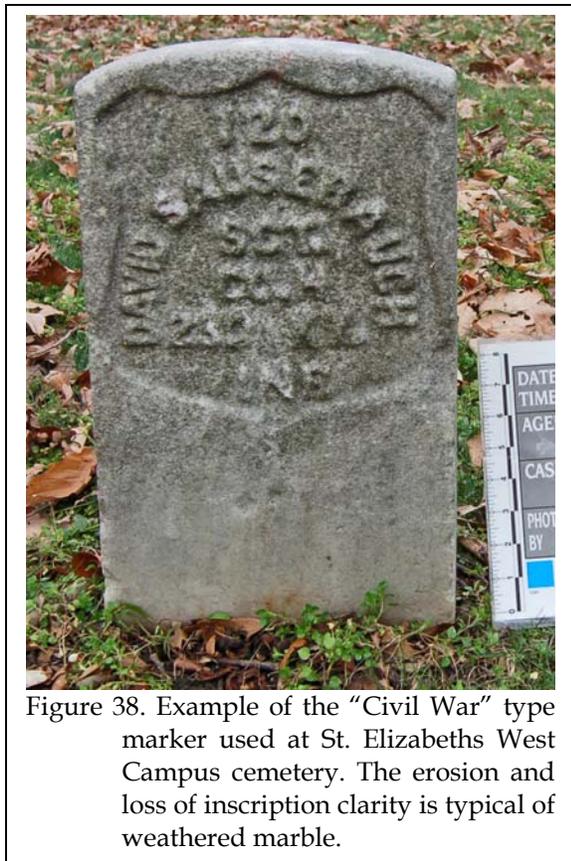
Figure 38. Example of the "Civil War" type marker used at St. Elizabeths West Campus cemetery. The erosion and loss of inscription clarity is typical of weathered marble.

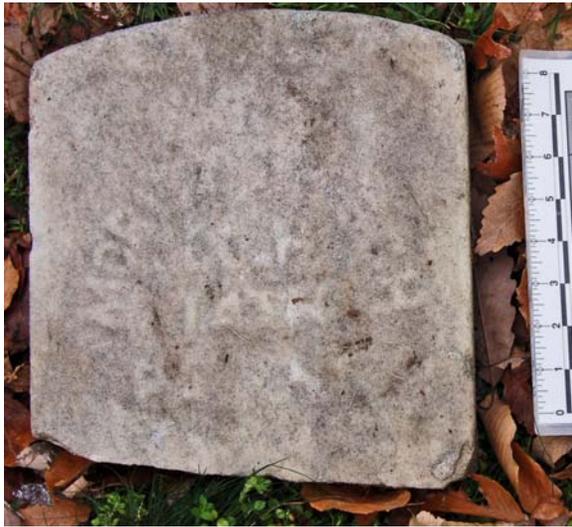
Figure 39. Example of a West Campus marker that is sugaring. Cleaning will require special care to prevent additional loss.

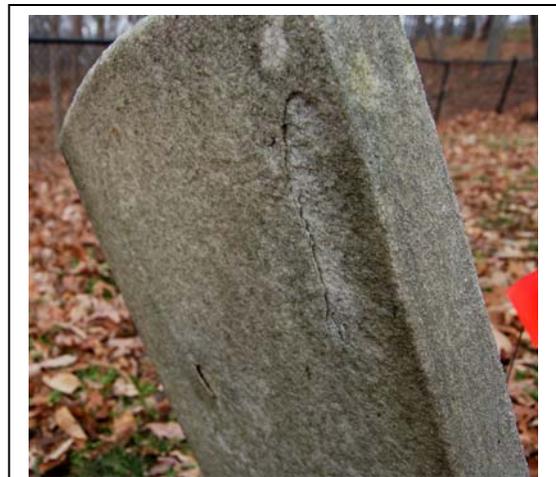
Figure 40. Example of spalling marble.

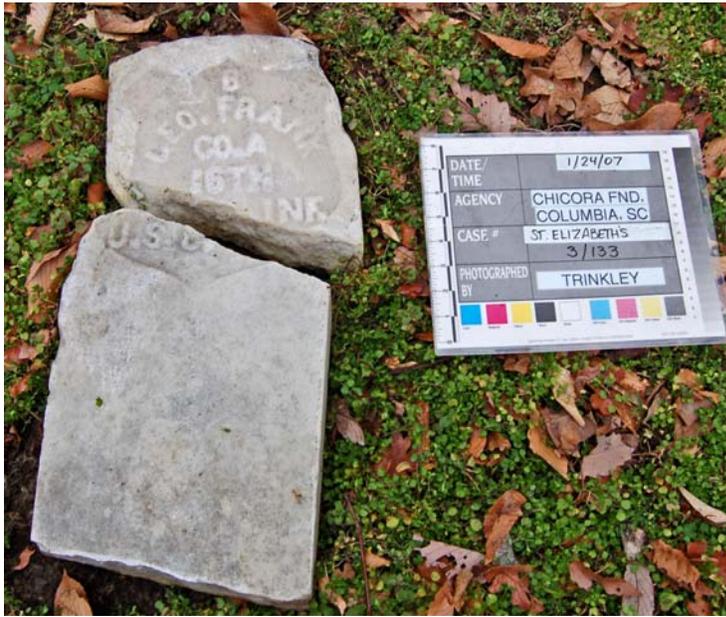
Figure 41. Example of a marker that can be repaired using standard conservation practices. Its repair will allow the original fabric to remain in the cemetery.

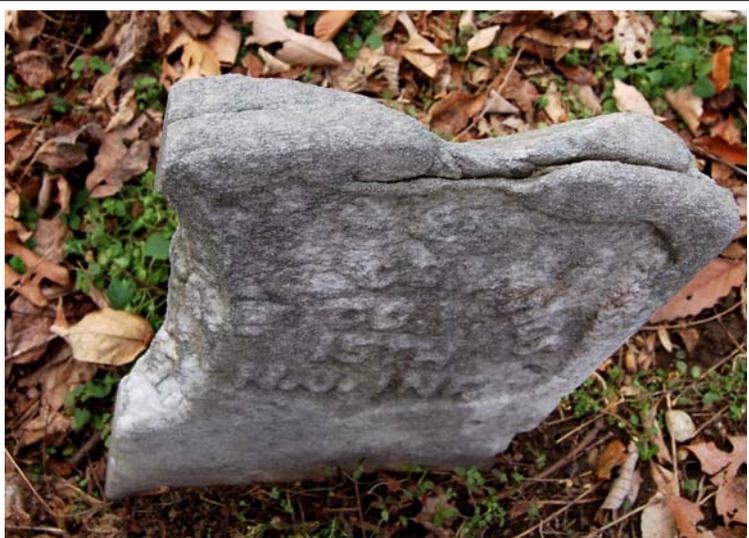
Figure 42. Example of a significant crack in a West Campus marker, as well as impact loss on the left side and abrasion at the top.

Marble (as well as other stones) may evidence cracks (sometimes along bedding planes). The use of injection grout can infill these fine cracks, preventing water penetration. Many grouts also have a cementitious quality, helping to prevent additional spalling or delamination. Grouts may include Jahn M30 for cracks up to 3/16-inch or Jahn M40 for cracks from 3/16 to 9/16-inch.

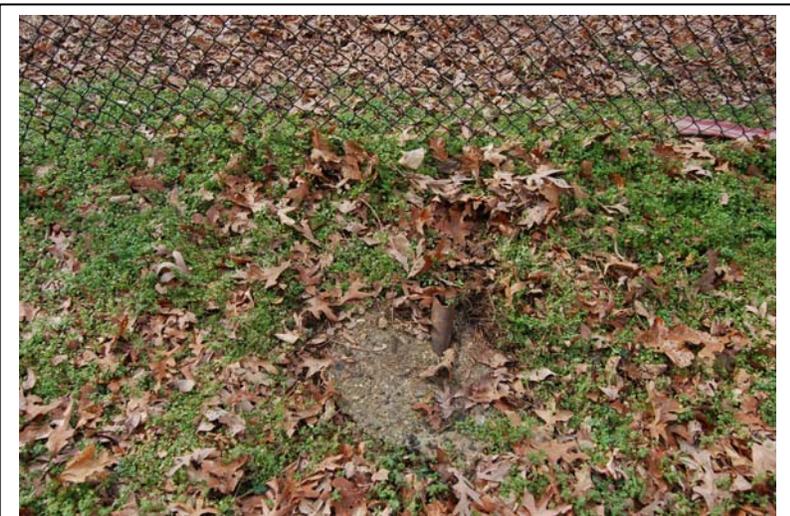
Figure 43. Old fence post several feet beyond the existing fence and representing a decrease in the cemetery boundaries.
