**MANAGEMENT SUMMARY OF DATA RECOVERY
EXCAVATIONS AT 38CH2091,
A ST. PAUL PARISH PLANTATION,
CHARLESTON COUNTY, SOUTH CAROLINA**

CHICORA RESEARCH CONTRIBUTION 491

Prepared By:
Michael Trinkley, Ph.D., RPA,

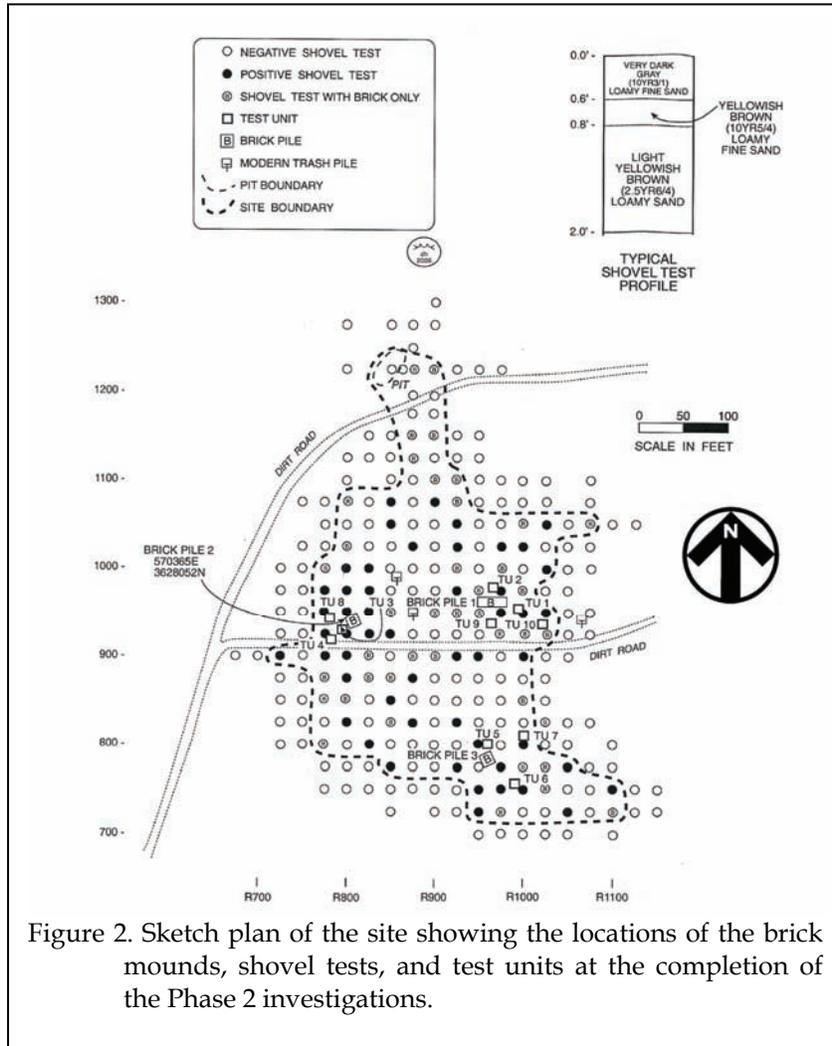
Figure 2. Sketch plan of the site showing the locations of the brick mounds, shovel tests, and test units at the completion of the Phase 2 investigations.

A mean ceramic date (MCD) calculated from the test units at each of the three brick piles, revealed that brick piles 1 and 2 were generally contemporary, with brick pile 1 having a MCD of 1786 and brick pile 2 having a MCD of 1798.6. Brick pile 3, however, exhibited a MCD of 1821.5. Taken together, the MCD for the site (using all artifacts from shovel testing and test units) was found to 1797.3 (Southerland and Trinkley 2006).

Brick pile 1 was the largest scatter, extending almost 30 feet. No intact brick was found and three of the four test units (TU 1, TU 2, and TU 9) produced a layer of very dark grayish brown (10YR3/2) sand,

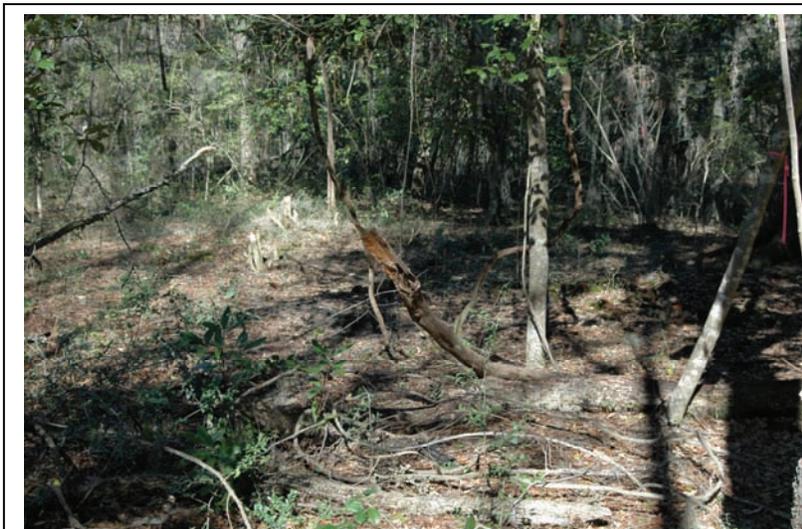
Figure 3. Area of brick pile 1, looking north.

representing a burn layer. Burned artifacts and melted glass were recovered from several of the test units.

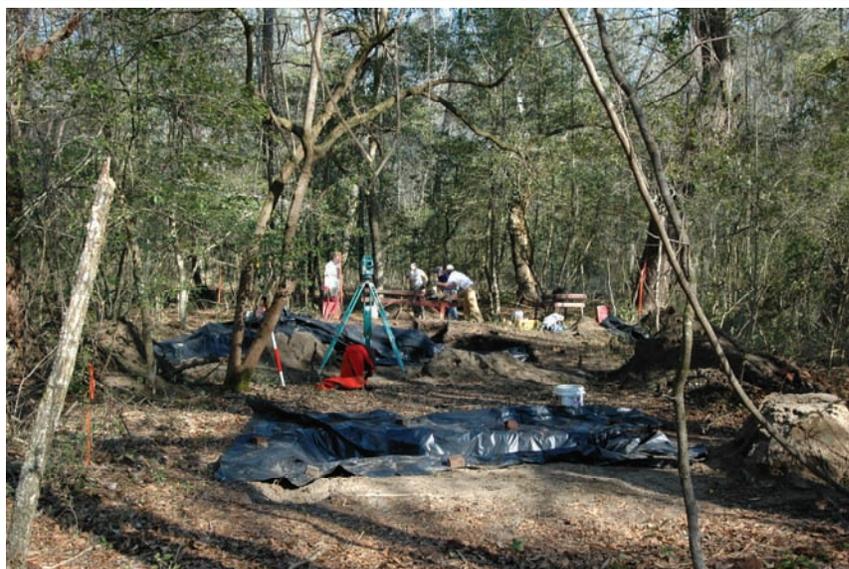
Figure 4. Brick pile 2, excavations in progress, looking north.

Brick pile 2, to the west, appeared smaller, with the brick more scattered. Subsequent examinations (with the area cleared

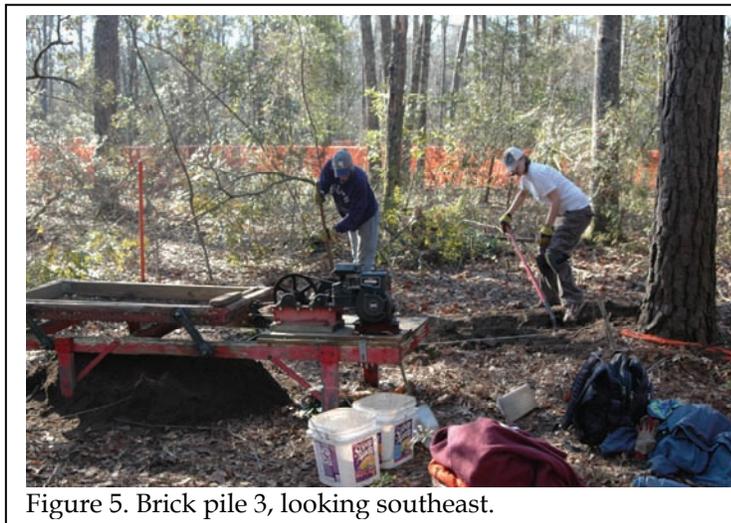
Figure 5. Brick pile 3, looking southeast.

Brick pile 3 was a small (and low density) brick scatter compared to the first two loci. In addition, artifacts were less abundant with three test units (TU 5, TU 6, and TU 7) producing less than 20 specimens each.

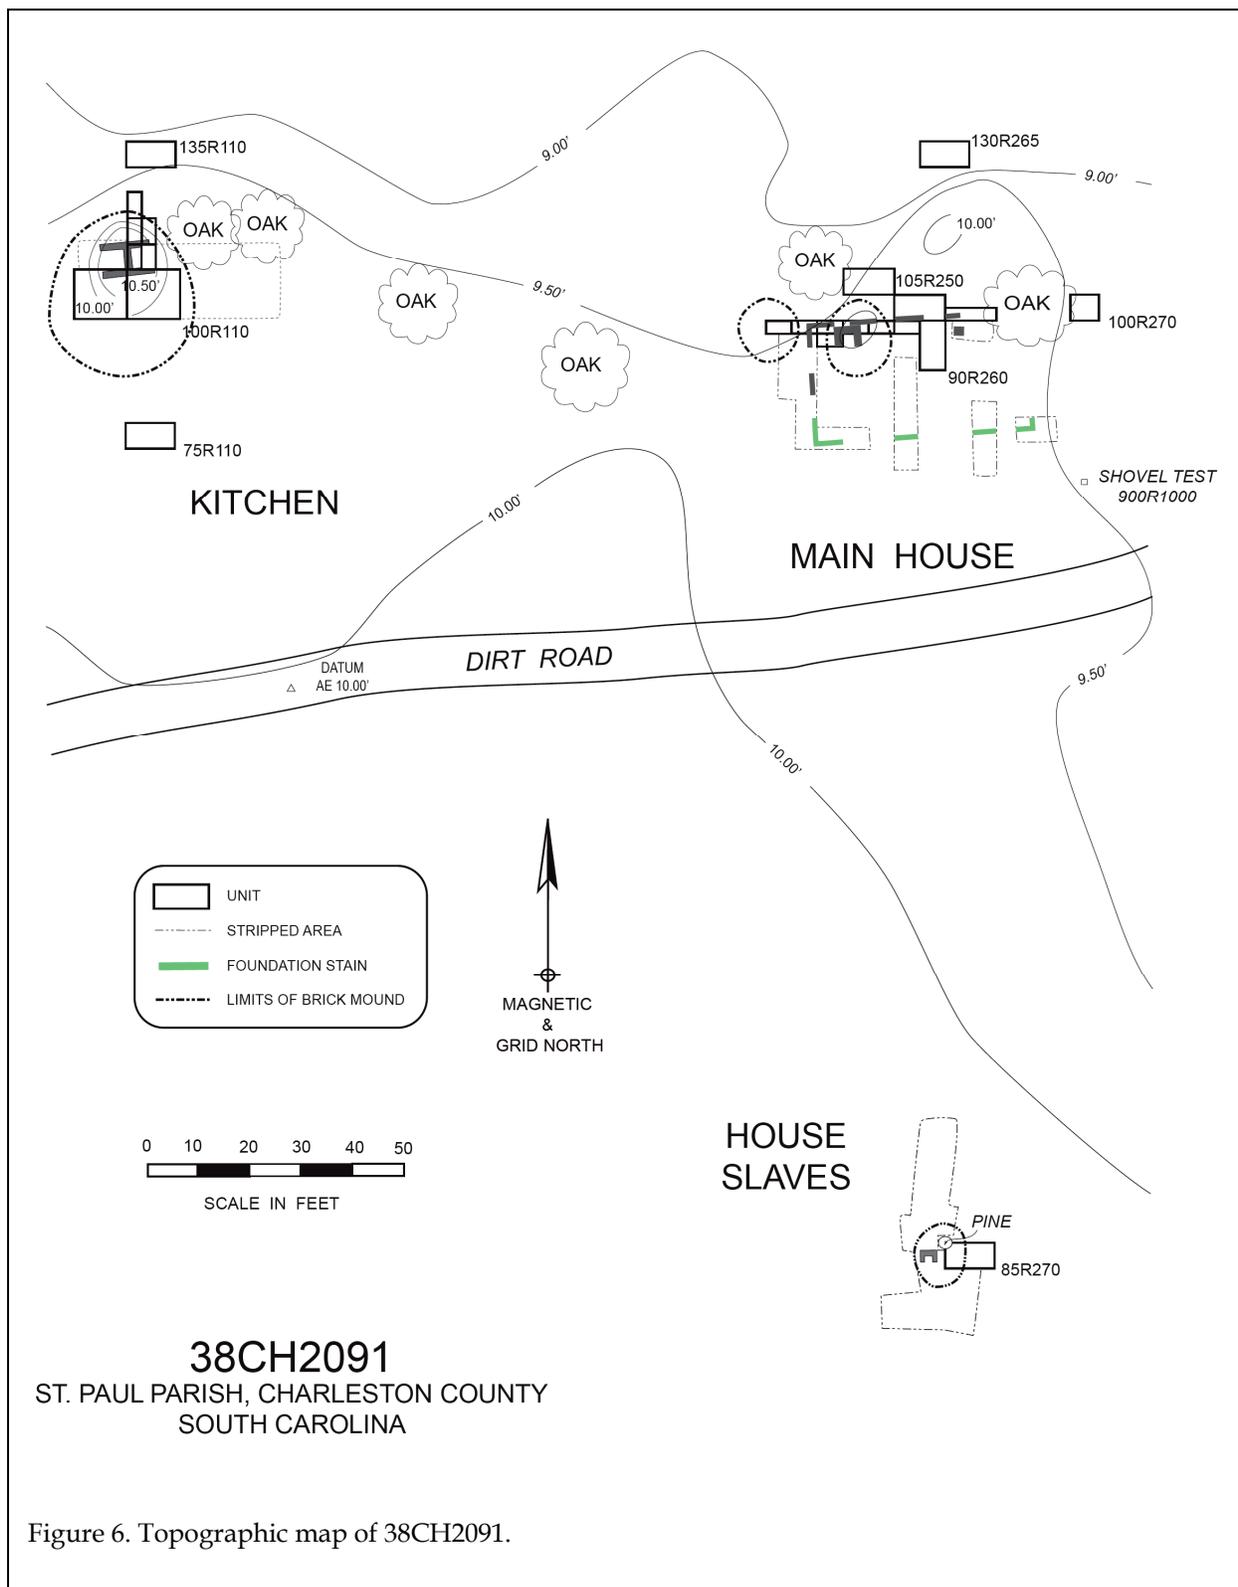
Figure 6. Topographic map of 38CH2091.

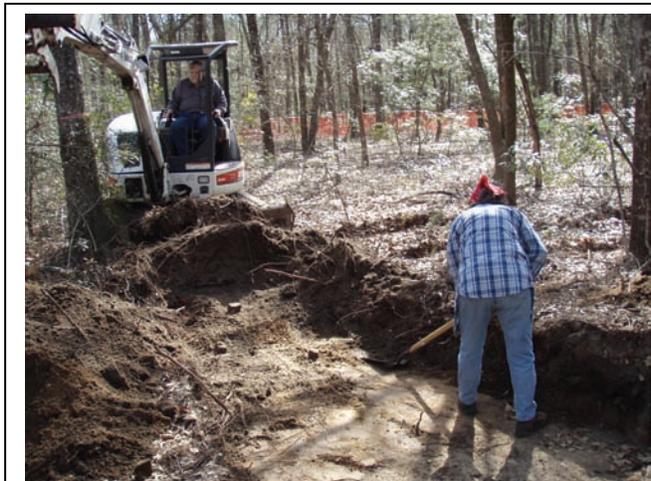
Figure 7. Stripping using a Bobcat and a toothless bucket followed by flat shoveling.

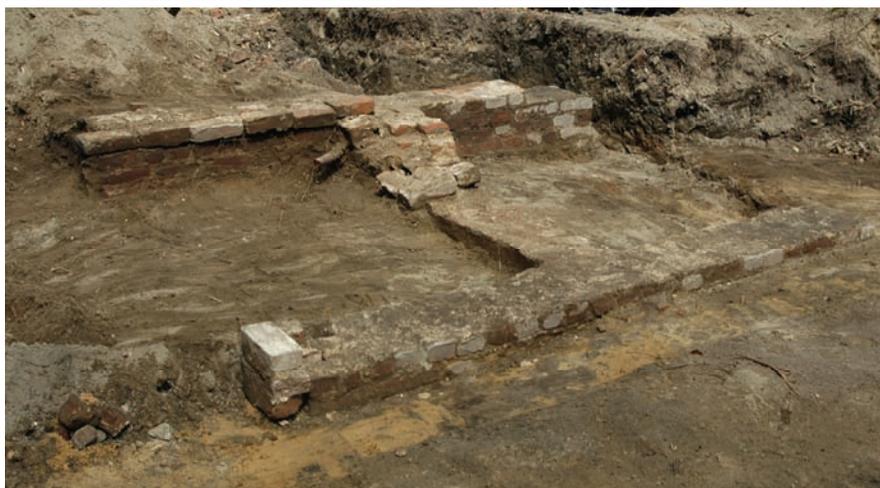
Figure 8. Chimney exposed in the western brick mound, view to the northeast.

These units immediately produced a brick wall oriented just off east-west that measured about 9 feet in length and was a double wythe of brick (about 1.1-1.2 feet). The stratigraphy evidenced two distinct zones. The upper, about 0.7 foot in depth, consisted of a black (7.5YY2.5/1) loamy sand with dense rubble. Below was a dark brown (7.5YR3/3) loamy sand with little or no rubble. Zone 1 represents building collapse or demolition, while Zone 2 likely represents original A horizon soils and sheet midden built up around the structure. Zone 2 graded into a brownish yellow (10YR6/6) sand that was frequently heavily mottled. This represents the subsoil at the site.

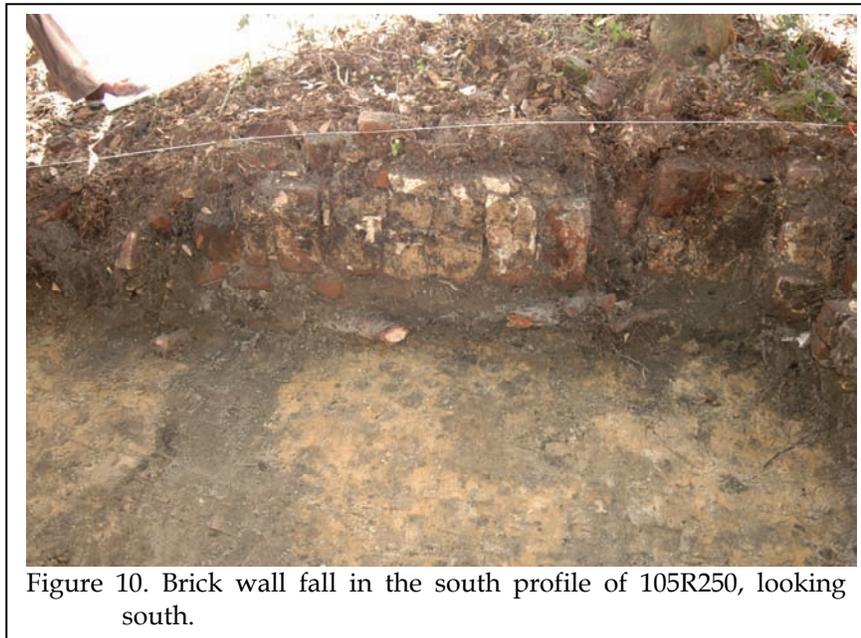
Figure 10. Brick wall fall in the south profile of 105R250, looking south.

produced far fewer artifacts. Stratigraphy was simple, consisting of very dark brown (7.5YR2.5/3) loamy sand and dense brick rubble overlying a mottled brownish yellow (10YR6/6) subsoil sand.

the wall fall was most likely associated with a nearby chimney.

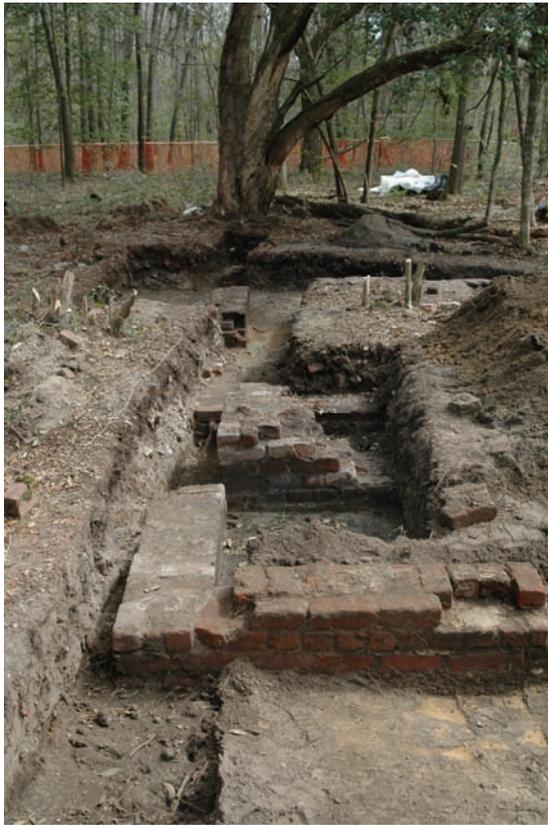
Figure 11. North wall of the eastern structure exposed by excavations and stripping. View to the east.

absent a corner, we began laying in units chasing the one wall identified. These included 2.5x10 foot units 97.5R255, 95R245, 97.5R245, and 97.5R235 to the west, and 100R270 to the east. This work identified a series of three piers, each of a different length and a corner (in 97.5R235). The matching northeast corner, however, could not be located and we felt it was likely destroyed by several very large live oaks.

Stripping was necessary to completely expose the structure. The western wall pier was found intact, piers for the southwest and southeast corners, as well as the south wall, were evidenced only by remnant stains. It appears that the piers in these areas had been robbed out. This robbing episode appears to correlate with differences in soil texture - indicating that the area south of about N80 line has been cultivated in the past. It is likely that the main house rubble was left largely intact at the edge of an agricultural field, representing too much effort to clear the debris.

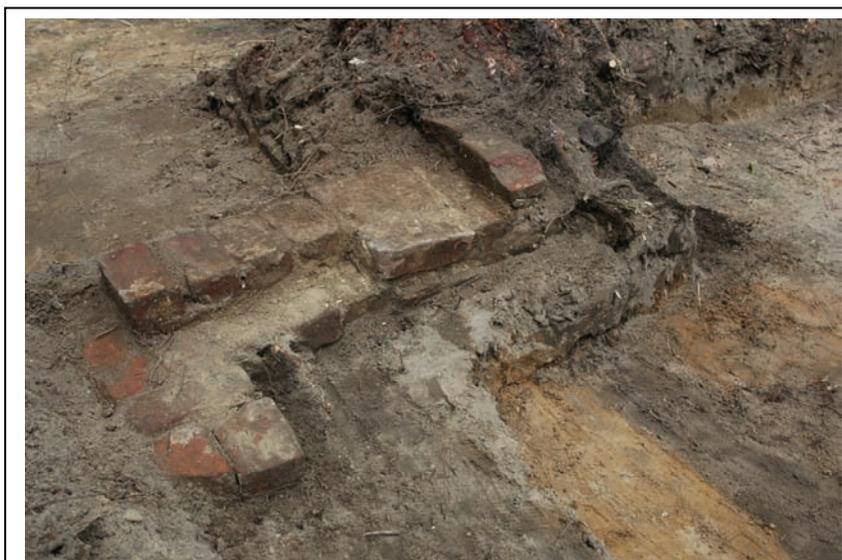
Figure 12. Brick fire box in the southern brick mound exposed by stripping. Unit -85R270 is situated to the upper right. The east (right) arm of the fire box was no longer in situ because of tree roots. View to the northeast.

Stripping in this area, however, revealed that our excavation missed a brick fire box to the east by only a foot (it was situated just beyond the pine). The fire box, measuring 3.2 by 2.2 feet, is centered in the mound which represents fall associated with the structure. We were unable to identify any surrounding piers – probably because this site area has been previously cultivated.

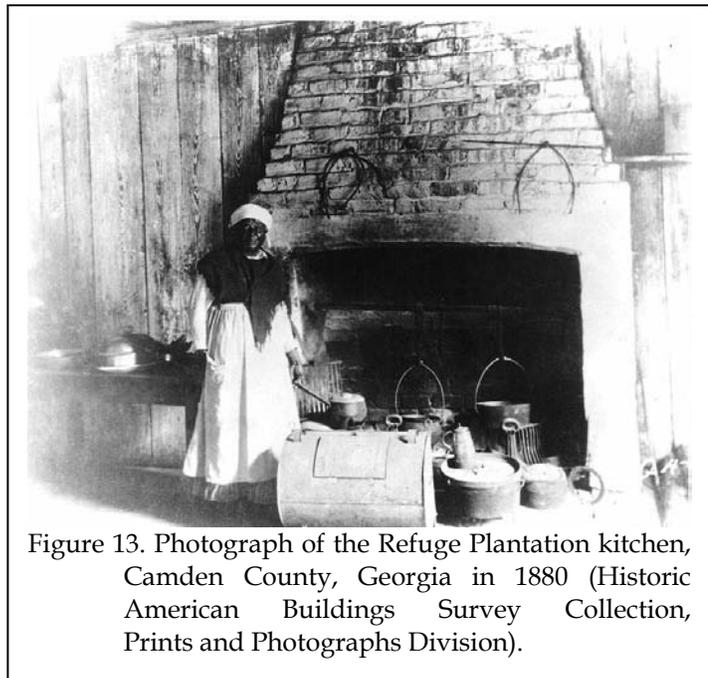
Figure 13. Photograph of the Refuge Plantation kitchen, Camden County, Georgia in 1880 (Historic American Buildings Survey Collection, Prints and Photographs Division).

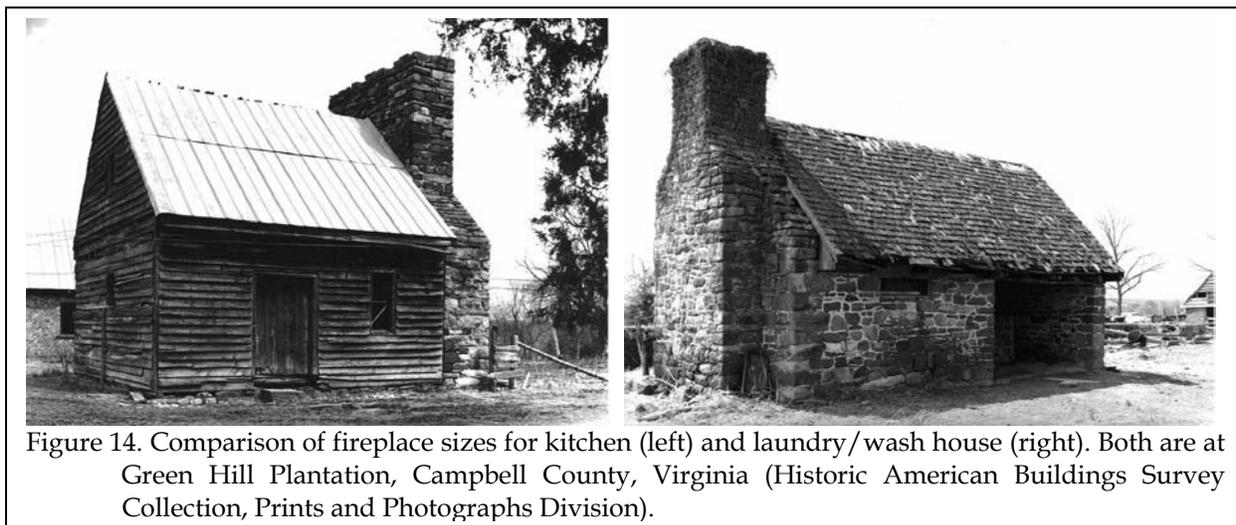
Figure 14. Comparison of fireplace sizes for kitchen (left) and laundry/wash house (right). Both are at Green Hill Plantation, Campbell County, Virginia (Historic American Buildings Survey Collection, Prints and Photographs Division).
