**CHICORA RESEARCH CONTRIBUTION 535**

# **ANALYSIS OF REMAINS FROM MOUT OLIVE CEMETERY, PORTSMOUTH, VIRGINIA**

Prepared By:  
Debi Hacker  
and  
Michael Trinkley, Ph.D., RPA

December 29, 2010

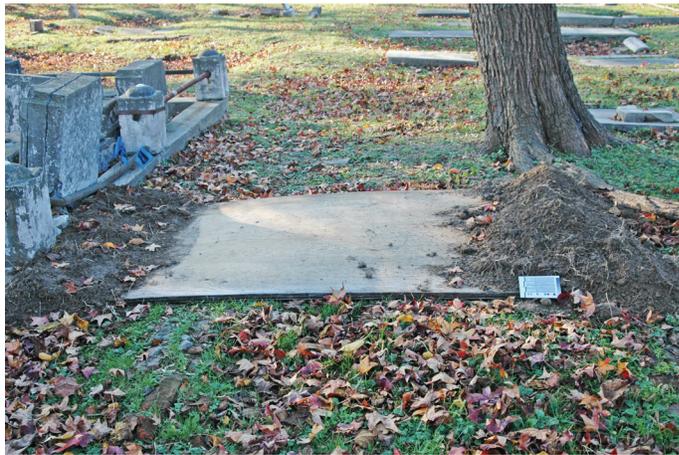
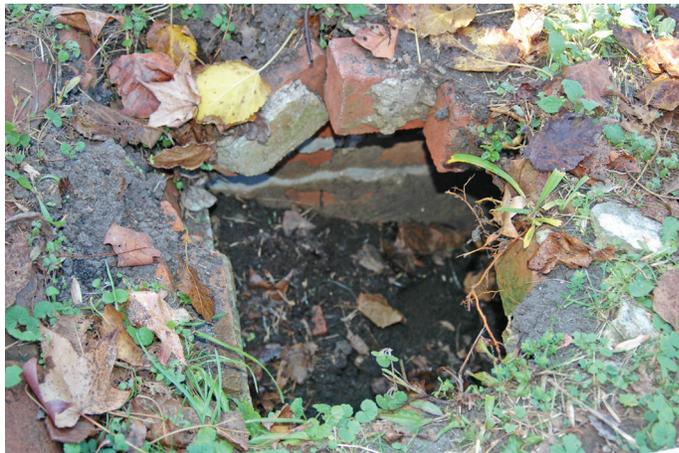
The grave was below ground, in a brick vault with a slightly arched top. The east, or foot of the grave, closest to the coping of an adjacent Mingo family plot, had caved in, exposing the interior.

The grave vault is oriented east-west, and is constructed of brick laid with a cementitious mortar. It measures 30" wide, 72" long, and 24" in height on the east and west walls, with the arch being 26" high. The sides of the vault were originally stuccoed with

Figure 3. Area of vault prior to work. The top photograph shows the plywood covering placed by the City. The bottom photograph shows the collapsed portion of the vault looking east.

Damage is almost certainly the result of several factors. While vaulted, none of the arches observed have any significant mass of masonry on the sides in order to absorb the lateral thrust created by the arches. They are therefore inherently

unstable. Some vaults did not use an arch, but were covered by flat constructions, some of brick (probably originally supported by now decayed wood, perhaps even the shipping container for the casket) or concrete. The very wet conditions in the cemetery are a contributing factor, degrading the mortar and weakening construction. The most significant factor may be the operation of riding mowers in the cemetery. These mowers weight 500 to 800 pounds and use on the vaults is problematical.

With the remains replaced in a vault, it is possible to secure the burial site. This should be accomplished in a manner that is consistent with the Secretary of Interior’s Standards for Preservation. In other words, the vault top should be repaired or replaced – the grave should not simply be filled in with soil.

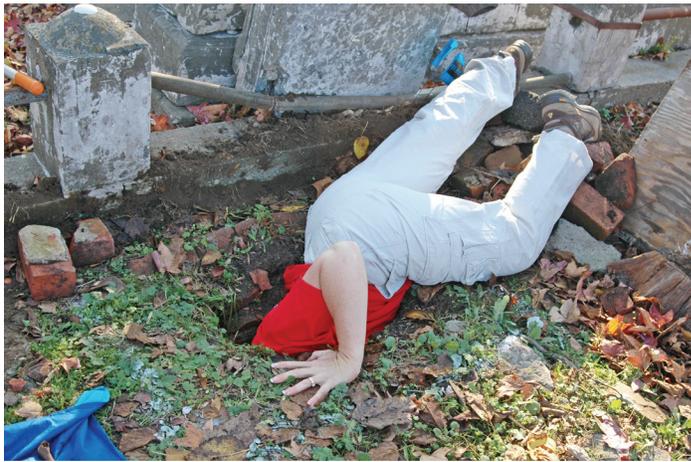
the group was to not remove any of the intact brick from the collapsed area, so the entrance to the grave remained about 18" by 20".

Figure 4. Recovery efforts were hampered by the small opening size. The decision not to expand the opening was made to minimize damage to the vault.

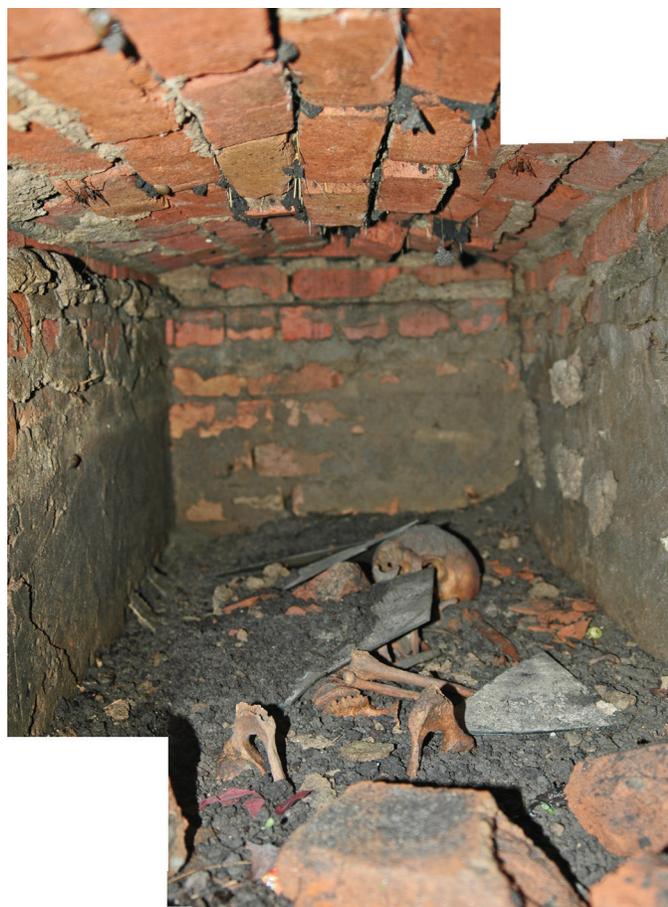
Inside the collapsed vault opening were brick and concrete fragments, tree debris and leaf litter. These were removed and set aside so that the interior of the grave could be viewed. Inside, the grave vault appeared to be in good condition, with the skull, innominate and left long bones visible, as well as coffin hardware and a fragment of viewing glass lying across the skull and ribs. The skull was located at the west end of the grave, resting on its left side. The consensus of

The skeletal remains appeared largely undisturbed, with the skull located near the north end of the grave, and the legs near the south end. The left radius and ulna were positioned across the midsection. Fragments of coffin viewing glass lay across the skull and upper torso region. One coffin handle was located in the southeast area of the vault. No coffin wood was identified.

Figure 5. Interior of the vault, looking west.

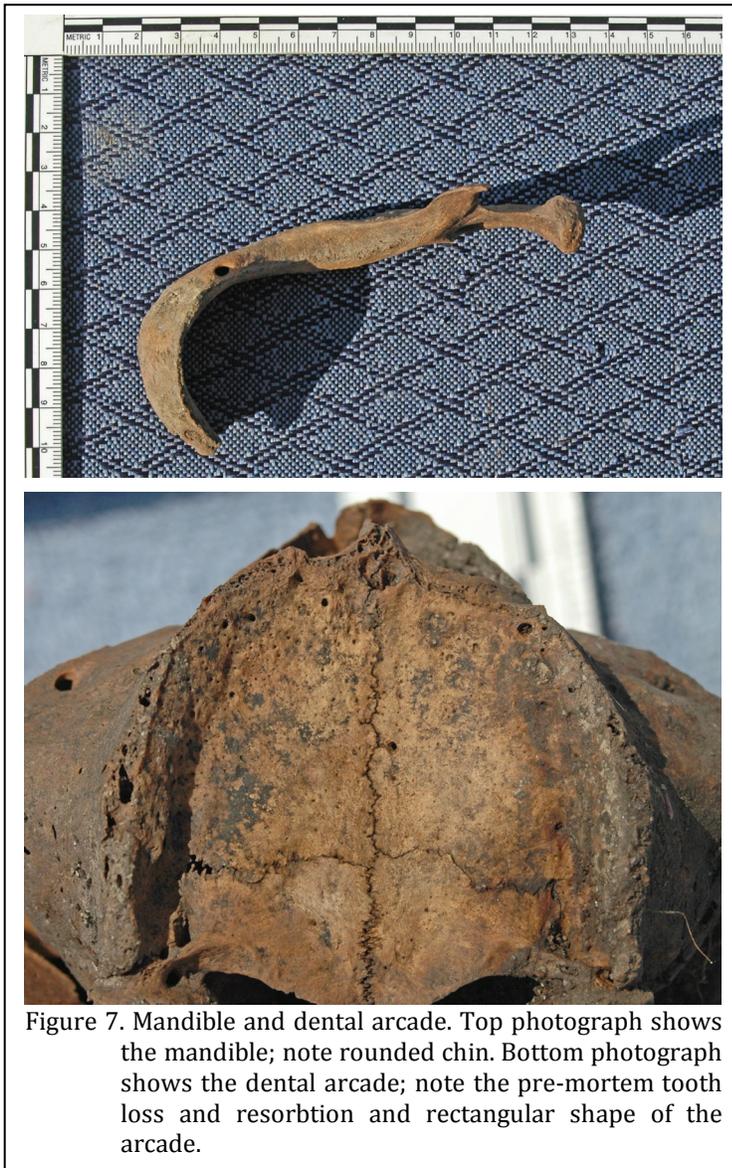
Figure 7. Mandible and dental arcade. Top photograph shows the mandible; note rounded chin. Bottom photograph shows the dental arcade; note the pre-mortem tooth loss and resorbtion and rectangular shape of the arcade.

The face was a medium width, with rectangular orbit shape, a projecting maxilla alveolar, wide interorbital distance, and wide nasal bridge and aperture. Although all teeth were missing pre-mortem, the dental arcade was rectangular, and the chin shape was rounded. Based on these morphological attributes, the person appears to be of African descent.

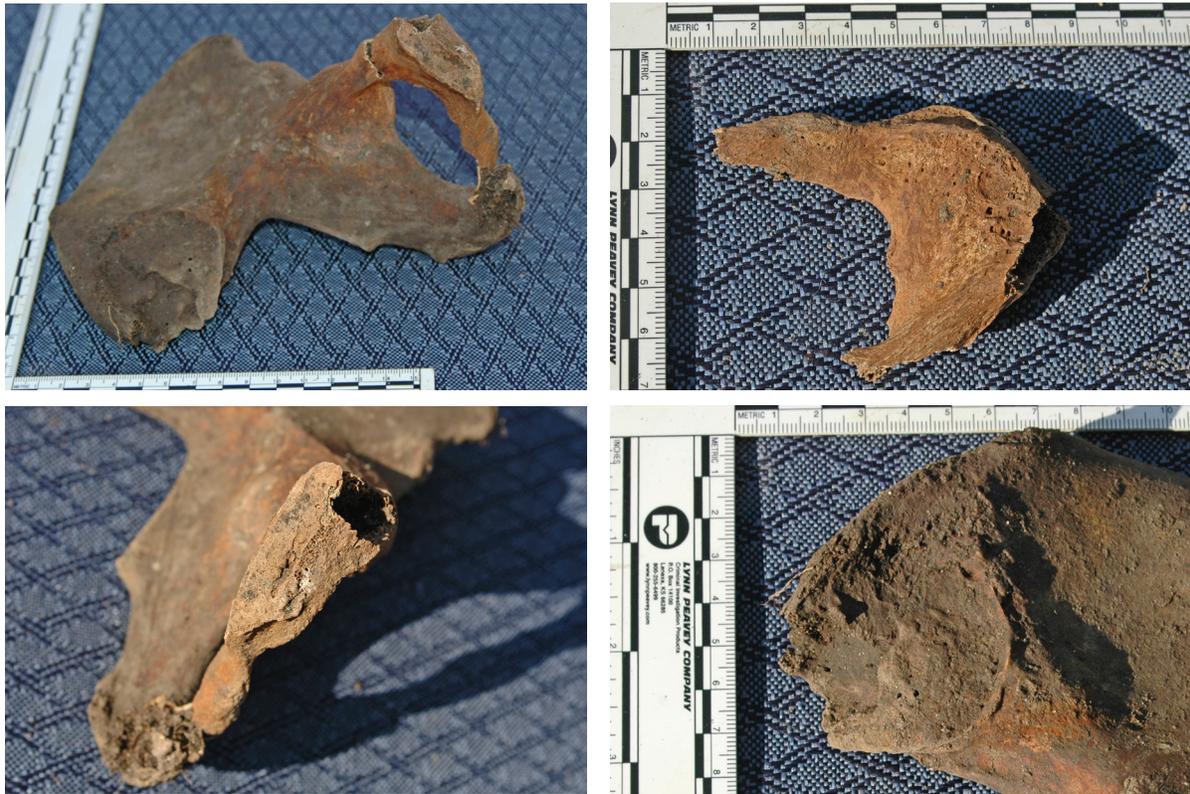
Figure 8. Left innominate. Upper left is a sagittal view; note the wide greater sciatic notch, preauricular sulcus, and sharp medial aspect of the ischiopubic ramus. Upper right is a lateral view of the left pubis (broken post-mortem); note subpubic concavity and pronounced ventral arc. Lower left is the public symphysis; note irregular, pitted face and eroded rim. Lower right is a view of the auricular surface.

The auricular surface of the posterior portion of the ilium was also examined for age related changes as described by Lovejoy (Ubelaker 1989: 82). Noted were a marginal breakdown at the

posterior, an irregular, dense surface, some macroporosity, and irregular lipping of margins. There was moderate retroauricular activity, but this may also be the result of osteoarthritis. Given these characteristics, the auricular surface was determined to be in Stage 7, with an age range of 50-59 years (Schwartz 2007: 240).

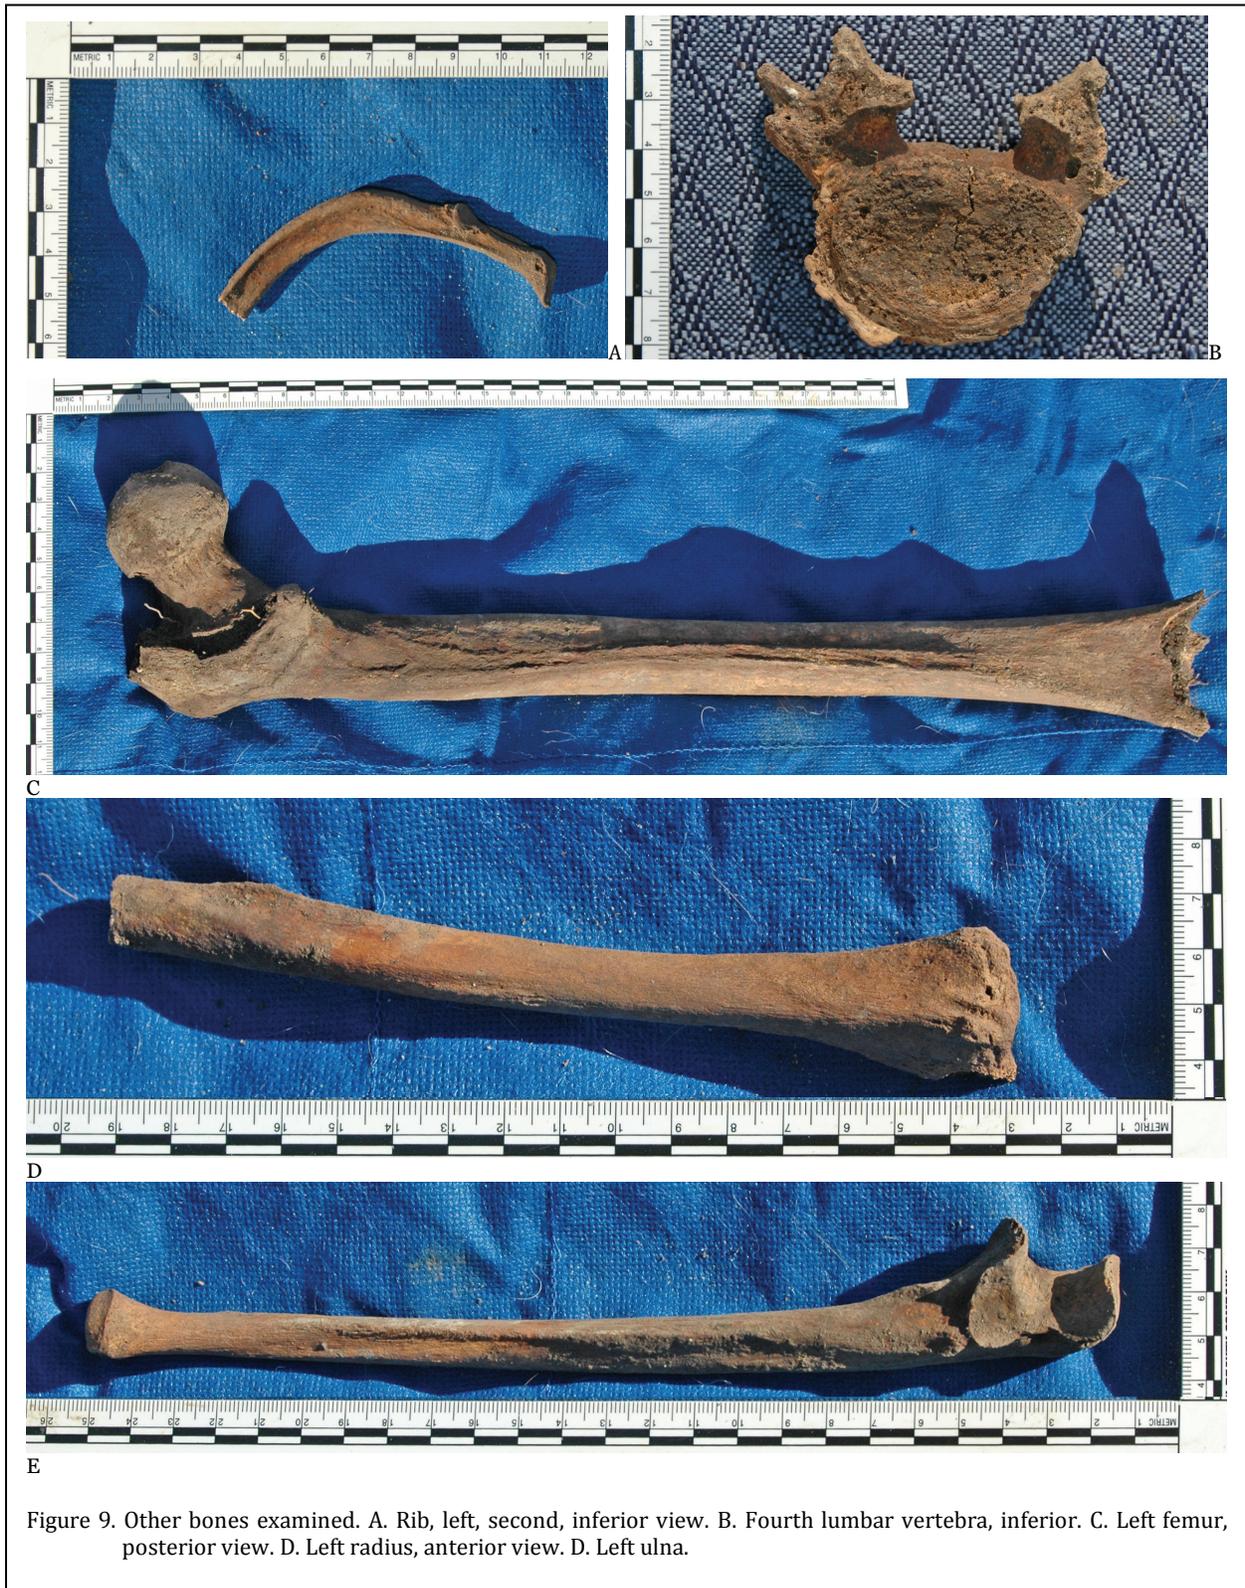
Figure 9. Other bones examined. A. Rib, left, second, inferior view. B. Fourth lumbar vertebra, inferior. C. Left femur, posterior view. D. Left radius, anterior view. D. Left ulna.

One rib was examined. It was the second left rib, and while in good condition, the sternal end was broken post-mortem, removing any possibility of using it for aging purposes, although the epiphyses for the head and tubercle are fused, indicating an age over 24 years (Bass 1995: 137). The head and tubercle are lipped, an indication of middle to old age (Mann & Hunt 2005: 112)

One vertebra was removed and examined. The fourth lumbar vertebra had broken and crumbled post-mortem; however, there was significant lipping on the anterior body, indicating

The left femur was removed in hopes that it was intact. Unfortunately, upon examination it was found to have a distal post-mortem break. The maximum length on the osteometric board was 395 mm, with an estimate of 420 mm. While there was minimal evidence of osteoarthritis, there was marked evidence of musculature on the posterior of the bone, indicating strenuous use of the gluteus maximus muscle (White 2000:233). The epiphyses were closed, indicating an age of over 18 years (Bass 1995: 227).

The left radius was also broken post-mortem, and the head was not located; the maximum length on the osteometric board was 167 mm, the estimated length was 222 mm. No evidence of disease was noted. The epiphysis present was closed, indicating an age of over 17 years (Bass 1995: 168).

The left ulna was removed complete and undamaged, possibly due to its location across the torso, and no contact with the soil. It was 245 mm in length, with osteoarthritic lipping on the head, olecranon, and coronoid process. All epiphyses are closed, indicating an age of over 18 years (Bass 1995: 174). As the only complete long bone from the burial, it was the only one used in estimating maximum stature. The Trotter & Gleser stature tables indicate that this individual may have been 156 cm (61 7/8" or 5'1 7/8"). However, since the individual appears to be over the age of 30, the maximum stature may range from 153-155 cm (60 1/4" - 61" or 5' 1/4" to 5'1").

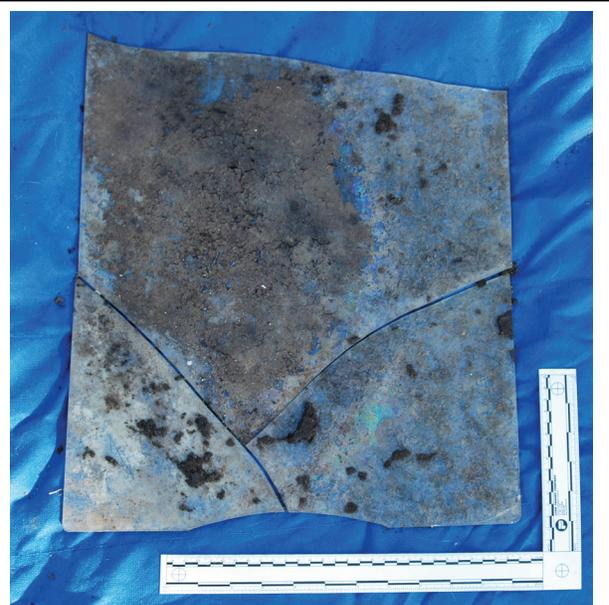
Three fragments of the viewing glass were successfully removed and reassembled on the surface, providing a measurement of 14.5" in width, greater than 17.5" in length, and a thickness of 1/16".

The size and placement of this glass indicates that the casket had glass covering the

Figure 10. Viewing glass, reassembled.

The glass associated with this casket was very uniform in appearance, exhibiting no distortions or irregularities. As previously mentioned, the glass thickness was 1/16" or 1.6mm. This is very thin (we have seen viewing plate glass twice this thickness) and it is not surprising that the plate shattered as the

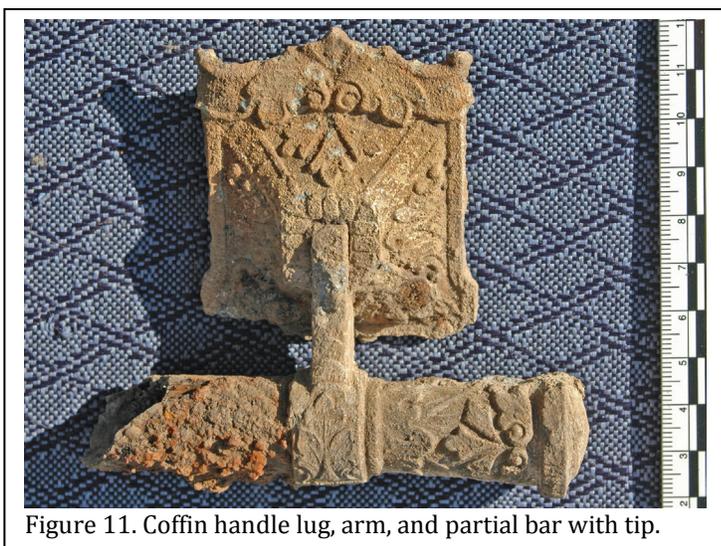
The item recovered was a portion of a short bar handle consisting of the lug, arm, a fragment of the bar, and tip. The lug is a white metal, and the bar is a plated ferrous metal over a wood core.

Figure 11. Coffin handle lug, arm, and partial bar with tip.
