PRESERVATION ASSESSMENT OF THE CLAY CEMETERY, ATLANTA, GEORGIA

Chicora Research Contribution 536

Prepared By:
Michael Trinkley, Ph.D.
and
Debi Hacker

March 11, 2011

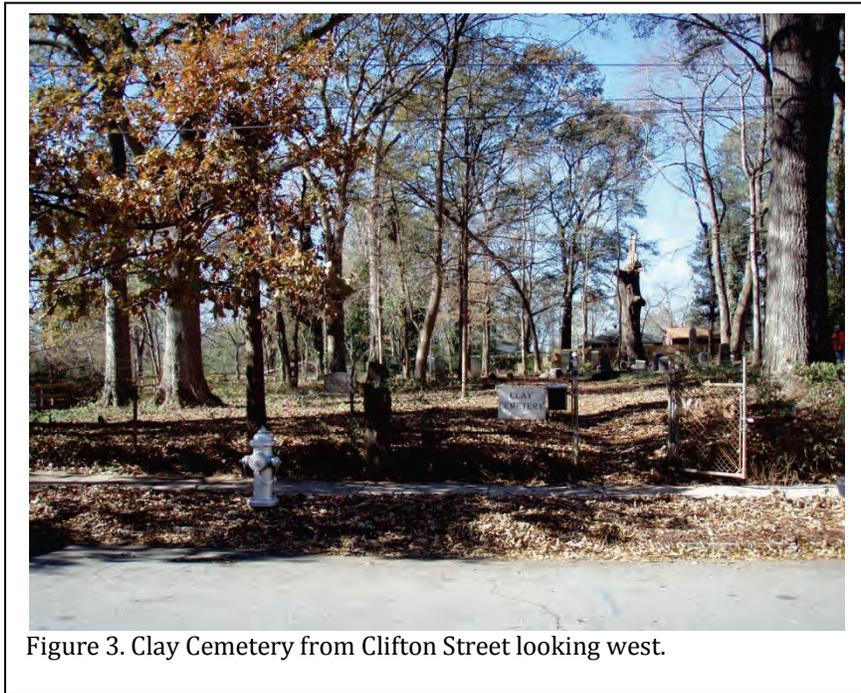
Figure 3. Clay Cemetery from Clifton Street looking west.

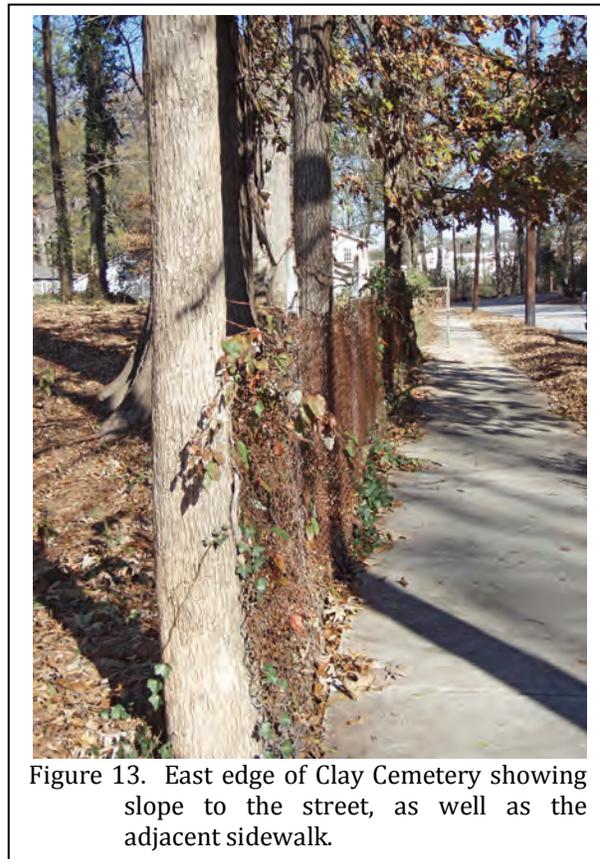
Figure 13. East edge of Clay Cemetery showing slope to the street, as well as the adjacent sidewalk.

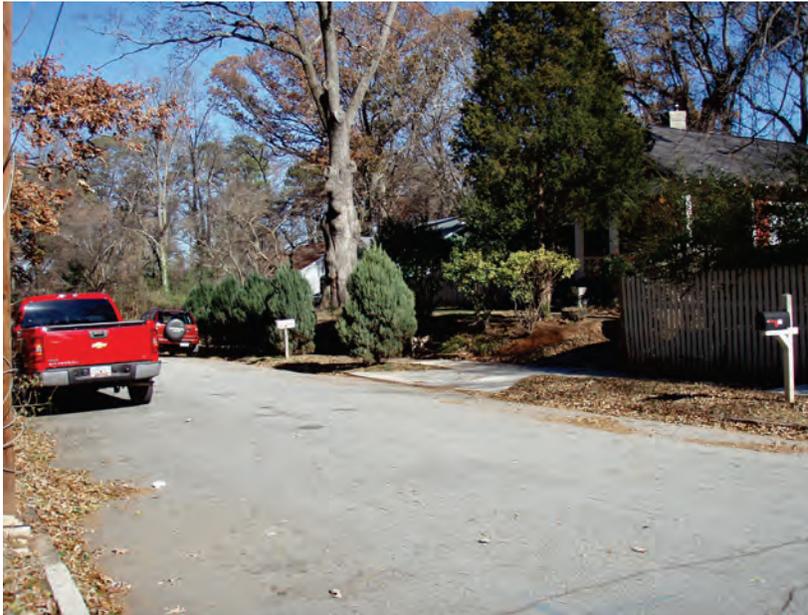
traffic lane (see Figure 14). Parking is not designated and even the curb in front of hydrants is not marked as no-parking.

Figure 14. Clifton Street immediately in front of the Clay Cemetery, looking northeast.

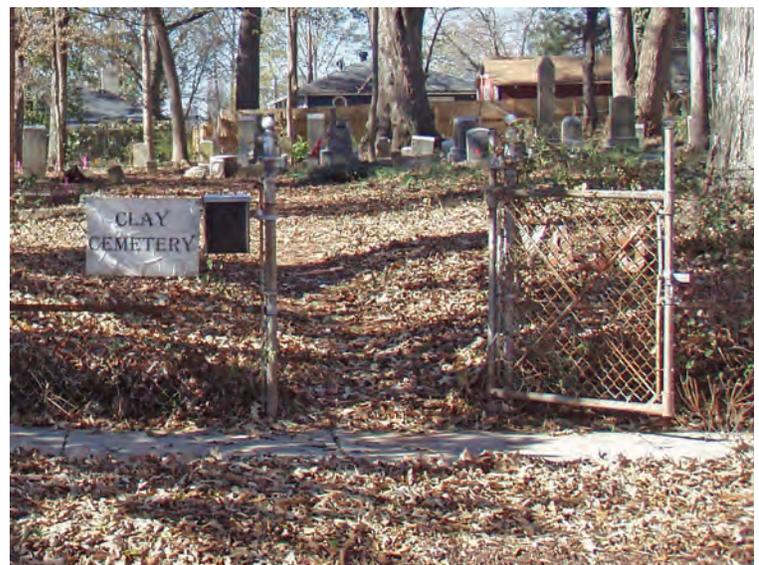
An issue of considerable concern is the slope immediately within the gate of the cemetery. For about 20 feet the slope, leaves and vegetation, and clay soils make pedestrian access treacherous (Figure 15). This area requires immediate

Figure 15. Entrance to the cemetery. The slope, leaves, and slick soil make this a dangerous entrance for many pedestrians.

improvement. These improvements may require the area be examined for the presence of graves.

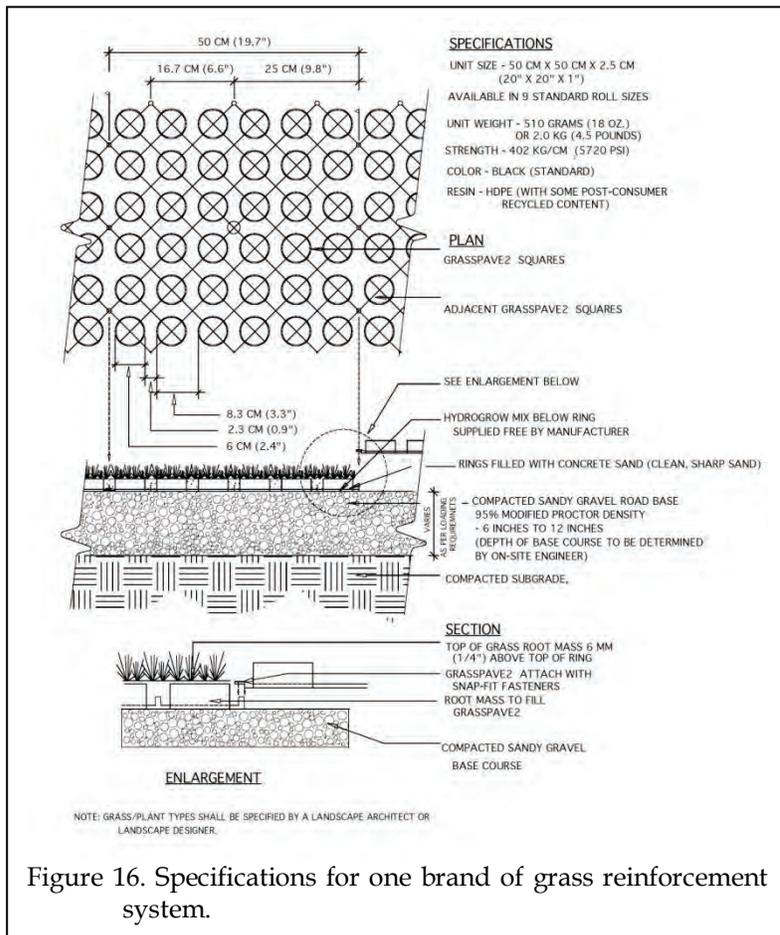
Figure 16. Specifications for one brand of grass reinforcement system.

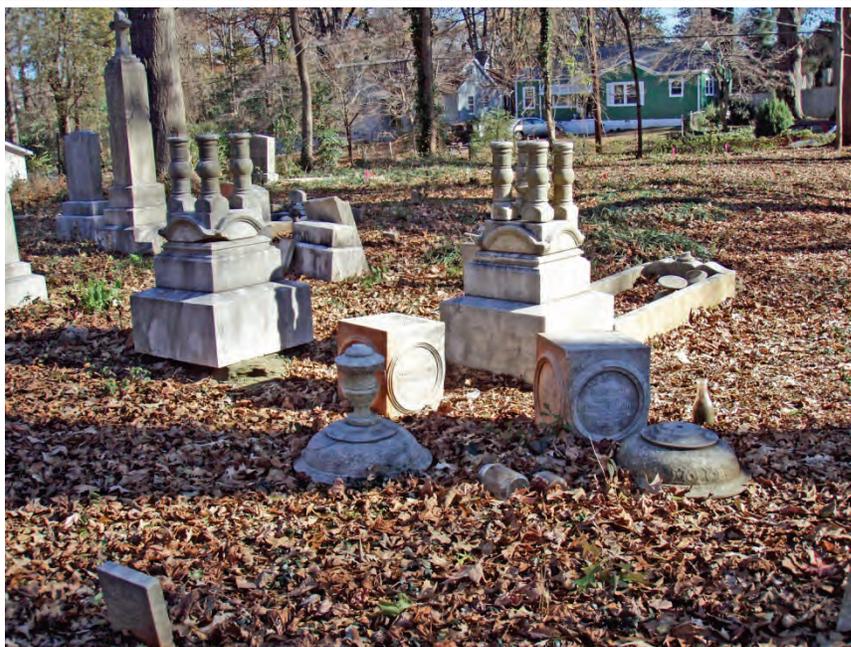
Figure 17. Toppled stones do not necessarily indicate vandalism.

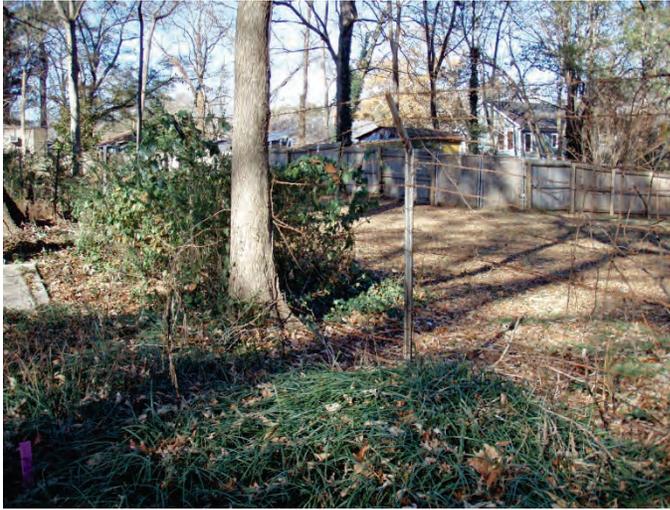
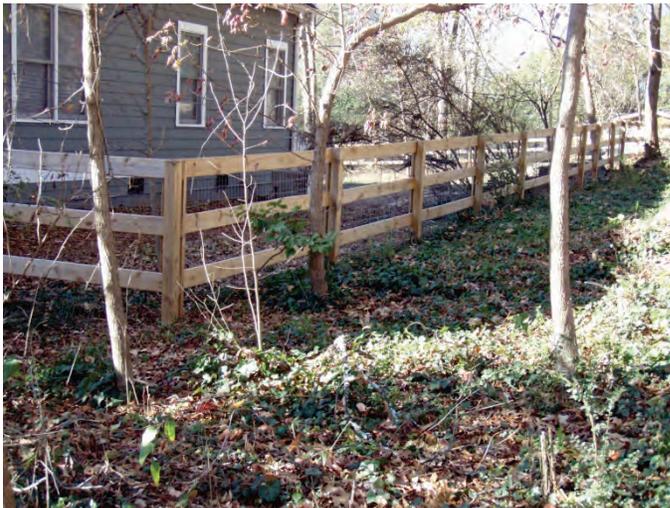
Figure 18. Existing fences along the edge of the property. Top photo shows the north fence; bottom photo shows the south fence.

The fence should be repainted with Rust-

Oleum Chain Link Fence Paint or with a product such as ZRC Cold Galvanizing Compound.

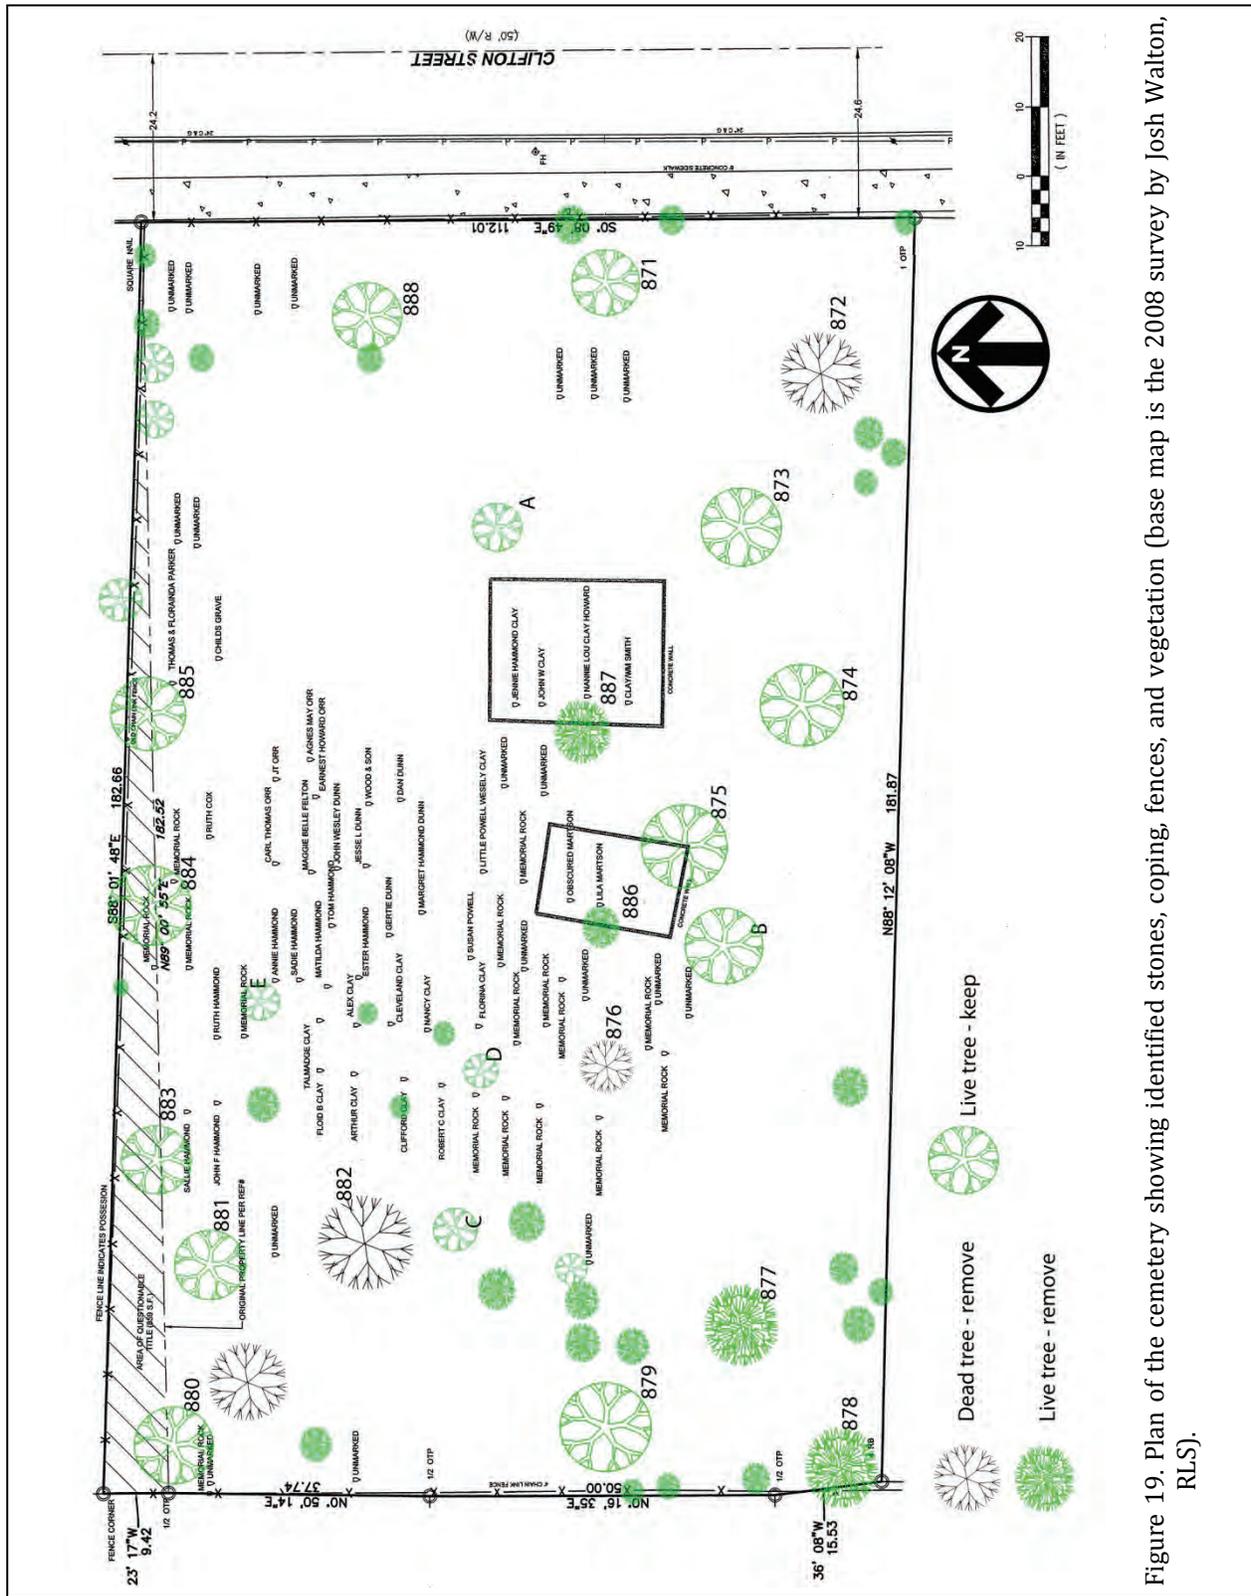
Figure 19. Plan of the cemetery showing identified stones, copings, fences, and vegetation (base map is the 2008 survey by Josh Walton, RLS).

Figure 19 is a map of the cemetery that includes the identified trees (each with its assigned number), as well as the smaller trees that were not included in the assessment.

All of the dead trees in the cemetery should be removed as soon as practical. These include three numbered trees: 872 (in poor condition in 2008), 876, and 882. We understand that several were topped and limbed, but were allowed to remain as a cost saving move. Contrary to the opinion of the arborist, these trees do not provide “interest value.” They degrade the cemetery landscape and pose a threat to the monuments. In addition, the cost of their removal will only increase as they age and they become more hazardous.

In addition, two years after the assessment we identified four numbered trees that should also be removed. These include two sweet gums (886 and 887), a water oak (877), and a Southern red oak (878).

The two sweet gums are damaging coping and pose a threat to monuments. Sweet gums also produce a great deal of trash and better trees can be selected for a cemetery landscape. The water oak and Southern red oak were both identified as being in poor condition in 2008 and have deteriorated since that time. They should be removed before they cause damage to the cemetery or its monuments.

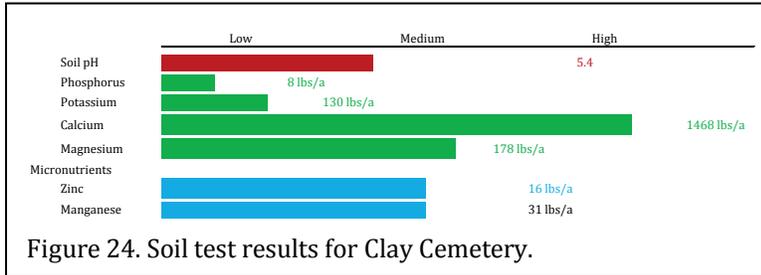
A single test was collected as part of this assessment. The results are shown in Figure 24. Soil pH is slightly less than optimal (5.5-6.0) for most trees. Because of nitrate's transient nature, it is not generally part of the soil test. Phosphorus and potassium are very low to low. Calcium levels are high and magnesium levels are adequate. The micronutrients examined, zinc and manganese, are both sufficient.

Figure 24. Soil test results for Clay Cemetery.

Using conventional 10-10-10 fertilizer the report recommends broadcasting 1 pound per 100 square feet of canopy spread between late fall (when the leaves have fallen), through early spring (before new growth begins). Also recommended are 50 pounds of lime per 1,000 square feet.

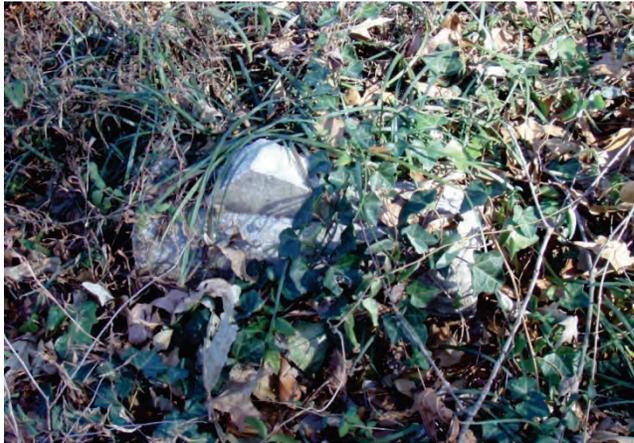
Figure 26. Example of a broken stone at the Clay Cemetery.

Figure 26 illustrates one broken tab in socket stone.

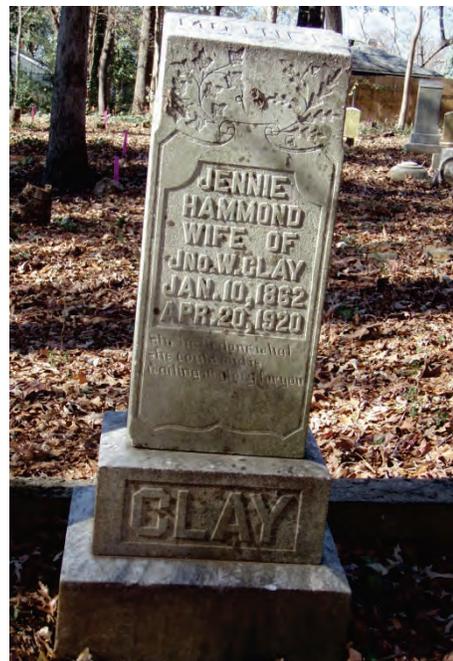
Figure 27. Example of a large, top heavy monument that is unstable.

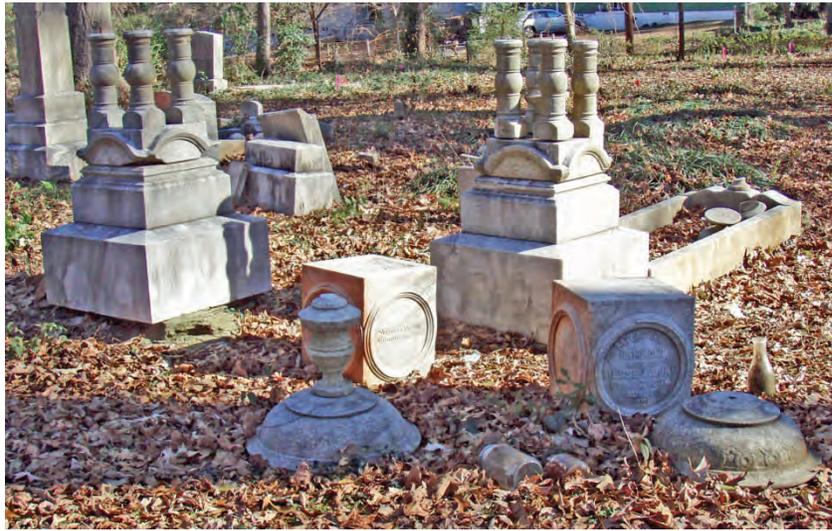
There are two monuments in the Clay Cemetery that have collapsed over the years, likely after being struck by tree limbs. The two monuments were large and their collapse represents a significant loss to the cemetery

Figure 28. Collapsed monuments require resetting, often with associated repairs and pinning. In the background is a toppled monument that also requires pinning and resetting.
