# ARCHAEOLOGICAL TESTING IN THE SIDE YARD OF ELIJAH'S HOUSE (31BW787\*\*7), ORTON PLANTATION

Prepared By:  
Michael Trinkley, Ph.D.  
and  
Debi Hacker

## CHICORA RESEARCH CONTRIBUTION 561

May 2015

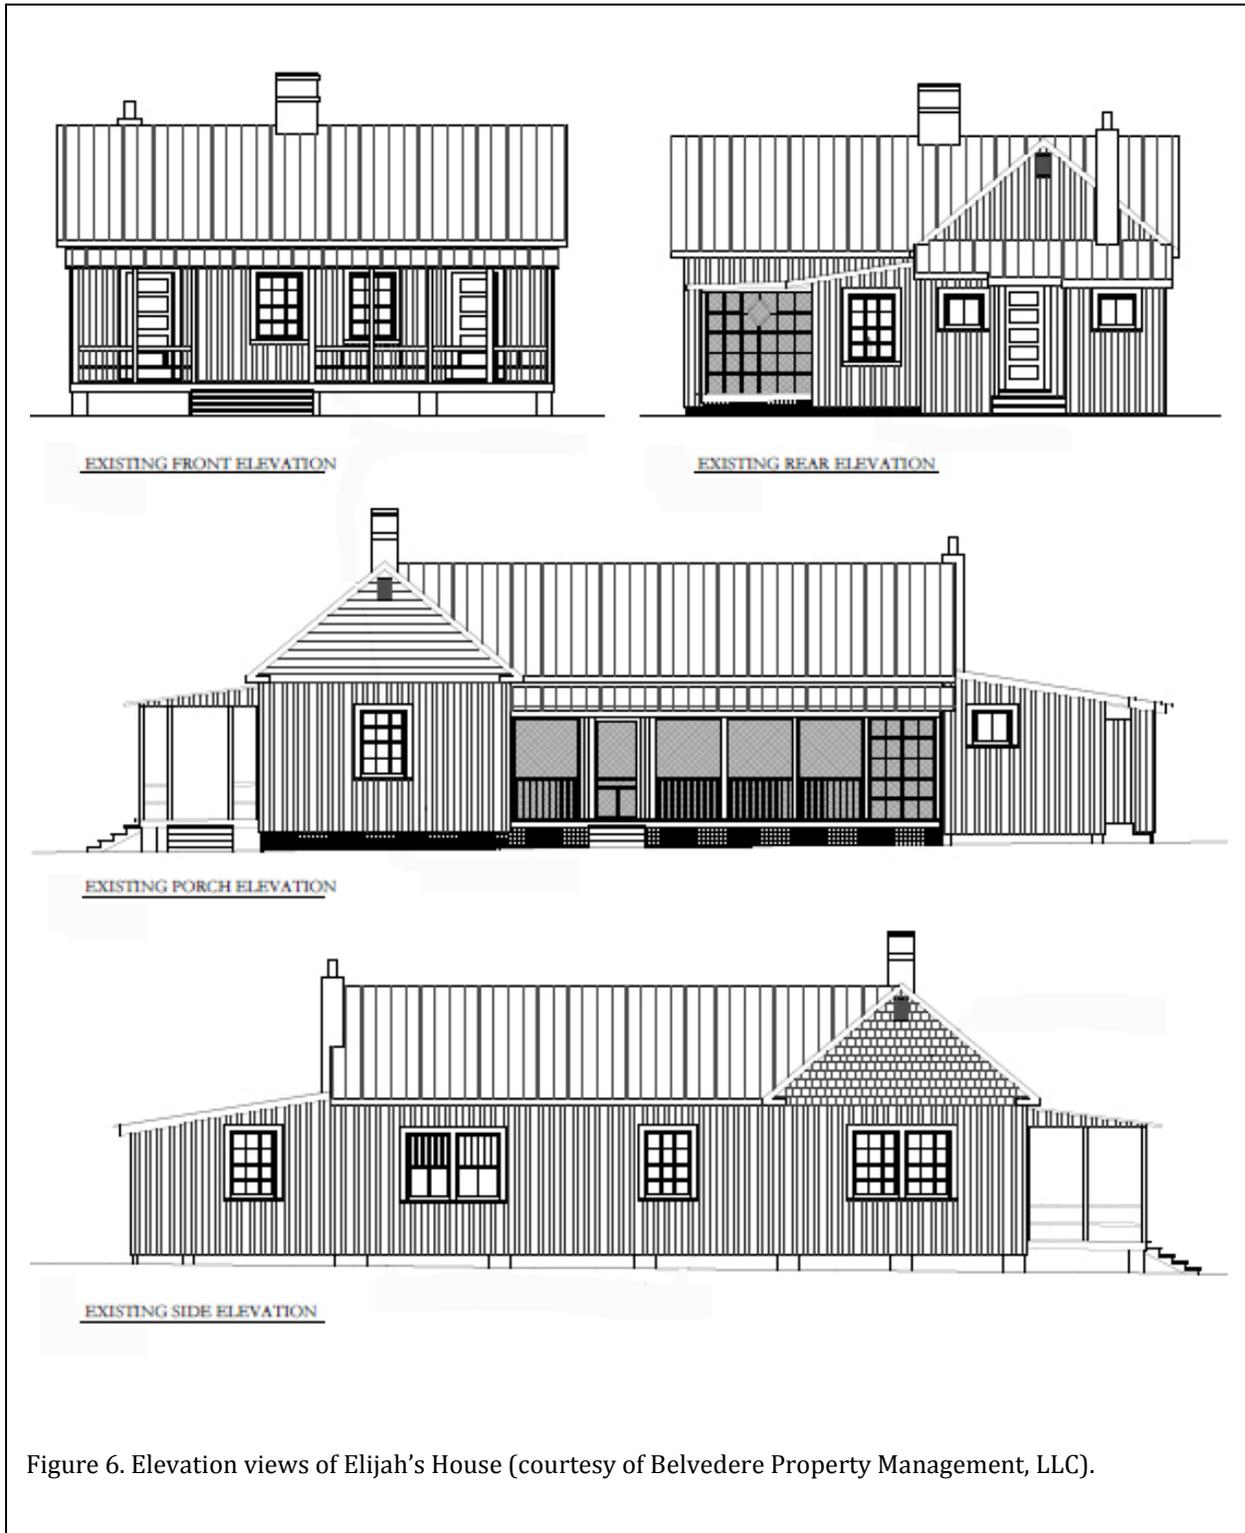
Figure 6. Elevation views of Elijah's House (courtesy of Belvedere Property Management, LLC).

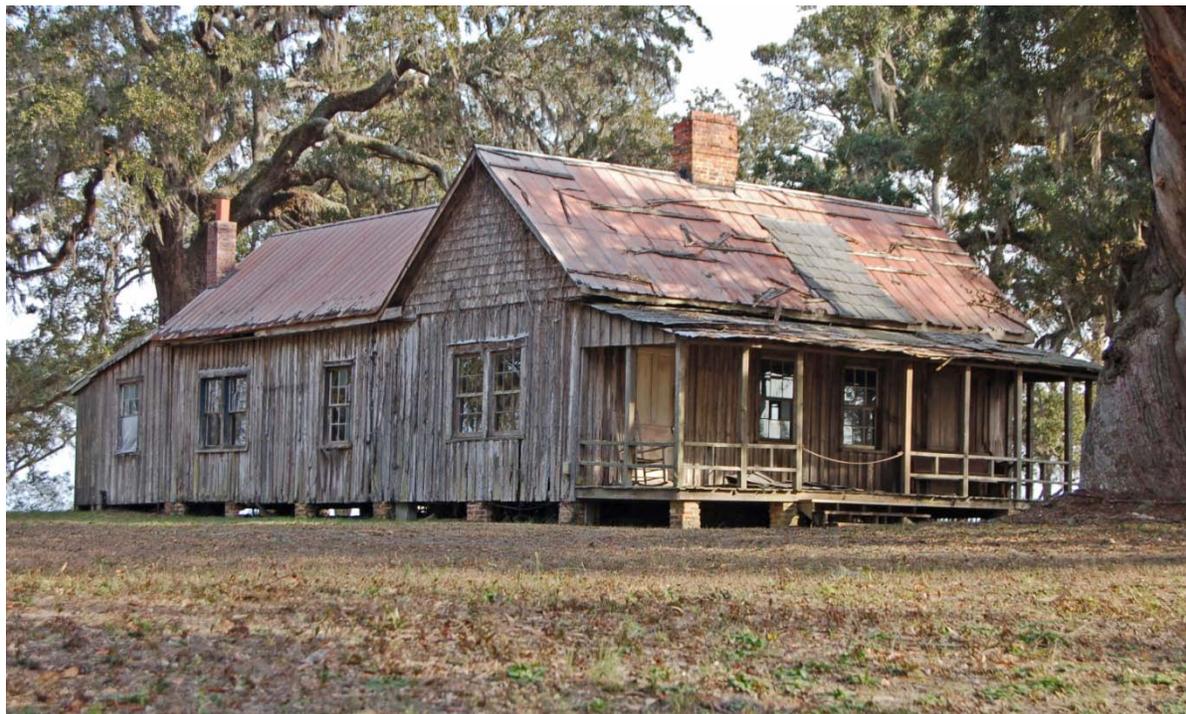
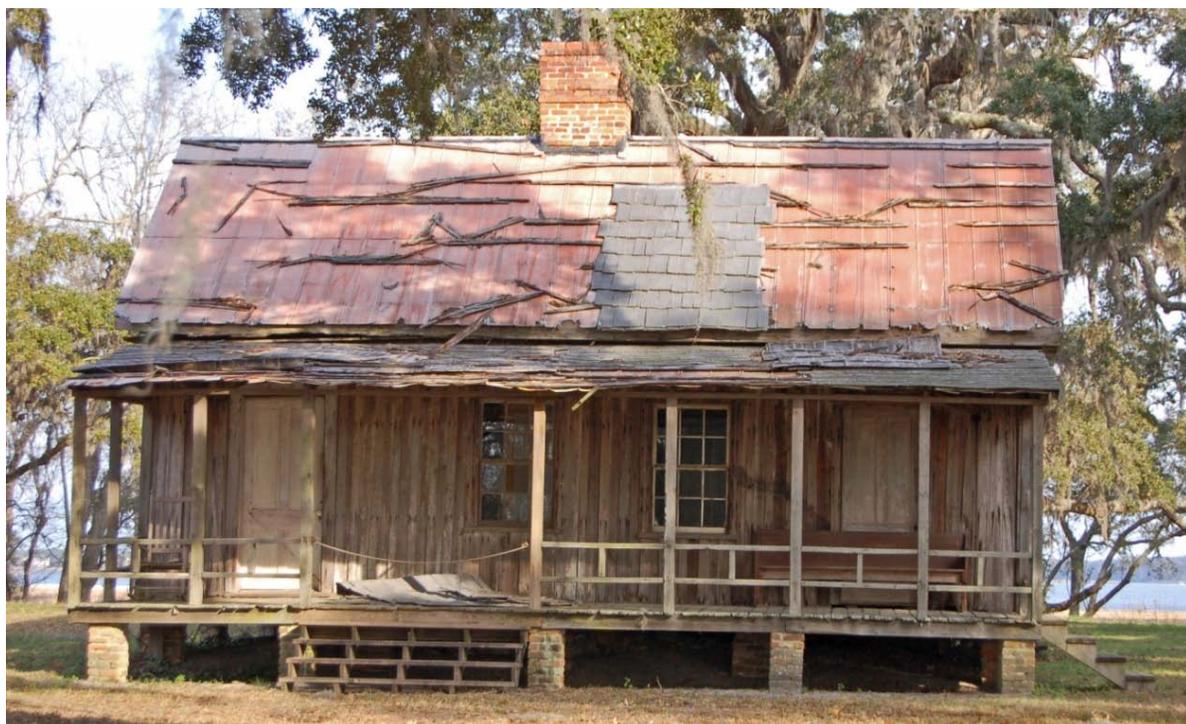
Figure 7. Standing structure at 31BW787\*\*7. Top photograph is an oblique view to the southeast. Below is a view of the front, looking east.

The standing structure is sheathed with board-and-batten siding which extends up to roof level at the rear gable ends. The gable end has been resided with modern weatherboard; the opposite end is clad in similar wood shingle, without a vent opening.

The central chimney is nicely detailed with corbeled banding and appears to be the original configuration. The structure has a smaller exterior chimney or flue at the rear elevation associated with the added kitchen. The single and double window openings retain wood sash with 6/6 lights.

Foundation piers that are visible are brick, although the central chimney is built on ballast stone, possibly salvaged from Brunswick Town to the south of Orton.

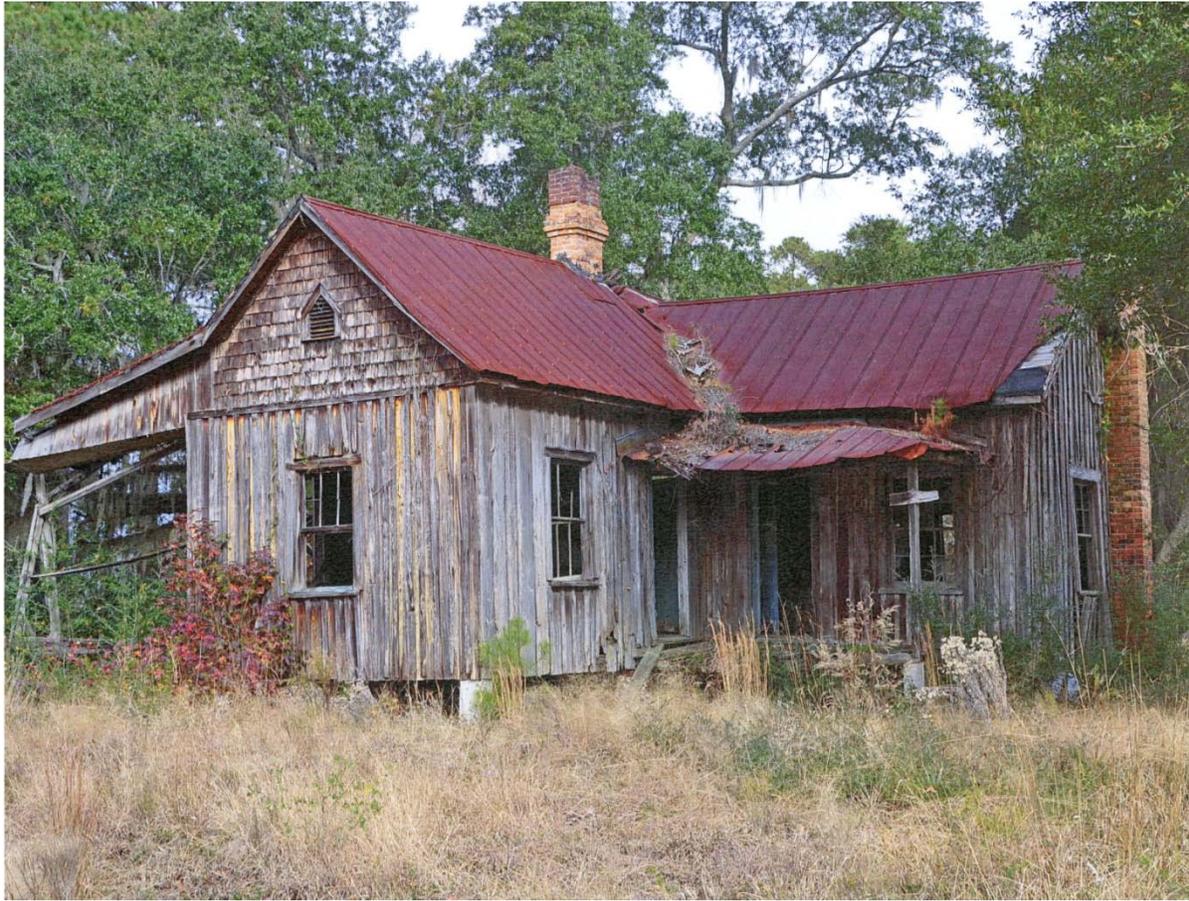
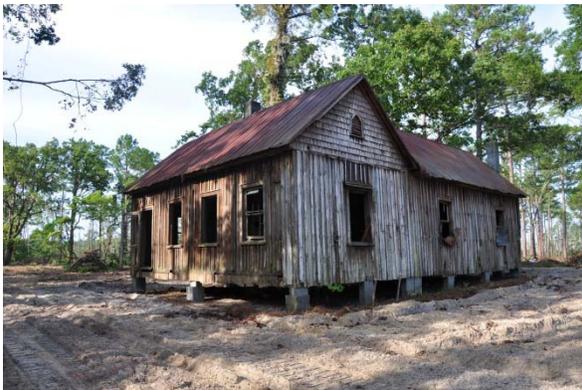
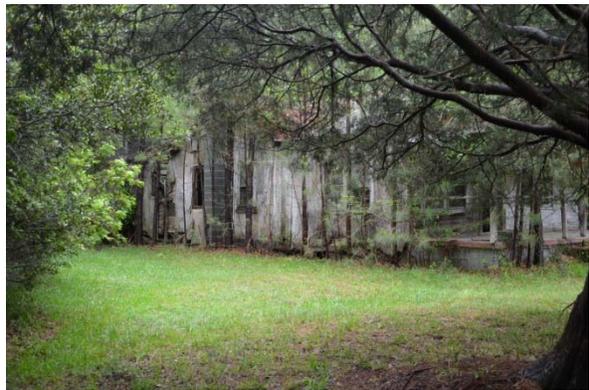
Figure 8. Orton structures similar to Elijah's House at 31BW787\*\*7. The upper photo shows the house at 31BW787\*12 that accidentally burned. The lower left photo is a house on the west side of NC 133. The photo on the right shows a house sold and moved off Orton, probably when Sunny Point was created. It is situated on the east side of NC 133, south of Kendal Chapel, and is today abandoned.

The photo of the burned house at 31BW787\*\*12 shows the original configuration of the extant building. The long sides of the rectangular core present the front façade and rear of the dwelling. The lateral gabled roof is fairly steeply pitched above the narrow side elevations, and has a brick central chimney rising through the ridgeline. A rear gabled wing one room wide gives the dwelling an L-shape. The height of the wing is slightly lower than the front core, so that the ridgelines are not engaged with each other. At the inside of the rear ell, a narrow porch with a

The house was sheathed with board-and-batten siding which extended up to roof level at the rear gable ends. It had wood-shingle siding and a small peaked vent at the main gable end visible in the photo.

The shed roof structure of the porch of the burned house was formed as an extension of the slope of the main roof. The roof structure at the rear porch is separate from the main roof. Roofing is V-crimped metal.

The central chimney is nicely detailed with corbeled banding, but appears to have had its upper section replaced or extended with newer brick. It had a smaller exterior chimney or flue at the rear elevation. The single and double window openings had wood sash with 6/6 lights.

The visible foundation piers are formed concrete. This might indicate that the house was moved at some point, but it seems more likely that the foundation was shored up or reinforced.

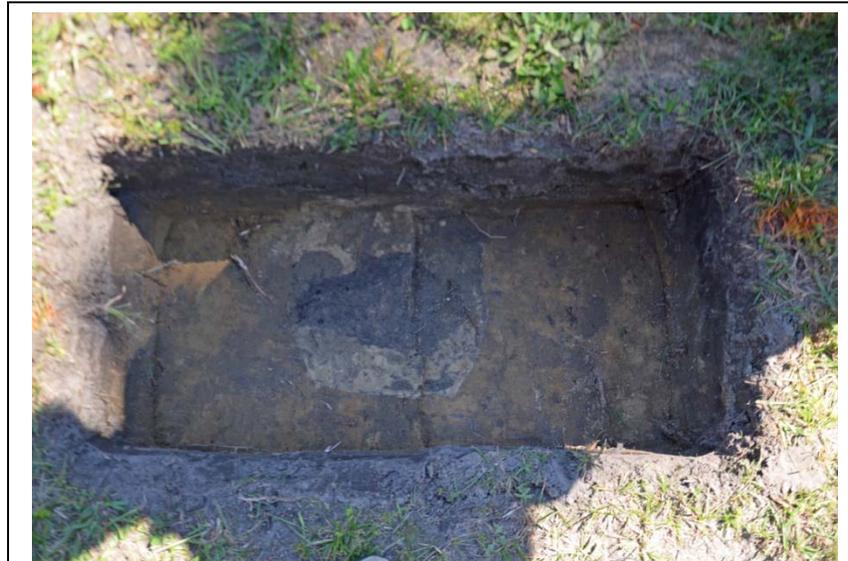
Figure 12. Test Units 16 (left) and 14 (right) looking east at the base of excavations. Posthole 1 is shown in the middle.

the base of most excavations, suggestive of intense occupation, no features were encountered. One posthole was recovered, originally in Test Unit 14 and more fully exposed with the excavation of Test Unit 16 to the north (Figure 11). These two 2-foot units revealed a posthole measuring 2-feet in diameter, with a post mold measuring about a foot square. Upon excavation the posthole was found to be about a foot in depth with a rounded bottom.

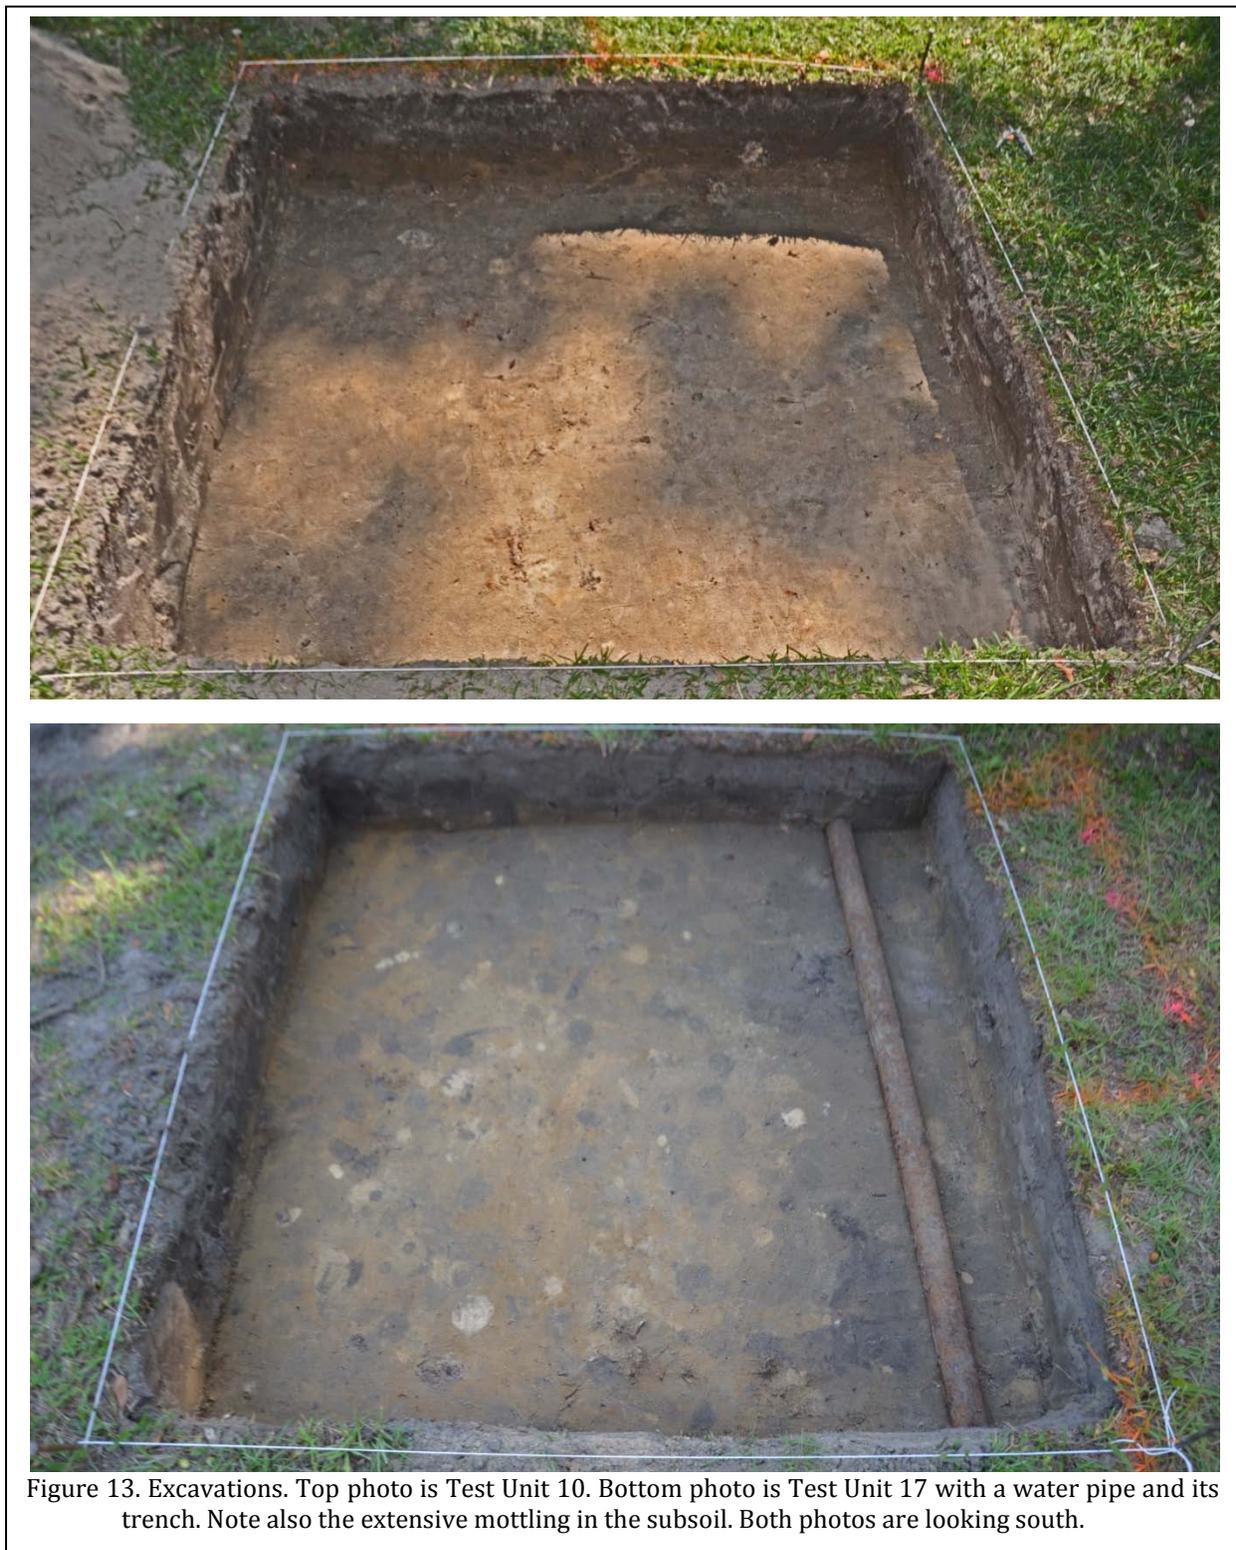
Figure 13. Excavations. Top photo is Test Unit 10. Bottom photo is Test Unit 17 with a water pipe and its trench. Note also the extensive mottling in the subsoil. Both photos are looking south.

At the base of Test Unit 17 we identified a 2-inch corroded pipe running north-south and its associated trench. We presume this line provided water to Elijah's House, although we do not know where it originated.

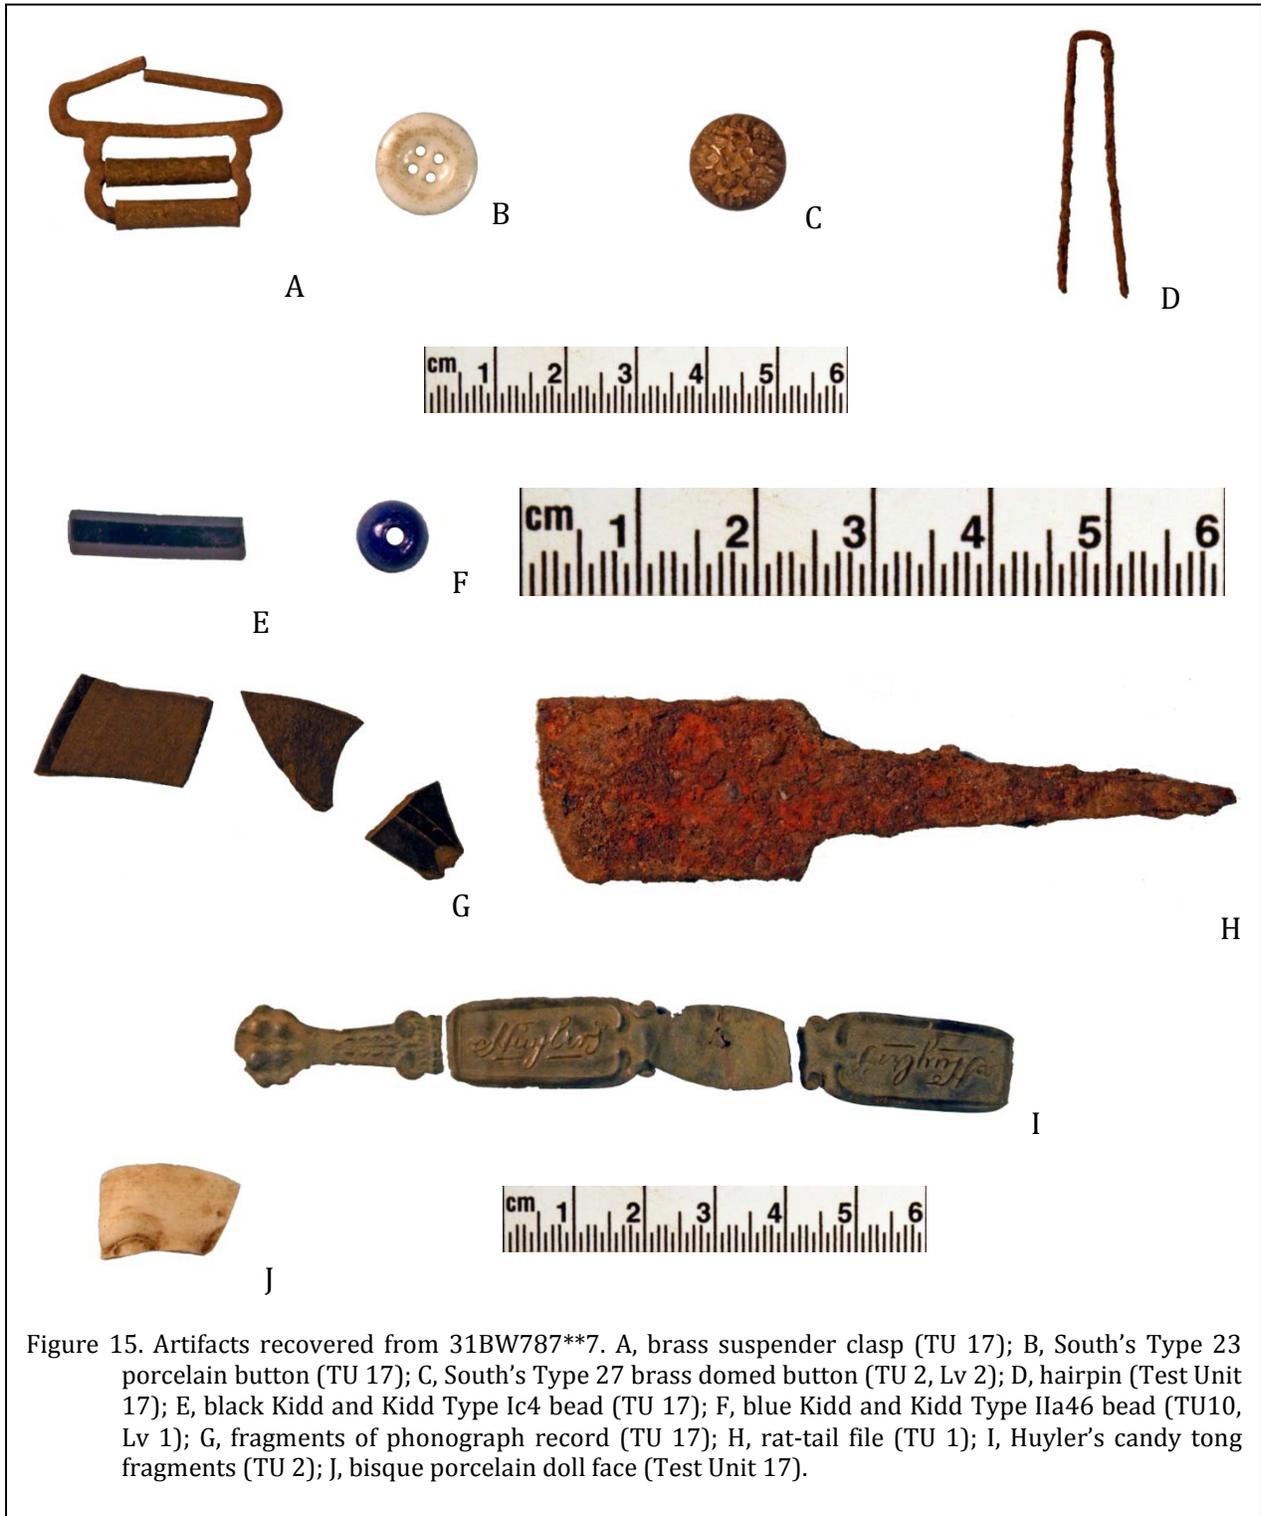
Figure 15. Artifacts recovered from 31BW787\*\*7. A, brass suspender clasp (TU 17); B, South's Type 23 porcelain button (TU 17); C, South's Type 27 brass domed button (TU 2, Lv 2); D, hairpin (Test Unit 17); E, black Kidd and Kidd Type Ic4 bead (TU 17); F, blue Kidd and Kidd Type Iia46 bead (TU10, Lv 1); G, fragments of phonograph record (TU 17); H, rat-tail file (TU 1); I, Huyler's candy tong fragments (TU 2); J, bisque porcelain doll face (Test Unit 17).
