# ARCHAEOLOGICAL STUDIES ASSOCIATED WITH THE NINETEENTH CENTURY OWENS-THOMAS CARRIAGE HOUSE, SAVANNAH, GEORGIA

**RESEARCH SERIES 38**

Michael Trinkley  
Natalie Adams  
Debi Hacker

Chicora Foundation, Inc.  
P.O. Box 8664 ■ 861 Arbutus Drive  
Columbia, South Carolina 29202

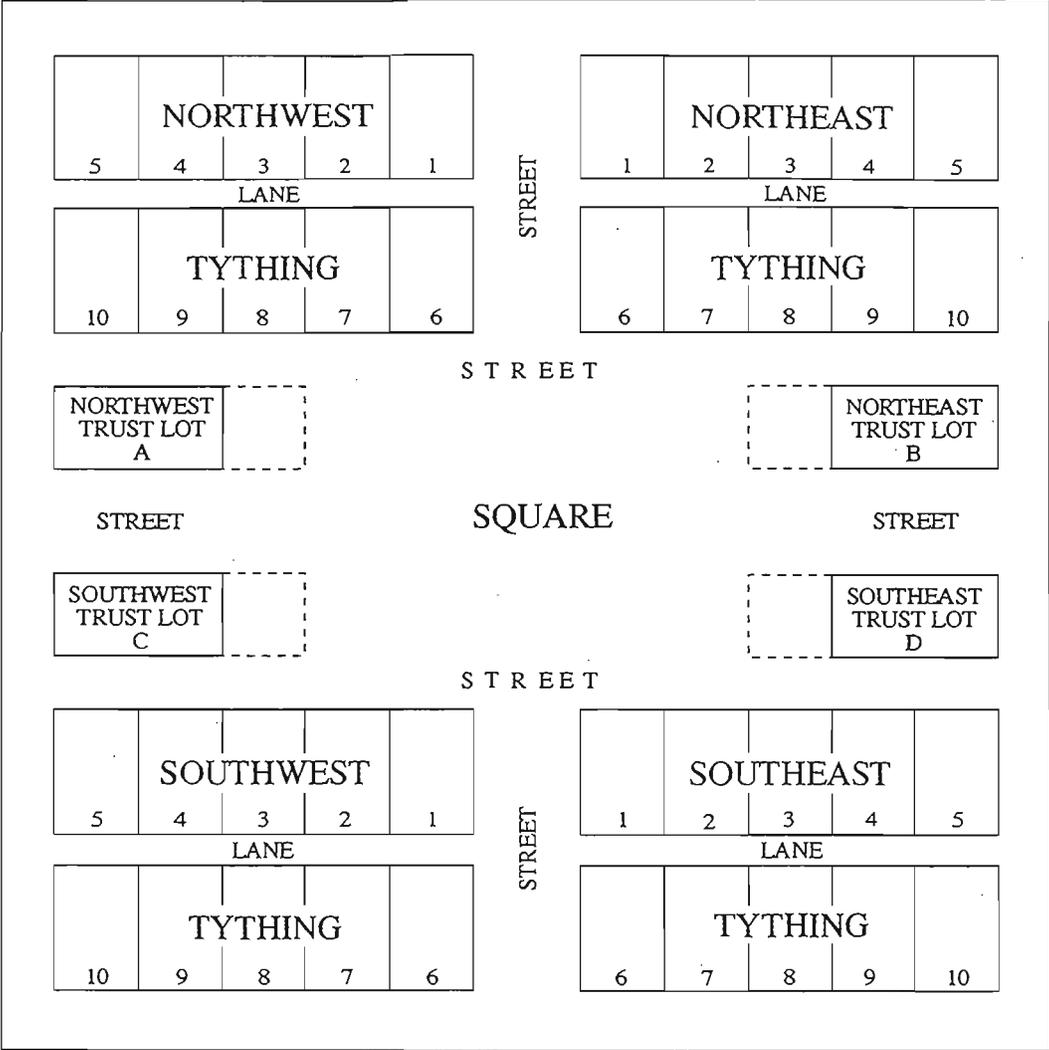
Figure 2. Reconstruction of the basic module of Oglethorpe's Savannah Plan (adapted from Fichter 1992:Figure 1).

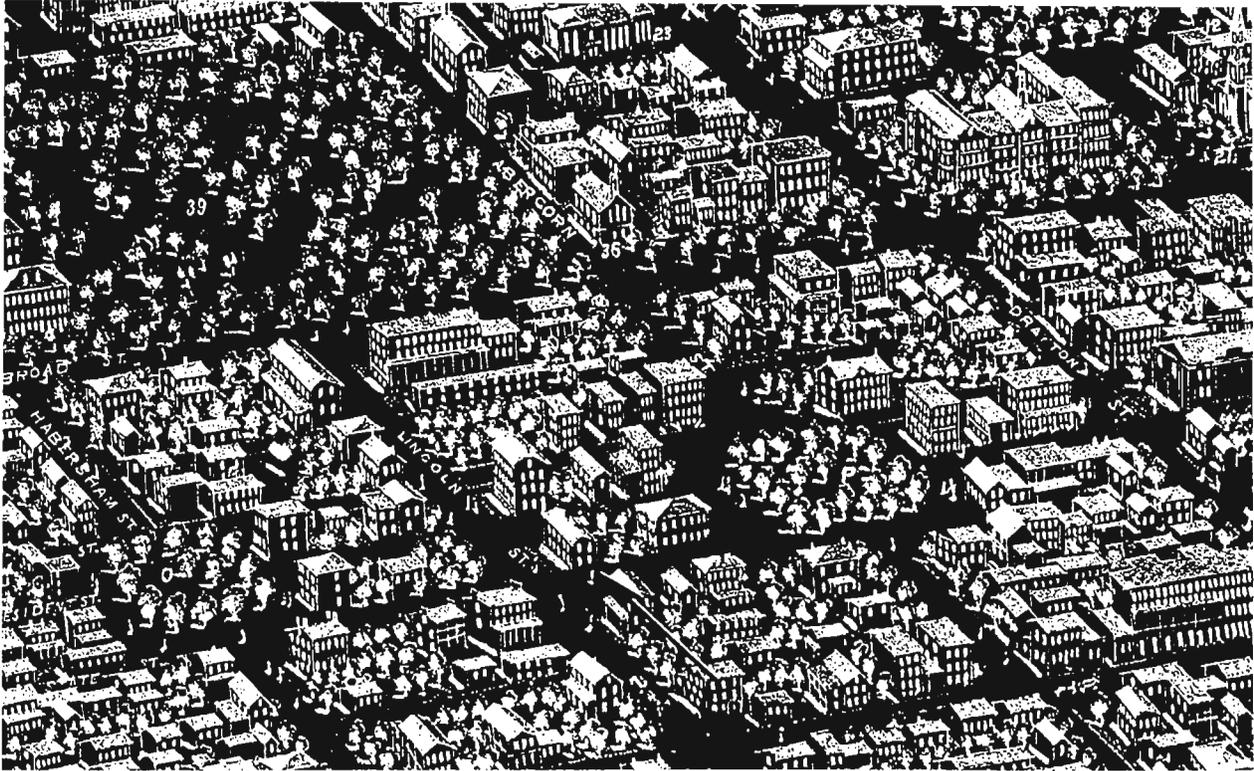
Figure 6. Bird's Eye View of the City of Savannah in 1871, showing the Owens-Thomas lot and structures (Georgia Historical Society, 1361 MP, #15 SAV).

Relatively little is known about the site during the last half of the nineteenth century. The 1871 Birds Eye View of the City of Savannah (Figure 6) shows only two structures -- the main house and the carriage house. While the accuracy of this map is typically accepted, and it does appear to show the structures known to be present correctly, there are minor inconsistencies. For example, the rear wall is not shown. Consequently, this drawing must be cautiously accepted as a general representation.

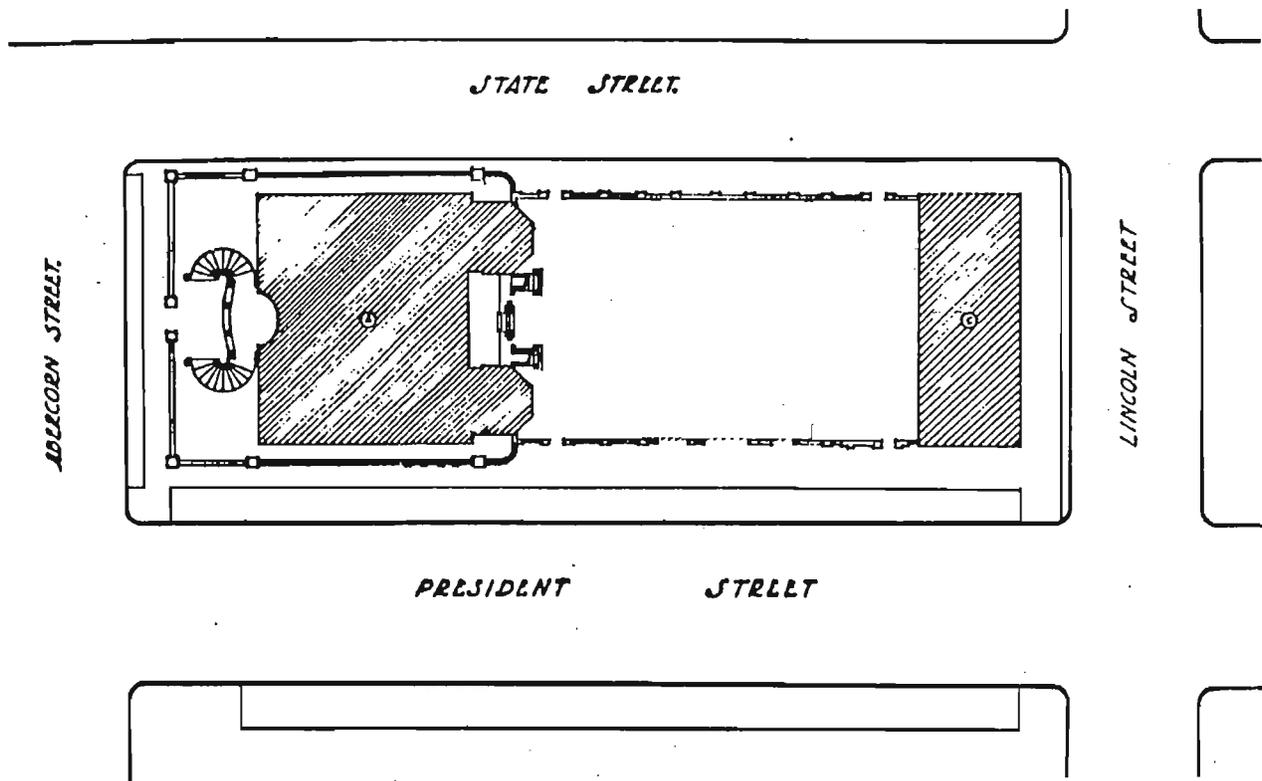
Figure 11. HABS plan of the Owens-Thomas House lot.

In 1934, when the house was drawn by a HABS survey team, the lot layout consisted of the main building, the carriage house, the office on President Street, and a privy on State Street. The carriage entrance onto President Street was already closed, and the carriage house yard was bisected by an east-west privacy wall (Figure 11).

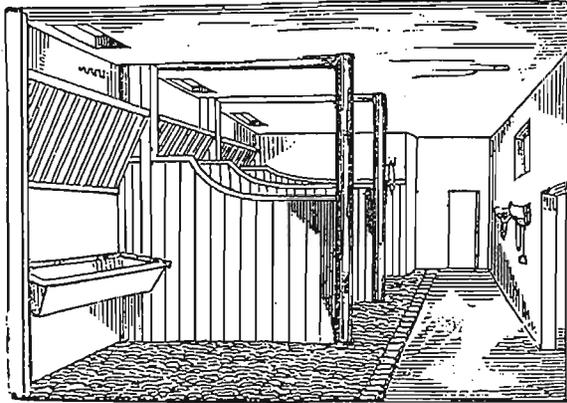
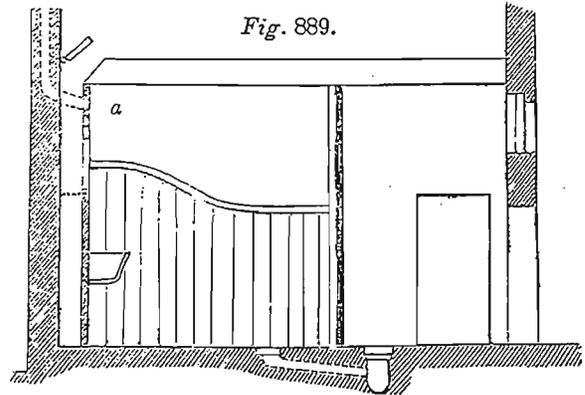
Figure 12. An appropriate stable arrangement as illustrated by Reese's *An Encyclopaedia of Domestic Economy*.

six feet wide in general, and should be eight or nine feet in depth . . . the height of the partition should be seven feet at the head and five at the heels. . . . The stall posts are uprights at the bottom of the stall to stay the partition [see Figure 12] . . . . Each side of this post should have a ring for pillar reins, which are used when the horse is

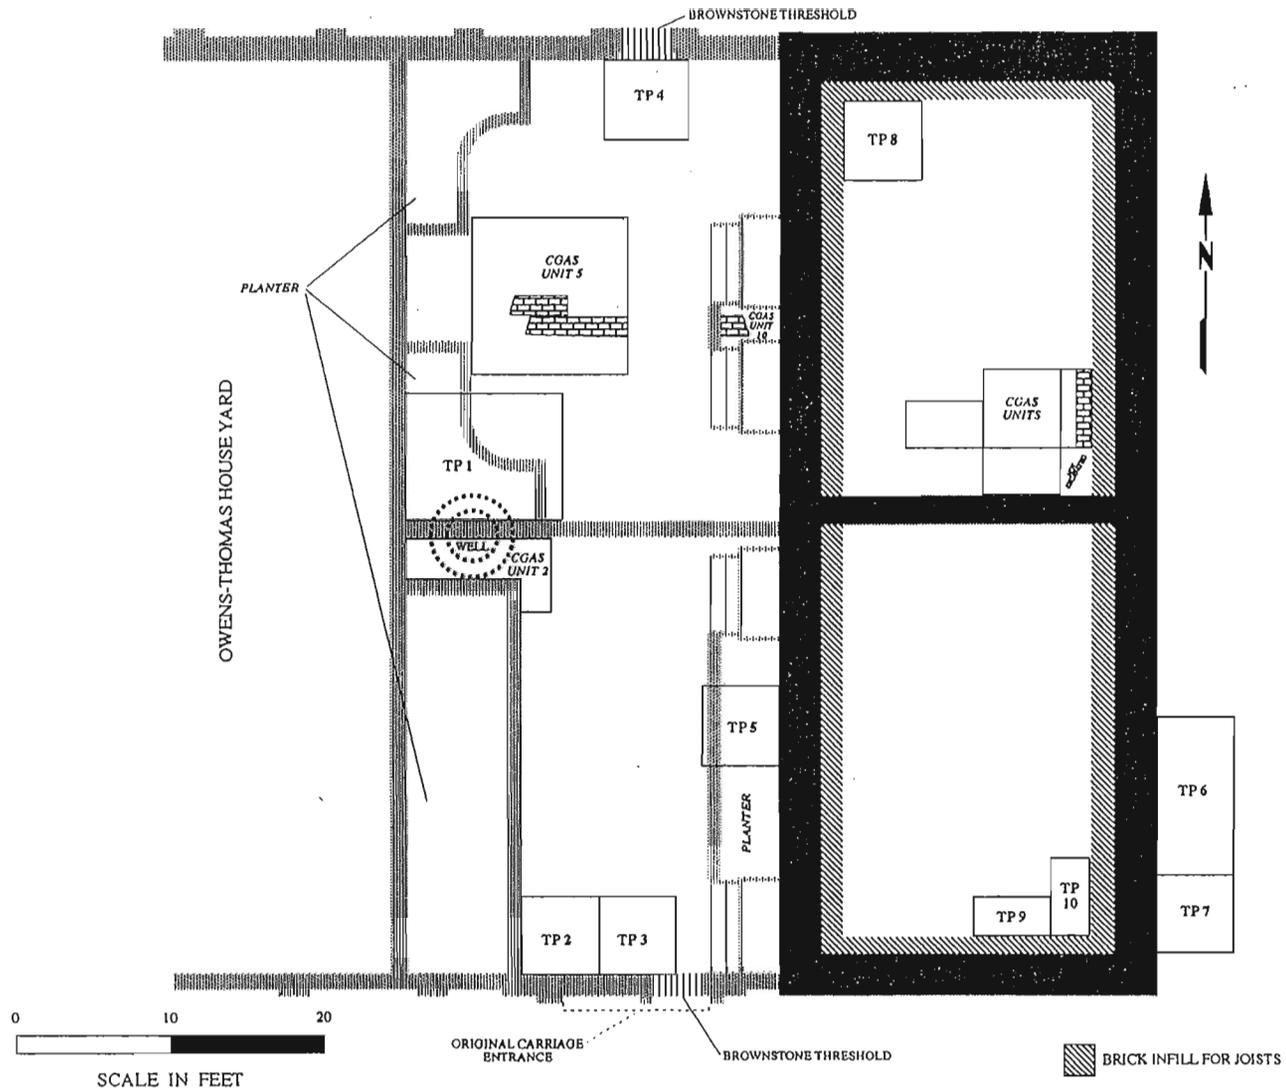
Figure 14. Chicora's excavations at the Owens-Thomas Carriage and Slave Quarters.

These units were placed in the yard area adjacent to the southern wall with the western unit (TP 2) also adjacent to the planter wall (see Figure 14 and 17). Forming a 5 by 10 foot unit combined, these two units were excavated to explore the carriage drive area, associated yard debris, the construction of the carriage gate which is now bricked up, and examine the eighteenth century stratigraphic deposits in this portion of the yard.

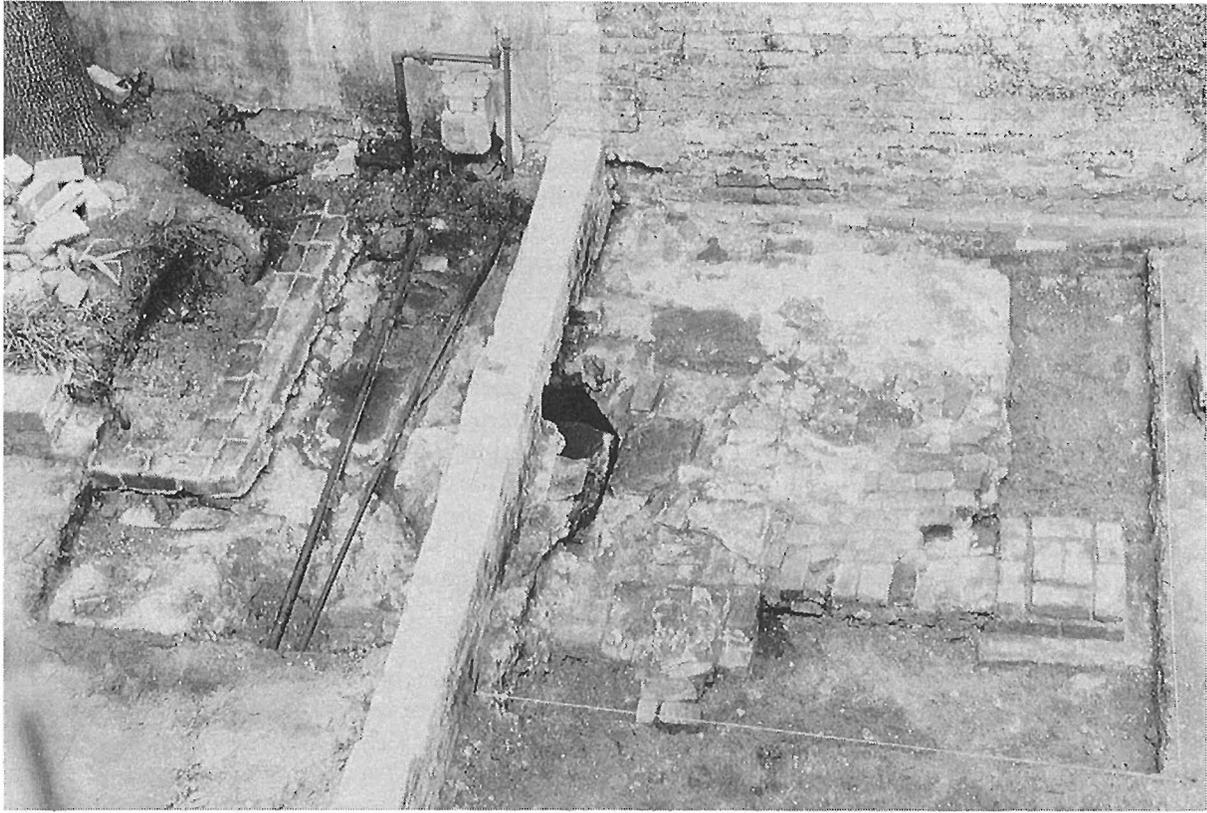
Figure 15. Test Pit 1, view to the west from the second floor of the carriage house.

Upon cleaning this unit revealed a brick pier measuring 1.5 by 1.4 feet in the northeast quadrant (a matching pier was identified in Test Pit 2 to the south, discussed below). Southwest and south of this pier is heavily worn and patched brick flooring. This flooring extends south of the pier, with neatly laid brick work forming an eastern wall. While there is an addition to the east in the southeast quadrant of the unit, the eastern terminus is well defined further to the south and is expected to measure about 13 feet north-south, with a matching pier situated under the northeast corner of the southern planter. The floor appears to measure about 7 feet east-west, with its western terminus about 0.6 foot east of the garden wall. This brick floor exhibits very heavy wear, with areas of extensive damage to the brick coupled with very sloppy repairs consisting only of mortar and rubble laid down to maintain a roughly level surface. Examination of the floor reveals a series of at least three floor levels, one laid on top of the other. It is likely that it was easier to lay a new floor than to attempt major repairs, hence the build up of flooring material.

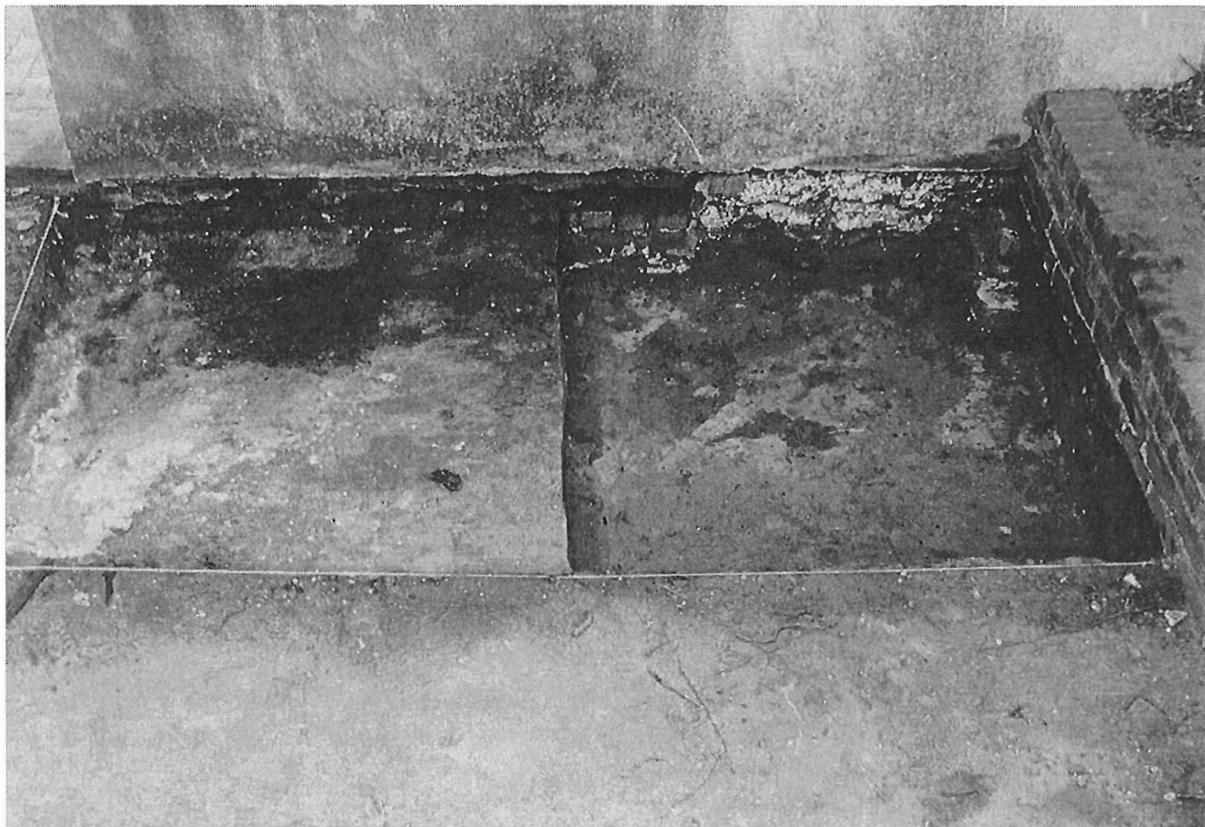
Figure 17. Test Pits 2 (to the right adjacent to the planter wall) and 3 (to the left), view to the south.

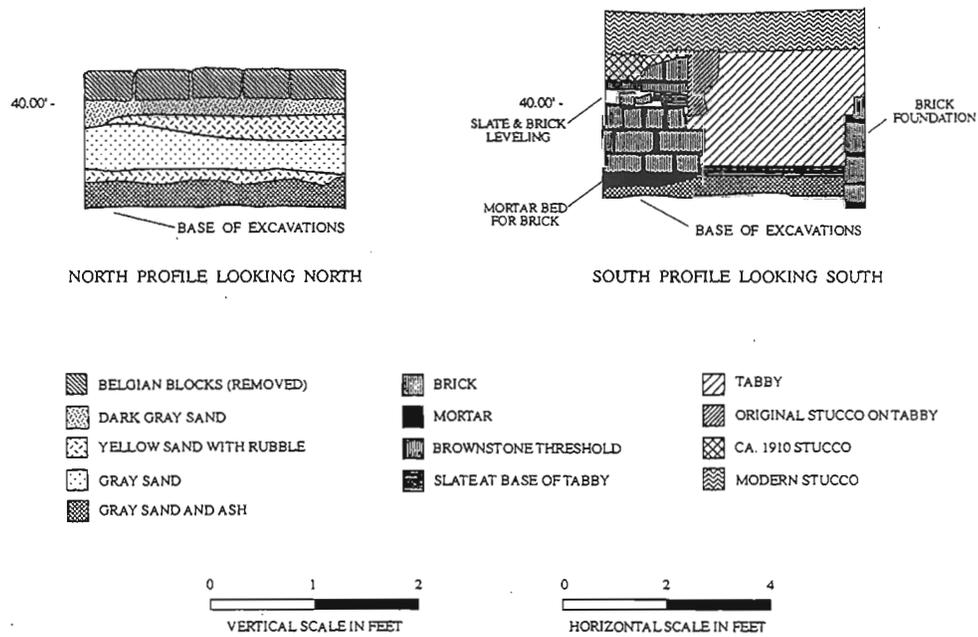
Figure 18. Test Pit 2, north and south profiles.

were at an elevation of approximately 40.30 feet MSL), recently removed by the Owens-Thomas House staff. This paving was apparently placed in the yard during the ca. 1910 renovations. There is no oral history regarding what was present in the yard area prior to this work. Below the Belgian blocks (beginning at about 40.00 feet MSL) in Test Pit 2 this work identified between 0.2 and 0.3 foot of a dark gray sand (10YR3/2) overlying a 0.2 foot lens of yellow sand and mixed construction rubble (10YR5/4). Below this was about 0.4 foot of gray sand (10YR4/3) and a second 0.05 to 0.1 foot thick lens of yellow sand (10YR5/4) and construction debris. At the base of the excavations was a 0.3 foot thick level of gray sand and ash (10YR4/3) which appears to grade into the yellow sand taken as sterile throughout the site area at 39.00 feet MSL (Figure 18).

Inside, Test Pit 2 revealed three course of brick laid in a mortar bed to support the brownstone threshold. It had been leveled on the brick using clinkers and slate. The tabby wall had then been poured around the brick infill. A portion of the original cement stucco on the tabby was preserved below grade, as was the ca. 1910 stucco over the brick infill of the gate opening. At the base of the tabby wall the builders used a layer of slate (similar to the stone foundation of the carriage house) to prevent the tabby from wicking moisture (Figure 18).

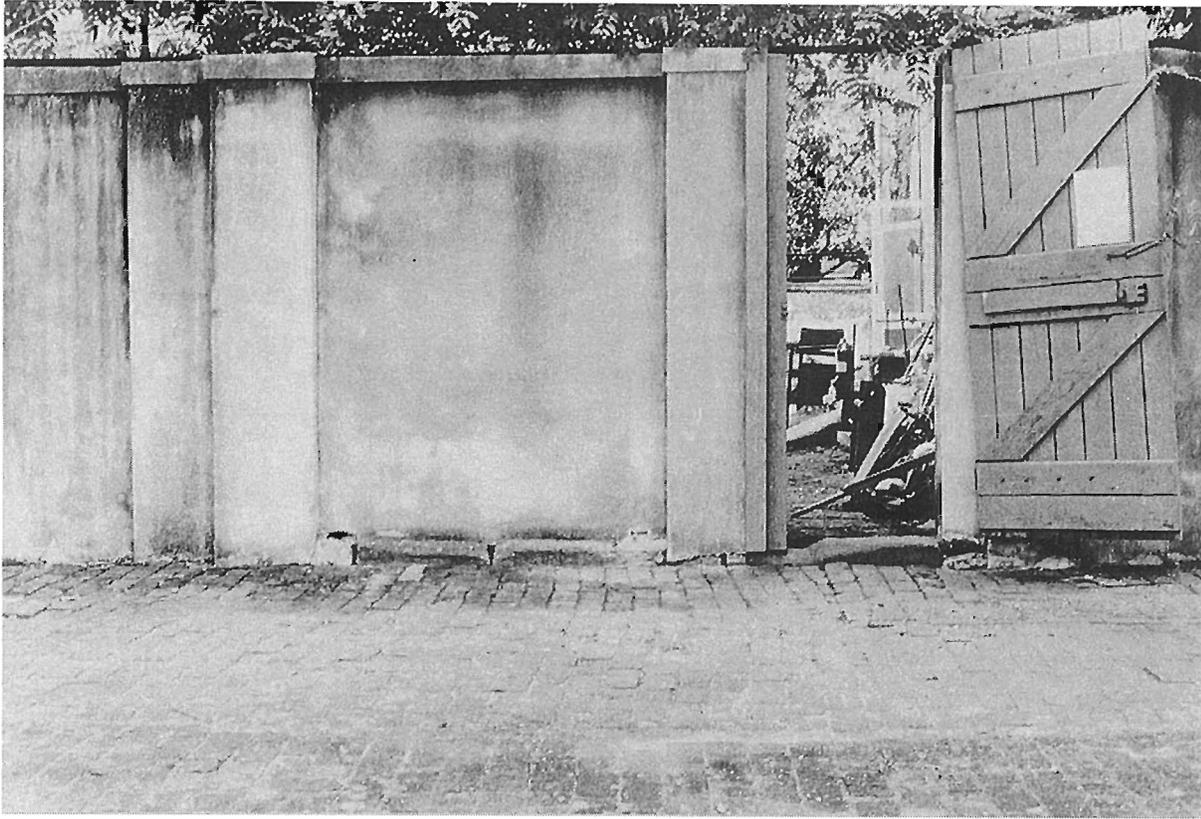
Figure 19. Original carriage entrance, view from President Street to the north.

Moving from the units to the associated carriage entrance, the archaeological investigations were helpful in better understanding the construction of the gate, its threshold, the stucco applications, and its eventually closing. From the exterior (Figure 19) it is clear that the brown stone or sand stone threshold is currently in the three sections (Figure 20). From west to east these include sections measuring 3.35 feet, 3.3 feet, and 2.2 feet. Each is about 1.1 feet in width and about 0.28 foot

in thickness. The eastern most section exhibits an area intentionally prepared to lower the threshold, probably for yard drainage into the street (just as the pedestrian gate on the north side shows two similarly prepared drains)(Figure 21). George Fore suggests that this area has received additional wear from the carriage wheels, expanding and rounding the drain opening. The center block exhibits a iron stop set in lead and a bolt hole worn to the south from the drag of the bolt. To the west the details become less clear since the brick in-fill wall covers much of the threshold; however, there is evidence of additional wear and fragmentation of the threshold from the passage of carriage wheels. Also on the outside three of the original four hand wrought hook hinges are still present (with two being used to hold the present pedestrian gate). The upper left hook hinge evidences considerable wear from the gate swing. The fourth hook hinge, at the lower edge of the east side, is still present under the modern stucco. The pedestrian gate also reveals evidence of what are probably the remains of the original hand wrought eye hinges, significantly reduced in length.

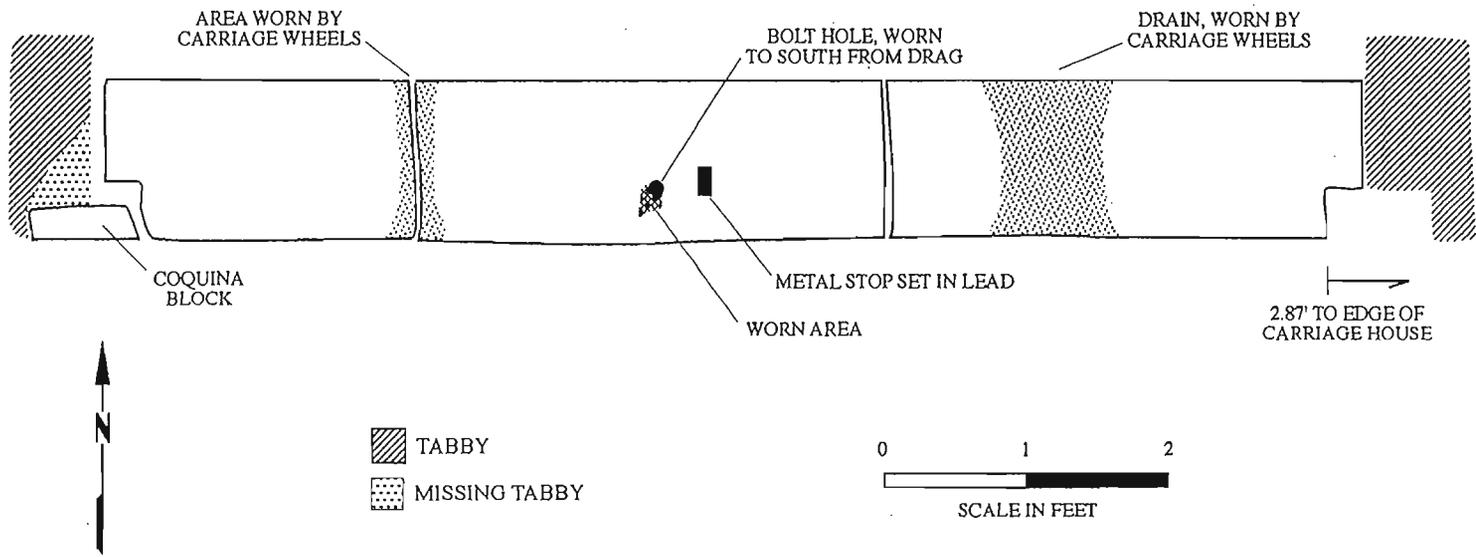
Figure 20. Plan of the brownstone threshold.

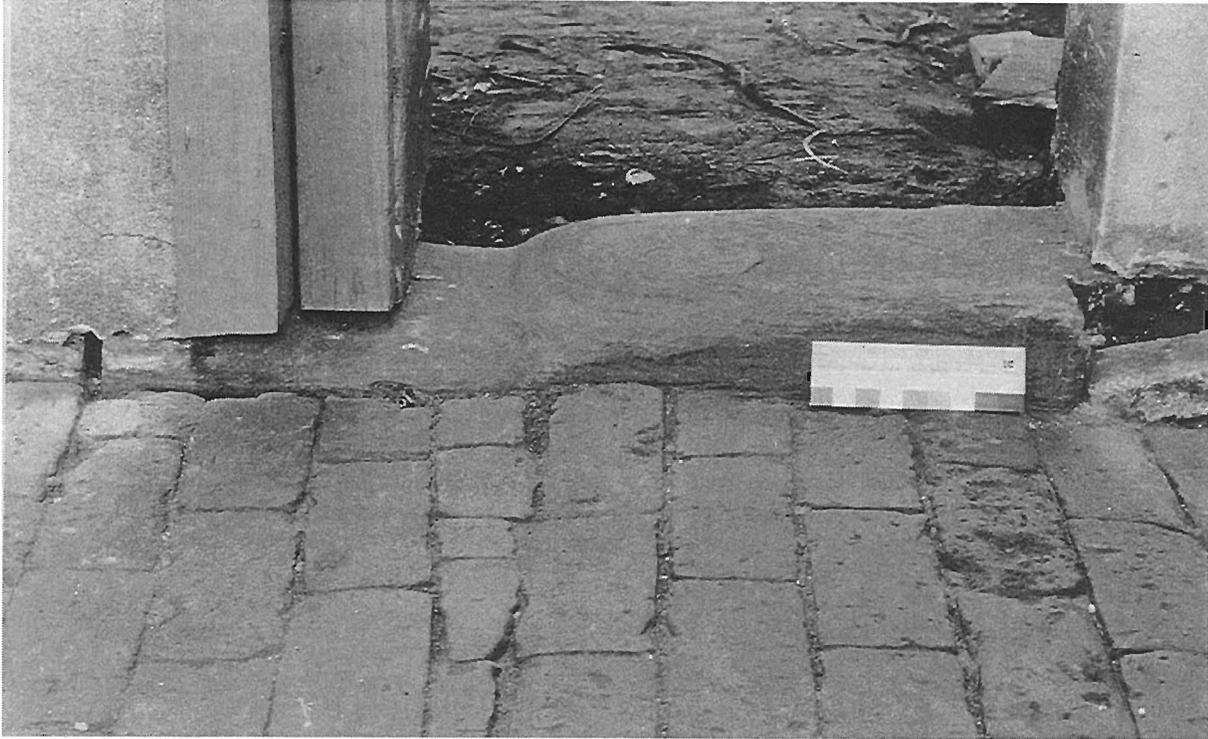
Figure 21. Eastern threshold section showing prepared drainage enlarged by carriage wheel. Sidewalk paving likely dates from the last quarter of the nineteenth century.

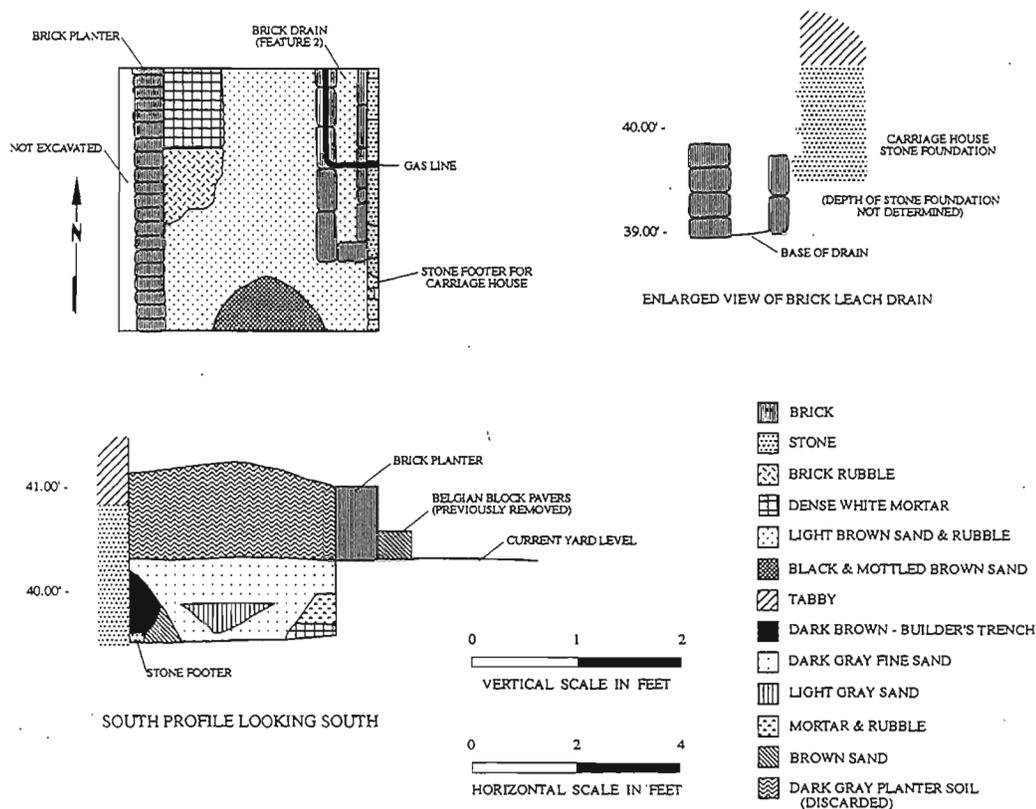
Figure 22. Excavations in Test Pit 5 and brick drain.

The excavations, unfortunately, provided virtually no information regarding early nineteenth century site use. We quickly discovered that this particular area was crossed that three relatively modern water pipes (one for each of the two apartments created in 1910 plus one which may be a replacement), a PVC drain pipe dating the past 20 years, and an electrical conduit associated with an outdoor light. In addition, the eastern half of the unit revealed disturbance to a level of at least 3 feet, likely representing an early twentieth century plumber's chase (excavated as Feature 1). This major disturbance was filled with a large quantity of debris from the first quarter of the twentieth century, including several large sections of glazed drain pipe, probably representing the goal of the excavations.

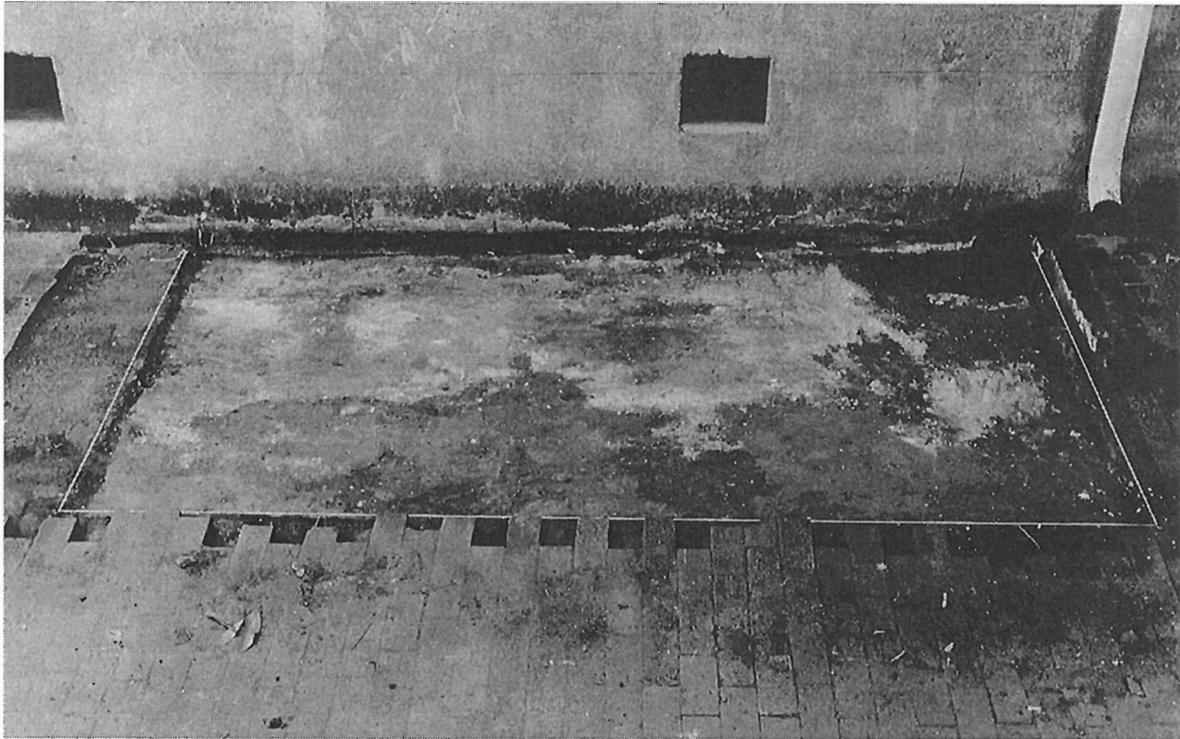
Figure 23. Test Pits 6 and 7, view to the north.

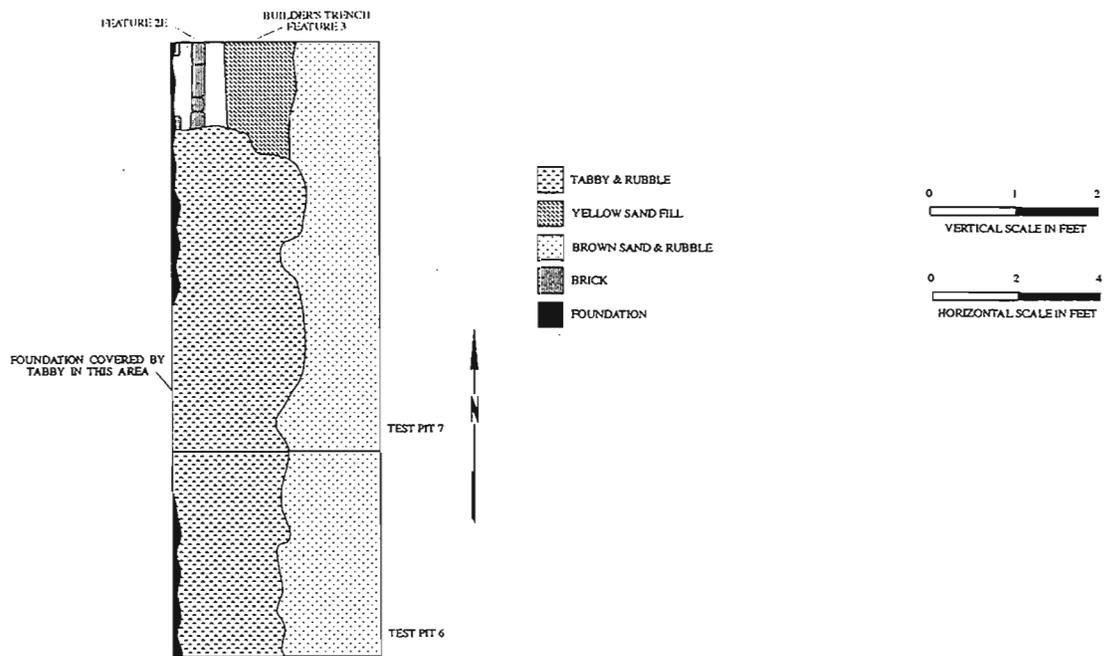
Figure 24. Plan view of Test Pits 6 and 7.

eliminate consideration of a carriage entrance from Lincoln Street. While it is possible that controlled excavation of the tabby "apron" might suggest its function, or allow a better understanding of its formation process, it seems unlikely that this will substantively contribute to the interpretation of the structure.

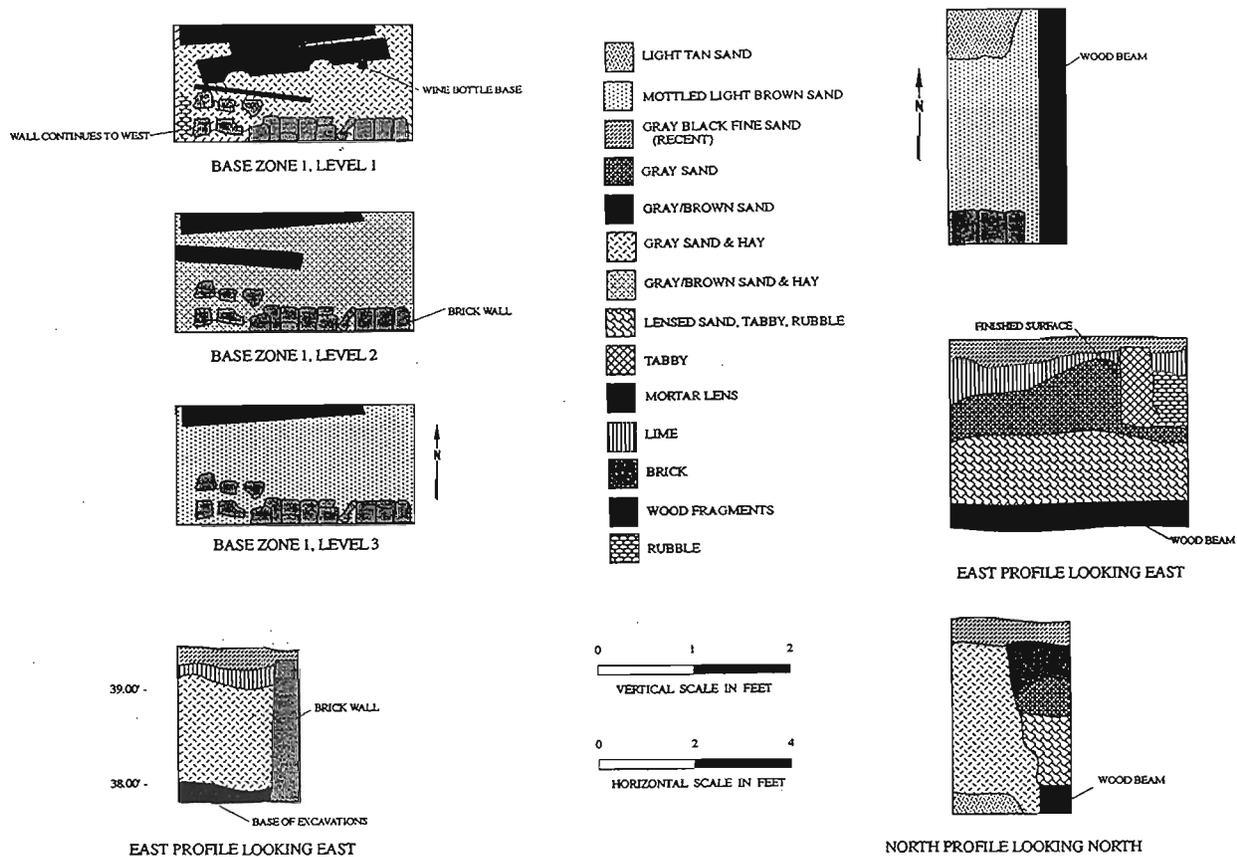
Figure 25. Plan and profile views of Test Pits 9 and 10 within the carriage house.

Excavation in Test Pit 9 (Figure 25) found about 0.2 foot of recent, very fine powdery black soil. Under this was a lens of lime about 0.2 foot thick, probably intended to cap the stable deposits during the ca. 1910 renovations. Below this lime the investigations identified nearly a foot

and a half of very dry lensed soil and hay. The desiccant quality of the hay, combined with the incredibly dry conditions under the house, created a micro-environment capable of extraordinary preservation. Materials recovered from the hay and gray sand zone (which was excavated in three arbitrary levels) includes rat and horse feces, large quantities of straw, wood timbers and boards (several with preserved paint or a lime wash), a wood basket, several carved wood containers, and
