**FURTHER INVESTIGATION OF THE
STONE/BAYNARD MAIN HOUSE,
HILTON HEAD ISLAND, BEAUFORT COUNTY,
SOUTH CAROLINA**

RESEARCH SERIES 47

Prepared for:
Friends of Stoney/Baynard Ruins
The Environmental and Historical Museum of Hilton Head Island

Prepared By:
Michael Trinkley, Ph.D.

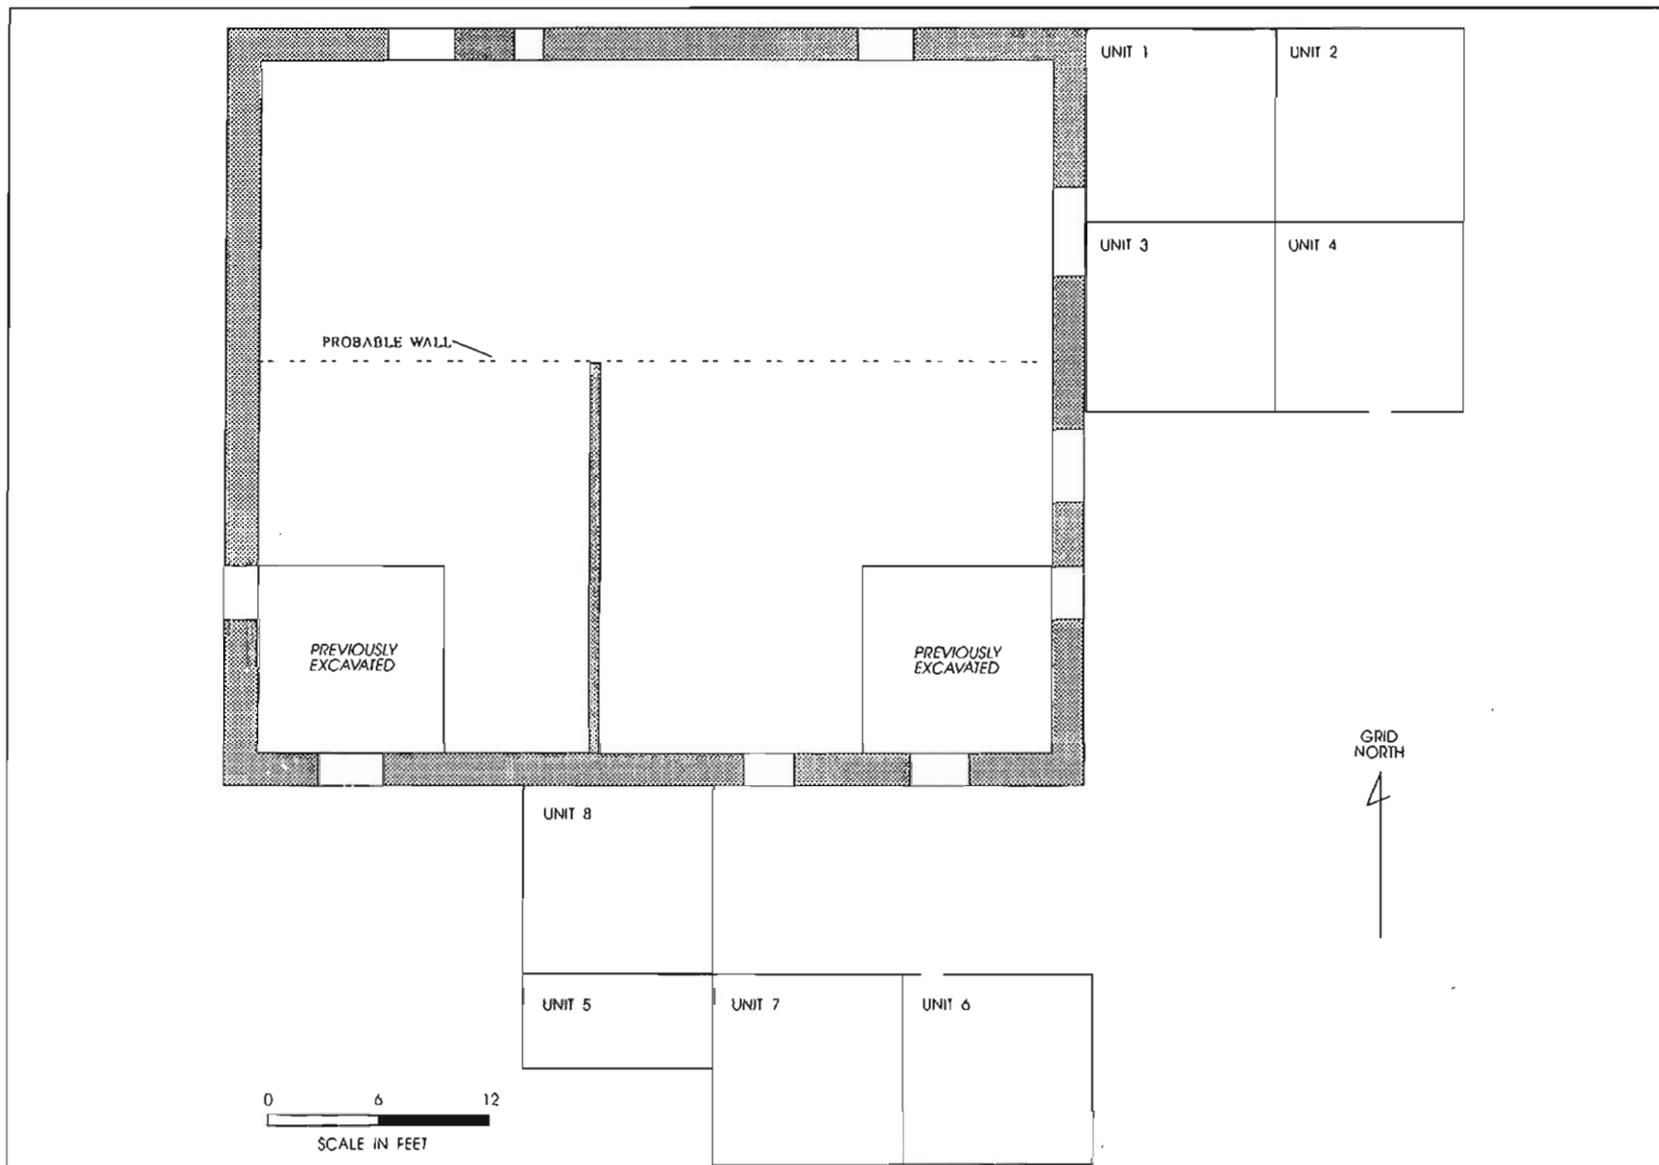
Figure 5. Block excavations and unit designations on the east and south facades of the main house.

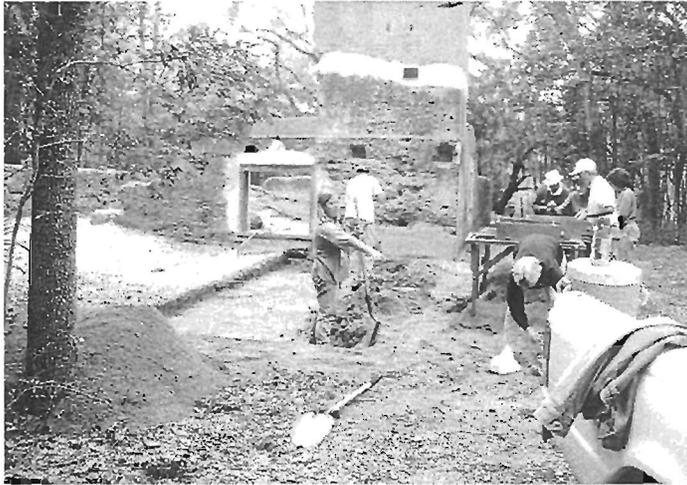
Figure 6. Excavations in Units 1 and 2 along the east side of the main house. In the background can be seen the joist sockets in the tabby wall for the porch thought to be located in this area.

Feature 3 is interpreted to represent a robbed pier to support the eastern piazza or porch. It is found 9 feet from the east facade and in line with one of the joist sockets. It was only 0.55 foot in depth, suggesting that the porch supports were very shallowly placed.

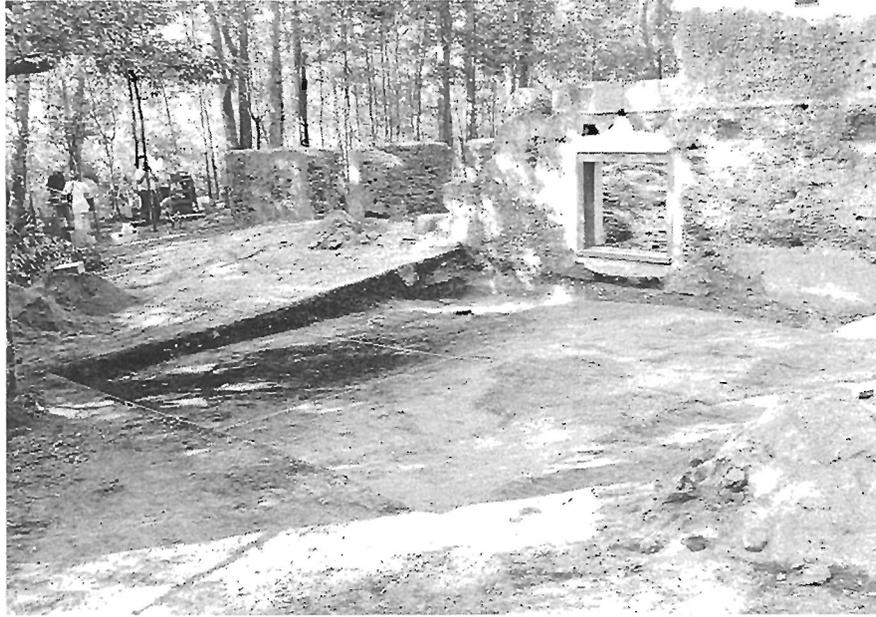
Figure 8. View of the block excavations on the east side of the mansion, looking to the southwest. Visible in this photograph is the standing tabby wall with the recently repaired opening, Feature 1-3, the brick flooring, and the amorphus black stain encompassing most of Unit 4.

Identified in the block excavations, but not removed, were three additional features. Encompassing most of Unit 4 and extending into Units 3 and 2 was a large amorphous black stain with abundant brick rubble. Although no function can be ascribed to this feature, it was not excavated because it produced rather large quantities of modern materials during troweling. At least portions of it appear to be the remains of

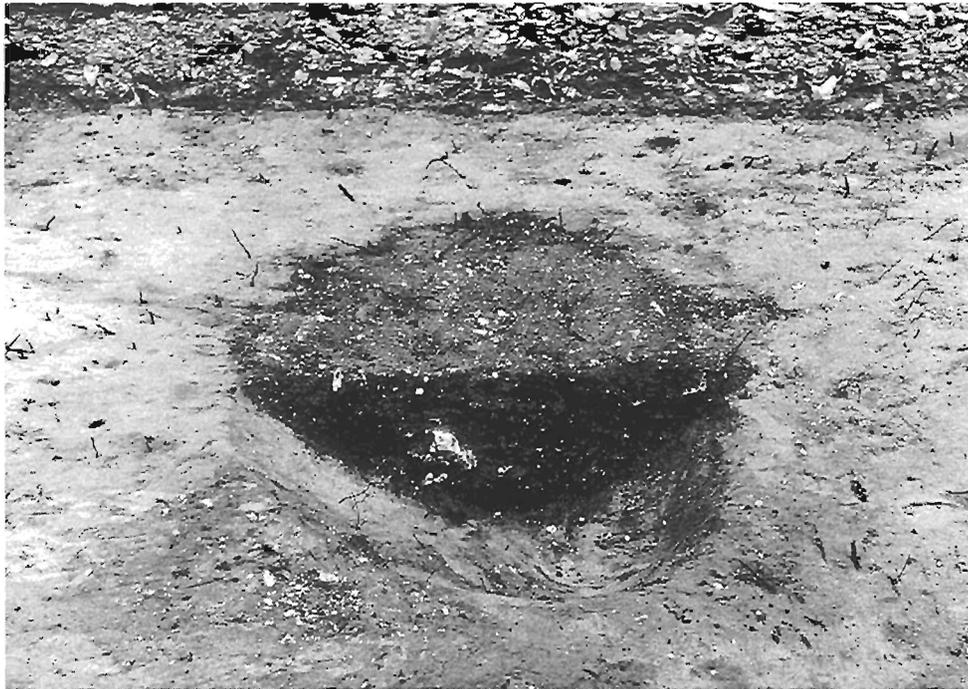
Figure 9. Feature 1, eastern half excavated, view to the west (tabby wall is in the background).

Feature 1, found in the northwest quadrant of Unit 1, was a oval pit measuring about 1.8 feet north-south by 2.5 feet east-west. It had been previously identified in testing, but was not

Feature 1 was 0.63 foot in depth (Figure 9) and consisted of brown sand and shell. It contained a total of 17 pounds of rubble (including a mix of both shell and mortar, although no tabby was present). The pit produced a small assortment of trash, including window glass, a broken hoe, a brass rod, and a small amount of fish bone. Also incorporated in the collection was a white metal regimental number "7." Our initial assessment that the feature represented a trash pit excavated by a military detachment seems accurate. The assortment of trash, including the regimental number, seems consistent with military policing activities.

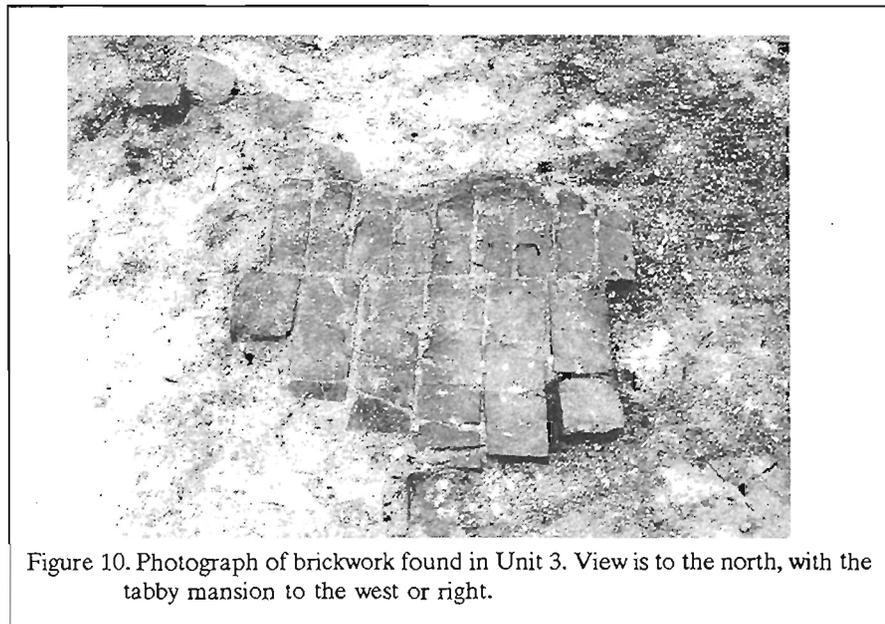
Figure 10. Photograph of brickwork found in Unit 3. View is to the north, with the tabby mansion to the west or right.

The other feature, encountered in the central portion of Unit 3, consists of the remains of a brick floor found on the western edge of the black stain (Figure 10). It seems likely that at least some, if not all, of the bricks found in the stain, are from this floor.

With the small amount left intact it can't be determined whether this represents flooring under the porch, some type of walkway, or possibly a remnant drainage. Unfortunately, one explanation is no better than the other. If the walk extended under the entire porch, it seems that some evidence of the brick work, or it being robbed, would have been found in Unit 1. It seems equally unlikely that if the brickwork extended to the north that the edging course would have been required. There is, however, no doorway to the west of this brickwork which would support its identification as a walkway. While it may represent a drainage, those which have been identified at other rural sites (such as at the Kiawah Shoolbred house) have the sailors sunken below the soldiers in order to channel the water. In addition, the example at Stoney/Baynard is essentially level and provides no fall away from the house.

Whatever the feature was originally, it has been extensively robbed — an activity which probably took place during or shortly after the plantation's occupation by Union troops (probably at about the same time other architectural details were being removed). In order to better understand this feature it will be necessary to open a considerably larger area in the hopes of finding additional paving which can help identify its function. In particular, areas south of the feature, under the tabby wall fall, and areas on the west side of the house, also under tabby fall wall, are the most likely candidates to have offered protection to the feature.

While the function of this brickwork cannot be immediately identified, it is nevertheless important in helping us to understand the development of soils around the mansion. The upper surface of the brick — at 22.28 feet AMSL — is assumed to have been at the original grade. Today this is at about the level of what is being called subsoil, meaning that little humus development was present when the mansion was built. If this is correct, then the basement floor level of the southwestern room, identified at 22.7 feet AMSL, was about 0.4 foot above the exterior grade, perhaps to encourage drainage away from the structure and prevent flooding during heavy

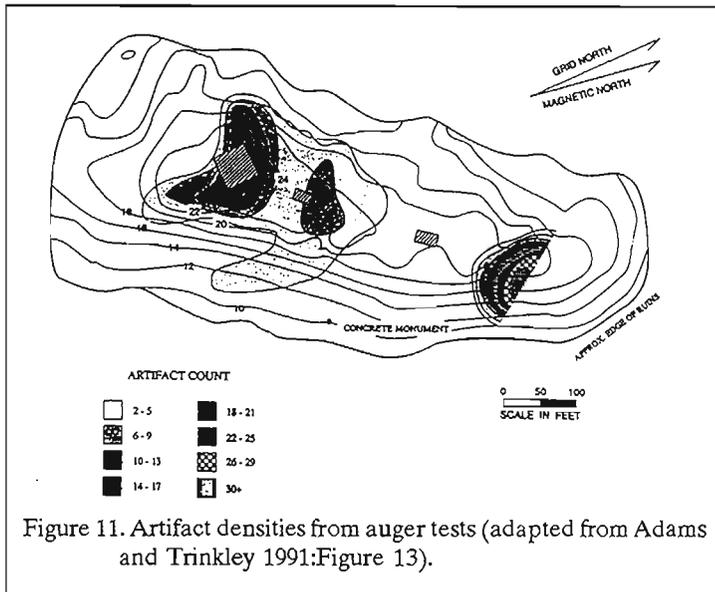
Figure 11. Artifact densities from auger tests (adapted from Adams and Trinkley 1991:Figure 13).

This was a portion of the site which had never been examined, outside of the auger tests conducted during the first season's investigations. These tests, at 50-foot intervals, revealed a crescent-shaped concentration of artifacts sweeping from the south elevation of the main house to the northwestern corner and beyond. A somewhat similar concentration of shell was noted, with the greatest densities found primarily from the northwest corner to about 75 feet to the north of the house (Adams et al. 1991:Figures 13 and 14; Figure 13 is reproduced here as Figure 11). These findings seemed anomalous, but lacking additional investigation little could be made of the results. We hoped that the additional work on the south side of the main house, in addition to the primary goals, might help us better understand the results of this initial auger survey and perhaps even focus future research around the main house.

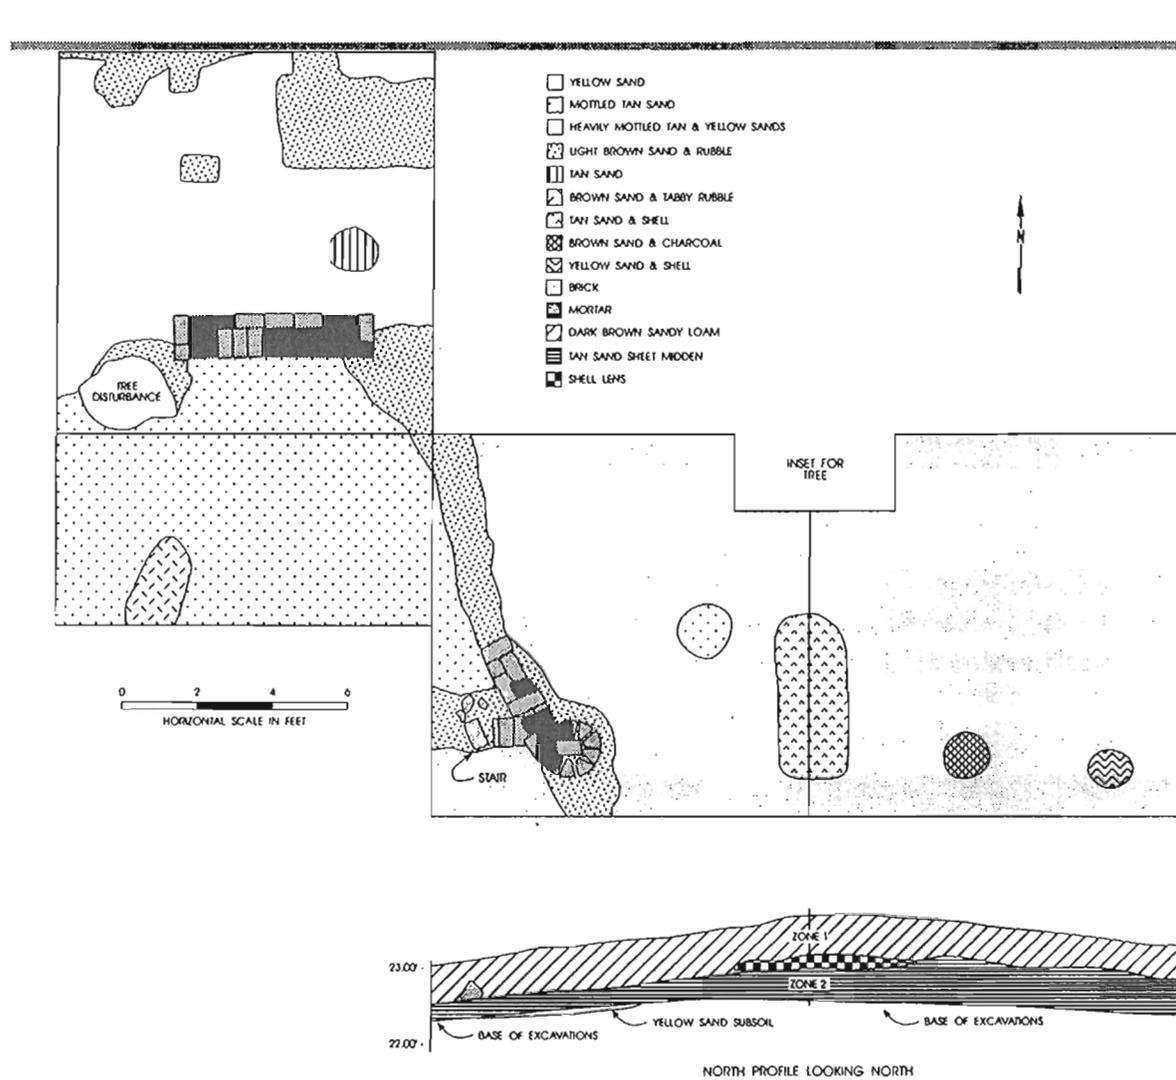
Figure 13. Plan view and profiles of excavations on the south side of the main house.

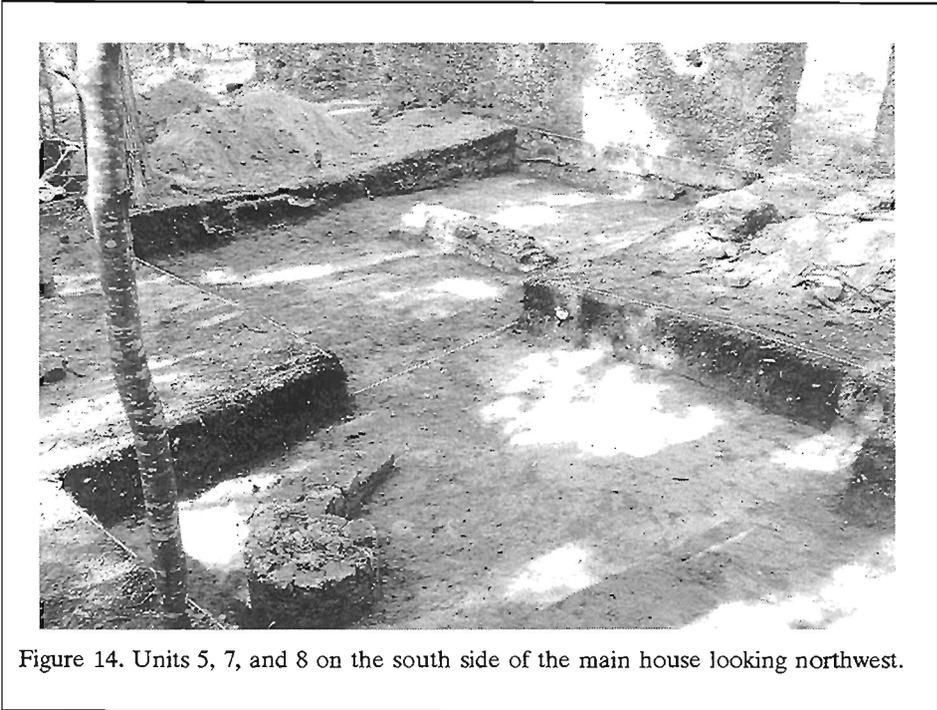
Figure 14. Units 5, 7, and 8 on the south side of the main house looking northwest.

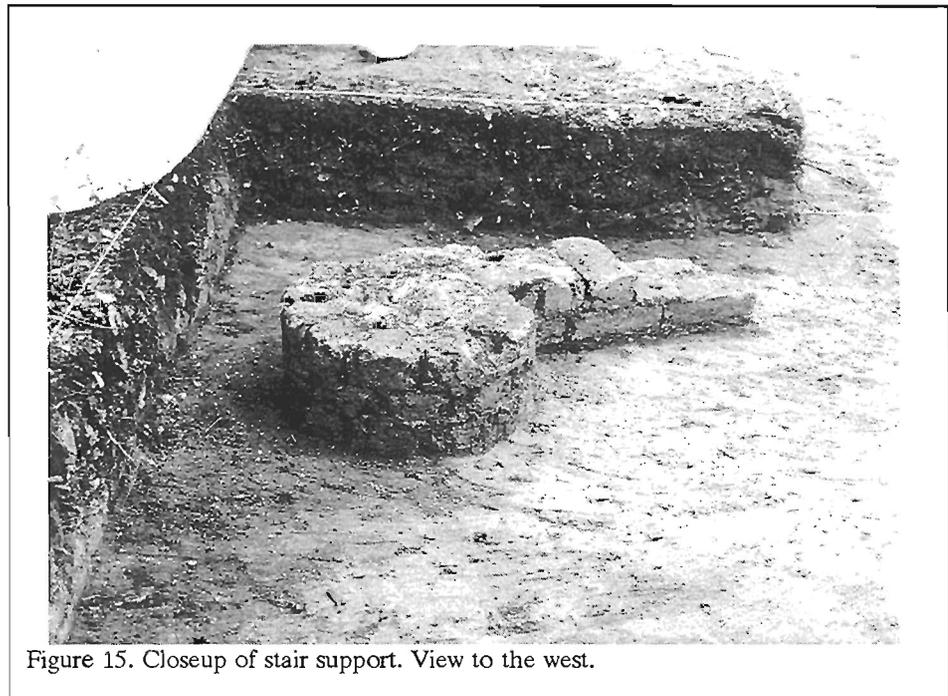
Figure 15. Closeup of stair support. View to the west.

In addition to the midden identified as Zone 2, the excavations produced two architectural features of special importance to our interpretation of the main house. The first is the eastern stair support found in Unit 7 (Figure 15; see also Figure 13). This support might also be described as the eastern stringer for the stairs which flared out, ending in a circular detail which perhaps provided support for the newel post. This feature is also referred to as a "ramp." The first tread is still partially in place.

The stair support was constructed of mortar brick, not cast tabby, and was probably originally stuccoed. Given the damage to the stair support, which appears to have been robbed, it is impossible to determine if it was solid to the

A total run of 10.2 feet suggests that the stairs had to ascend to a height of almost 8 feet, about 84 inches, resulting in 12 rises with a 7-inch unit rise and 10½-inches for the unit run. This scenario would result in a total run of 10.5 feet, much closer to that observed. Consequently, it seems likely that the porch was about 8 feet above the ground level, providing perhaps 7 feet of head clearance in the lower half story of the Stoney/Baynard mansion.

The stair support is 15.6 feet from the eastern corner and the back support is 24.3 feet from the same southeastern corner of the mansion.

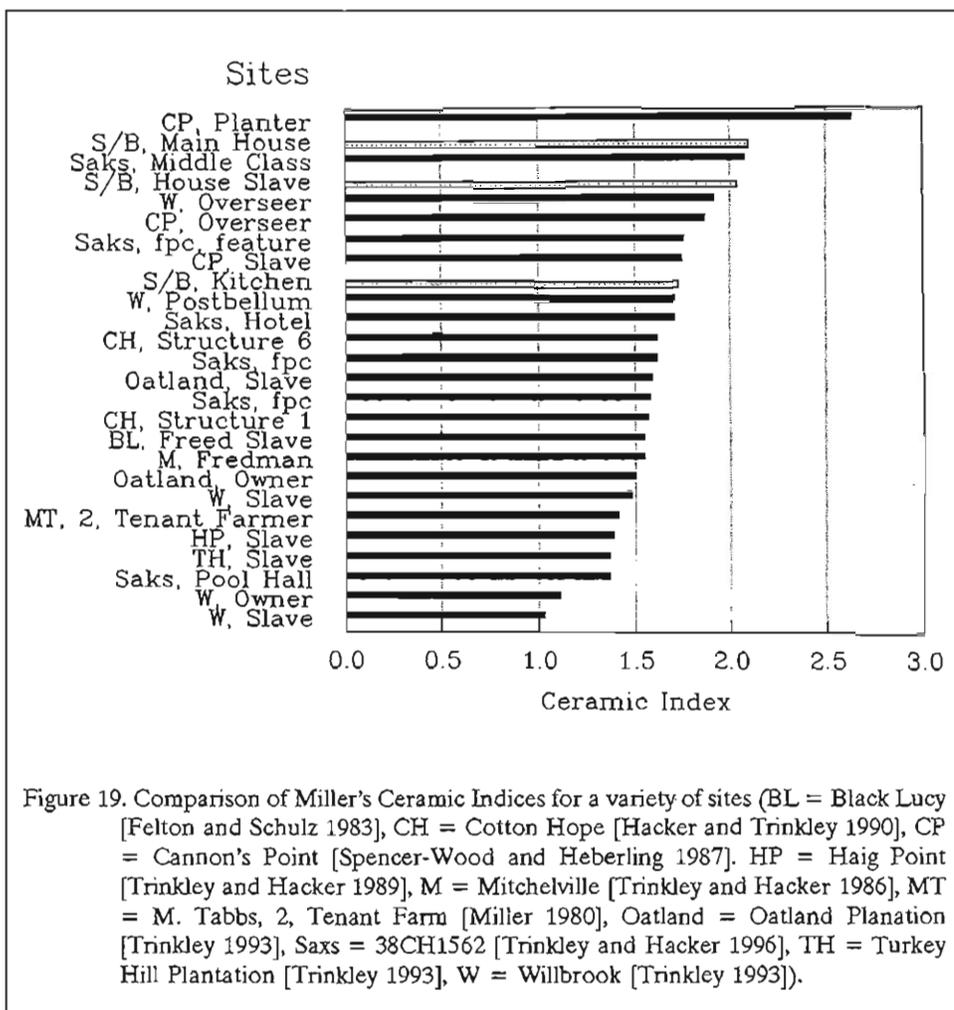
Figure 19. Comparison of Miller's Ceramic Indices for a variety of sites (BL = Black Lucy [Felton and Schulz 1983], CH = Cotton Hope [Hacker and Trinkley 1990], CP = Cannon's Point [Spencer-Wood and Heberling 1987], HP = Haig Point [Trinkley and Hacker 1989], M = Mitchelville [Trinkley and Hacker 1986], MT = M. Tabbs, 2, Tenant Farm [Miller 1980], Oatland = Oatland Plantation [Trinkley 1993], Saks = 38CH1562 [Trinkley and Hacker 1996], TH = Turkey Hill Plantation [Trinkley 1993], W = Willbrook [Trinkley 1993]).

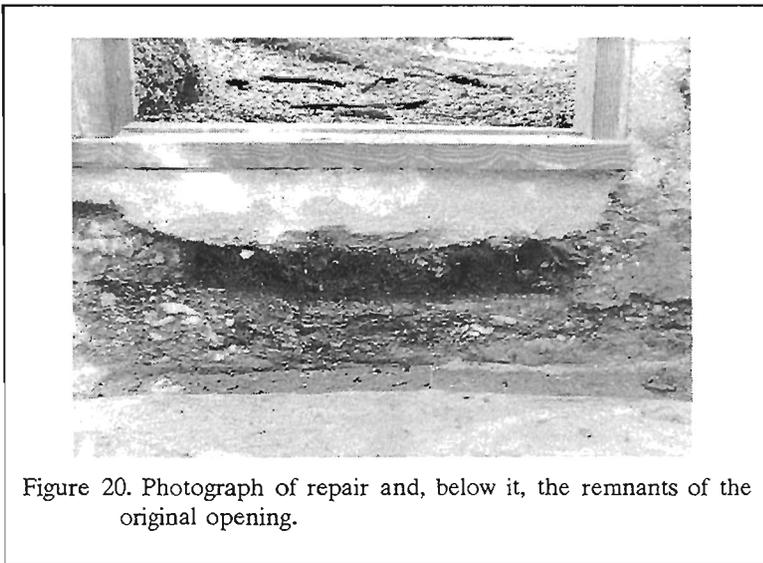
Figure 20. Photograph of repair and, below it, the remnants of the original opening.

Nevertheless, some efforts have not achieved the intended goals. For example an "experimental" capping on the domestic slave house foundation (Structure 1) is aesthetically stark, poorly documented, and likely to cause long-term damage. One of the most obvious flaws in repair efforts thus far can be seen in the opening on the east side of the main house. Here, without appropriate archaeological investigations or documentation of current conditions, a window was

"recreated." Although the tabby was eroded and seriously damaged above grade, the current archaeological study revealed a well defined, narrower and taller opening below grade (Figure 20). It is likely that removing the incorrect repair, reframing this opening, and repatching the tabby will be both costly and potentially dangerous to the historic fabric.
