ROAD AND PEDESTRIAN ISSUES

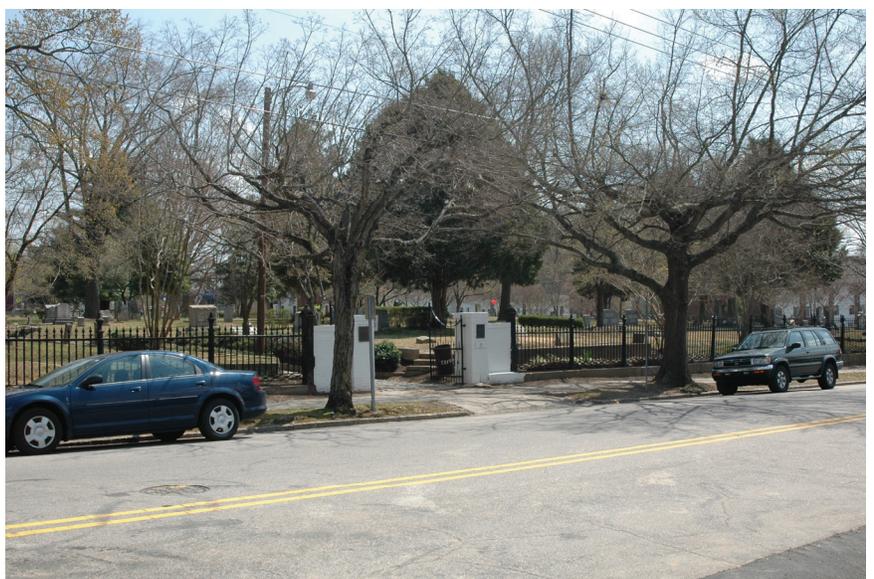
Given the number of entrances, the focal point of a "main" entrance is diluted. In addition, this entrance off East Street is not particularly dramatic or otherwise distinguished from the others (Figure 21). On-street parking

can detract from the entrance, as well as make entry more difficult. The entrance is further compromised by the topping of the street trees by the utility company. This has resulted in disfigurement of the trees and the loss of the trees' natural shape.

Figure 21. East Street entrance to City Cemetery.

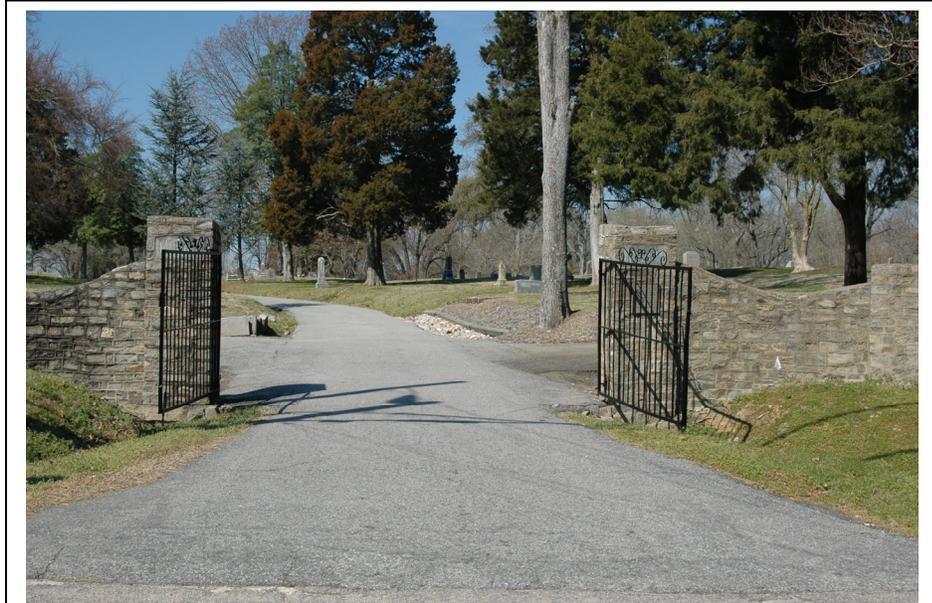
Mount Hope has one formal entrance at the middle of the Fayetteville Street side. Although it seems unlikely that this gate and its stone columns are original to the cemetery, they are clearly historic and should be carefully

Figure 22. Main entrance into Mount Hope Cemetery off Fayetteville Street looking west.

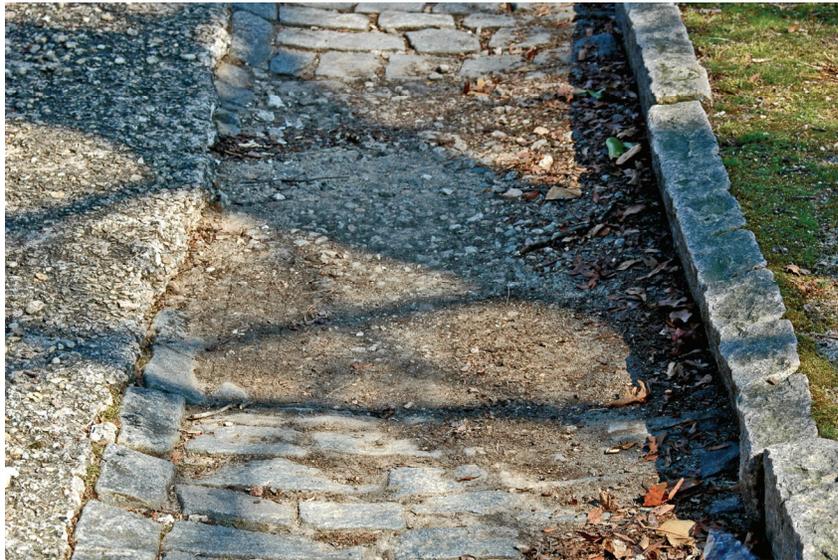
Figure 23. Inappropriate repair of damaged granite blocks using concrete.

Repairs of this roadway have, unfortunately, been careless and represent poor workmanship. Figure 23 illustrates an inappropriate repair of this historic fabric.

It appears that the road foundation began to collapse. This might be related to a grave that is partially under the road or to a weak area in the base material. The dip in the gutter area resulted in loss of granite blocks. The appropriate repair would have involved the removal of the granite blocks for the entire dipped area, repair of the foundation, and then replacement of the blocks, identifying new blocks for those lost or damaged. Instead, the hole was filled using concrete. This failed to resolve the original problem, damaged the historic fabric (concrete is very difficult to remove from stone), and damaged the aesthetics of the roadway.

The roads in City Cemetery exhibit damage and inappropriate repairs. It is important that granite curbing be replaced where missing and that the granite block gutters be repaired using compatible materials. Modern road repair techniques based on concrete and asphalt should be avoided.

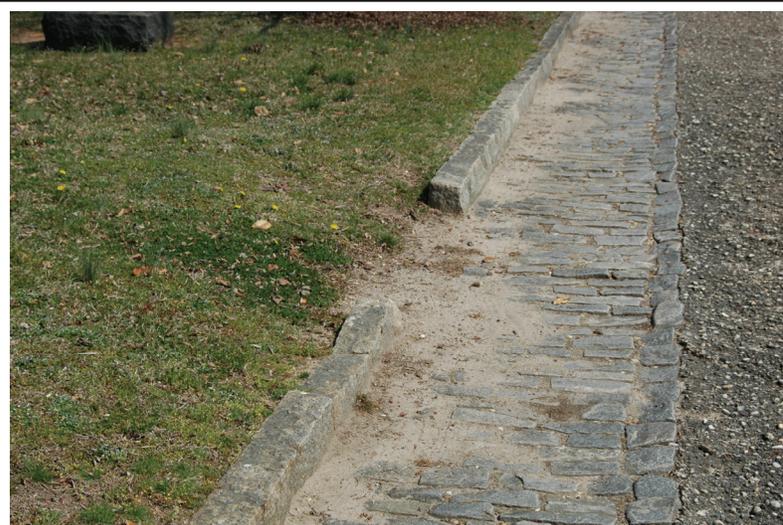
Figure 24. Loss of granite curbing. This requires replacement in order to prevent additional damage and cost.

section of granite curbing is missing. This requires replacement, using rusticated granite curbing to match the original. Following a review of the draft report, the city has contracted for the curb to be replaced. This is good since it helps restore the original appearance of the roadway.

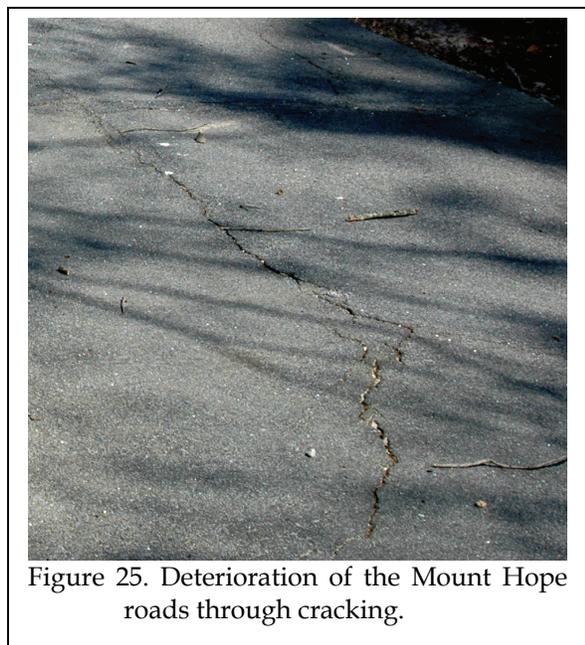
The wear coat on many roads appears to be in good condition. There are, however, several areas where the wear coat is cracked and deteriorating (Figure 25). Cracks such as these allow water to get into the roadway base and subgrade, resulting in pavement breakup and potholes. The cracks we observed in Mount Hope Cemetery roads appear to be good candidates for filling or sealing. This is a job that

Figure 25. Deterioration of the Mount Hope roads through cracking.

likely can be performed at little cost by the City's own roads department.

Two of the most critical issues affecting the treatment of cracks are the cleaning and drying of the cracks, as well as the preparation and application of the chosen material. Cold temperatures, soil, and moisture can prevent proper adhesion between the sides of the crack and the sealing material. Therefore, the use of hot compressed air followed by a heat lance is often recommended – and would be appropriate for the Mount Hope paving.

A 1999 study by the Federal Highway Administration, though based on much heavier traffic than Mount Hope's roads see, found that several techniques provide good, long-term performance. The city should consider an asphalt rubber or rubberized asphalt used as either a flush-fill or overband configuration (Federal Highway Administration 1999).

The Mount Hope roads are generally in satisfactory condition, although several areas of premature cracking and erosion were identified. These should be repaired by the City. Asphalt rubber or rubberized asphalt used as either a flush-fill or overband configuration should be considered.

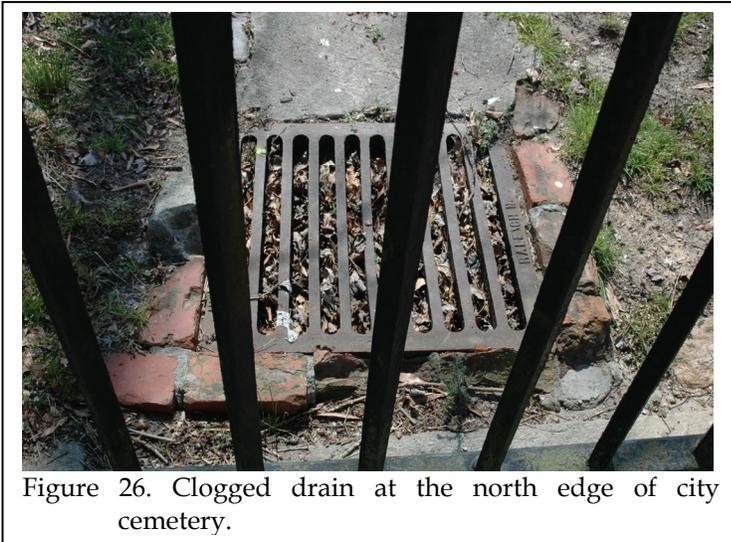
I did, however, observe at least one catch basin drain on the northern edge of the cemetery at New Bern. The drain, however, was entirely clogged with leaves and soil. There may

Figure 26. Clogged drain at the north edge of city cemetery.

I understand that subsequent to our study, the City has cleaned these drains and an effort is being made to examine the drain lines. The drains and drain lines should be placed on a preventative maintenance schedule.

All catch basins and drains in both City Cemetery and Mount Hope should be cleaned and repaired as needed. Open drains in Mount Hope Cemetery should be camouflaged using rip rap.

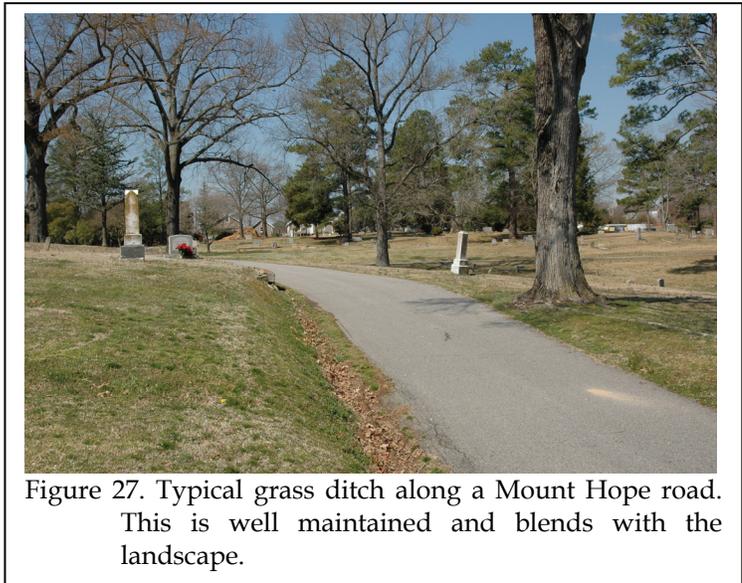
Figure 27. Typical grass ditch along a Mount Hope road. This is well maintained and blends with the landscape.

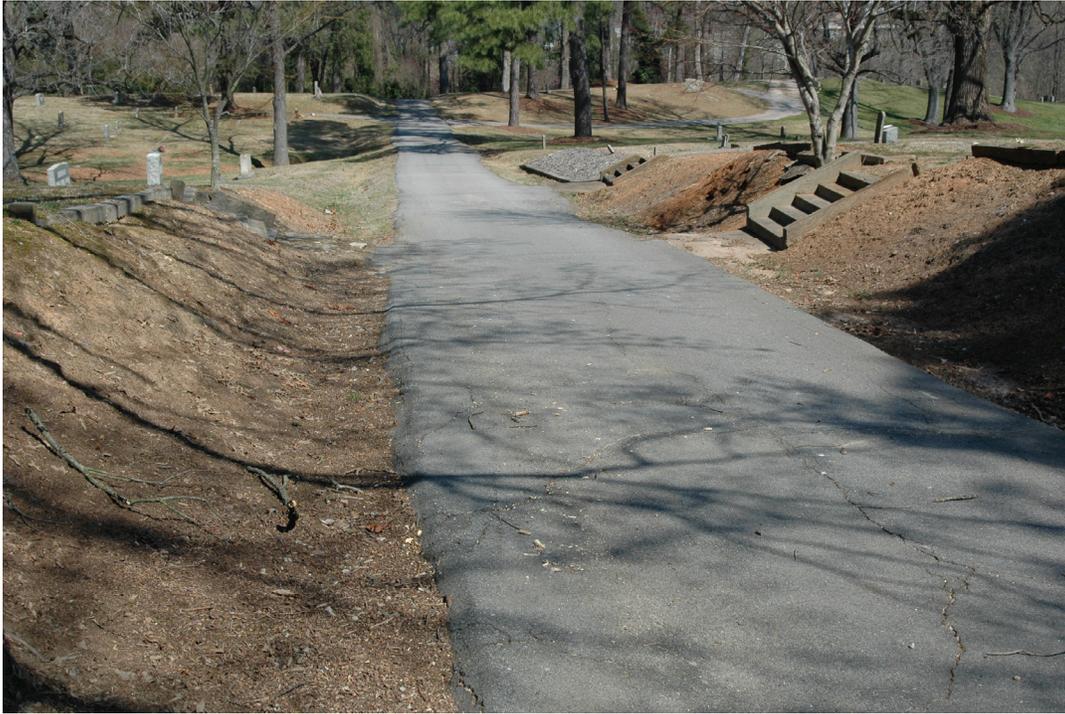
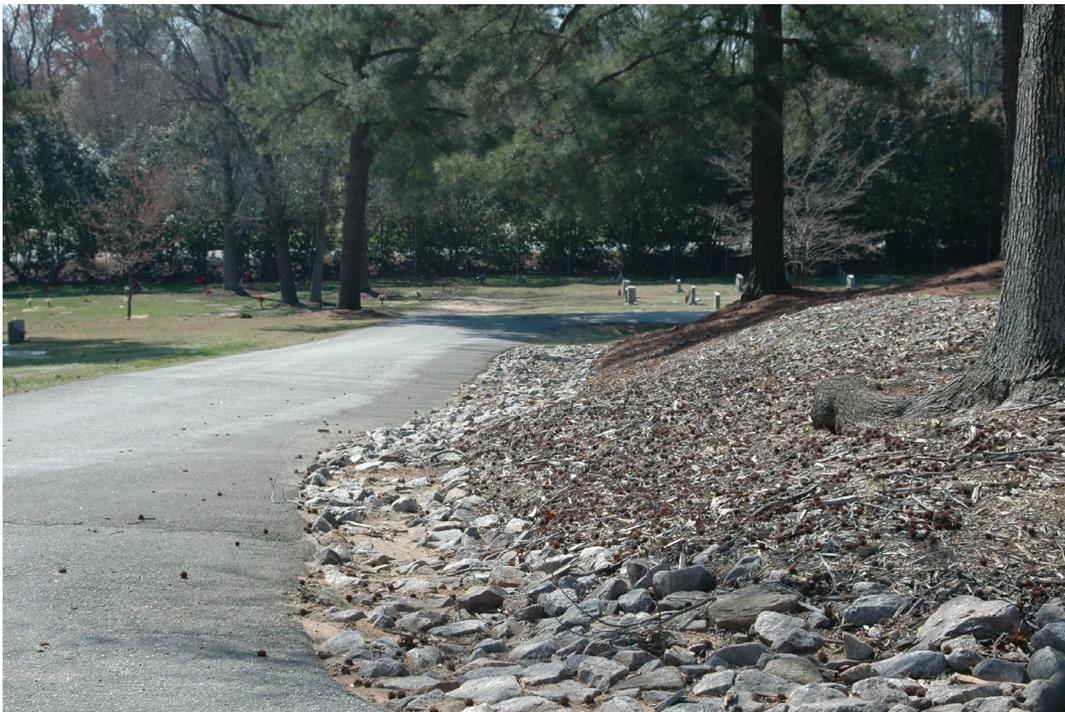
Figure 28. Erosion in Mount Hope. Top photograph shows an area of erosion. Areas have landscape timbers or mulch being used for control. Bottom photograph shows excellent use of granite rip rap to control erosion. This approach should be expanded throughout the cemetery.

We recommend that where additional road side erosion control is necessary that rip rap be exclusively used. Areas where mulch or landscape timbers have been used should be converted to rip rap. We understand the concern with cleaning up vegetation, especially sweetgum, in these areas. However, the use of blowers combined with a gradual replacement of sweetgum with more appropriate trees will resolve these concerns.

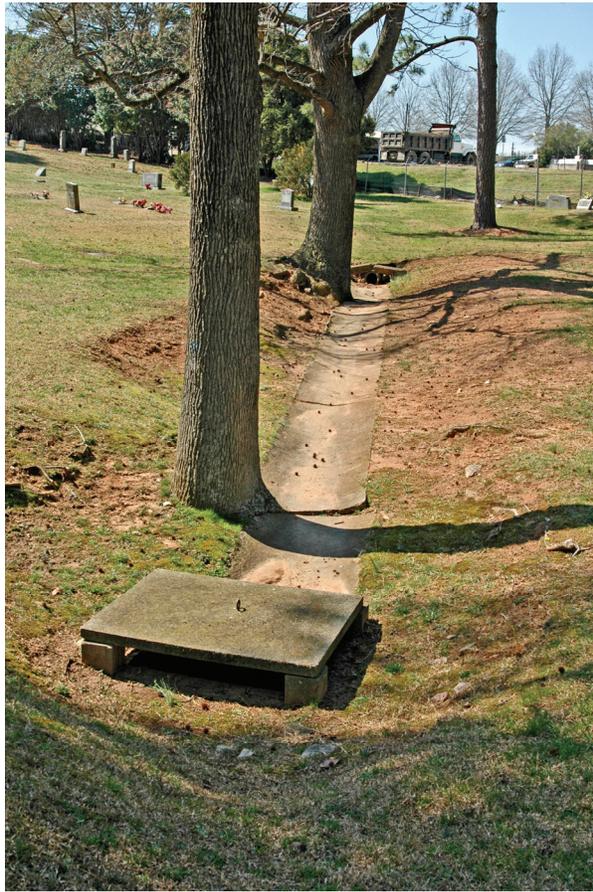
Figure 29. Unattractive open drain in Mount Hope. This could be improved through the addition of rip rap.

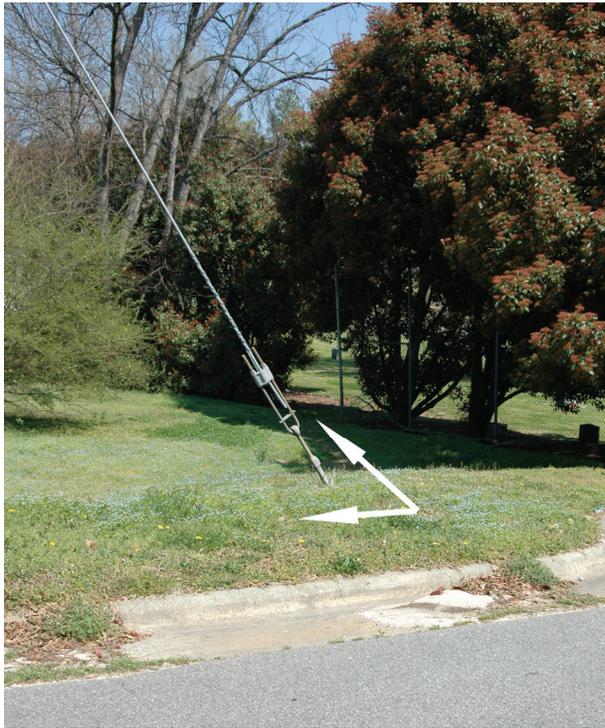
During this assessment we noted only one inappropriate cut-through with landscape damage (Figure 30). This one example was found running off Prospect Street northeast into the cemetery.

Figure 30. Beginning of an inappropriate pedestrian pathway through Mount Hope.

The City should identify inappropriate pathways and take immediate action to prevent landscape damage. A typical approach is the installation of signage asking citizens not to damage the plantings and immediately replanting the worn grass. This direct confrontation – through signage and replanting – is usually adequate to control the process. If it does not work, we recommend selecting plantings, such as yucca, osage orange (although a tree, they can be planted close together and pruned to promote an almost invincible hedge), or hollies that will deter pedestrian access.

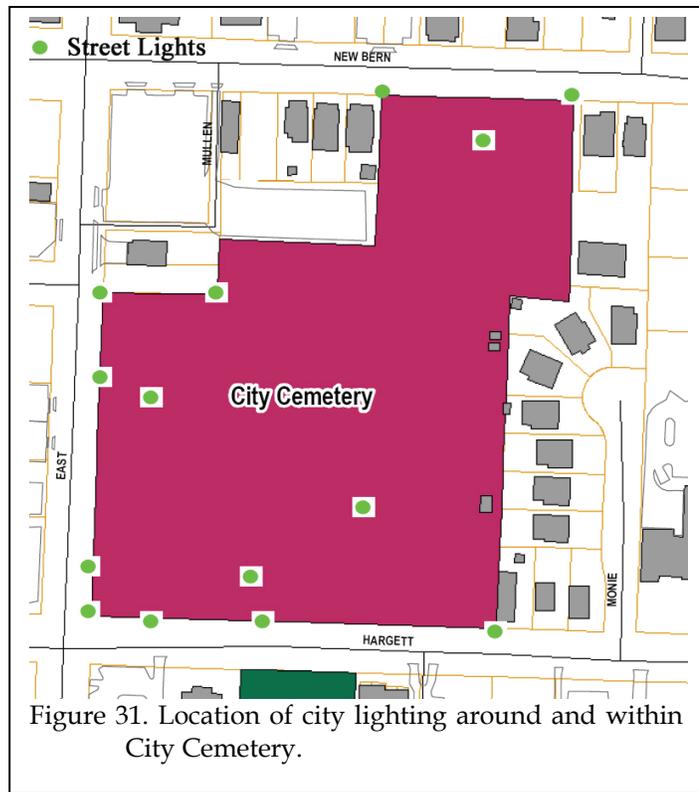
Figure 31. Location of city lighting around and within City Cemetery.

In addition, the cemetery hardest hit by vandalism - City Cemetery - has considerable lighting already. In fact, it has more lighting than I have observed at any other urban core historic cemetery. Figure 31 shows the location of city pressure sodium lamps surrounding and

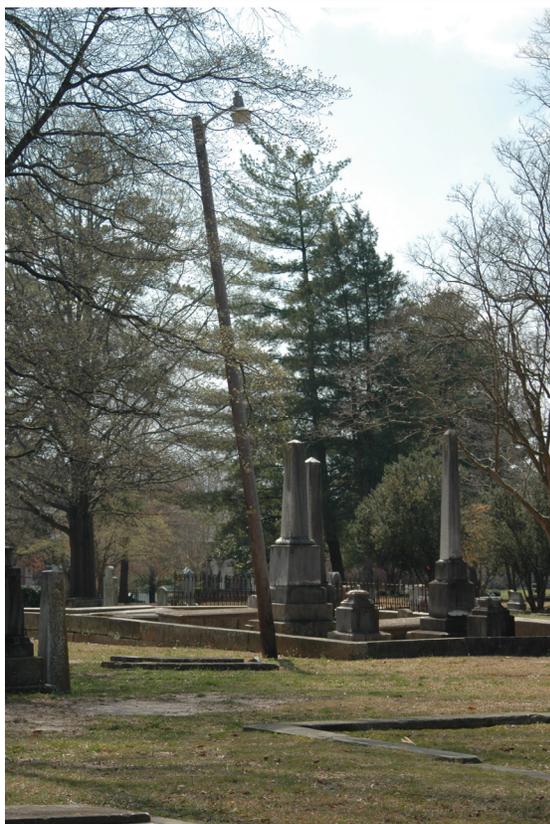
Figure 32. Example of inappropriate lighting in City Cemetery. Given the extent of vandalism, this lighting is serving little purpose.

within City Cemetery. Figure 32 reveals how unattractive and intrusive these lights and poles actually are.

Given the extent of vandalism at City Cemetery, it is clear that the security lighting already present is providing little protection. We do not recommend any additional lighting.

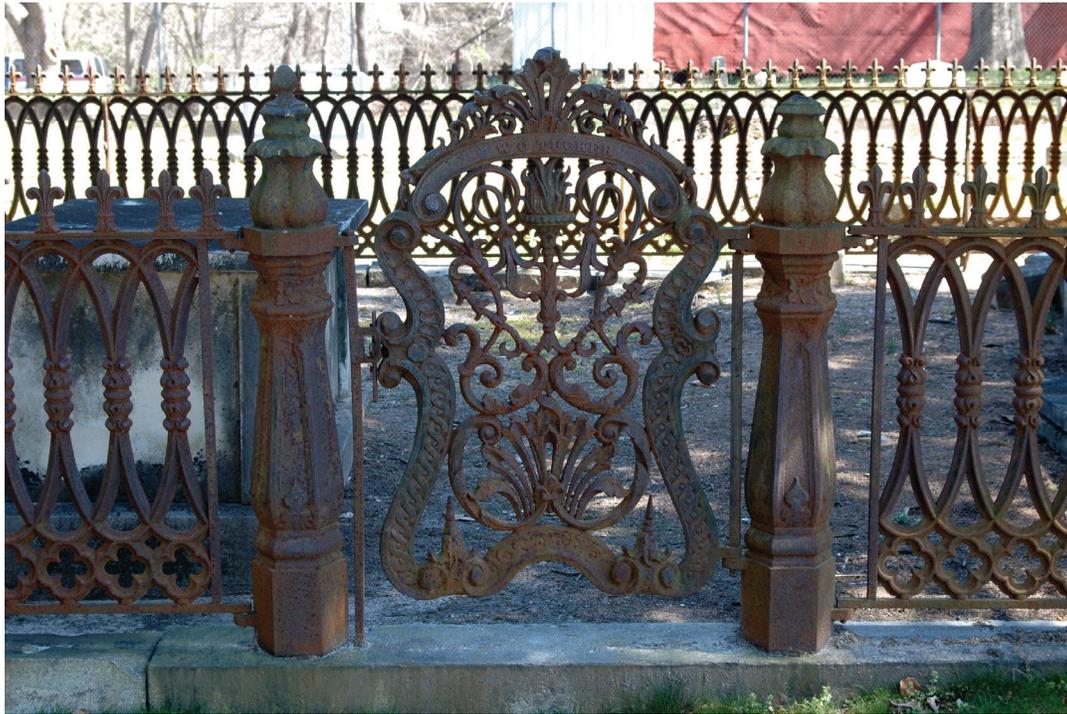
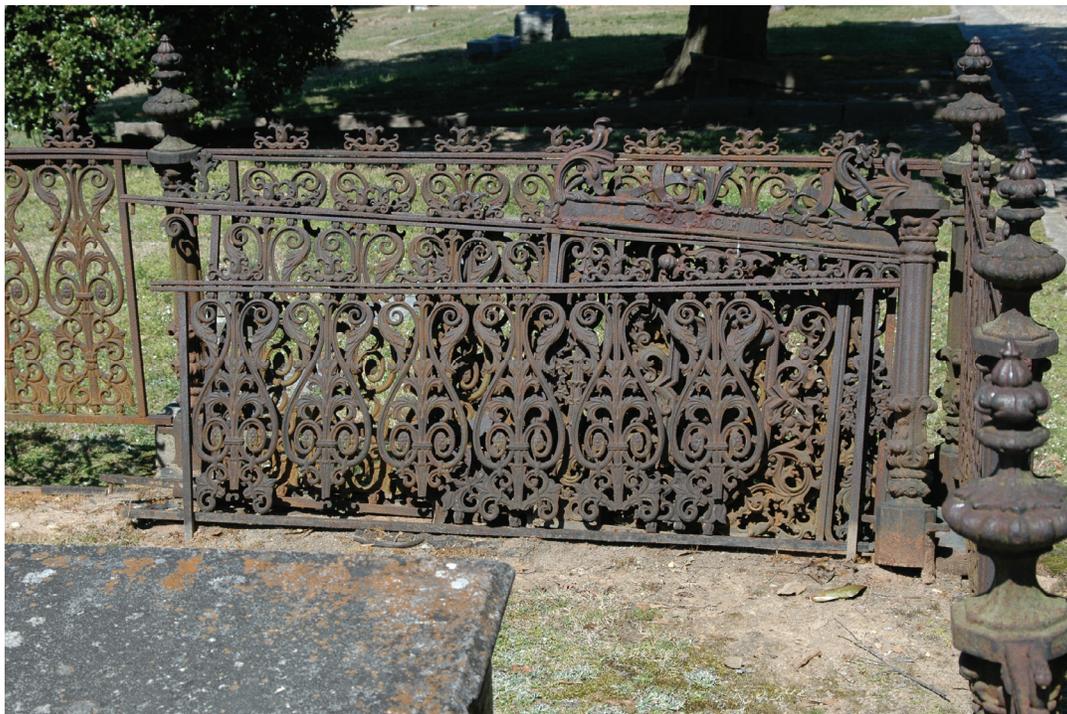
Figure 33. Fencing that invites theft and vandalism. The top photo shows an unsecured gate that could be stolen in minutes. The bottom photograph shows stacked fencing and a gate that are unsecured and could be easily stolen.

During this assessment we discovered that virtually all of the fence gates on individual plots were susceptible to theft since none were secured. It is a simple maintenance step to use woven stainless steel wire to secure gates to their hinge posts. This allows the gate to open and close, but makes it considerably more difficult to lift the gate off its hinges and steal it. The per gate cost is less than \$20 and the time involved is about 15 minutes per gate. This is

There are also fence sections stacked in some plots – these, too, make attractive targets of theft. They can be secured on-site or removed to a secure off-site storage facility prior to repair and reinstallation.

All plot gates in the cemetery should be secured using woven stainless steel wire, attaching the gate to its hinge post.

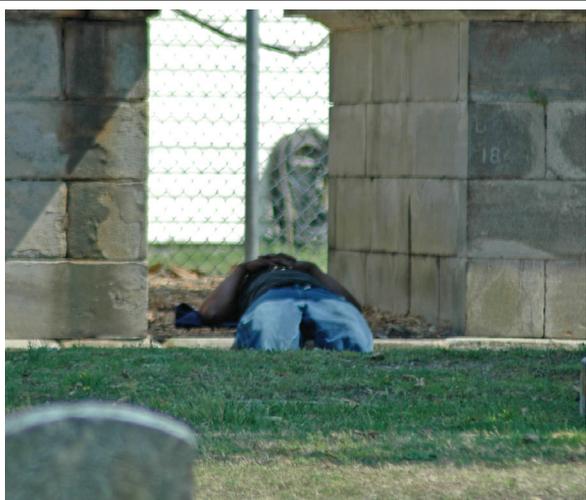
Figure 34. Inappropriate use of the City Cemetery.

Another problem, especially at City Cemetery, is the inappropriate use of the property by the homeless. The homeless population in Wake County is reported to have grown by at least 50% since 1993. While the City has joined with Wake County, Triangle United Way, and the Wake Continuum of Care, to develop a 10-year plan, there nevertheless is still inappropriate use of the cemetery. During my brief visit I observed at least one instance (Figure 34).

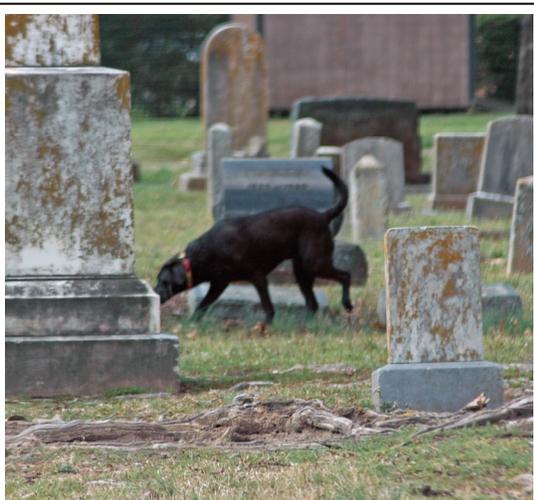
Figure 35. The use of cemetery property for off-leash dog walking or runs should be prohibited by Parks and Recreation.

Another problem use of City Cemetery, reported by staff and observed during my visit (Figure 35) is the use of the facility as an off-leash dog run. This is a problem for several reasons. First, it poses a hazard to the public who may visit the property for serene contemplation or who may be afraid of animals. Second, Raleigh has a leash law, which is being violated by this behavior (Raleigh Municipal

In a following section we recommend signage that includes a prohibition of this off leash dog walking. The staff and Friends groups should work to enforce this provision.

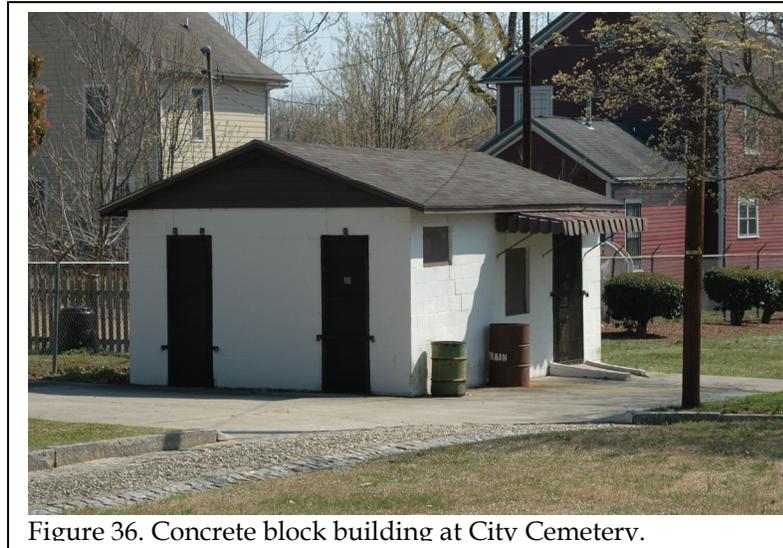
Today there is a ca. 1950 concrete block structure located at the southeast corner of the cemetery (Figure 36). At one time used as a small office, it is today largely vacant, used only for its bathroom facilities. Items stored in the

Figure 36. Concrete block building at City Cemetery.

crews. It should, however, be retained at least for the near future since it would provide excellent storage for supplies and equipment necessary during any major conservation effort at the cemetery. The structure could also be used for safe, secure storage of monument fragments and fence sections. Eventually, however, we believe that this building should be demolished and alternate use found for this space, perhaps as a small open-air museum.

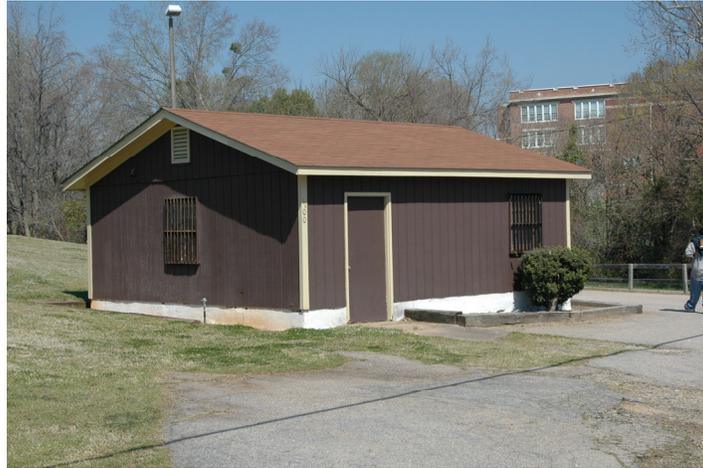
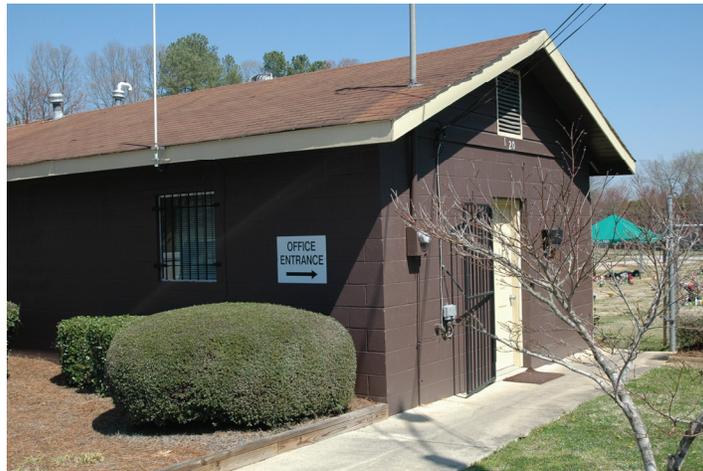
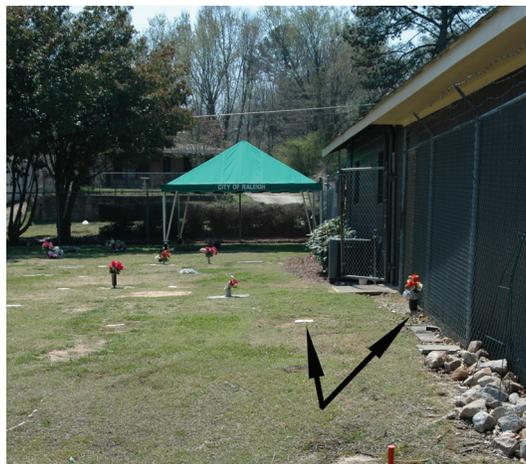
These structures are disharmonious with the quiet dignity of a cemetery and make landscape improvements difficult. In addition, it is unfortunate that graves have been laid literally adjacent to the building (Figure 37).

Figure 37. Structures at Mount Hope. The top photo shows one of the two structures at the northeast edge of the cemetery. The middle photo shows the current office. At the bottom is the rear of the office showing how close graves have been laid in next to the building.

It may help if there is adequate space to allow plantings to screen the structure. Even with little space, much of the rear is covered with chain

link, on which Confederate Jessamine (*Trachelospermum jasminoides*) could be planted to quickly hide the wall and soften its impact.

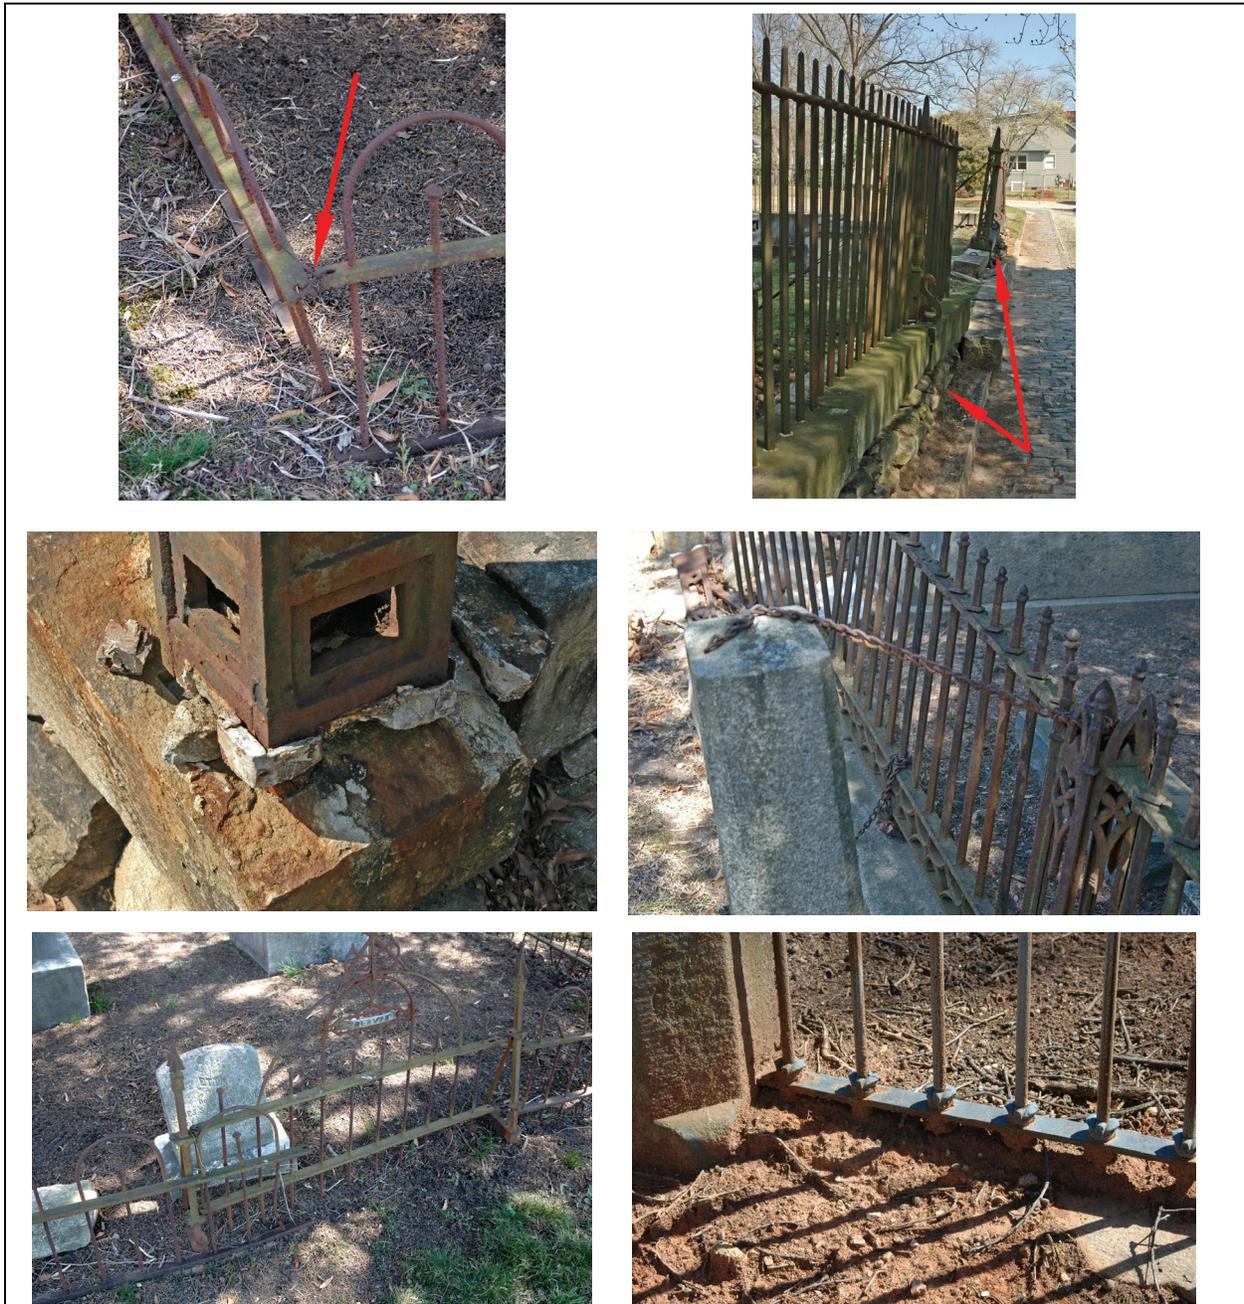
These fences, however, are in various states of deterioration and several require immediate attention. Problems include collapse of coping and fence supports, corrosion and failure of various anchoring materials, failure of section connectors on line and corner posts, incorrect previous repairs, and failure of coatings leading to extensive corrosion. In spite of these problems, most fences in City Cemetery can be rehabilitated, ensuring that they continue to contribute to the cemetery landscape.

Figure 38. Typical fence problems. Upper left shows a fence being held together with ferrous wire. Upper right illustrates the failure of the fence coping, resulting in leaning and eventual collapse. Center left shows extensive iron jacking and dislocation of the lead used to set the fence. Center right photo reveals a plot chain being used to retain an adjacent plot fence. Lower left shows a gate that no longer fits its opening and that is unsecured. Lower right shows the O'Rourke fence partially buried in soil – which exacerbates corrosion.

While repairs are needed, the primary recommendation is that the fences be painted – this will improve their appearance and will reduce future conservation problems.

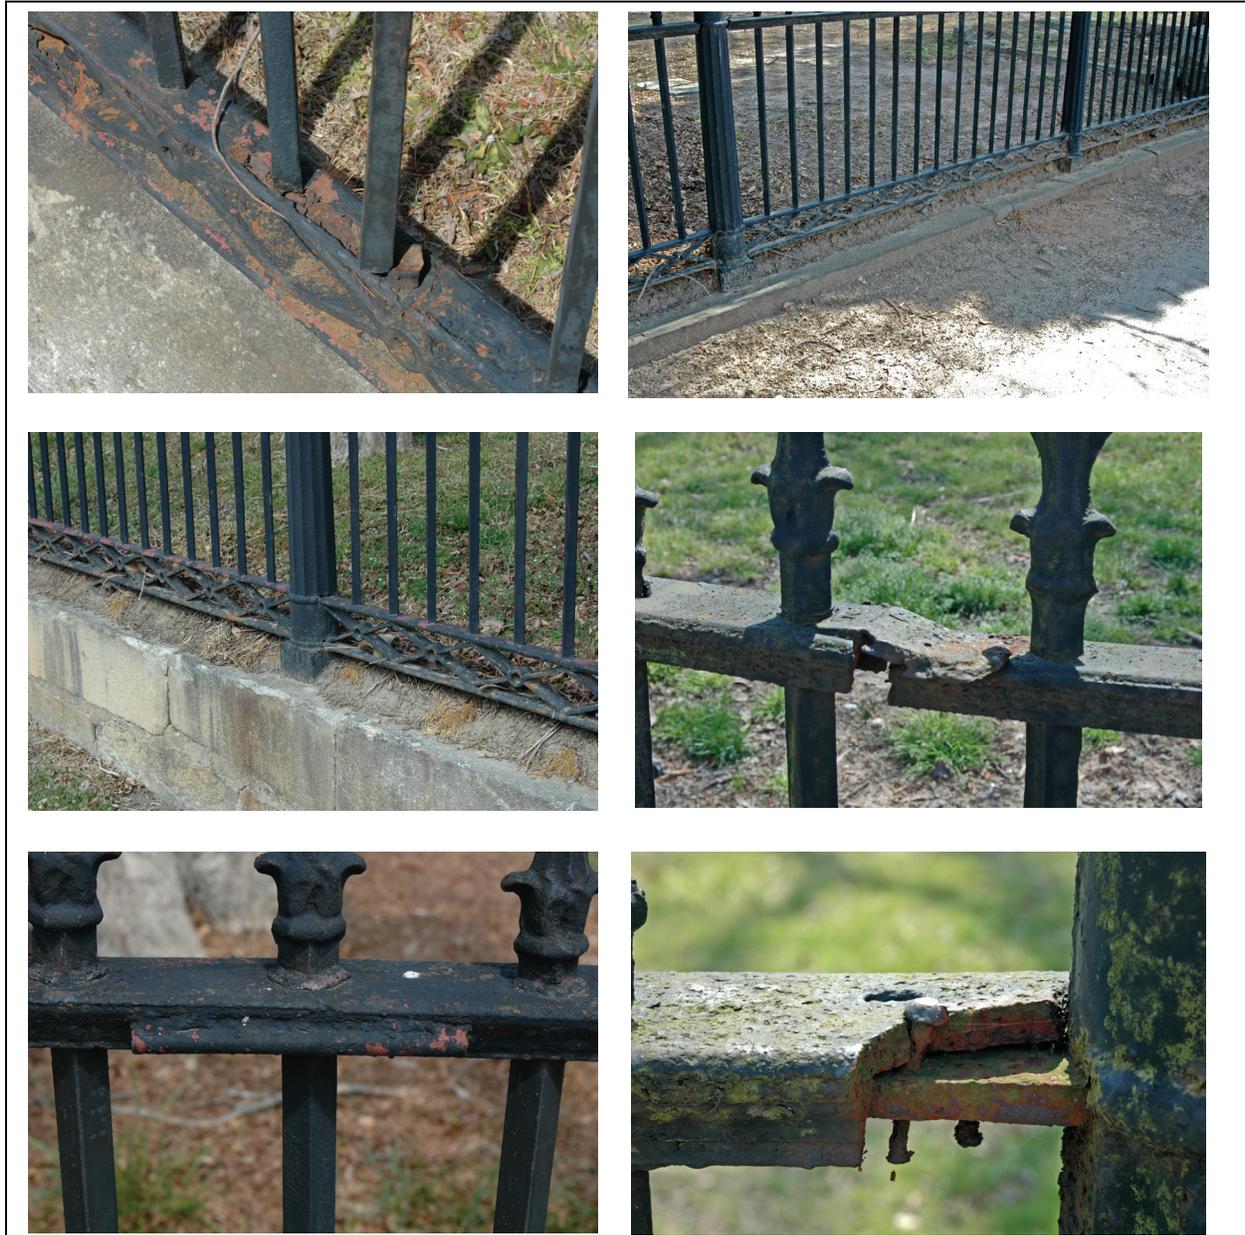
- ❖ There are several areas, both on Hargett and East streets, where the fence has become buried in the soil. This is exacerbating the corrosion problem and requires immediate attention. The ground should be sculpted back to expose the fence and the graded area should be resodded to prevent erosion.

- ❖ There are numerous areas where broken fabric has been repaired by welding. Welding, if performed using continuous (not spot) welds that are ground smooth, is acceptable where little or no expansion or contraction of the iron is anticipated. Where there were originally slip joints, however,

Figure 39. Boundary fence problems at City Cemetery. Top left shows paint failure and resulting heavy corrosion. Top right and middle left both illustrate sections of fence partially buried in soil. Middle right and lower left show inappropriate welds that no longer allow movement of the fence sections. The weld in the first photograph has failed because of this. This weld also illustrates extensive corrosion resulting from poor workmanship. The lower right photograph shows a slip joint with the top rail connected to the line post using a rivet. This allows appropriate expansion and contraction of the fence section.

welding is inappropriate since it will create stresses that can cause additional damage. For these areas it is necessary to infill the fabric and recreate slip joints that allow movement.

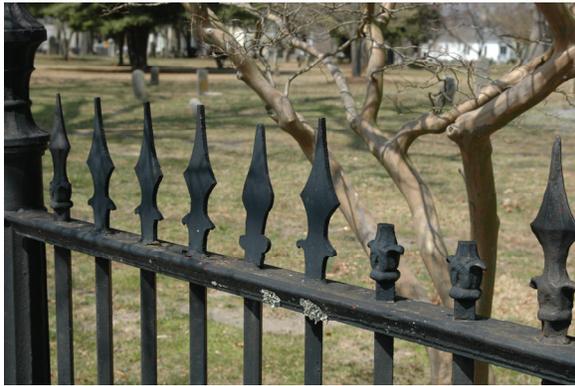
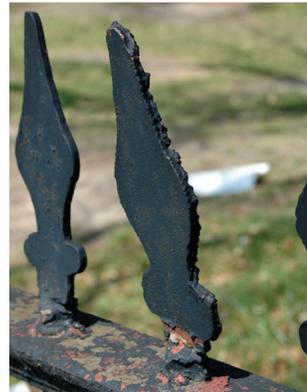
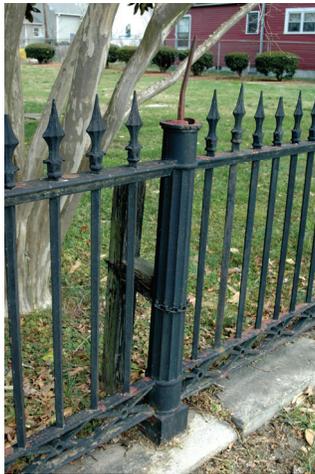
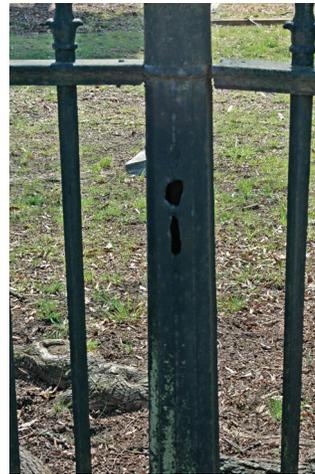
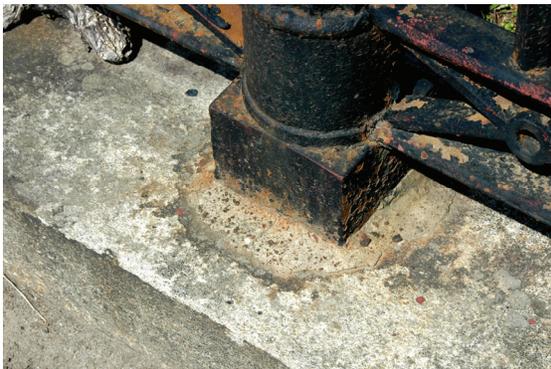
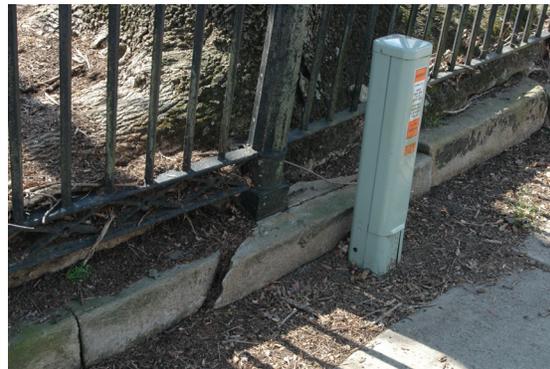
Figure 40. Boundary fence problems at City Cemetery. Upper photos show extremely poor efforts to replicate finials. Middle left shows missing cap with exposed central rod. This is allowing corrosion within the post. Middle right illustration shows a line post with corrosion that has penetrated the sides. Lower left photo shows a line post reset in concrete. Note also the extensive corrosion. The lower right photo shows damage to the fence and granite coping caused by an adjacent tree.

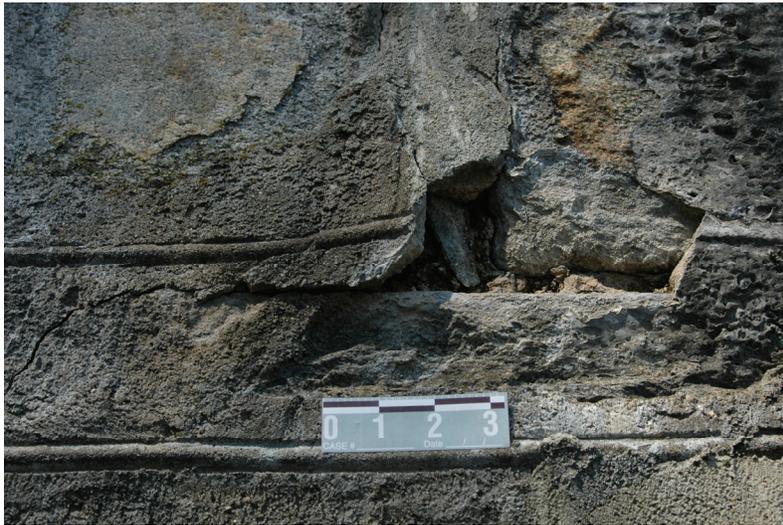
The mausoleum in Mount Hope has been repaired, albeit poorly. It appears that the gable walls were splaying, or butterflying, outward. An effort was made to draw them inward using tie rods. This was coupled with the extensive use of Portland cement in an effort to “glue” the structure together. These repair efforts are in the process of failing. There is

Figure 41. Spalling of a concrete stucco on the Mount Hope mausoleum.

extensive cracking, including evidence of foundation subsidence or settling. There are numerous cracks that are allowing water entry; some have vegetation growing in them. The iron rods are corroding and this is affecting their stability. The stucco, which appears to be a sprayed concrete, has been applied over much of the stone and is badly spalling (Figure 41). This monument, which is a unique historical asset, requires immediate attention.

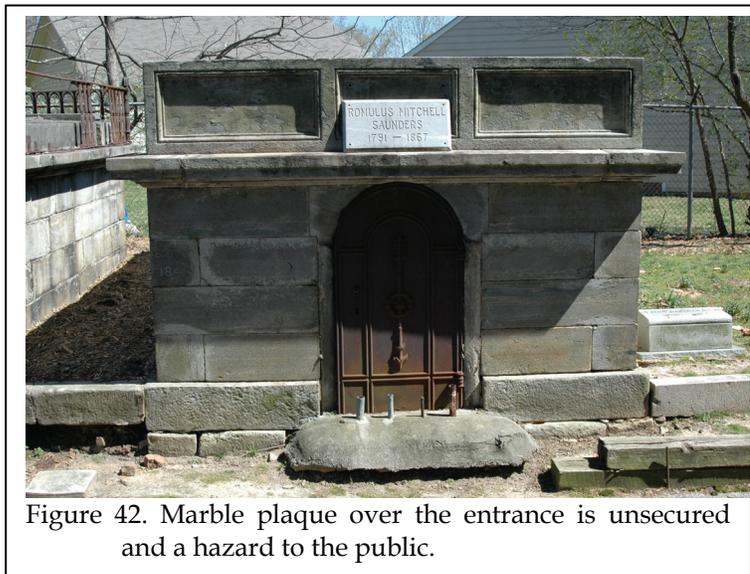
Figure 42. Marble plaque over the entrance is unsecured and a hazard to the public.
