OTHER MAINTENANCE ISSUES

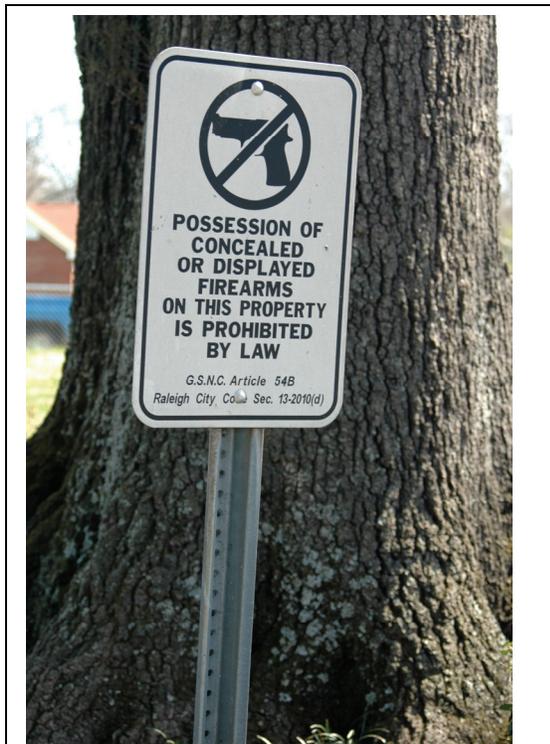
Figure 54. The most prominently displayed signage at each city cemetery warns against concealed or displayed weapons. This detracts from the cemetery landscape and certainly degrades the experience of the visit.

consistent theme between the three properties is a prominently posted sign at each, warning that concealed or displayed weapons is a violation of North Carolina and Raleigh law (Figure 54). This does not provide effective promotion of the properties. An effort should be made to reduce the impact of this negative signage on visitors, perhaps by incorporating its message with other regulations (discussed below).

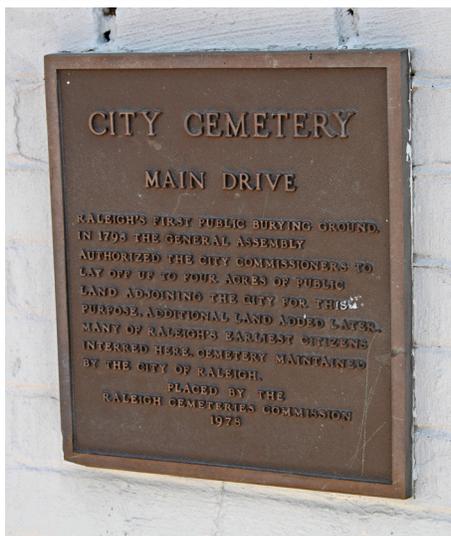
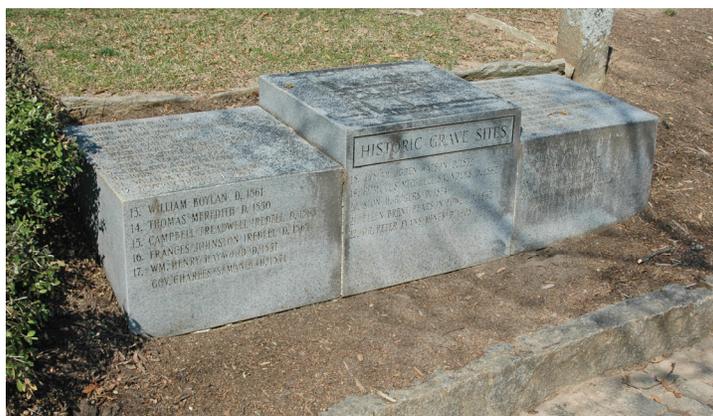
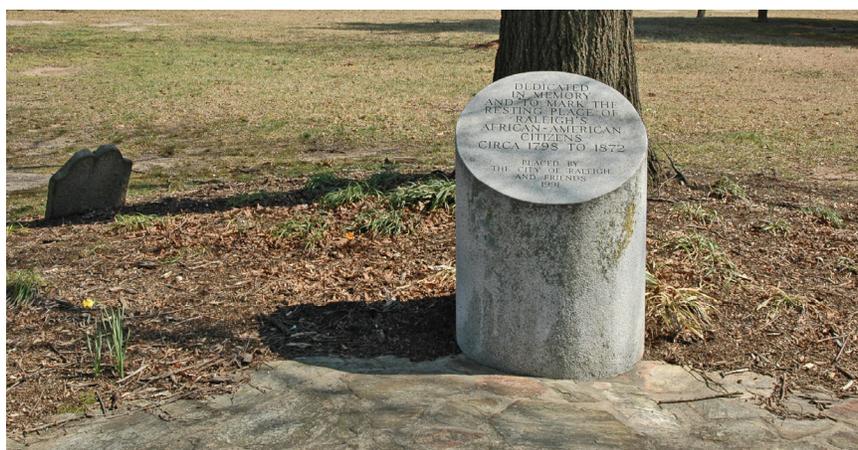
The only identification signage is the one plaque at the East Street entrance (Figure 55). This sign is scratched and has been stained by paint - these reflect the overall worn appearance of the cemetery itself. While the sign announces the presence of "many of Raleigh's earliest citizens," it is silent regarding the enslaved African Americans buried there. The other three entrances have no identification.

Figure 55. Existing City Cemetery signage. None provide a compelling story or enhance the cemetery visit. All should be replaced or expanded upon.

The marker erected at the African American section is so discrete that it can be easily overlooked. It fails to provide any information concerning the life or death of Raleigh's free persons of color or African American slaves. In fact, it is ambiguous even in stating that the plot is the grave yard for black residents. This is another area that requires more complete interpretation, helping the public understand, for example, the nature of African American burials.

We recommend that the signage, which dates from 1978, be revitalized by at least briefly mentioning the presence of African American burials and that it be posted at each of the four entrances.

This signage should be replaced with either numbers at graves keyed to a readily available walking tour pamphlet or with graveside signage that tells a story, perhaps also illustrating the individual in life, his or her Raleigh house, or some artifact of their life to add interest and variety. There must be a compelling story.

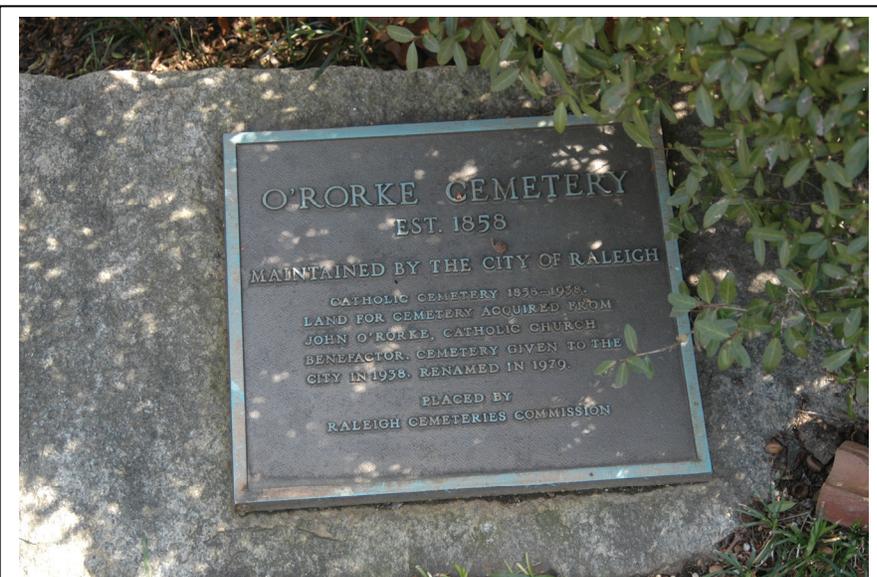
Figure 56. The only signage at the O'Rorke Cemetery fails to adequately identify the cemetery as both consecrated ground and extensively used by Wake County's paupers.

cemetery is laid vertically to one side of the double gate entrance off Pender Street (Figure 56). It is inconspicuous and probably unseen by

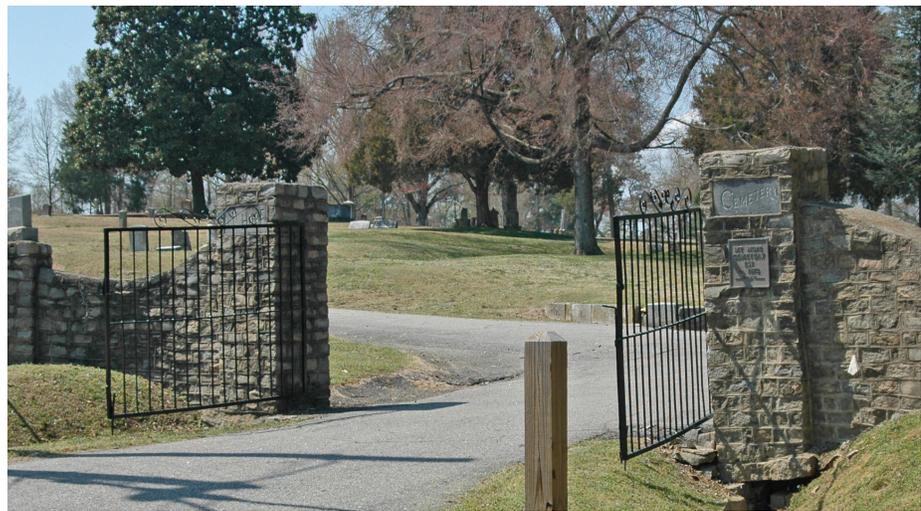
Figure 57. Sparse signage at Mount Hope Cemetery.

Mount Hope Cemetery also has inadequate identification signage. New signage should be erected at all three entrances. Signage at the main entrance, however, should not obscure or overwhelm the entrance gates, which are both beautiful and historic. Regulatory signage is also required. The cemetery has no interpretative signage and the compelling story of Raleigh's African American cemetery should be told.

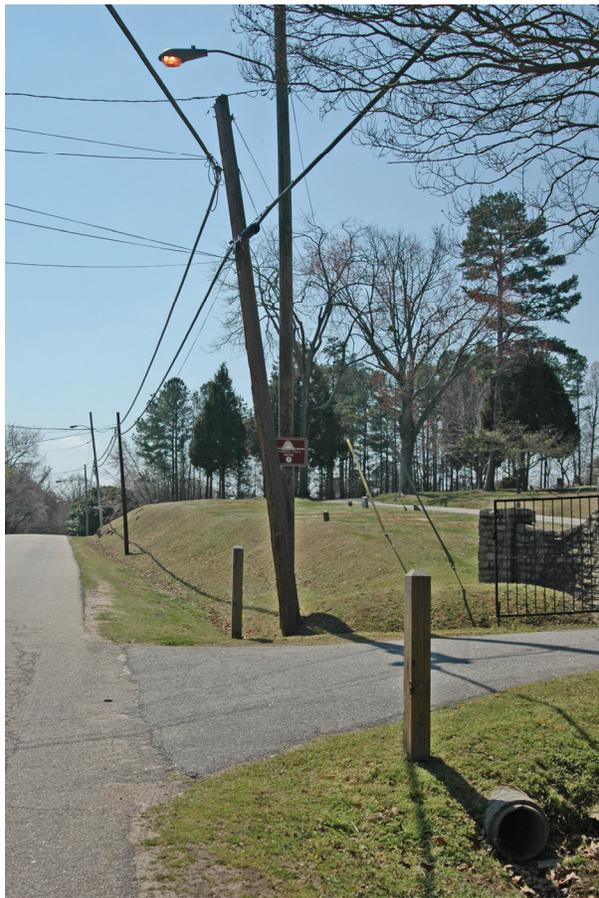
Both City Cemetery and Mount Hope are located on the Capital City Trail. At Mount Hope the small, discrete brown sign is almost hidden by an adjacent power pole (Figure 58). In addition, the sign is placed so high that it is doubtful that many visitors even know it is present.

Figure 58. Example of the small brown Raleigh Capital City Trail almost hidden at Mount Hope Cemetery.

The existing Capital City Trail signage is antiquated, obscured, and fails to reasonably engage visitors. It competes against other tours that are better publicized. It also provides little promotion for the two cemeteries (O'Rorke is not listed). The Wayfinding Study recommends all Capital City Trail Signage be removed - we concur in this recommendation.

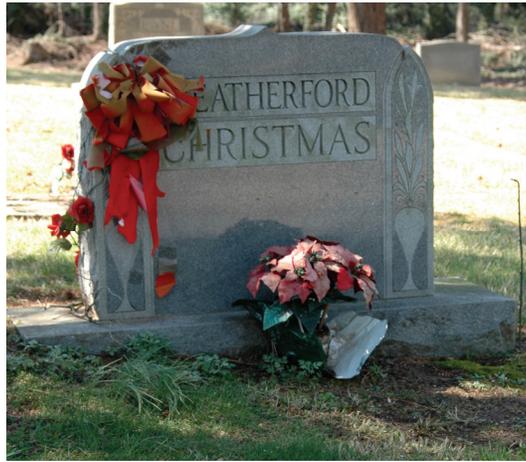
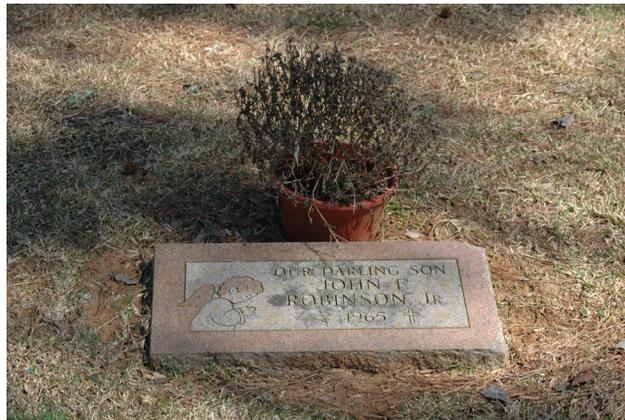
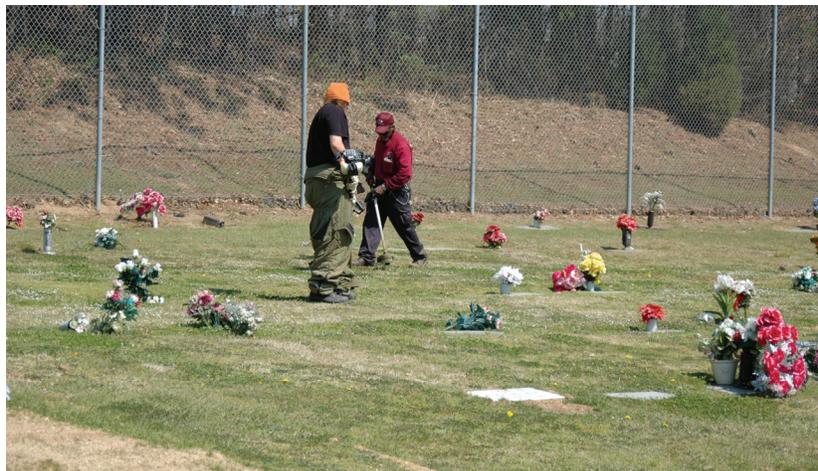
Figure 59. Floral problems at Mount Hope. At the top is a photo of artificial holiday flowers that have not been removed and are now deteriorated and unsightly. The middle photo shows dead plants left in the cemetery. At the bottom there is the new section showing the large numbers of flowers that must be moved to allow maintenance.

In addition to the issue of flowers in the new section, when we visited Mount Hope in mid-March, we found numerous Christmas decorations still being displayed (Figure 59). This detracts from the dignity and beauty of the cemetery. Plastic flowers, if accidentally mowed, also create significant debris that will not decompose.

The city should establish flower regulations for its cemeteries that maintain the dignity of the cemetery and allow reasonable maintenance. We recommend that all floral displays be either in a vase integrated into the flush marker or use a flower holder. Either will

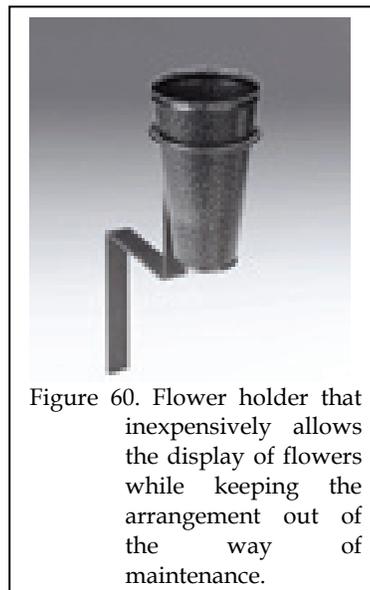
Figure 60. Flower holder that inexpensively allows the display of flowers while keeping the arrangement out of the way of maintenance.

Second, we recommend that the cemetery establish a regulation that all floral displays in the new section must be placed in vases integral to the stone or that a vase mounted vase holder be used (Figure 60). These choices provide a wide range of cost options for families while still ensuring that the maintenance staff can perform their duties. These are available from a variety of monument companies for about \$20 retail or could be ordered by the city and sold directly (see www.thompsonmonuments.com/flower_holder_s.html).

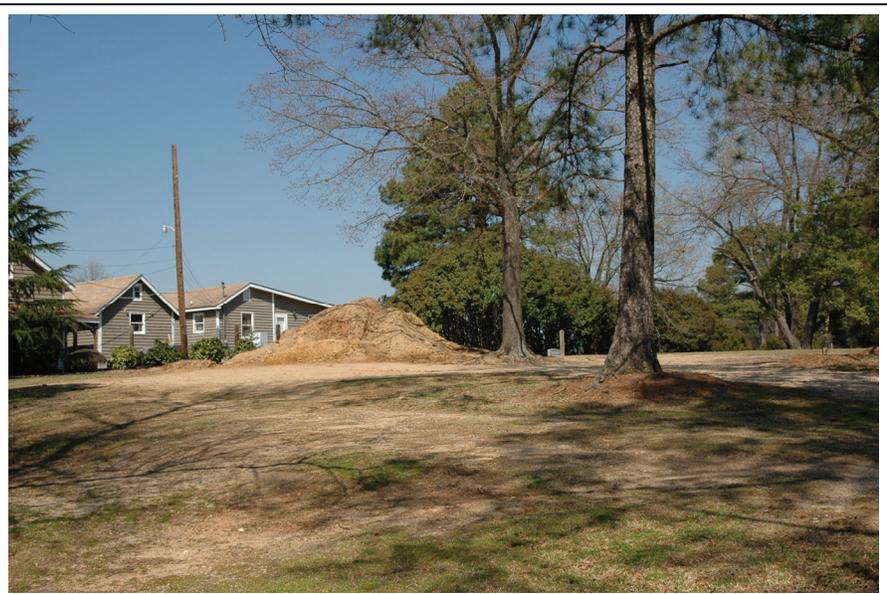
Figure 61. Stockpiled soil in this barren, compacted portion of the Backside Section at Mount Hope detracts from the cemetery.

Backside Section where apparently no graves are located. The city is storing soil in this area, which is compacted, barren, and eroding into the street (Figure 61). There is another area being used for stockpiling mulch in the Durfey Section and we recommend that the materials be removed from the Backside section. This area should then be sodded and made presentable to the public. It could be a pleasant green area with a little care.

Mount Hope Cemetery exhibits several areas that require screening from the general public. These include the spoil pile at the edge of the Backside Section. This particular area is also compacted with little vegetation. The spoil should be removed and this area sodded to enhance the appearance of the cemetery. There is another spoil and debris area at the edge of the Durfey Section. This should be closed to public access. There are stones seemingly dumped at the edge of the road - this presents a poor impression to the public and is disrespectful. The stones should be replaced or put into storage until their locations can be determined. The current office and maintenance building presents a harsh view to families using the New Section. These facilities should never have been allowed to be in such close proximity to the graves. Today it is critical that the area be screened to soften the view.

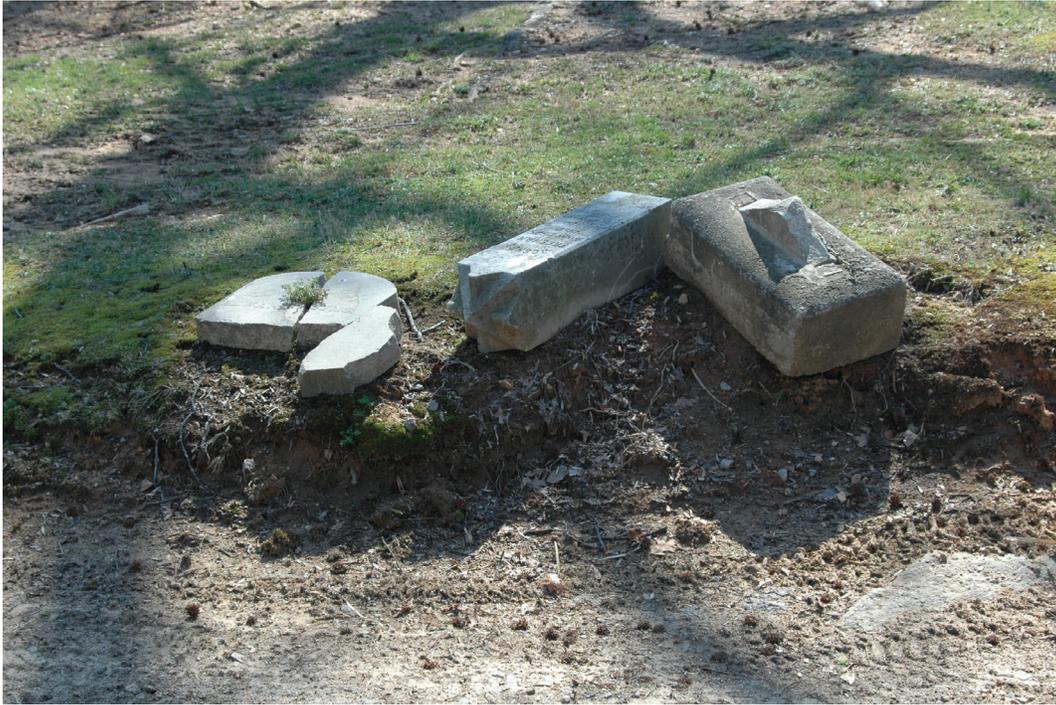
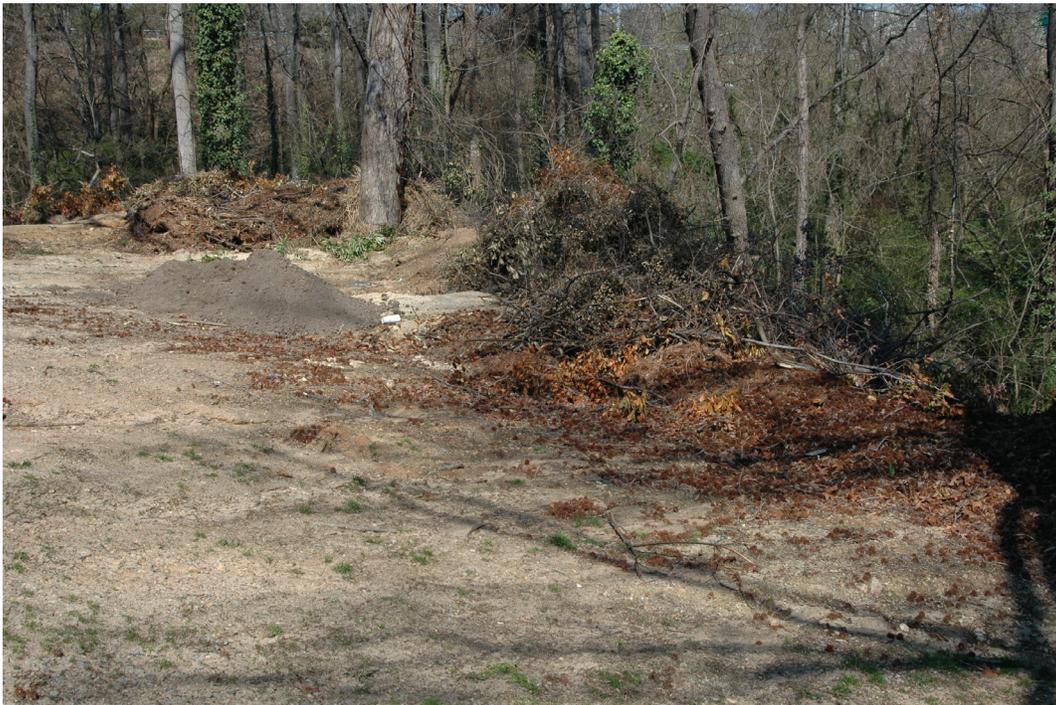
Figure 62. Screening problems at Mount Hope in the Durfey Section. The top photo shows what appear to be discarded monuments. The bottom photo shows lawn debris and soil.

A second area of concern is the dirt road leading into the Durfey Section. Along this road are several damaged monuments (Figure 62). This gives the appearance that the graves have been destroyed or are in the roadway. Either is inappropriate and the situation should be rectified.

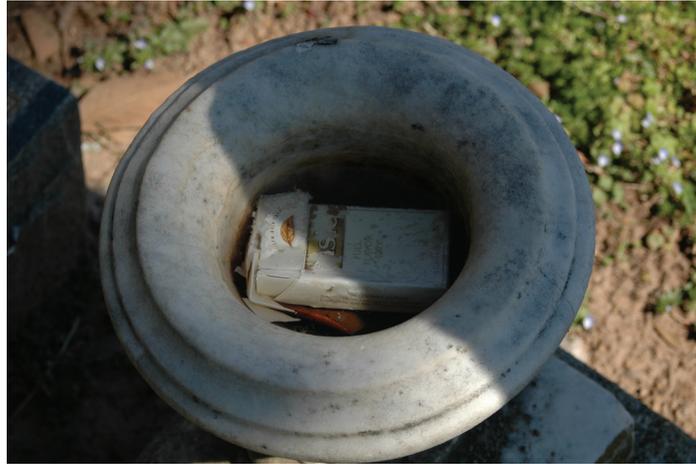
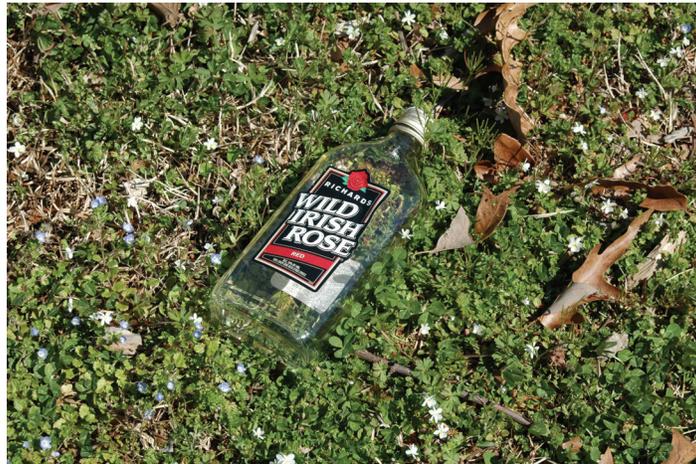
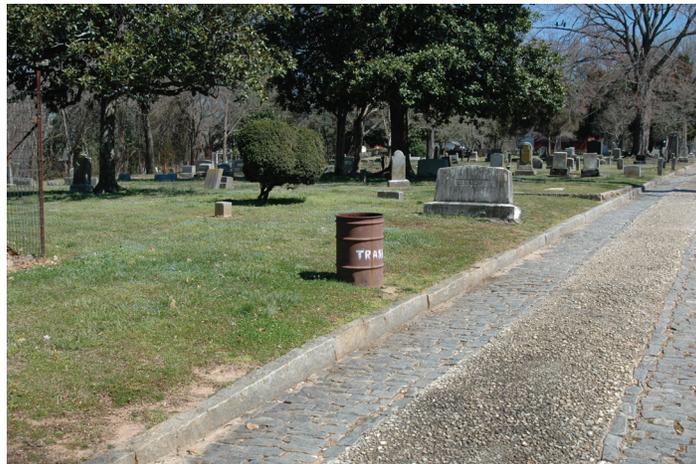
At City Cemetery we saw a variety of trash problems, including trash disposed of in the center of boxwoods, trash tossed in urns, and trash left in the open. We believe that at least some of the problems are likely caused by vagrants. At O'Rorke Cemetery we observed several alcohol containers in the cemetery (Figure 63).

At City Cemetery we found containers – brown 55 gallon drums with “trash” on their sides in white paint. These are an eyesore and should be immediately replaced.

Figure 63. Trash problems at the city's cemeteries. The top photo shows trash hidden in City Cemetery. The middle photo shows one of several alcohol containers at O'Rorke Cemetery. The bottom photo shows the unsightly trash containers being used in the City Cemetery.

At City Cemetery the trash containers, 55 gallon drums, detract from the dignity and beauty of this historic property. They should be replaced with more fitting containers that better blend in with the property.

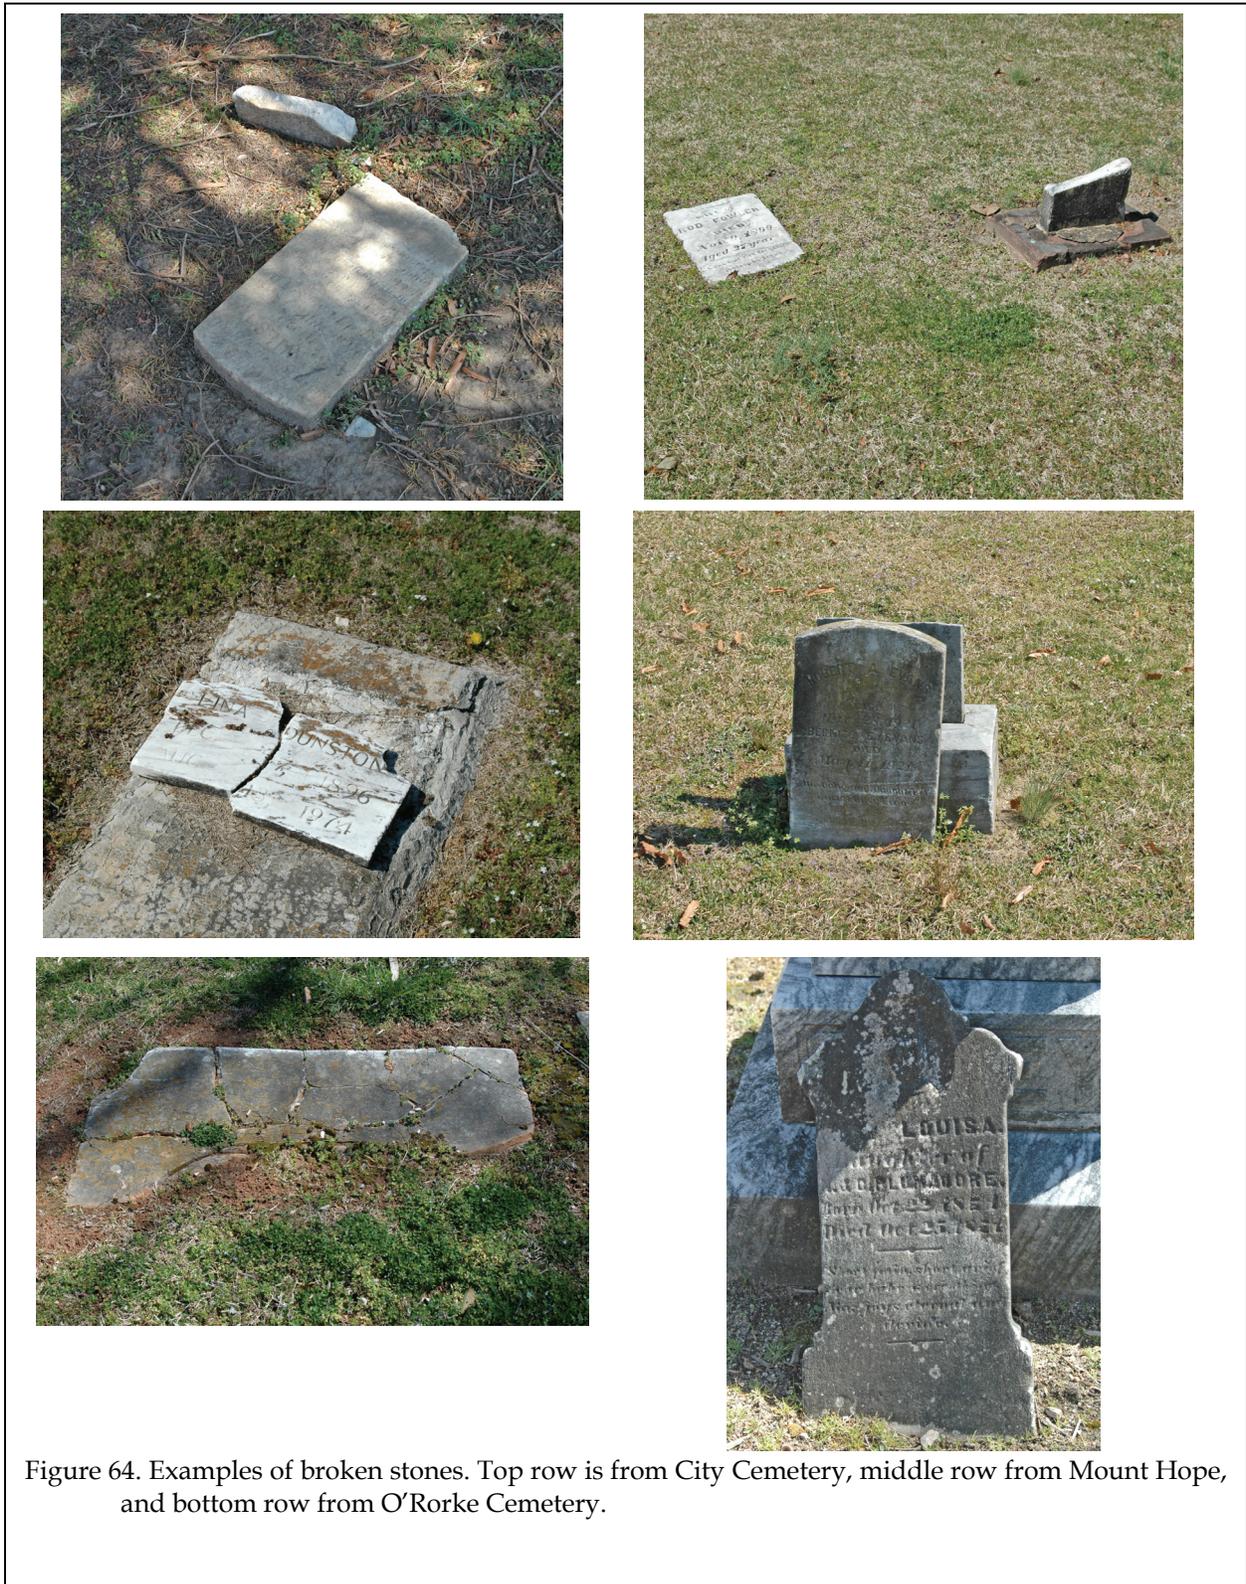
There are many examples (likely hundreds) of broken stones. Many of these

stones should receive a high priority for conservation treatments since the stones are either a hazard to the public (endangering visitors) or a hazard to themselves (if they fall there will be additional, significant damage that will dramatically increase the cost of repair). The identification of these stones and development of treatment proposals by a professional conservator should be a very high priority. It is only with the development of detailed treatment proposals and cost estimates that a reasonable budget for this conservation work can be determined. Given the deterioration of the historic fabric, we recommend this work be conducted over the next 2 to 3 years.

Figure 64. Examples of broken stones. Top row is from City Cemetery, middle row from Mount Hope, and bottom row from O'Rorke Cemetery.

Appropriate conservation treatment will usually involve drilling and pinning, carefully aligning the two fragments. Threaded 316 stainless steel rod (or occasionally nylon) and epoxy adhesives formulated for the specific stone are used in this type of repair. Diameters and lengths of pins vary with the individual application, depending on the nature of the break, the thickness of the stone, its condition, and its expected post-repair treatment.

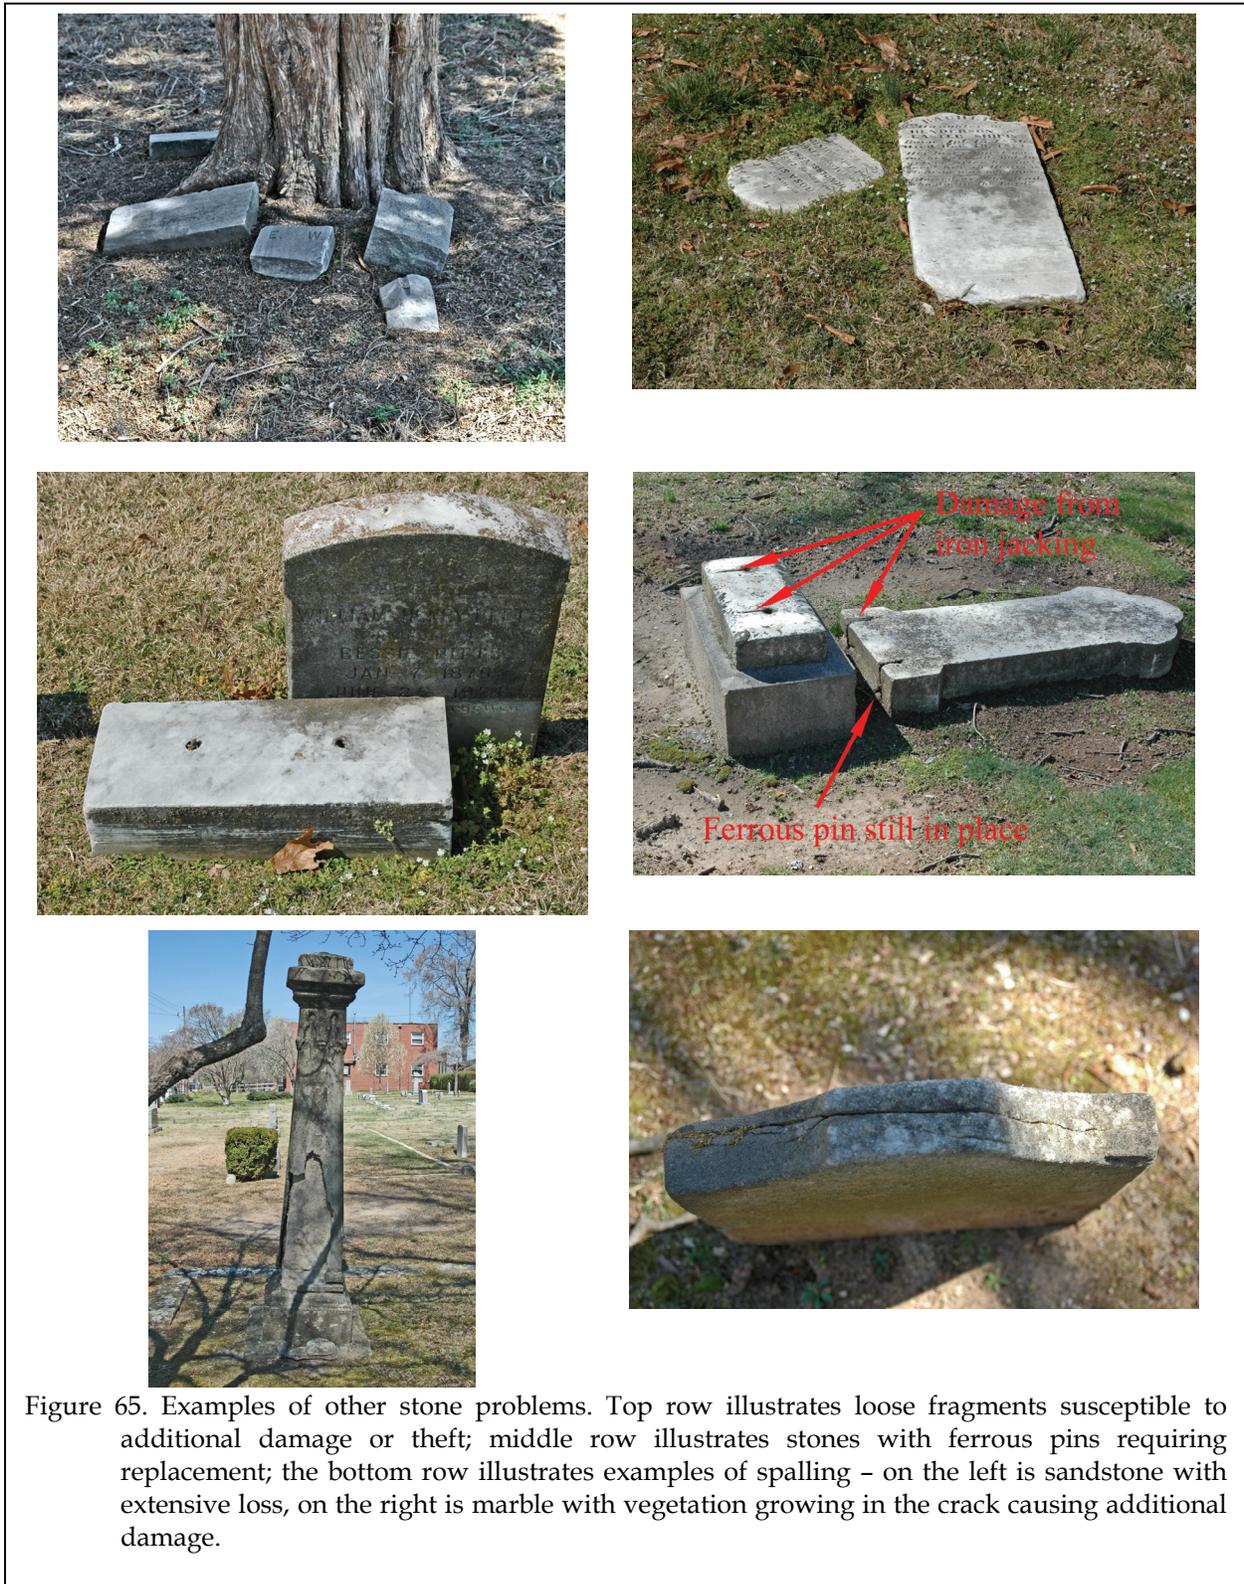
Figure 65. Examples of other stone problems. Top row illustrates loose fragments susceptible to additional damage or theft; middle row illustrates stones with ferrous pins requiring replacement; the bottom row illustrates examples of spalling – on the left is sandstone with extensive loss, on the right is marble with vegetation growing in the crack causing additional damage.

There are also a number of loose stones or stone fragments. These, too, may pose a significant risk to the public, depending on the size and degree of instability of each stone. Some stones will require equipment to allow disassembly and correctly repair. Others are smaller and the treatment may involve drilling for the installation of stainless steel pins to help hold the stone in place. A few of the problems may be resolved using commercial setting compound.

Many of the stones were noted with ferrous pins. The results of their deterioration is also clearly evident. These should be given a high treatment priority since, left untreated, the corrosion will cause significant spalling, cracking, and breakage of the stones. In these cases it will be necessary to use diamond core drills to remove the ferrous pins. They will then need to be replaced with stainless steel pins.

After many such repairs it will be necessary to fill the voids with a natural cementitious composite stone material resembling the original as closely as possible in texture, color, porosity, and strength. This type of repair may be used to fill gaps or losses in marble and is often used to help slow scaling of bedded sandstone exposed to the elements.

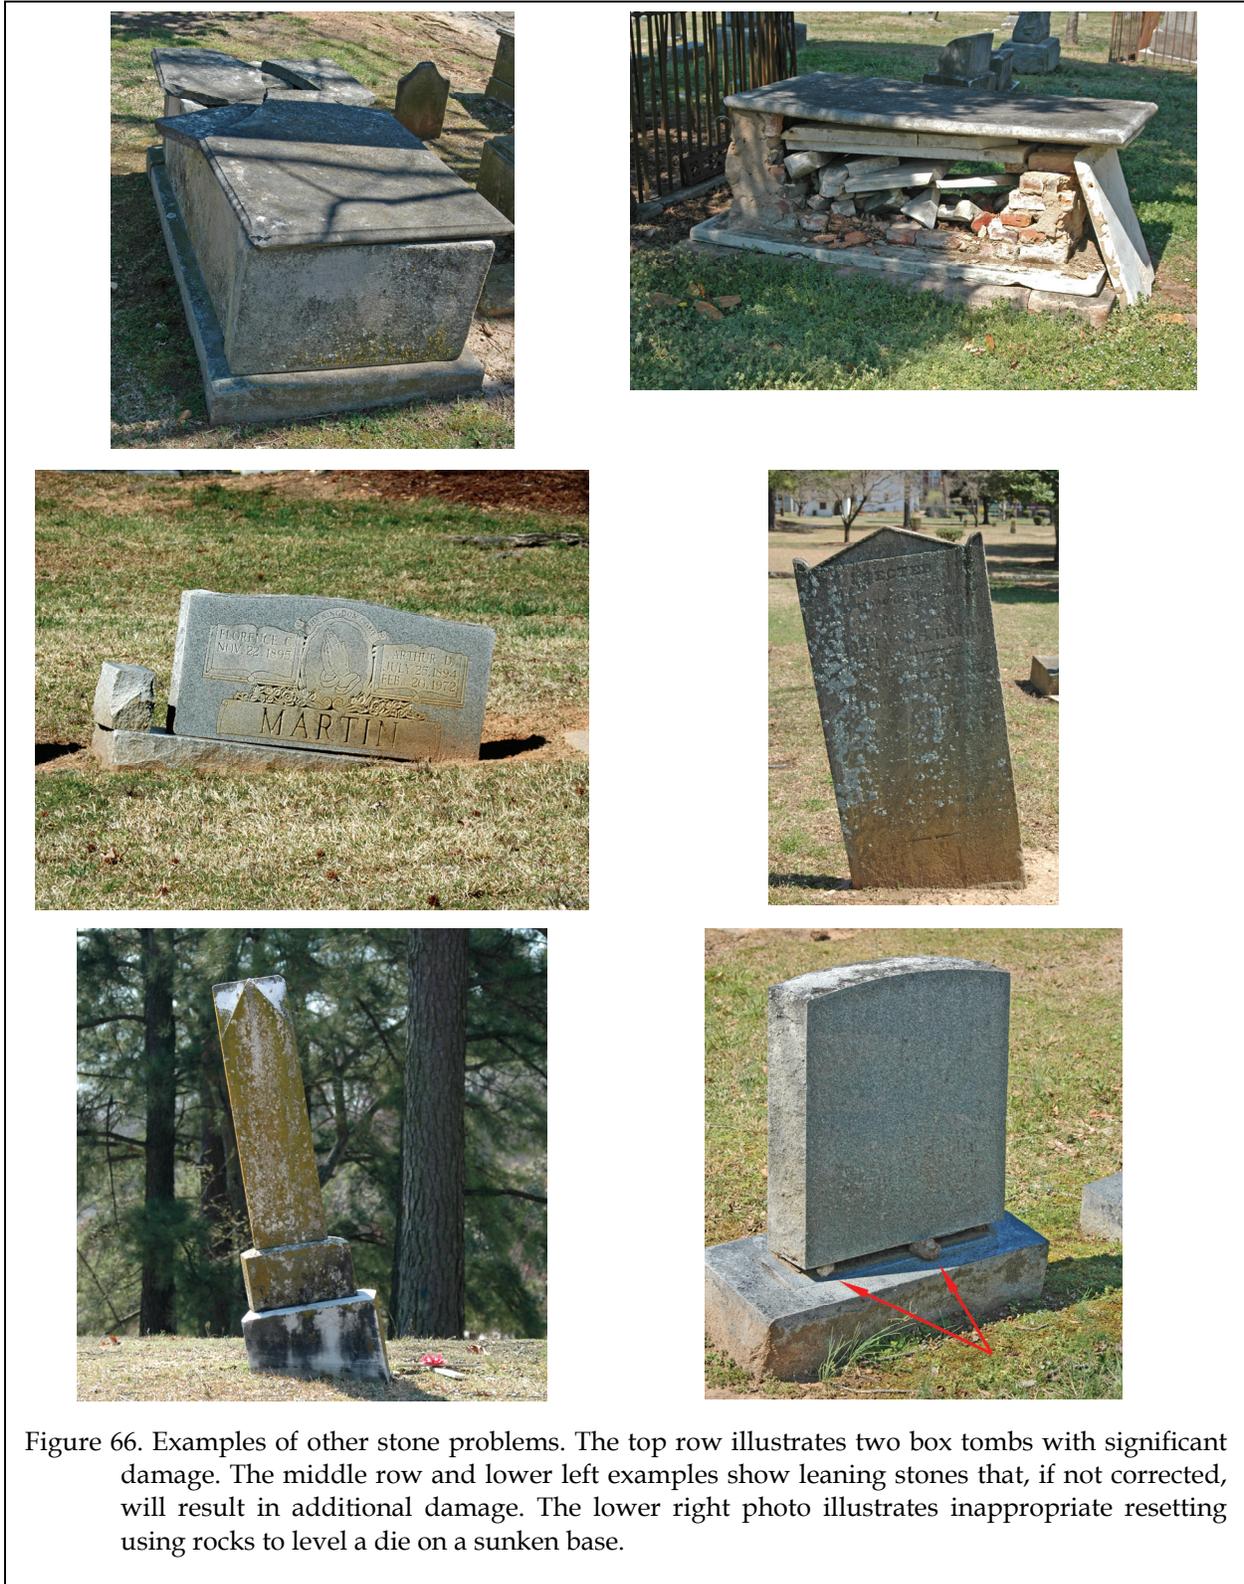
Figure 66. Examples of other stone problems. The top row illustrates two box tombs with significant damage. The middle row and lower left examples show leaning stones that, if not corrected, will result in additional damage. The lower right photo illustrates inappropriate resetting using rocks to level a die on a sunken base.

There are a number of failing box and table tombs. Some have failed and are simply piles. Others pose an imminent hazard to the public. Support of ledgers is often undermined, creating a significant potential that the ledger will be damaged - and this dramatically increases the cost of repair. Consequently, these ledgers should receive a relatively high priority for repair.

Many of the stones are seriously leaning. When this occurs to headstones, the tilt may be sufficient to precipitate a ground break, dramatically increasing the cost of repair. For other monuments the tilt may be sufficient to cause the monument to fail and, in the process, there may be additional damage. We also

observed monuments in the cemetery that had been improperly reset. In at least one case the monument was reset in a manner that poses an additional hazard to the public – and a liability to the city.

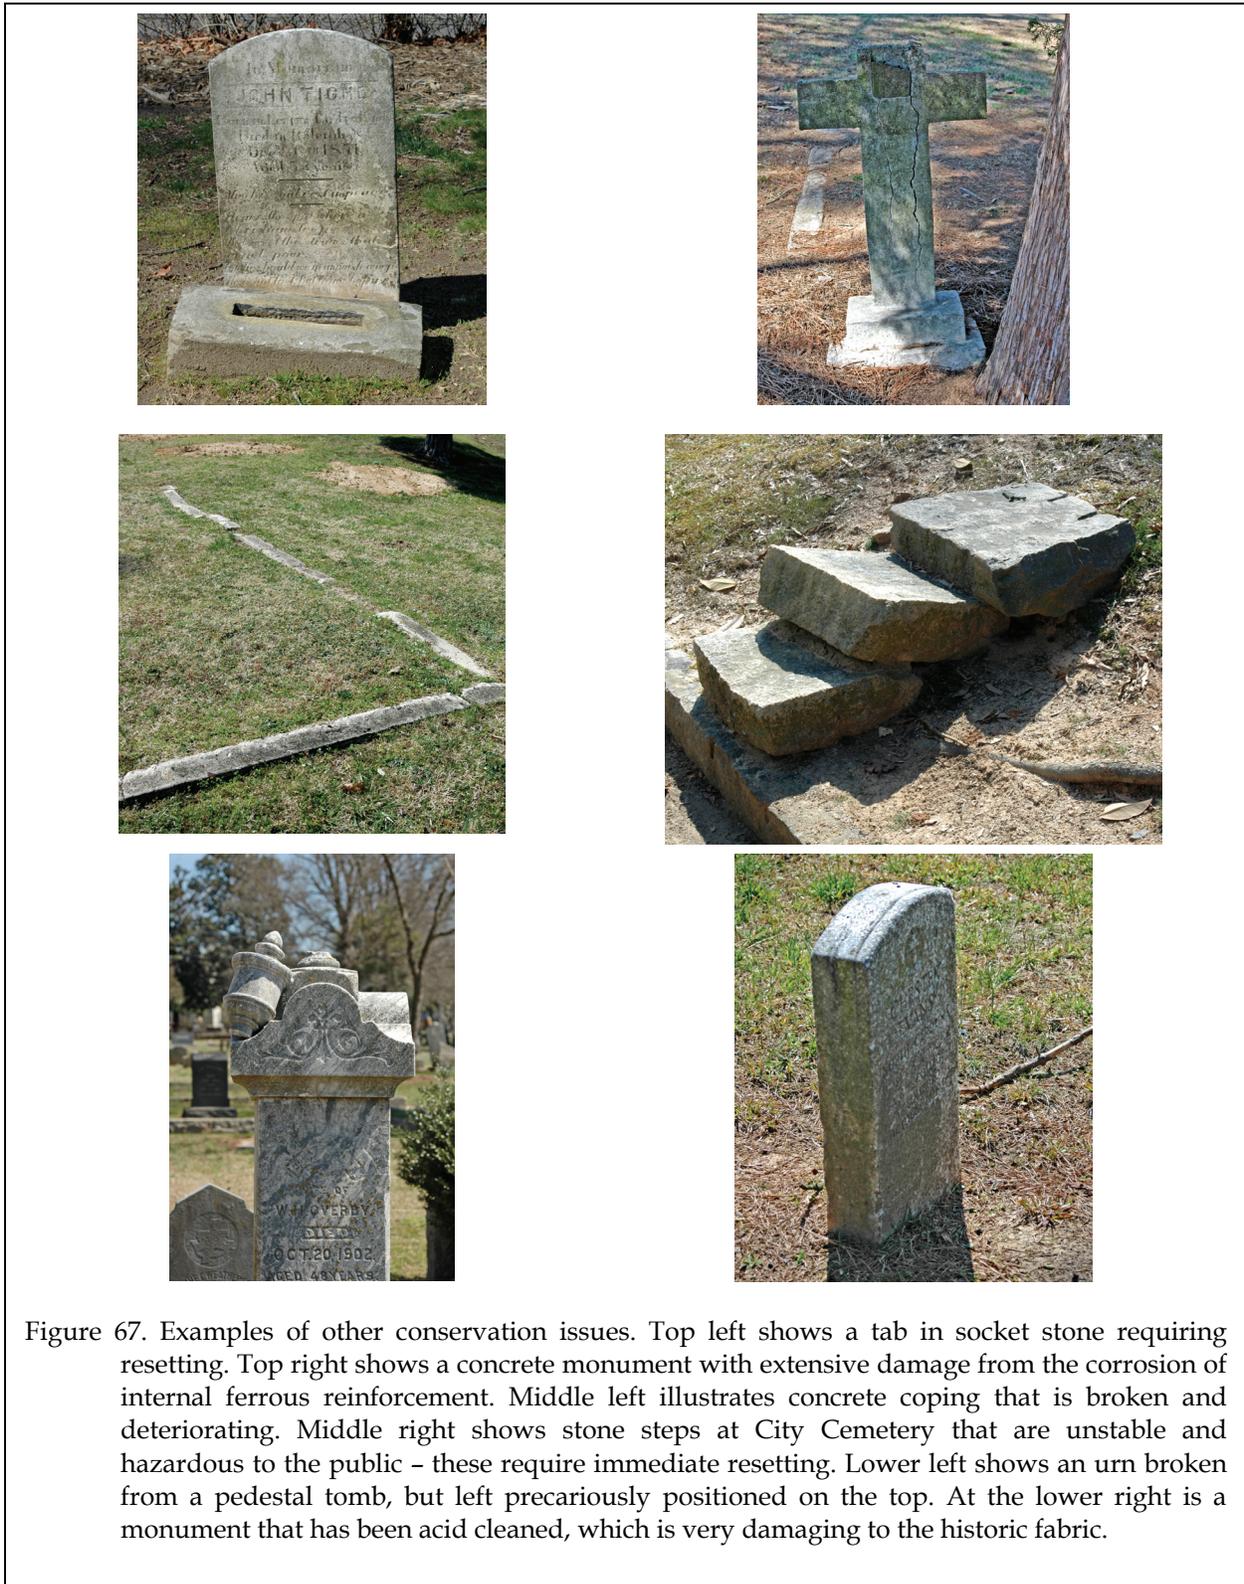
Figure 67. Examples of other conservation issues. Top left shows a tab in socket stone requiring resetting. Top right shows a concrete monument with extensive damage from the corrosion of internal ferrous reinforcement. Middle left illustrates concrete coping that is broken and deteriorating. Middle right shows stone steps at City Cemetery that are unstable and hazardous to the public - these require immediate resetting. Lower left shows an urn broken from a pedestal tomb, but left precariously positioned on the top. At the lower right is a monument that has been acid cleaned, which is very damaging to the historic fabric.

A significant amount of damage may result from inappropriate cleaning techniques. The most common cleaning technique is the use of a bleach product – probably because bleach (either sodium hypochlorite or calcium hypochlorite) is widely available and inexpensive. It is, nevertheless, unacceptable for historic monuments.

A few stones require resetting in their still extant sockets. This, too, is a fairly simple procedure that can be accomplished with little time or funds, but which will minimize the potential for additional damage to the stone.

In such cases resetting involves the use of a high lime mortar mix. In this and all other areas of treatment, the city should avoid the use of Portland cement. It is entirely too hard for the stones and may contain impurities that will damage the stone through long-term exposure. More appropriate is a 1:3 (or 1:2) mix of NHL 3.5 and sand. Epoxy and other adhesives should never be used since once set it is virtually impossible to remove the material. Even the use of commercial setting compounds used by the monument industry should be limited to use on granite markers produced within the last 50 years.
