INITIAL ASSESSMENT, LANDRY TOMB, DONALDSONVILLE, LA

Chicora Research Contribution 516

Prepared By:
Michael Trinkley, Ph.D.

May 2009

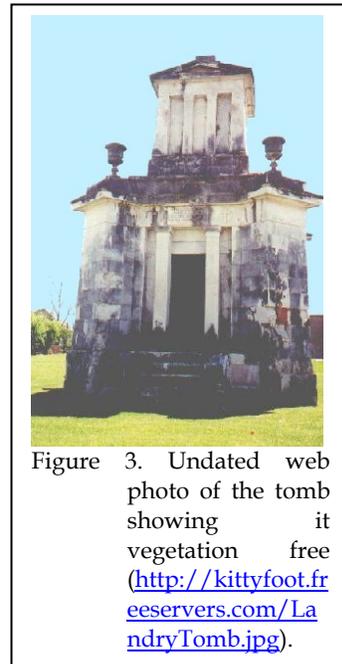
The photographs associated with this report provide little detail, although they do indicate considerable vegetation. This extensive growth, however, has not always been so overwhelming. At least one undated photograph found on the web shows the tomb with no evidence of vines (Figure 3).

Figure 3. Undated web photo of the tomb showing it free of vegetation (<http://kittyfoot.fr.eservers.com/LandryTomb.jpg>).
