# **PRESERVATION ASSESSMENT OF TOLSON'S CHAPEL CEMETERY, SHARPSBURG, MARYLAND**

**Chicora Research Contribution 552**

Prepared By:  
Michael Trinkley, Ph.D.  
and  
Debi Hacker

May 1, 2013

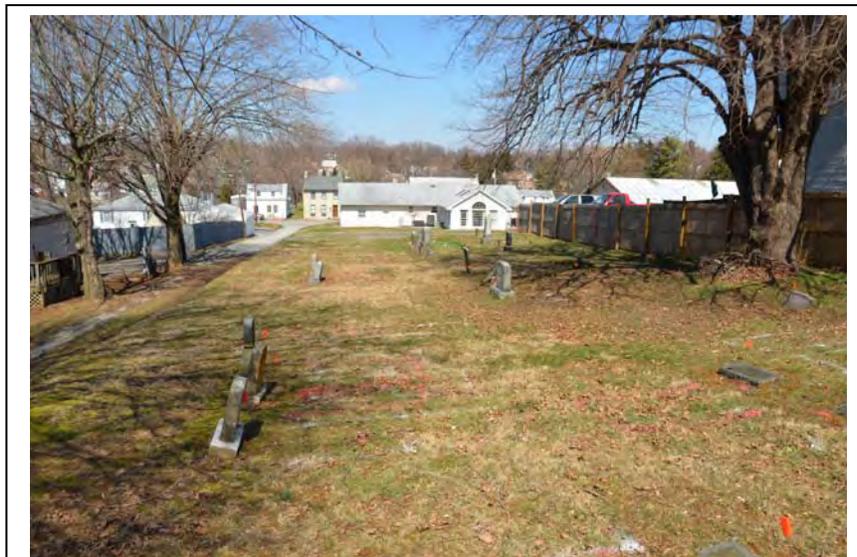
Figure 3. Tolson's Chapel cemetery from the chapel looking north.

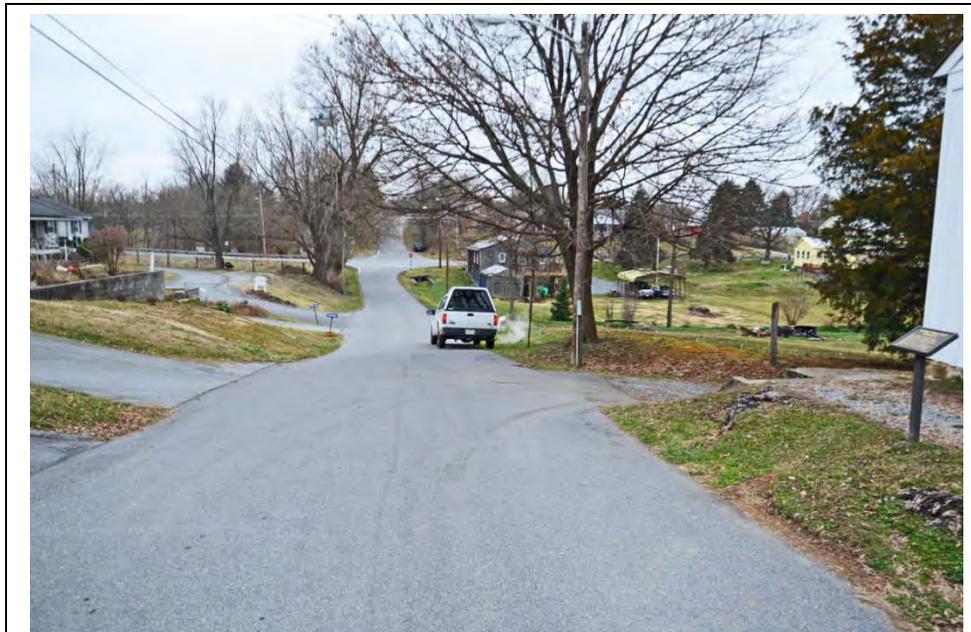
This is an issue at the chapel since the only parking for visitors is on the grassed area immediately in front of the double gates to the east of the chapel. Immediately in front of the chapel there is a slight elevation, steps, and a tree stump. Alternative parking is presumably available in the alley to the west, although it consists of only one gravel travel lane, about 8 feet in width. Parking here, at least on a regular basis, would hinder residential use of the alley for house access.

The entrance to the churchyard incorporates a double gate, allowing about 8 feet of clearance. This does allow vehicle access, although the topography slopes downward to the north and graves begin within about 15 feet of the entrance. While

Figure 17. High Street with Tolson’s Chapel to the right looking west. The alley along the west side of the cemetery is shown leading off High Street. Note also the slope from the road up to the chapel building.

**The cemetery and associated chapel have limitations on accessibility. FOTC should explore whether they are responsible for the stairs at the front left of the chapel. We also recommend signage warning visitors of the steep slope and potentially slippery terrain.**

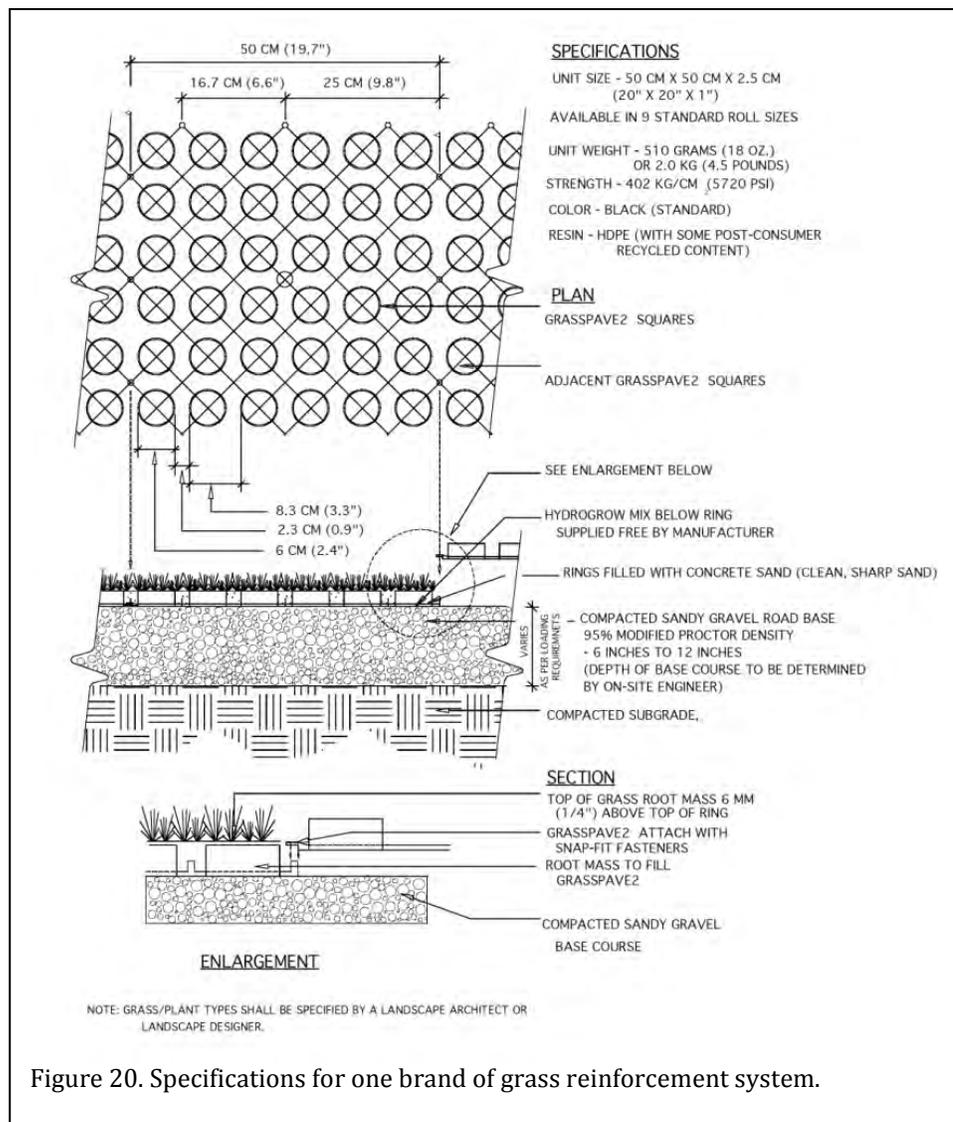
Figure 20. Specifications for one brand of grass reinforcement system.

**The cemetery lacks pathways, but none are recommended, at this time, given the relatively low visitation. If necessary in the future we recommend that grass reinforcement systems may be the most appropriate.**

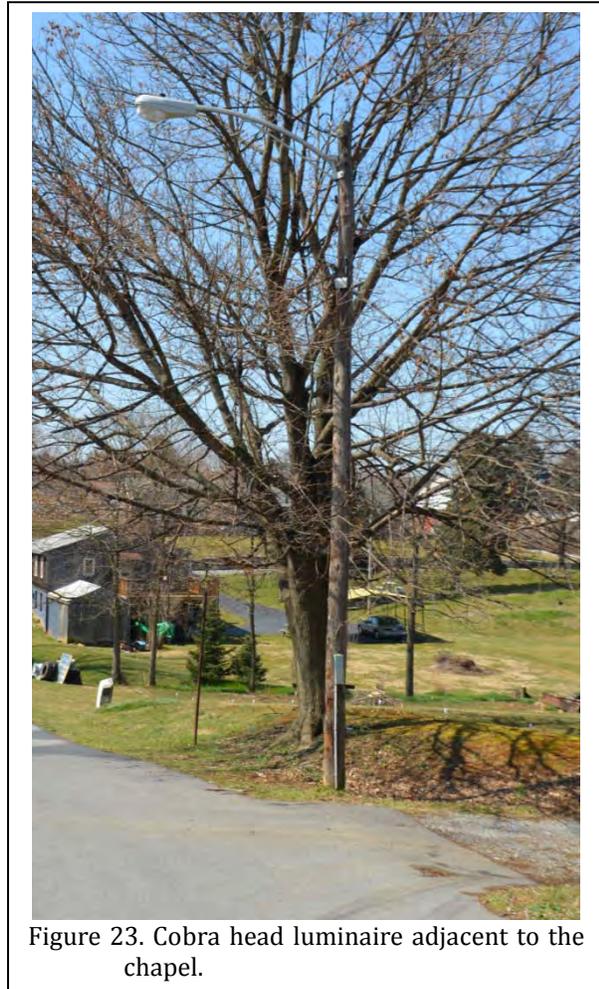
Figure 23. Cobra head luminaire adjacent to the chapel.

There is a standard single arm steel bracket with cobra head luminaire mounted on a utility pole southwest of the chapel, adjacent to the alleyway. We do not recommend that any additional lighting be installed.

**Lighting is adequate and we do not recommend any additions.**

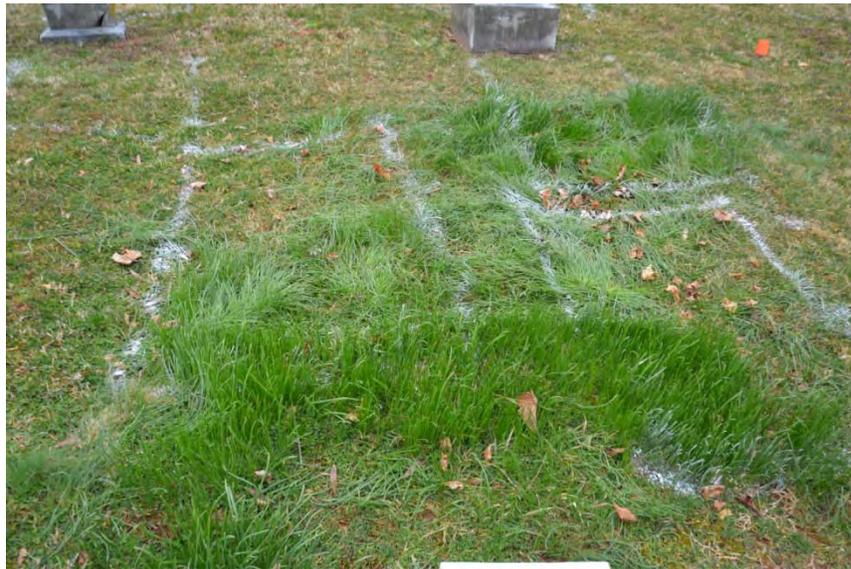
In several areas there are very large stands of wild garlic (*Allium vineale*). A good introduction to this weed is <http://www.clemson.edu/extension/hgic/pests/pdf/hgic2311.pdf> (Figure 26).

Figure 26. Weeds in the cemetery showing a large stand of wild garlic. While the turf is still dormant, the weeds already suggest the need to mow.

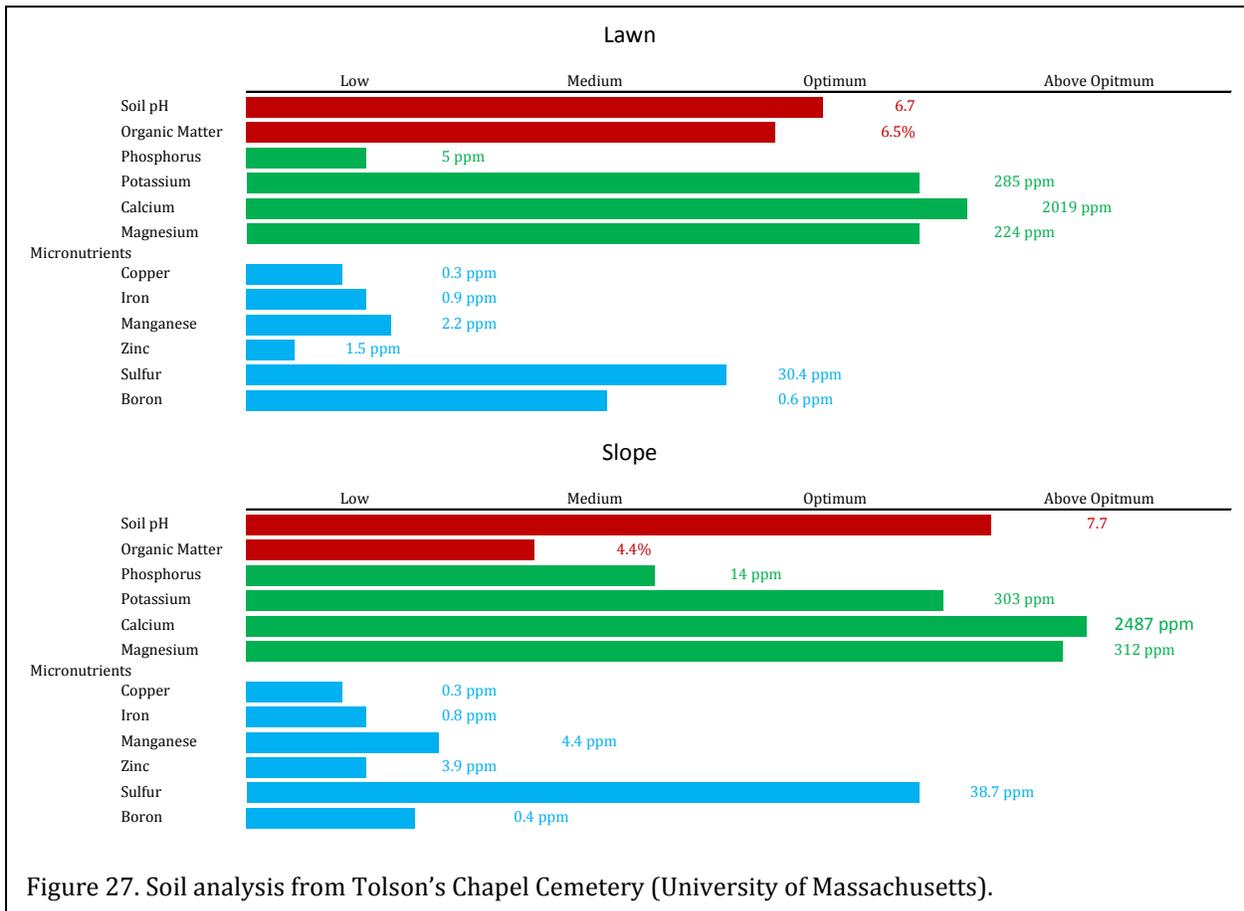
In order to weigh these different options, it may be helpful to evaluate the condition of the current lawn. The presence of a variety of weeds and moss is suggestive of compacted and infertile soil. Figure 27 shows the results of soil tests. The clay soils have typical cation exchange capacity (between 13 and 16 Meg/100g) and would be significantly higher if the soils contained more organic matter.

Soil pH is good and no liming is currently necessary. Macronutrients are likewise generally high, with only phosphorus (P) low to medium in the two samples. The micronutrients, with the exception of sulfur (S) are all low. While these macronutrients are necessary for plant growth, soil test recommendations for micronutrients are not available. The plants found on-site don't exhibit evidence of damage; if such evidence presents itself in the future, we recommend

Figure 27. Soil analysis from Tolson's Chapel Cemetery (University of Massachusetts).

The soils were also tested for aluminum (Al). This is not a plant nutrient and at elevated levels can be toxic to plants. The levels found were very low and pose no problem. Lead (Pb) may be naturally occurring or contributed by early embalming materials and was therefore part of the testing program. Lead levels were low in both samples. Finally, we also tested for soluble salts. These may be contributed by road salts, but are common in virtually all commercial fertilizers. They can affect not only the plants, but also the stones at the cemetery. Soluble salt levels were between 0.06 and 0.09 dS/M (mmho/cm) and these levels are considered very low.

are generally adequate, if an effort is made to improve the turf, we minimally recommend the application of phosphorus.

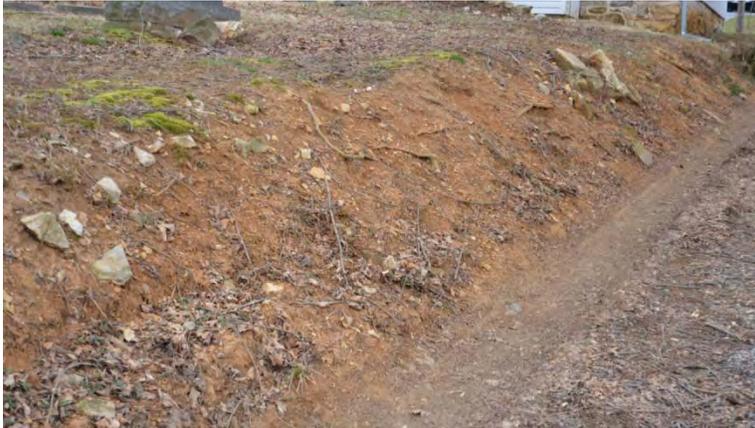
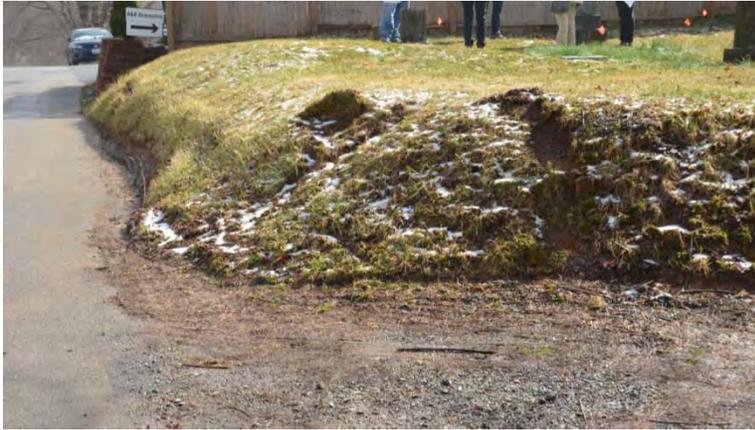
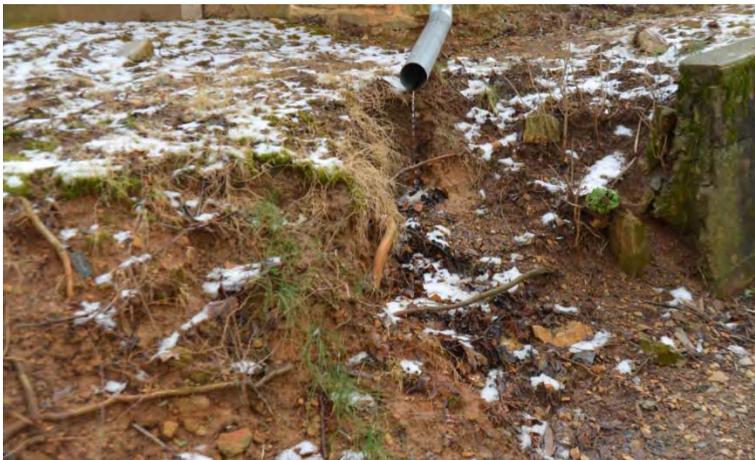
Figure 28. Erosion at the cemetery. The upper photo shows erosion along the west bank. The middle photo shows erosion from using the northwest corner as a bicycle ramp. The bottom photo shows erosion from a church building gutter draining directly onto the slope.

As Figure 28 reveals, there is erosion along the bank at the western and northern edges of the cemetery. Causes include shade from nearby trees, inappropriate drainage from the new roof, and the use of the slope as a bicycle ramp.

**To minimize the use of the northern cemetery slope as a bicycle ramp we recommend the installation of hand placed rip-rap softened with the planting of a hardy, low maintenance ground cover such as lirioppe. This is likely more effective, easier to integrate into the historic landscape, and will require less maintenance than a fence.**

Rip-rap is even possible on very steep slopes by extending the toe of the rock outward (see Figure 30). The cost is likely about \$25 to \$50 per square yard. If rip-rap is placed only where needed, we estimate that approximately 100 square yards will be required. If installed properly, rip-rap does not typically require much maintenance, although it should be periodically inspected for evidence of failure.

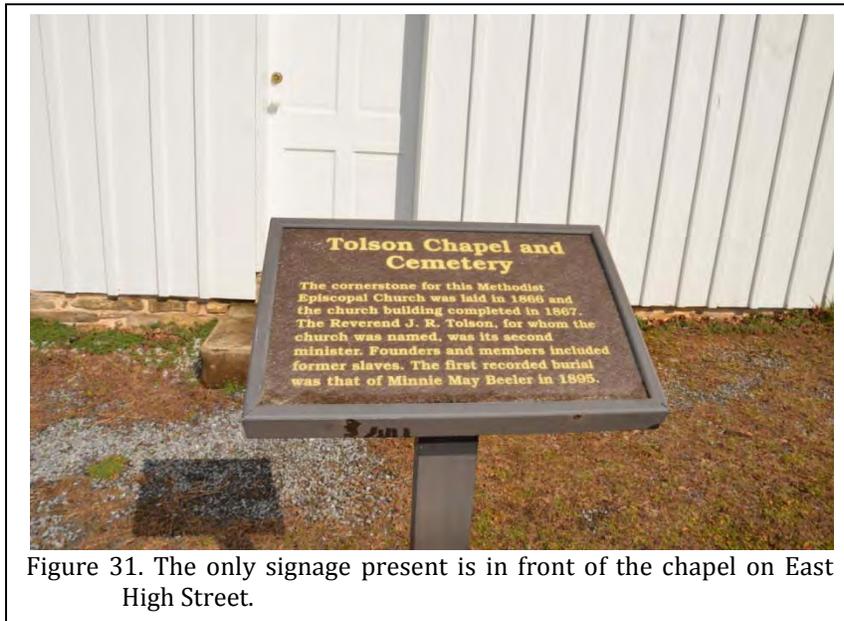
Identification signage might include the name of the cemetery and might also include the cemetery's date of founding and historic significance (i.e., listed on the National Register). The existing plaque (Figure 31) is an example of identification signage.

Regulatory signage specifies laws, regulations, or expected standards of behavior. There is no regulatory signage at the cemetery and this should receive a very high priority. We recommend the following items be included in the regulations affecting the cemetery:

Figure 31. The only signage present is in front of the chapel on East High Street.

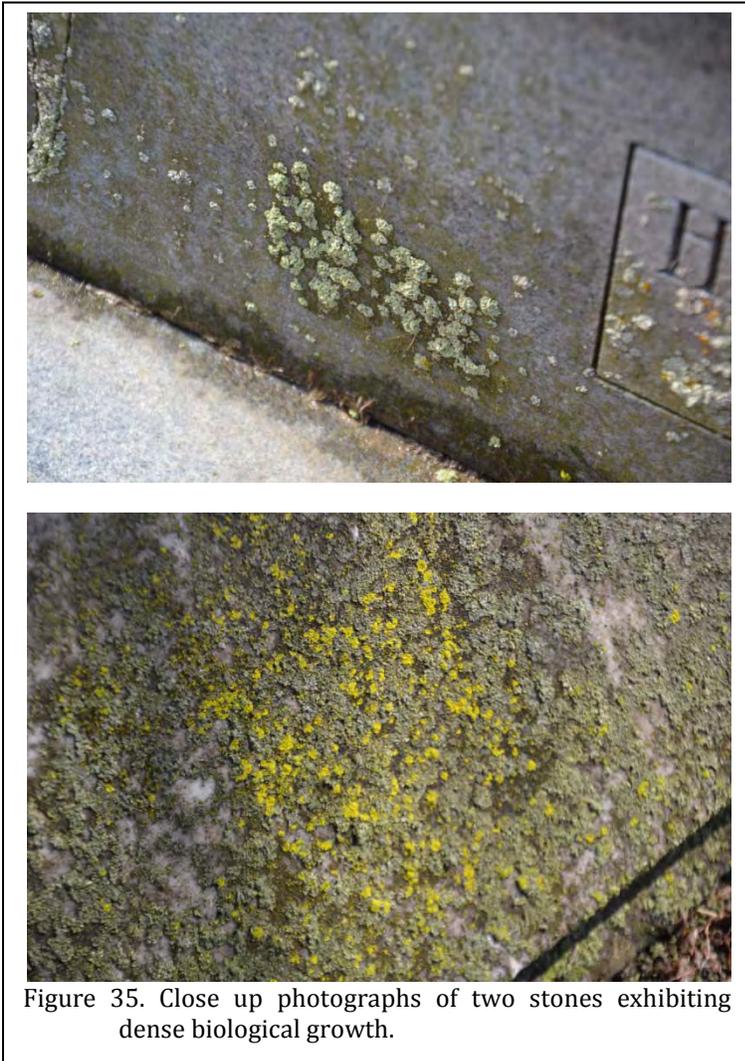
Figure 35. Close up photographs of two stones exhibiting dense biological growth.

A suitable biocide for cleaning stones is

D/2 Biological Solution (<http://d2bio.com/>) available from a variety of conservation suppliers. Stones should always be prewetted prior to application of D/2 and after dwelling for a few minutes followed by gentle scrubbing, should be flushed from the stone.

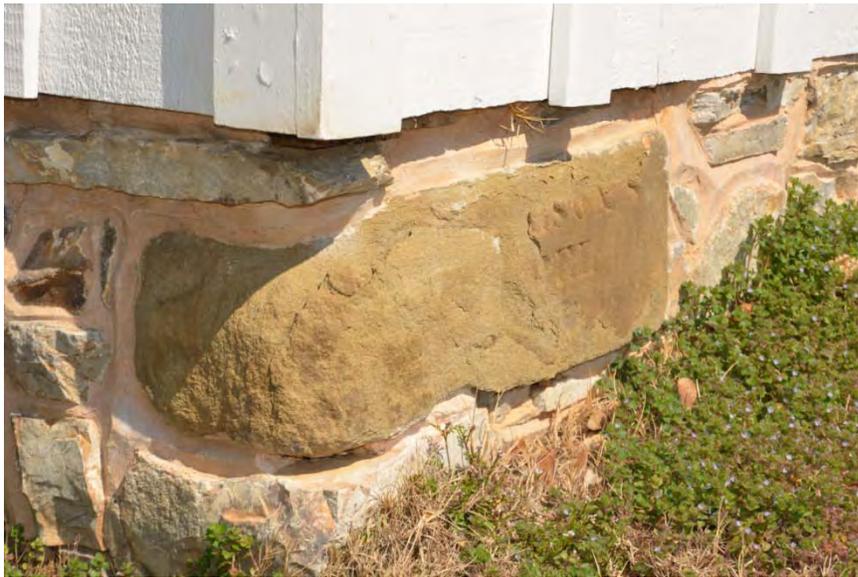
While not specifically included in this project, it may be useful to briefly mention the badly deteriorated condition of the Tolson's Chapel cornerstone (Figure 36).

Figure 36. Cornerstone showing extensive spalling of the sandstone with the loss of most of the original carving.

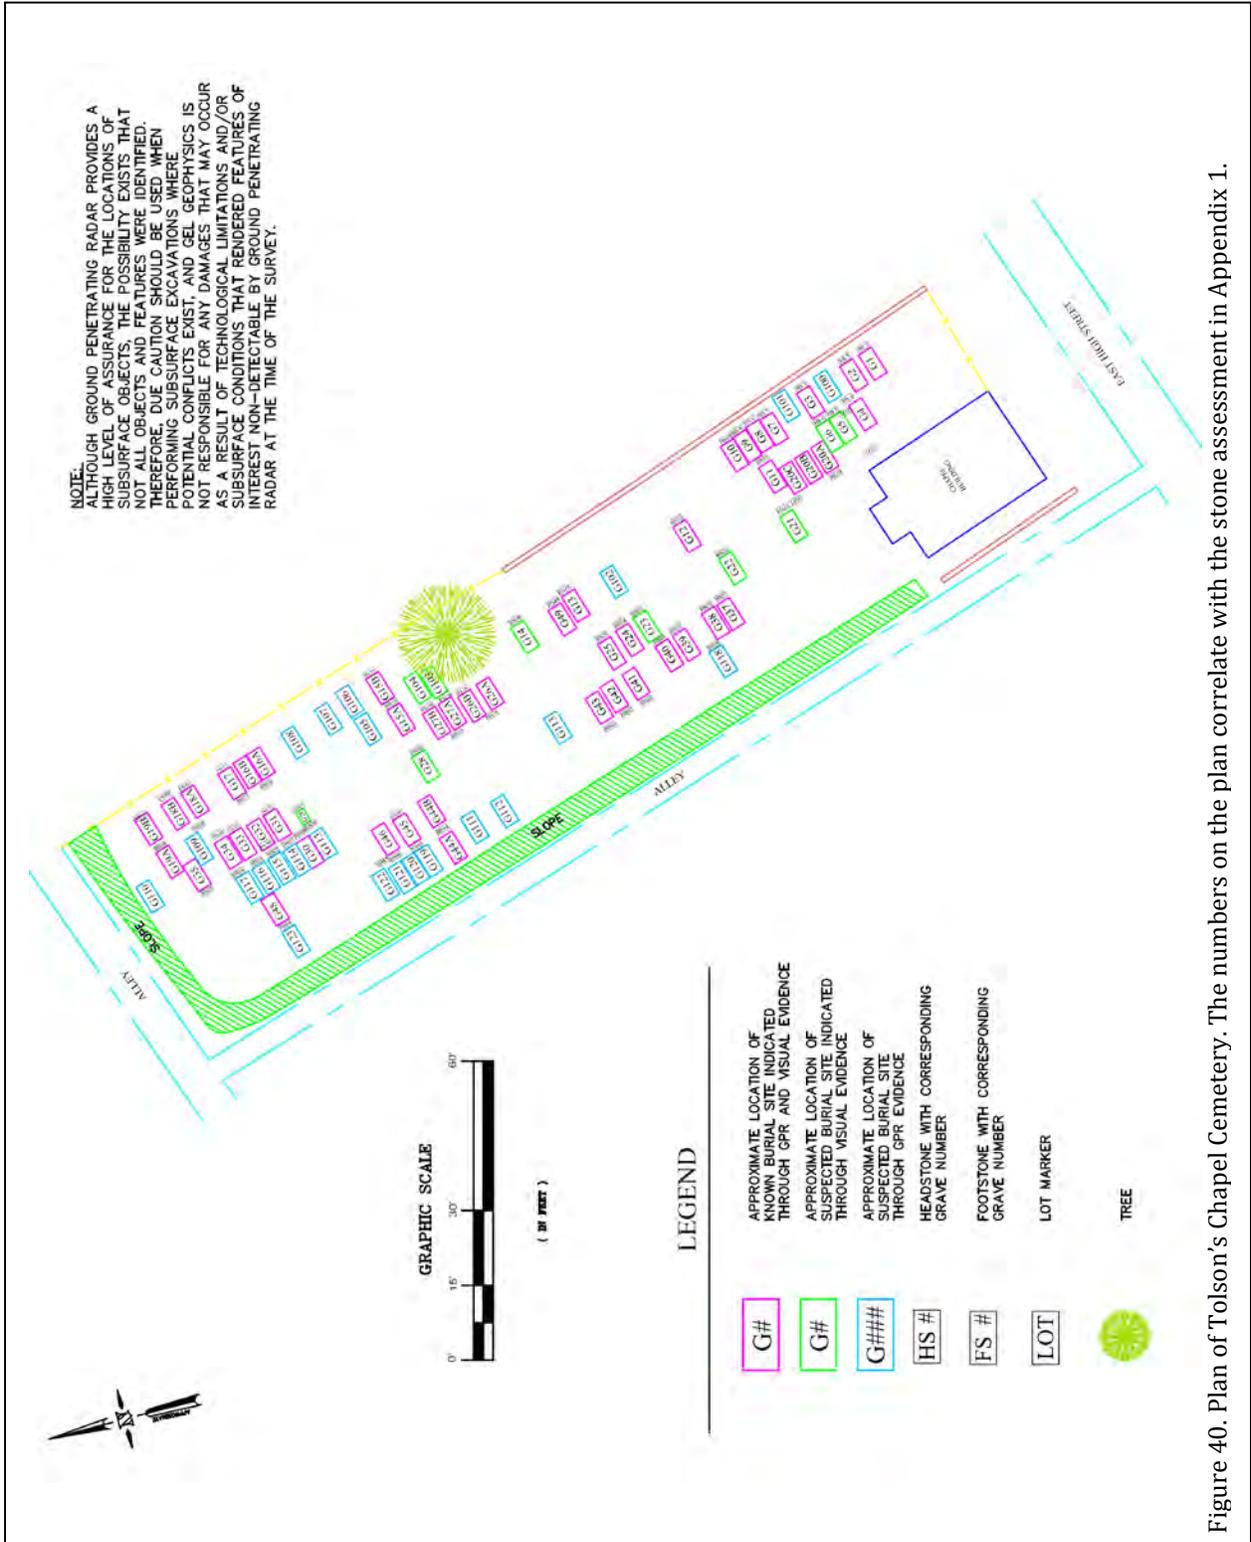
Figure 40. Plan of Tolson's Chapel Cemetery. The numbers on the plan correlate with the stone assessment in Appendix 1.

The results of this study are illustrated in Figure 40.

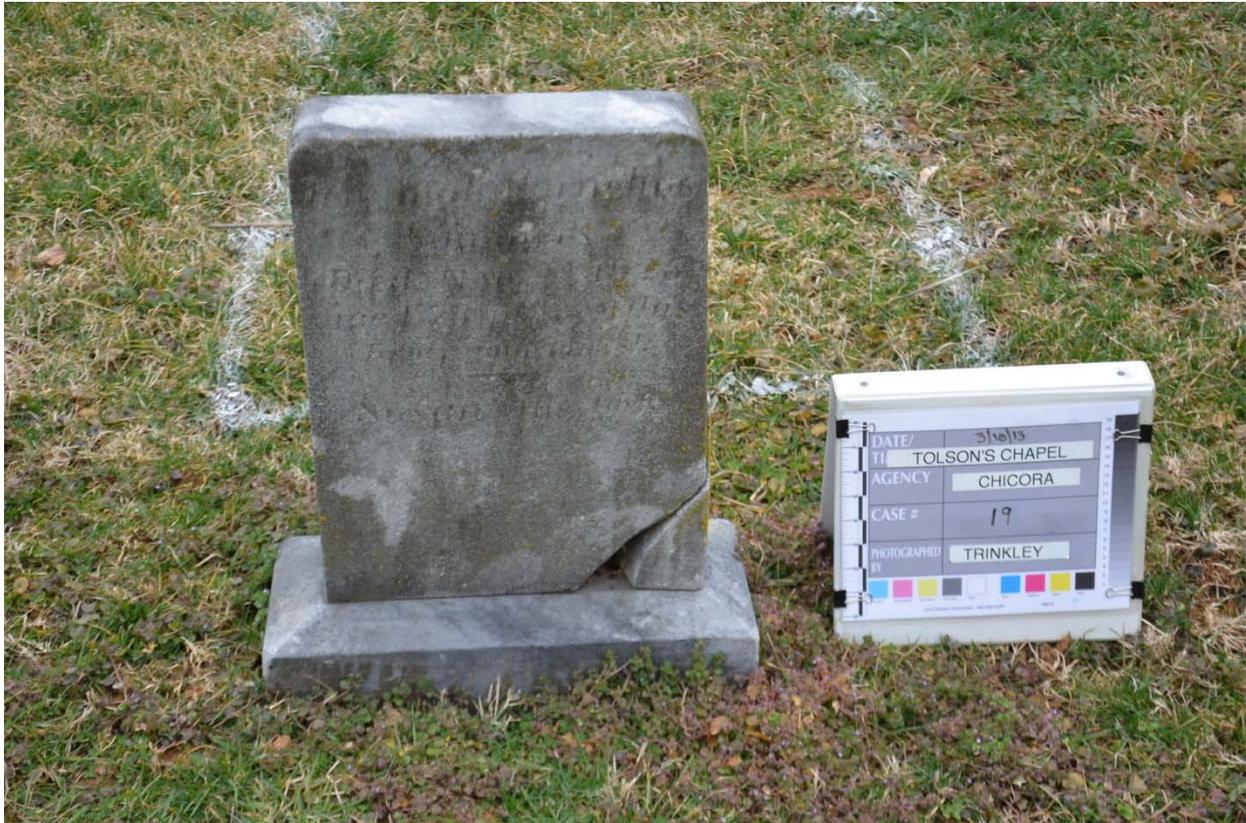
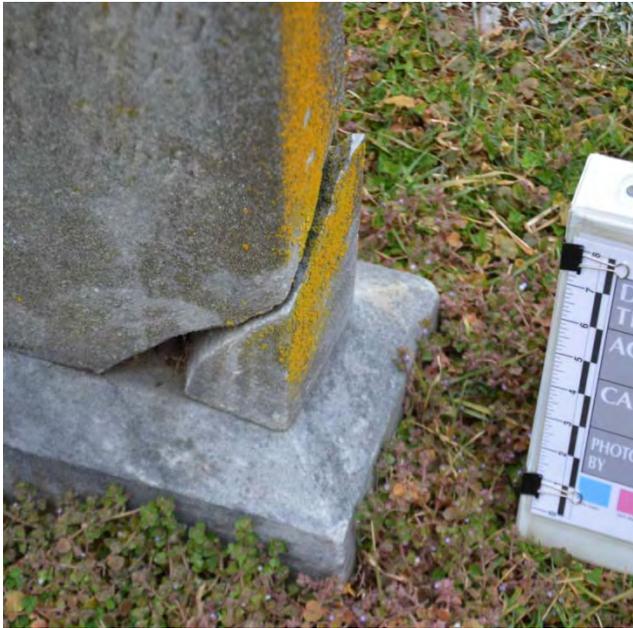
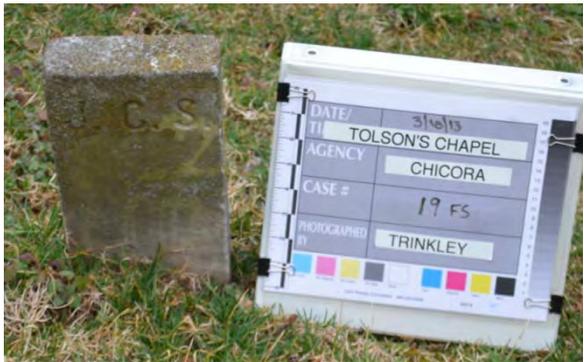
**Footstone:**      **Material:** marble      **Design/initials:** J.C.S.      **Condition:** tilted, mower damage, biologicals

**Deterioration:**  broken  cracked  losses  flaking/sugaring  ferrous pins  brass pins  
 delamination/detachment  spalling  missing fragments  other: iron jacking, mower damage

**Treatment:**  core drill  drill and pin  simple adhesive repair  injection grout  replace bricks  
 mortar  repoint  infill  other: replace ferrous pin with fiberglass; infill with Jahn M-120

**Cost:** \$850

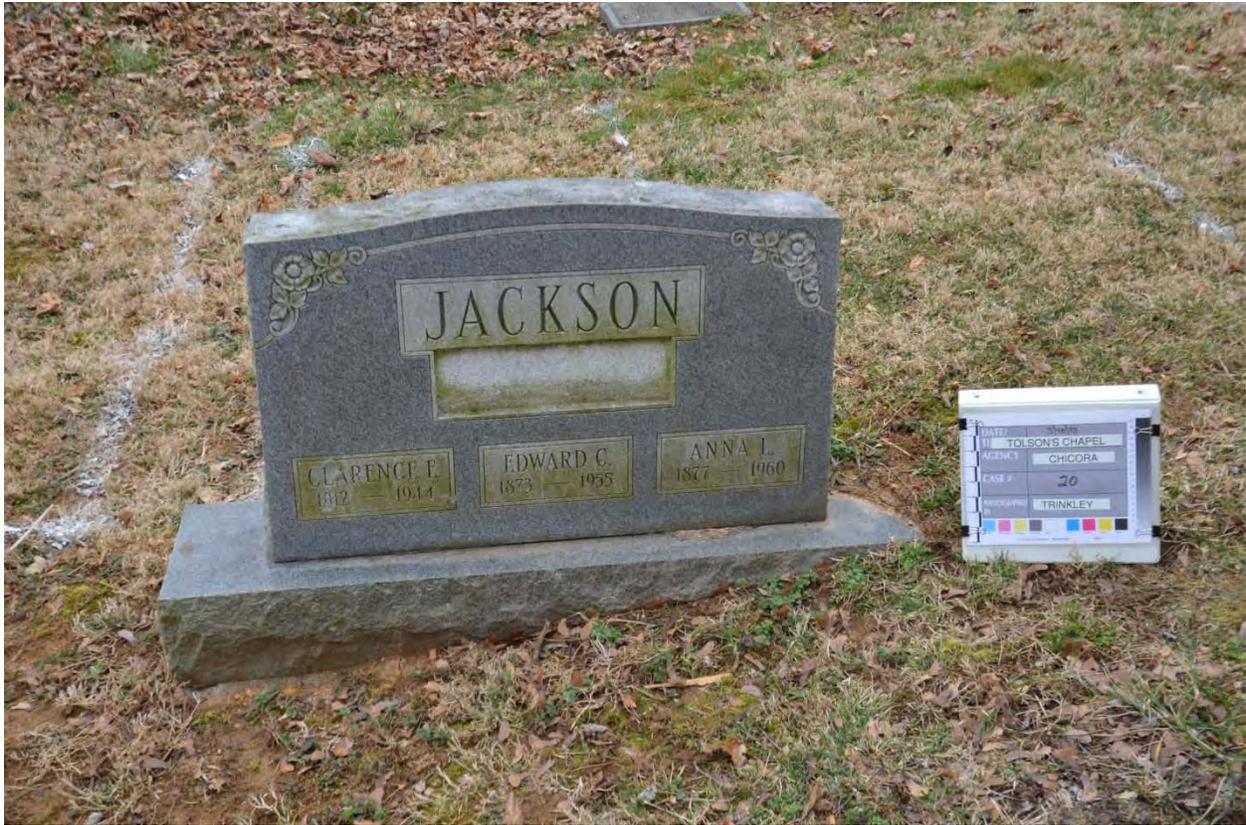
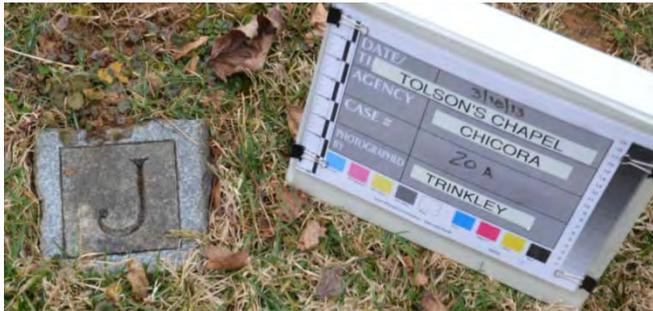
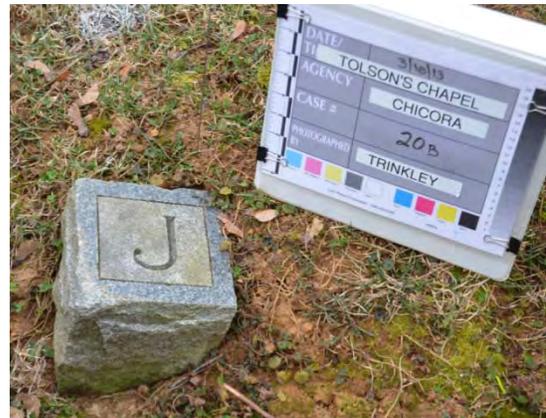
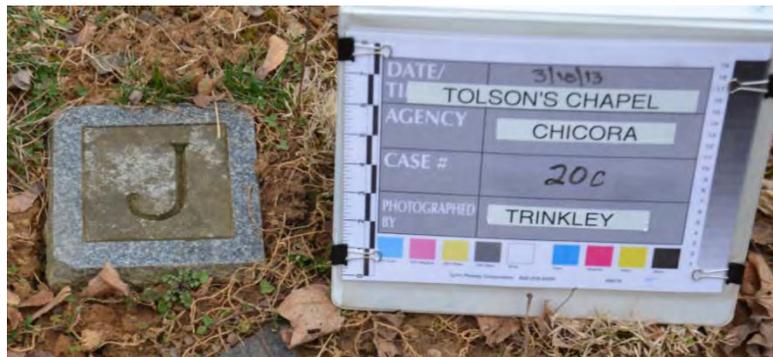
**Coping:**      **Material:** granite      **Design:** J      **Condition:** tilted, sunken  
 (3 corner markers, 6" x 6")

**Failed/Old Treatments:**  metal  adhesives/coatings  mortar  other: set in OPC

**Treatment:**  core drill  drill and pin  simple adhesive repair  injection grout  replace bricks  
 mortar  repoint  infill  other: reset lot corners

**Cost:** \$400

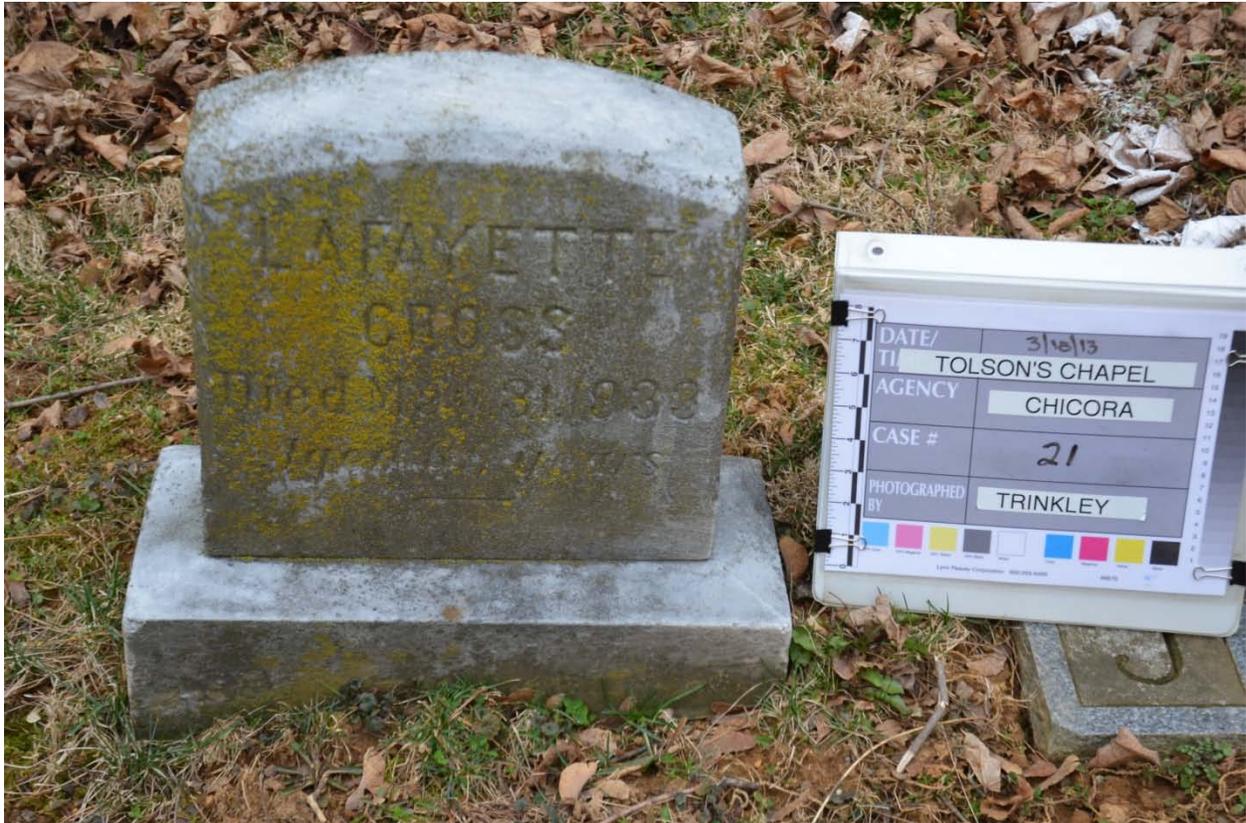
DATE/TI	3/18/13
AGENCY	TOLSON'S CHAPEL
CASE #	CHICORA
PHOTOGRAPHER BY	21
	TRINKLEY

**Deterioration:**  broken  cracked  losses  flaking/sugaring  ferrous pins  brass pins  
 delamination/detachment  spalling  missing fragments  other: possible ferrous pins, but no deterioration observed

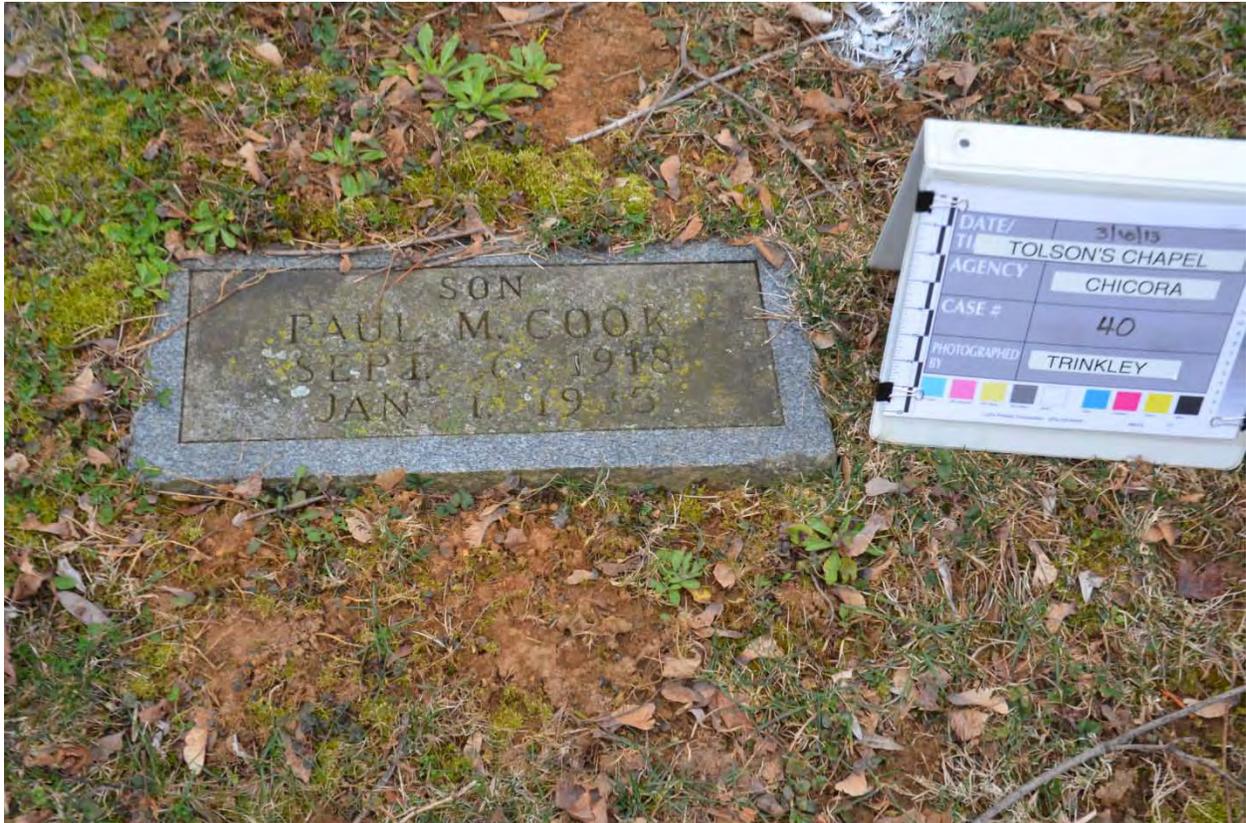
DATE/TITLE	3/6/13
AGENCY	TOLSON'S CHAPEL
CASE #	40
PHOTOGRAPHED BY	TRINKLEY

SON  
PAUL M. COOK  
SEPT. 6, 1918  
JAN. 1, 1983

**Failed/Old Treatments:**  metal  adhesives/coatings  mortar  other: set in OPC

**Position:**  reset/level in ground  reset/level to existing base  construct new base  resquare  
 possible new base required  stabilize foundation  reset with 1:2.5 NHL 3.5 mix  reset with compound  
 other: remove OPC

**Priority:** 2      1) hazardous, immediate action; 2) unstable, requires treatment ASAP; 3) ongoing deterioration, treatment required 2-3 years; 4) re-inspect in 5-10 years; 5) irreparable      **Cost:** \$175

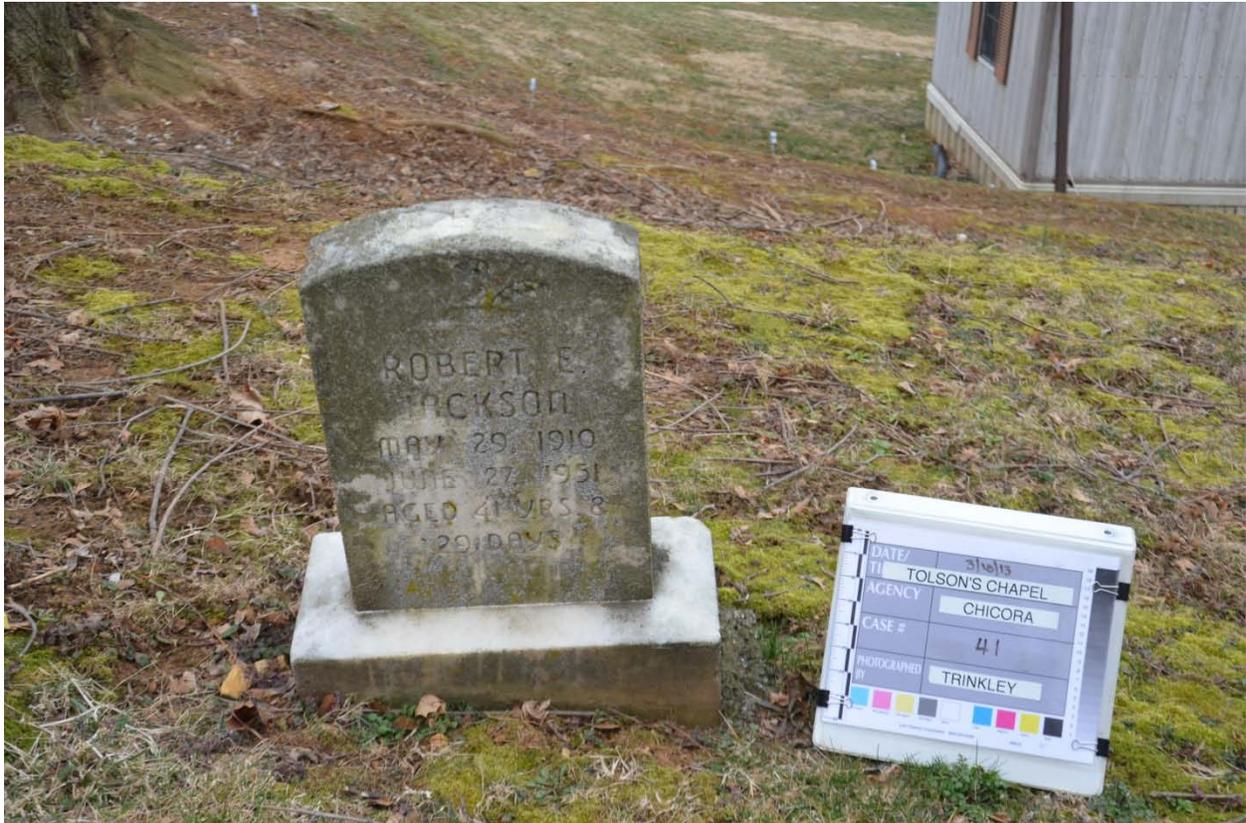
**Failed/Old Treatments:**  metal  adhesives/coatings  mortar  other: set in OPC

**Position:**  reset/level in ground  reset/level to existing base  construct new base  resquare  
 possible new base required  stabilize foundation  reset with 1:2.5 NHL 3.5 mix  reset with compound  
 other: remove OPC

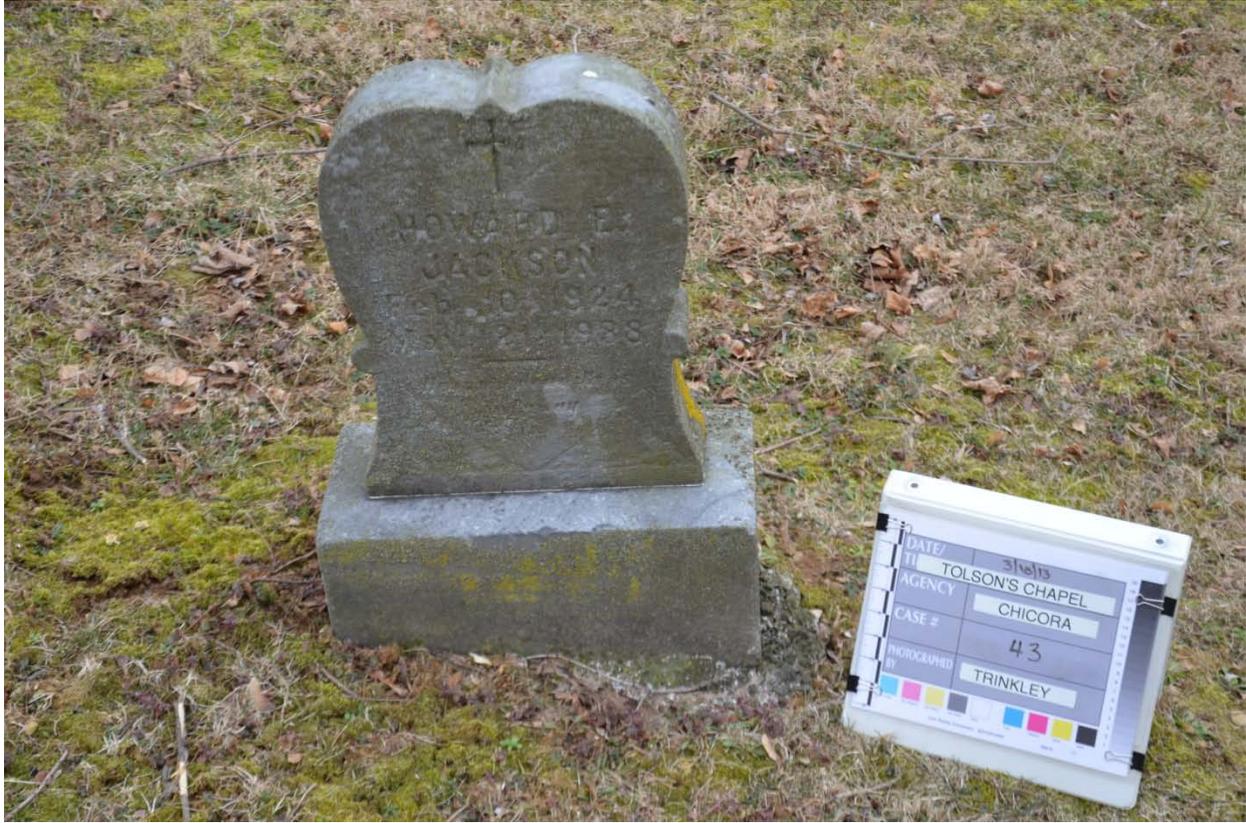
**Deterioration:**  broken  cracked  losses  flaking/sugaring  ferrous pins  brass pins  
 delamination/detachment  spalling  missing fragments  other: possible ferrous pins, but no deterioration observed

**Priority:** 3      1) hazardous, immediate action; 2) unstable, requires treatment ASAP; 3) ongoing deterioration, treatment required 2-3 years; 4) re-inspect in 5-10 years; 5) irreparable      **Cost:** \$210

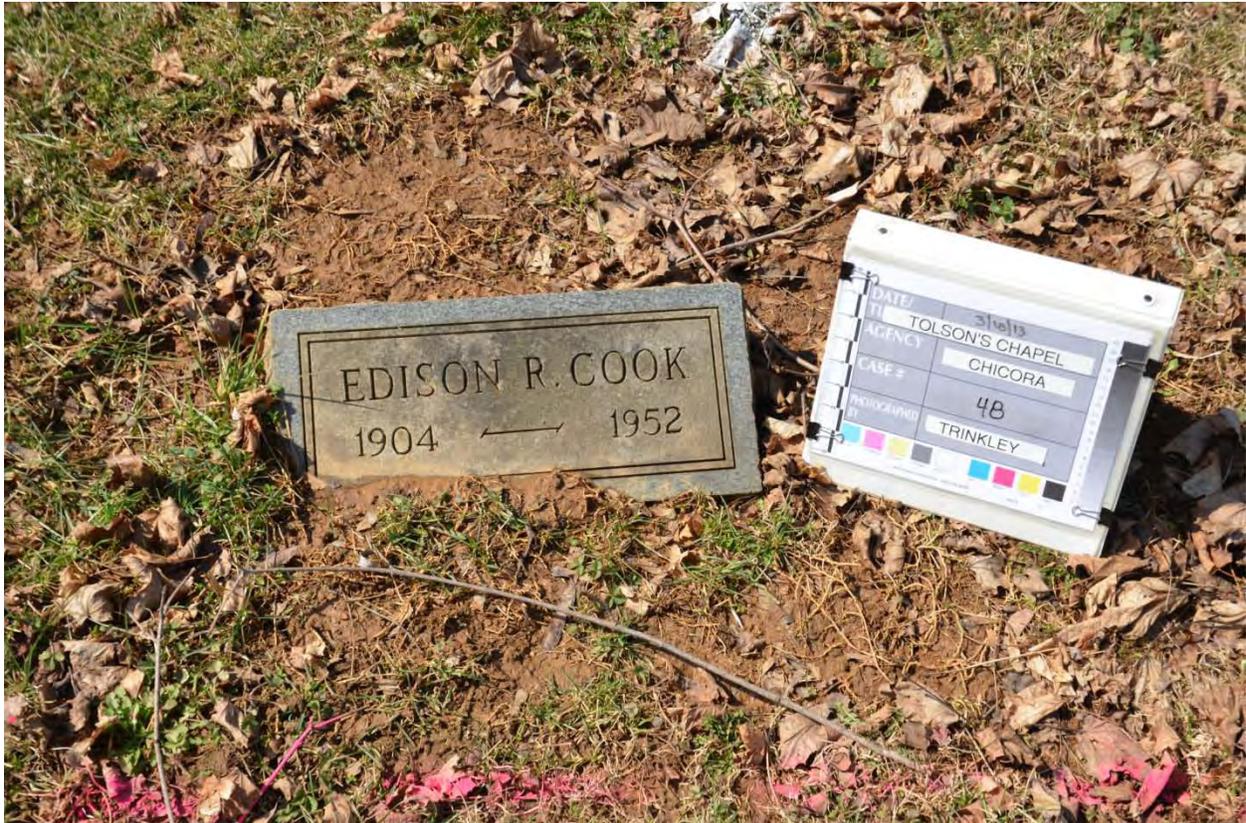
DATE/TIME	3/16/13
AGENCY	TOLSON'S CHAPEL
CASE #	CHICORA
PHOTOGRAPHER BY	48 TRINKLEY

EDISON R. COOK  
1904 ——— 1952
