PRESERVATION ASSESSMENT OF THE LYNNHAVEN HOUSE CEMETERY, VIRGINIA BEACH, VIRGINIA

Preservation Assessment of the Lynnhaven House Cemetery, Virginia Beach, Virginia

Prepared By:
Michael Trinkley, Ph.D.
and
Debi Hacker

August 2013

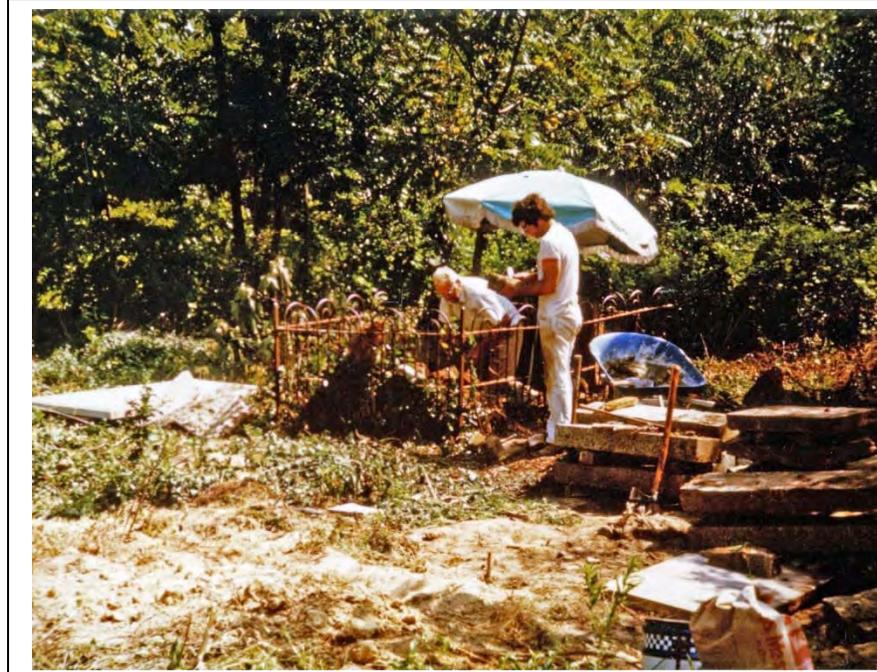
Figure 11. Mason restoring the box tomb of Eliza J.S. Walke in July 1975 (City of Virginia Beach Department of Museums).

A photograph from the same July 1975 set shows a mason and his helper “restoring” the brick box tomb (Figure 11). The other tombs have been stacked up to the south and appear to be waiting their restoration.

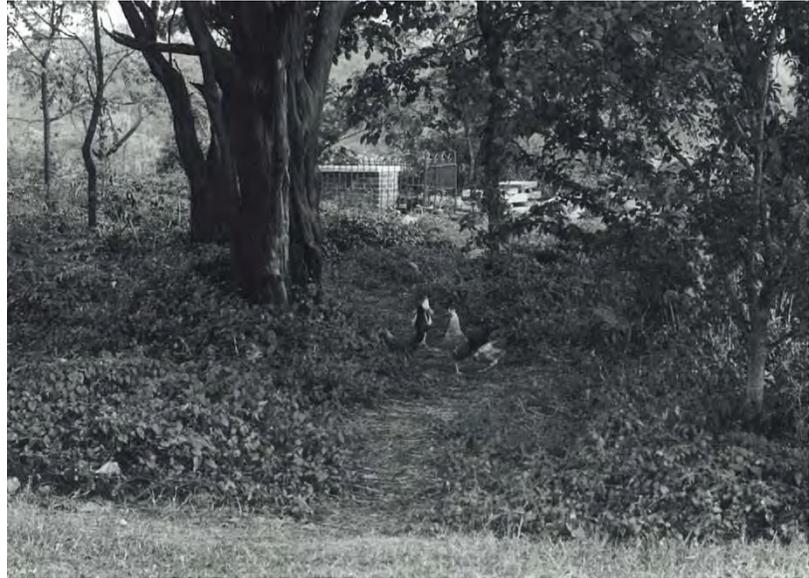
12). The photo reveals that the marble box tombs were still stacked up and only the brick box tomb

had been restored. There was no landscaping in the cemetery area, with only a narrow path leading to the cleared area.

Figure 12. August 1975 photograph of the cemetery showing that the brick box tomb had been restored, but work had not yet begun on the other monuments (City of Virginia Beach Department of Museums).

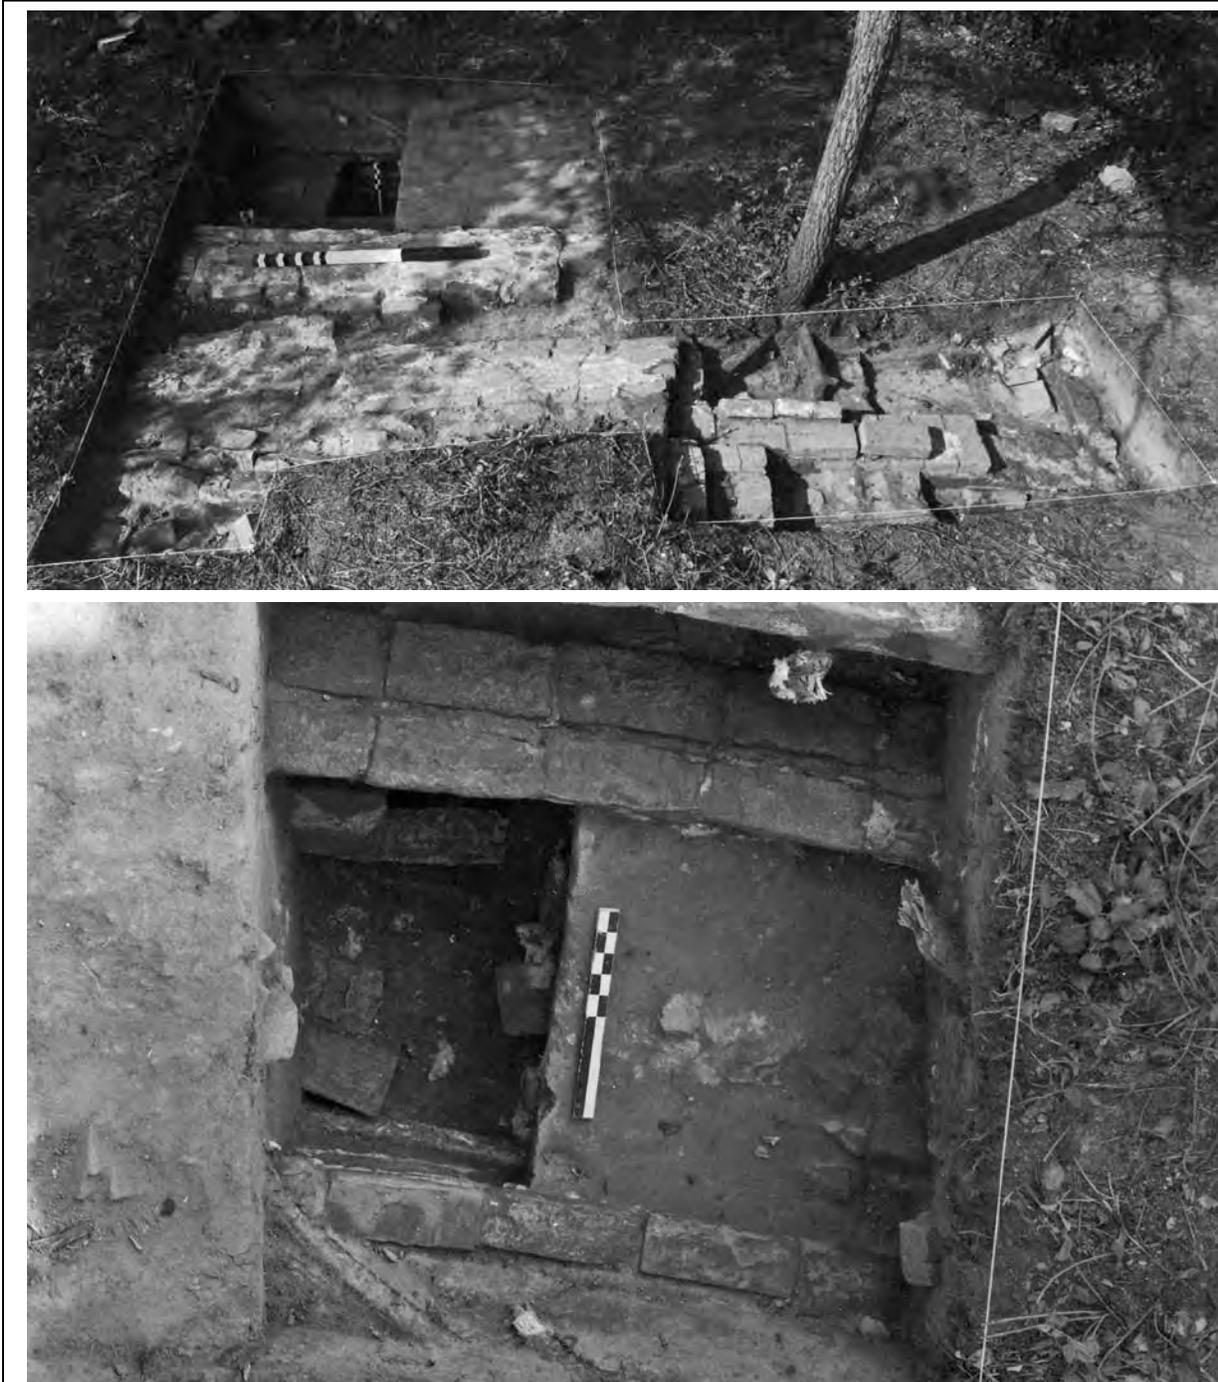
As more of the brickwork was exposed it became obvious that the excavation had uncovered a series of subterranean burial crypts constructed of brick. At least five of these chambers were partially excavated, each chamber seemingly using brick of different textures and colors, indicating individual periods of

Because of the unusual configuration of these crypts, one was excavated further to document that these were indeed human burials and not a structural feature. Once a human femur was identified, further excavation of the crypts was discontinued and the test backfilled. In the single burial that was partially exposed, no evidence of a coffin for the interment was discovered (Fisher 1983:33-34).

Figure 15. Units 84-86. The upper photograph shows the four crypts or vaults exposed by the excavation, looking to the north. The lower photograph shows the one vault in the NW corner that was partially excavated to reveal human remains, looking down on the excavation (north is at the bottom of the photo) (courtesy Virginia Department of Historic Resources).

While the archaeological examination was able to identify four vaults and one burial that may not have been vaulted, there was no intensive examination to determine the total number of burials. Ground penetrating radar should be used in an effort to determine where all burials are situated so they can be avoided by future interpretative

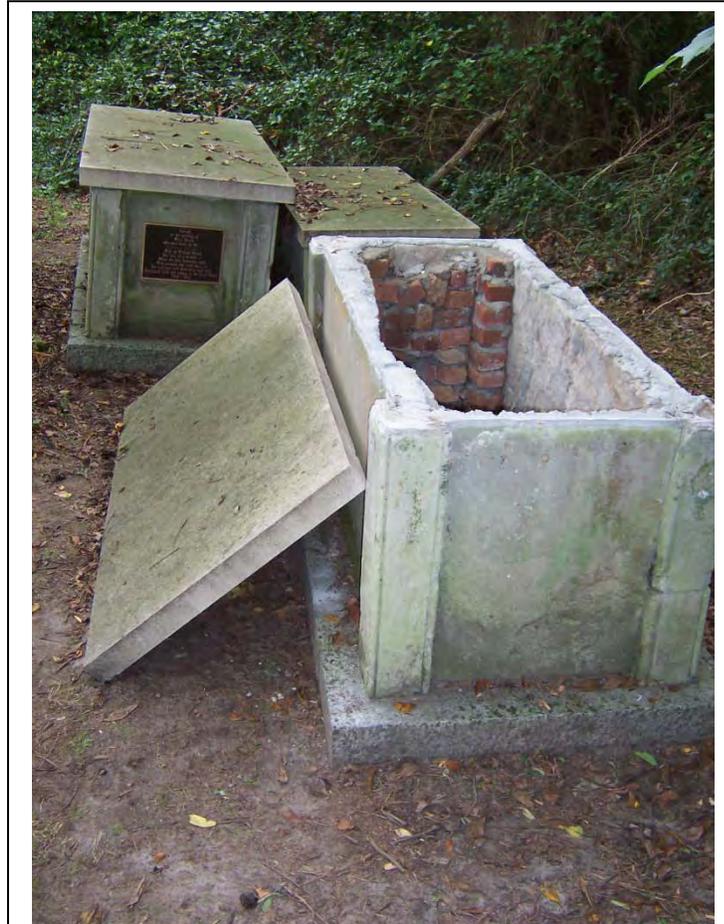
Figure 16. Vandalized tomb of William Boush looking east, October 2007.

(Figure 16). We have noted that the effort to look inside box tombs is rather common since many believe the coffin is within the box, not buried below the box.

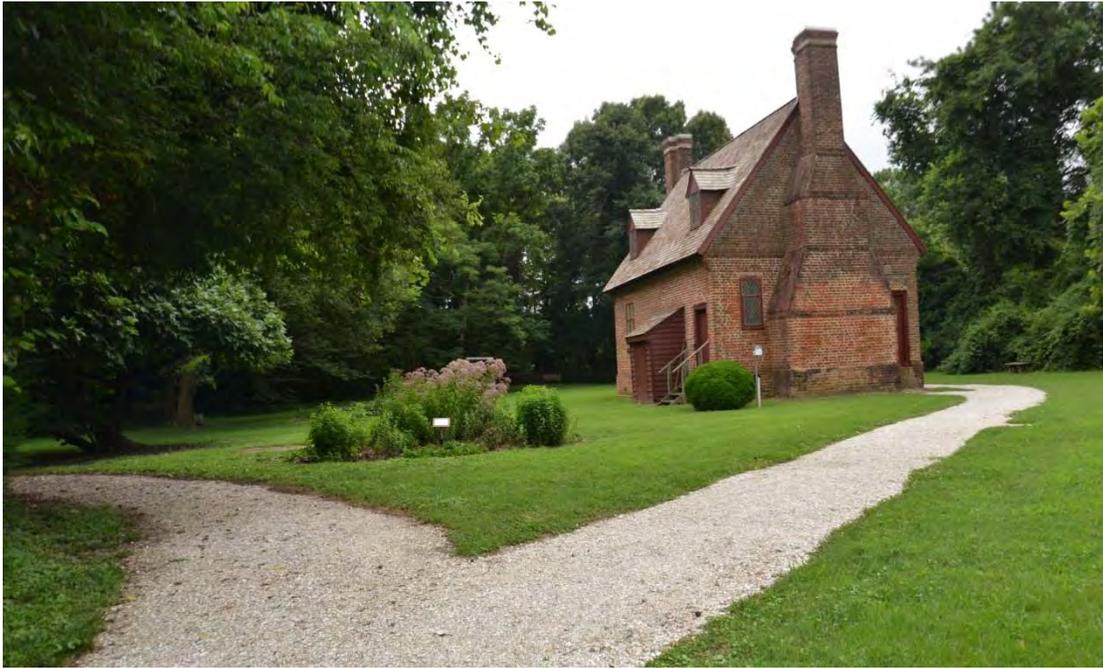
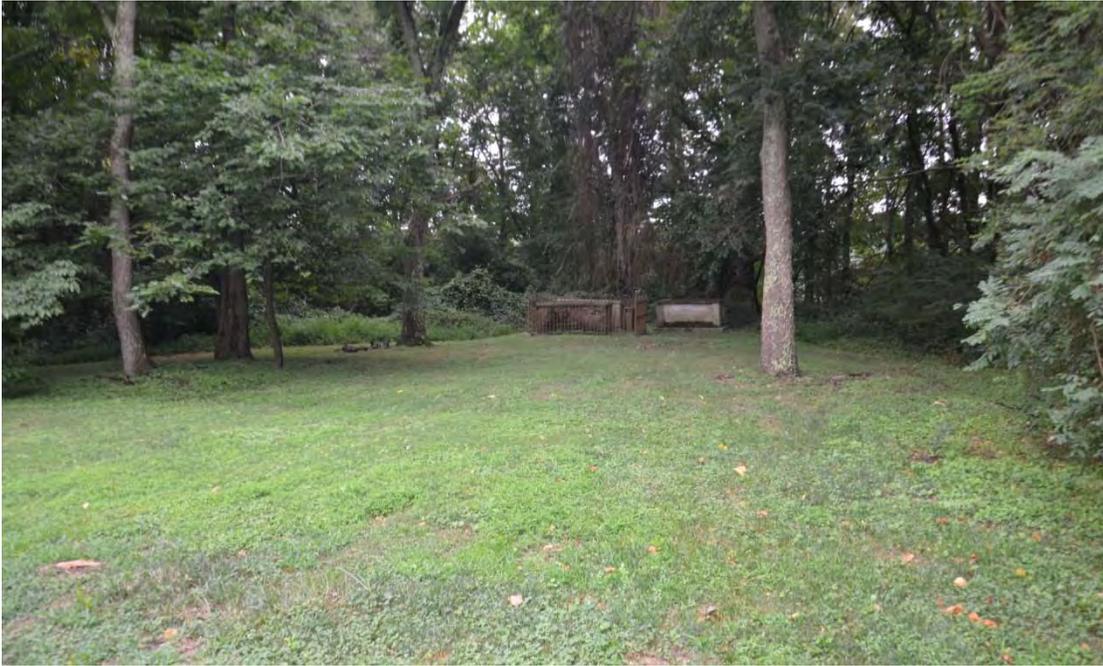
Access to the cemetery is not defined and thus far visitation is so low that there are no discernible wear patterns in the grass from social pathways.

Figure 17. Pedestrian access. The upper photograph shows the shell pathway leading from the interpretative center to the Lynnhaven House. To the left is the pathway from the caretaker's house used by maintenance vehicles. The lower photograph shows the grassed area between the Lynnhaven House and cemetery.

There are three options. The most obvious is to extend the existing shell pathway since it would be consistent with what already exists. This option should be selected only if the pathway is verified as meeting ADAAG standards.

The second option is to use a soil, shell, or stone pathway that has been stabilized to meet ADA requirements. Examples of stabilizers

The third option is the use of grass tracks underlain by a reinforcing system to provide a firm, but free draining layer on which vegetation can grow. One grass reinforcement system is the Grasspave² porous pavement by Invisible Structures, Inc. (<http://www.invisiblestructures.com/grasspave2.html>). This system has the added benefit of having been approved for ADA use (Figure 19).

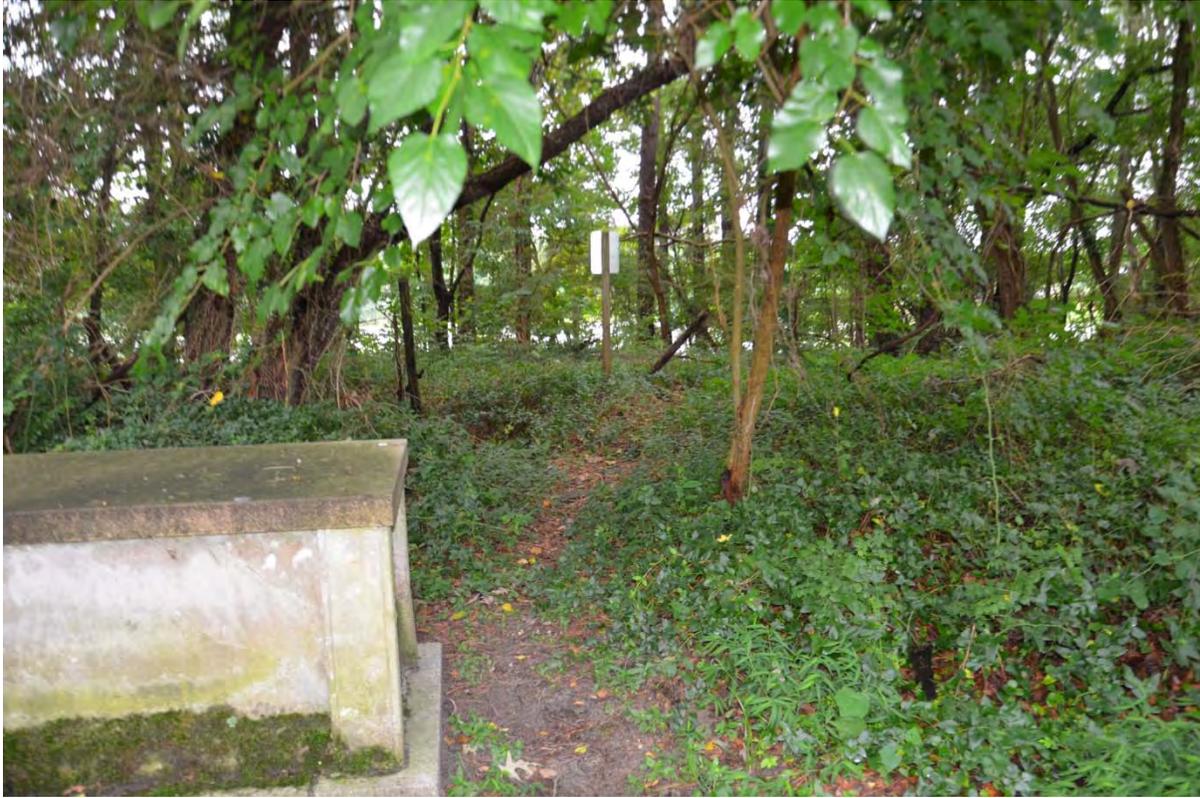
Figure 18. Social path from the cemetery southward to the property fence and Wishart Lake.

the fence south of the cemetery to the cemetery itself. The reason for the pathway, and its clear definition, is unknown.

The presence of a social path leading from the cemetery to Wishart Lake (Figure 18) may be the only suggestion that individuals from outside the park are making their way through the cemetery.

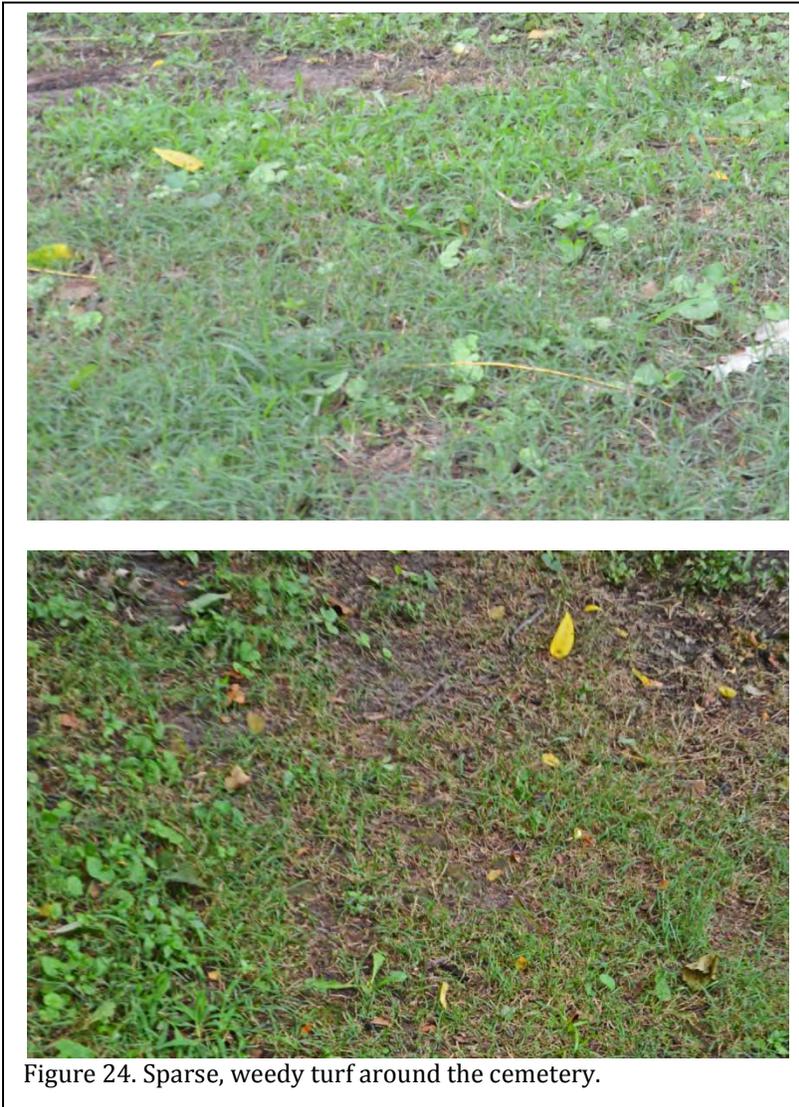
Although the cemetery is dominated by "grass" it is composed almost entirely of different broadleaf weeds with some Bermuda turf. The invasion of broad leaf weeds is especially noticeable (Figure 24). Because of the shade the turf is sparse, with many areas of open soil, especially around the tombs.

Figure 24. Sparse, weedy turf around the cemetery.

Weedy turf should be replaced by mulching around the trees and the various box tombs in the cemetery. This will reduce the need for mowing and use of nylon trimmers around the monuments.

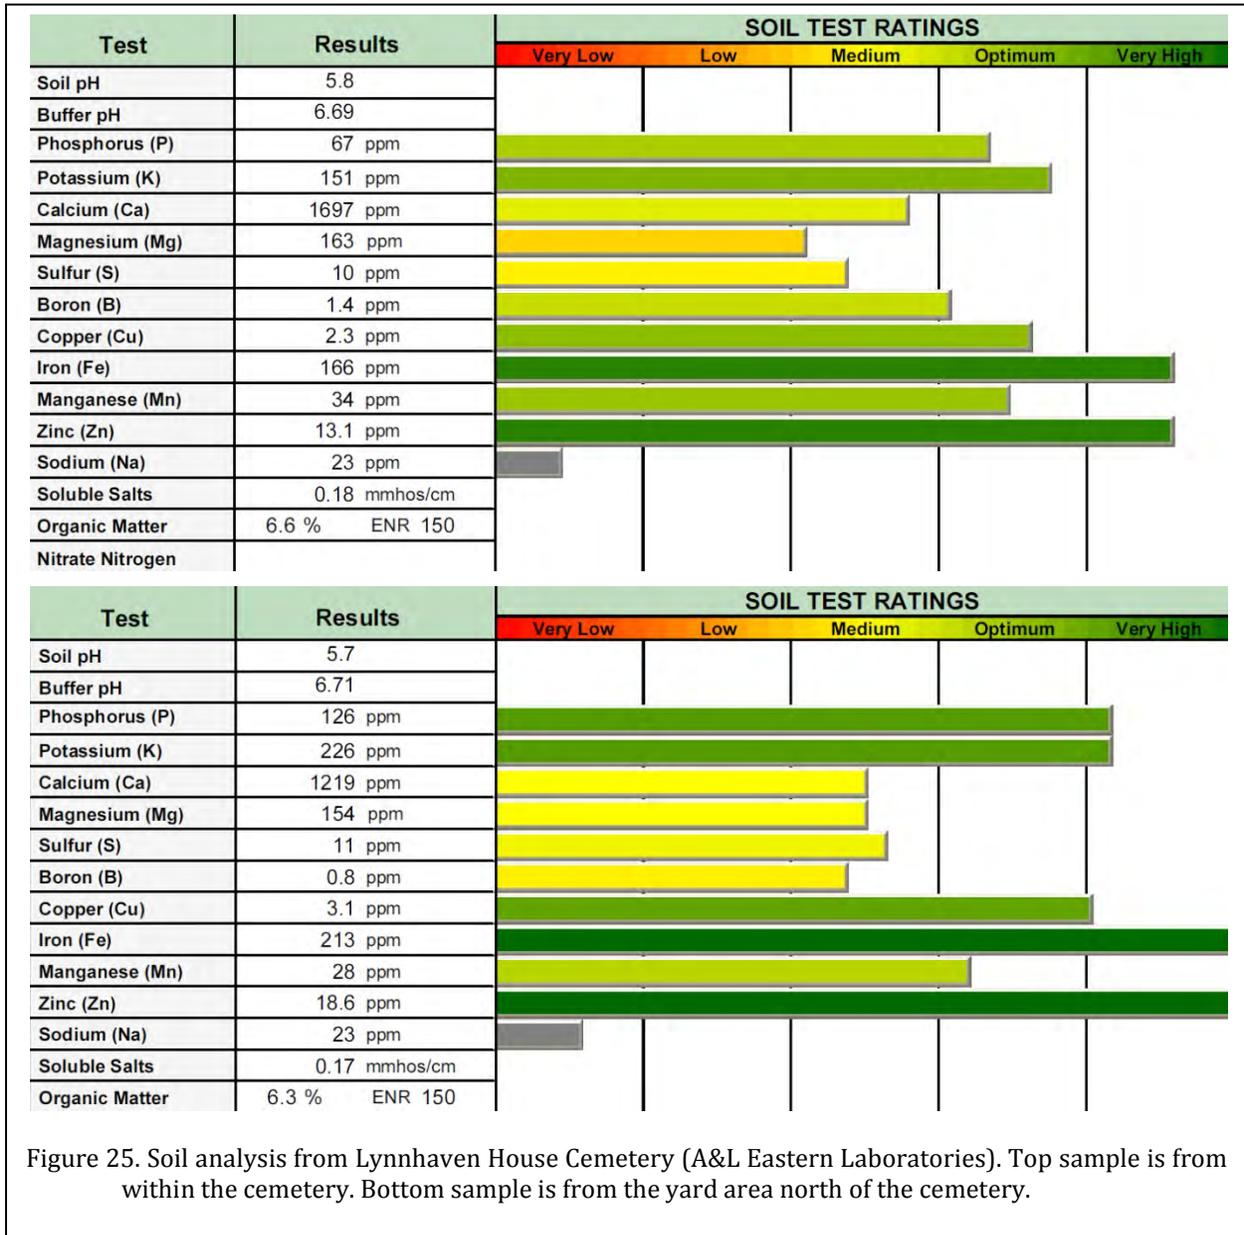
For soils that have not been amended, both samples reveal relatively high levels of essential macronutrients such as potassium (K) and phosphorus (P). While plants prefer soil pH between 5.5 and 7.0, nutrients are most readily accessible between pH 6 and 6.5. Thus, the soil pH at Lynnhaven is slightly acidic and the soil would benefit from an application of 30-50 pounds of lime per 1,000 square feet (the lower amount is suitable within the cemetery, the higher amount is

Figure 25. Soil analysis from Lynnhaven House Cemetery (A&L Eastern Laboratories). Top sample is from within the cemetery. Bottom sample is from the yard area north of the cemetery.

appropriate in the yard area). These applications are designed to raise the pH to about 6.2.

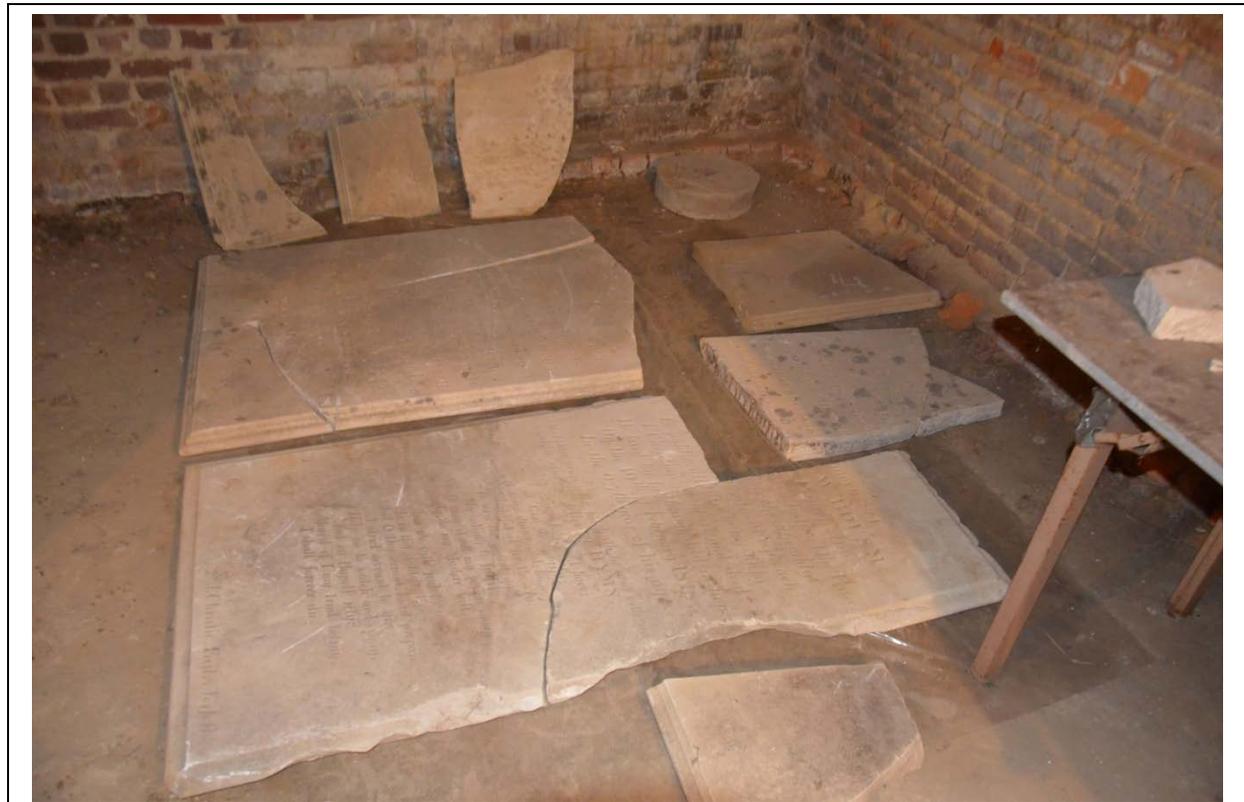
The fragments of the broken ledgers from the cemetery are being stored in the locked Lynnhaven House basement. This provides safe and secure storage and the City has even placed plastic under the stones to minimize their uptake of ground moisture. This storage location is satisfactory.

Figure 28. Example of ledger stones stored in the house basement.

Care must be taken, however, to prevent damage to the stones should repairs or other maintenance be required in the basement.

Storage of damaged ledgers in the house basement is satisfactory, although care must be taken to prevent additional damage during house maintenance activities.

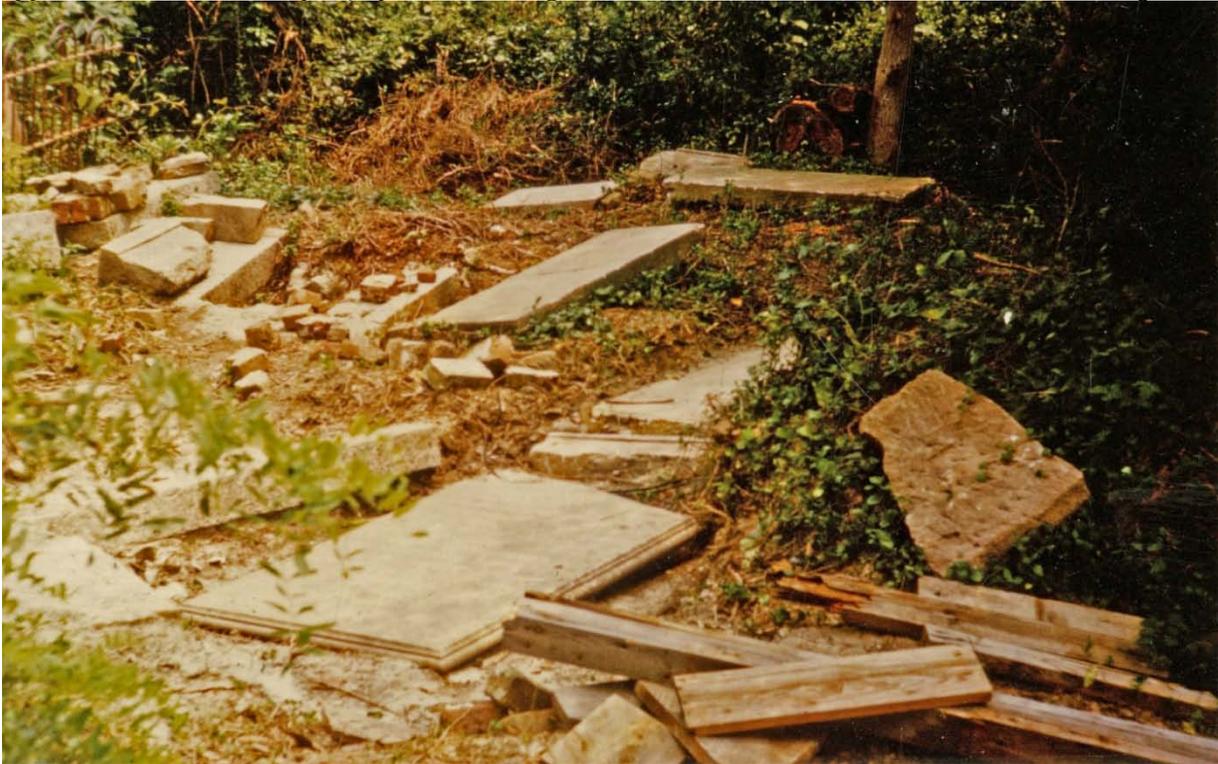
Marker 1, William Boush

Appearance of the cemetery in July 1975 showing that the William Bosch monument was not standing:

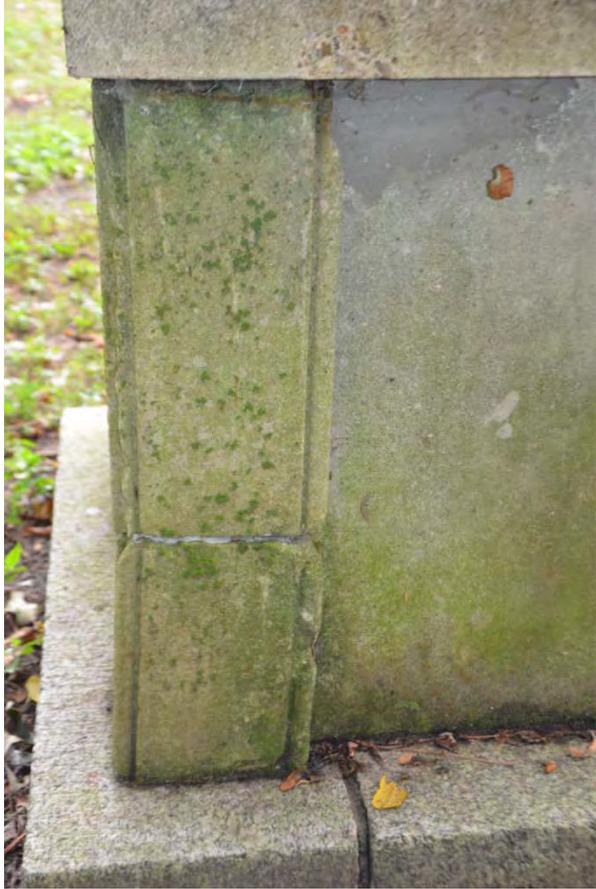
Old break on southwest leg:

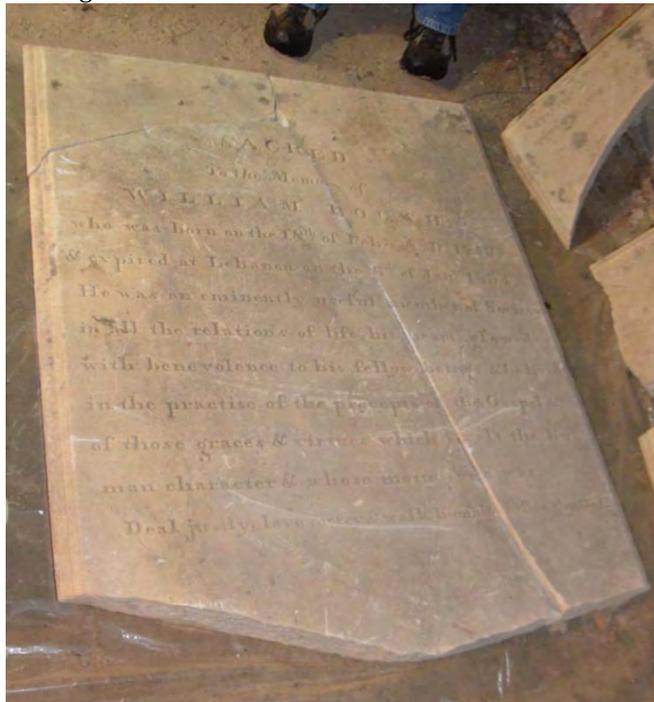
Remnants of William Boush ledger:

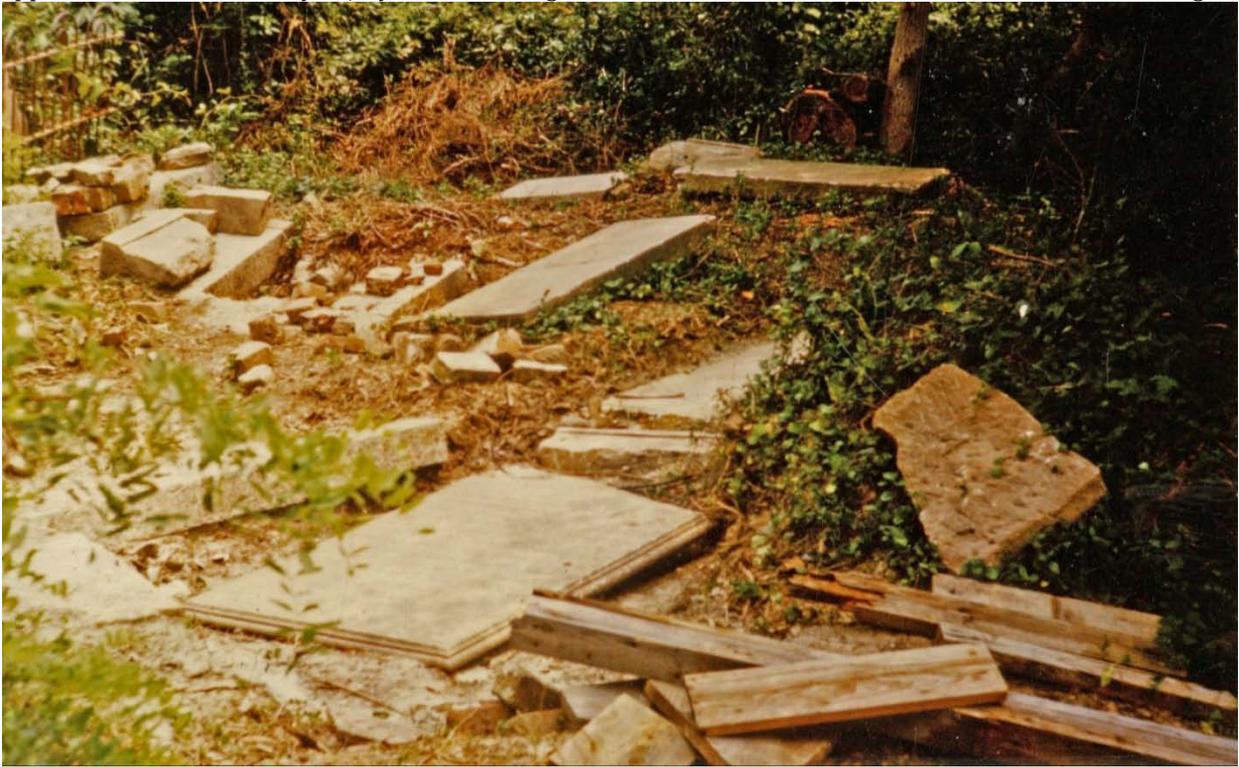
Marker 2, William F.W. Boush

Appearance of the cemetery in July 1975 showing that the William F.W. Bosch monument was not standing:

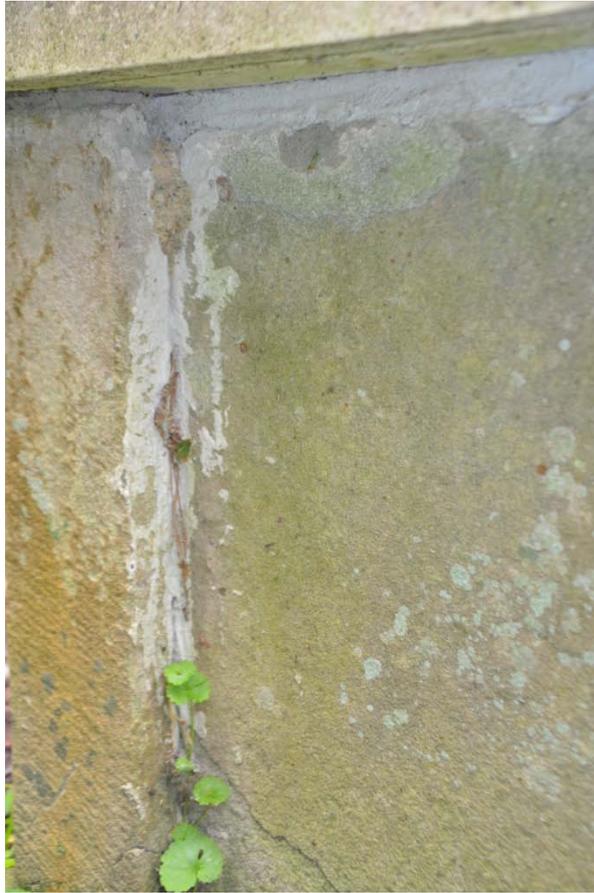
South side, southwest leg showing OPC:

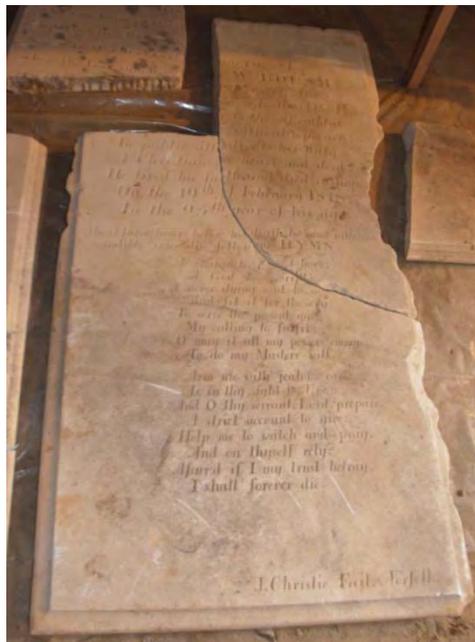
Remnants of William F.W. Boush ledger:

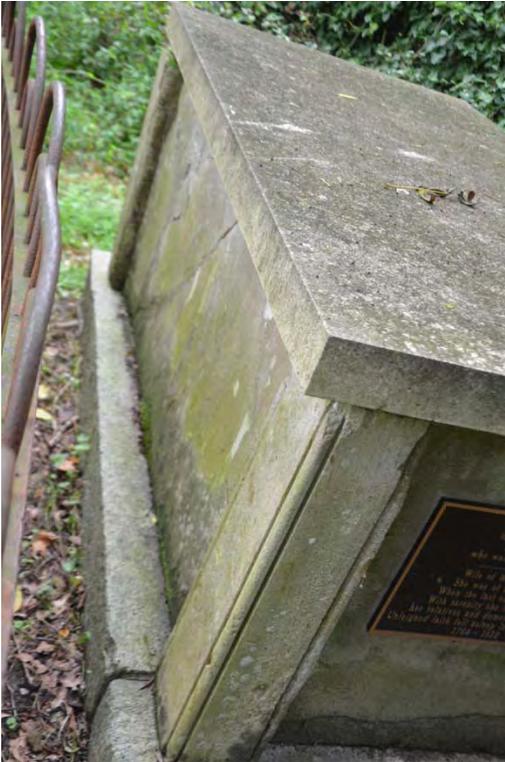
North side:

At a minimum, we recommend that this condition report and associated photographs be used for yearly monitoring to verify that there is no significant change in condition that might warrant treatment options to be reconsidered. This monitoring may be done by staff, but should be reviewed by a stone conservator. Of particular concern is the crack in the north side of the box panel.

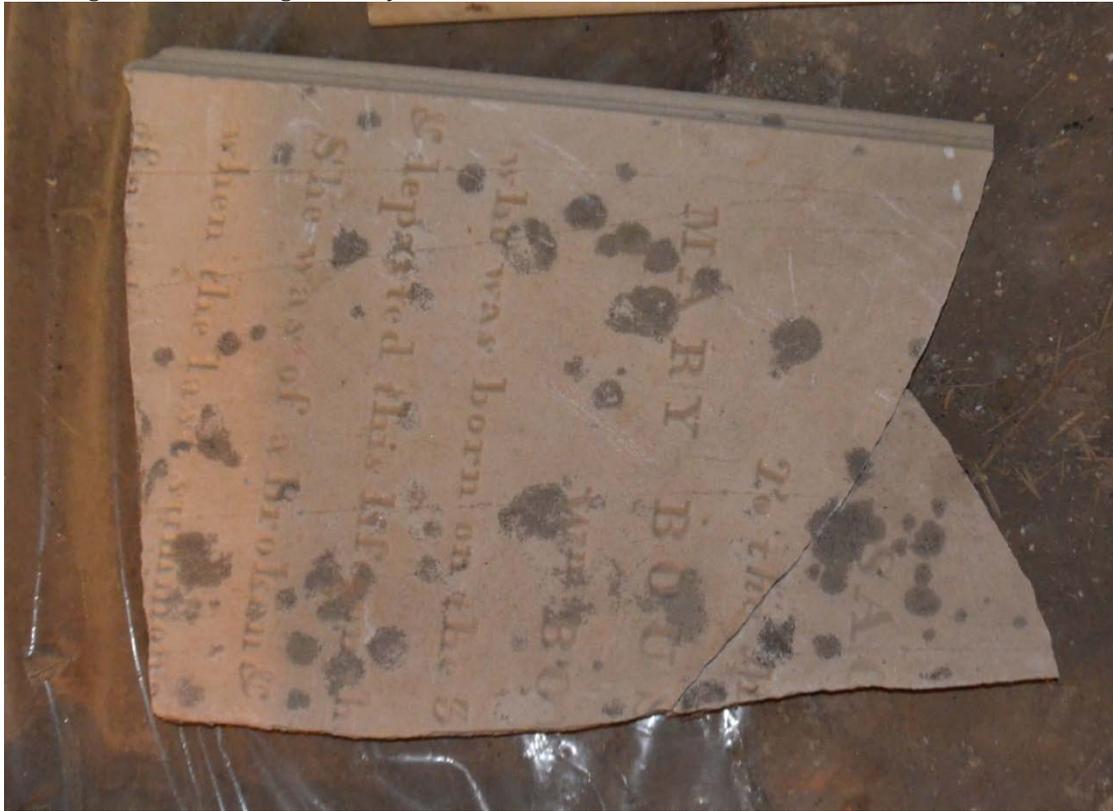
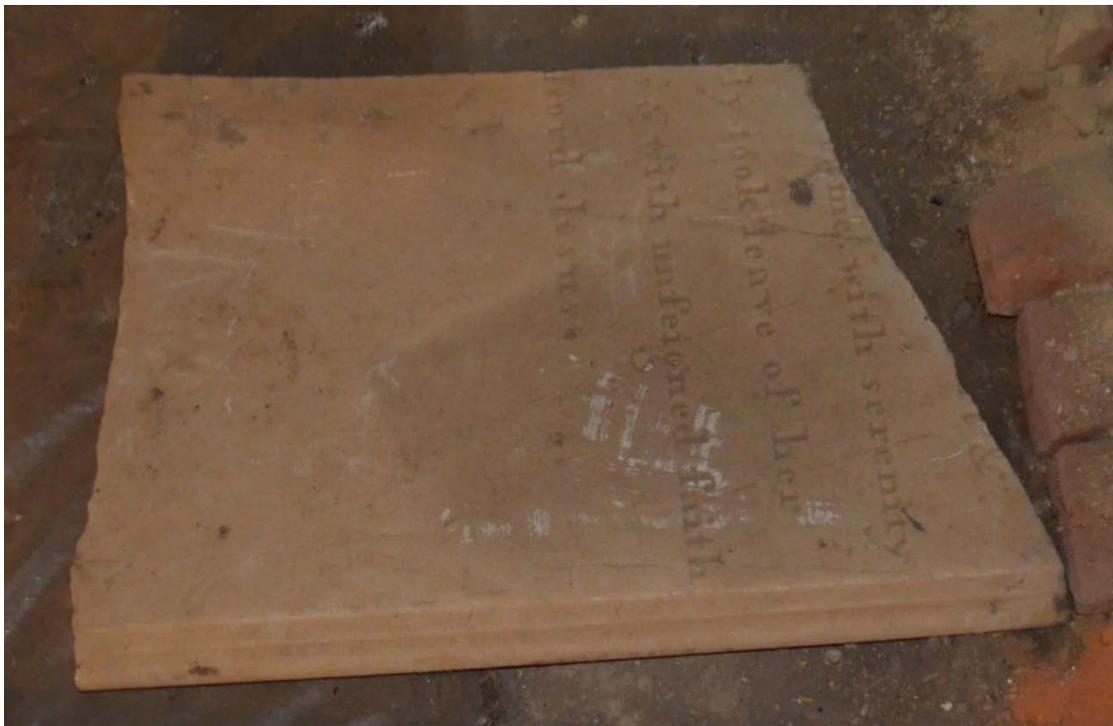
Two fragments of the original Mary Boush stone:

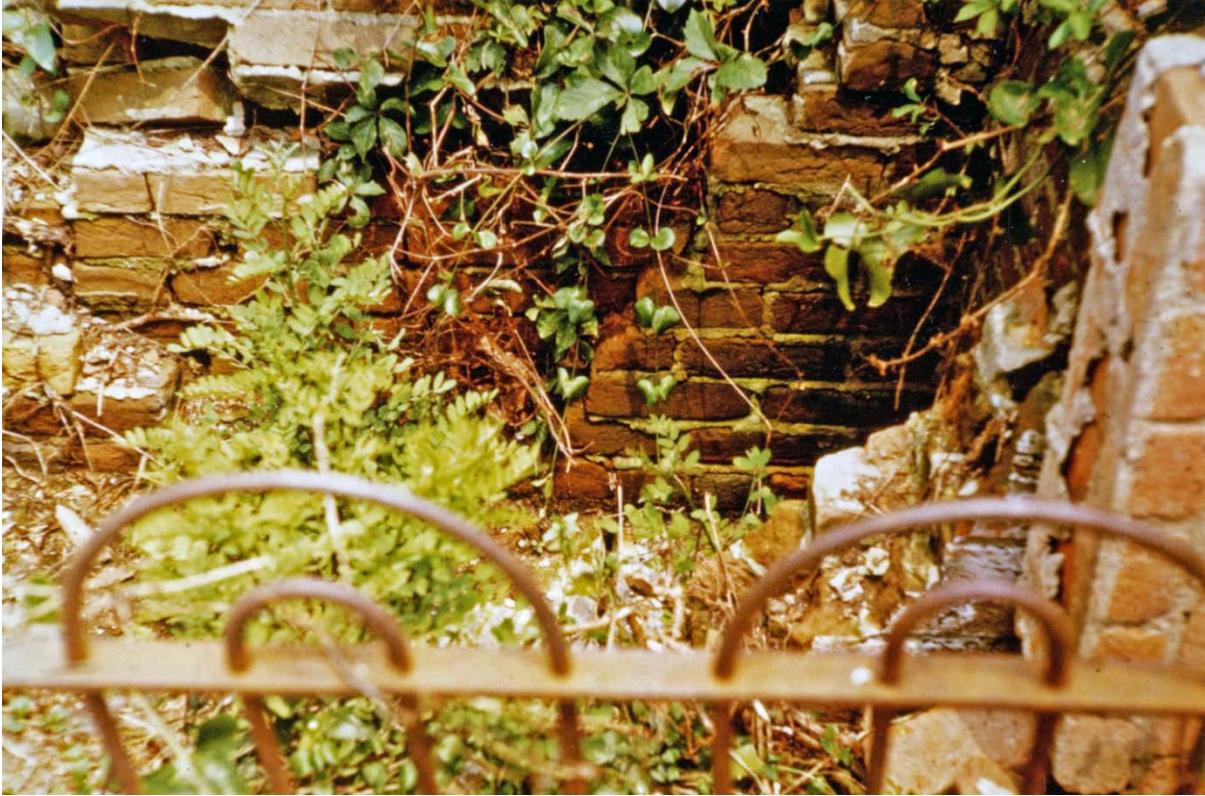
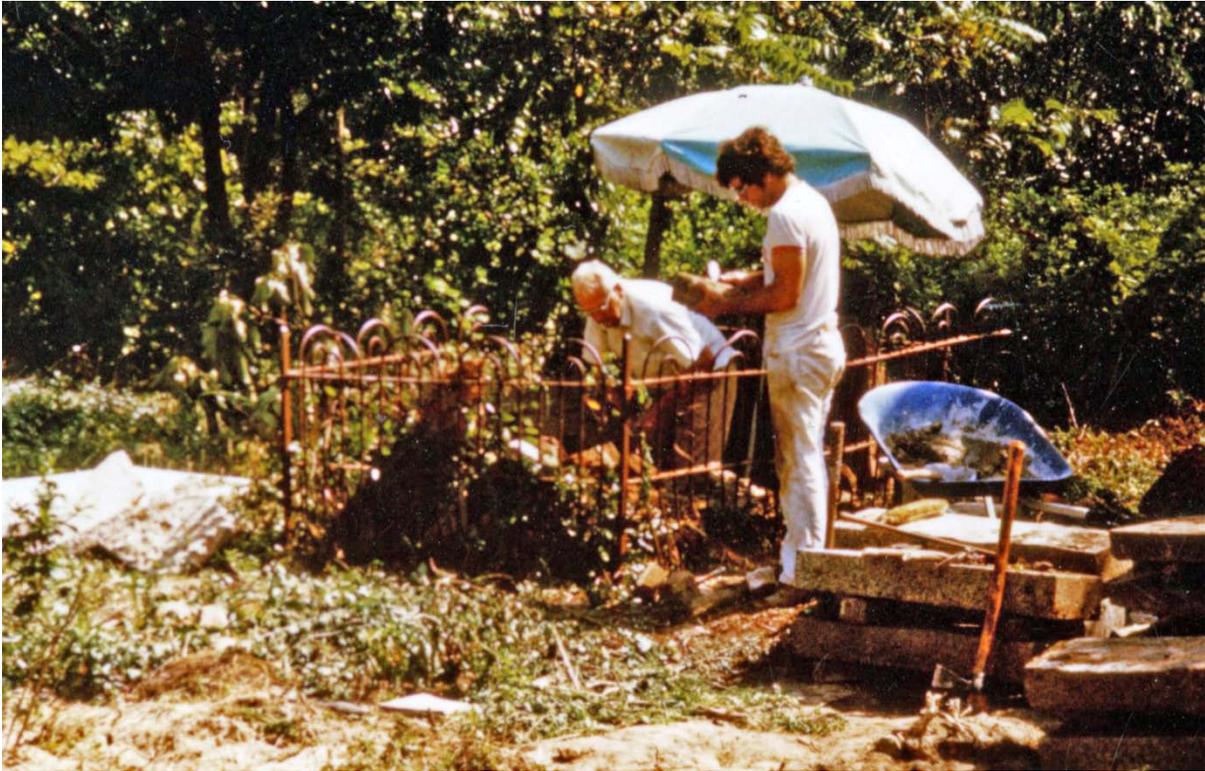
Marker 4, Eliza J.S. Walke

Appearance of the Eliza J.S. Walke monument in July 1975 showing the condition of the remnant box and repair efforts:

It is almost certain that the south wall will require repair within the next 2-3 years and this work should be performed prior to any additional damage to the box. The repair work should use either lime putty (if the work is conducted allow at least six months prior to freezing weather) or a 1:2.5 mix of NHL 3.5 and sand. Both have low compressive strength because of their high lime content and would be appropriate for the soft brick of the box.

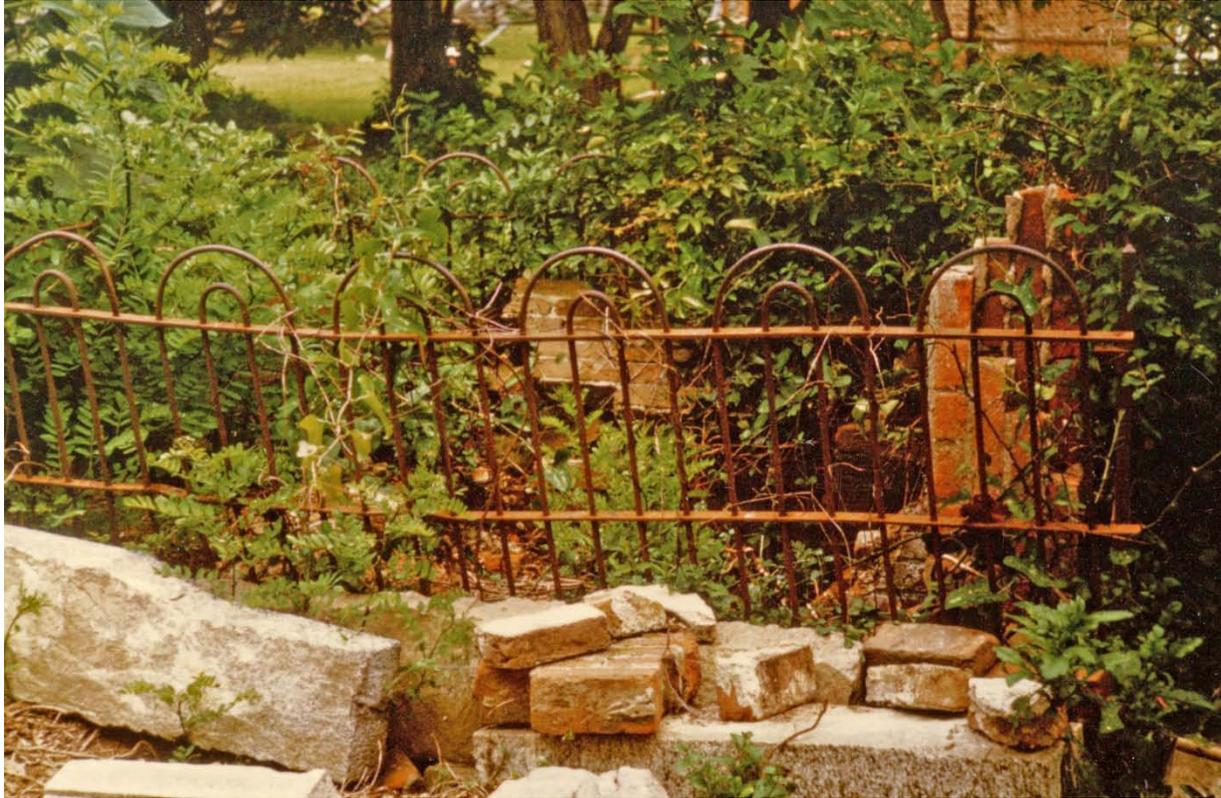
Appearance of the Eliza J.S. Walke fence in July 1975 showing its condition at the time (view to the north):

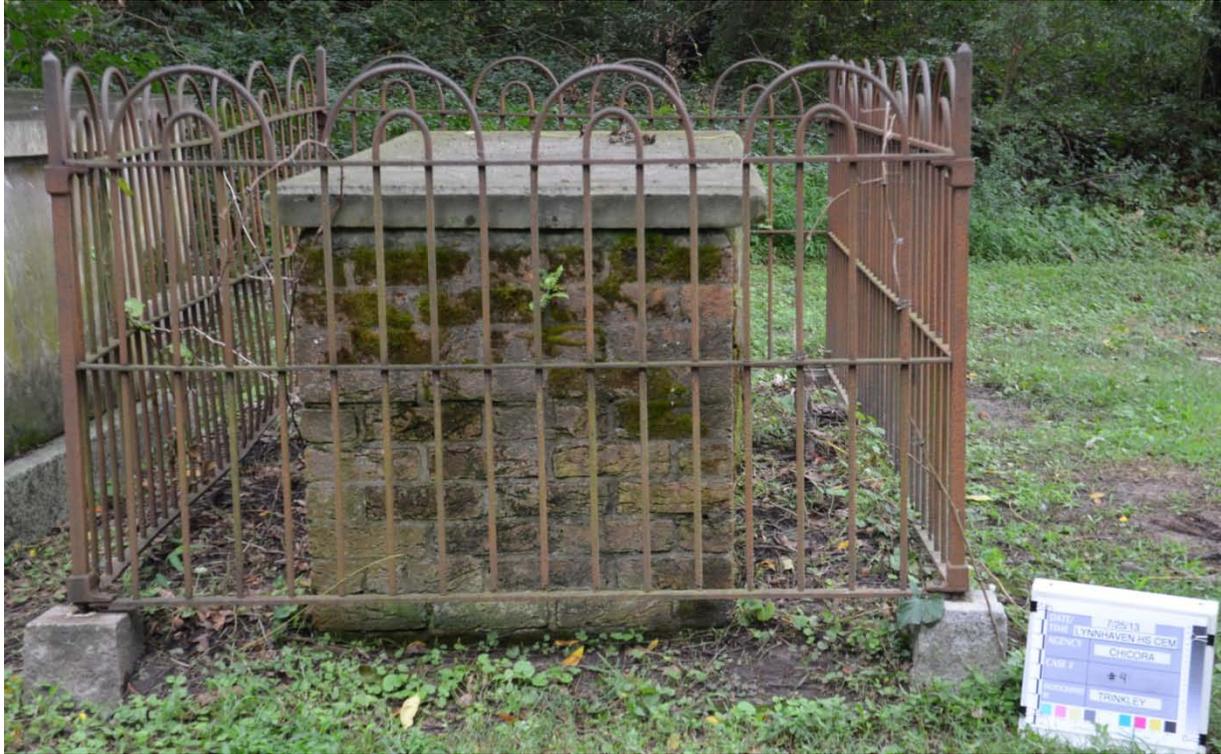
East side of fence:

The fence is stable and no treatments (other than the maintenance actions outlined above) are recommended.

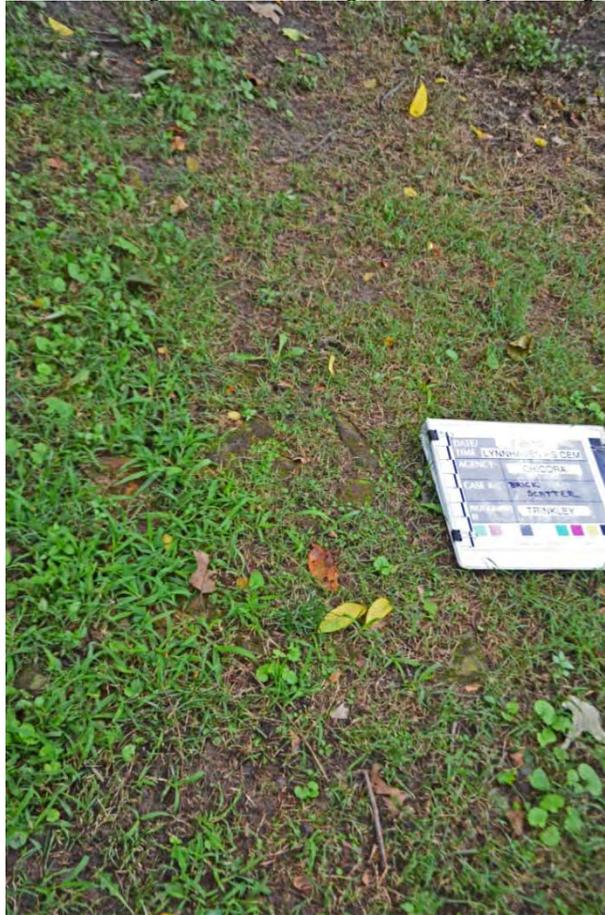
Marker 5, unidentified

Appearance of the brick mound indicating the presence of grave 5 today, looking west:

If remains of the box cannot be found, we recommend that the archaeological investigations continue until the grave shaft is clearly identified. After full documentation it would be possible to create a suitable box surrounding the grave shaft to achieve the same goal as above.

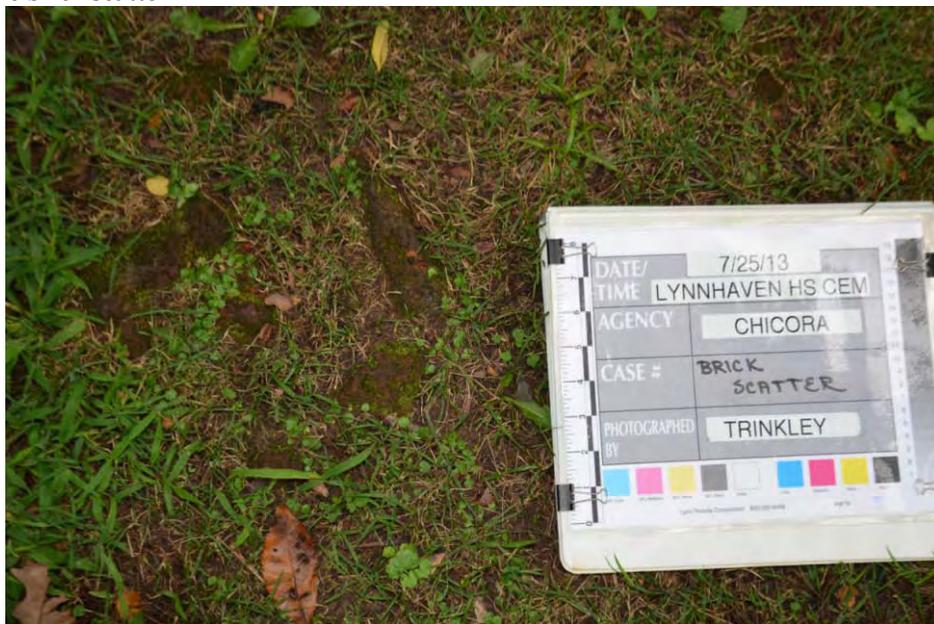
Close-up of the brick scatter:
