# **ASSESSMENT OF THE CHURCH STREET GRAVEYARD, MOBILE, ALABAMA**

**Chicora Research Contribution 566**

Michael Trinkley  
And  
Debi Hacker

September 2015

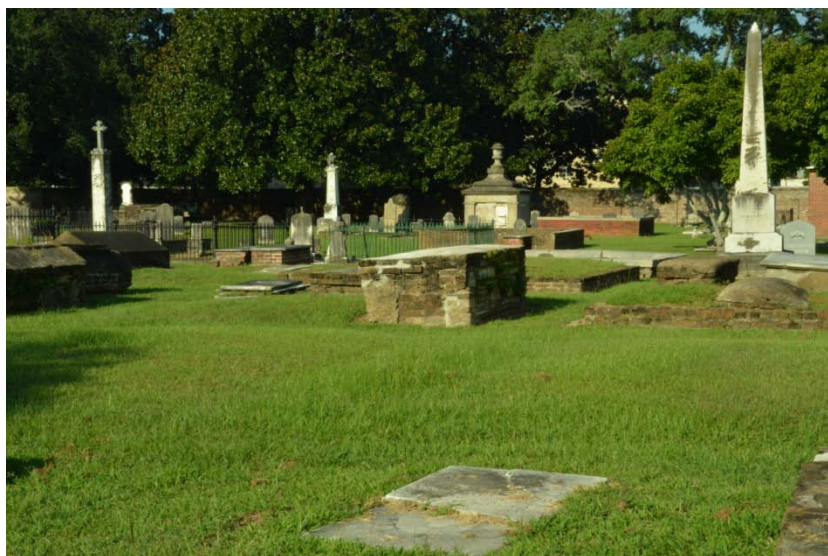
Figure 3. Church Street Graveyard, showing not only its beauty, but also its gradual deterioration.

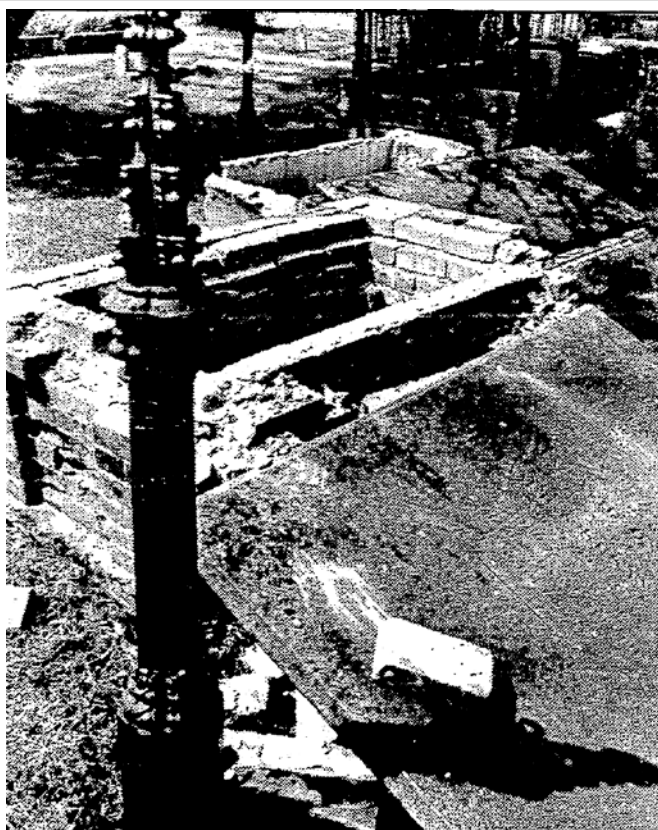
In 1989 Church Street Graveyard suffered its worst single vandalism event. On August 11, 1989 17 graves were opened, with holes in some 3-feet deep (Figure 20). A pewter cross was removed from one grave. Bone fragments and deteriorated cloth were found. Damage was estimated at \$20,000 or more. By August 17 four individuals were arrested, two adults, 23 and 41, and two juveniles, a boy, 15, and a girl, 13. All four lived together and a police raid recovered bones turned over to the Alabama Department of Forensic Sciences. One of the juveniles was reported to be on probation for a previous conviction of grave desecration (*Mobile Register*, August 13, 1989, pg. 1; August 15, 1989, pg. 9; August 18, 1989, pg. 1; August 22, 1989, pg. 9;

Figure 20. Vandalism from August 11, 1989 (courtesy of the *Mobile Register*, press photographer Ron Colquilt, August 15, 1989). Shown is R15, L26.

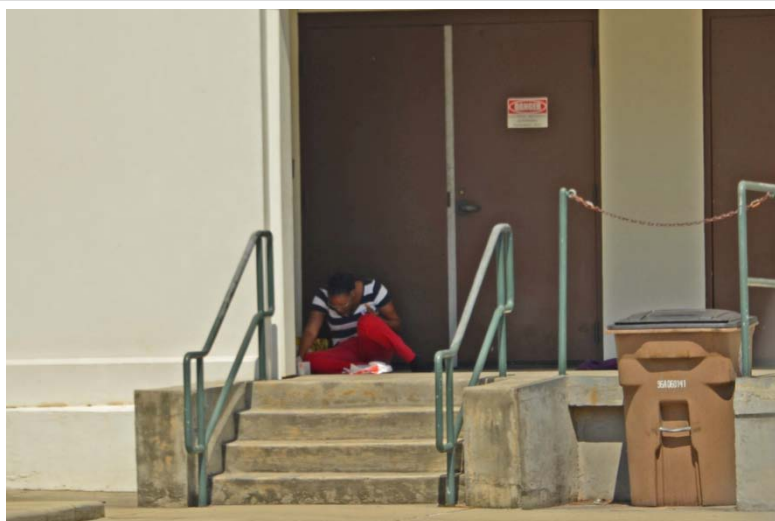
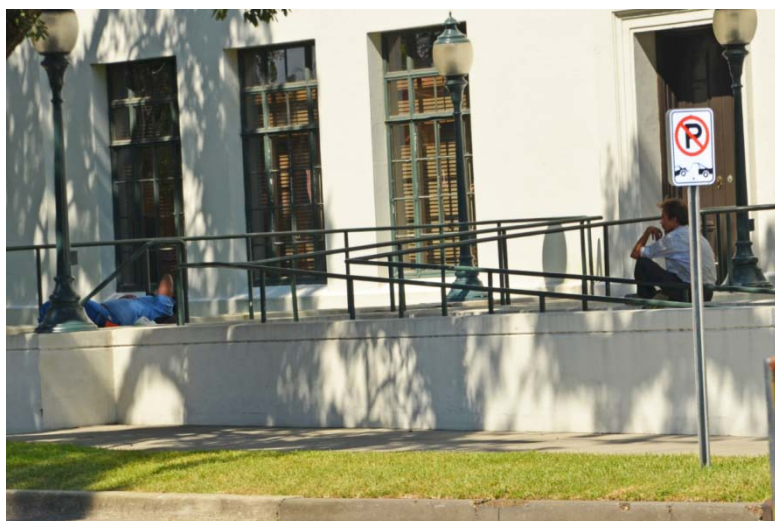
Figure 23. Homeless congregating around the Public Library in the vicinity of the Church Street Graveyard.

Street steps, ramp, and loading dock, as well as at the main entrance where homeless have taken over the benches in the pocket park (Figure 23). We have observed individuals essentially camped out in these locations all-day. At least a few of these individuals are known to have been waiting for us to leave, so they could go into the cemetery for the night. The Library Board should be requested to establish a no-loitering policy outside its building and request that this policy be enforced by the City police.

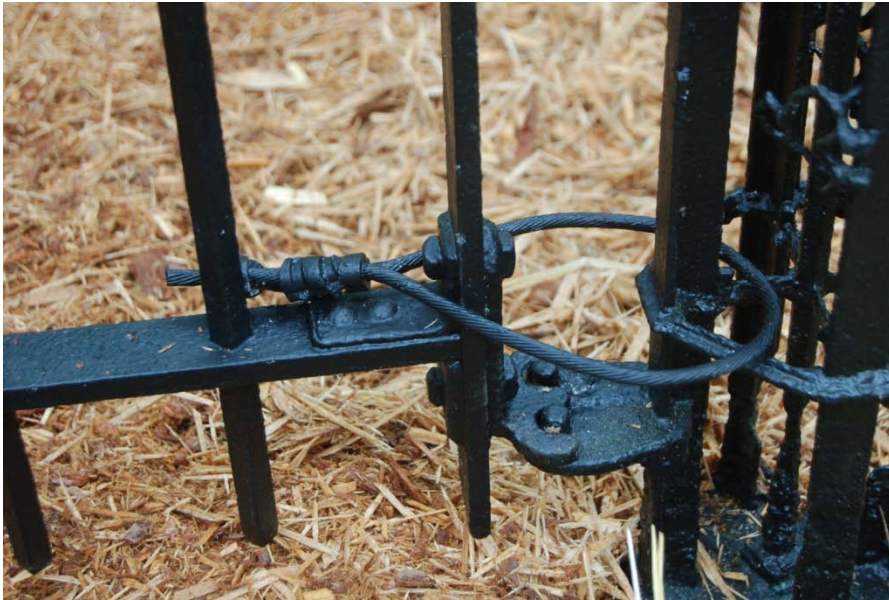
Figure 24. Example of a gate protected with stainless steel cabling that has been painted to blend with the fence.

It is a simple maintenance step to use woven stainless steel wire to secure gates to their hinge posts (Figure 24). This allows the gates to open and close, but makes them considerably more difficult to lift off their hinges and steal. The cost to protect gates is less than \$20 each and the time involved is about 15 minutes. This is something that the Parks Department staff or volunteers could easily accomplish. The article, found in this publication <http://npshistory.com/newsletters/crm/crm-v25n2.pdf>, provides additional information.

- The Library Board should be requested to enact a rule prohibiting loitering outside the building and this should be enforced by staff and the police department.
- All plot gates should have stainless steel cabling used to attach the gate to the hinge post to reduce the potential for theft.

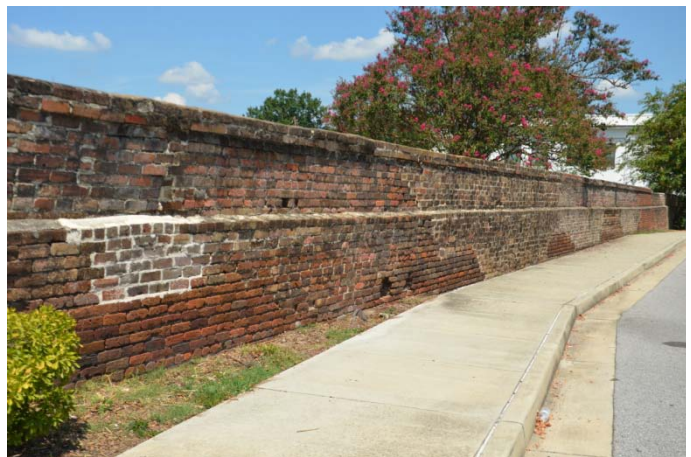
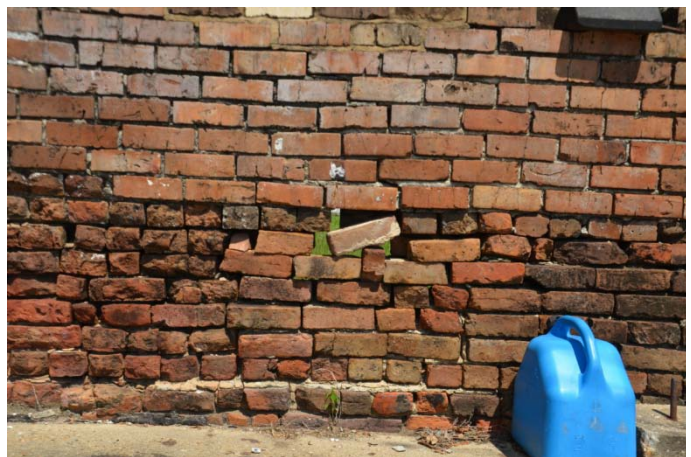
There are innumerable repairs to the wall, almost all of very poor quality, using hard Portland cement mortar and exhibiting very poor bonding techniques. In addition, the wall, in numerous locations is in, or on the verge of, failure. It is not a matter of if, but rather when, there is another massive failure such as occurred several years ago at the ice plant on the cemetery's south edge.

There have been two relatively responsible repairs – one on the south wall where it recently collapsed and another along the west wall. In these two areas it appears that a substantial foundation was created and the bonding is consistent and well-executed. The bricks and mortar, however, appear new and it seems there was little effort to attempt to match the original wall.

Figure 25. Examples of boundary wall problems. Upper photo shows the exterior of the east wall with multiple repair episodes, none meeting preservation standards. Lower photo shows a portion of the south wall approaching failure.

Regardless of the decision, the City should anticipate repair or replacement of the wall within the next two years.

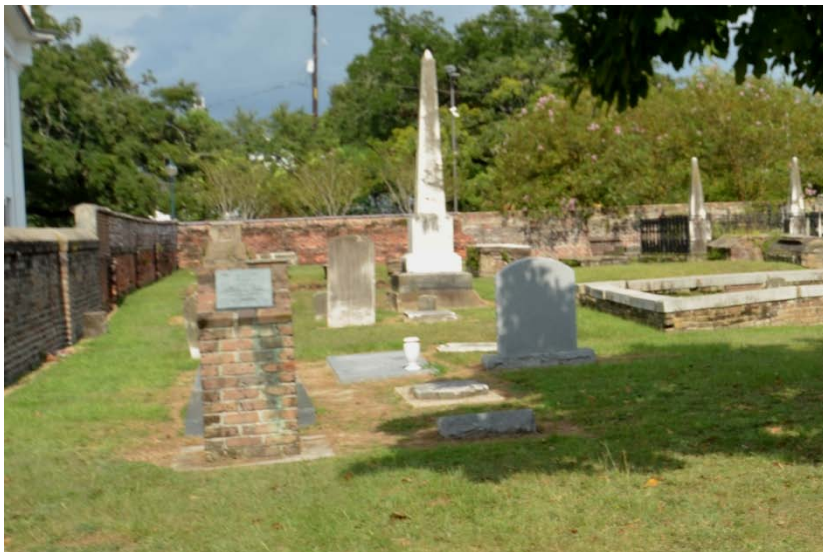
Figure 26. These new monuments are intrusive elements and disturb the scale and three-dimension aspect of the cemetery. New burials should not be allowed and new monuments should be carefully controlled.

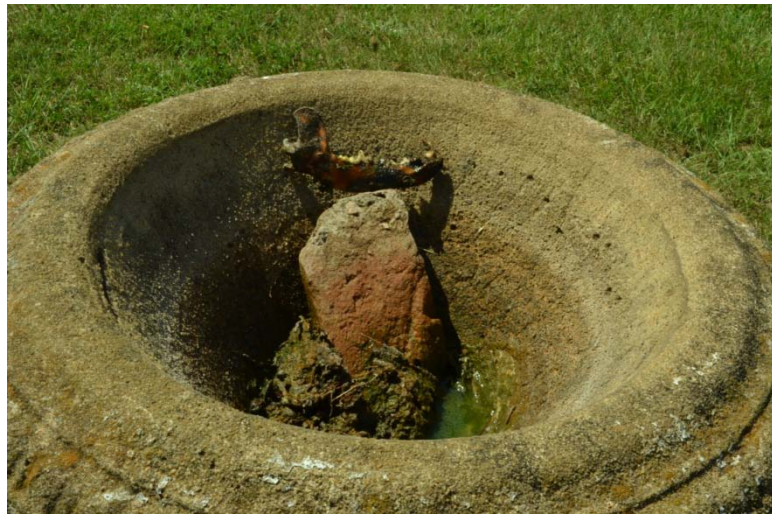
Figure 27. Example of an vase that is filled with sludge and trash.

of the upkeep. As a result, the urns often hold water, breed mosquitoes, collect trash, are turned upside down, or are just ignored. They are rarely repaired or replaced when broken. They are likely not used since most floral arrangements today come in their own plastic container, rendering the urns and vases redundant.

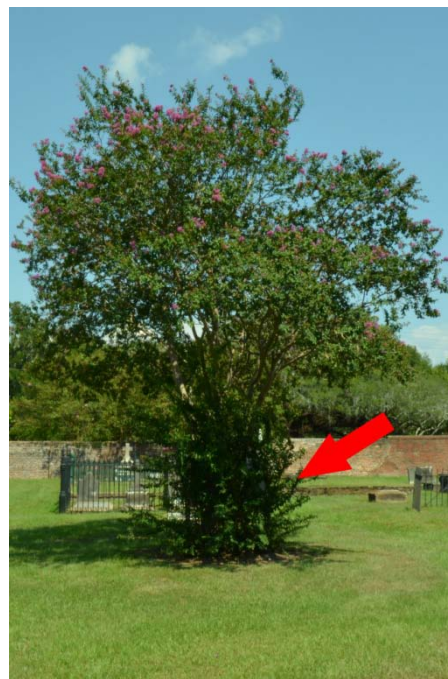
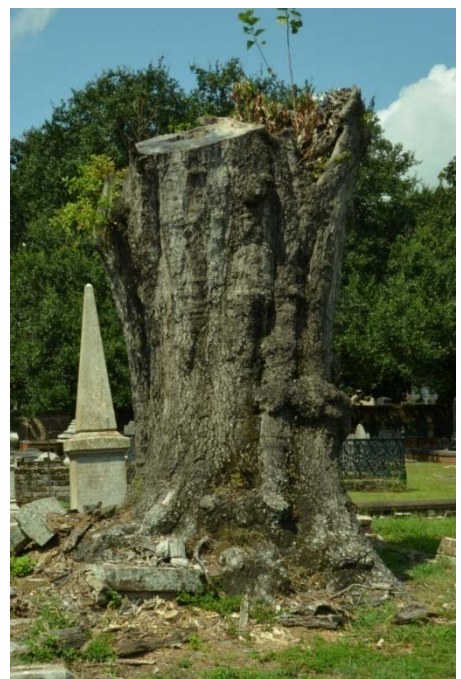
Figure 28. Specific tree problems at the Church Street Graveyard. The photo on the left shows a crepe myrtle with dense suckering at the base that must be pruned. The photo on the right shows a large “stump” left behind after a tree removal. This stump must be removed from the cemetery.

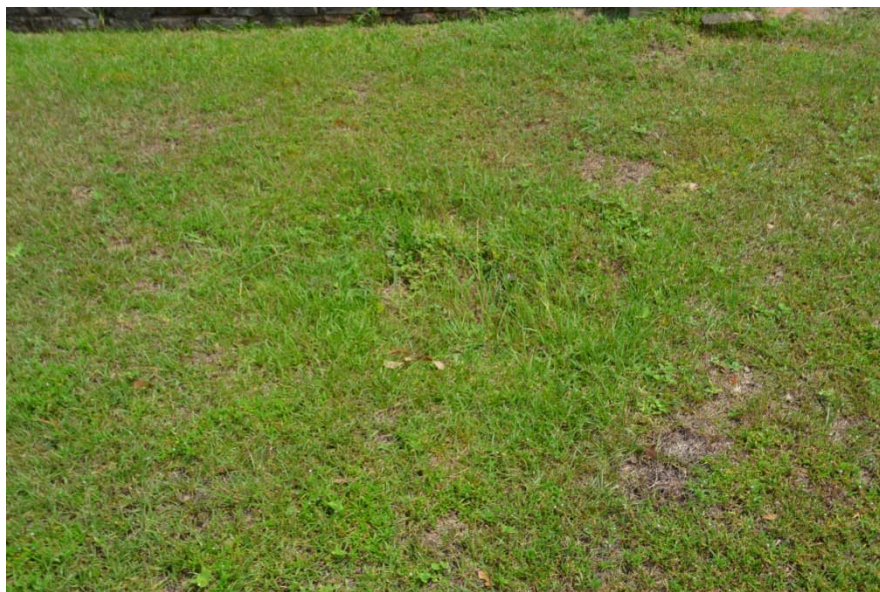
Figure 33. Sunken graves such as this blend into the landscape and pose a hazard to pedestrians.

The cemetery has a number of sinking or collapsing graves. These depressions mark grave locations and they should not be filled until such time that all depressions have been accurately mapped. After that is accomplished, backfilling them with clean sand and seeding will reduce mowing difficulty and improve general pedestrian safety.

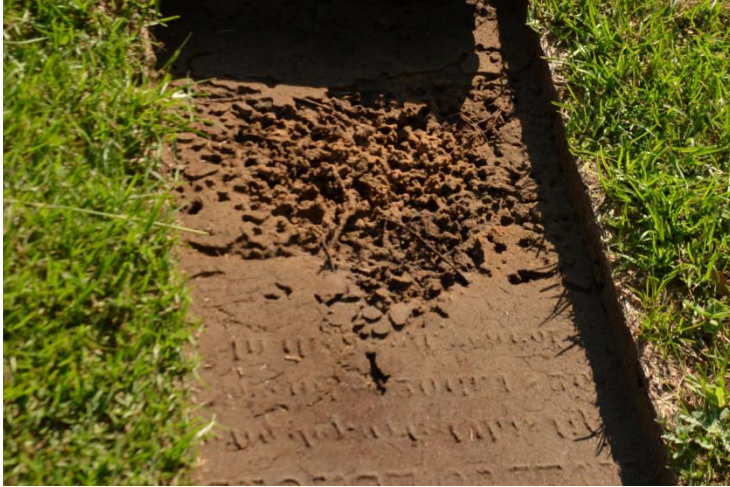
Figure 34. Fire ants under a collapsed monument.

After 10-14 days the Amdro should be used as an individual mound treatment on any mounds that continue to be a problem or that remain in high traffic areas.

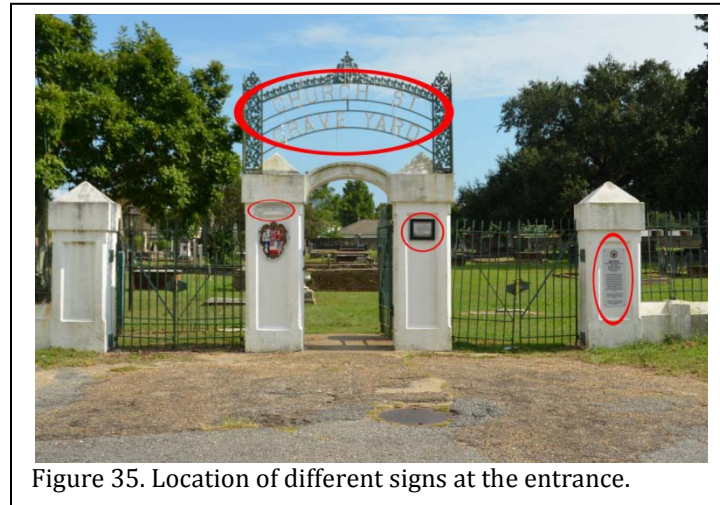
Figure 35. Location of different signs at the entrance.

It lacks a unified theme, repeats itself, and is located in several places. The use of narrative paragraphs, rather than numbered items tends to make it more difficult to understand. But most importantly, it fails to cover all of the rules critical for cemeteries today, especially those in urban centers.

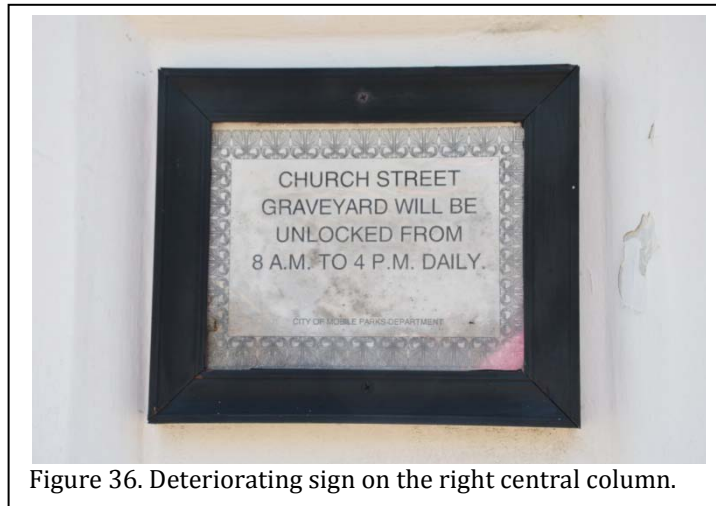
The primary regulatory signage is mounted on the far right column and is easily overlooked. The long paragraphs discourage attention to the regulations, which are not clearly spelled out. For example, the hours the cemetery is open are included, but apparently so often overlooked a second sign has been added to the right central column. This sign, apparently paper behind glass that is not weather tight, is growing mold and looks unattractive (Figure 36).

Figure 36. Deteriorating sign on the right central column.

If the City does not have a uniform style for signage, we like a classic black with rich gold lettering using a contemporary, but easily read typeface. The new sign should be located just inside the gates, beckoning visitors, but easily read even when the gates are closed. We do not

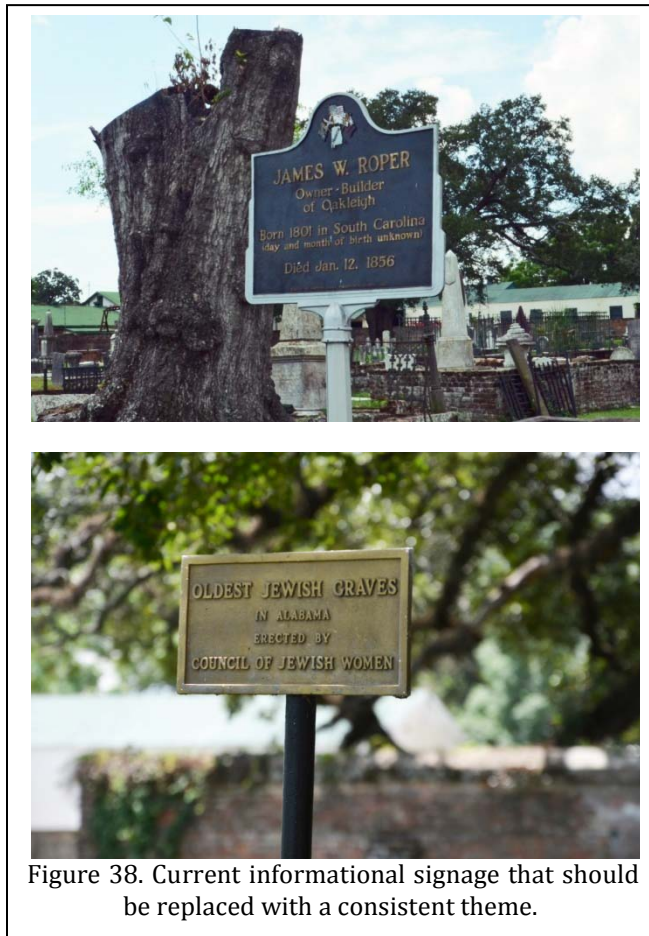
Figure 38. Current informational signage that should be replaced with a consistent theme.

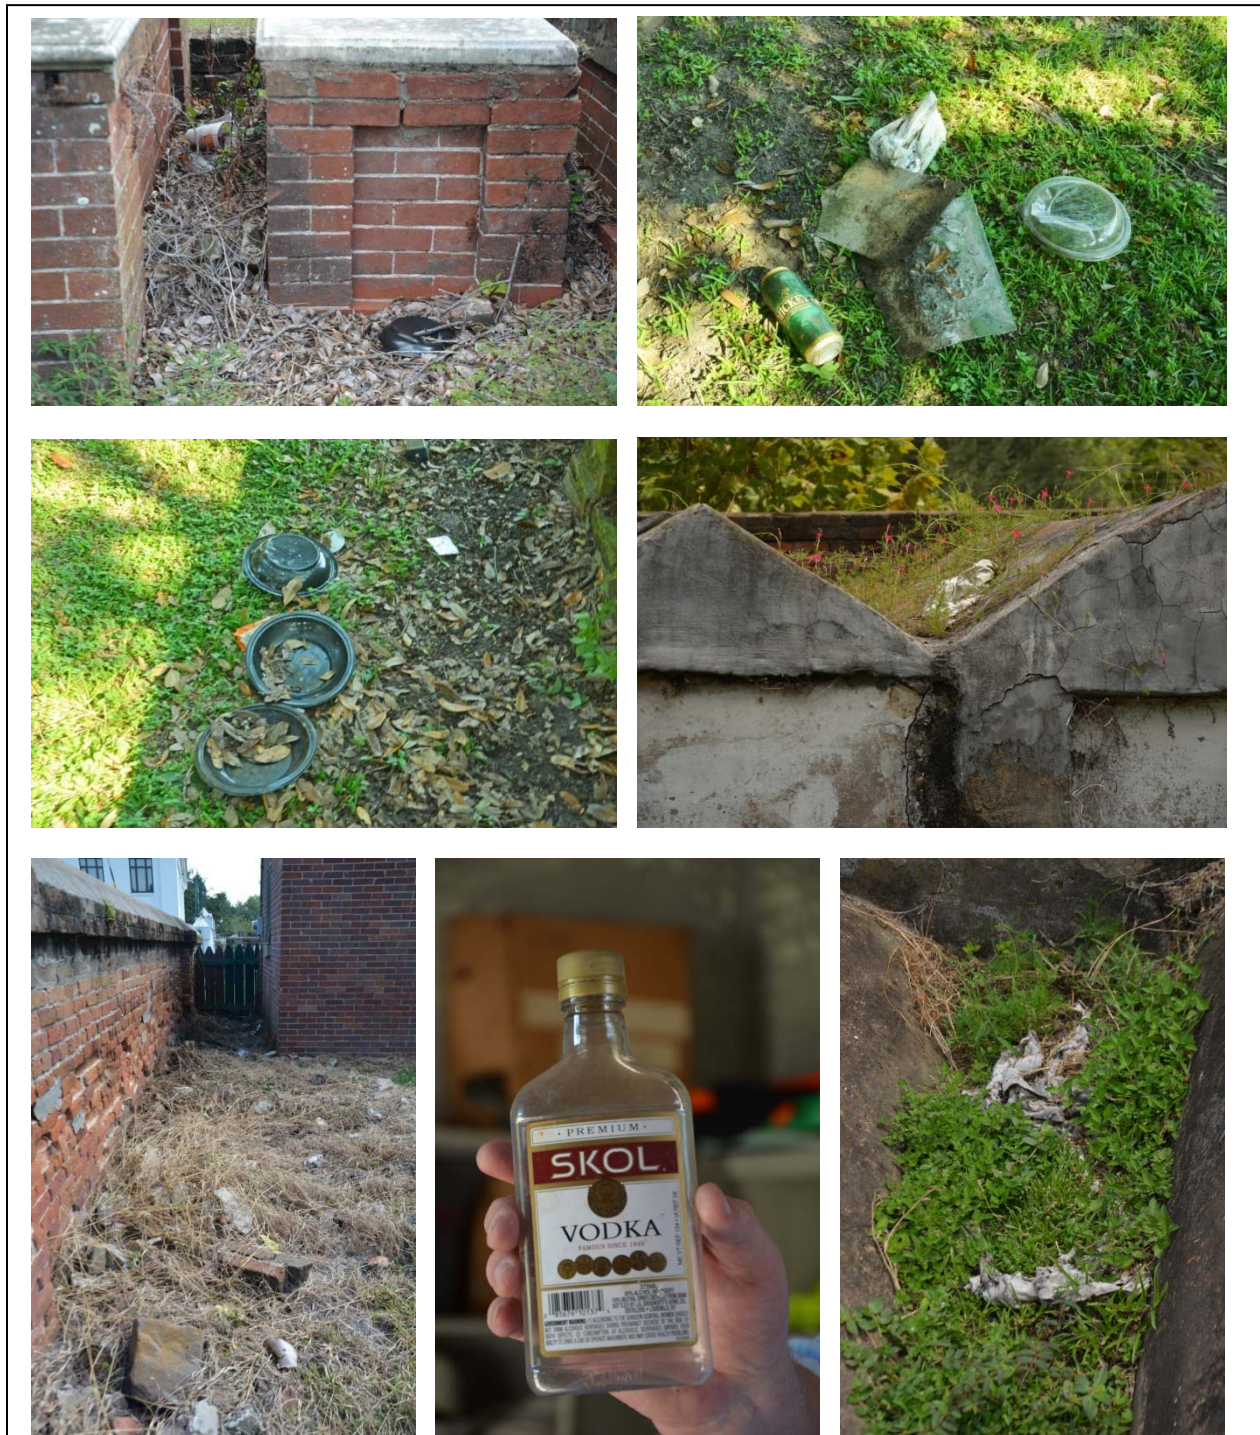
Trash is a very significant problem at the Church Street Graveyard. It appears to us that most of this trash, including food containers, beer cans, liquor bottles, discarded clothing, piles of cigarette butts, and other debris, has been generated by the homeless. Some examples of this problem have been illustrated by Figure 22 and are also shown in Figure 39. Control of the homeless problem in the cemetery will likely reduce the overall litter levels.

Figure 39. Trash problems in the Church Street Graveyard.

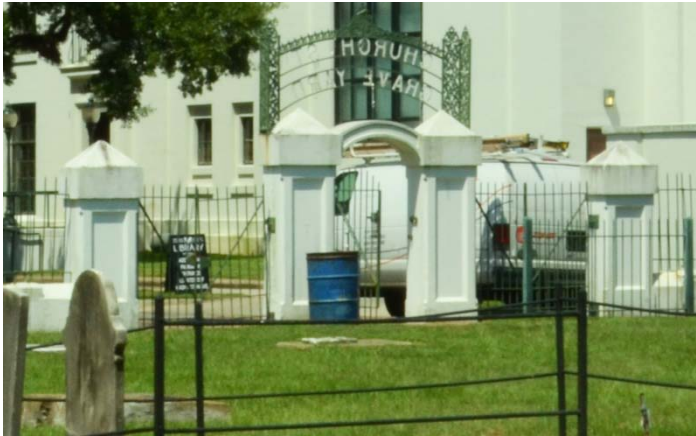
Figure 40. Trash barrel at the entrance to the cemetery.

It is also important that the container be emptied on a regular basis, perhaps with the current low visitation once a week. It would also be useful to line the new trash can with an appropriate sized bag, since it is far easier – and safer – to remove a bag than to shovel trash out using even gloved hands (the current container has no lining).

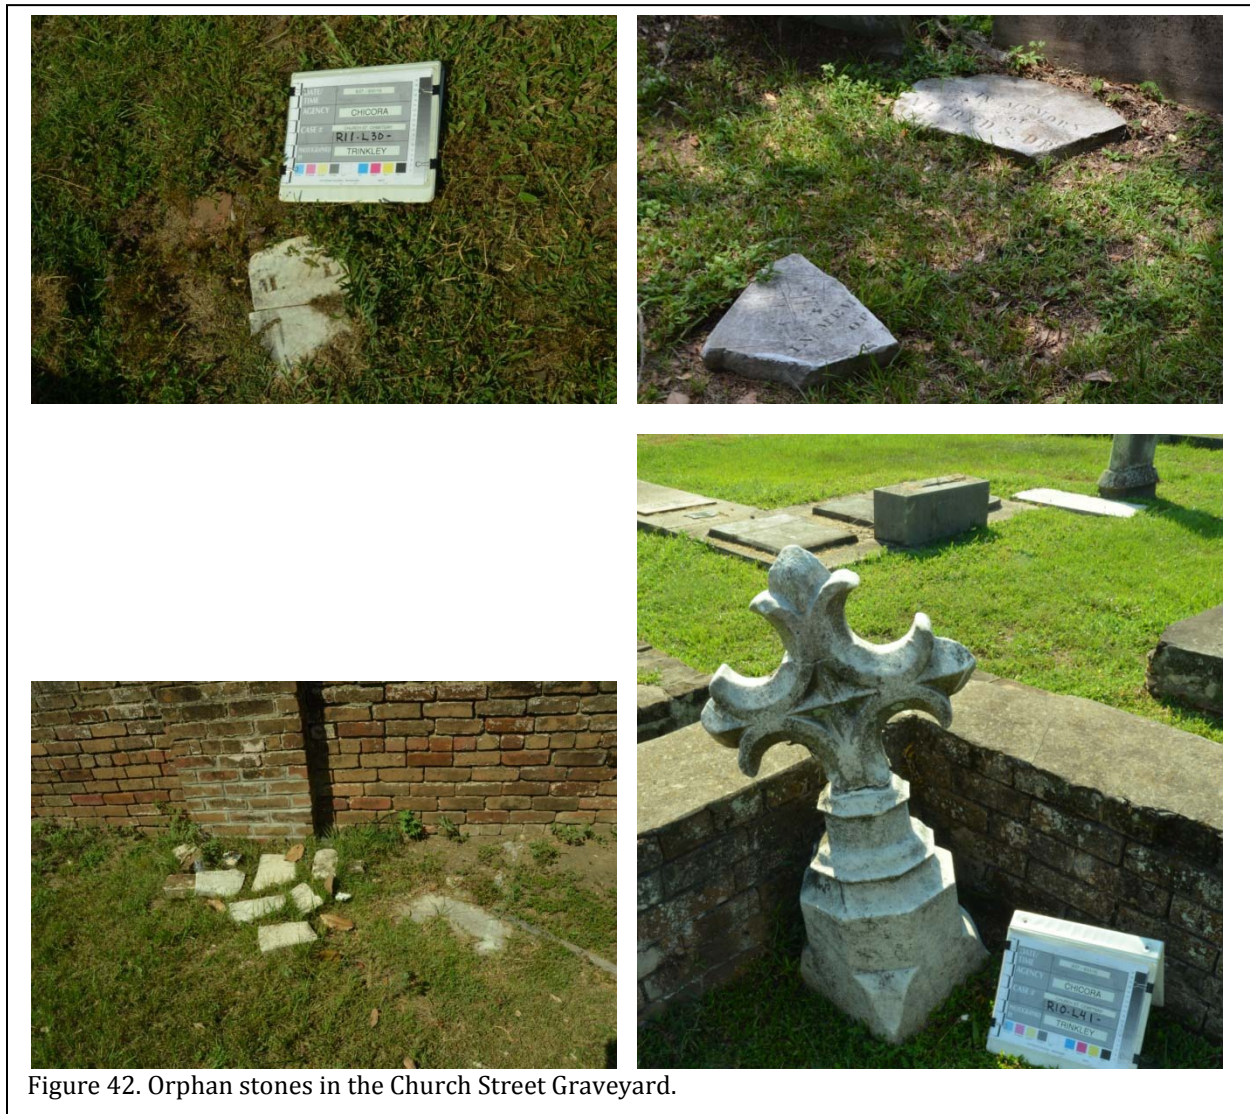
Figure 42. Orphan stones in the Church Street Graveyard.

is it being removed, where is it being stored, what should be done to reset the stone, what action is being taken to resolve the issue. Staff must understand that once a stone is separated from the grave, the potential that the grave will become lost – regardless of the quality of the cemetery records – dramatically increases. Thus, every effort should be made to ensure that stones remain on their grave.

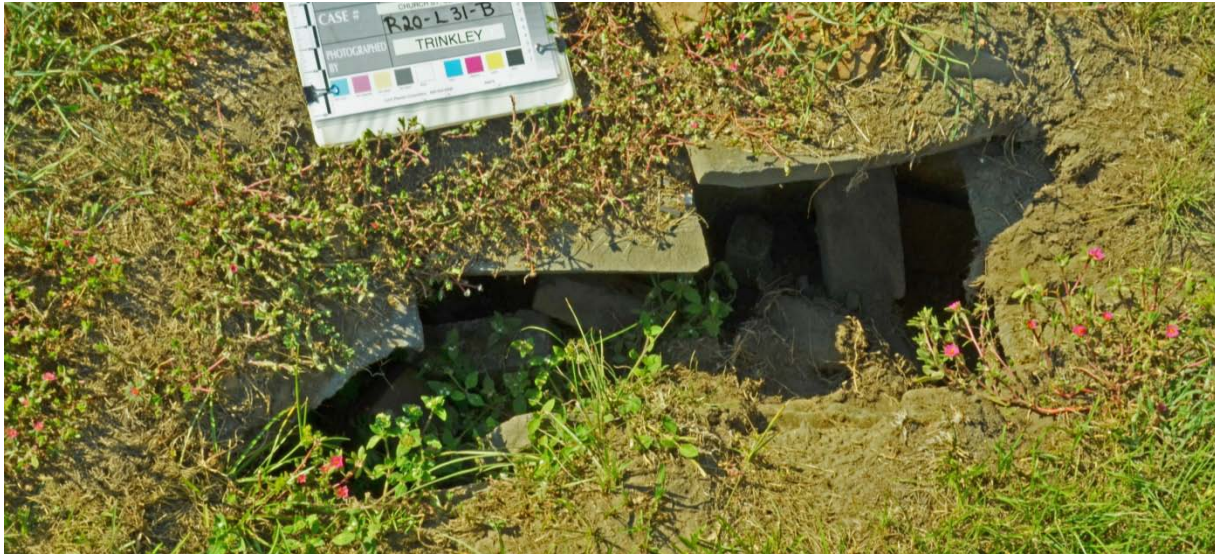
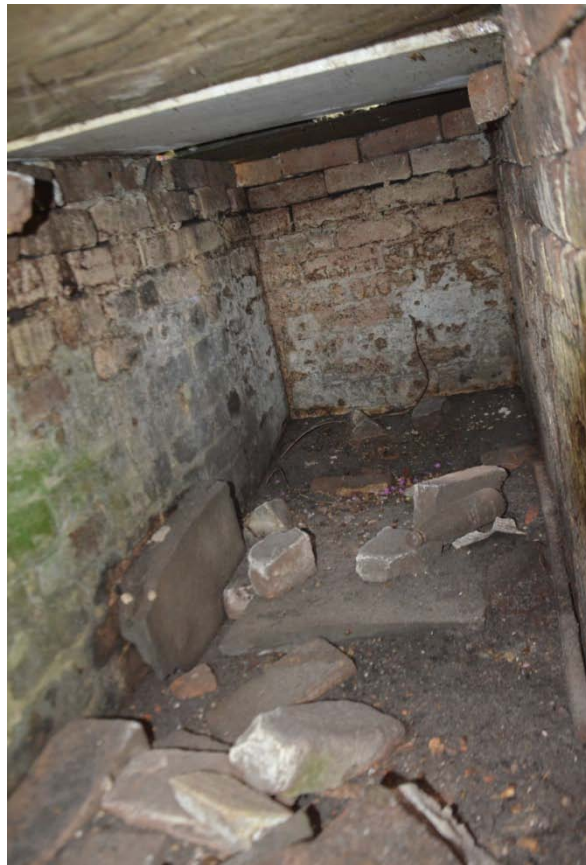
Figure 45. Open graves at the Church Street Graveyard. Upper view is open grave R20, L31. Lower photo shows the interior of R15, L66. No remains are visible, but may be present.

During this assessment two partially open graves were identified (Figure 45). One, previously discussed, is open as a result of using equipment that is too heavy, causing the cover to fracture. The other is likely open simply as a result of natural forces. Both require intervention.

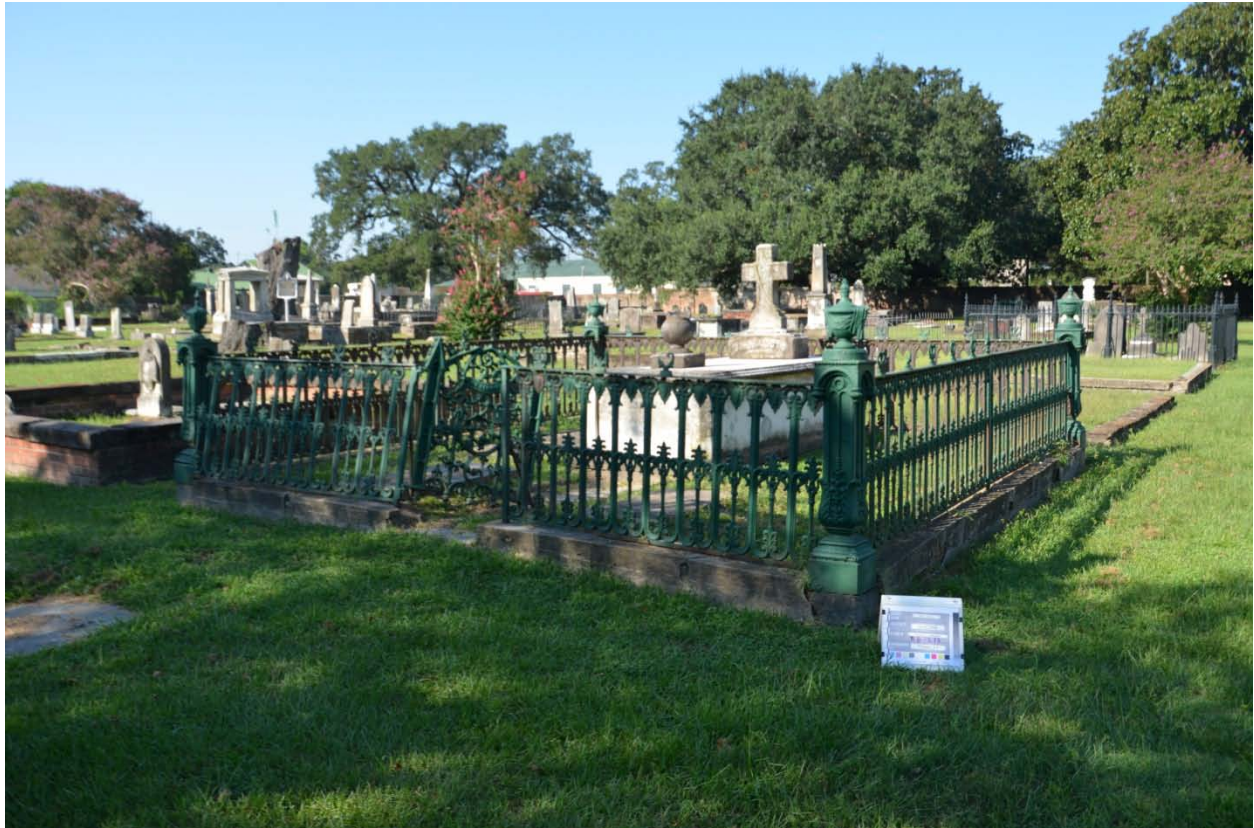
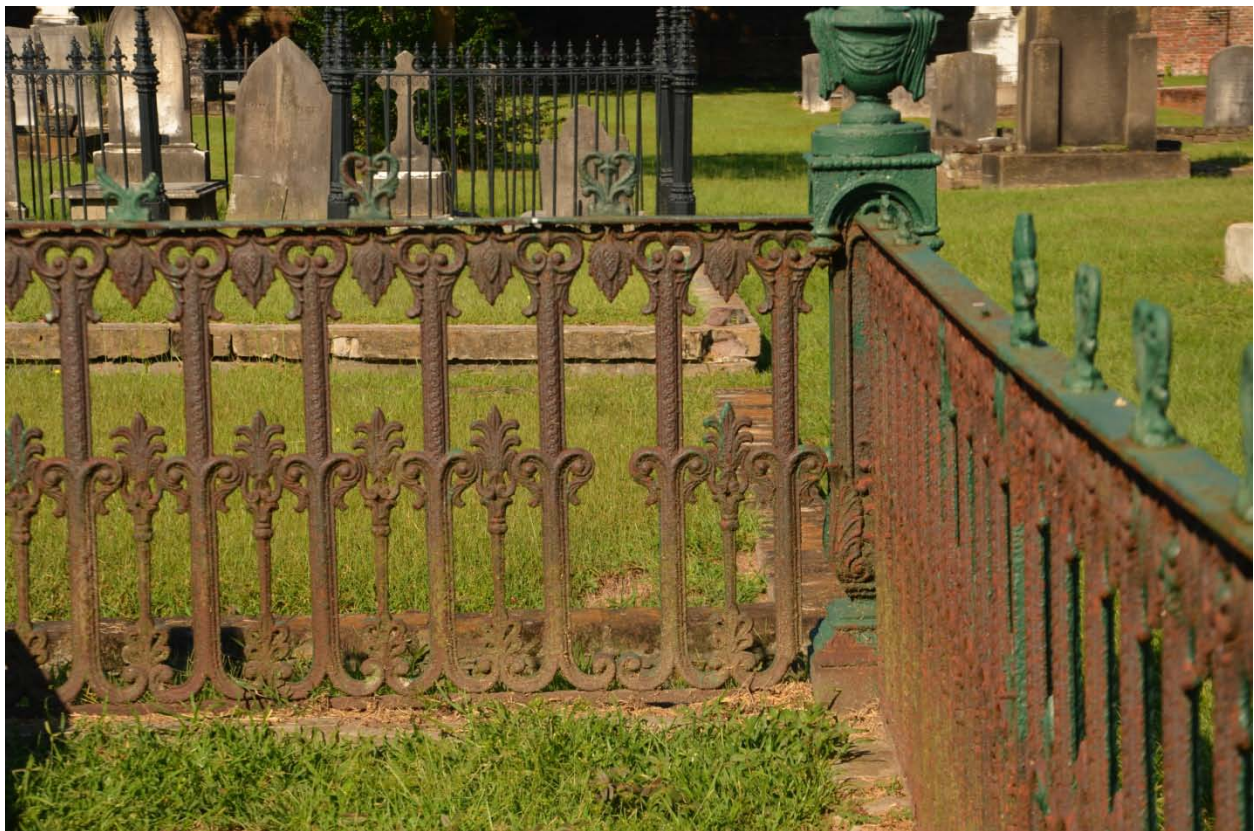
**Row: 6**

**Position:** ☒ fallen ☐ tilted ☒ unstable ☒ unattached/loose ☐ missing

**Condition of Baystays:** ☐ none present ☒ good, stable ☐ unattached ☐ missing, unstable

**Deterioration:** ☒ broken ☐ cracked ☐ losses ☐ corrosion ☒ covered in soil  
☐ missing fragments ☐ other:

**Failed/Old Treatments:** ☐ welds ☐ adhesives/coatings ☐ ferrous metals  
☐ wire/other attachment ☒ paint, color: blk? ☐ other:

**Foundations/Coping:** ☐ brick ☐ concrete ☐ granite ☒ other: brick infill

**Position:** ☒ stabilize foundation ☐ reset line posts ☒ reset corner posts ☐ reset/realign gate posts/gate

**Treatment:** ☒ remove soil from fence bottom rails ☒ re-attach fence sections ☐ backstays  
☐ straighten sections ☒ caulk prior to painting ☒ other: repair broken corner post

**Paint:** ☐ test for lead ☐ air abrasion ☒ hand tools ☐ rust converter primer ☒ primer  
☒ top coat alkyd flat paint (two coats) ☐ other:

**Cost: \$9,500**

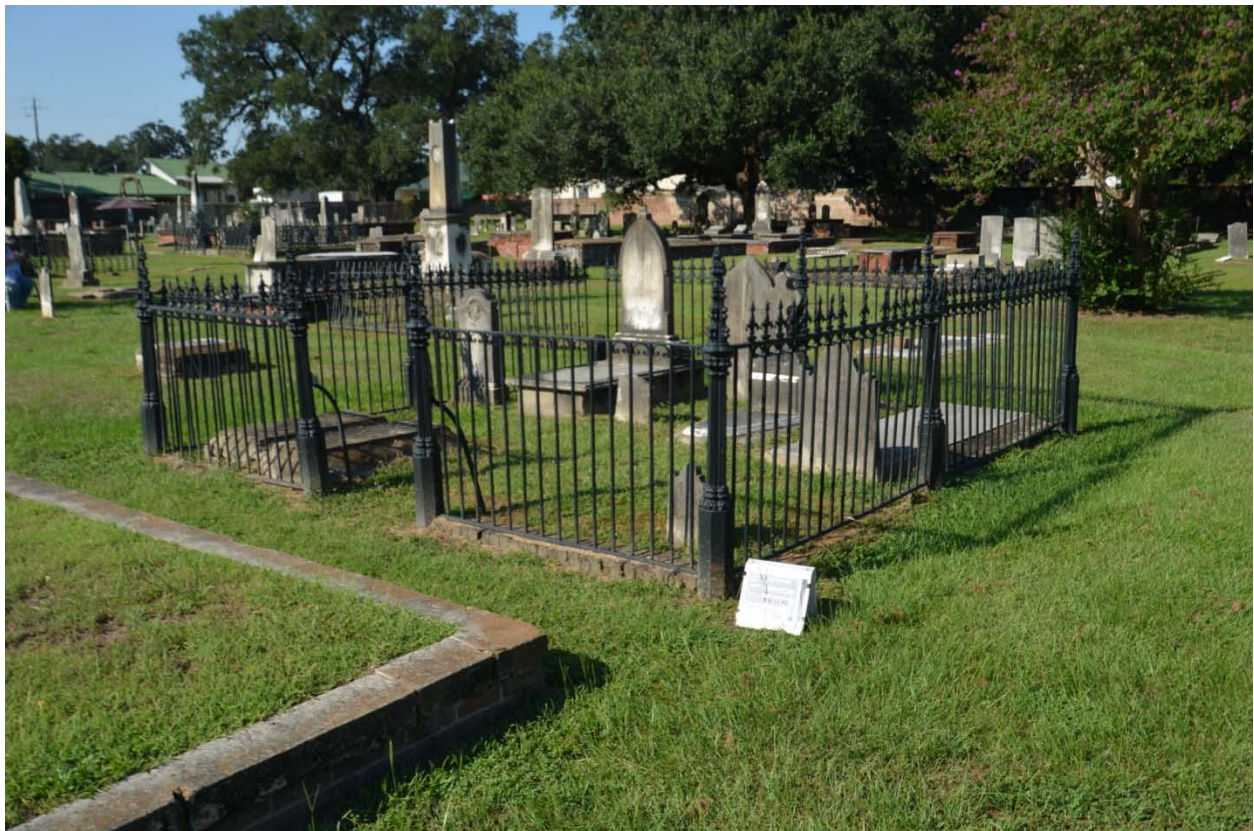
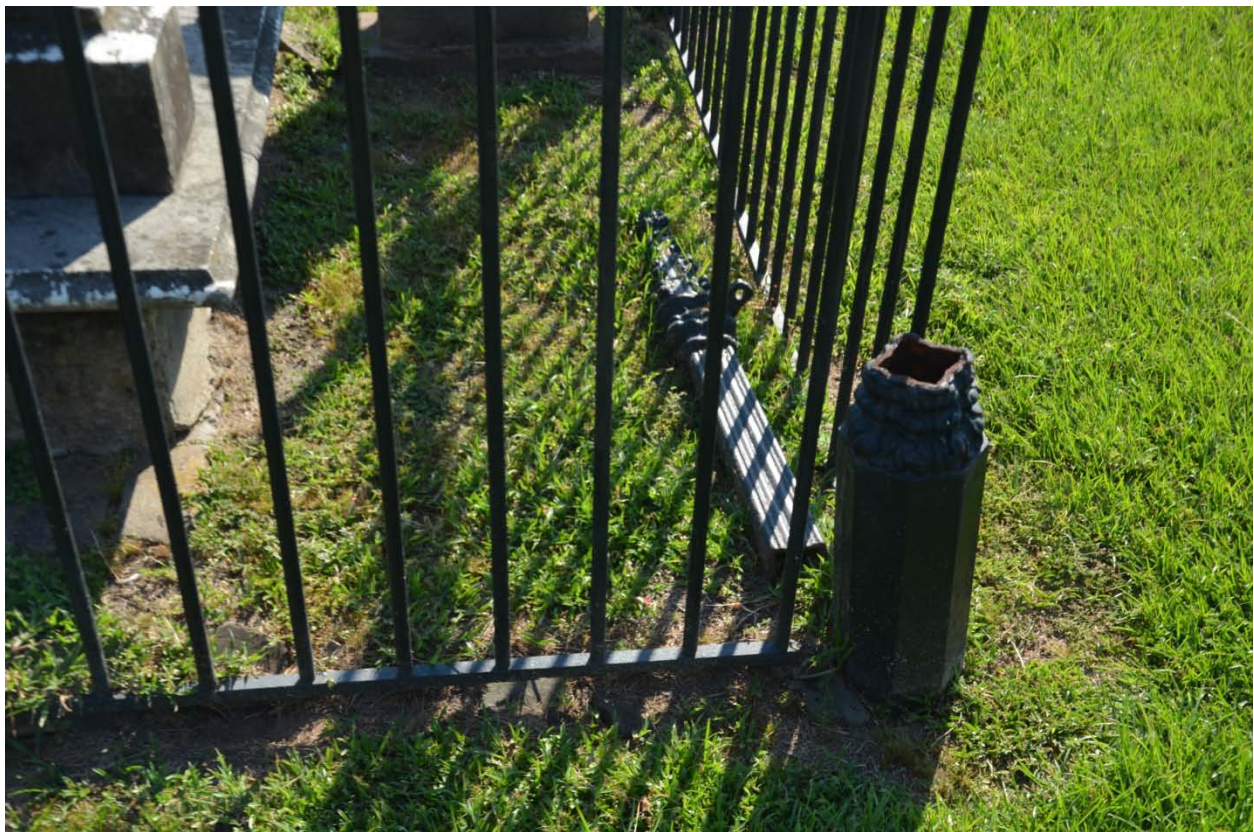
**Row: 7**

Previous Info	Historic Photos: Previous Observation(s) or Assessment(s): 1994 Narrative: wrought bars with C-spacers, poor condition
Existing Condition	<b>Position:</b> <input checked="" type="checkbox"/> fallen <input type="checkbox"/> tilted <input checked="" type="checkbox"/> unstable <input checked="" type="checkbox"/> unattached/loose <input checked="" type="checkbox"/> missing
	<b>Elements Present:</b> 0 of 4 corner posts 1 of 3 line posts 1 of 2 gate posts 1 of 1 gate(s)
	<b>Condition of Baystays:</b> <input type="checkbox"/> none present <input type="checkbox"/> good, stable <input checked="" type="checkbox"/> unattached <input checked="" type="checkbox"/> missing, unstable
	<b>Deterioration:</b> <input checked="" type="checkbox"/> broken <input type="checkbox"/> cracked <input checked="" type="checkbox"/> losses <input checked="" type="checkbox"/> corrosion <input checked="" type="checkbox"/> covered in soil <input checked="" type="checkbox"/> missing fragments <input type="checkbox"/> other:

<b>Extent:</b> <input checked="" type="checkbox"/> extensive >50% <input type="checkbox"/> partial 25-50% <input type="checkbox"/> minimal <25% <input type="checkbox"/> not applicable
	<b>Failed/Old Treatments:</b> <input type="checkbox"/> welds <input type="checkbox"/> adhesives/coatings <input type="checkbox"/> ferrous metals <input type="checkbox"/> wire/other attachment <input checked="" type="checkbox"/> paint, color: blk? <input type="checkbox"/> other:
	<b>Foundations/Coping:</b> <input type="checkbox"/> brick <input type="checkbox"/> concrete <input type="checkbox"/> granite <input type="checkbox"/> other:
	<b>Foundation/Coping Condition:</b> <input type="checkbox"/> brick loose, displaced <input type="checkbox"/> mortar damaged <input type="checkbox"/> coping displaced <input type="checkbox"/> coping missing <input type="checkbox"/> iron jacking <input type="checkbox"/> other:
	<b>Position:</b> <input type="checkbox"/> stabilize foundation <input checked="" type="checkbox"/> reset line posts <input checked="" type="checkbox"/> reset corner posts <input checked="" type="checkbox"/> reset/realign gate posts/gate

<b>Foundation/Coping:</b> <input type="checkbox"/> point wall <input type="checkbox"/> rebuild wall <input type="checkbox"/> reset coping <input type="checkbox"/> repair iron jacking location <input type="checkbox"/> other:
Treatment Strategy	<b>Treatment:</b> <input checked="" type="checkbox"/> remove soil from fence bottom rails <input checked="" type="checkbox"/> re-attach fence sections <input checked="" type="checkbox"/> backstays <input type="checkbox"/> straighten sections <input checked="" type="checkbox"/> caulk prior to painting <input checked="" type="checkbox"/> other: replace posts
	<b>Needed Replacement Elements:</b> 4 corner posts, 2 line posts, 1 gate post
	<b>Other Detailed Observations:</b>
	<b>Paint:</b> <input type="checkbox"/> test for lead <input type="checkbox"/> air abrasion <input checked="" type="checkbox"/> hand tools <input type="checkbox"/> rust converter primer <input checked="" type="checkbox"/> primer <input checked="" type="checkbox"/> top coat alkyd flat paint (two coats) <input type="checkbox"/> other:

**Cost: \$11,000**

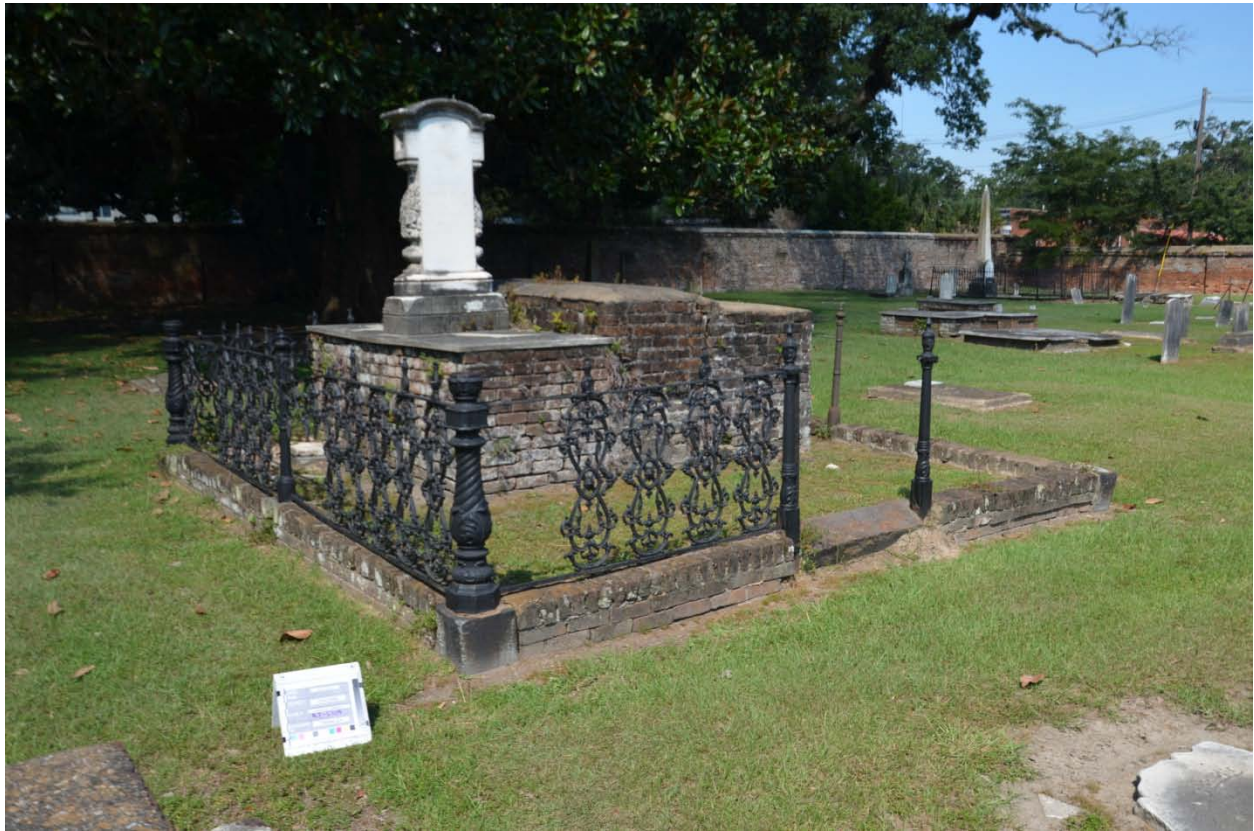
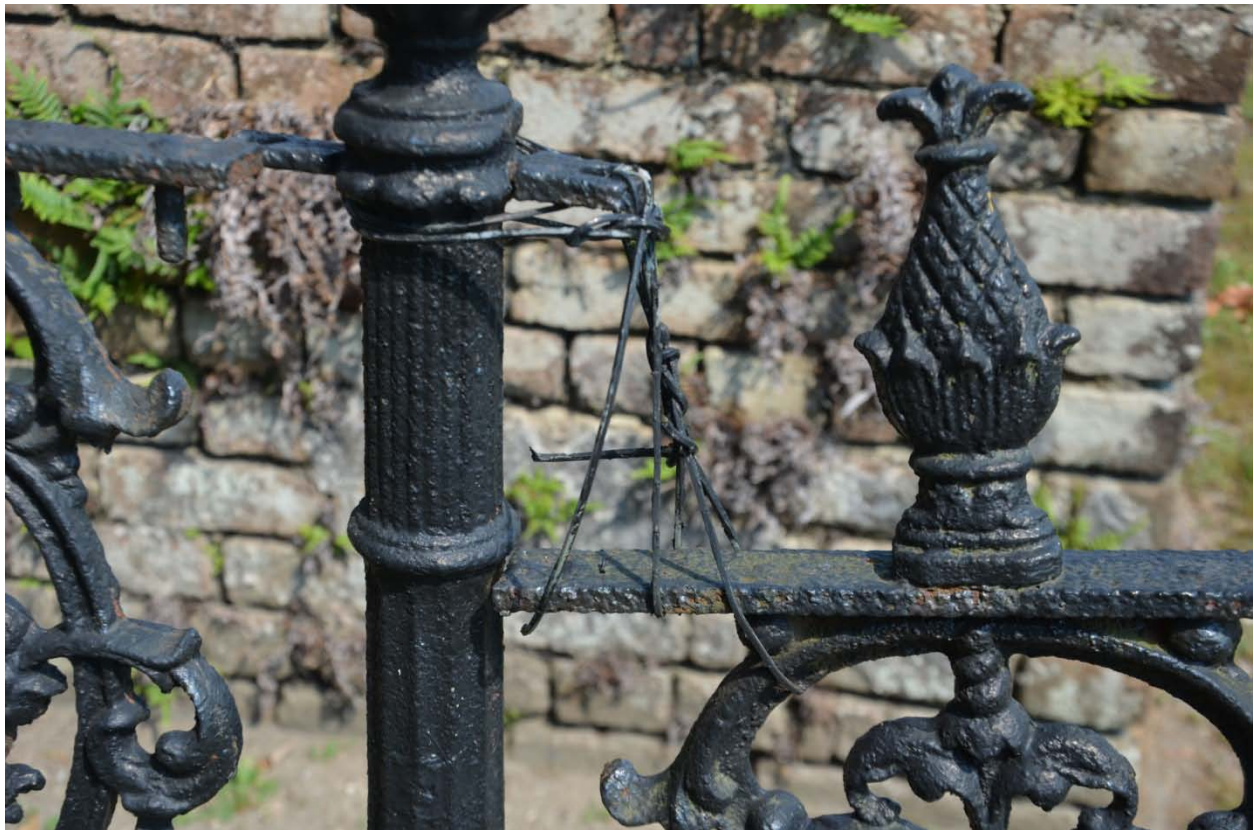
**Row: 8**

Previous Info	Historic Photos:
Existing Condition	<b>Previous Observation(s) or Assessment(s):</b> 1994
	<b>Narrative:</b> flat uprights, flat repetitive oral and floral sections, 1 piece missing, good condition
	<b>Position:</b> <input type="checkbox"/> fallen <input checked="" type="checkbox"/> tilted <input checked="" type="checkbox"/> unstable <input checked="" type="checkbox"/> unattached/loose <input checked="" type="checkbox"/> missing
	<b>Elements Present:</b> 4 of 4 corner posts 5 of 6 line posts 1 of 2 gate posts 0 of 1 gate(s)
	<b>Condition of Baystays:</b> <input checked="" type="checkbox"/> none present <input type="checkbox"/> good, stable <input type="checkbox"/> unattached <input type="checkbox"/> missing, unstable
	<b>Deterioration:</b> <input checked="" type="checkbox"/> broken <input type="checkbox"/> cracked <input type="checkbox"/> losses <input checked="" type="checkbox"/> corrosion <input checked="" type="checkbox"/> covered in soil <input checked="" type="checkbox"/> missing fragments <input type="checkbox"/> other:

<b>Extent:</b> <input type="checkbox"/> extensive >50% <input checked="" type="checkbox"/> partial 25-50% <input type="checkbox"/> minimal <25% <input type="checkbox"/> not applicable
	<b>Failed/Old Treatments:</b> <input type="checkbox"/> welds <input type="checkbox"/> adhesives/coatings <input type="checkbox"/> ferrous metals <input checked="" type="checkbox"/> wire/other attachment <input checked="" type="checkbox"/> paint, color: green <input type="checkbox"/> other:
	<b>Foundations/Coping:</b> <input checked="" type="checkbox"/> brick <input type="checkbox"/> concrete <input type="checkbox"/> granite <input checked="" type="checkbox"/> other: sandstone cap; OPC stucco
	<b>Foundation/Coping Condition:</b> <input checked="" type="checkbox"/> brick loose, displaced <input checked="" type="checkbox"/> mortar damaged <input checked="" type="checkbox"/> coping displaced <input type="checkbox"/> coping missing <input checked="" type="checkbox"/> iron jacking <input type="checkbox"/> other:

**Cost: \$16,500**
