# **ASSESSMENT OF THE CHURCH STREET GRAVEYARD, MOBILE, ALABAMA**

**Chicora Research Contribution 566**

Michael Trinkley  
And  
Debi Hacker

September 2015

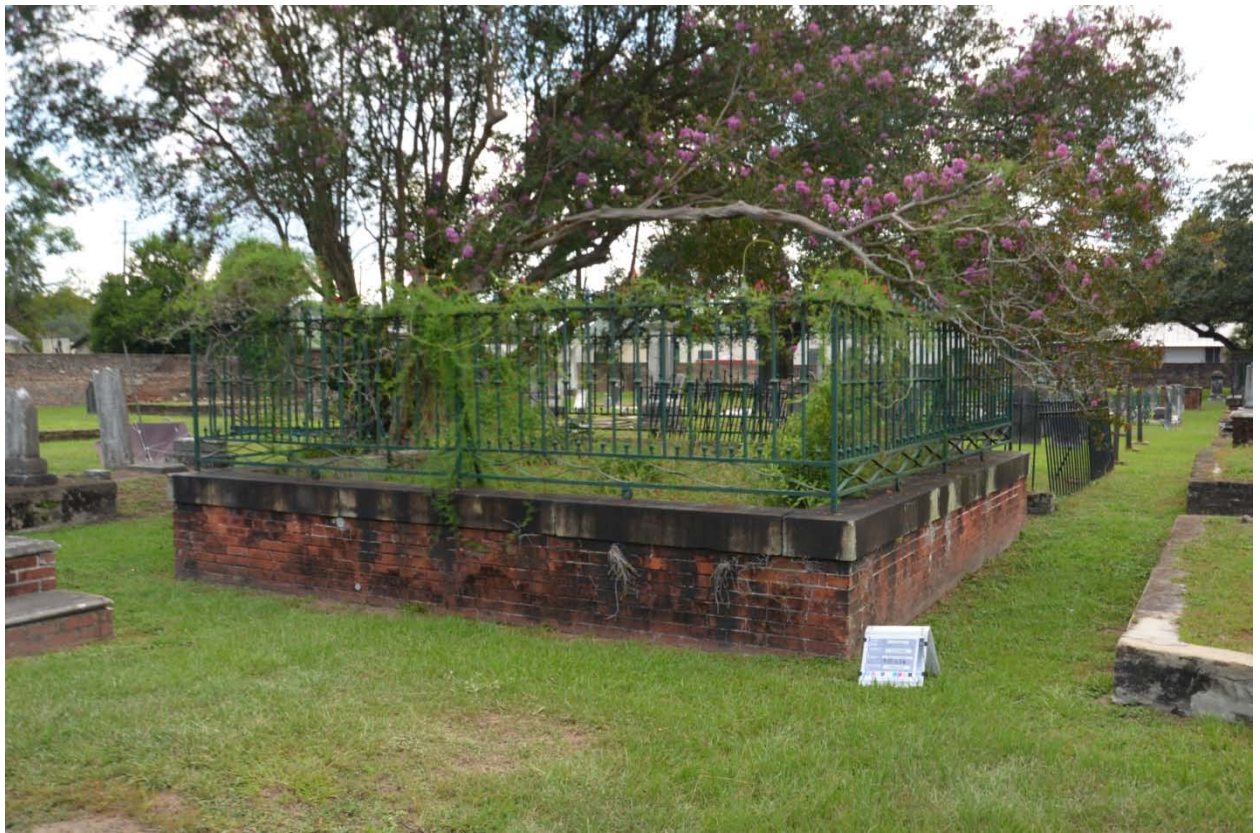
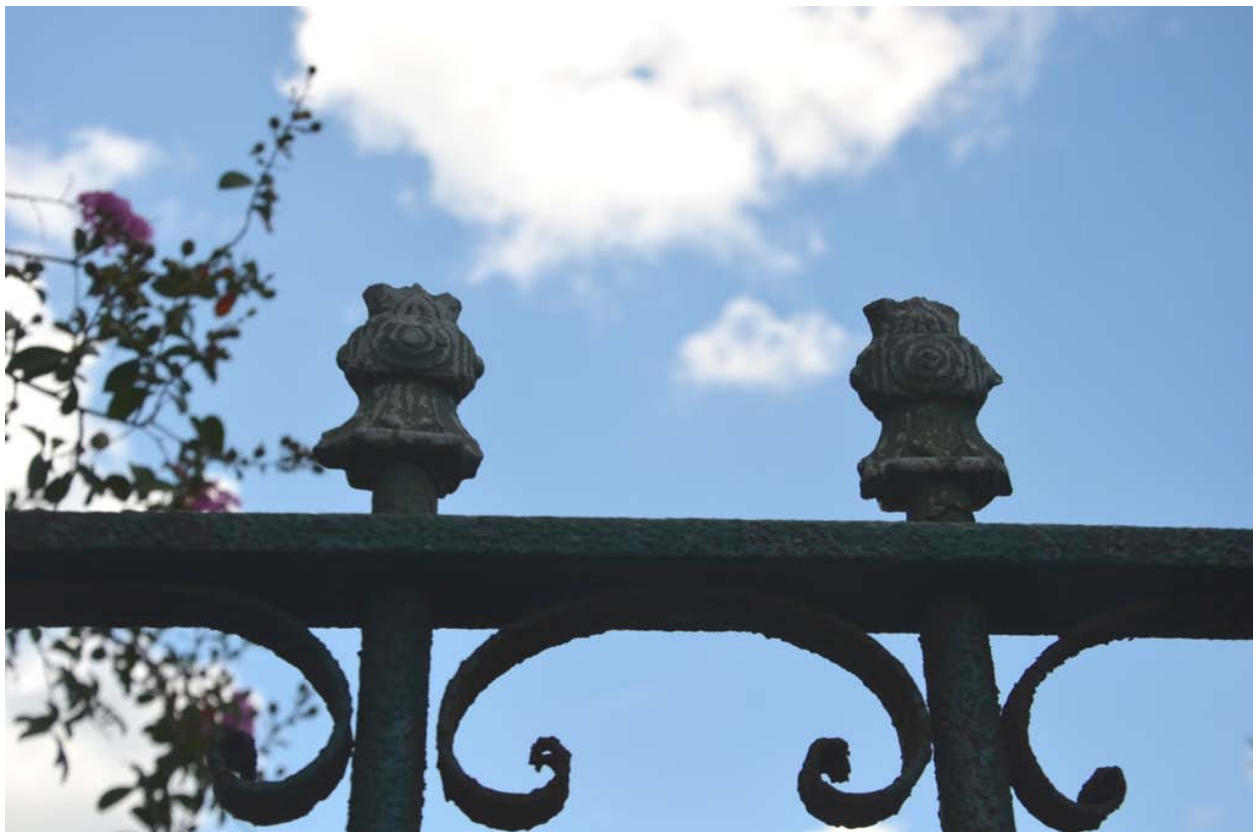
**Church Street Graveyard, Mobile, AL**  
**Fence Treatment Proposal**

Previous Info	Existing Condition	Treatment Strategy
<b>Historic Photos:</b>		
<b>Previous Observation(s) or Assessment(s):</b> 1994		
<b>Narrative:</b> wrought bars with C-spacers, fleur-de-lis motif, cast collars on bars, w section missing, fair condition		
<b>Position:</b> <input type="checkbox"/> fallen <input checked="" type="checkbox"/> tilted <input checked="" type="checkbox"/> unstable <input type="checkbox"/> unattached/loose <input checked="" type="checkbox"/> missing		
<b>Elements Present:</b> 3 of 4 corner posts 2 of 3 line posts 0 of 2 gate posts 0 of 1 gate(s)		
<b>Condition of Baystays:</b> <input type="checkbox"/> none present <input type="checkbox"/> good, stable <input checked="" type="checkbox"/> unattached <input checked="" type="checkbox"/> missing, unstable		
<b>Deterioration:</b> <input type="checkbox"/> broken <input type="checkbox"/> cracked <input type="checkbox"/> losses <input checked="" type="checkbox"/> corrosion <input type="checkbox"/> covered in soil <input checked="" type="checkbox"/> missing fragments <input type="checkbox"/> other:

<b>Extent:</b> <input checked="" type="checkbox"/> extensive >50% <input type="checkbox"/> partial 25-50% <input type="checkbox"/> minimal <25% <input type="checkbox"/> not applicable		
<b>Failed/Old Treatments:</b> <input type="checkbox"/> welds <input type="checkbox"/> adhesives/coatings <input type="checkbox"/> ferrous metals <input type="checkbox"/> wire/other attachment <input checked="" type="checkbox"/> paint, color: dk green <input type="checkbox"/> other:		
<b>Foundations/Coping:</b> <input checked="" type="checkbox"/> brick <input type="checkbox"/> concrete <input type="checkbox"/> granite <input type="checkbox"/> other:		
<b>Foundation/Coping Condition:</b> <input checked="" type="checkbox"/> brick loose, displaced <input type="checkbox"/> mortar damaged <input type="checkbox"/> coping displaced <input type="checkbox"/> coping missing <input type="checkbox"/> iron jacking <input checked="" type="checkbox"/> other: brick collapsing

<b>Position:</b> <input checked="" type="checkbox"/> stabilize foundation <input checked="" type="checkbox"/> reset line posts <input checked="" type="checkbox"/> reset corner posts <input type="checkbox"/> reset/realign gate posts/gate		
<b>Foundation/Coping:</b> <input checked="" type="checkbox"/> point wall <input checked="" type="checkbox"/> rebuild wall <input type="checkbox"/> reset coping <input type="checkbox"/> repair iron jacking location <input type="checkbox"/> other:		
<b>Treatment:</b> <input type="checkbox"/> remove soil from fence bottom rails <input checked="" type="checkbox"/> re-attach fence sections <input checked="" type="checkbox"/> backstays <input type="checkbox"/> straighten sections <input checked="" type="checkbox"/> caulk prior to painting <input type="checkbox"/> other:		
<b>Needed Replacement Elements:</b> 1 corner post		
<b>Other Detailed Observations:</b>		
<b>Paint:</b> <input type="checkbox"/> test for lead <input type="checkbox"/> air abrasion <input checked="" type="checkbox"/> hand tools <input type="checkbox"/> rust converter primer <input checked="" type="checkbox"/> primer <input checked="" type="checkbox"/> top coat alkyd flat paint (two coats) <input type="checkbox"/> other:

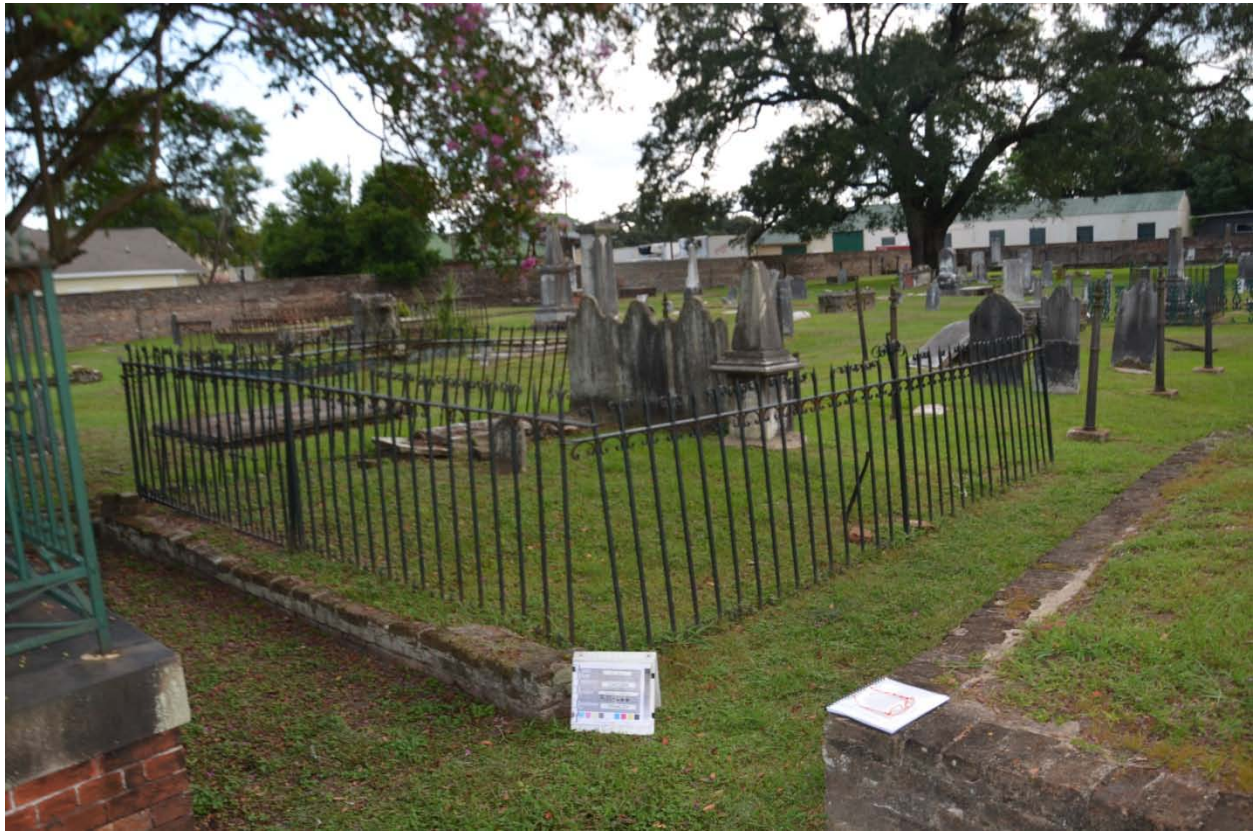
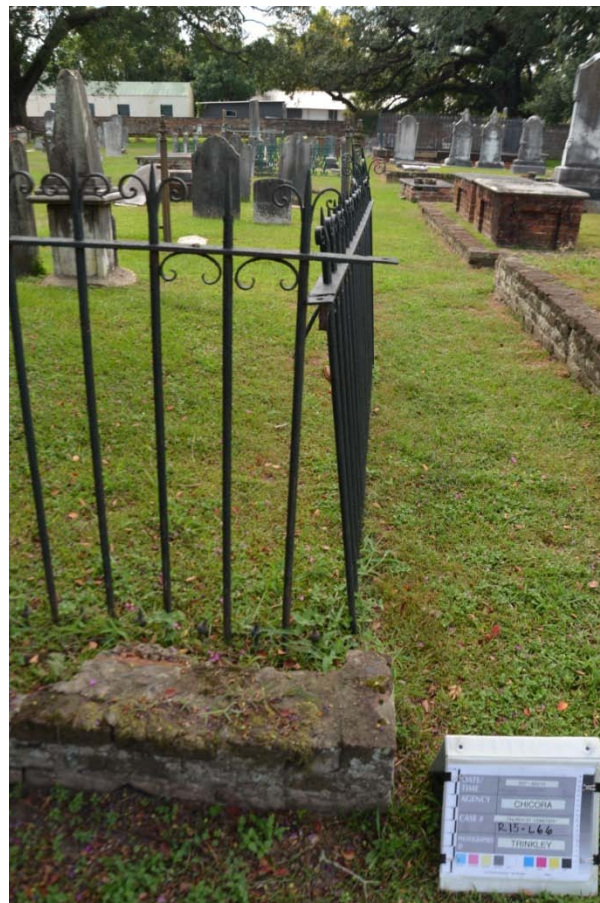
**Church Street Graveyard, Mobile, AL**  
**Fence Treatment Proposal**

Previous Info	Historic Photos:
Existing Condition	Previous Observation(s) or Assessment(s): 1994
	Narrative: Victorian posts only, not assessed
	Position: <input type="checkbox"/> fallen <input type="checkbox"/> tilted <input type="checkbox"/> unstable <input type="checkbox"/> unattached/loose <input checked="" type="checkbox"/> missing
	Elements Present: 4 of 4 corner posts 3 of 3 line posts 2 of 2 gate posts 0 of 1 gate(s)
	Condition of Baystays: <input checked="" type="checkbox"/> none present <input type="checkbox"/> good, stable <input type="checkbox"/> unattached <input type="checkbox"/> missing, unstable
	Deterioration: <input checked="" type="checkbox"/> broken <input type="checkbox"/> cracked <input checked="" type="checkbox"/> losses <input type="checkbox"/> corrosion <input type="checkbox"/> covered in soil <input checked="" type="checkbox"/> missing fragments <input type="checkbox"/> other:

Extent: <input checked="" type="checkbox"/> extensive >50% <input type="checkbox"/> partial 25-50% <input type="checkbox"/> minimal <25% <input type="checkbox"/> not applicable
	Failed/Old Treatments: <input type="checkbox"/> welds <input type="checkbox"/> adhesives/coatings <input type="checkbox"/> ferrous metals <input type="checkbox"/> wire/other attachment <input checked="" type="checkbox"/> paint, color: v dk green <input checked="" type="checkbox"/> other: 3 posts broken
	Foundations/Coping: <input type="checkbox"/> brick <input type="checkbox"/> concrete <input type="checkbox"/> granite <input type="checkbox"/> other:
	Foundation/Coping Condition: <input type="checkbox"/> brick loose, displaced <input type="checkbox"/> mortar damaged <input type="checkbox"/> coping displaced <input type="checkbox"/> coping missing <input type="checkbox"/> iron jacking <input checked="" type="checkbox"/> other: posts set in OPC blocks

Treatment Strategy	Position: <input type="checkbox"/> stabilize foundation <input checked="" type="checkbox"/> reset line posts <input checked="" type="checkbox"/> reset corner posts <input type="checkbox"/> reset/realign gate posts/gate
	Foundation/Coping: <input type="checkbox"/> point wall <input type="checkbox"/> rebuild wall <input type="checkbox"/> reset coping <input type="checkbox"/> repair iron jacking location <input type="checkbox"/> other:
	Treatment: <input type="checkbox"/> remove soil from fence bottom rails <input type="checkbox"/> re-attach fence sections <input type="checkbox"/> backstays <input type="checkbox"/> straighten sections <input checked="" type="checkbox"/> caulk prior to painting <input checked="" type="checkbox"/> other: repair broken posts
	Needed Replacement Elements:
	Other Detailed Observations:
Paint: <input type="checkbox"/> test for lead <input type="checkbox"/> air abrasion <input checked="" type="checkbox"/> hand tools <input type="checkbox"/> rust converter primer <input checked="" type="checkbox"/> primer <input checked="" type="checkbox"/> top coat alkyd flat paint (two coats) <input type="checkbox"/> other:	Recast/Replace: <input type="checkbox"/> describe:

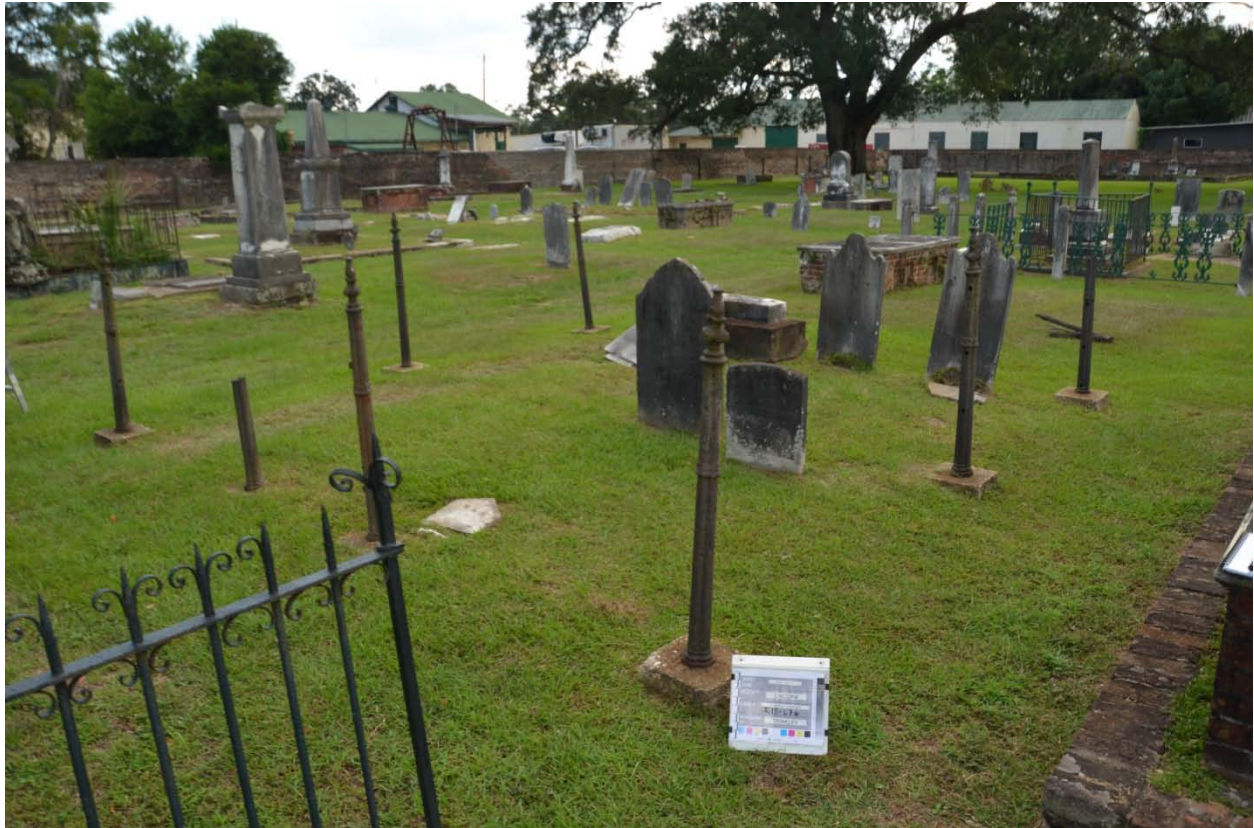
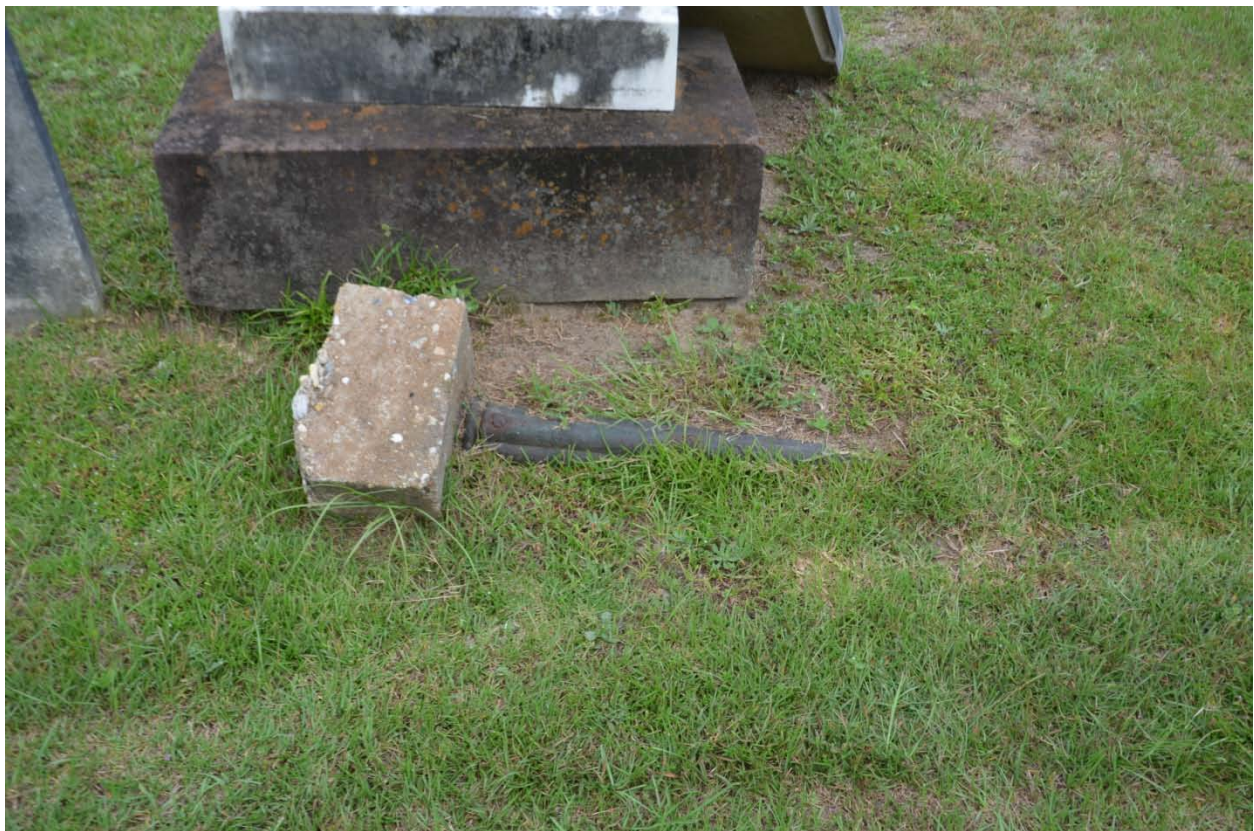
**Church Street Graveyard, Mobile, AL**  
**Fence Treatment Proposal**

Previous Info	Historic Photos:
Existing Condition	Previous Observation(s) or Assessment(s): 1994
	Narrative: concrete uprights with cast fence sections, some missing, not assessed
	Position: <input checked="" type="checkbox"/> fallen <input checked="" type="checkbox"/> tilted <input checked="" type="checkbox"/> unstable <input checked="" type="checkbox"/> unattached/loose <input checked="" type="checkbox"/> missing
	Elements Present: 4 of 4 corner posts 2 of 3 line posts 2 of 2 gate posts 0 of 1 gate(s)
	Condition of Baystays: <input checked="" type="checkbox"/> none present <input type="checkbox"/> good, stable <input type="checkbox"/> unattached <input type="checkbox"/> missing, unstable
	Deterioration: <input checked="" type="checkbox"/> broken <input type="checkbox"/> cracked <input checked="" type="checkbox"/> losses <input checked="" type="checkbox"/> corrosion <input type="checkbox"/> covered in soil <input checked="" type="checkbox"/> missing fragments <input checked="" type="checkbox"/> other: posts are OPC, 1 is broken

Extent: <input checked="" type="checkbox"/> extensive >50% <input type="checkbox"/> partial 25-50% <input type="checkbox"/> minimal <25% <input type="checkbox"/> not applicable
	Failed/Old Treatments: <input type="checkbox"/> welds <input type="checkbox"/> adhesives/coatings <input type="checkbox"/> ferrous metals <input type="checkbox"/> wire/other attachment <input checked="" type="checkbox"/> paint, color: green <input type="checkbox"/> other:
	Foundations/Coping: <input type="checkbox"/> brick <input type="checkbox"/> concrete <input type="checkbox"/> granite <input type="checkbox"/> other:
	Foundation/Coping Condition: <input type="checkbox"/> brick loose, displaced <input type="checkbox"/> mortar damaged <input type="checkbox"/> coping displaced <input type="checkbox"/> coping missing <input type="checkbox"/> iron jacking <input type="checkbox"/> other:
Treatment Strategy	Position: <input type="checkbox"/> stabilize foundation <input checked="" type="checkbox"/> reset line posts <input type="checkbox"/> reset corner posts <input type="checkbox"/> reset/realign gate posts/gate

Foundation/Coping: <input type="checkbox"/> point wall <input type="checkbox"/> rebuild wall <input type="checkbox"/> reset coping <input type="checkbox"/> repair iron jacking location <input type="checkbox"/> other:
	Treatment: <input type="checkbox"/> remove soil from fence bottom rails <input checked="" type="checkbox"/> re-attach fence sections <input type="checkbox"/> backstays <input type="checkbox"/> straighten sections <input checked="" type="checkbox"/> caulk prior to painting <input checked="" type="checkbox"/> other: repair line post
	Needed Replacement Elements:
	Other Detailed Observations:
	Paint: <input type="checkbox"/> test for lead <input type="checkbox"/> air abrasion <input checked="" type="checkbox"/> hand tools <input type="checkbox"/> rust converter primer <input checked="" type="checkbox"/> primer <input checked="" type="checkbox"/> top coat alkyd flat paint (two coats) <input type="checkbox"/> other:

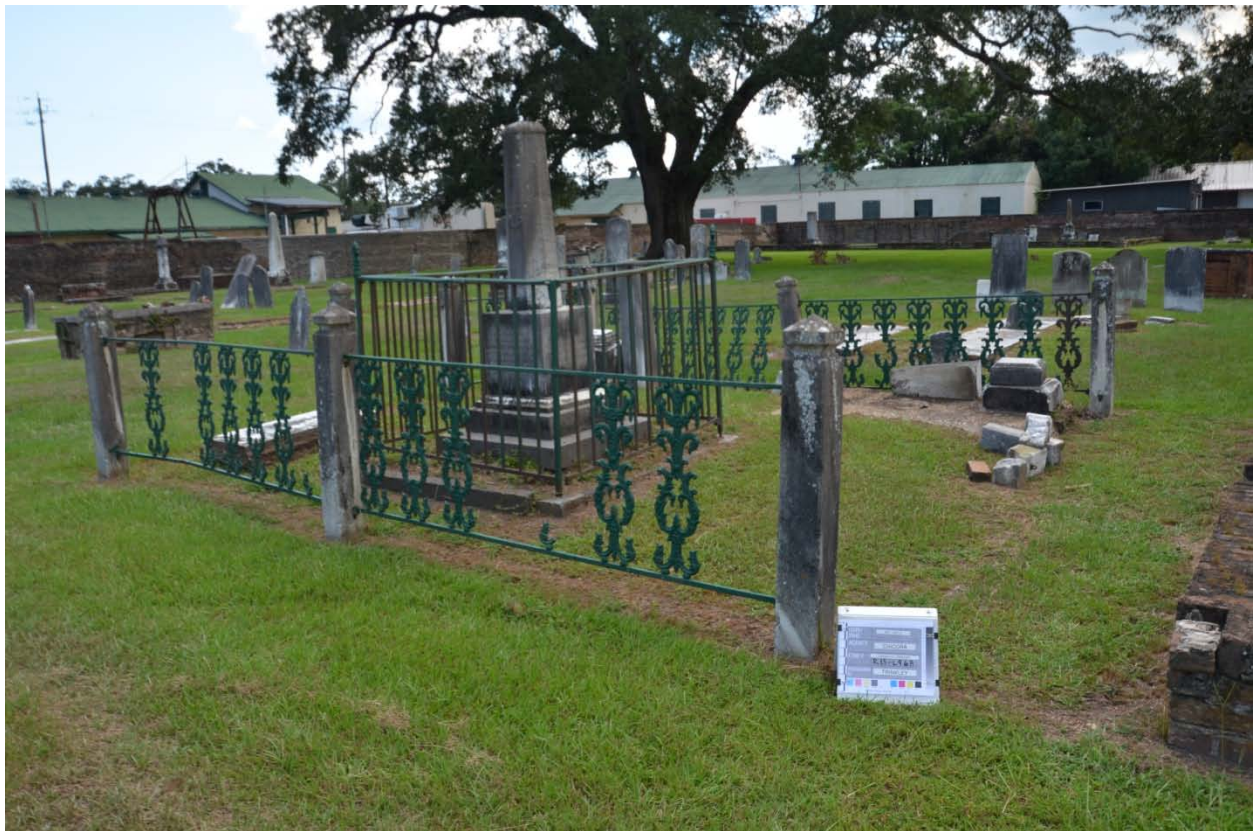
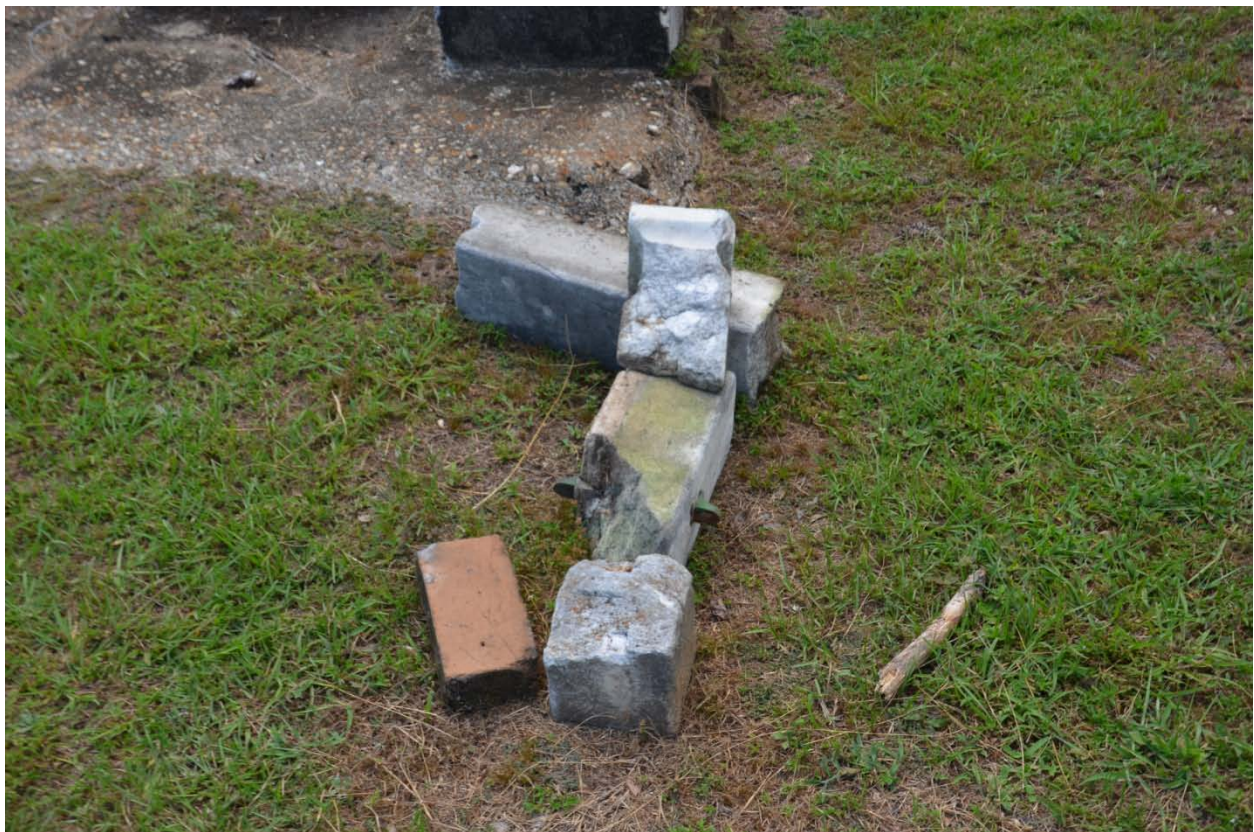
**Church Street Graveyard, Mobile, AL**  
**Fence Treatment Proposal**

Previous Info	<b>Historic Photos:</b> <b>Previous Observation(s) or Assessment(s):</b> 1994 <b>Narrative:</b> wrought, small shell motif corner finials, condition not assessed
	<b>Position:</b> <input type="checkbox"/> fallen <input type="checkbox"/> tilted <input checked="" type="checkbox"/> unstable <input type="checkbox"/> unattached/loose <input type="checkbox"/> missing <b>Elements Present:</b> 4 of 4 corner posts of line posts of gate posts of gate(s) <b>Condition of Baystays:</b> <input type="checkbox"/> none present <input type="checkbox"/> good, stable <input type="checkbox"/> unattached <input type="checkbox"/> missing, unstable <b>Deterioration:</b> <input type="checkbox"/> broken <input type="checkbox"/> cracked <input type="checkbox"/> losses <input checked="" type="checkbox"/> corrosion <input type="checkbox"/> covered in soil <input type="checkbox"/> missing fragments <input checked="" type="checkbox"/> other: "wasting" of corner posts at marble blocks <b>Extent:</b> <input type="checkbox"/> extensive >50% <input type="checkbox"/> partial 25-50% <input checked="" type="checkbox"/> minimal <25% <input type="checkbox"/> not applicable <b>Failed/Old Treatments:</b> <input type="checkbox"/> welds <input type="checkbox"/> adhesives/coatings <input type="checkbox"/> ferrous metals <input type="checkbox"/> wire/other attachment <input checked="" type="checkbox"/> paint, color: green <input type="checkbox"/> other: <b>Foundations/Coping:</b> <input type="checkbox"/> brick <input type="checkbox"/> concrete <input type="checkbox"/> granite <input checked="" type="checkbox"/> other: marble <b>Foundation/Coping Condition:</b> <input type="checkbox"/> brick loose, displaced <input type="checkbox"/> mortar damaged <input type="checkbox"/> coping displaced <input type="checkbox"/> coping missing <input type="checkbox"/> iron jacking <input type="checkbox"/> other:

Existing Condition	<b>Position:</b> <input type="checkbox"/> stabilize foundation <input type="checkbox"/> reset line posts <input checked="" type="checkbox"/> reset corner posts <input type="checkbox"/> reset/realign gate posts/gate <b>Foundation/Coping:</b> <input type="checkbox"/> point wall <input type="checkbox"/> rebuild wall <input type="checkbox"/> reset coping <input type="checkbox"/> repair iron jacking location <input type="checkbox"/> other: <b>Treatment:</b> <input type="checkbox"/> remove soil from fence bottom rails <input type="checkbox"/> re-attach fence sections <input type="checkbox"/> backstays <input type="checkbox"/> straighten sections <input checked="" type="checkbox"/> caulk prior to painting <input checked="" type="checkbox"/> other: repair corner post, may require splicing <b>Needed Replacement Elements:</b> <b>Other Detailed Observations:</b> <b>Paint:</b> <input type="checkbox"/> test for lead <input type="checkbox"/> air abrasion <input checked="" type="checkbox"/> hand tools <input type="checkbox"/> rust converter primer <input checked="" type="checkbox"/> primer <input checked="" type="checkbox"/> top coat alkyd flat paint (two coats) <input type="checkbox"/> other: <b>Recast/Replace:</b> <input type="checkbox"/> describe:

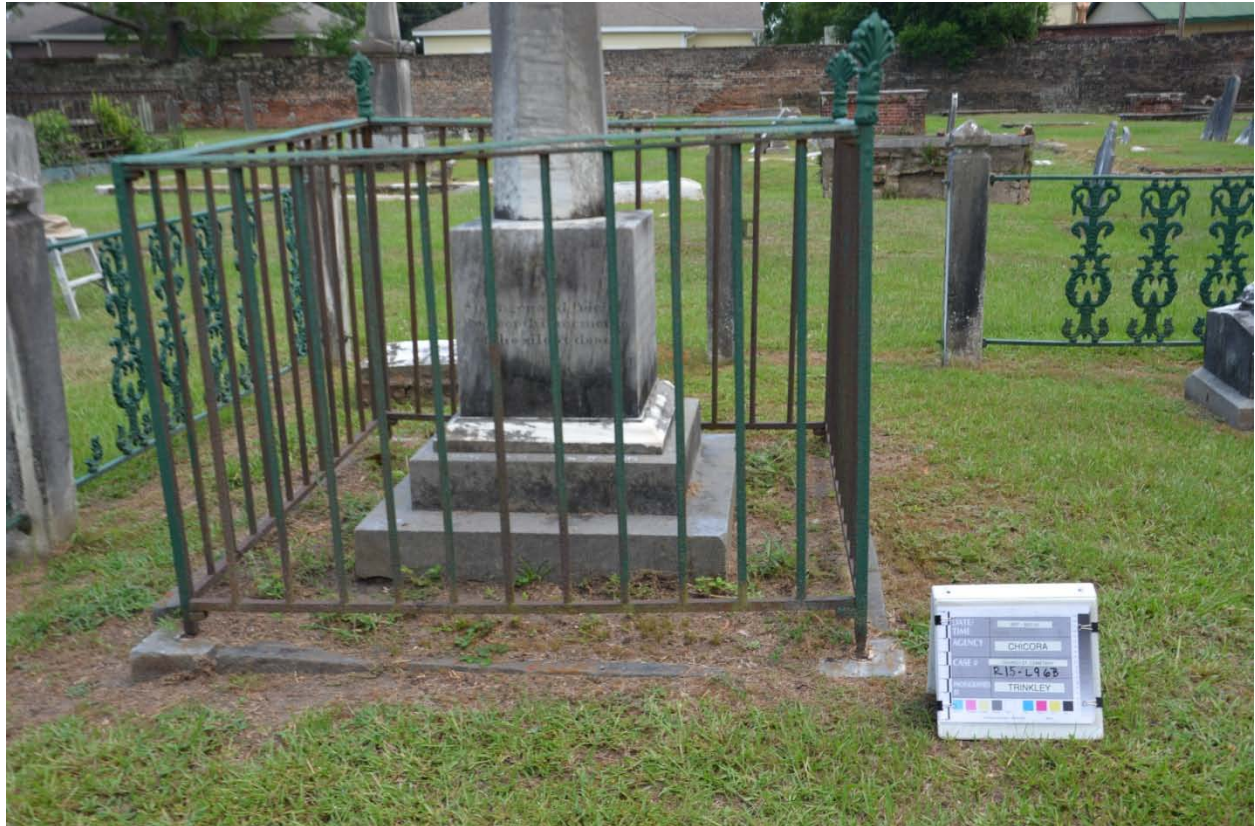
**Church Street Graveyard, Mobile, AL**  
**Fence Treatment Proposal**

Previous Info	Historic Photos:
Existing Condition	<b>Previous Observation(s) or Assessment(s):</b> 1994
	<b>Narrative:</b> wrought bars, C-spacers, cast upright with flared heads, fair condition
	<b>Position:</b> <input type="checkbox"/> fallen <input type="checkbox"/> tilted <input checked="" type="checkbox"/> unstable <input type="checkbox"/> unattached/loose <input type="checkbox"/> missing
	<b>Elements Present:</b> 4 of 4 corner posts 3 of 3 line posts 2 of 2 gate posts 0 of 1 gate(s)
	<b>Condition of Baystays:</b> <input checked="" type="checkbox"/> none present <input type="checkbox"/> good, stable <input type="checkbox"/> unattached <input type="checkbox"/> missing, unstable
	<b>Deterioration:</b> <input type="checkbox"/> broken <input type="checkbox"/> cracked <input type="checkbox"/> losses <input checked="" type="checkbox"/> corrosion <input type="checkbox"/> covered in soil <input type="checkbox"/> missing fragments <input checked="" type="checkbox"/> other: 7 posts with iron jacking, mid-panel supports damaged

<b>Extent:</b> <input type="checkbox"/> extensive >50% <input checked="" type="checkbox"/> partial 25-50% <input type="checkbox"/> minimal <25% <input type="checkbox"/> not applicable
	<b>Failed/Old Treatments:</b> <input type="checkbox"/> welds <input type="checkbox"/> adhesives/coatings <input type="checkbox"/> ferrous metals <input checked="" type="checkbox"/> wire/other attachment <input type="checkbox"/> paint, color: <input type="checkbox"/> other:
	<b>Foundations/Coping:</b> <input checked="" type="checkbox"/> brick <input type="checkbox"/> concrete <input type="checkbox"/> granite <input checked="" type="checkbox"/> other: marble
	<b>Foundation/Coping Condition:</b> <input type="checkbox"/> brick loose, displaced <input type="checkbox"/> mortar damaged <input type="checkbox"/> coping displaced <input type="checkbox"/> coping missing <input checked="" type="checkbox"/> iron jacking <input type="checkbox"/> other:

Treatment Strategy	<b>Position:</b> <input checked="" type="checkbox"/> stabilize foundation <input type="checkbox"/> reset line posts <input type="checkbox"/> reset corner posts <input type="checkbox"/> reset/realign gate posts/gate
	<b>Foundation/Coping:</b> <input type="checkbox"/> point wall <input type="checkbox"/> rebuild wall <input type="checkbox"/> reset coping <input checked="" type="checkbox"/> repair iron jacking location <input checked="" type="checkbox"/> other: repair of iron jacking will require removal of some posts
	<b>Treatment:</b> <input type="checkbox"/> remove soil from fence bottom rails <input checked="" type="checkbox"/> re-attach fence sections <input type="checkbox"/> backstays <input type="checkbox"/> straighten sections <input checked="" type="checkbox"/> caulk prior to painting <input type="checkbox"/> other:
	<b>Needed Replacement Elements:</b>
	<b>Other Detailed Observations:</b>

<b>Paint:</b> <input type="checkbox"/> test for lead <input type="checkbox"/> air abrasion <input checked="" type="checkbox"/> hand tools <input checked="" type="checkbox"/> rust converter primer <input type="checkbox"/> primer <input checked="" type="checkbox"/> top coat alkyd flat paint (two coats) <input type="checkbox"/> other:
<b>Recast/Replace:</b> <input type="checkbox"/> describe:

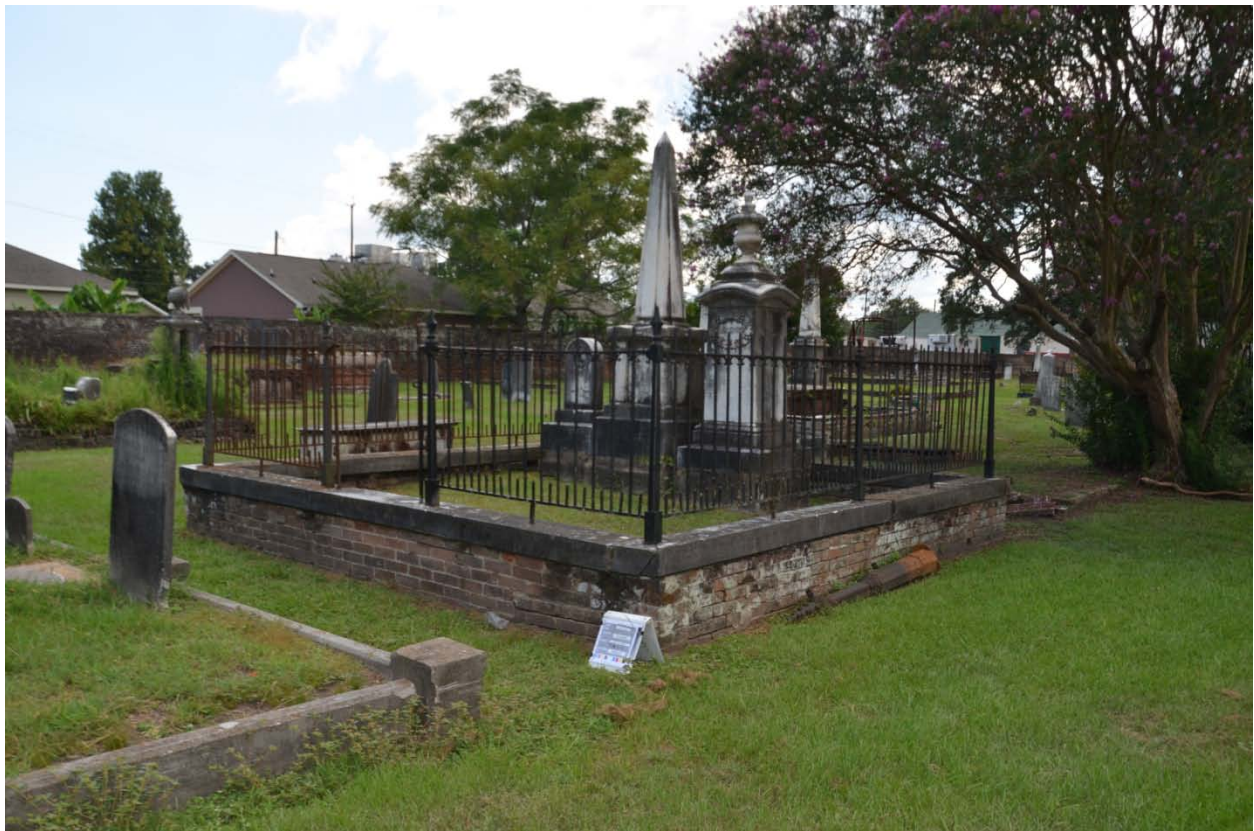
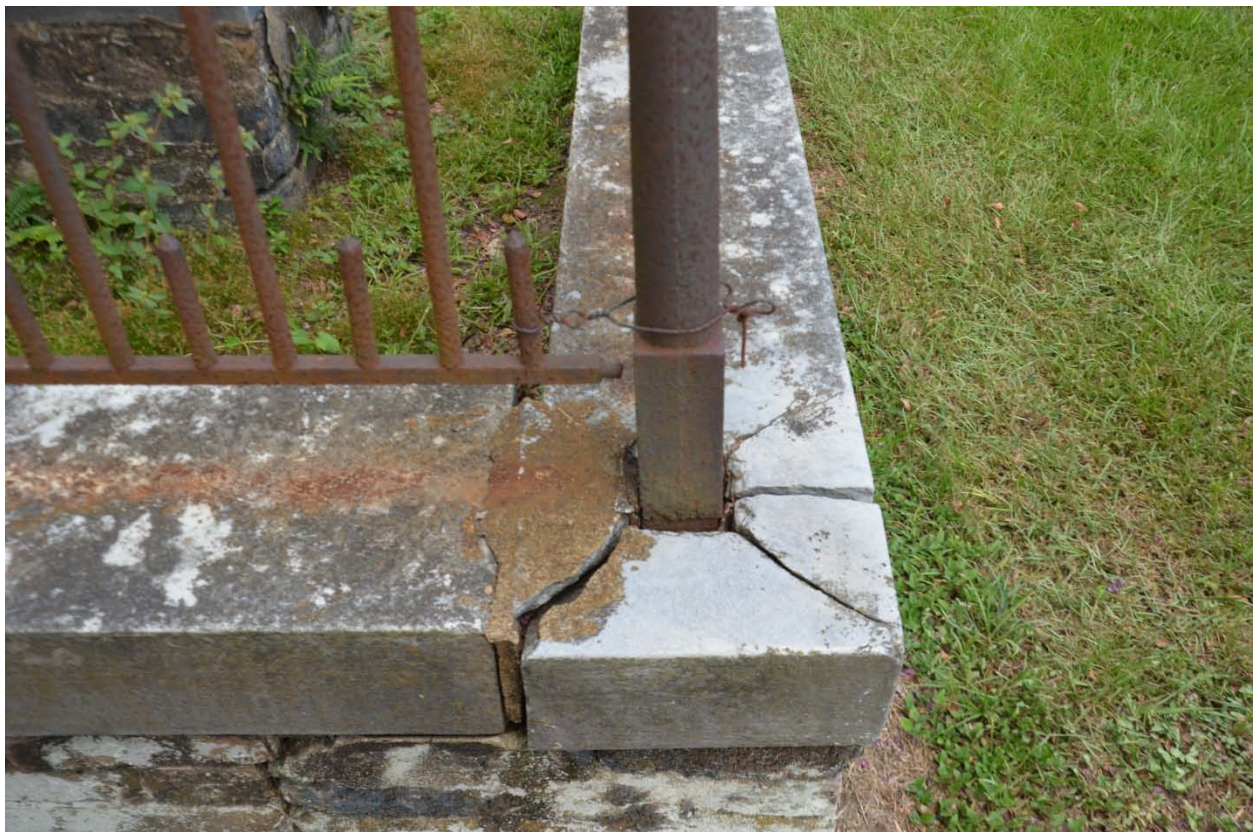
**Church Street Graveyard, Mobile, AL**  
**Fence Treatment Proposal**

**Narrative:** 1963, well-preserved simple fence on iron base; 1993, wrought bars, C-spacers, crests missing, bottom border with wrought strips fastened by cast rosettes, cast coping, good condition

**Position:** ☐ fallen ☐ tilted ☐ unstable ☒ unattached/loose ☐ missing

**Condition of Baystays:** ☐ none present ☒ good, stable ☒ unattached ☐ missing, unstable

**Deterioration:** ☐ broken ☐ cracked ☐ losses ☒ corrosion ☐ covered in soil  
☐ missing fragments ☒ other: tree, now 4' stump, grown into fence; 1 section badly bent

**Failed/Old Treatments:** ☐ welds ☐ adhesives/coatings ☐ ferrous metals  
☐ wire/other attachment ☒ paint, color: blue ☐ other:

**Paint:** ☐ test for lead ☐ air abrasion ☐ hand tools ☒ rust converter primer ☐ primer  
☒ top coat alkyd flat paint (two coats) ☐ other:

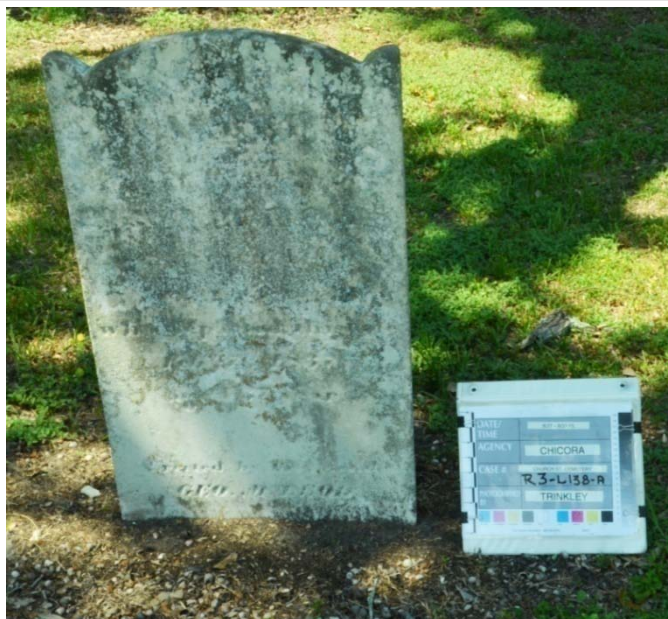
**Row: 4**

**Position:** ☐ fallen ☐ tilted ☐ unstable ☒ unattached/loose ☐ missing

**Legibility:** ☐ sharp, tooling evident ☒ clear, but worn ☐ partially discernable ☐ not discernable

**Deterioration:** ☒ broken ☐ cracked ☐ losses ☐ flaking/sugaring ☐ ferrous pins  
☐ brass pins ☐ delamination/detachment ☐ spalling ☒ missing fragments  
☐ other:

**Soiling:** ☒ biological ☐ staining ☐ efflorescence ☐ other:

**Treatment:** ☐ core drill ☒ drill and pin ☐ simple adhesive repair ☐ injection grout ☐ set bricks  
☐ mortar ☐ repoint ☒ infill ☐ other:

**Cost: \$1,200**

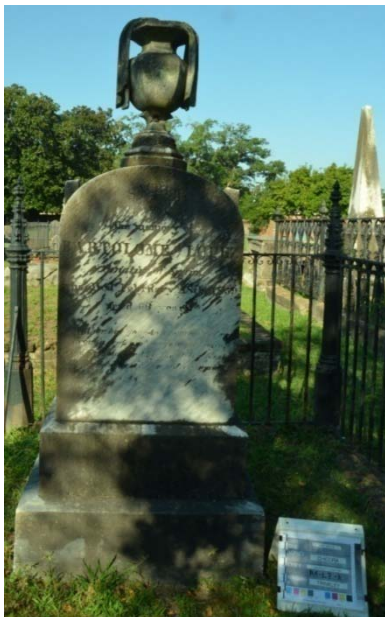
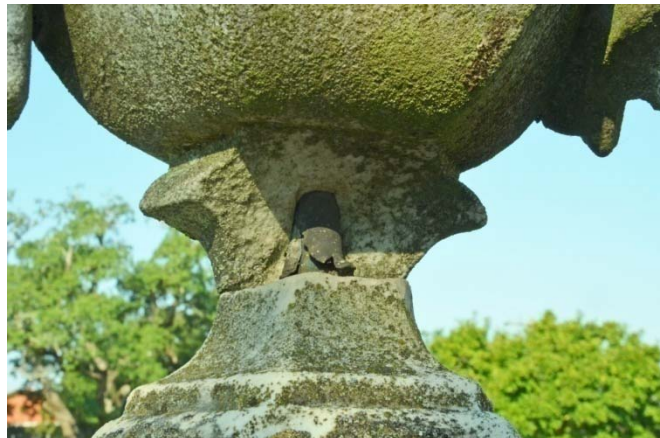
Row: 4

Deterioration: ☐ broken ☐ cracked ☐ losses ☐ flaking/sugaring ☐ ferrous pins  
☐ brass pins ☐ delamination/detachment ☒ spalling ☐ missing fragments  
☐ other:

Soiling: ☒ biological ☐ staining ☐ efflorescence ☒ other: vegetation

Cost: \$800

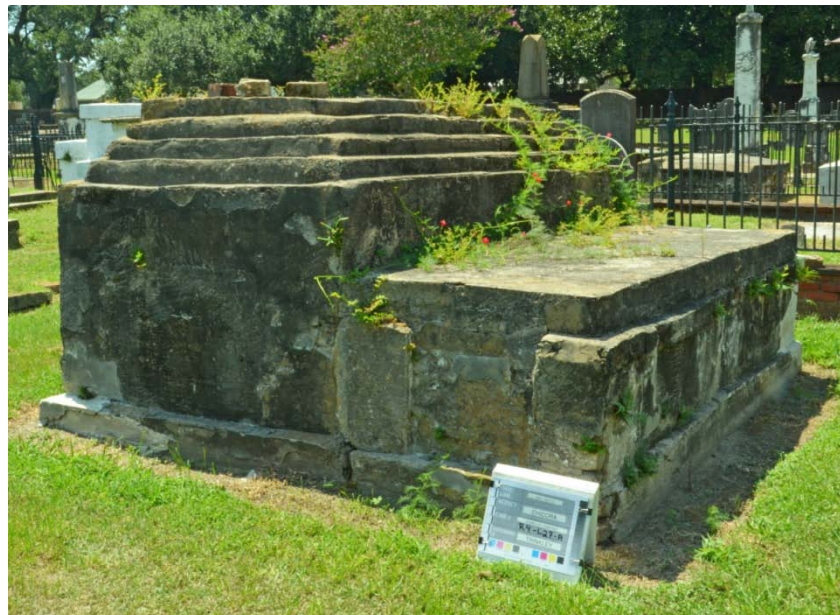
Row: 4

Position: ☒ fallen ☐ tilted ☐ unstable ☐ unattached/loose ☐ missing

Legibility: ☐ sharp, tooling evident ☐ clear, but worn ☒ partially discernable ☐ not discernable

Deterioration: ☒ broken ☐ cracked ☐ losses ☒ flaking/sugaring ☐ ferrous pins  
☐ brass pins ☐ delamination/detachment ☒ spalling ☐ missing fragments  
☒ other: mower damage

Soiling: ☒ biological ☐ staining ☐ efflorescence ☐ other:

Position: ☐ reset/level in ground ☐ use existing base ☐ construct new base ☐ resquare  
☐ new base required ☐ stabilize foundation ☐ reset with NHL ☐ reset with compound  
☒ other: if base can't be found, reset in new OPC socket

Treatment: ☐ core drill ☒ drill and pin ☐ simple adhesive repair ☐ injection grout ☐ set bricks  
☐ mortar ☐ repoint ☒ infill ☐ other:

Cost: \$1,700

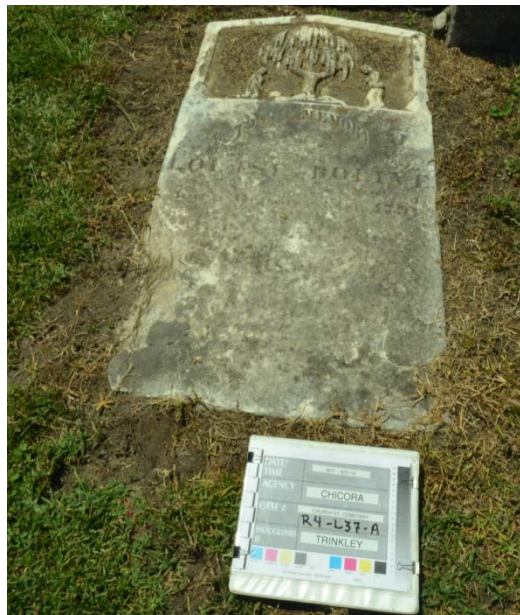
Row: 4

Position: ☐ fallen ☐ tilted ☒ unstable ☒ unattached/loose ☐ missing

Legibility: ☐ sharp, tooling evident ☒ clear, but worn ☐ partially discernable ☐ not discernable

Deterioration: ☐ broken ☐ cracked ☐ losses ☐ flaking/sugaring ☐ ferrous pins  
☐ brass pins ☐ delamination/detachment ☐ spalling ☐ missing fragments  
☒ other: UID pins

Soiling: ☒ biological ☐ staining ☐ efflorescence ☐ other:

Position: ☐ reset/level in ground ☐ use existing base ☐ construct new base ☐ resquare  
☐ new base required ☐ stabilize foundation ☒ reset with NHL ☐ reset with compound  
☐ other:

Treatment: ☒ core drill ☒ drill and pin ☐ simple adhesive repair ☐ injection grout ☐ set bricks  
☐ mortar ☐ repoint ☐ infill ☒ other: both head and foot have pins and are loose

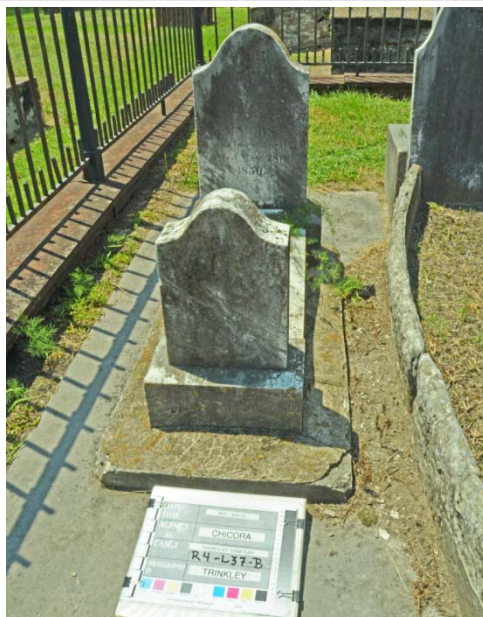
**Row: 4**

**Position:** ☐ fallen ☒ tilted ☒ unstable ☒ unattached/loose ☐ missing

**Deterioration:** ☐ broken ☐ cracked ☐ losses ☐ flaking/sugaring ☐ ferrous pins  
☐ brass pins ☐ delamination/detachment ☐ spalling ☐ missing fragments  
☒ other: set on base of bricks and bricks deteriorating

**Soiling:** ☒ biological ☐ staining ☐ efflorescence ☐ other:

**Position:** ☒ reset/level in ground ☐ use existing base ☐ construct new base ☐ resquare  
☐ new base required ☐ stabilize foundation ☒ reset with NHL ☐ reset with compound  
☒ other: remove bricks and establish good foundation

**Treatment:** ☒ core drill ☒ drill and pin ☐ simple adhesive repair ☐ injection grout ☐ set bricks  
☐ mortar ☐ repoint ☐ infill ☐ other:

**Cost: \$1,800**

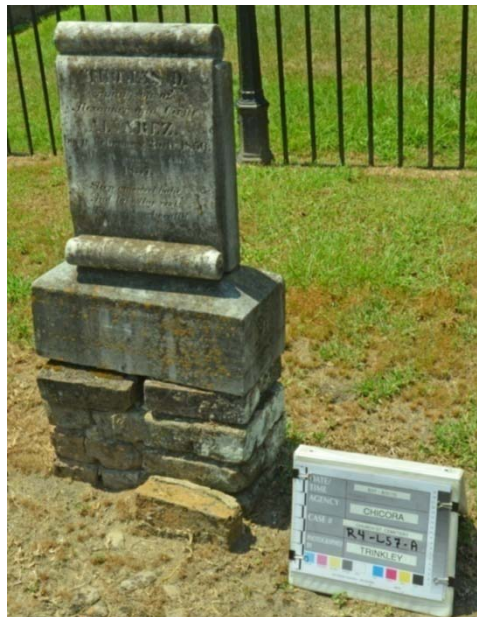
Row: 4

Position: ☐ fallen ☒ tilted ☒ unstable ☒ unattached/loose ☐ missing

Legibility: ☐ sharp, tooling evident ☒ clear, but worn ☐ partially discernable ☐ not discernable

Deterioration: ☐ broken ☐ cracked ☐ losses ☐ flaking/sugaring ☐ ferrous pins  
☐ brass pins ☐ delamination/detachment ☐ spalling ☐ missing fragments  
☒ other: no pins

Soiling: ☒ biological ☐ staining ☐ efflorescence ☐ other:

Position: ☐ reset/level in ground ☐ use existing base ☐ construct new base ☐ resquare  
☐ new base required ☐ stabilize foundation ☒ reset with NHL ☐ reset with compound  
☐ other:

Treatment: ☐ core drill ☒ drill and pin ☐ simple adhesive repair ☐ injection grout ☐ set bricks  
☐ mortar ☐ repoint ☐ infill ☐ other:

Cost: \$1,800

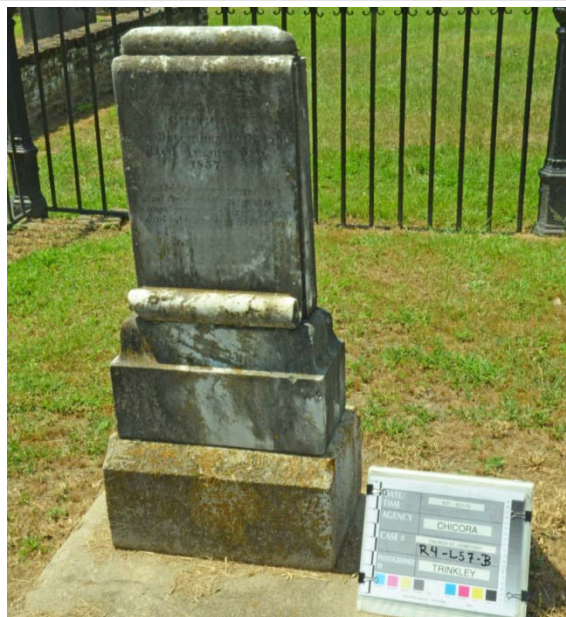
Row: 4

Position: ☒ fallen ☒ tilted ☒ unstable ☐ unattached/loose ☐ missing

Legibility: ☐ sharp, tooling evident ☒ clear, but worn ☐ partially discernable ☐ not discernable

Deterioration: ☒ broken ☐ cracked ☐ losses ☐ flaking/sugaring ☐ ferrous pins  
☐ brass pins ☐ delamination/detachment ☐ spalling ☐ missing fragments  
☐ other:

Failed/Old Treatments: ☐ metal ☐ adhesives/coatings ☐ mortar ☒ other: OPC

Soiling: ☒ biological ☐ staining ☐ efflorescence ☐ other:

Position: ☒ reset/level in ground ☐ use existing base ☐ construct new base ☐ resquare  
☐ new base required ☐ stabilize foundation ☐ reset with NHL ☐ reset with compound  
☒ other: if base can't be found, reset in new OPC socket

Failed Treatments: ☐ drill/grind ☒ hand tools ☐ solvents ☐ other:

Treatment: ☐ core drill ☒ drill and pin ☐ simple adhesive repair ☐ injection grout ☐ set bricks  
☐ mortar ☐ repoint ☒ infill ☐ other:

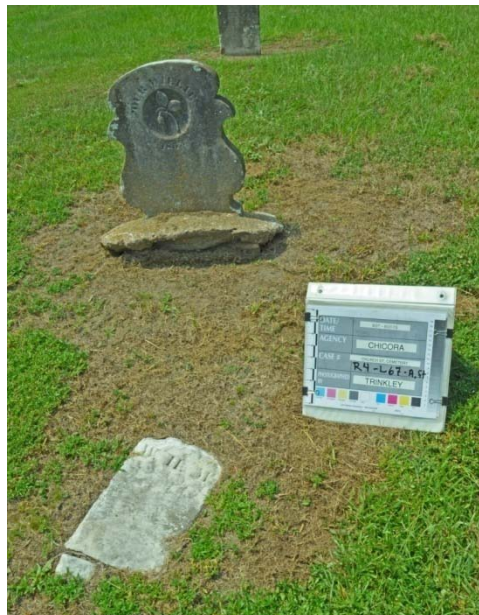
Row: 4

Position: ☒ fallen ☐ tilted ☐ unstable ☐ unattached/loose ☐ missing

Legibility: ☐ sharp, tooling evident ☒ clear, but worn ☐ partially discernable ☐ not discernable

Deterioration: ☒ broken ☐ cracked ☐ losses ☒ flaking/sugaring ☐ ferrous pins  
☐ brass pins ☐ delamination/detachment ☐ spalling ☐ missing fragments  
☐ other:

Position: ☒ reset/level in ground ☐ use existing base ☐ construct new base ☐ resquare  
☐ new base required ☐ stabilize foundation ☐ reset with NHL ☐ reset with compound  
☐ other:

Treatment: ☐ core drill ☒ drill and pin ☐ simple adhesive repair ☐ injection grout ☐ set bricks  
☐ mortar ☐ repoint ☐ infill ☒ other: if stone not suitable for drilling, reset in new OPC socket

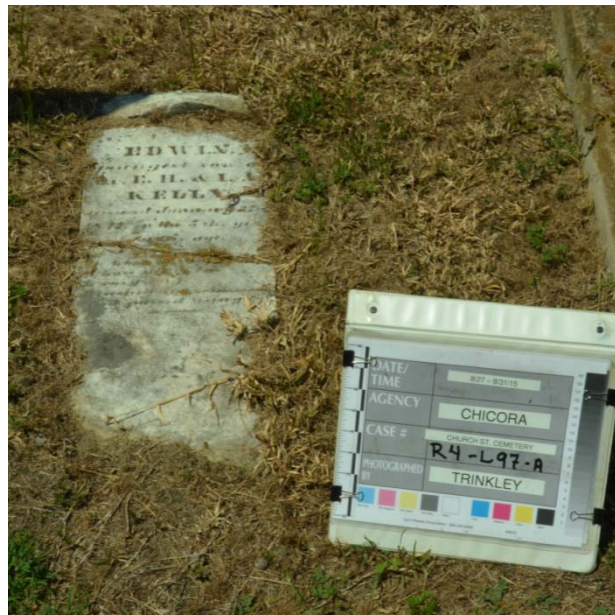
Row: 4

Legibility: ☐ sharp, tooling evident ☐ clear, but worn ☒ partially discernable ☐ not discernable

Failed/Old Treatments: ☐ metal ☐ adhesives/coatings ☐ mortar ☒ other: OPC infills

Cost: \$10,500

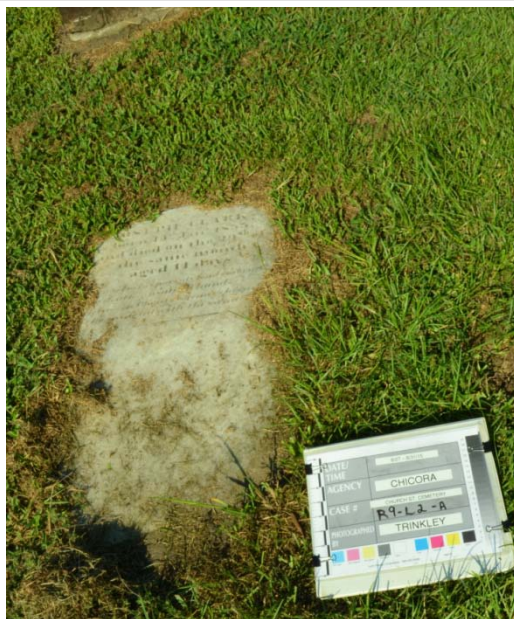
Row: 9

Position: ☒ fallen ☐ tilted ☐ unstable ☐ unattached/loose ☐ missing

Legibility: ☐ sharp, tooling evident ☐ clear, but worn ☒ partially discernable ☐ not discernable

Deterioration: ☒ broken ☐ cracked ☐ losses ☒ flaking/sugaring ☐ ferrous pins  
☐ brass pins ☐ delamination/detachment ☐ spalling ☐ missing fragments  
☒ other: none of fragments mend

Soiling: ☒ biological ☐ staining ☐ efflorescence ☐ other:

Position: ☐ reset/level in ground ☐ use existing base ☒ construct new base ☐ resquare  
☐ new base required ☐ stabilize foundation ☐ reset with NHL ☐ reset with compound  
☐ other:

Treatment: ☐ core drill ☐ drill and pin ☐ simple adhesive repair ☐ injection grout ☐ set bricks  
☐ mortar ☐ repoint ☐ infill ☒ other: collect and bury frags

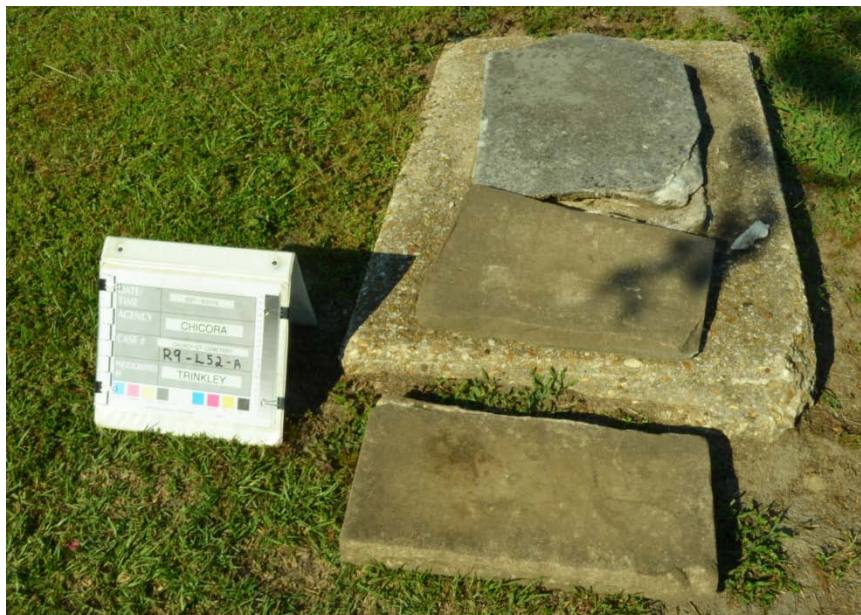
Row: 9

Legibility: ☐ sharp, tooling evident ☒ clear, but worn ☐ partially discernable ☐ not discernable

Deterioration: ☒ broken ☐ cracked ☐ losses ☐ flaking/sugaring ☐ ferrous pins  
☐ brass pins ☐ delamination/detachment ☐ spalling ☐ missing fragments  
☐ other:

Soiling: ☒ biological ☐ staining ☐ efflorescence ☐ other:

Treatment: ☐ core drill ☐ drill and pin ☒ simple adhesive repair ☐ injection grout ☐ set bricks  
☐ mortar ☐ repoint ☒ infill ☐ other:
