# **ASSESSMENT OF THE CHURCH STREET GRAVEYARD, MOBILE, ALABAMA**

**Chicora Research Contribution 566**

Michael Trinkley  
And  
Debi Hacker

September 2015

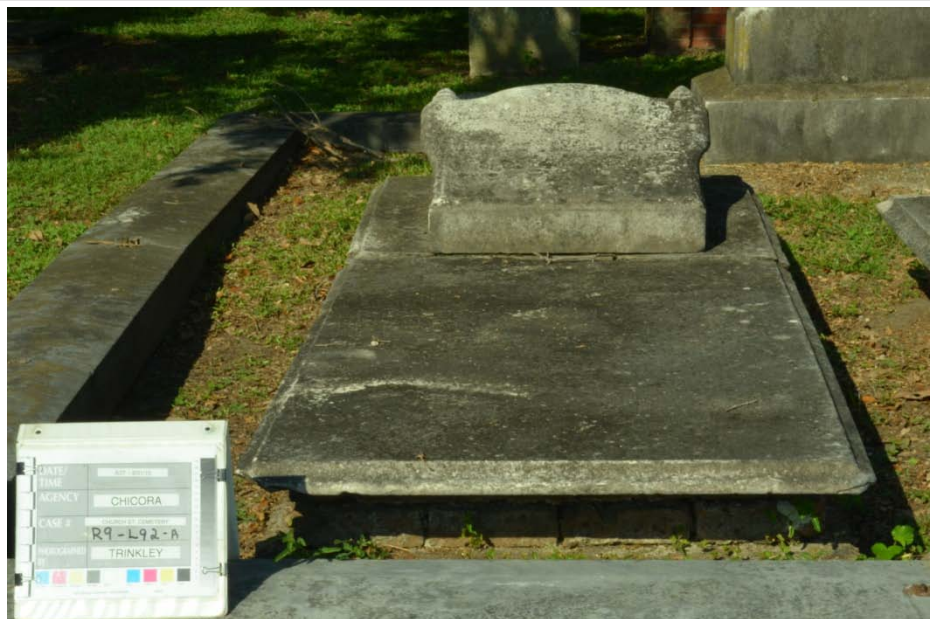
Row: 9

Position: ☒ fallen ☐ tilted ☐ unstable ☐ unattached/loose ☐ missing

Legibility: ☐ sharp, tooling evident ☒ clear, but worn ☐ partially discernable ☐ not discernable

Deterioration: ☒ broken ☐ cracked ☐ losses ☐ flaking/sugaring ☐ ferrous pins  
☐ brass pins ☐ delamination/detachment ☐ spalling ☐ missing fragments  
☐ other:

Soiling: ☒ biological ☐ staining ☐ efflorescence ☐ other:

Position: ☒ reset/level in ground ☐ use existing base ☐ construct new base ☐ resquare  
☐ new base required ☐ stabilize foundation ☐ reset with NHL ☐ reset with compound  
☒ other: if base can't be found, reset in new OPC socket

Treatment: ☐ core drill ☒ drill and pin ☐ simple adhesive repair ☐ injection grout ☐ set bricks  
☐ mortar ☐ repoint ☒ infill ☐ other:

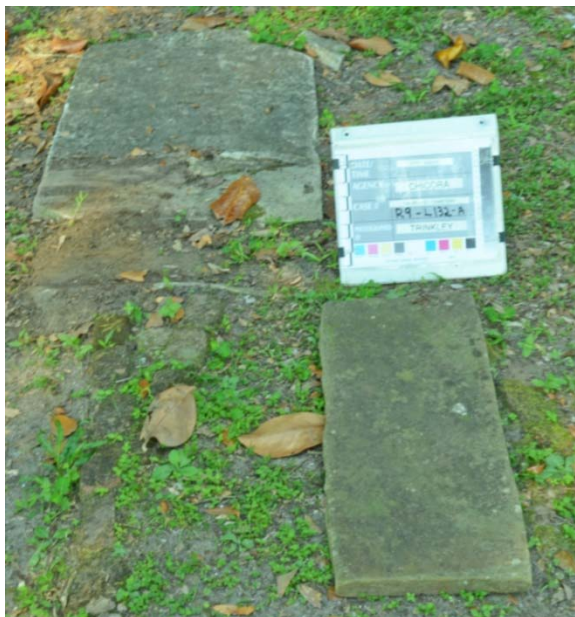
Row: 10

Position: ☒ fallen ☐ tilted ☐ unstable ☐ unattached/loose ☐ missing

Legibility: ☐ sharp, tooling evident ☒ clear, but worn ☐ partially discernable ☐ not discernable

Deterioration: ☒ broken ☐ cracked ☐ losses ☐ flaking/sugaring ☐ ferrous pins  
☐ brass pins ☐ delamination/detachment ☐ spalling ☐ missing fragments  
☒ other: mower damage

Soiling: ☒ biological ☐ staining ☐ efflorescence ☐ other:

Position: ☐ reset/level in ground ☐ use existing base ☒ construct new base ☐ resquare  
☐ new base required ☐ stabilize foundation ☐ reset with NHL ☐ reset with compound  
☐ other:

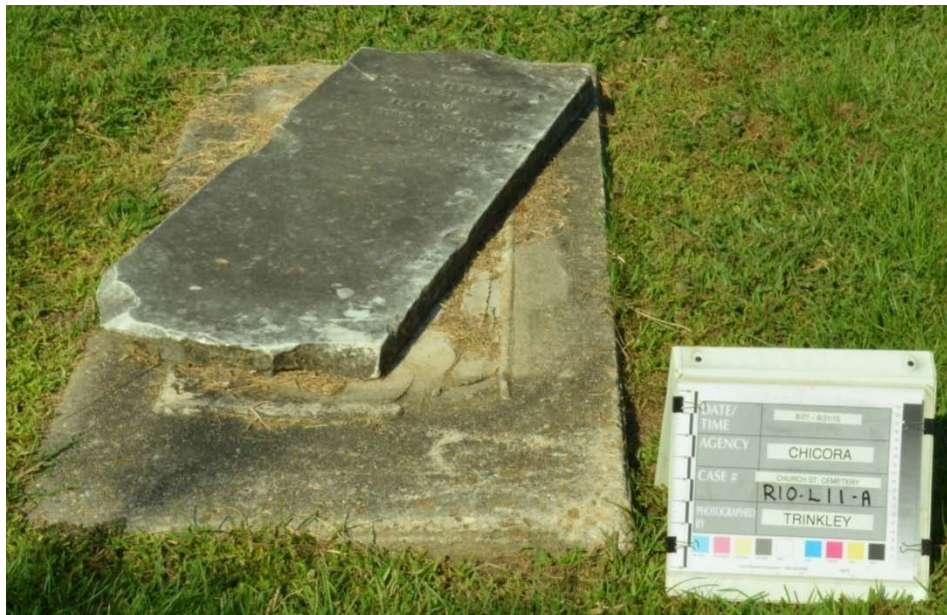
Row: 10

Position: ☐ fallen ☒ tilted ☒ unstable ☐ unattached/loose ☐ missing

Legibility: ☐ sharp, tooling evident ☒ clear, but worn ☐ partially discernable ☐ not discernable

Soiling: ☒ biological ☐ staining ☐ efflorescence ☐ other:

Position: ☒ reset/level in ground ☐ use existing base ☐ construct new base ☐ resquare  
☐ new base required ☐ stabilize foundation ☐ reset with NHL ☐ reset with compound  
☐ other:

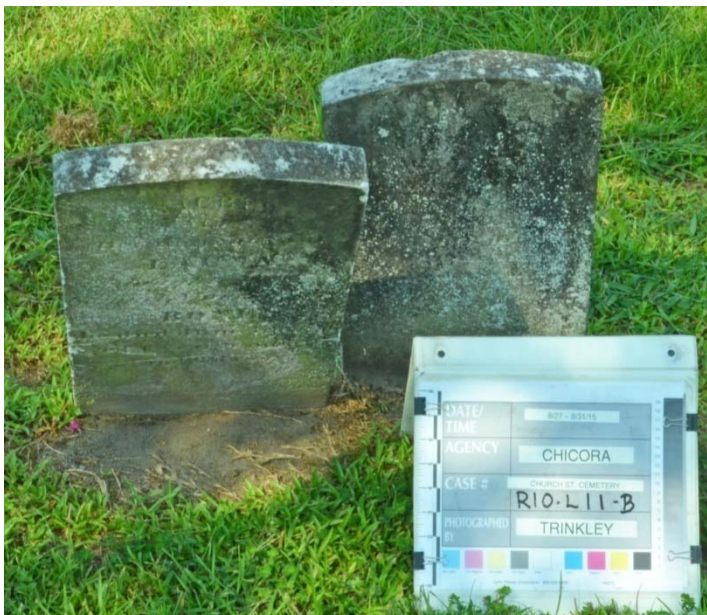
Row: 10

Position: ☐ fallen ☒ tilted ☒ unstable ☐ unattached/loose ☐ missing

Legibility: ☐ sharp, tooling evident ☐ clear, but worn ☒ partially discernable ☐ not discernable

Soiling: ☒ biological ☐ staining ☐ efflorescence ☐ other:

Position: ☒ reset/level in ground ☐ use existing base ☐ construct new base ☐ resquare  
☐ new base required ☐ stabilize foundation ☐ reset with NHL ☐ reset with compound  
☐ other:

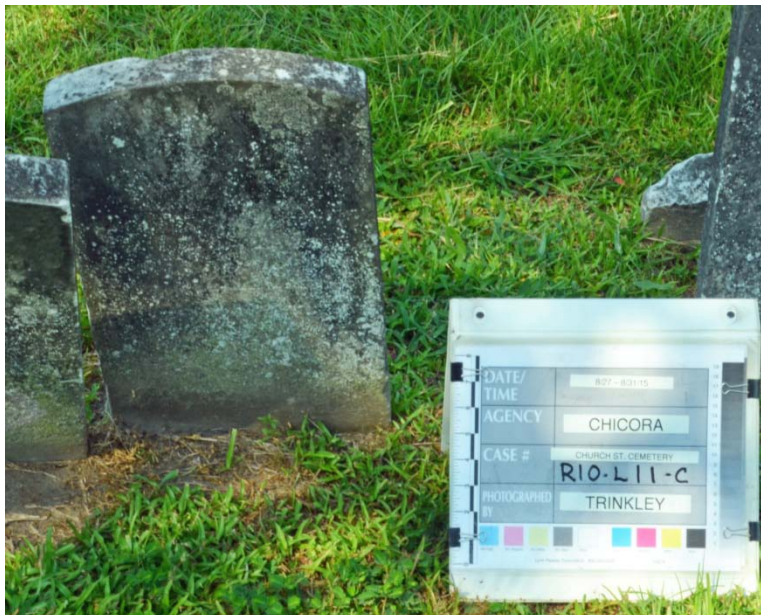
**Row: 10**

**Position:** ☐ fallen ☒ tilted ☒ unstable ☐ unattached/loose ☐ missing

**Legibility:** ☐ sharp, tooling evident ☒ clear, but worn ☐ partially discernable ☐ not discernable

**Deterioration:** ☒ broken ☐ cracked ☐ losses ☐ flaking/sugaring ☐ ferrous pins  
☐ brass pins ☐ delamination/detachment ☐ spalling ☐ missing fragments  
☒ other: mower damage

**Soiling:** ☒ biological ☐ staining ☐ efflorescence ☐ other:

**Position:** ☒ reset/level in ground ☐ use existing base ☐ construct new base ☐ resquare  
☐ new base required ☐ stabilize foundation ☐ reset with NHL ☐ reset with compound  
☒ other: if base can't be found, reset in new OPC socket

**Treatment:** ☐ core drill ☒ drill and pin ☐ simple adhesive repair ☐ injection grout ☐ set bricks  
☐ mortar ☐ repoint ☒ infill ☐ other:

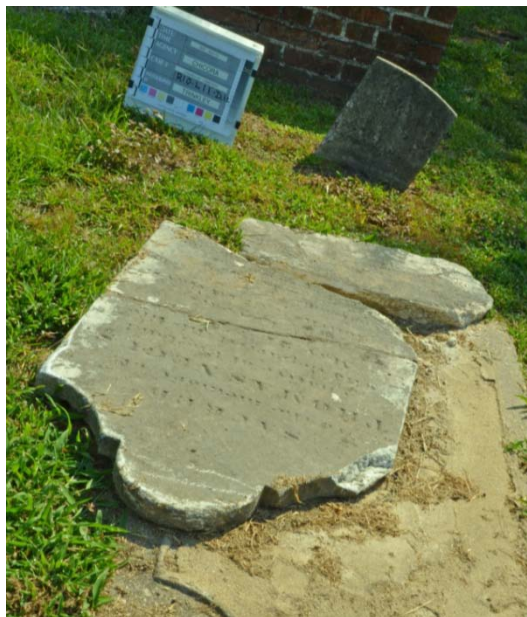
Row: 10

Position: ☐ fallen ☒ tilted ☒ unstable ☒ unattached/loose ☐ missing

Legibility: ☐ sharp, tooling evident ☒ clear, but worn ☐ partially discernable ☐ not discernable

Deterioration: ☐ broken ☐ cracked ☐ losses ☐ flaking/sugaring ☐ ferrous pins  
☒ brass pins ☐ delamination/detachment ☐ spalling ☐ missing fragments  
☐ other:

Soiling: ☒ biological ☐ staining ☐ efflorescence ☐ other:

Position: ☐ reset/level in ground ☐ use existing base ☐ construct new base ☐ resquare  
☐ new base required ☐ stabilize foundation ☒ reset with NHL ☐ reset with compound  
☐ other:

Treatment: ☐ core drill ☐ drill and pin ☐ simple adhesive repair ☐ injection grout ☐ set bricks  
☐ mortar ☐ repoint ☐ infill ☒ other: inspect pins, remove and replace if necessary

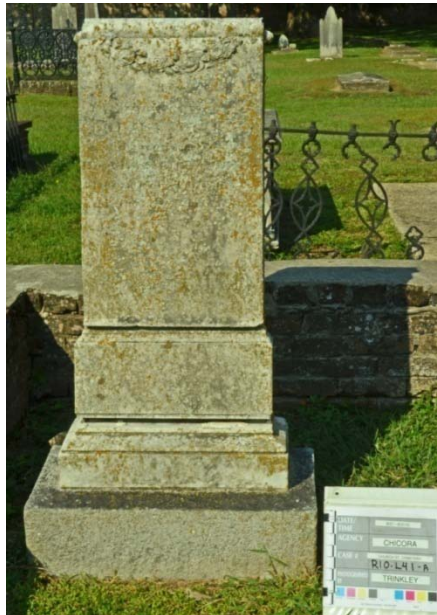
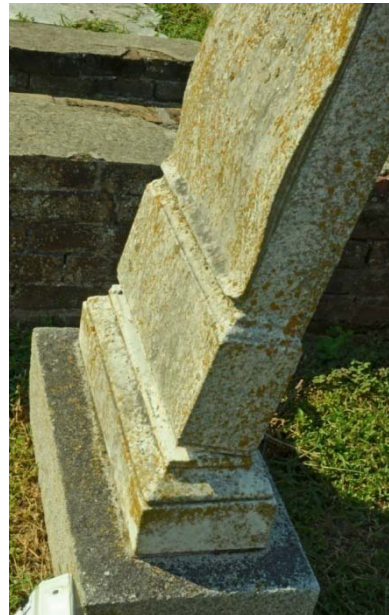
Row: 10

Position: ☒ fallen ☒ tilted ☒ unstable ☐ unattached/loose ☐ missing

Legibility: ☐ sharp, tooling evident ☒ clear, but worn ☐ partially discernable ☐ not discernable

Soiling: ☒ biological ☐ staining ☐ efflorescence ☐ other:

Position: ☒ reset/level in ground ☐ use existing base ☐ construct new base ☐ resquare  
☐ new base required ☐ stabilize foundation ☐ reset with NHL ☐ reset with compound  
☐ other:

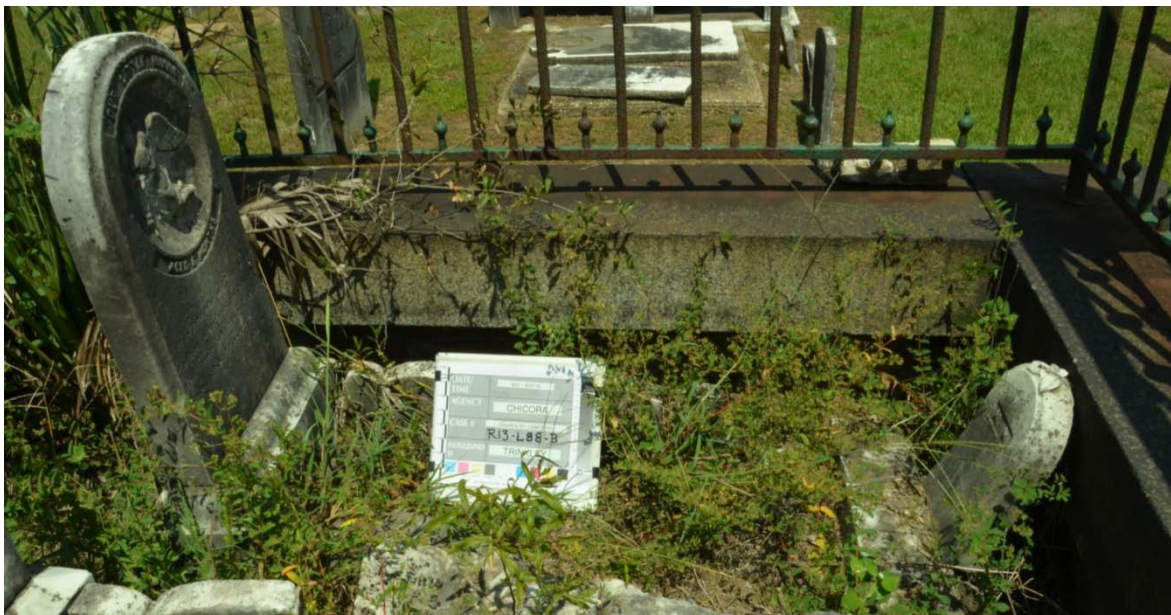
Row: 13

Position: ☒ fallen ☒ tilted ☐ unstable ☐ unattached/loose ☐ missing

Legibility: ☐ sharp, tooling evident ☒ clear, but worn ☐ partially discernable ☐ not discernable

Deterioration: ☒ broken ☐ cracked ☐ losses ☐ flaking/sugaring ☐ ferrous pins  
☐ brass pins ☐ delamination/detachment ☐ spalling ☐ missing fragments  
☐ other:

Soiling: ☒ biological ☐ staining ☐ efflorescence ☐ other:

Position: ☒ reset/level in ground ☐ use existing base ☐ construct new base ☐ resquare  
☐ new base required ☐ stabilize foundation ☐ reset with NHL ☐ reset with compound  
☐ other:

Treatment: ☐ core drill ☒ drill and pin ☐ simple adhesive repair ☐ injection grout ☐ set bricks  
☐ mortar ☐ repoint ☒ infill ☐ other:

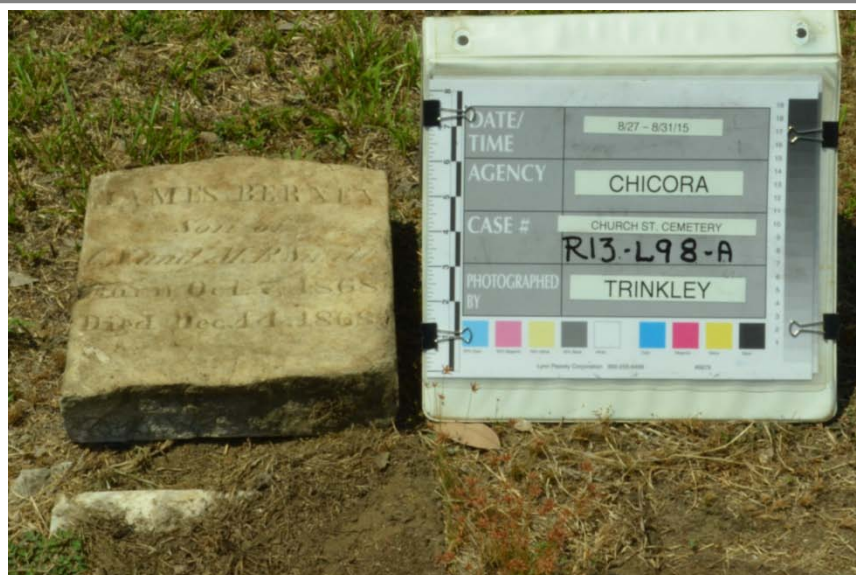
Row: 13

Position: ☒ fallen ☐ tilted ☐ unstable ☐ unattached/loose ☐ missing

Legibility: ☐ sharp, tooling evident ☒ clear, but worn ☐ partially discernable ☐ not discernable

Soiling: ☒ biological ☐ staining ☐ efflorescence ☐ other:

Position: ☒ reset/level in ground ☐ use existing base ☐ construct new base ☐ resquare  
☐ new base required ☐ stabilize foundation ☐ reset with NHL ☐ reset with compound  
☐ other:

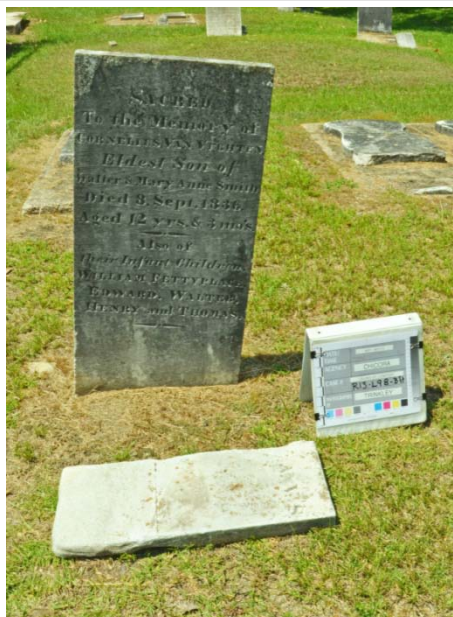
**Row: 13**

**Position:** ☒ fallen ☐ tilted ☐ unstable ☐ unattached/loose ☐ missing

**Legibility:** ☐ sharp, tooling evident ☐ clear, but worn ☒ partially discernable ☐ not discernable

**Deterioration:** ☒ broken ☐ cracked ☐ losses ☐ flaking/sugaring ☐ ferrous pins  
☐ brass pins ☐ delamination/detachment ☐ spalling ☐ missing fragments  
☐ other:

**Soiling:** ☒ biological ☐ staining ☐ efflorescence ☐ other:

**Position:** ☐ reset/level in ground ☐ use existing base ☐ construct new base ☐ resquare  
☐ new base required ☐ stabilize foundation ☐ reset with NHL ☐ reset with compound  
☒ other: if base can't be found, reset in new OPC socket

**Treatment:** ☐ core drill ☒ drill and pin ☒ simple adhesive repair ☐ injection grout ☐ set bricks  
☐ mortar ☐ repoint ☐ infill ☒ other: headstone may be beyond repair

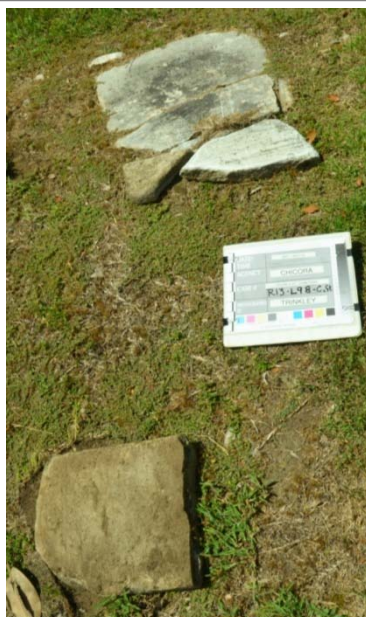
Row: 13

Position: ☒ fallen ☐ tilted ☐ unstable ☐ unattached/loose ☐ missing

Legibility: ☐ sharp, tooling evident ☒ clear, but worn ☐ partially discernable ☐ not discernable

Deterioration: ☒ broken ☐ cracked ☐ losses ☐ flaking/sugaring ☐ ferrous pins  
☐ brass pins ☐ delamination/detachment ☐ spalling ☐ missing fragments  
☐ other:

Soiling: ☒ biological ☐ staining ☐ efflorescence ☐ other:

Position: ☒ reset/level ☐ in ground ☐ use existing base ☐ construct new base ☐ resquare  
☐ new base required ☐ stabilize foundation ☐ reset with NHL ☐ reset with compound  
☐ other:

Treatment: ☐ core drill ☒ drill and pin ☐ simple adhesive repair ☐ injection grout ☐ set bricks  
☐ mortar ☐ repoint ☒ infill ☐ other:

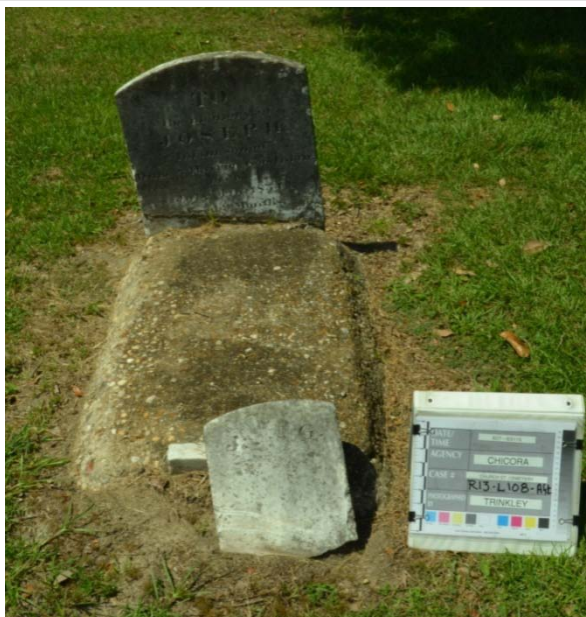
**Row: 13**

**Position:** ☒ fallen ☐ tilted ☐ unstable ☒ unattached/loose ☐ missing

**Legibility:** ☐ sharp, tooling evident ☒ clear, but worn ☐ partially discernable ☐ not discernable

**Deterioration:** ☒ broken ☐ cracked ☐ losses ☐ flaking/sugaring ☐ ferrous pins  
☐ brass pins ☐ delamination/detachment ☐ spalling ☐ missing fragments  
☒ other: 1 or more fragments set behind

**Soiling:** ☒ biological ☐ staining ☐ efflorescence ☐ other:

**Position:** ☒ reset/level in ground ☐ use existing base ☐ construct new base ☐ resquare  
☐ new base required ☐ stabilize foundation ☐ reset with NHL ☐ reset with compound  
☒ other: if base can't be found, reset in new OPC socket

**Treatment:** ☐ core drill ☒ drill and pin ☐ simple adhesive repair ☐ injection grout ☐ set bricks  
☐ mortar ☐ repoint ☒ infill ☐ other:

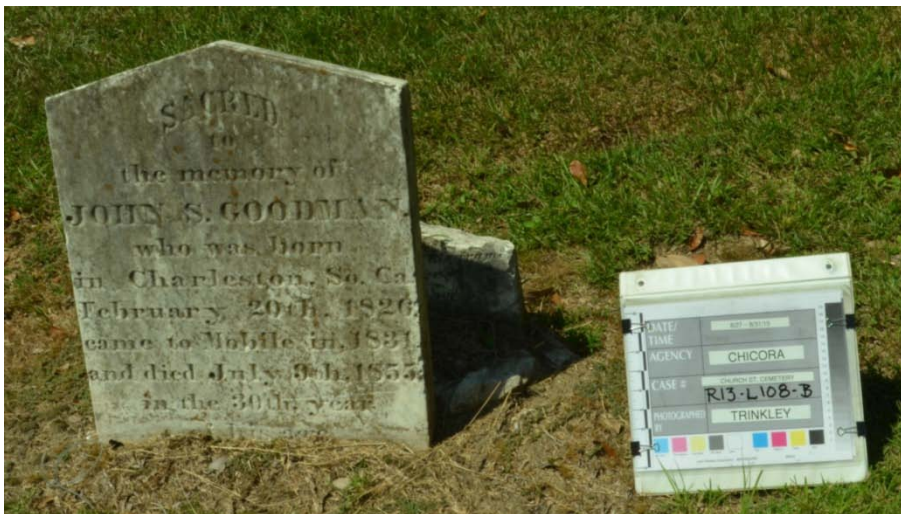
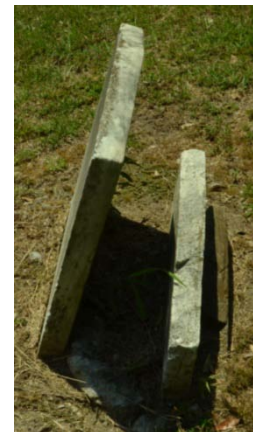
**Row: 13**

**Position:** ☒ fallen ☐ tilted ☐ unstable ☐ unattached/loose ☐ missing

**Legibility:** ☐ sharp, tooling evident ☒ clear, but worn ☐ partially discernable ☐ not discernable

**Deterioration:** ☒ broken ☐ cracked ☐ losses ☐ flaking/sugaring ☐ ferrous pins  
☐ brass pins ☐ delamination/detachment ☐ spalling ☐ missing fragments  
☐ other:

**Soiling:** ☒ biological ☐ staining ☐ efflorescence ☐ other:

**Position:** ☐ reset/level in ground ☐ use existing base ☐ construct new base ☐ resquare  
☐ new base required ☐ stabilize foundation ☐ reset with NHL ☐ reset with compound  
☒ other: if base can't be found, reset in new OPC socket

**Treatment:** ☐ core drill ☐ drill and pin ☒ simple adhesive repair ☐ injection grout ☐ set bricks  
☐ mortar ☐ repoint ☒ infill ☐ other:

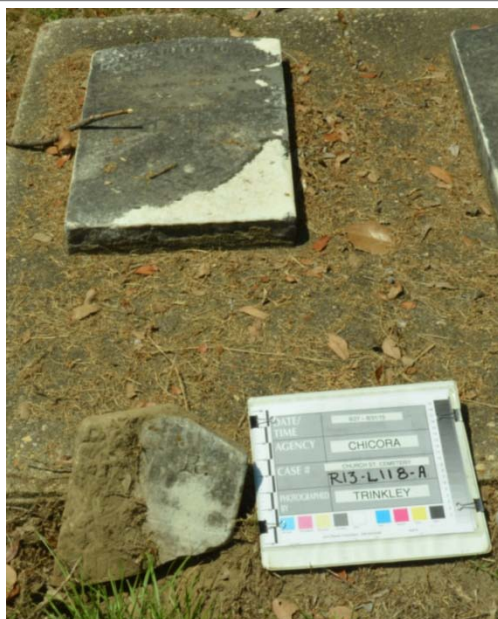
**Row: 13**

**Position:** ☐ fallen ☒ tilted ☒ unstable ☐ unattached/loose ☐ missing

**Legibility:** ☐ sharp, tooling evident ☒ clear, but worn ☐ partially discernable ☐ not discernable

**Deterioration:** ☐ broken ☐ cracked ☐ losses ☐ flaking/sugaring ☐ ferrous pins  
☐ brass pins ☐ delamination/detachment ☐ spalling ☐ missing fragments  
☒ other: mower damage

**Soiling:** ☒ biological ☐ staining ☐ efflorescence ☐ other:

**Position:** ☒ reset/level in ground ☐ use existing base ☐ construct new base ☐ resquare  
☐ new base required ☐ stabilize foundation ☐ reset with NHL ☐ reset with compound  
☐ other:

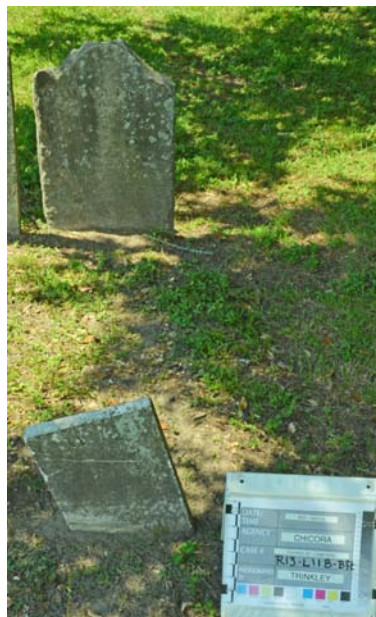
Row: 13

Position: ☐ fallen ☒ tilted ☒ unstable ☐ unattached/loose ☐ missing

Legibility: ☐ sharp, tooling evident ☒ clear, but worn ☐ partially discernable ☐ not discernable

Soiling: ☒ biological ☐ staining ☐ efflorescence ☐ other:

Position: ☒ reset/level in ground ☐ use existing base ☐ construct new base ☐ resquare  
☐ new base required ☐ stabilize foundation ☐ reset with NHL ☐ reset with compound  
☐ other:

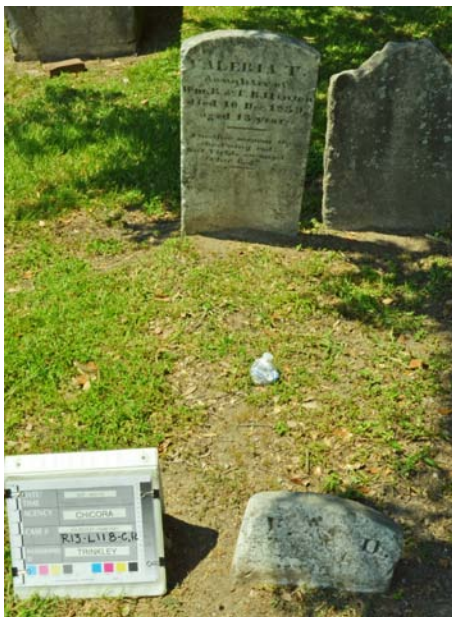
Row: 14

Position: ☐ fallen ☐ tilted ☒ unstable ☒ unattached/loose ☐ missing

Legibility: ☐ sharp, tooling evident ☒ clear, but worn ☐ partially discernable ☐ not discernable

Soiling: ☒ biological ☐ staining ☐ efflorescence ☐ other:

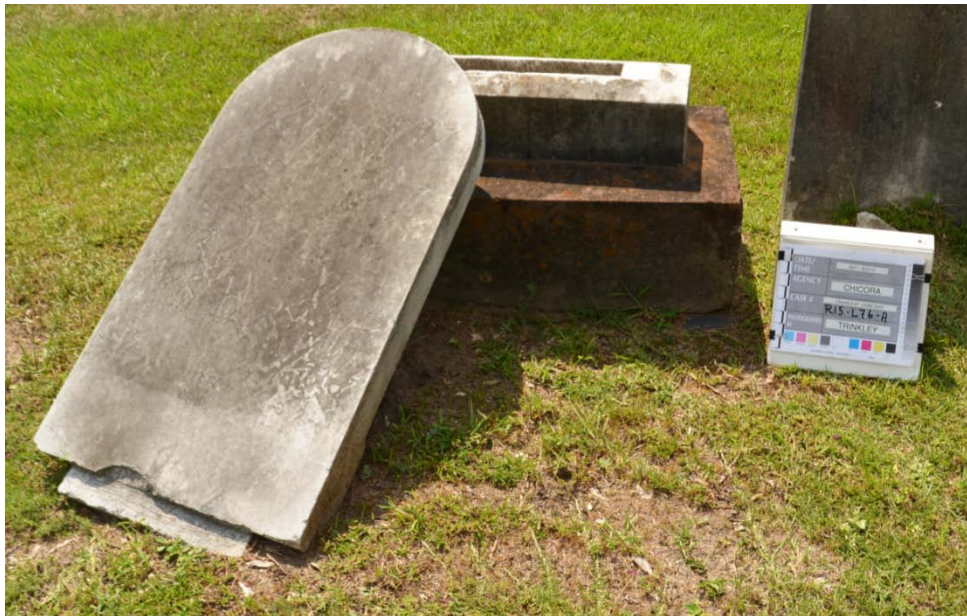
Row: 15

Existing Condition

Position: ☒ fallen ☐ tilted ☐ unstable ☐ unattached/loose ☐ missing

Legibility: ☐ sharp, tooling evident ☒ clear, but worn ☐ partially discernable ☐ not discernable

Deterioration: ☐ broken ☐ cracked ☐ losses ☐ flaking/sugaring ☐ ferrous pins  
☐ brass pins ☐ delamination/detachment ☐ spalling ☒ missing fragments  
☐ other:

Soiling: ☒ biological ☐ staining ☐ efflorescence ☐ other:

Position: ☐ reset/level in ground ☒ use existing base ☐ construct new base ☐ resquare  
☐ new base required ☐ stabilize foundation ☒ reset with NHL ☐ reset with compound  
☐ other:

Cost: \$400

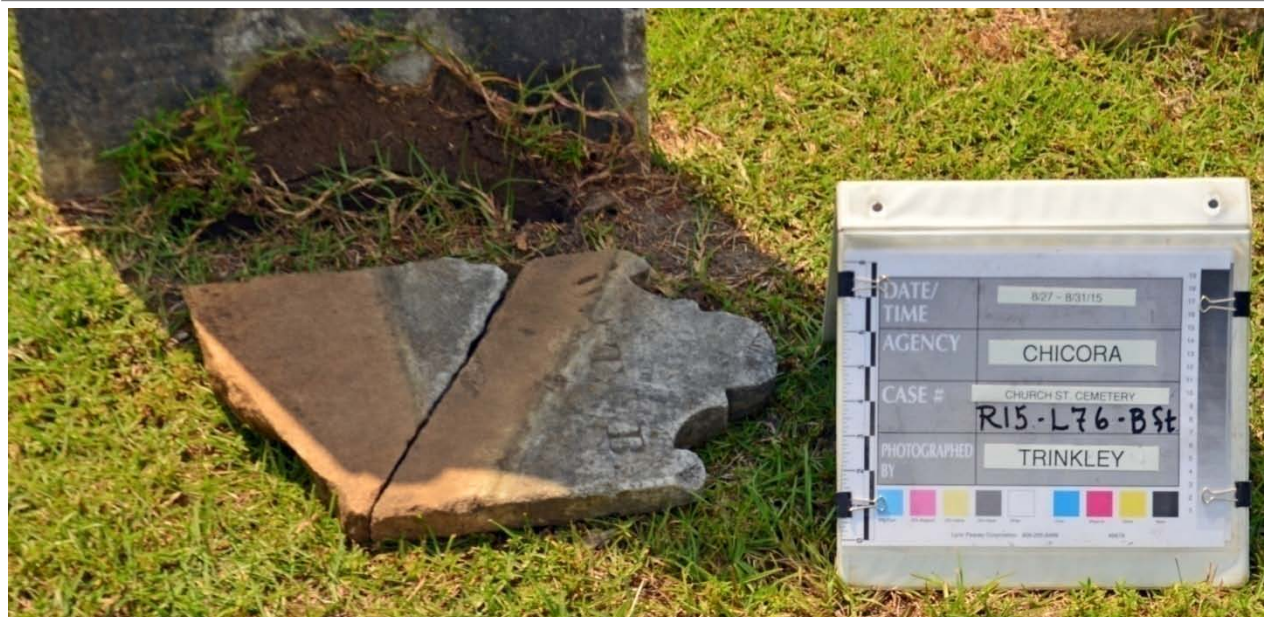
Row: 15

Existing Condition

Position: ☒ fallen ☐ tilted ☐ unstable ☐ unattached/loose ☐ missing

Legibility: ☐ sharp, tooling evident ☒ clear, but worn ☐ partially discernable ☐ not discernable

Deterioration: ☒ broken ☐ cracked ☐ losses ☐ flaking/sugaring ☐ ferrous pins  
☐ brass pins ☐ delamination/detachment ☐ spalling ☒ missing fragments  
☐ other:

Soiling: ☒ biological ☒ staining ☐ efflorescence ☐ other:

Position: ☐ reset/level in ground ☐ use existing base ☐ construct new base ☐ resquare  
☐ new base required ☐ stabilize foundation ☐ reset with NHL ☐ reset with compound  
☒ other: if base can't be found, reset in new OPC socket

Treatment: ☐ core drill ☐ drill and pin ☒ simple adhesive repair ☐ injection grout ☐ set bricks  
☐ mortar ☐ repoint ☐ infill ☐ other:

Cost: \$500

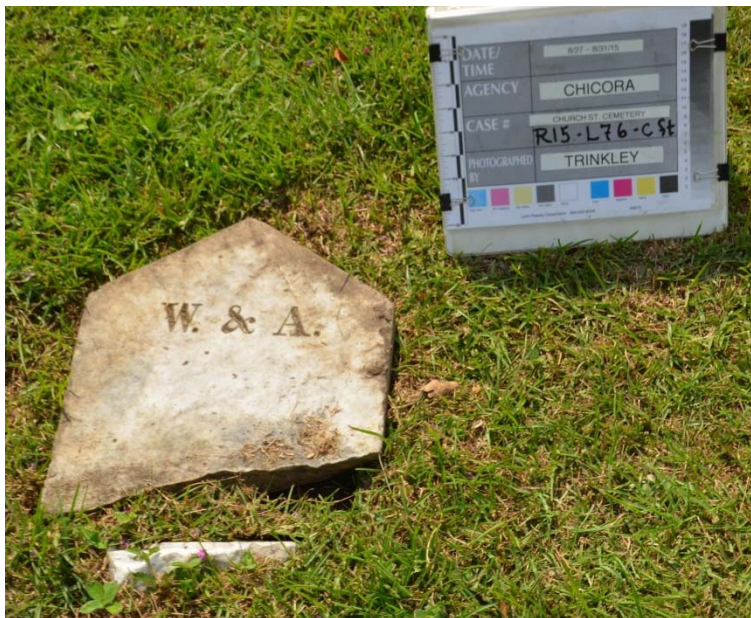
Row: 15

Existing Condition

Position: ☒ fallen ☐ tilted ☐ unstable ☐ unattached/loose ☐ missing

Legibility: ☐ sharp, tooling evident ☒ clear, but worn ☐ partially discernable ☐ not discernable

Deterioration: ☒ broken ☐ cracked ☐ losses ☐ flaking/sugaring ☐ ferrous pins  
☐ brass pins ☐ delamination/detachment ☐ spalling ☐ missing fragments  
☐ other:

Soiling: ☒ biological ☐ staining ☐ efflorescence ☐ other:

Position: ☐ reset/level in ground ☐ use existing base ☐ construct new base ☐ resquare  
☐ new base required ☐ stabilize foundation ☐ reset with NHL ☐ reset with compound  
☒ other: if base can't be found, reset in new OPC socket

Treatment: ☐ core drill ☐ drill and pin ☒ simple adhesive repair ☐ injection grout ☐ set bricks  
☐ mortar ☐ repoint ☐ infill ☐ other:

Cost: \$400

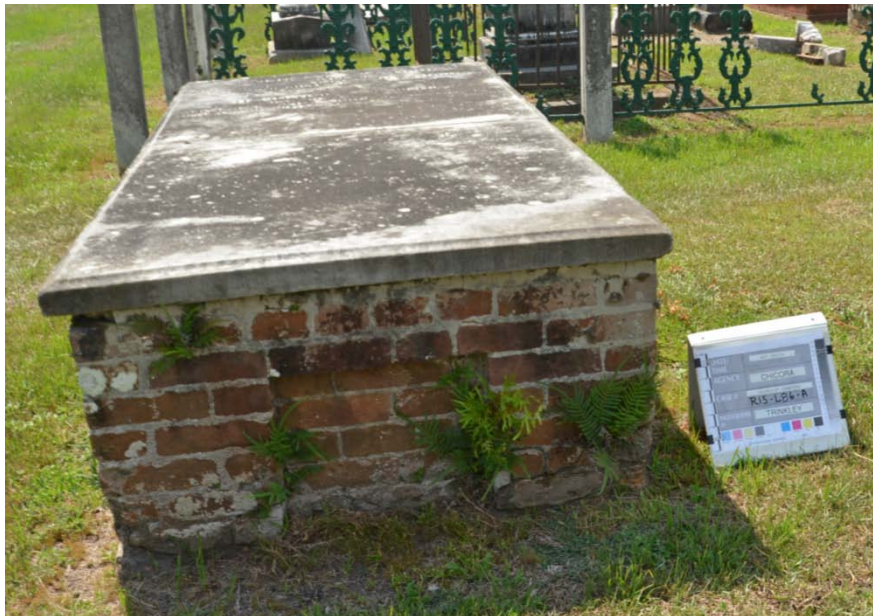
**Row: 15**

Existing Condition

**Legibility:** ☐ sharp, tooling evident ☒ clear, but worn ☐ partially discernable ☐ not discernable

**Deterioration:** ☒ broken ☐ cracked ☐ losses ☐ flaking/sugaring ☐ ferrous pins  
☐ brass pins ☐ delamination/detachment ☐ spalling ☐ missing fragments  
☐ other:

**Soiling:** ☒ biological ☐ staining ☐ efflorescence ☒ other: vegetation

**Treatment:** ☐ core drill ☐ drill and pin ☒ simple adhesive repair ☐ injection grout ☐ set bricks  
☐ mortar ☐ repoint ☐ infill ☐ other:

**Cost: \$950**

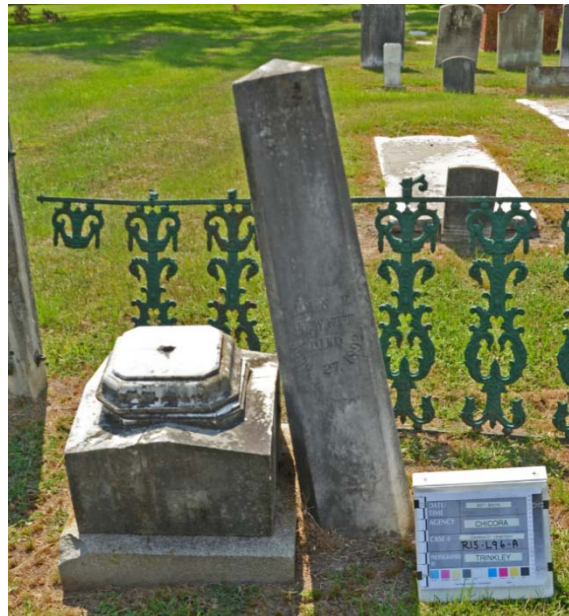
Row: 15

Existing Condition

Position: ☒ fallen ☐ tilted ☐ unstable ☒ unattached/loose ☐ missing

Deterioration: ☐ broken ☒ cracked ☐ losses ☐ flaking/sugaring ☐ ferrous pins  
☐ brass pins ☐ delamination/detachment ☐ spalling ☐ missing fragments  
☐ other:

Soiling: ☒ biological ☐ staining ☐ efflorescence ☐ other:

Position: ☒ reset/level in ground ☐ use existing base ☐ construct new base ☐ resquare  
☐ new base required ☒ stabilize foundation ☒ reset with NHL ☐ reset with compound  
☐ other:

Treatment: ☐ core drill ☒ drill and pin ☐ simple adhesive repair ☐ injection grout ☐ set bricks  
☐ mortar ☐ repoint ☐ infill ☐ other:

Cost: \$1,800

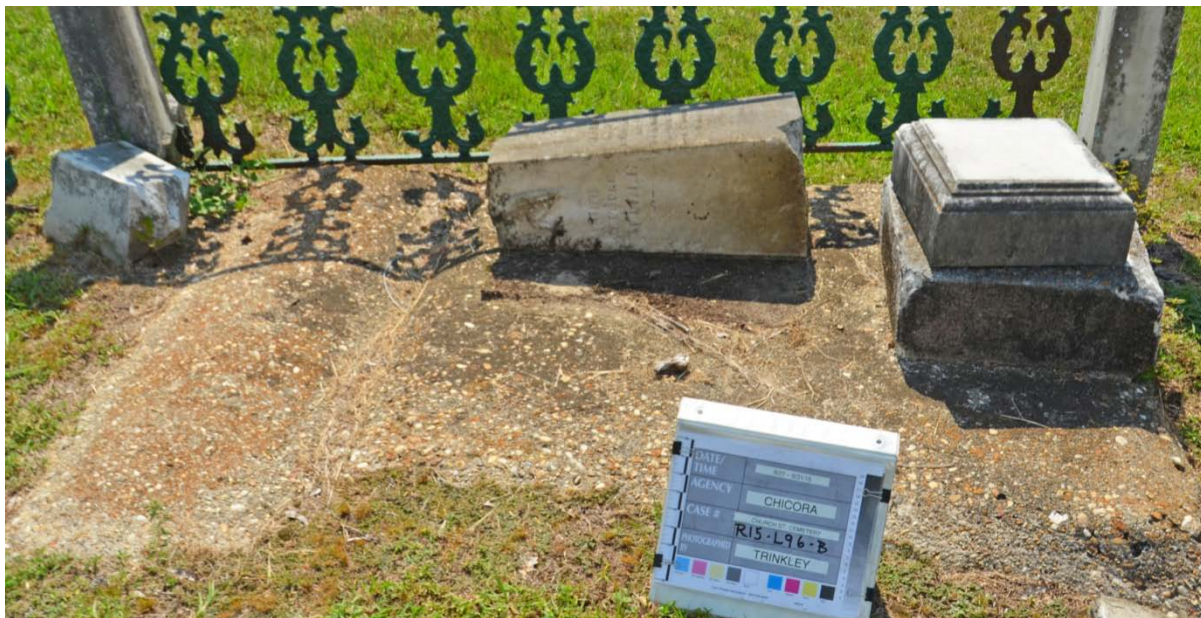
Row: 15

Existing Condition

Position: ☒ fallen ☐ tilted ☐ unstable ☒ unattached/loose ☐ missing

Legibility: ☐ sharp, tooling evident ☒ clear, but worn ☐ partially discernable ☐ not discernable

Deterioration: ☒ broken ☐ cracked ☒ losses ☐ flaking/sugaring ☐ ferrous pins  
☐ brass pins ☐ delamination/detachment ☐ spalling ☐ missing fragments  
☐ other:

Soiling: ☒ biological ☐ staining ☐ efflorescence ☐ other:

Position: ☒ reset/level in ground ☐ use existing base ☐ construct new base ☐ resquare  
☐ new base required ☒ stabilize foundation ☒ reset with NHL ☐ reset with compound  
☐ other:

Treatment: ☐ core drill ☒ drill and pin ☐ simple adhesive repair ☐ injection grout ☐ set bricks  
☐ mortar ☐ repoint ☒ infill ☐ other:

Cost: \$2,200

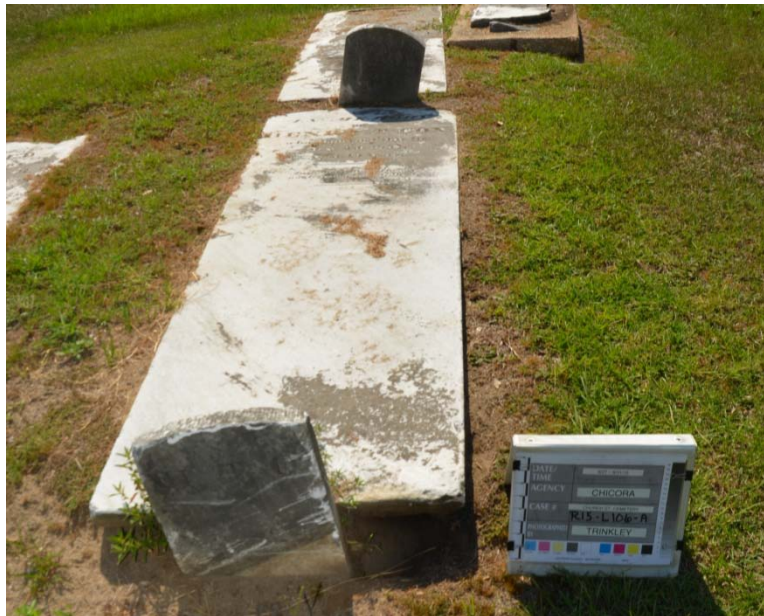
**Row: 15**

Existing Condition

**Position:** ☒ fallen ☐ tilted ☐ unstable ☐ unattached/loose ☐ missing

**Legibility:** ☐ sharp, tooling evident ☒ clear, but worn ☐ partially discernable ☐ not discernable

**Deterioration:** ☐ broken ☐ cracked ☐ losses ☐ flaking/sugaring ☐ ferrous pins  
☐ brass pins ☐ delamination/detachment ☐ spalling ☐ missing fragments  
☒ other: tablet has been laid as a ledger; should be set upright for long-term preservation; mower damage

**Soiling:** ☒ biological ☐ staining ☐ efflorescence ☐ other:

**Position:** ☒ reset/level in ground ☐ use existing base ☐ construct new base ☐ resquare  
☐ new base required ☐ stabilize foundation ☐ reset with NHL ☐ reset with compound  
☐ other:

**Cost: \$300**

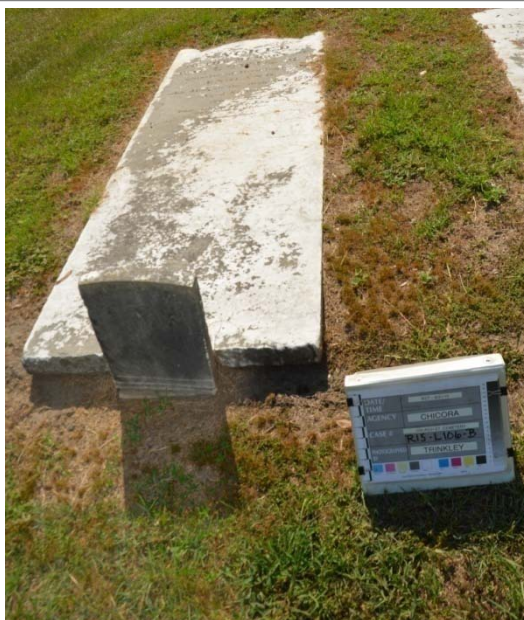
Row: 15

Existing Condition

Position: ☒ fallen ☐ tilted ☐ unstable ☐ unattached/loose ☐ missing

Legibility: ☐ sharp, tooling evident ☒ clear, but worn ☐ partially discernable ☐ not discernable

Deterioration: ☐ broken ☐ cracked ☐ losses ☐ flaking/sugaring ☐ ferrous pins  
☐ brass pins ☐ delamination/detachment ☐ spalling ☐ missing fragments  
☒ other: tablet has been laid as a ledger; should be set upright for long-term preservation; mower damage

Soiling: ☒ biological ☐ staining ☐ efflorescence ☐ other:

Position: ☒ reset/level in ground ☐ use existing base ☐ construct new base ☐ resquare  
☐ new base required ☐ stabilize foundation ☐ reset with NHL ☐ reset with compound  
☐ other:

Cost: \$300

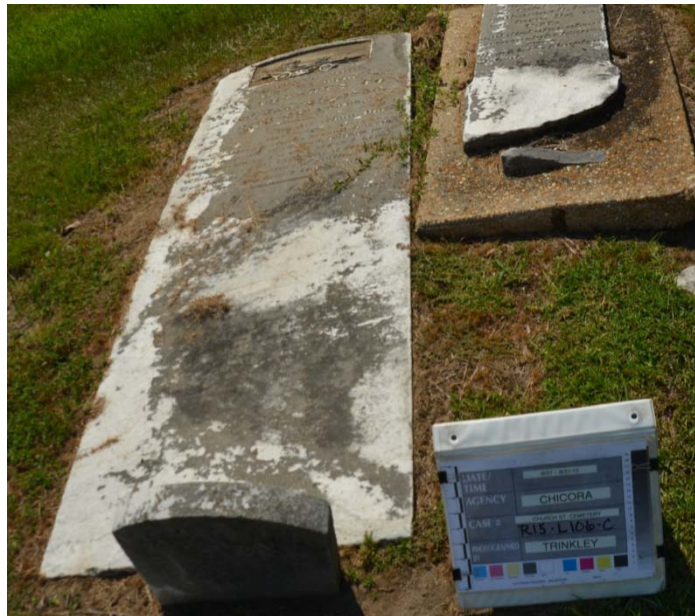
**Row: 15**

Existing Condition

**Position:** ☒ fallen ☐ tilted ☐ unstable ☐ unattached/loose ☐ missing

**Legibility:** ☐ sharp, tooling evident ☒ clear, but worn ☐ partially discernable ☐ not discernable

**Deterioration:** ☐ broken ☐ cracked ☐ losses ☐ flaking/sugaring ☐ ferrous pins  
☐ brass pins ☐ delamination/detachment ☐ spalling ☐ missing fragments  
☒ other: tablet has been laid as a ledger; should be set upright for long-term preservation; mower damage

**Soiling:** ☒ biological ☐ staining ☐ efflorescence ☐ other:

**Position:** ☒ reset/level in ground ☐ use existing base ☐ construct new base ☐ resquare  
☐ new base required ☐ stabilize foundation ☐ reset with NHL ☐ reset with compound  
☐ other:

**Cost: \$300**

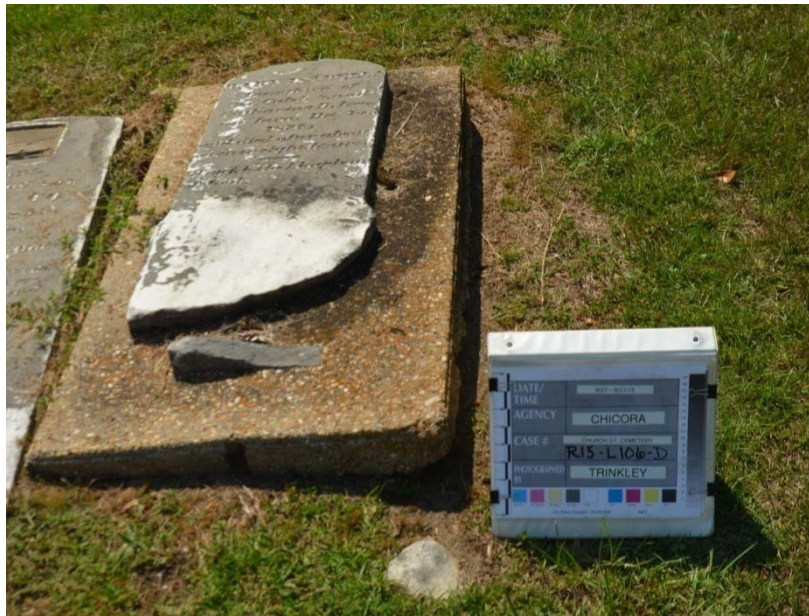
**Row: 15**

Existing Condition

**Legibility:** ☐ sharp, tooling evident ☒ clear, but worn ☐ partially discernable ☐ not discernable

**Deterioration:** ☒ broken ☐ cracked ☐ losses ☐ flaking/sugaring ☐ ferrous pins  
☐ brass pins ☐ delamination/detachment ☐ spalling ☐ missing fragments  
☐ other:

**Soiling:** ☒ biological ☐ staining ☐ efflorescence ☐ other:

**Cost: \$400**

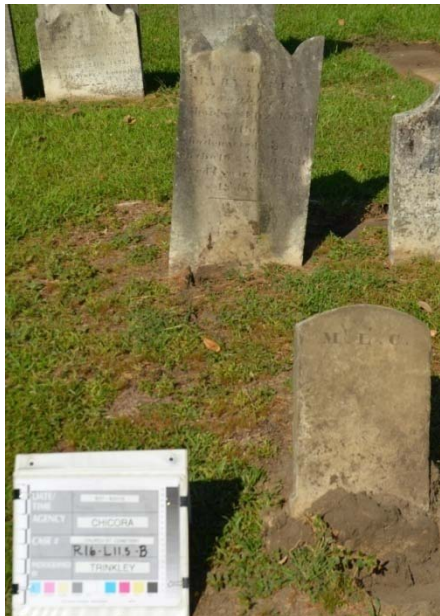
**Row: 16**

**Position:** ☒ fallen ☐ tilted ☐ unstable ☐ unattached/loose ☐ missing

**Deterioration:** ☒ broken ☐ cracked ☐ losses ☐ flaking/sugaring ☐ ferrous pins  
☐ brass pins ☐ delamination/detachment ☐ spalling ☐ missing fragments  
☐ other:

**Soiling:** ☒ biological ☐ staining ☐ efflorescence ☐ other:

**Position:** ☐ reset/level in ground ☐ use existing base ☐ construct new base ☐ resquare  
☐ new base required ☐ stabilize foundation ☐ reset with NHL ☐ reset with compound  
☒ other: if base can't be found, reset in new OPC socket

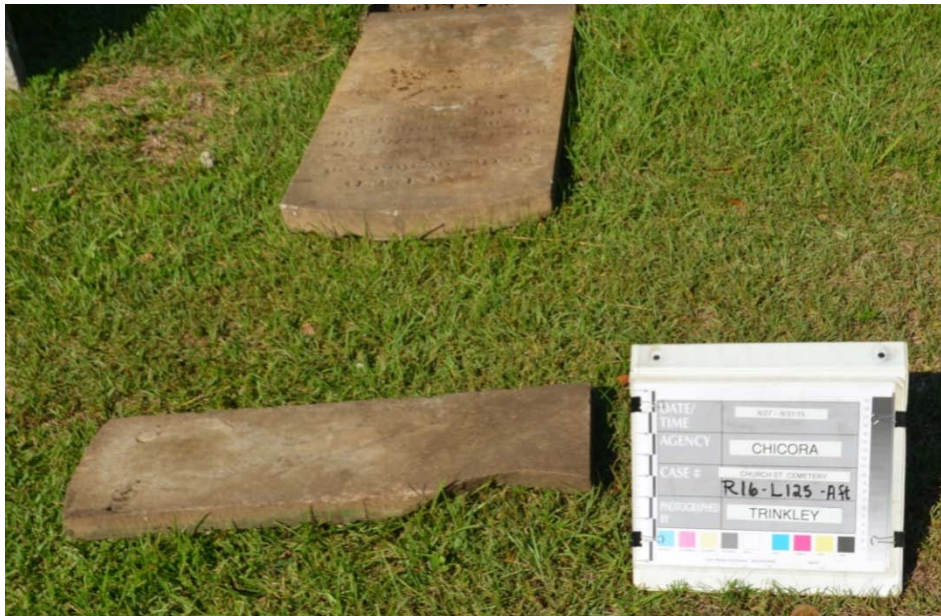
**Row: 16**

**Position:** ☒ fallen ☒ tilted ☒ unstable ☐ unattached/loose ☐ missing

**Deterioration:** ☒ broken ☐ cracked ☐ losses ☐ flaking/sugaring ☐ ferrous pins  
☐ brass pins ☐ delamination/detachment ☐ spalling ☐ missing fragments  
☒ other: frags stacked behind; top reset in soil

**Soiling:** ☒ biological ☐ staining ☐ efflorescence ☐ other:

**Position:** ☒ reset/level in ground ☐ use existing base ☐ construct new base ☐ resquare  
☐ new base required ☐ stabilize foundation ☐ reset with NHL ☐ reset with compound  
☐ other:

**Treatment:** ☐ core drill ☒ drill and pin ☐ simple adhesive repair ☐ injection grout ☐ set bricks  
☐ mortar ☐ repoint ☒ infill ☐ other:

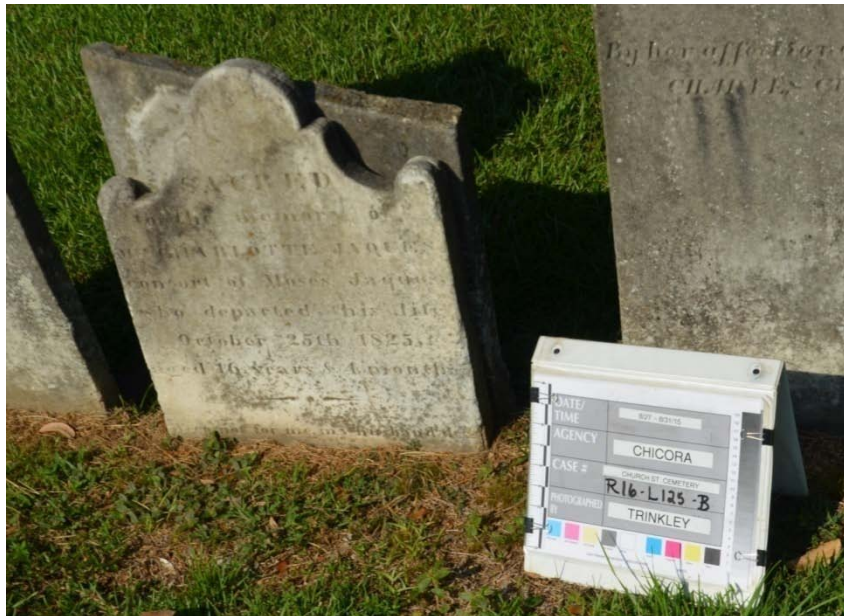
Row: 16

Position: ☒ fallen ☐ tilted ☐ unstable ☐ unattached/loose ☐ missing

Soiling: ☒ biological ☐ staining ☐ efflorescence ☐ other:

Position: ☒ reset/level in ground ☐ use existing base ☐ construct new base ☐ resquare  
☐ new base required ☐ stabilize foundation ☐ reset with NHL ☐ reset with compound  
☐ other:

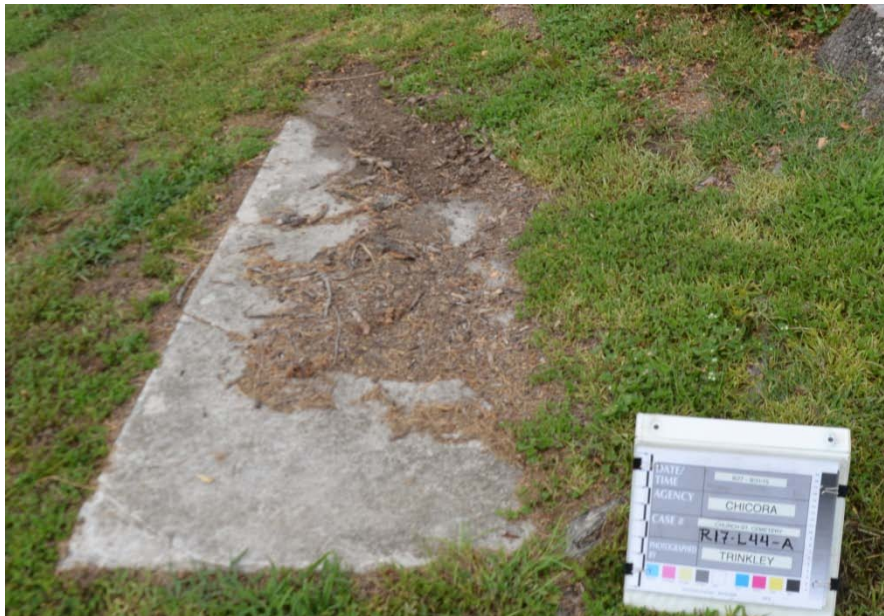
Row: 17

Position: ☐ fallen ☒ tilted ☒ unstable ☐ unattached/loose ☐ missing

Deterioration: ☐ broken ☐ cracked ☐ losses ☐ flaking/sugaring ☐ ferrous pins  
☐ brass pins ☐ delamination/detachment ☐ spalling ☐ missing fragments  
☒ other: mower damage

Soiling: ☒ biological ☐ staining ☐ efflorescence ☐ other:

Position: ☒ reset/level in ground ☐ use existing base ☐ construct new base ☐ resquare  
☐ new base required ☐ stabilize foundation ☐ reset with NHL ☐ reset with compound  
☐ other:

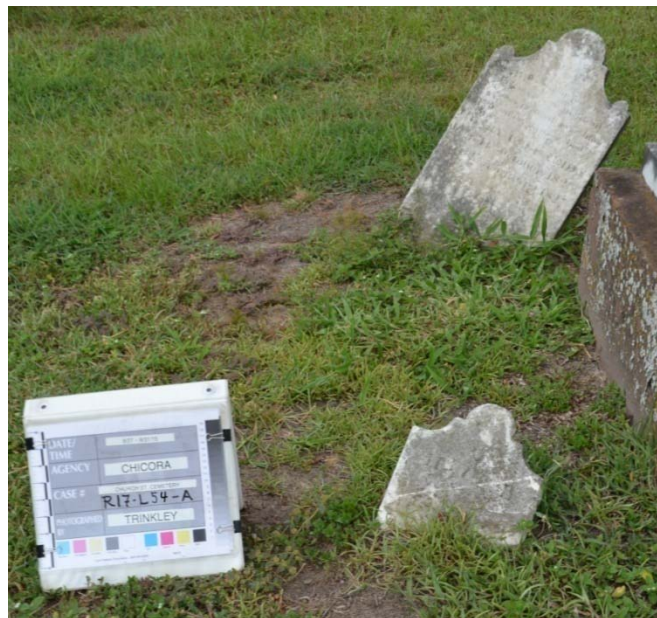
Row: 17

Position: ☒ fallen ☐ tilted ☐ unstable ☐ unattached/loose ☐ missing

Deterioration: ☒ broken ☐ cracked ☐ losses ☐ flaking/sugaring ☐ ferrous pins  
☐ brass pins ☐ delamination/detachment ☐ spalling ☐ missing fragments  
☐ other:

Soiling: ☒ biological ☐ staining ☐ efflorescence ☐ other:

Position: ☒ reset/level in ground ☐ use existing base ☒ construct new base ☐ resquare  
☐ new base required ☐ stabilize foundation ☐ reset with NHL ☐ reset with compound  
☐ other:

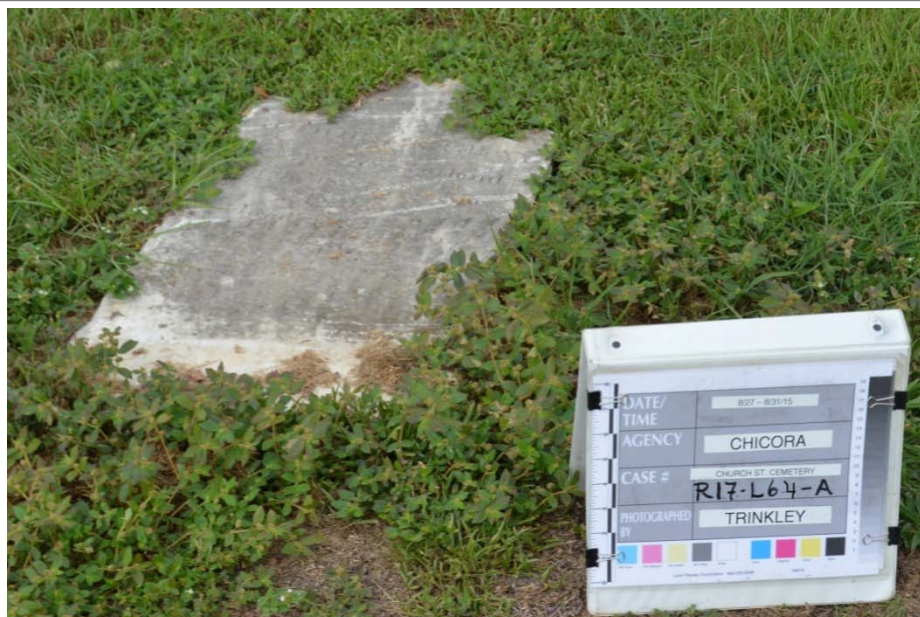
Row: 17

Position: ☐ fallen ☒ tilted ☒ unstable ☒ unattached/loose ☐ missing

Legibility: ☐ sharp, tooling evident ☐ clear, but worn ☒ partially discernable ☐ not discernable

Deterioration: ☐ broken ☐ cracked ☐ losses ☒ flaking/sugaring ☐ ferrous pins  
☐ brass pins ☐ delamination/detachment ☐ spalling ☐ missing fragments  
☒ other: warping; pins may be present

Soiling: ☒ biological ☐ staining ☐ efflorescence ☐ other:

Position: ☒ reset/level in ground ☒ use existing base ☐ construct new base ☐ resquare  
☐ new base required ☐ stabilize foundation ☒ reset with NHL ☐ reset with compound  
☐ other:

Treatment: ☐ core drill ☒ drill and pin ☐ simple adhesive repair ☐ injection grout ☐ set bricks  
☐ mortar ☐ repoint ☐ infill ☐ other:

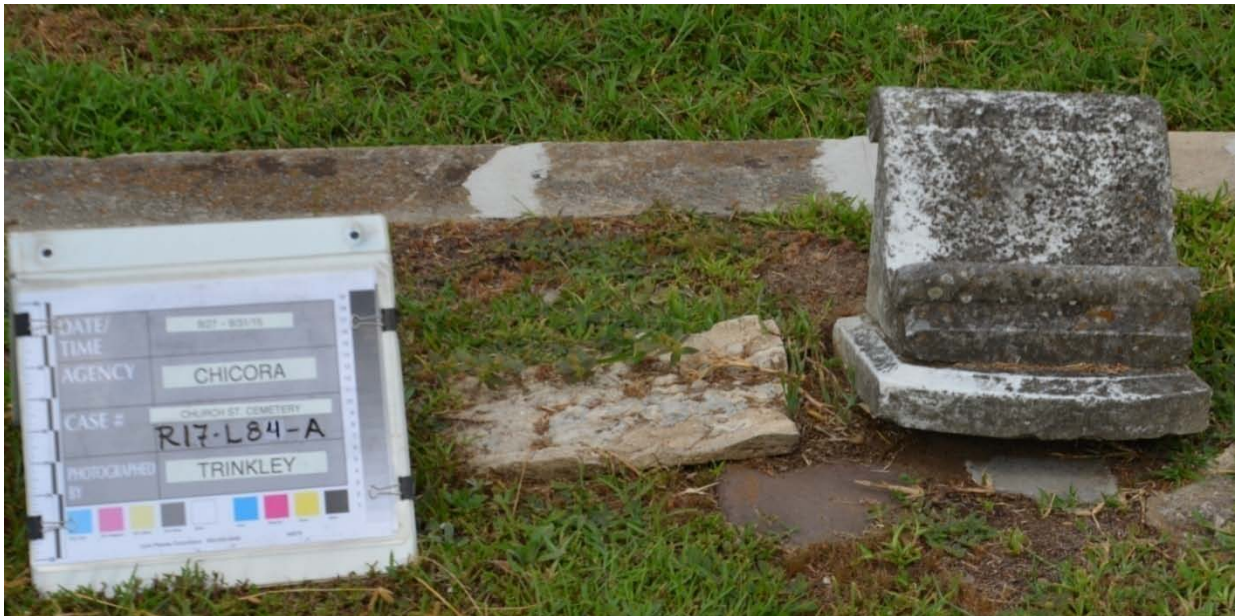
**Row: 17**

**Position:** ☒ fallen ☐ tilted ☐ unstable ☐ unattached/loose ☐ missing

**Deterioration:** ☒ broken ☐ cracked ☐ losses ☐ flaking/sugaring ☐ ferrous pins  
☐ brass pins ☐ delamination/detachment ☐ spalling ☐ missing fragments  
☐ other:

**Soiling:** ☒ biological ☐ staining ☐ efflorescence ☐ other:

**Position:** ☒ reset/level in ground ☐ use existing base ☐ construct new base ☐ resquare  
☐ new base required ☐ stabilize foundation ☐ reset with NHL ☐ reset with compound  
☐ other:

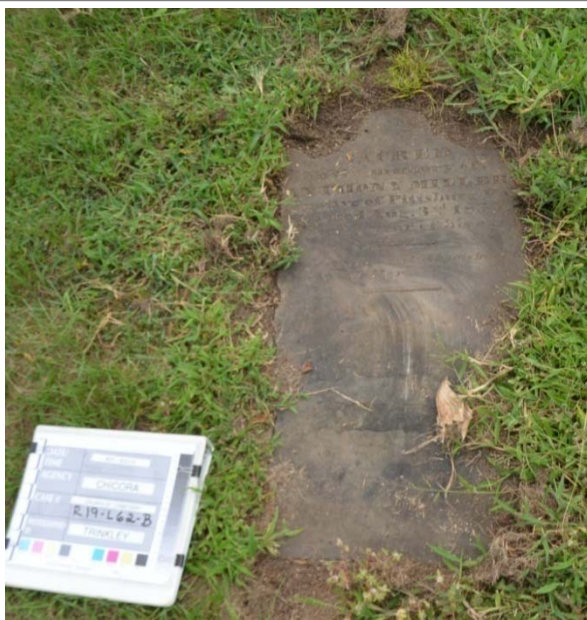
Row: 19

Position: ☒ fallen ☐ tilted ☐ unstable ☐ unattached/loose ☐ missing

Legibility: ☐ sharp, tooling evident ☒ clear, but worn ☐ partially discernable ☐ not discernable

Soiling: ☒ biological ☐ staining ☐ efflorescence ☐ other:

Position: ☐ reset/level in ground ☐ use existing base ☒ construct new base ☐ resquare  
☐ new base required ☐ stabilize foundation ☐ reset with NHL ☐ reset with compound  
☐ other:

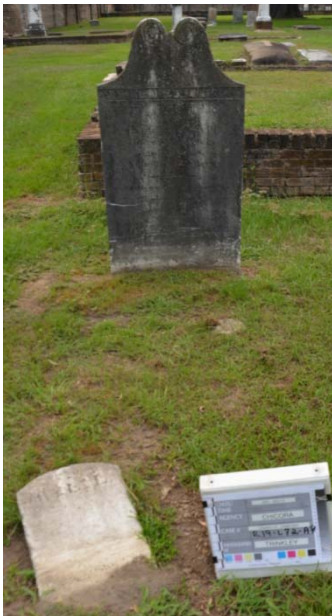
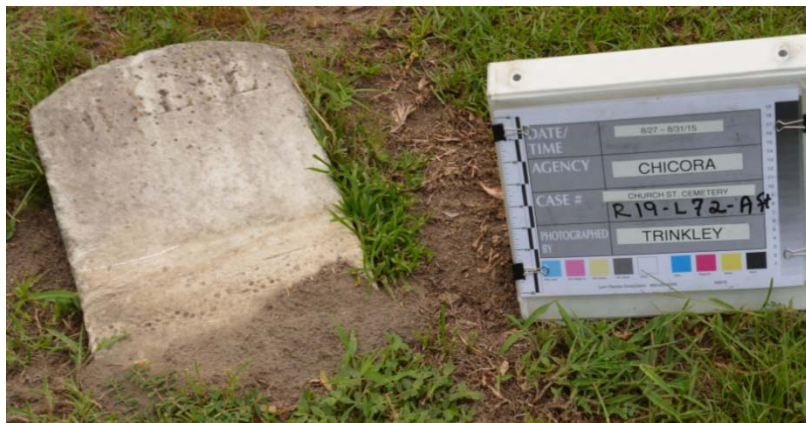
Row: 19

Position: ☐ fallen ☒ tilted ☐ unstable ☐ unattached/loose ☐ missing

Legibility: ☐ sharp, tooling evident ☒ clear, but worn ☐ partially discernable ☐ not discernable

Soiling: ☒ biological ☐ staining ☐ efflorescence ☐ other:

Position: ☒ reset/level in ground ☐ use existing base ☐ construct new base ☐ resquare  
☐ new base required ☐ stabilize foundation ☐ reset with NHL ☐ reset with compound  
☐ other:
