# **ASSESSMENT OF THE CHURCH STREET GRAVEYARD, MOBILE, ALABAMA**

**Chicora Research Contribution 566**

Michael Trinkley  
And  
Debi Hacker

September 2015

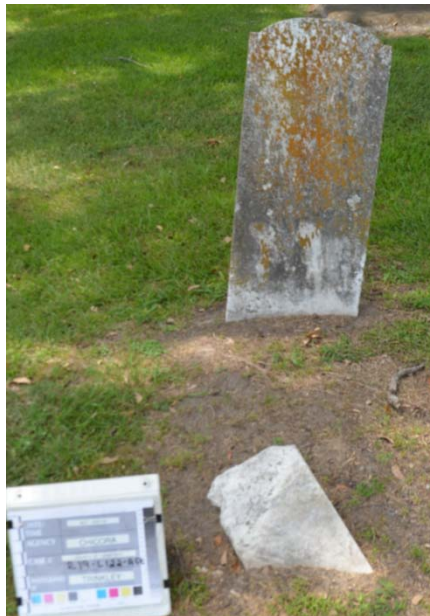
Row: 20

Position: ☒ fallen ☐ tilted ☐ unstable ☐ unattached/loose ☐ missing

Legibility: ☐ sharp, tooling evident ☒ clear, but worn ☐ partially discernable ☐ not discernable

Deterioration: ☒ broken ☐ cracked ☐ losses ☐ flaking/sugaring ☐ ferrous pins  
☐ brass pins ☐ delamination/detachment ☐ spalling ☐ missing fragments  
☒ other: base not seen

Soiling: ☒ biological ☐ staining ☐ efflorescence ☐ other:

Position: ☐ reset/level in ground ☐ use existing base ☒ construct new base ☐ resquare  
☐ new base required ☐ stabilize foundation ☐ reset with NHL ☐ reset with compound  
☐ other:

Treatment: ☐ core drill ☐ drill and pin ☒ simple adhesive repair ☐ injection grout ☐ set bricks  
☐ mortar ☐ repoint ☐ infill ☐ other:

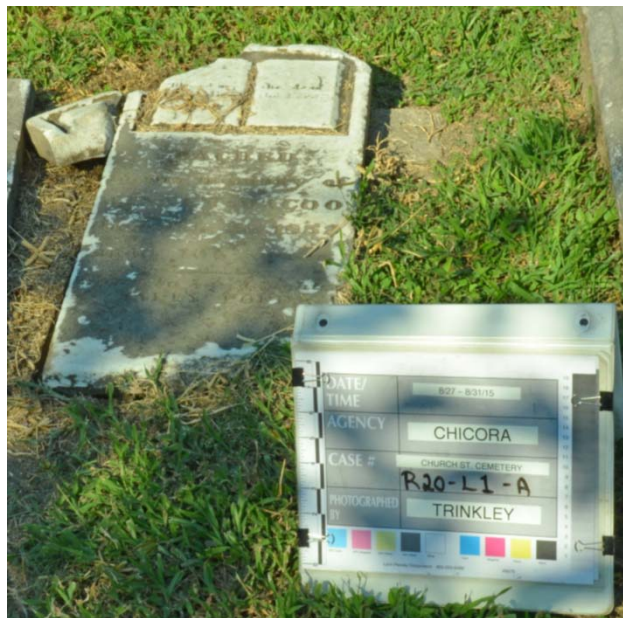
Row: 20

Position: ☒ fallen ☐ tilted ☐ unstable ☐ unattached/loose ☐ missing

Legibility: ☐ sharp, tooling evident ☒ clear, but worn ☐ partially discernable ☐ not discernable

Deterioration: ☒ broken ☐ cracked ☐ losses ☐ flaking/sugaring ☐ ferrous pins  
☐ brass pins ☐ delamination/detachment ☐ spalling ☐ missing fragments  
☒ other: base not seen

Position: ☐ reset/level in ground ☐ use existing base ☒ construct new base ☐ resquare  
☐ new base required ☐ stabilize foundation ☐ reset with NHL ☐ reset with compound  
☐ other:

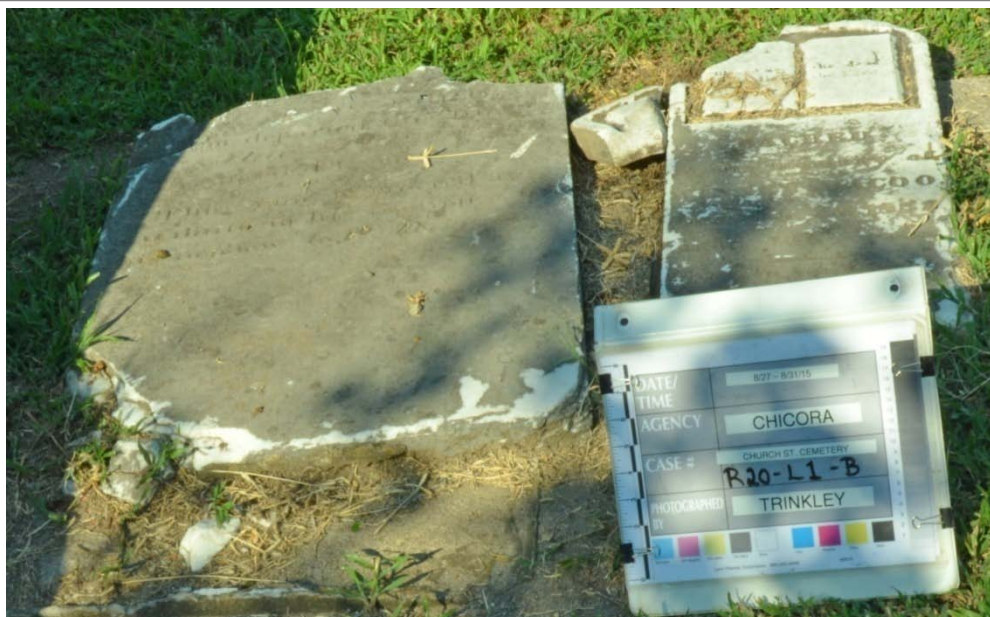
Row: 20

Soiling: ☒ biological ☐ staining ☐ efflorescence ☒ other: vegetation

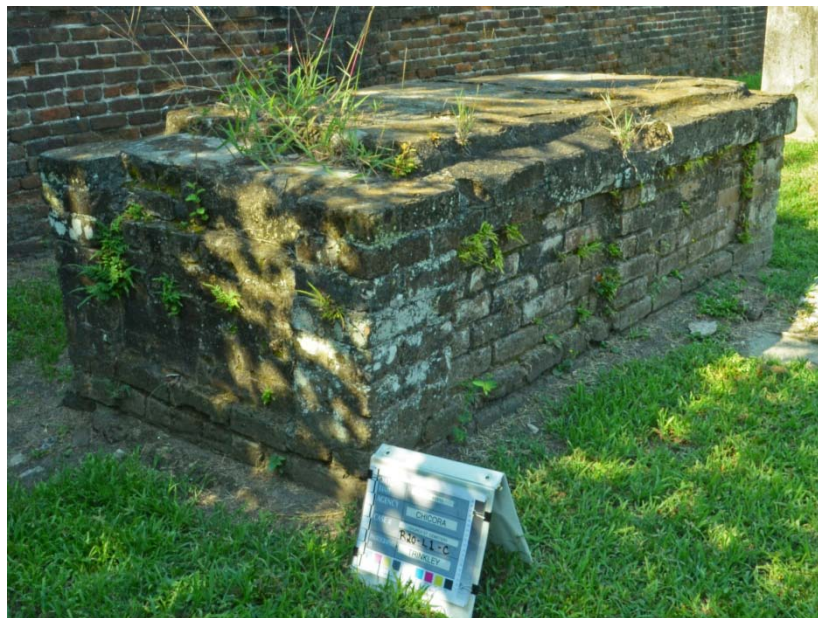
Row: 20

Position: ☐ fallen ☒ tilted ☐ unstable ☐ unattached/loose ☐ missing

Legibility: ☐ sharp, tooling evident ☐ clear, but worn ☐ partially discernable ☒ not discernable

Deterioration: ☐ broken ☐ cracked ☐ losses ☐ flaking/sugaring ☐ ferrous pins  
☐ brass pins ☐ delamination/detachment ☐ spalling ☐ missing fragments  
☒ other: mower damage

Soiling: ☒ biological ☐ staining ☐ efflorescence ☒ other: tire tracks

Position: ☒ reset/level in ground ☐ use existing base ☐ construct new base ☐ resquare  
☐ new base required ☐ stabilize foundation ☐ reset with NHL ☐ reset with compound  
☐ other:

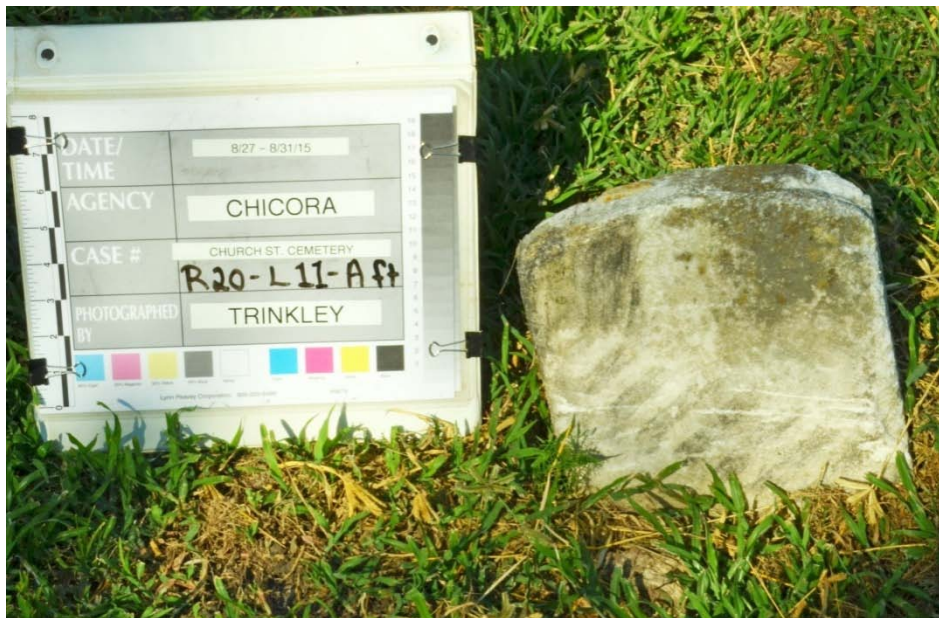
Row: 20

Position: ☐ fallen ☒ tilted ☐ unstable ☐ unattached/loose ☐ missing

Legibility: ☐ sharp, tooling evident ☐ clear, but worn ☒ partially discernable ☐ not discernable

Deterioration: ☐ broken ☐ cracked ☐ losses ☐ flaking/sugaring ☐ ferrous pins  
☐ brass pins ☐ delamination/detachment ☐ spalling ☐ missing fragments  
☒ other: mower damage

Soiling: ☒ biological ☐ staining ☐ efflorescence ☐ other:

Position: ☒ reset/level in ground ☐ use existing base ☐ construct new base ☐ resquare  
☐ new base required ☐ stabilize foundation ☐ reset with NHL ☐ reset with compound  
☐ other:

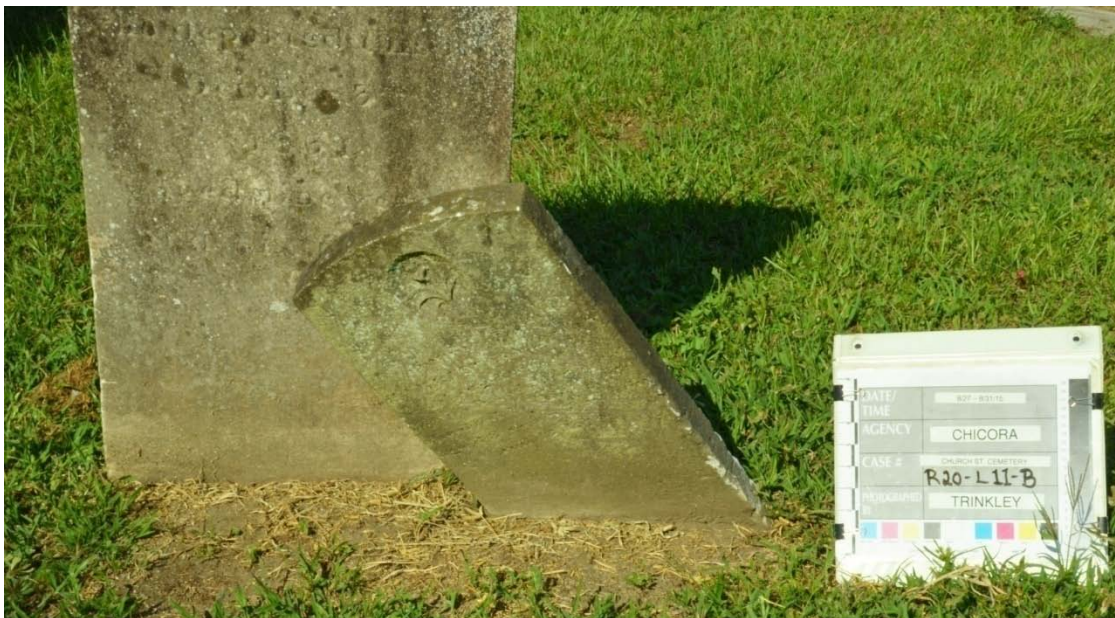
Row: 20

Position: ☒ fallen ☐ tilted ☐ unstable ☐ unattached/loose ☐ missing
