A BRIEF EXAMINATION OF THE MIDDLETON
PLACE MILL, MIDDLETON PLACE PLANTATION
(38DR16): PHASE ONE

A BRIEF EXAMINATION OF THE MIDDLETON PLACE MILL,
MIDDLETON PLACE PLANTATION (38DR16): PHASE ONE

Michael Trinkley

Research Contribution 114

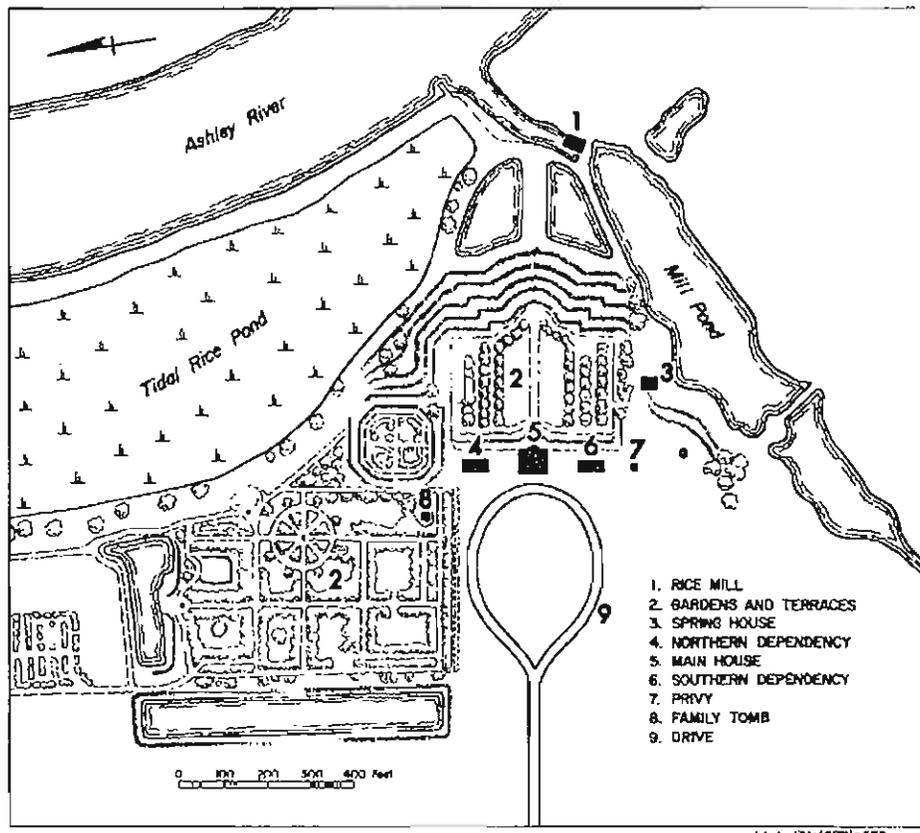
Figure 2. Middleton Place, adapted from Lewis and Hardesty (1979:Figure 4).

The mill is situated on a relatively flat terrace at the edge of the marsh overlooking the Ashley River (Figure 2). A tidal pond has been created to the southwest to feed into the raceway, while a more natural, spring fed water source is found to the south. To the west are the "butterfly" ponds and garden area of Middleton Place. The mill pond empties into a tidal slough which appears, superficially, to have been widened and deepened at some point, perhaps for the transport of rice barges to the mill for off-loading. While originally the pond at the end of this slough would have been filled at high tide, only to be emptied at low tide for operation of the mill, it is today stable, the tidal action being stopped at the spillway.

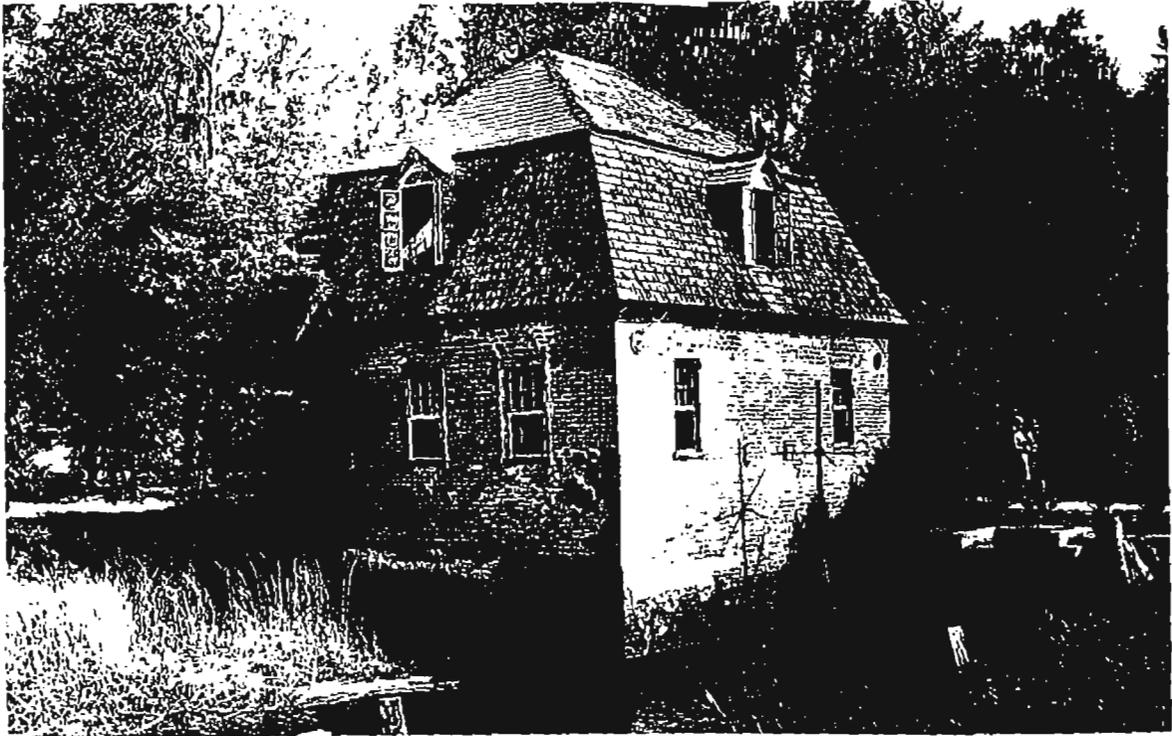
Figure 4. View of the mill from the north bank of the slough toward the southwest, ca. 1928.

asbestos shingles¹ currently on the structure (and shown in Figures 4 and 5) were mistaken for tiles by a reporter obviously covering the "social circle" of Charleston. The article also mentions that the walls were painted "Nile green," which can still be seen under the peeling paint of the exposed second floor joists and flooring today.

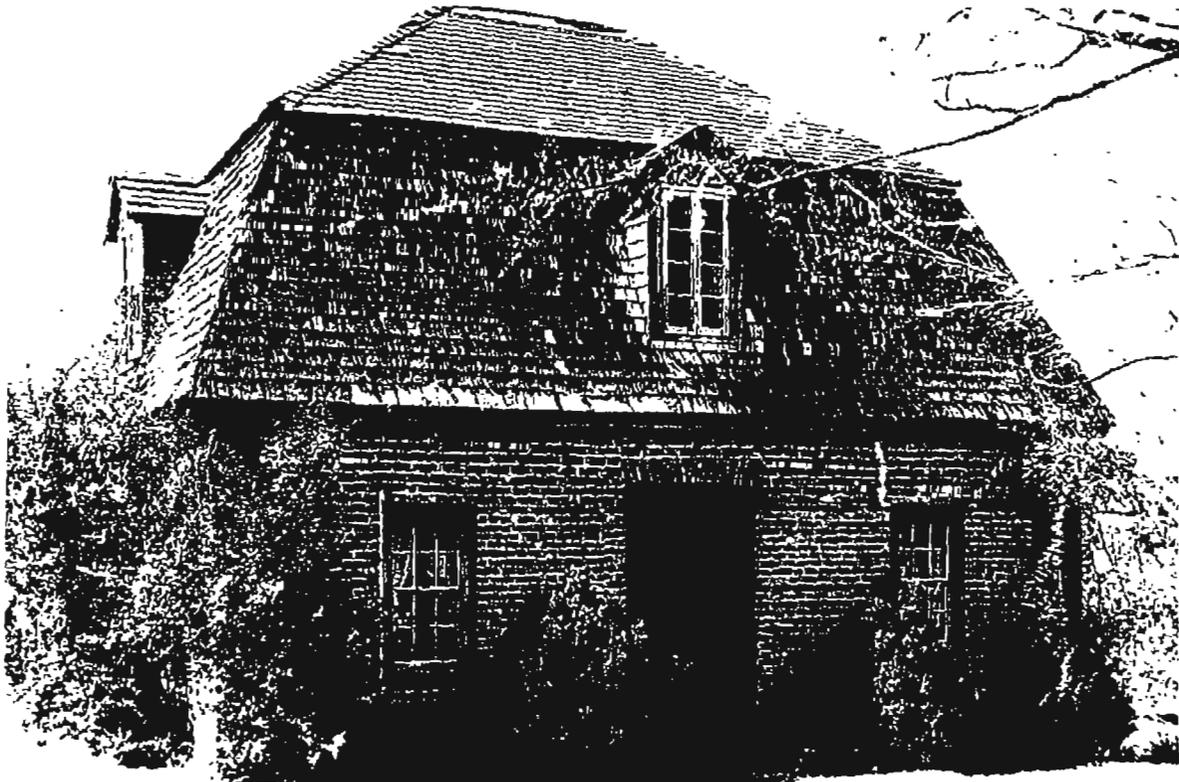
Figure 5. View of the mill taken from the carriage road showing the east elevation.

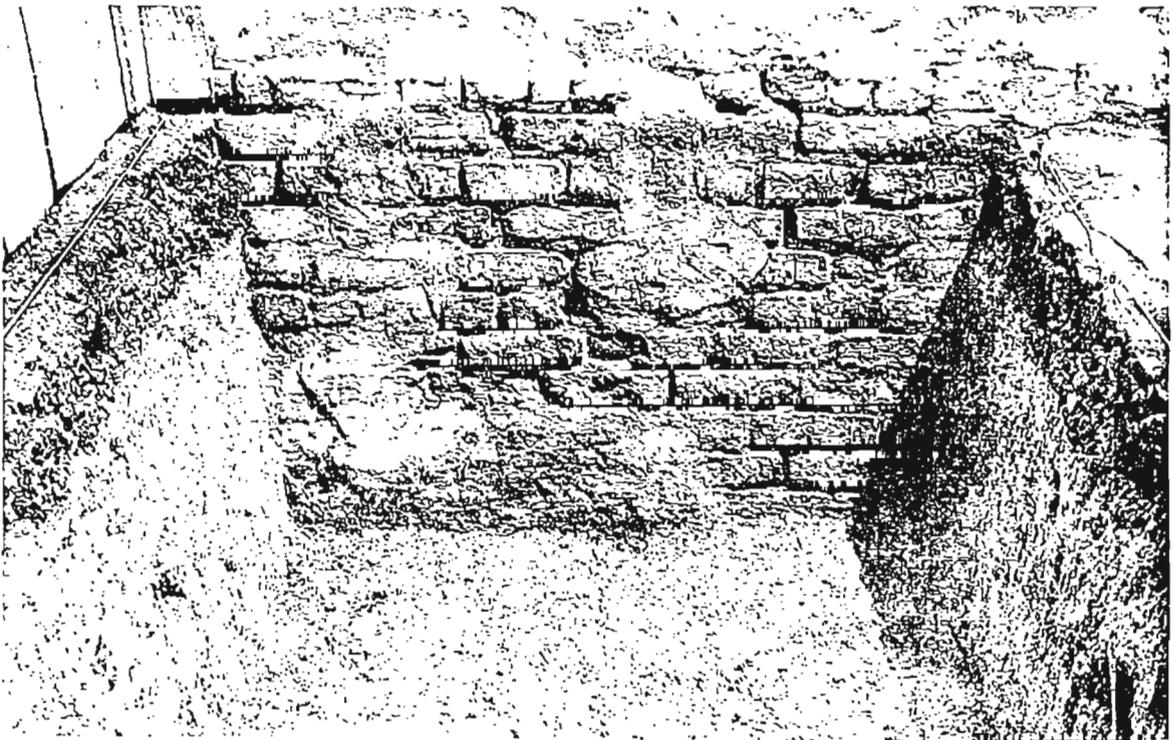
Figure 9. Test Pit 2, view to the west showing brick work on interior of west building elevation.

This unit provided some exceptional construction details, although it was virtually devoid of cultural material. Apparently the building was laid out on the edge, or just within the marsh, with the excavation cutting back into the high ground for walls. The excavations revealed patched joist seatings in the west wall, indicating that originally the floor was spanned east-west by joists to support a wood floor. Given the extensive disturbance to the building fabric it is difficult to reconstruct the original seatings, but they appear to have been 18 to 24 inches on center with a floor level at about 7.00 feet AE.

Examination of the brick work on the exposed portions of the below grade east and west walls reveals the extensive reworking which the building has suffered. It seems clear that little of the original fabric remains except below grade. Below grade it is possible to distinguish original workmanship from later repairs, repointing, and replacement. In fact, it appears that much of the above grade brick work may be reworked when compared to that below grade.
