ARCHAEOLOGICAL INVESTIGATIONS AT THE REED GOLD MINE
ENGINE MILL HOUSE (31CA18**1), REED GOLD MINE STATE HISTORIC SITE,
CABARRUS COUNTY, NORTH CAROLINA

RESEARCH SERIES 6

Michael Trinkley

March 1986

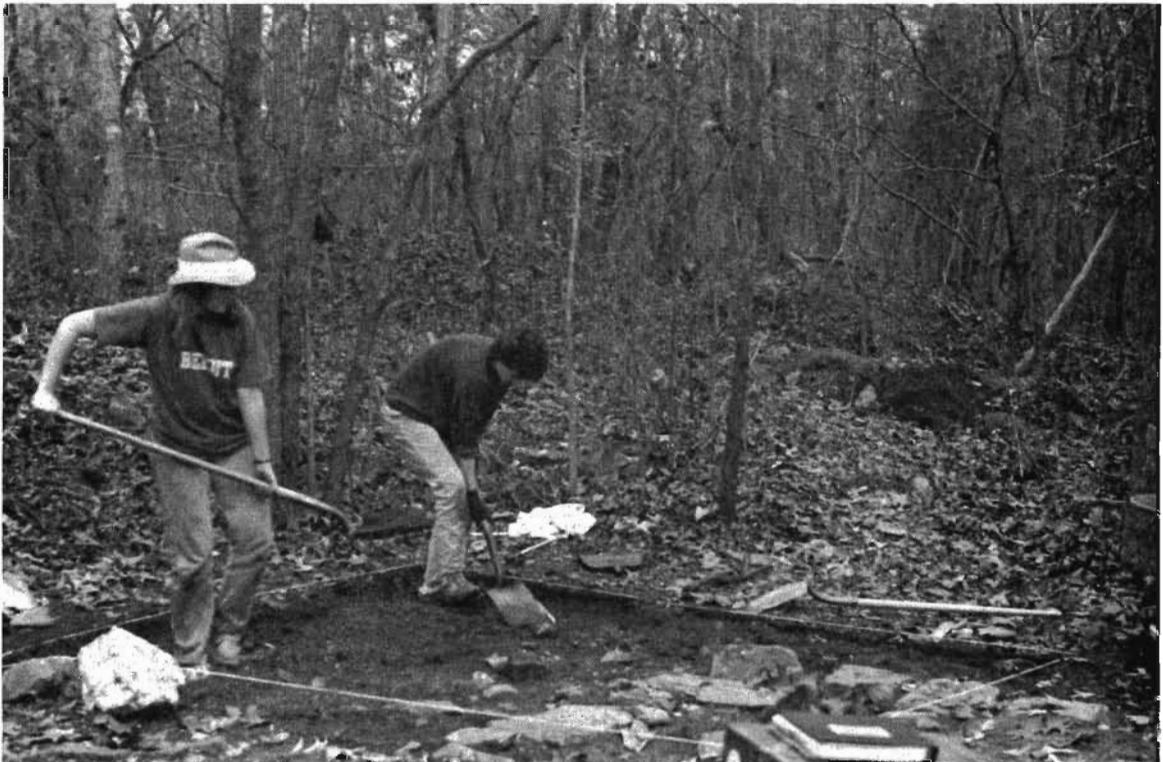
Figure 9. Excavation in square 60R20, view to the northwest.

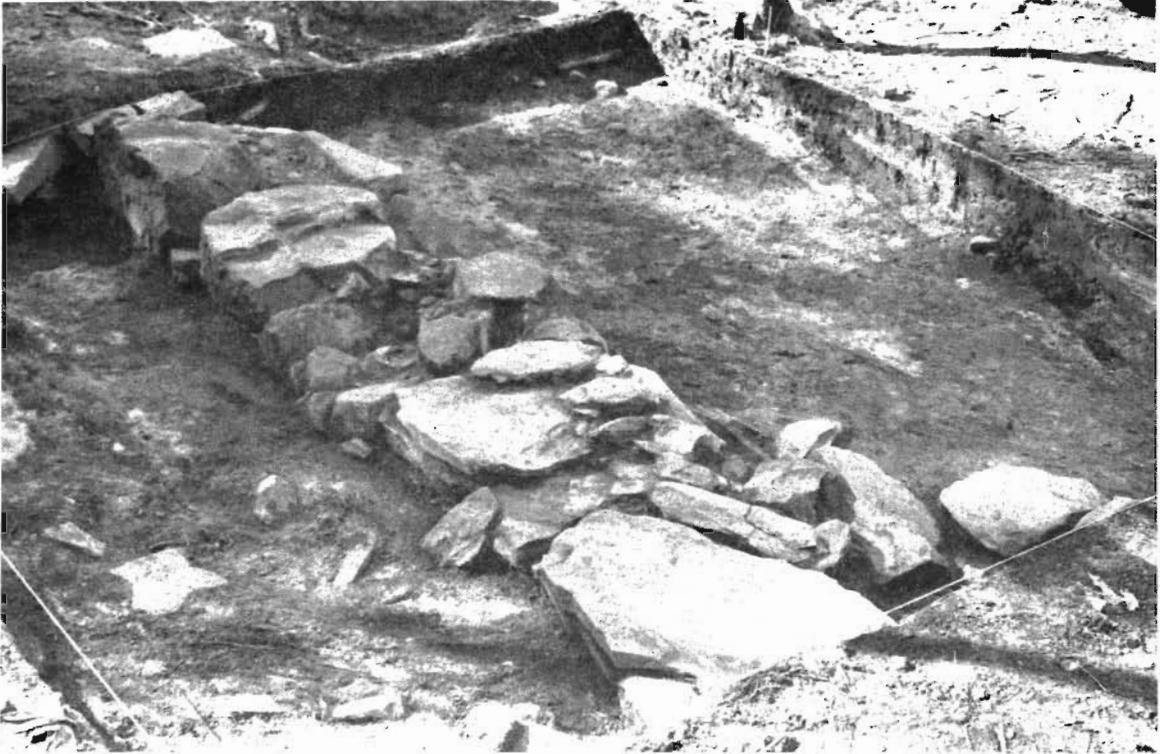
Figure 14. Northeast corner (foreground) of the 1854 structure, squares 55-60R60-65. Note the slurry deposits on the interior and the rotted wood on the exterior. View is to the southwest.

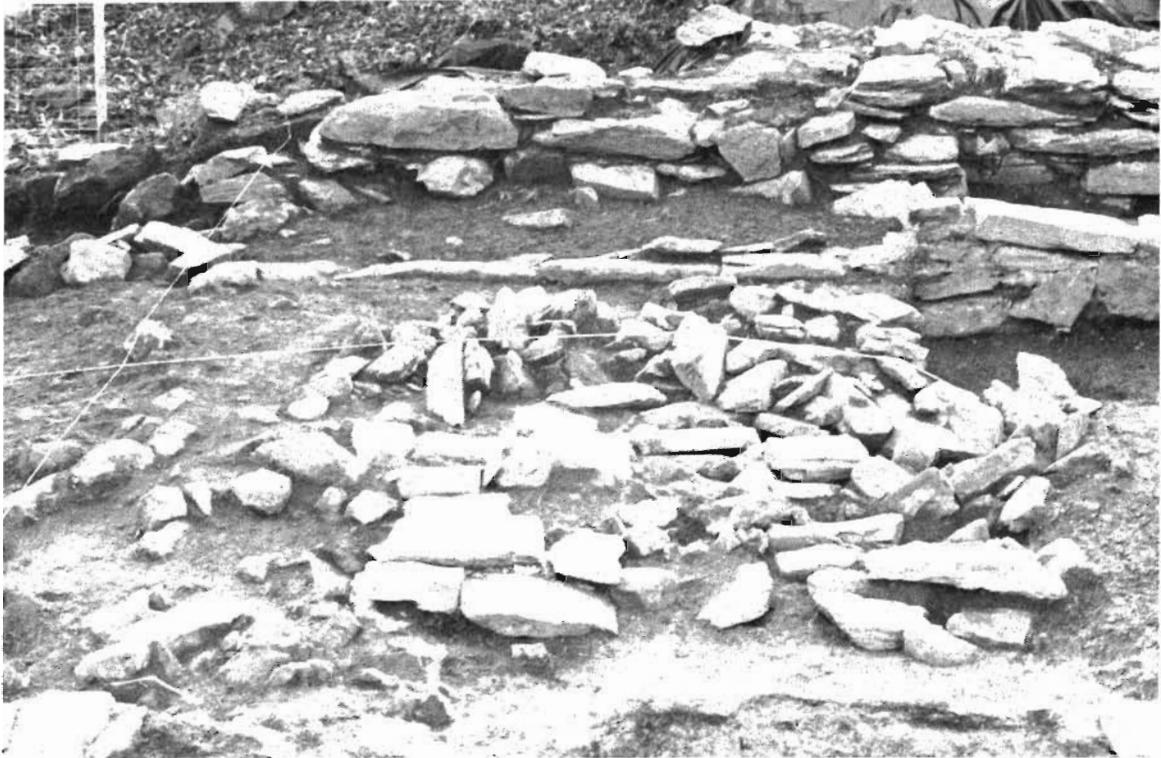
Figure 16. Rock rubble platform within the second structure. The north doorway is in the foreground and both the southern wall and the boiler pit wall are in the background. View is to the south.

The rock rubble platform is roughly rectangular in appearance, with its long axis parallel to the west structure wall. The feature, which measures about 14 by 6 feet and is situated in squares 40-50R30, appears to be constructed by loosely placing rock rubble in a 1 to 2 foot deep hole. The spaces around the rocks are partially filled with a sandy slurry. The soils to south, west, and east of this platform are primarily red clay tailings. To the north, however, there is abundant sandy slurry extending west to the northwest structure corner and eastward to squares 55-60R60-65.

The function of this platform has not been conclusively determined, although it is profitable to consider it in light of the equipment Partz discussed as being present in the engine mill house. The four sets of stamps are expected to have occupied as much as 450 square feet (based on a set measuring about 16 by 7 feet), an area far larger than represented by this feature. Regardless of size, this platform is neither sufficiently level, nor strong enough to support a stamp mill. The stamps would not have processed or produced this rock as a by-product, as mingling the waste rock with the ore produced a material very difficult to amalgamate (Janin 1895:317). The shaker tables, as previously mentioned, also are not expected to produce any recognizable archaeological signature. The drag mill or arrastra would have been circular, not rectangular. It is therefore unlikely that the feature represents either a destroyed or rubble filled drag mill. It is equally obvious that the feature does not represent the remains of a Chilean mill, although little is known about their set-up. These mills, however, required a flow of water during the entire grinding process, which might last from under an hour to over two days (Knapp 1973:158). The shorter period of time was more common, but regardless a

quantity of water and tailings would flow off the mill during its operation. The rock platform may have functioned as a sump, permitting drainage of at least some of the waste water (comingled with slurry). The platform may have assisted the leveling of the Chilean mills.

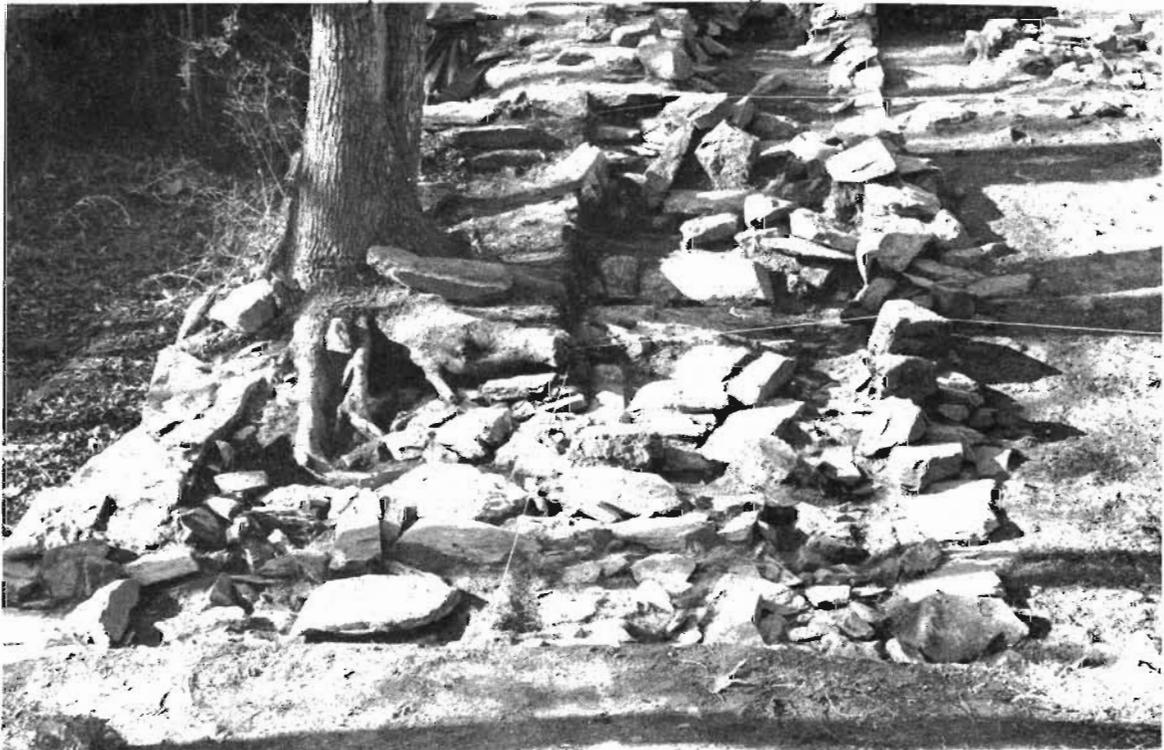
Figure 17. Rock apron between the second structure and the boiler pit. View is to the west.
