Chicora Foundation, Inc.
PO Box 8664, Columbia, SC 29202

February 2008

Monumental Issues

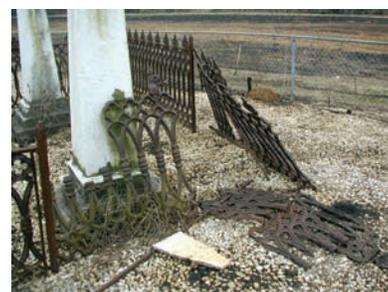
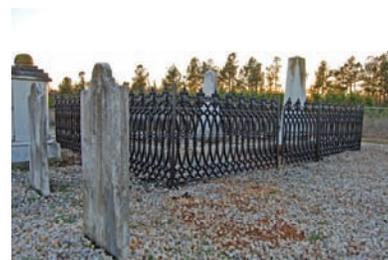
Before and after photographs of a fence treated by Chicora's conservators at Richardson Cemetery in Clarendon County, SC.

Timely treatments means that corrosion won't destroy connections and weaken the fence. So simple wire brushing will be adequate to remove loose rust.

Then one or two coats of the Rust-Oleum product Rust Reformer will convert the corrosion to a stable base that can receive a top coat paint.

Two thin coats are always better than one thick coat and will keep the fence looking good for years.

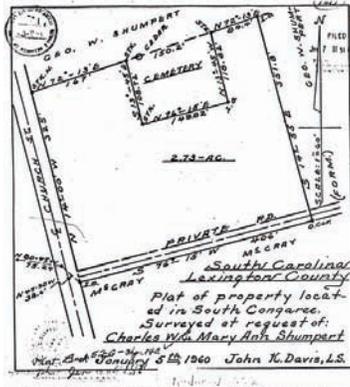
Plat showing the “lost” cemetery at the Lighthouse Baptist Church in South Congaree.

work also attracted the attention of an adjacent neighbor, who was interested in what we were doing. She quickly produced an old plat of the property — showing a cemetery!

The “rumors” were true — the church had purchased a 0.4 acre cemetery years ago as part of their church lot. Mystery solved — showing how often historic research can be as productive as field investigations!

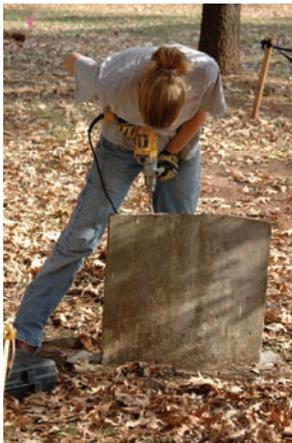
Conservator Nicole Southerland drilling one of the cemetery’s broken stones for insertion of threaded stainless steel rods.

The stone repair was relatively

straight forward, repairing breaks that were either caused by vandalism or natural events. One stone received a poultice to remove paint on its stucco.

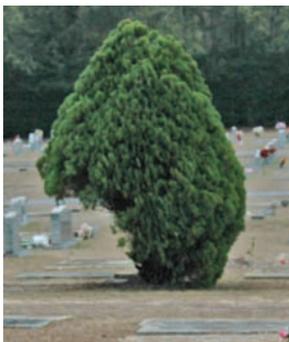
A graceful and beautiful arborvitae butchered by inappropriate pruning.

Beautiful arborvitae are not intended to be “carved out” like this example. Nor are they intended to have their crowns lifted. Any bad pruning isn’t recoverable — they don’t regrow!

Too often the crews responsible for the cemetery landscape aren’t trained in pruning — and the results can be disastrous as

seen in this illustration.
