Monumental Issues

White Monument at Oconee Hill Cemetery Repaired

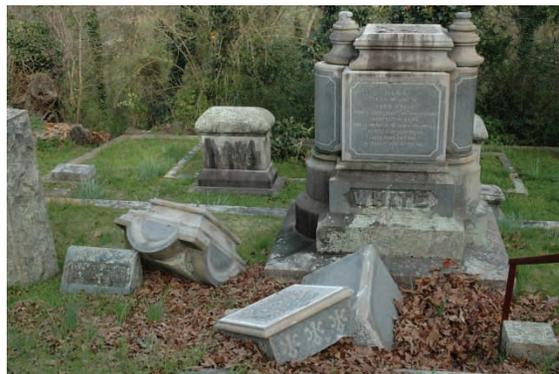
Before Treatment

The Friends of Oconee Hill Cemetery recently contracted with Chicora Foundation to reset the five downed monument sections and two broken urns. The largest portion on the ground weighed over 2,200 pounds, but all required special skill and very careful resetting. Using a local crane company and rigger, Chicora conservators were able to reset the monument in just over a day.

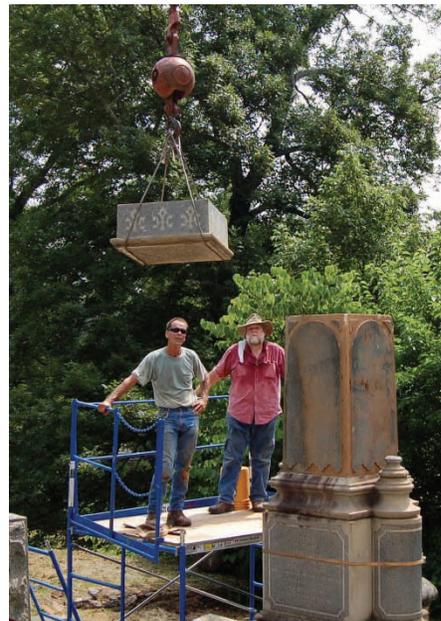
Monument rigging requires special skill, as well special pads and techniques to ensure that the stone is not further damaged. Using bits of canvas fire hose, rubber conveyor belt sections, and special nylon endless slings,

it was possible to reset the sections, while ensuring the safety of not only the monument, but also everyone involved in the work.

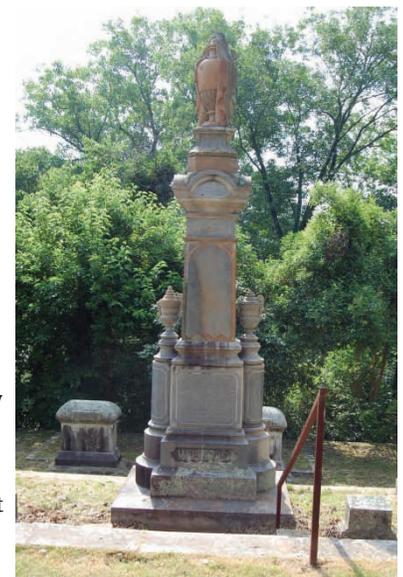
After Resetting

The monument, which includes both polished and dull finished faces with ornate carving, is topped by a draped urn, a common mourning symbol.

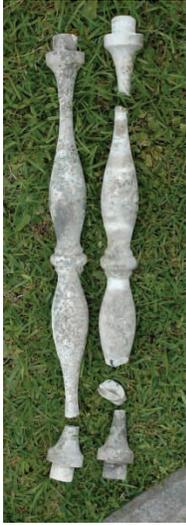
During Treatment — the hourglass spindles in the process of being pieced back together

The repair began with over 30

fragments of the hourglass base and two spindles that had to be individually drilled and pinned.

Once most of the fragments were together they had to be added to the portion of the hourglass still remaining atop the column — and that required precision drilling.

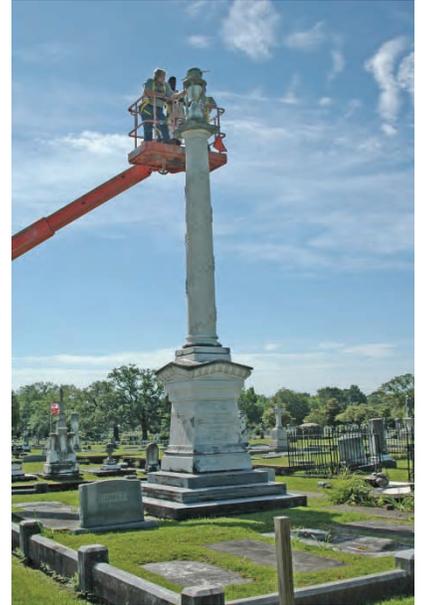
They were repairing and resetting a badly damaged winged orb and hourglass atop the Robert Williamson monument. Damaged by a lightning strike about a year ago, the Friends organization raised funds to ensure its repair.

During Treatment
