Monumental Issues

High Priority Treatments at South View Cemetery Completed

Chicora completed a preservation assessment for Atlanta's South View Cemetery in June 2008 and a stone-by-stone assessment in November 2008. We were asked to return this summer and conduct conservation treatments on a series of high priority stones.

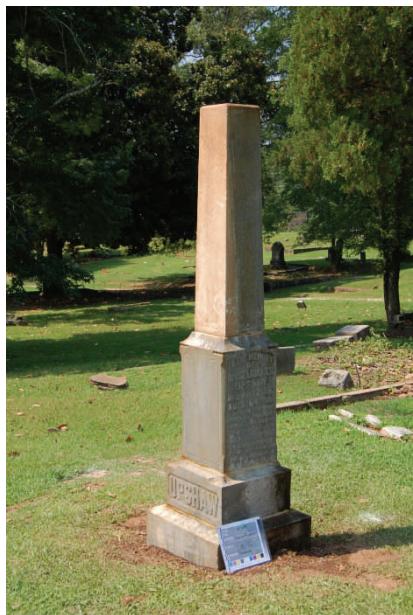
After Resetting

Some, however, were more complex, like the Upshaw monument shown here. Not only was the base sunk and tilted, but the upper portions of the pedestal tomb were at risk of falling — and potentially harming anyone standing nearby.

So, using a 1-ton tripod and a lot of careful planning, it was possible to disassemble the monument, use a diamond core drill to remove an existing ferrous pin, and install 316 stainless steel pins to ensure the monument should not suffer the same fate in the future.

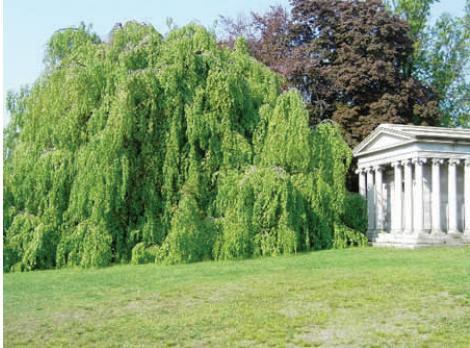
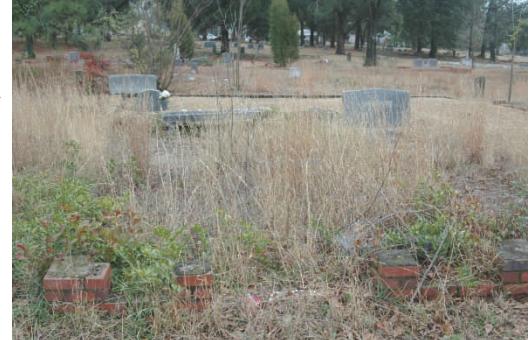
These photos show two extremes of cemetery care. Have you developed a plan for your cemetery landscape?

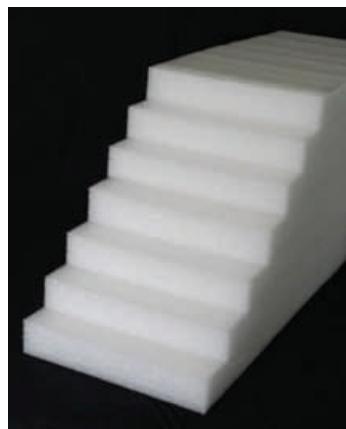
knife, or even a hand saw. They can be easily removed from the Portland cement. And they are inexpensive.

If you're interested in trying, you can probably find a local firm carrying foam planks in your city. Otherwise, Google "polyethylene foam planks." They come in widths from 1" to 3" in various sheet sizes.
